A riverside timber revetment at 130 Bridge Street, Peterborough

IAN MEADOWS

ABSTRACT

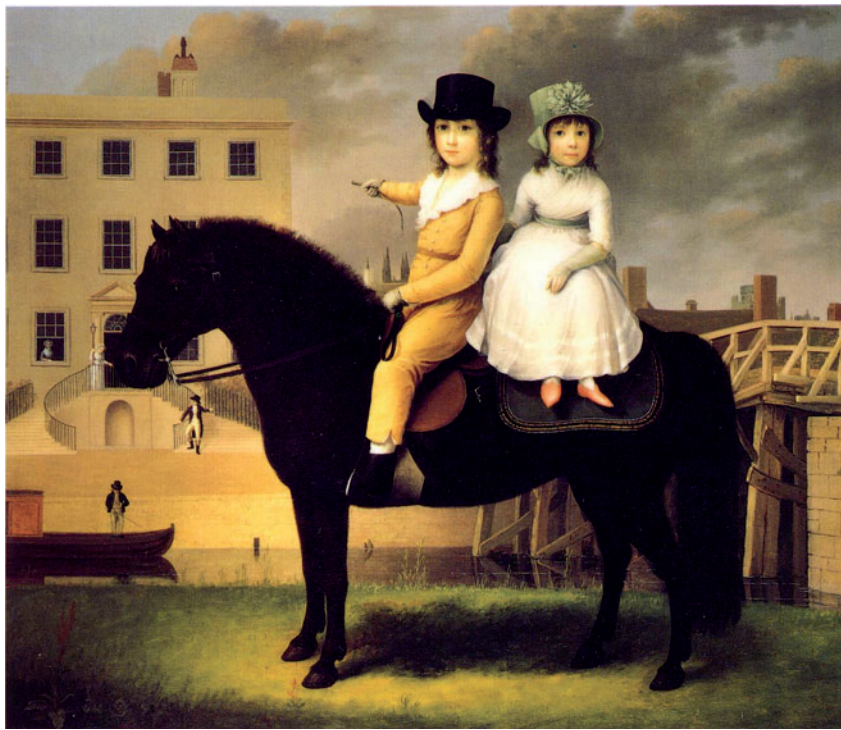
Fig 3 Nathan Fielding (1747-1814), Portrait of Thomas and Charlotte Squire c1795, and showing the Squire Mansion in the background (Reproduced courtesy of Peterborough Museum and Art Gallery)

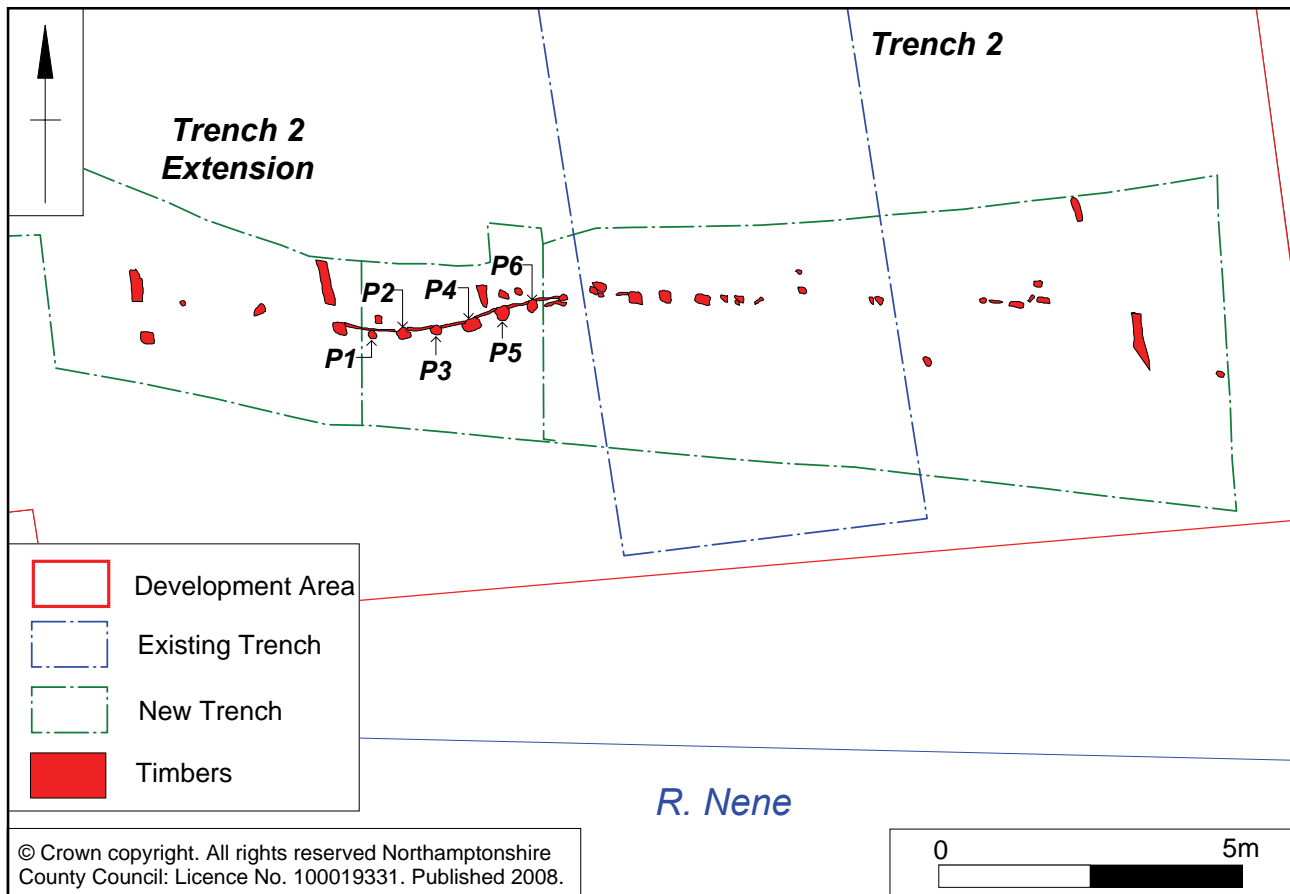
Fig 6 The exposed line of timber posts

At the southern end of the trench the top of a line of timbers was exposed only allowing the partial examination of their northern face. The timbers had to their rear a series of horizontally bedded, often organic deposits, interbedded with clay of distinctly alluvial type [30-32], but at this stage the precise relationship could not be determined.

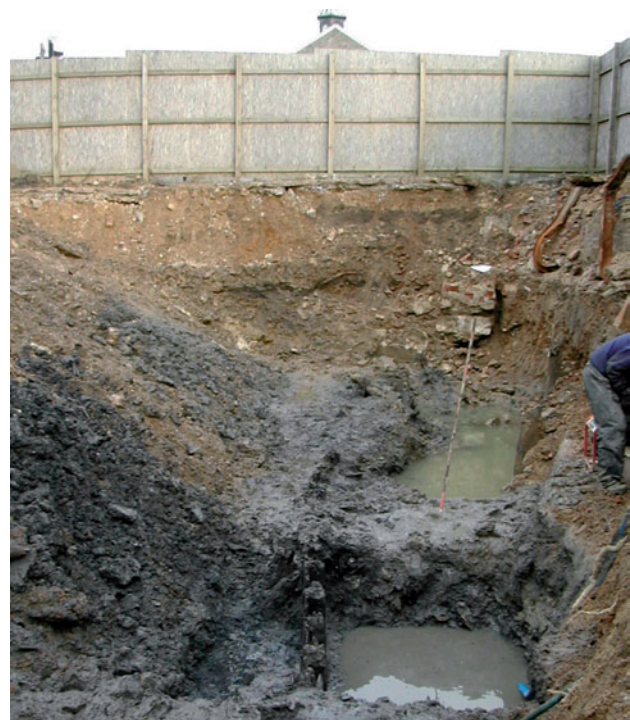
Fig 7 Trench extension, looking east, showing the exposed tops of the posts and the deeper intervention (foreground)

Due to the limitations of the initial evaluation trench a second stage of work was requested by PCCAS involving the extension of Trench 2 to expose the length of the timberline and allow the examination of both its inner and outer faces. After a number of abortive starts when the water level prohibited safe working, a trench about 20m long and between 7-10m wide was opened. The top of the upright timbers was clearly traced forming a slightly sinuous line from the eastern limit of excavation and stopping after about 12m (Figs 6 & 7). In order to be certain that the end was not just an artefact of shorter timbers a test trench was hand excavated 5m to the west across the line of any potential continuation. This trench was dug to a depth of 0.5m and no upright timbers were observed.

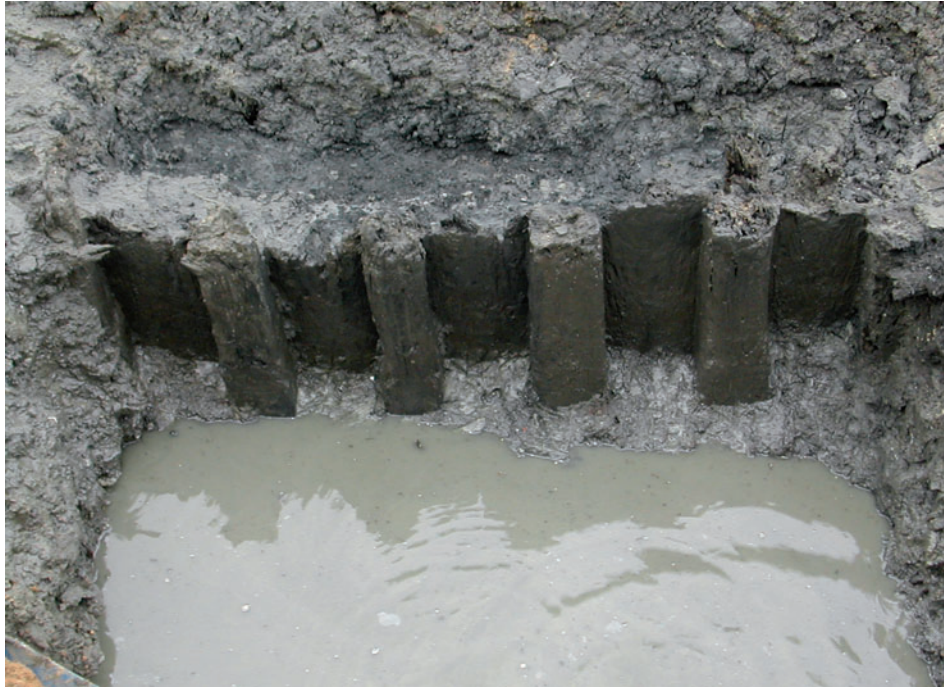
Fig 8 The exposed face of the timber and plank revetment

The timbers comprised roughly squared posts 0.2m x 0.16m, the upper portions of which had been rounded on their riverward face, presumably by erosion and weathering (Fig 8). The rear face of the post was cut with

The wooden structure appears to be a stave built revetment. With the exception of a short section, which was exposed to a depth of up to about 1m, only the top of the structure was revealed. The structure has two vertical components: The 'staves' and square framing timbers (Figs 8 & 9). Stave building was a popular method of constructing waterfront revetments in the fifteenth century in London (Period V, in Milne 1982, 29) but there is little comparative material from inland ports.
