A prefabricated temporary building at Cranford Primary School, Kettering, Northamptonshire

SUMMARY

INTRODUCTION

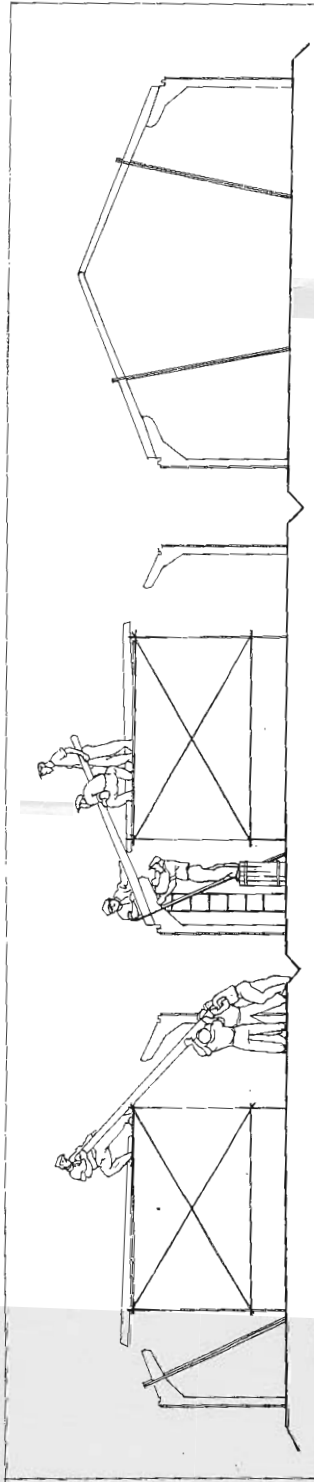
1. SET UP, ALIGN, PLUMB, & SECURE WITH WEDGES AS SHOWN, THE WHOLE OF THE POSTS GROUT THE POSTS IN, EACH ONE BEING SUPPORTED BY AN 'A' FRAME - AND NO FURTHER OPERATIONS BEING PERFORMED - UNTIL THE CONCRETE HAS HARDENED
2. SET UP A LIGHT PORTABLE GANTRY ABOUT 10'-0" HIGH, BY 13'-0" BY 4'-0" IN LINE BETWEEN A PAIR OF OPPOSITE POSTS. HOIST ONTO IT A PAIR OF RIBS
A PORTABLE CRANE OR SHEAR-LEGS, WITH NON-OVERHAULING BLOCK & TACKLE MAY BE USED, THE LOAD BEING SUSTAINED BY THE TACKLE, WHILE THE RIBS ARE BEING OFFERED TO THE POSTS. BOTH RIBS MAY BE ERECTED SIMULTANEOUSLY BY THE USE OF TWO HOISTING APPLIANCES. ● IF LIFTING TACKLE IS USED THE RIBS MUST BE PROTECTED FROM DAMAGE BY THE SLING
3. TWO MEN ON THE GANTRY NOW OFFER A RIB TO ITS POST, WHILE TWO MEN MAKE THE BOLTED CONNECTION. REPEAT WITH THE OPPOSITE POST, THE CONNECTIONS BEING HANDTIGHT ONLY. MAKE NECESSARY ADJUSTMENTS & THEN FIX APEX PIN

ON REMOVAL OF THE GANTRY TO THE NEXT BAY AN 'A' FRAME SHOULD BE PLACED BENEATH EACH RIB OF THE COMPLETED FRAME, AND THESE 'A' FRAMES MUST REMAIN IN POSITION UNTIL CONNECTIONS ARE FINALLY TIGHTENED

4. CONTINUE SIMILARLY WITH THE ERECTION OF THE SUCCEEDING RIBS
- RIDGE TIES BEING FIXED AND LINTOLS GROUTED IN AS THE WORK PROCEEDS
- ON EXPOSED SITES AN 'A' FRAME SHOULD BE LEFT UNDER EVERY FOURTH FRAME UNTIL THE PUPLINS HAVE BEEN FIXED
- POST-TO-RIB BOLTS ARE TO BE PLACED WITH NUTS UPPERMOST

This method involves the erection & grouting-in of all posts preceding the erection of the ribs.

Fig 3 Instructions for hut erection, from the Ministry of Works construction manual, 1943

The Standard 24 Hut was a sectional structure which allowed buildings of different sizes to be built by the addition of extra 6-foot sections (or bays) as required. The 24 denotes the span of the building at 24feet (7.32m). The construction manual, issued by the Ministry of Works, Hutting Section, Cleland House, Page Street, London SW1 in August 1943 issue, describes the form of these huts in some detail (MoW 1943). Copies of two pages showing the plan form and a method for erection of the framework are illustrated (Figs 2 & 3). These huts were to be erected on a prepared base of the most minimal specification-'strip turf and remove vegetable soil, excavate additional depth if directed for hardcore (to be kept to a minimum). Excavate for post foundations. Establish carefully the post positions'. The posts were to be set in sockets 'which must not exceed 10" by 9" and be 9" deep exactly', with the posts grouted in using a mortar comprising a ratio of 1:2 of cement and sand. A framework of reinforced concrete ribs was bolted to the bracketed posts and held at the ridge by a continuous tie. The description of the framework erection allowed for a minimum of four workmen to manhandle the posts and beams using A-frames and a light portable gantry (Fig 3).

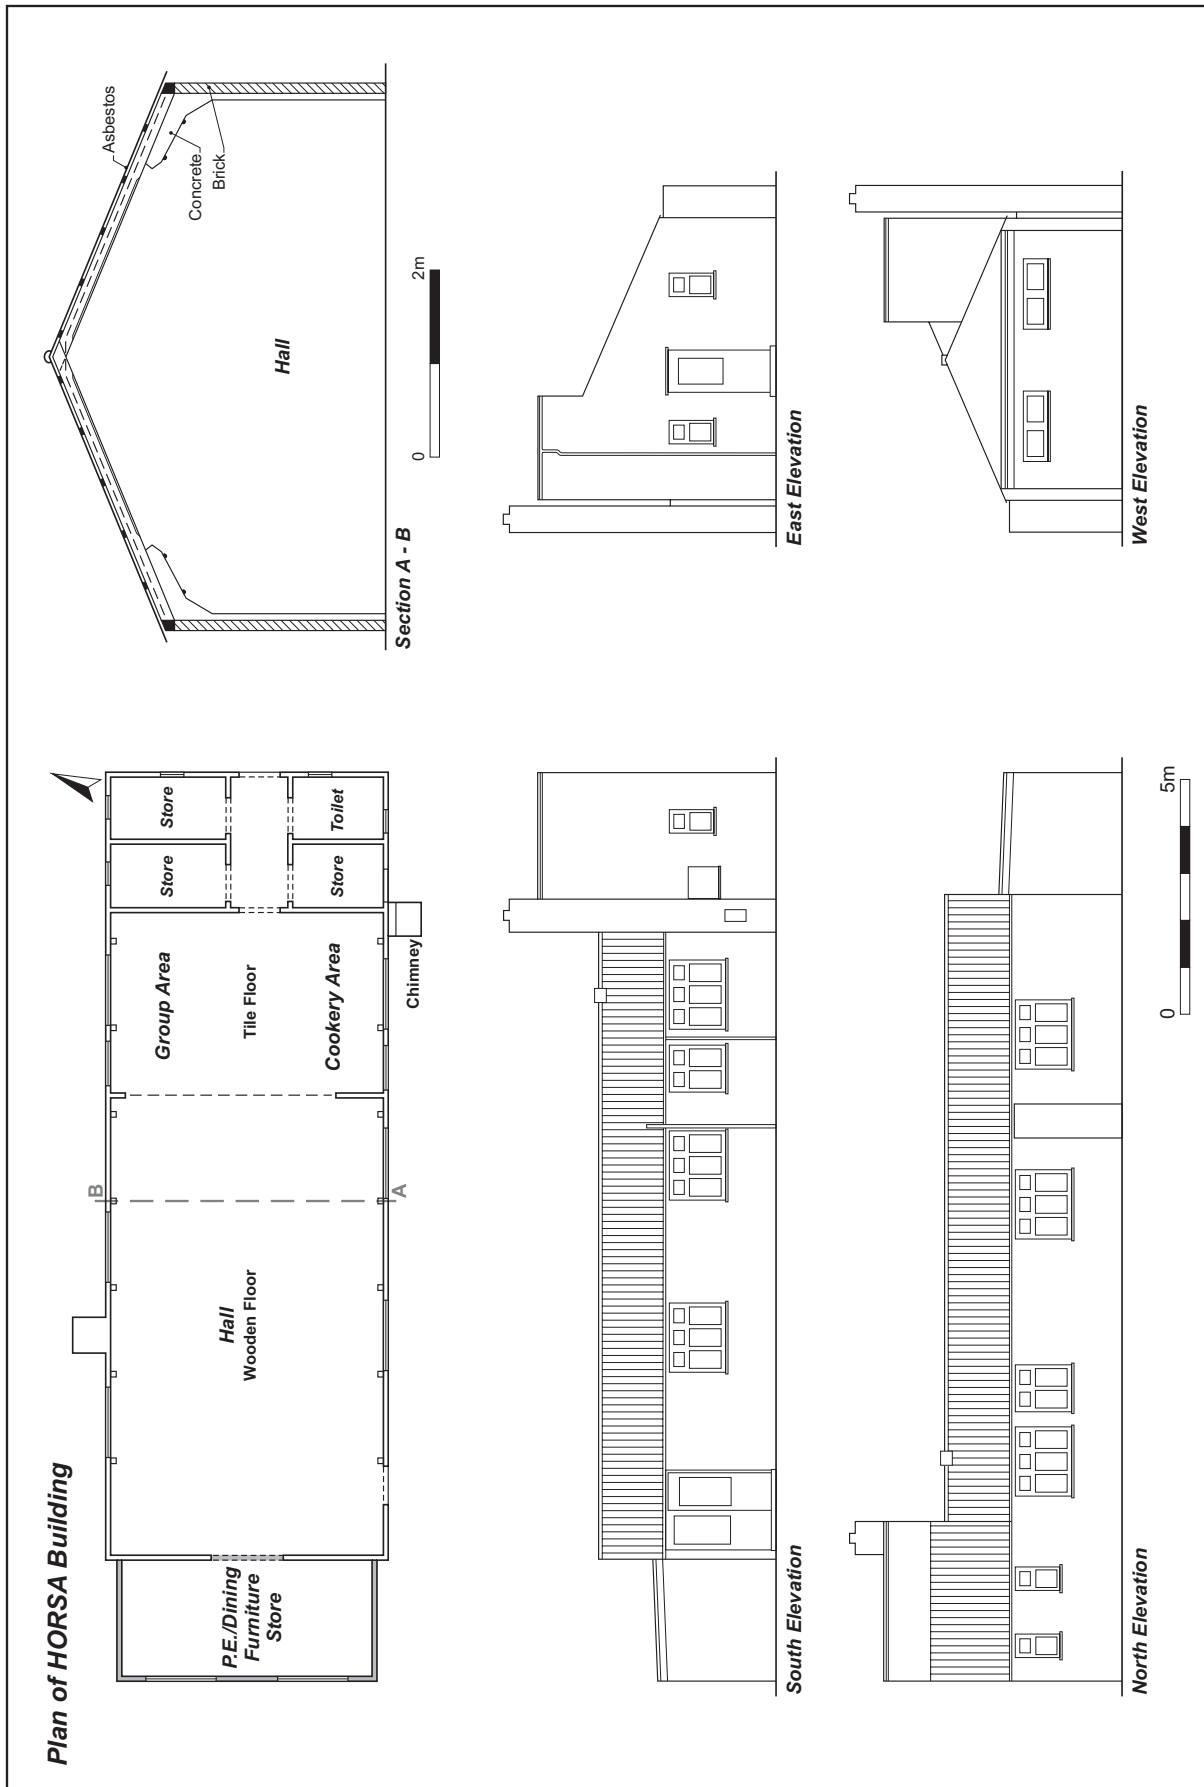
Fig 4 Plan and elevations of the Horsa Building

The building was aligned east to west and the original structure was 17m long (55' 9"), with a 2.5m long modern extension on the western end (Figs 4 & 5). The internal width of the building was 5.7m (c19 feet), 5-feet less than the 24-feet specified for the Type 24 Hut. The maximum internal height was 3.4m.

The construction method was clearly visible within the open room that comprised most of the interior. Seven concrete posts and brackets formed seven and a half bays bounded by end walls of brick (Figs 4 & 6). The ceiling ribs were simply bolted to the brackets (Fig 7). The ribs were halved at the apex and had a chamfer on their underside, which was repeated on the brackets (Fig 8). Between the posts there was brick infill to the wall plate and the apex of the gables. The external finish was of pebble-dashed render (Figs 5 & 9). Originally the windows would have contained metal frames, but these had been replaced with UPVC units. The roof was of corrugated asbestos sheeting. The northern elevation of the building was fenced off and very overgrown, and could not be photographed due to the close proximity of trees and bushes. The northern wall of the building was clearly the least stable, and had recently been reinforced with timber shoring. A possible disused chimney was noted between the western and central windows.

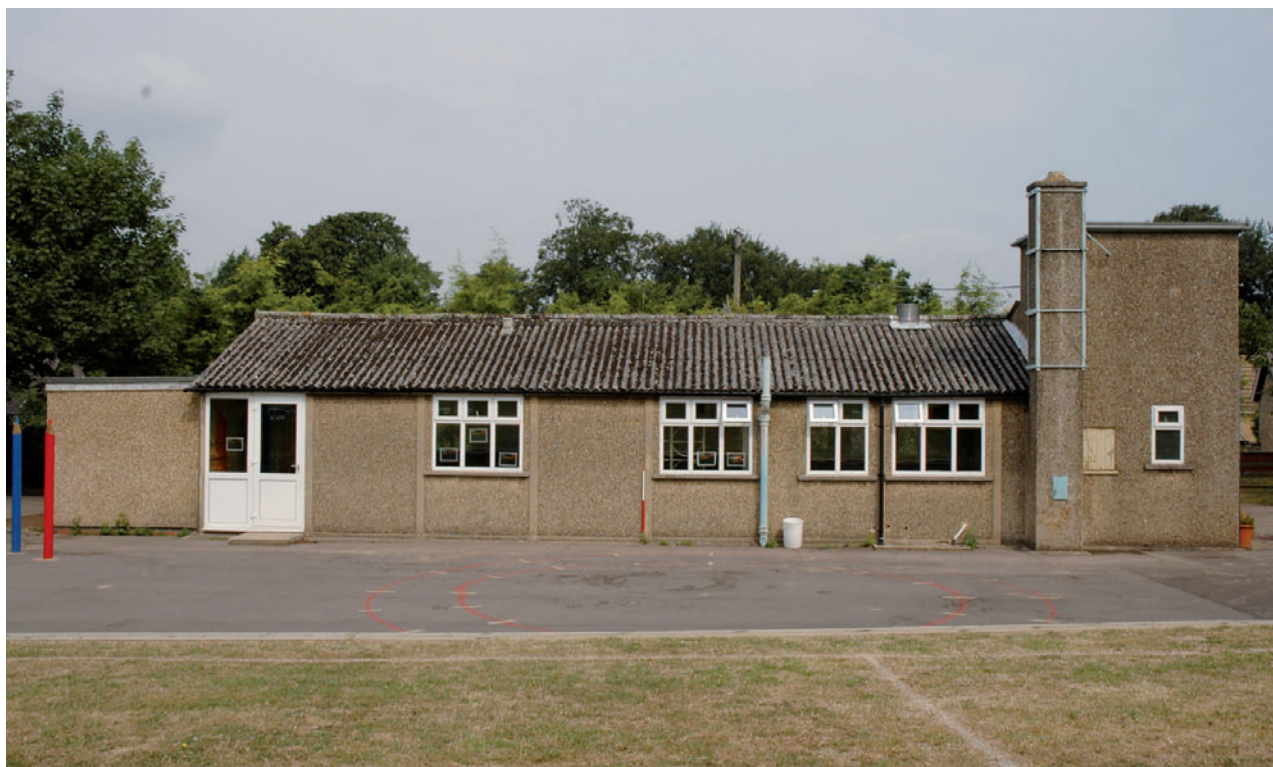
Fig 5 The southern elevation, with the service rooms (right) and the modern extension (left)

Originally the space was probably more formally divided, by a full wall or partition, with a stove or fireplace serving each. The chimney serving the eastern area still stood against the southern elevation (Figs 4, 5 & 10). The capped remnant of a chimney serving the larger western room stood against the northern elevation at the centre of the five-bay hall (Fig 4). The position of a former fireplace or stove base was indicated by a rectangular area of different flooring. Recently, the wooden-floored end of the building had been used for PE, as well as a dining area, with swing-out climbing bars on the south wall and brass fixing points in the floor.

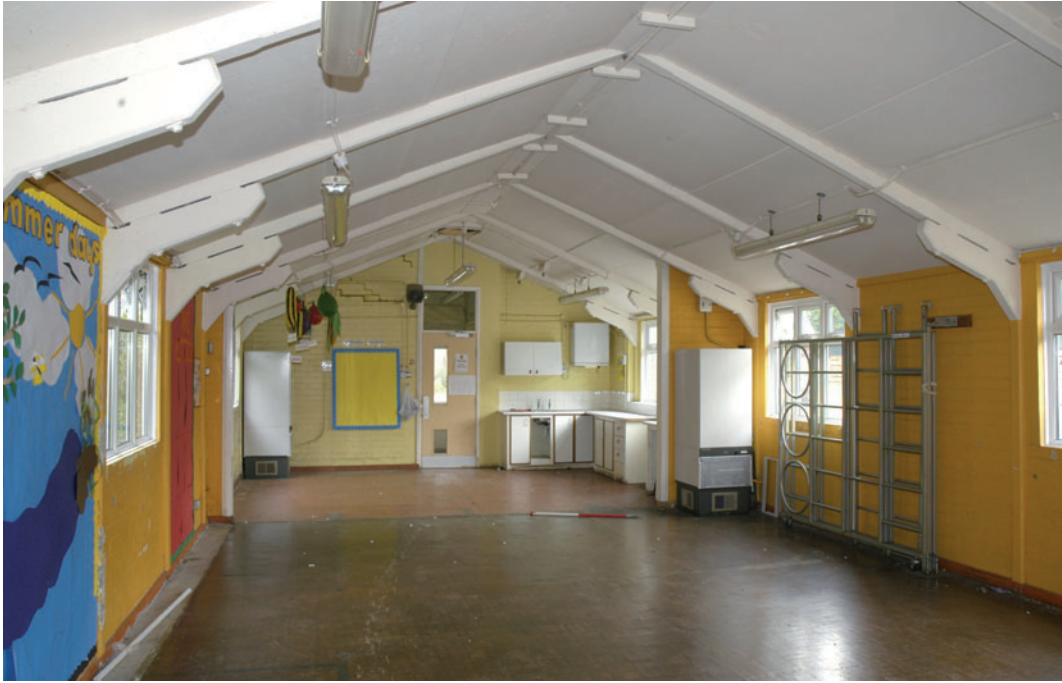
Fig 6 Interior of hall looking east, showing the partial partition between the main room and the cookery and group area (background)

The main part of the building was an open hall (Fig 6). At the east end, two and a half 'bays' were a cookery area, containing a sink and kitchen units, and on the north side was a 'Group Area' for teaching. These bays were partially separated from the hall space to the west by a brick wall extending *c* 2m from the southern wall and a projecting brick post on the northern wall. The division was also reflected in the flooring, with the cookery area having a red tile floor while the hall had wooden parquet flooring.

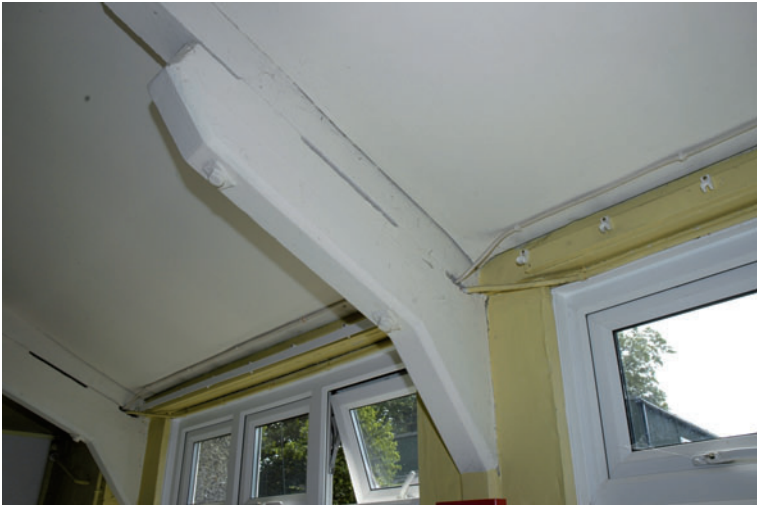
Fig 7 Detail of single bracket, showing bolts retaining rib

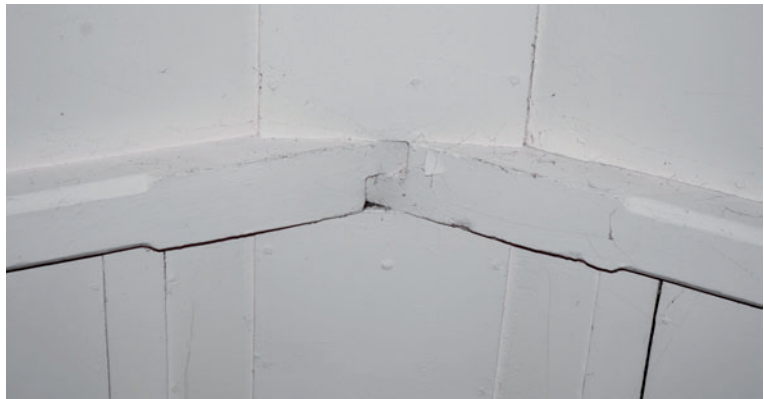
Fig 8 Detail of apex of ribs, showing halved joint and chamfering

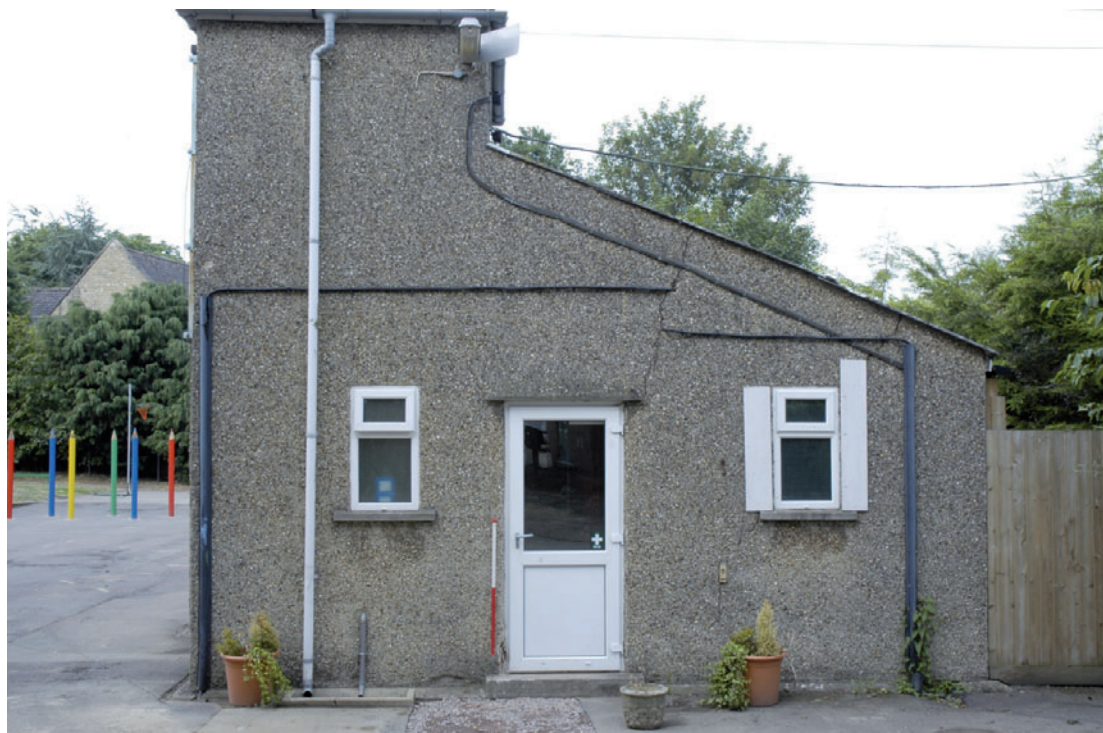
Fig 9 The eastern elevation, showing the raised water tank storage over the service rooms

Over the southern storeroom and toilet, the building was of double height with a flat roof, with a separate sloped roof to the north (Figs 9 and 10). On the southern elevation, at the junction of the single and double storeys there was a slender chimney, with a metal flue access panel. The chimney was held together by a series of

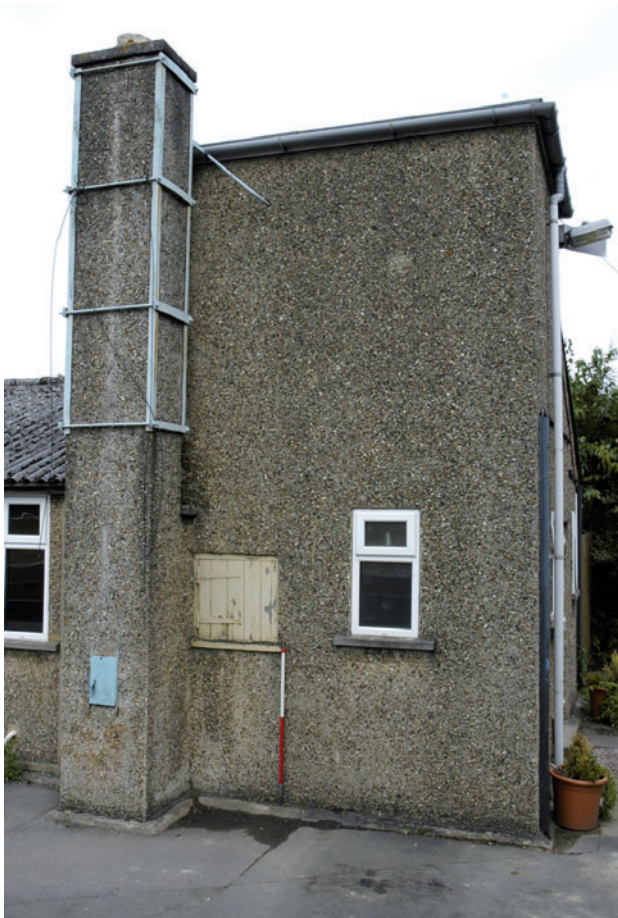
Fig 10 The service rooms, showing the chimney, with supporting metal bands, and hatch opening into the possible coal store

metal brackets. Immediately east of the chimney was a square hatch, presumably allowing access to the adjacent storeroom (Fig 10). This and the absence of a window, suggest that it once served as a coal store. The only fittings in this room were more recent, comprising the remains of veneered (MDF/chipboard) shelves. This room also contained a high-level access door into the double height roof space, through which a water tank could be seen.

The original asbestos roof had become brittle and the chimney was held together by a series of metal brackets. At the opposite end of the building a small flat-roofed extension, built of breeze blocks, was also suffering from the movement of the HORSAs building and was showing cracks to its walls.

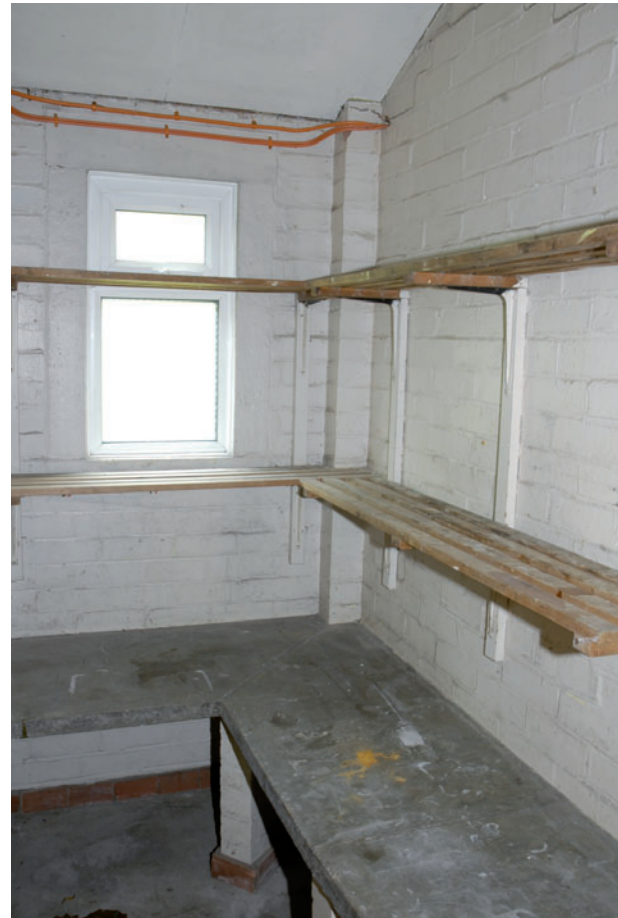
Fig 11 Store room, with stone slab shelf on brick piers, and wooden-slatted shelving

On the northern side of the corridor, the western store-room had stone-slab shelves upon brick bases (Fig 11), suggesting that it was used as a pantry, while the eastern storeroom contained the service controls, electricity meter etc, and also remnants of wooden slatted shelving. They were each lit by a single small window.
