A geological review of some early churches in the Northamptonshire area

JOHN F POTTER

SUMMARY

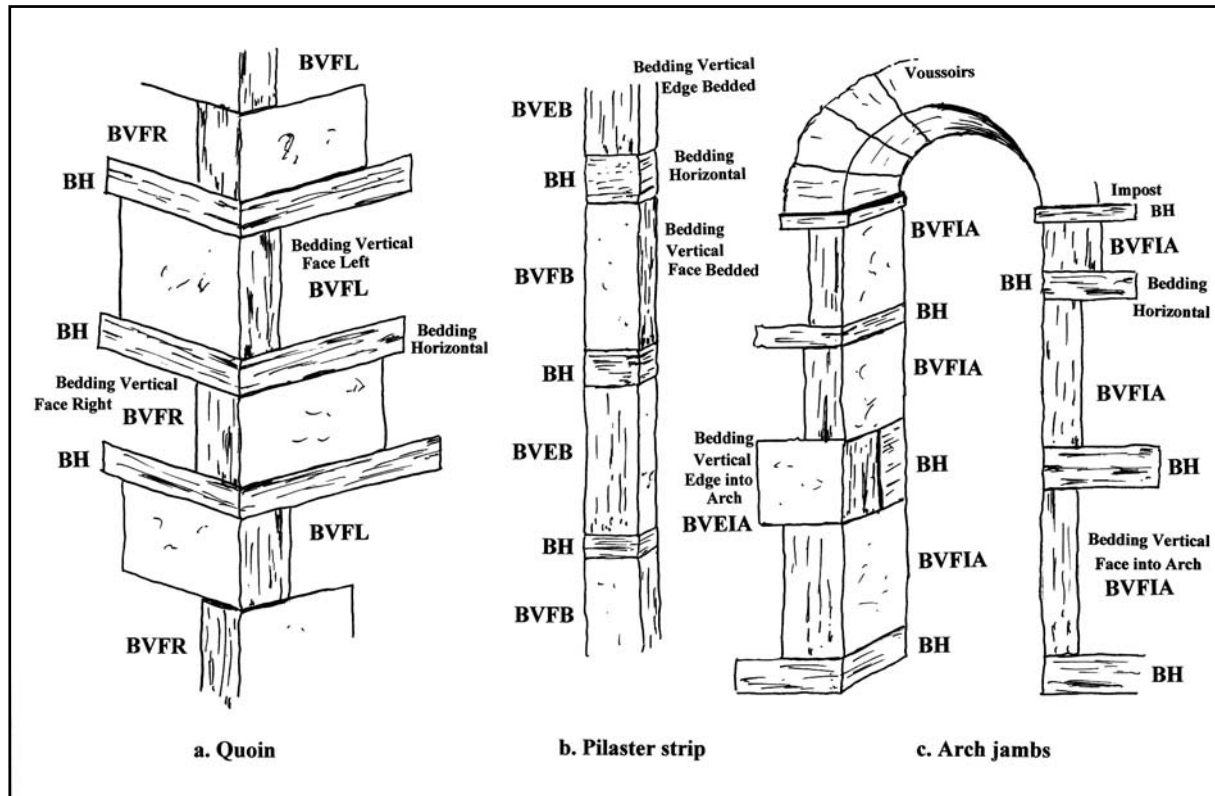
Fig 1 Possible stone bedding orientations of Anglo-Saxon 'Patterned' work

(It should be noted that bedding in stone is rarely as pronounced in appearance as is shown in the figure)
 (The BVEIA stone in the left arch jamb shares its position with a BH stone and would in this instance probably be a replacement stone dating from Post-Conquest times, as Anglo-Saxon arch jamb stones are normally through stones)

In order to describe in simple terms the orientation of stones in wall structures, a newly devised nomenclature has been established (Fig 1 and Potter 2005a):

Quoins, Fig 1a

- BH (Bedding Horizontal) stone placed in a wall in the orthodox manner, with the bedding traces horizontal
- BVFR (Bedding Vertical Face Right) the face of the bedding may be on the right in quoins where in Anglo-Saxon style the bedding laminations may be placed vertically, or
- BVFL (Bedding Vertical Face Left) to the left, as the quoin is viewed from the exterior.

Pilaster strips, Fig 1b

- BVFB (Bedding Vertical Face Bedded) stones with vertically orientated bedding, ie bedding face parallel to the wall face, or
- BVEB (Bedding Vertical Edge Bedded), edge bedded.

Arch or window jambs, Fig 1c

- BVFIA (Bedding Vertical Face Into Arch), placed with the face of the bedding into the arch, or
- BVEIA (Bedding Vertical Edge Into Arch) with the bedding traces parallel to the vertical joints on the inside of the arch.

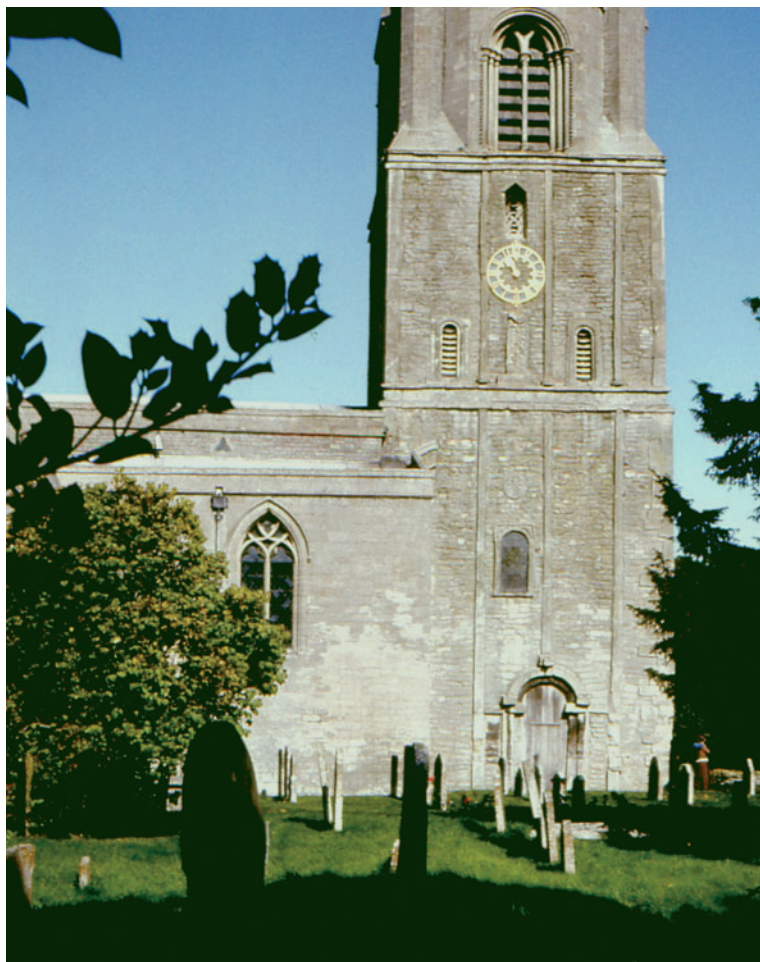
Fig 3 View of Barnack church, showing the Anglo-Saxon tower (photograph, A Chapman)

The church and, in particular, its tower has attracted much attention (Fig 3), with complete or partial descriptions provided by Rickman (1817, 162; 1836, 34); Wright (1845); Syers (1895-6; 1899); Micklethwaite (1896, 336); VCH (1906, 468-71); Brown (1903, 205-7; 1925, 443); Clapham (1930, 103-4); Fletcher and Jackson (1945); Jackson and Fletcher (1949, 103); Taylor and Taylor (1965, 43-7); Pevsner (1968, 207-10; Rivoira (1975, 194); Fernie (1983, 139-41); Goodwin (1990) and Potter (2005; 2006, 73). The most comprehensive accounts are those provided by Syers (1895-6), VCH (1906), the Taylors (1965) and Goodwin (1990). Although the Barnack Stone and the 'long and short' style of the tower quoins and pilasters have been referred to in these descriptions, on no occasion has the revealing detail of the stonework been described.

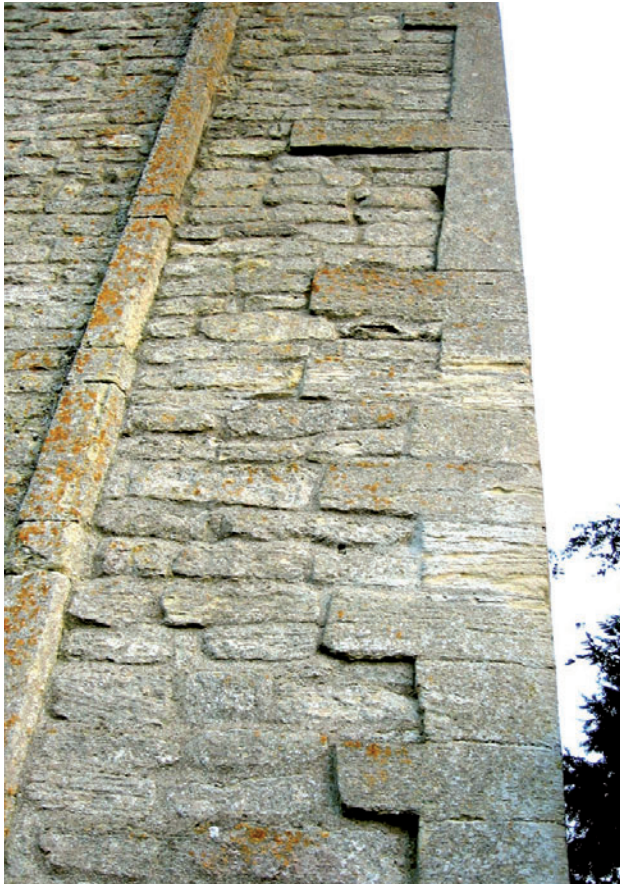
Fig 4 The north-west tower quoin of St John the Baptist, Barnack clearly displays the change in the Barnack Stone bedding orientation in its first stage (The lowest stones (below stone 19, stone 20 BVFL) bedded BH are later replacements)

Table 2: Barnack church, quoin orientation, north-west and south-west nave, north-west and south-west tower

Stone	NW nave	Stone	SW nave	Stone	NW tower	Stone	SW tower
					<i>Second stage</i>		
40	?	24	BH		Too high to read	11	Too high to read
39	BH	23	BVFR			10	Too high to read
38	?BVFL	22	BH			9	Too high to read
37	BH	21	BVFR			8	BH
36	?BVFR	20	BH			7	BVFR
		19	BH			6	BH
		18	?BVFR		<i>First stage</i>	5	?
24-35	BH small	17	BH small	26-top	Too high to read	4	BH
23	BVFL	16	BVFL broken	25	BH	3	BVFR
		14-15	BH small	24	BVFR	2	BH
		13	BVFR small	23	BH	1	BVFR
				22	BVFR		<i>First stage</i>
7-22	BH small	9-12	BH small	21	BH		
6	BH brown oolite	8	BVFL small	20	BVFL		All but 3 stones
				19	BH		BH
lower	BH small	lower	BH small	lower	BH		small and replaced

All the stones described as small, with one BH exception, appear to have been replaced; stone 6 in the NW nave quoin being replaced in more recent times with a rock of a different lithology. Even with the use of high power binoculars, the light at the time of inspections was too poor to read the orientation of the bedding in the highest stones, as in the second stage of the tower quoins. The nave quoins terminate at the roof lines of their respective

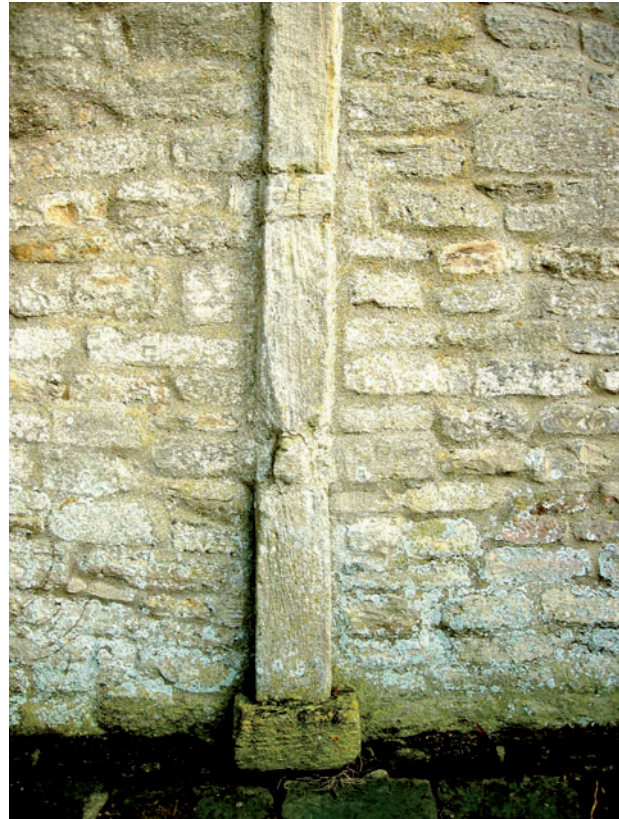
Fig 5 In the north face of the tower at Barnack church the north-east pilaster displays the frequency with which the long stones, in particular, are orientated BVEB

The lower portion of the NE pilaster in the tower north face is figured (Fig 5).

The longer stones are placed with their bedding orientated vertically in all determinable instances, either edge-bedded (BVEB) or face-bedded (BVFB). It is noticeable that the majority are edge-bedded or BVEB (refer also to Fig 5). It seems likely that the pilaster stones were generally split to the requisite pilaster face width within the quarry, and there can be observed to be some variation in the level of accuracy to which this was acceptably completed. In working the rock with a chisel it is simpler to follow the bedding, stratification or 'grain' of the rock. A mason in a quarry is, therefore, more likely to work a stratified rock from its edge to obtain a required thickness, which at Earls Barton for the pilaster stones was about 120mm. In many Anglo-Saxon churches it proved necessary to cut back part of particular stones to achieve such an equal ornamental width. The cutting back process, was generally best undertaken where the stone involved was held securely within a wall, as at Wittering. The practice was discussed also at some length in Potter (2006a).

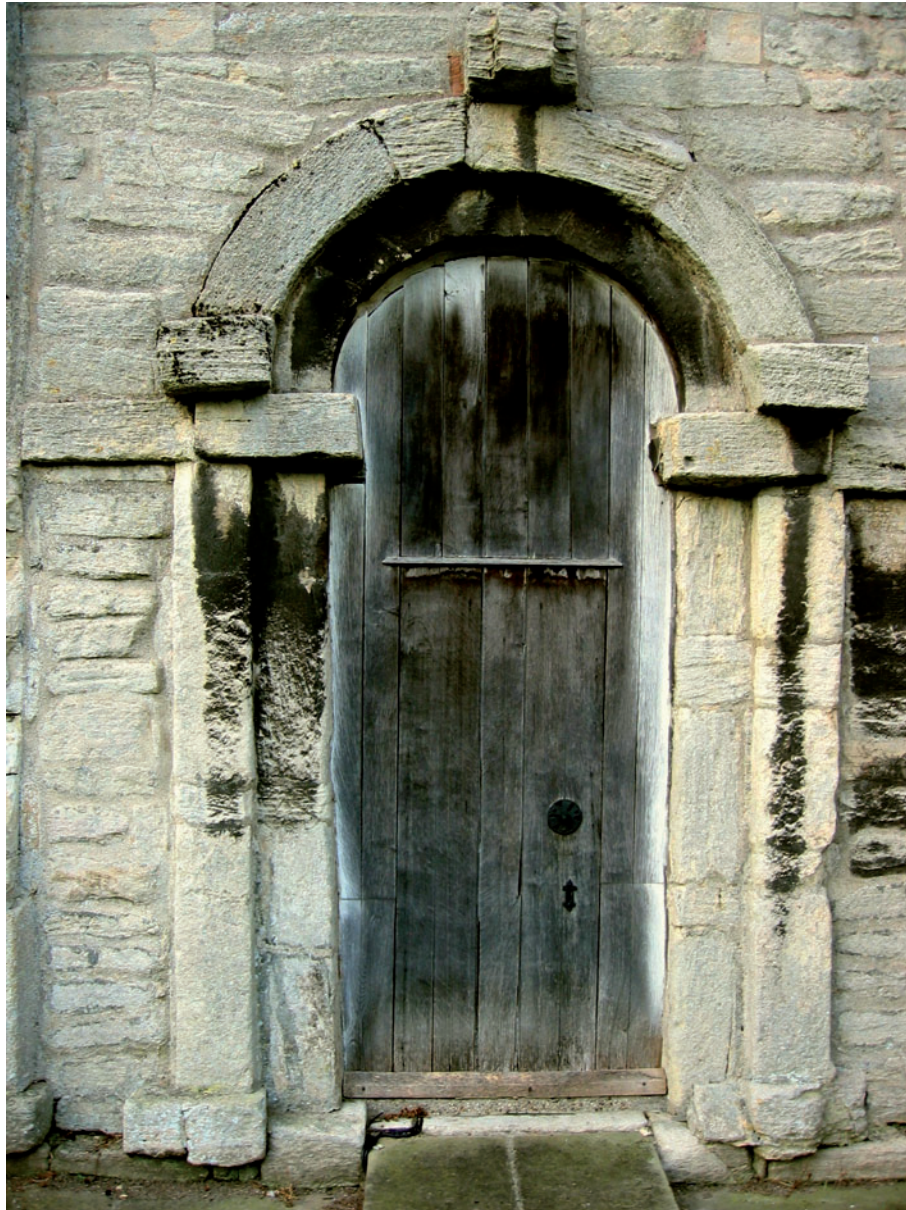
Fig 6 The south doorway of Barnack church has its vertically orientated stones set in Anglo-Saxon style (BVFIA and BH)

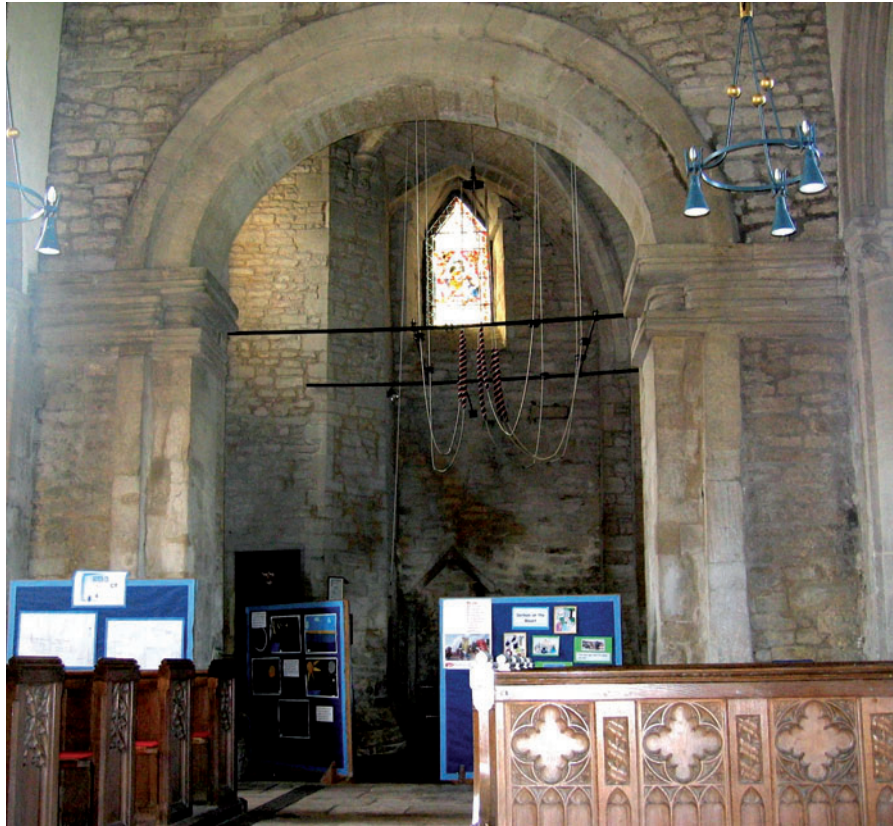
Fig 7 The tower arch of Barnack church is built in Anglo-Saxon style and the lowest readable jamb stones are orientated in the fashion of the period (BVFIA and BH)

ions beneath the now lightly plastered and once painted tower arch (although the lowest four through stones in either jamb are set BH, BVFIA, BH, BVFIA; Fig 7). Similarly, it is difficult to currently read the orientations in the stone seat set within the tower (in which the arching stones appear to have been replaced). Both structures appear to be constructed in Anglo-Saxon style (Taylor and Taylor 1965, 46). Syers (1895-6, 145) reported that the seat, together with others, was discovered on excavation below the mid-19th-century, then existing, tower floor. Taylor and Taylor also discussed the eastern extent of the nave. They, and other authors, described the many further interesting features of this church.

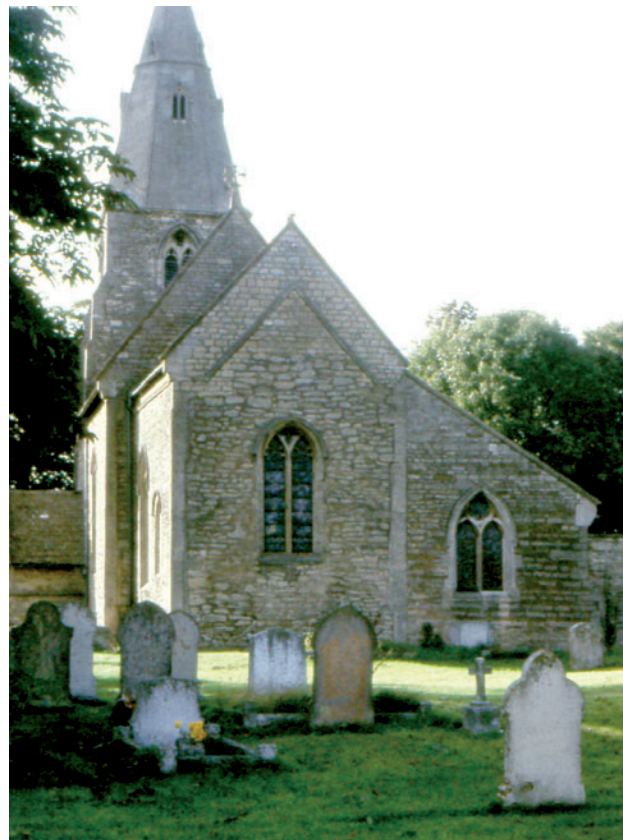
Fig 8 View of Wittering church, showing the Anglo-Saxon chancel and the later raised roof line (photograph, A Chapman)

Wittering church (Fig 8), within the boundaries of the City of Peterborough, is only about 3km from Barnack, on the opposite, western, side of the Roman Ermine Street (Fig 2). The body of the church is constructed of Barnack Stone, but of a lithology slightly at variance with this stone, suggesting an origin that might have been closer to Wittering. The nave and chancel provide an exemplar of many features of unaltered Anglo-Saxon or 'Patterned' workmanship. Despite this, the church has received less attention than many other churches of this period, with descriptions of variable quality appearing in Freeman (1849, 209); Sutton (1895-6, 85-7); VCH (1906, 540-1); Brown (1903, 107-9; 1925); Keyser (1917); Clapham (1930, 108, 111); Jackson and Fletcher (1949); Taylor and Taylor (1965, 678-80); Pevsner (1968, 367); Fernie (1983, 165) and Potter (2005a; 2006a).

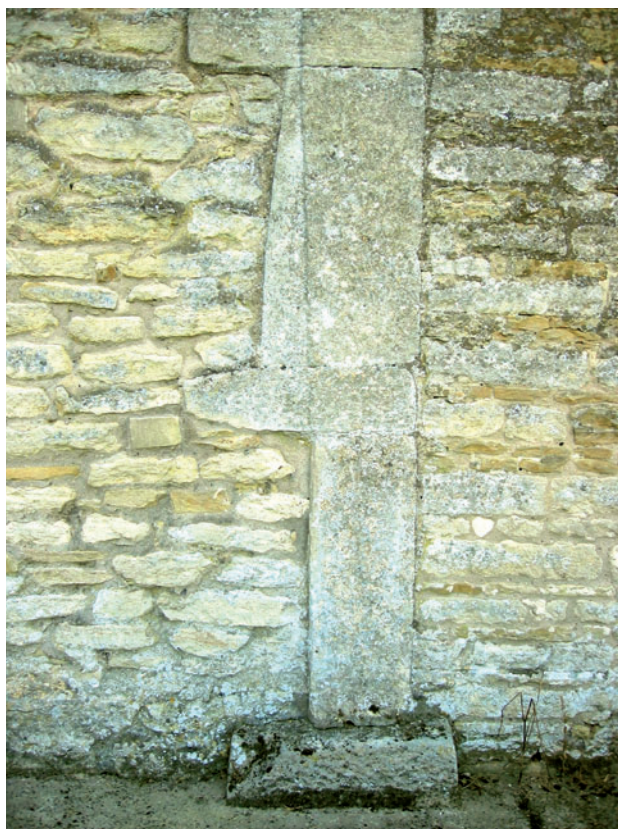
Fig 9 The stones in the north-east chancel quoin at Wittering church are set in Anglo-Saxon style; above the pedestal, stones 3, 4 and 5 have been cut back and stone 4 (BVFL) might be described as 'pear-shaped', and the quoin does not sit squarely on the plinth

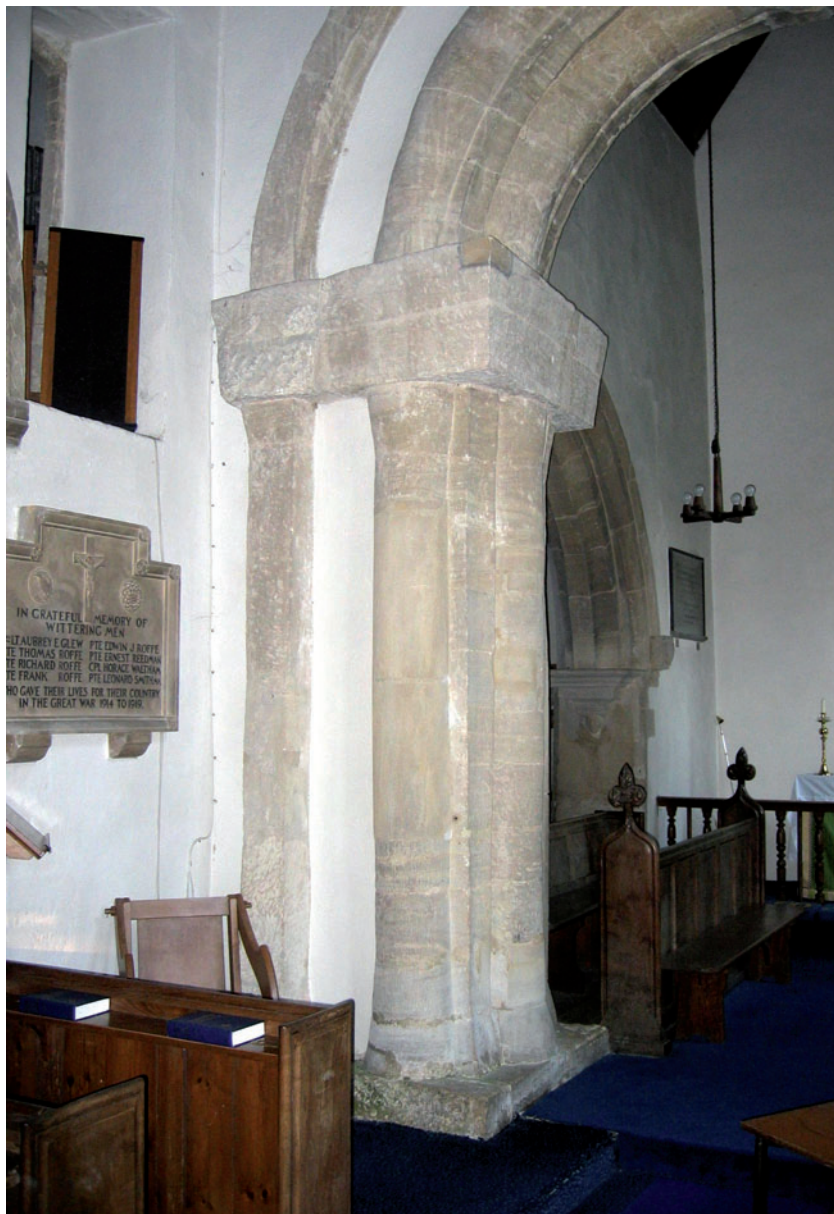
Fig 10 The north jamb of the chancel arch at Wittering, which is here viewed from the nave, exhibits typical Anglo-Saxon characteristics; however, many stones have been replaced, but the original through stone at its foot reveals that the complex carvings were created from a single stone.

Although the south doorway to the nave reveals none of its early origins and has been rebuilt; the chancel arch has been described as ‘of massive grandeur unequalled in any other of the smaller Anglo-Saxon churches’ (Taylor and Taylor 1965, 679). Perhaps originally true and well described architecturally by these authors, a detailed examination of the stonework reveals significant rebuilding. Possibly, much of the replacement was undertaken at the same time as the building of the Early English tower, both being of a similar Barnack-type Stone (although some of the still later ‘rebuilding’ appears to be of hard plaster). The opening is ornamented with a nearly rectangular pilaster-strip which is carried over the arch on the nave side. This decoration is absent on the east side. This both tapers, to the face, and upwards as it ascends the arch jambs. It is difficult to assess just how much of the archwork is original, for plaster and wash cover, and shadow on the south side, hide any bedding

lineations from view. On the north side the larger stones in the pilaster-strip are clearly placed BVFIA and some of the stones in the jamb itself although set with their bedding horizontal (BH) are through stones and probably original (Fig 10). Examination of the lowest stone of this jamb reveals that these original complex archwork carvings were all completed within individual large through stones. Although the dedication date for the church is recorded as 981, it is thought that such multifaceted workmanship, presumably completed on site, is likely to have been completed nearer to the end of the Anglo-Saxon period.

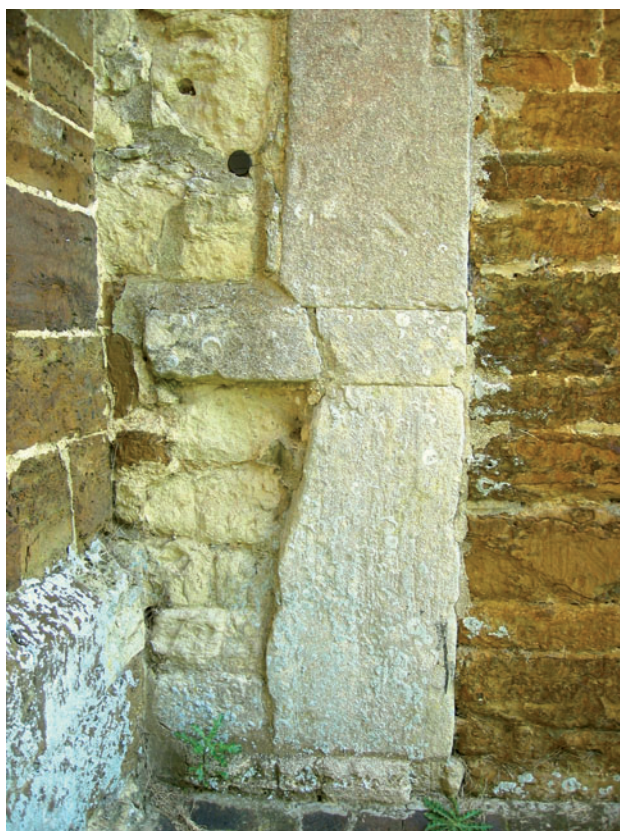
Fig 11 Three types of stone are visible in this view of the foot of the south-west nave quoin of Green's Norton church. The darker (brown) stone in the tower (left) and aisle (right) is from the Northampton Sand Formation; Anglo-Saxon stonework is represented by white limestone rubble in the nave wall, probably of local Blisworth Limestone, and its dressings in the Barnack-like Stone of the quoin, set BVFR, BH, BVFL

The bedding orientations in successive stones can be viewed most readily in the SW nave quoin, where they clearly display the workmanship of Anglo-Saxon masons and can be analysed from ground level as follows: BH, BVFR, BH, BVFL, BH, BVFL, BH, BVFR, BH, BVFL, BH, BVFR, BH, BVFR, BH, higher stones uncertain (Fig 11). The vestry in front of the north-west nave quoin prevents its structure being properly determined.

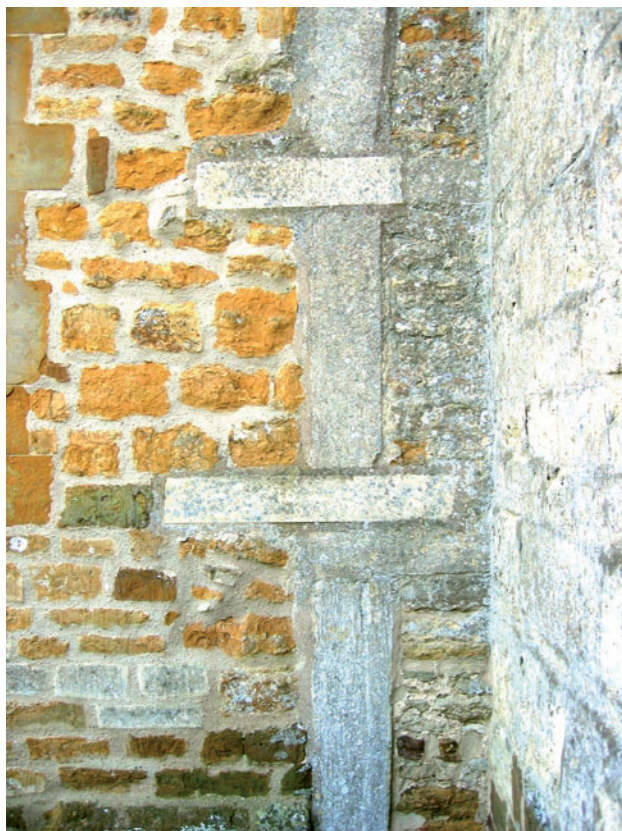
Fig 12 The north-west quoin of Pattishall church has been rebuilt to include stones of Middle Jurassic oolite to help to tie the aisle (left) to the original Anglo-Saxon nave

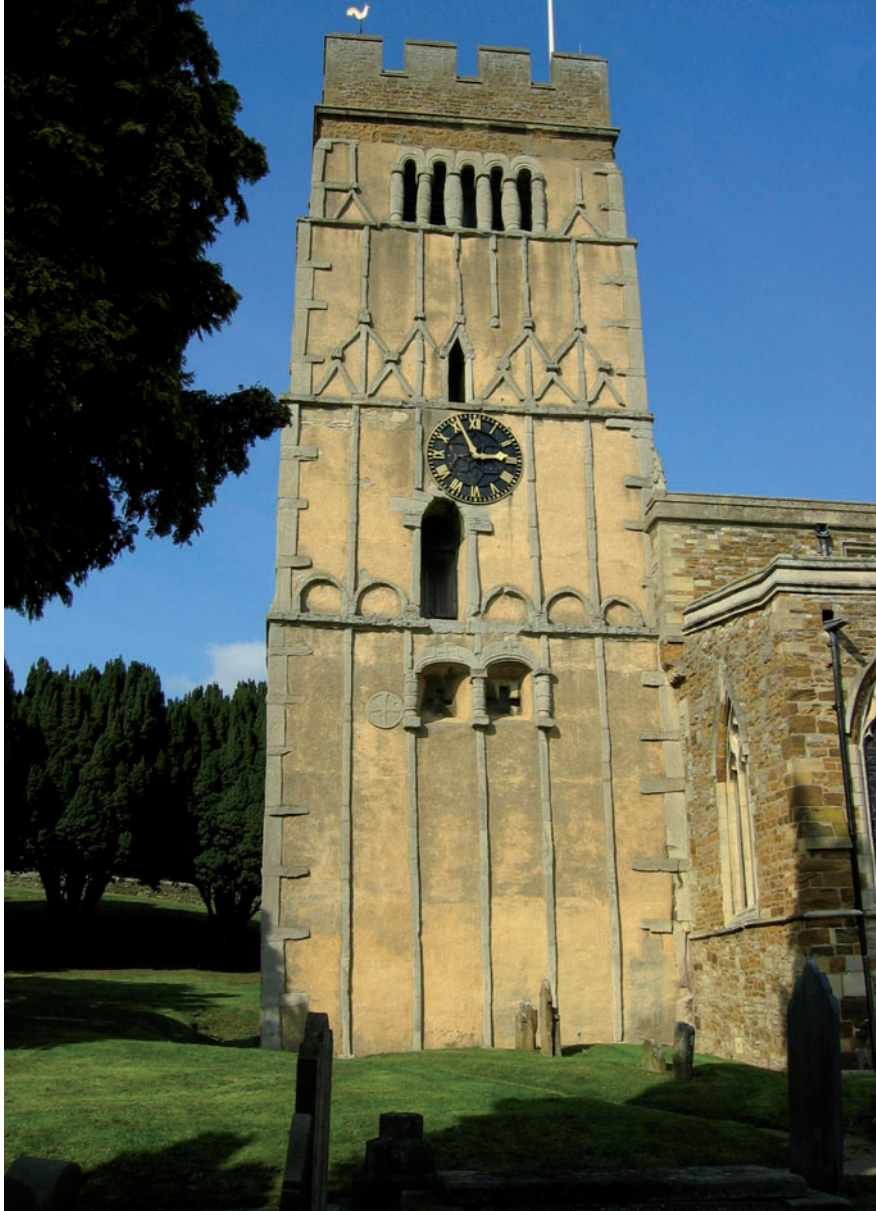
Fig 13 The south face of the Earls Barton, tower; note that the quoin stones are of variable width

Each of the tower's quoins is built in long and short style and preserved almost to the tower's full height (Fig 13). They are constructed of Barnack Stone which generally

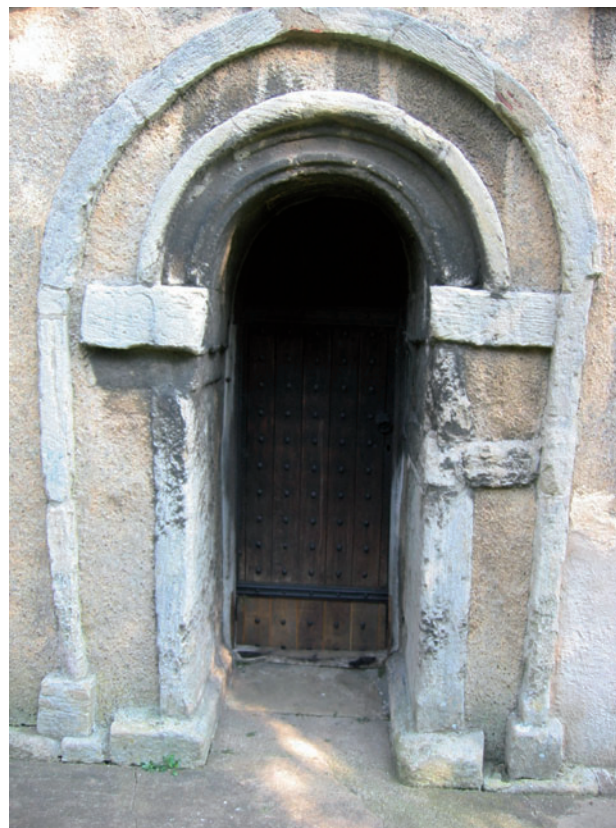
Fig 14 The stone orientations in the west doorway of Earls Barton tower support its Anglo-Saxon origin

Taylor and Taylor (1965, 223) described the west door of the tower as 'an outstanding example of monumental stone-work'. Both the door jamb stones and the surrounding pilaster strips exemplify quality Anglo-Saxon or 'Patterned' workmanship with the stones set either BVFIA or BH (Fig 14), and minor later repairs have only proved necessary to the south pilaster strip. The other openings in the tower have been well described by Taylor and Taylor (1965). In the west face the first stage double window, of which internally some evidence remains, has been replaced by a single window constructed at least in part with a limestone that is not Barnack Stone. The door that passed originally between the east face and the upper chamber of the nave would appear to have its jamb stones placed BH and would seem to be later or replaced.

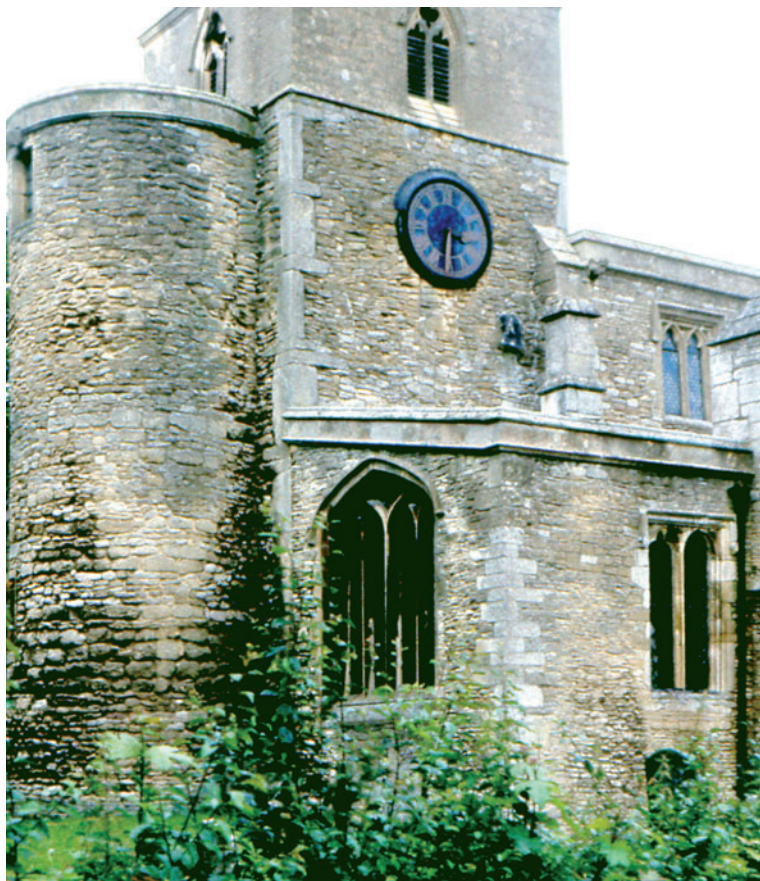
Fig 15 View of the Anglo-Saxon tower at Brigstock church, abutted by the circular stair turret, left, and a later aisle, right, (Photograph, A Chapman)

attracted considerable attention (as Carpenter 1865-6; Keyser 1920; Brown 1903, 336; 1925, 445; Clapham 1933; Fletcher and Jackson 1945; Jackson and Fletcher 1949; Taylor and Taylor 1965, 100-5; Pevsner and Cherry 1973, 122-3; Fernie 1983, 138-9; Howe 1999 and Potter 2005a, 190). Those portions of the church to be typically identified as of early pre-Conquest fabric are the tower (below the Decorated higher portion and spire) together with its western stair turret, and the remnants of the original nave (Figs 2 and 15).

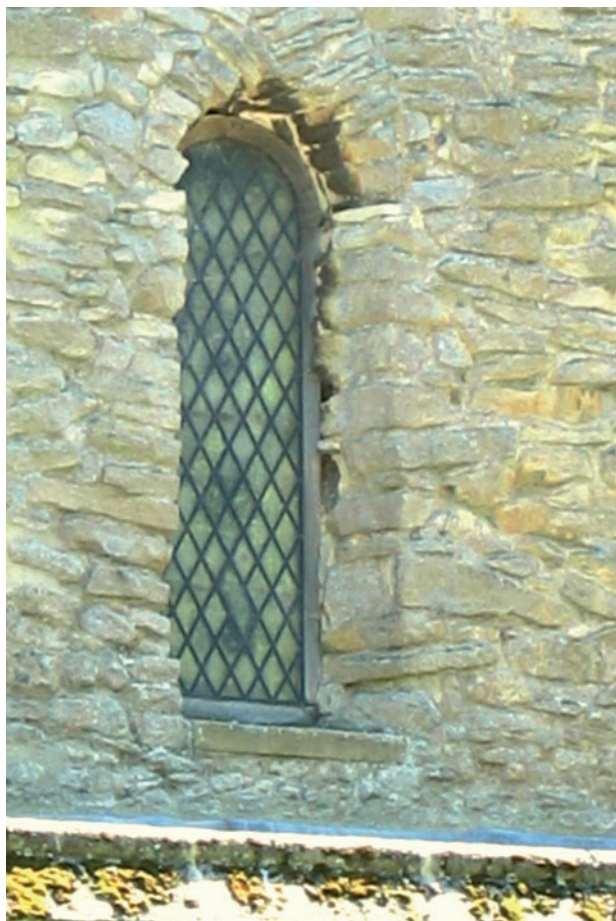
Fig 16 From the external view, the double-splayed window on the northern wall of the tower at Brigstock church shows evidence of having been replaced; note that the jamb stones (all BH), fit irregularly into the wall and that the sill stone is new
