Canal Lift Bridge GN5 at Rothersthorpe, Northampton

SUMMARY

A building record was made of Lift Bridge GN5 immediately prior to its dismantling in October 2004. It was built in 1815 as part of the Grand Union Canal, Northampton Arm to enable the farmer, whose land it was built on, to continue access with carts to fields otherwise cut off by the new canal. Although the Lift Bridge was renovated in 1914 and in the 1960s, several of the original iron fittings are thought to have been re-used in the structure.

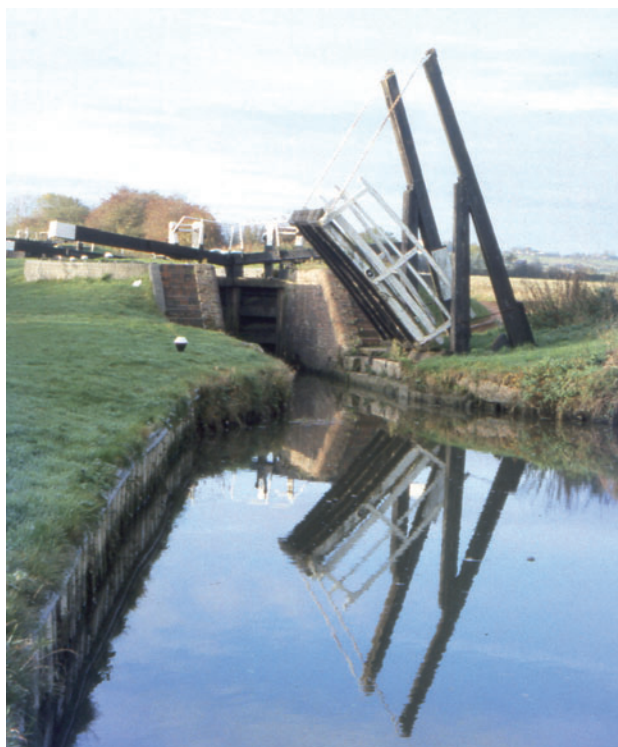
Fig 1 Rothersthorpe Lift Bridge GN5 in the up position, and lock number 5, looking south-west

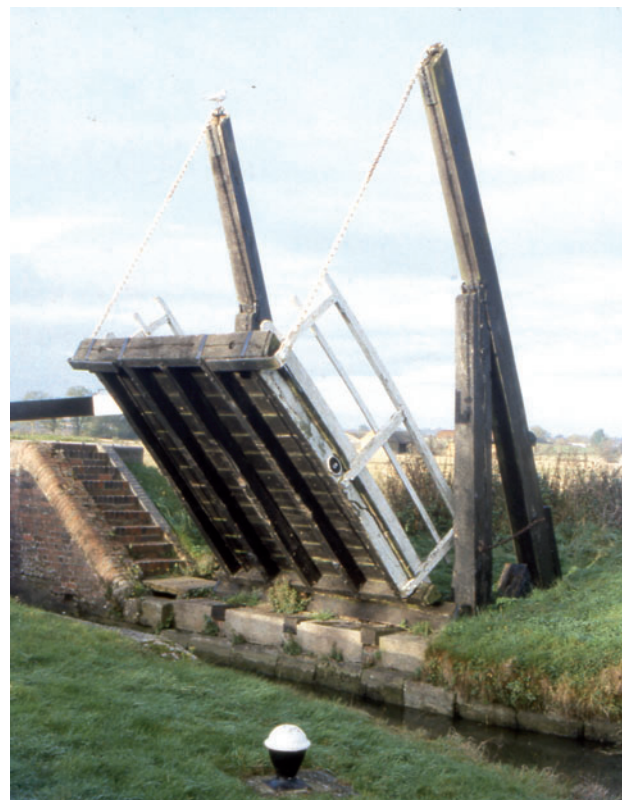
Fig 4 Rothersthorpe Lift Bridge GN5 in the up position, prior to dismantling, looking south-west

The bridge was secured in the up position due to its dangerous condition, and was recorded fully whilst it was in this mode (Fig 4). The watching brief on the dismantling then enabled the bridge to be inspected in the lowered position. The buildings record comprised

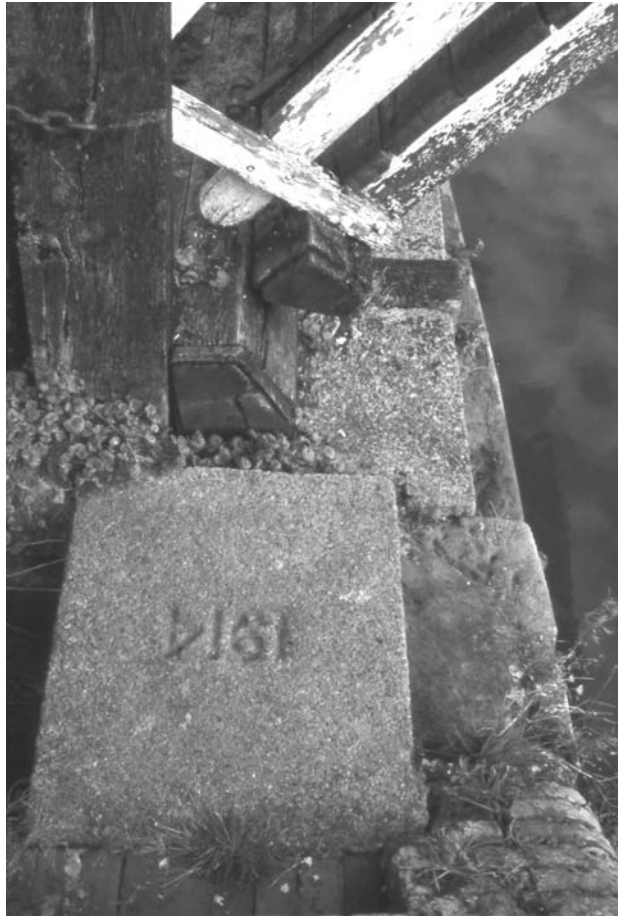
Fig 5 The date stone (1914) of the rebuild of bank surrounds, looking west

1895. It is probable that the sandstone edging, or rubbing blocks on the sides of the bank around the footbridge dated to the original construction rather than the 1914 renovation, which seems to have used concrete (Fig 5).

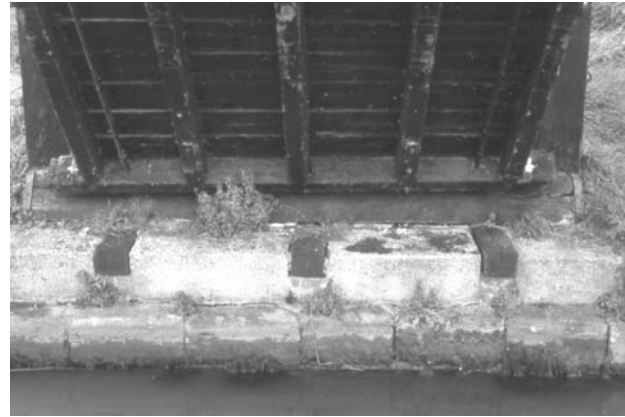
Fig 6 Detail of bank structure below the raised footbridge, looking west

The 1960s work involved further consolidation work of the bank with a concrete slab inserted below the footbridge structure with a timber and brick lacing (Figs 5, 6 and 14). The adjacent brick-lined overflow for the lock was rebuilt in the last ten year period. The timber structures are likely to date from the last works in the 1960s. All timbers are machine-cut and finished so that there are no saw or cut marks visible. All are probably made of oak, though this was not determined with certainty.

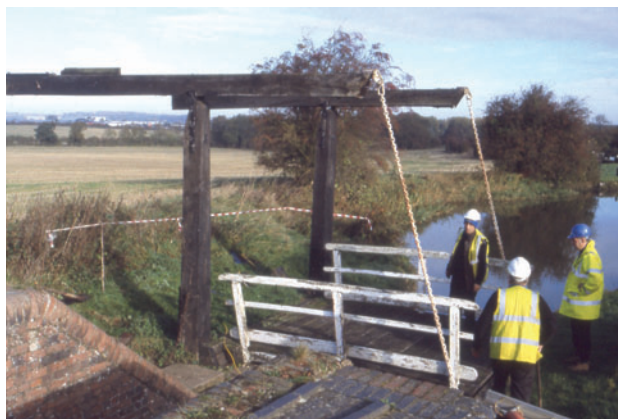
Fig 7 Lift Bridge GN5 in the lowered position, during dismantling, looking north-east

The tilting footbridge as a whole measures 3.60m long, spanning the canal and overlapping the east bank, by 0.20-0.25m and the west bank by 0.50m (Fig 7). A timber beam on the east bank acts as a stop; that on the west bank acts as an integral pivot to the structure but is only fastened to the footbridge by means of large strap hinges (Fig 6). It is prevented from moving backwards by a bank of concrete laid between the two uprights. The foot bridge is estimated to weigh between 1-2 tons.

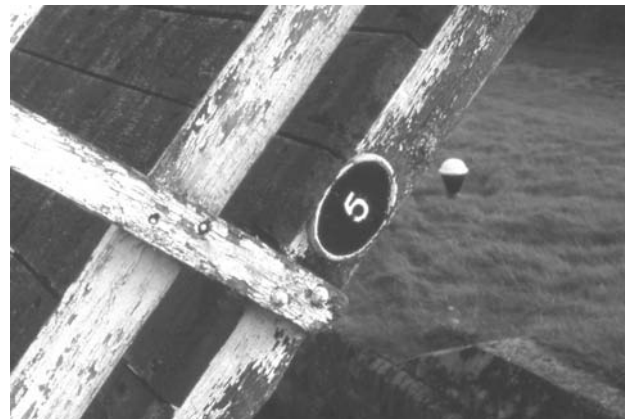
Fig 8 Detail of the footbridge assembly and cast number plate

three uprights, which in turn are bolted onto the outside of the footbridge and to two additional horizontal timbers (Figs 7, 9 and 16). All are painted white. A cast iron number plaque is fastened to each exterior side (Fig 8). The iron chain block which attaches to the chain between the uprights is a 1960s machine-made replacement fitting (Fig 10).

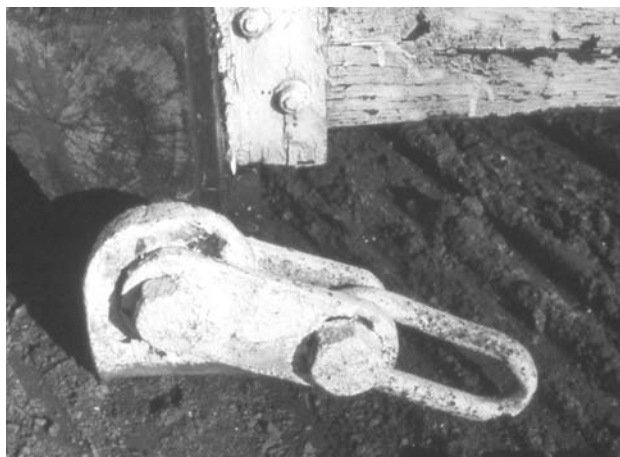
Fig 10 Detail of the replacement chain block fitting from the top of the counterbalancing beam

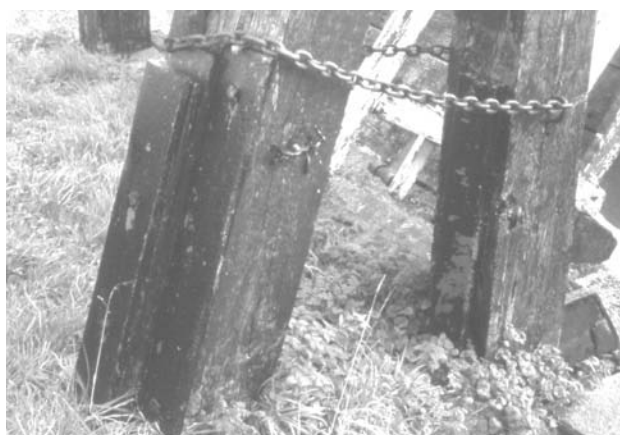
Fig 11 Detail of the iron plates at the base of the counterbalancing beam and upright post

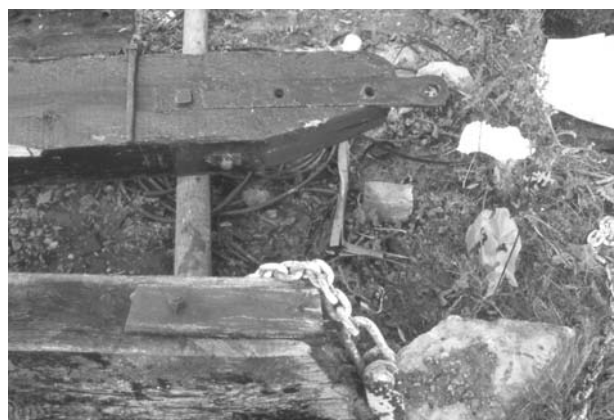
Fig 13 Detail of the original iron straps reused on the upright post and one of the bolt attachments, top, and detail of the 1960s refurbished chain assembly on the top of the counterbalancing beam, below
