Building Recording of Nissen Huts at former RAF Chelveston

Northamptonshire Archaeology carried out buildings recording at the former RAF Chelveston Airfield, Chelveston, Northamptonshire. Two of several Nissen huts constructed during World War 2 and used for the storage of small arms, ammunition and explosives were surveyed and photographed prior to their restoration for reuse as storage.

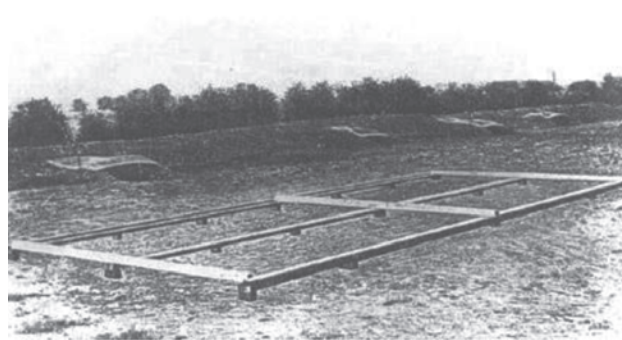
Fig 2 Wooden bearers are laid on level ground

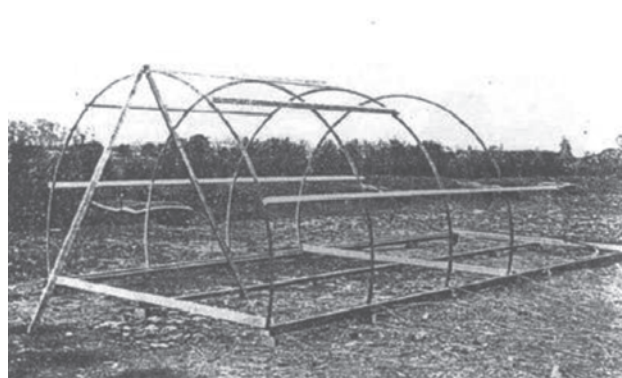
Fig 3 Steel ribs are bolted to the bearers and wooden purlins are fixed to the ribs with hook-bolts

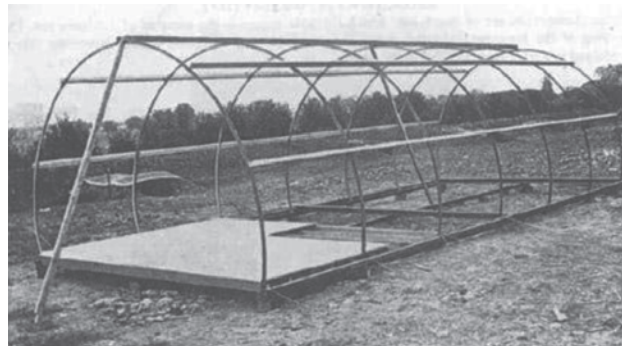
Fig 4 Wooden joists, screwed to the bearers, support wooden floor panels

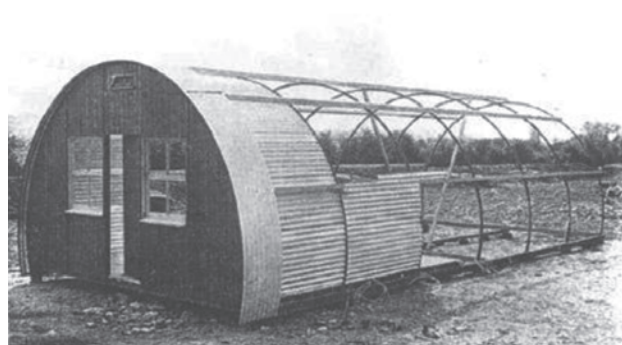
Fig 5 The hut is clad in corrugated iron

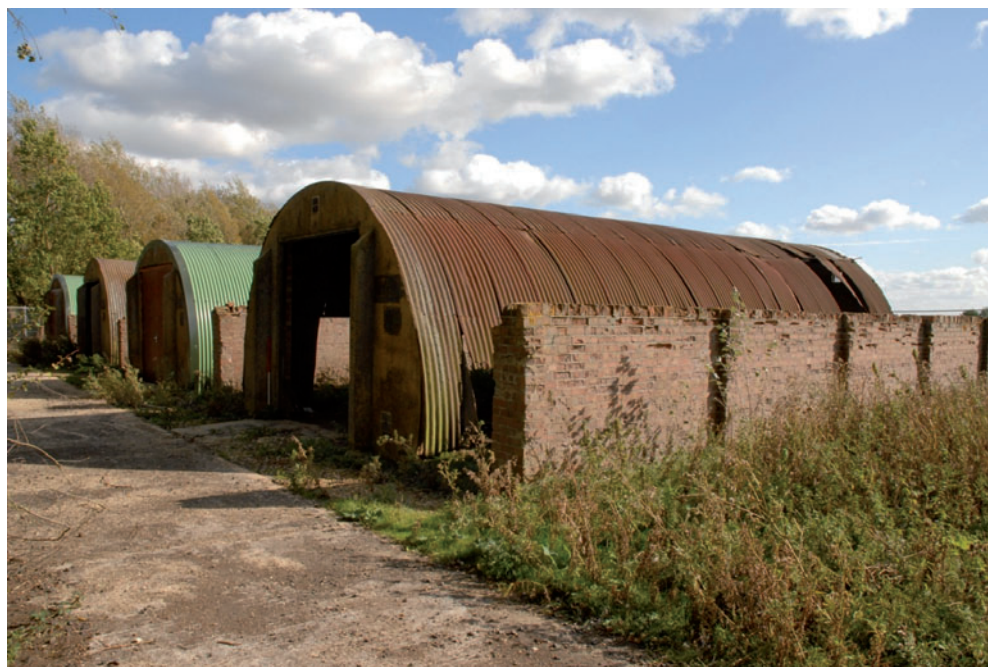
Fig 6 View of Nissen huts 141-144, looking east

The buildings surveyed were two of a group of four Nissen Huts that appeared to be contemporary with each other (Fig 6), with the huts being numbered in sequence 141-144, with the same stencilled information on each. They formed part of a wider group of nine Nissen Huts surviving in the northern corner of the airfield, 137-145 (Fig 7).

The other two huts within the group of four, buildings 142 and 144, have recently been renovated and are being reused. These four huts are separated by brick walls, 1.8m high, which acted as blast walls (Figs 6, 8 and 9). These were the only group of huts in this part of the airfield to have walls between them.

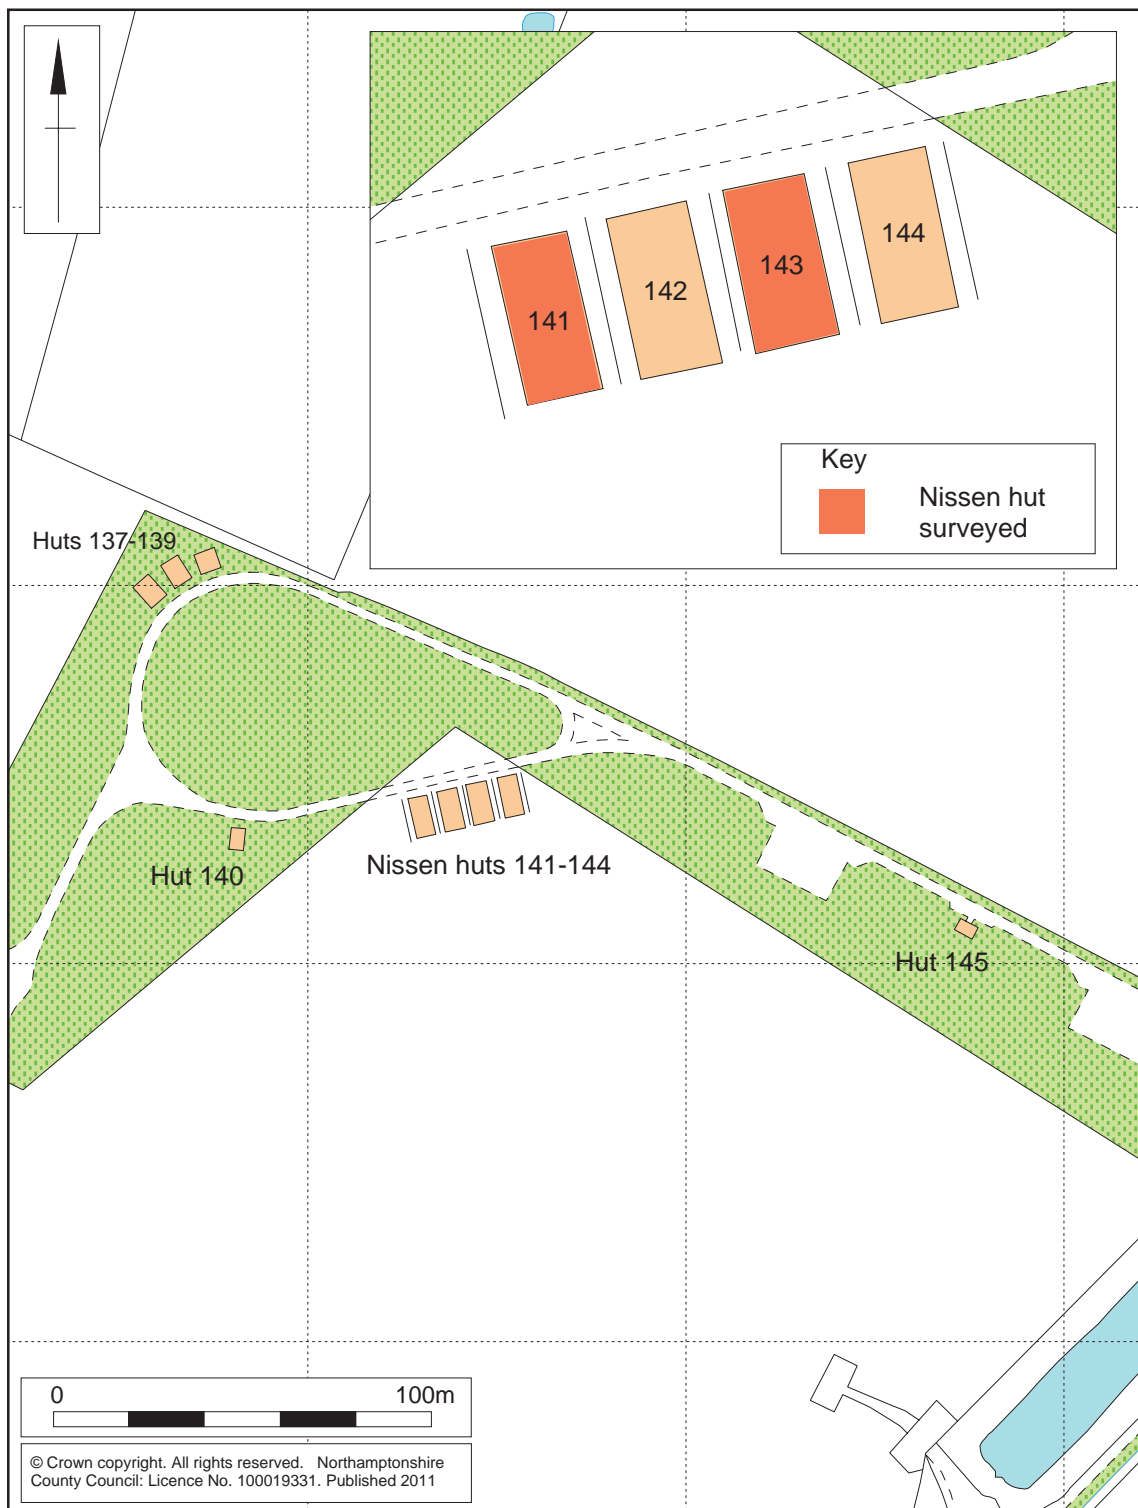
Fig 7 Location of Nissen huts

The 1944 records (Table 1), make it clear that the Nissen huts surveyed and examined, huts 137-145, were all used in WW2 for the storage of lighter munitions of various sorts; small arms and ammunition, small bombs and sea markers and flame floats (see Fig 7). The small arms and ammunition storage (SAA) in huts 137-140, could presumably have included varying calibres of weapons (up to 20mm/40mm for ground defence anti-aircraft guns?). Both incendiary and high explosives could be involved as would almost certainly be the case with the small bomb container stores in huts 141-144, which were provided with intervening brick blast walls. Flame floats, hut 145, were floating flares dropped on the water at night so the rear gunner could observe them and estimate the drift of the aircraft due to wind.

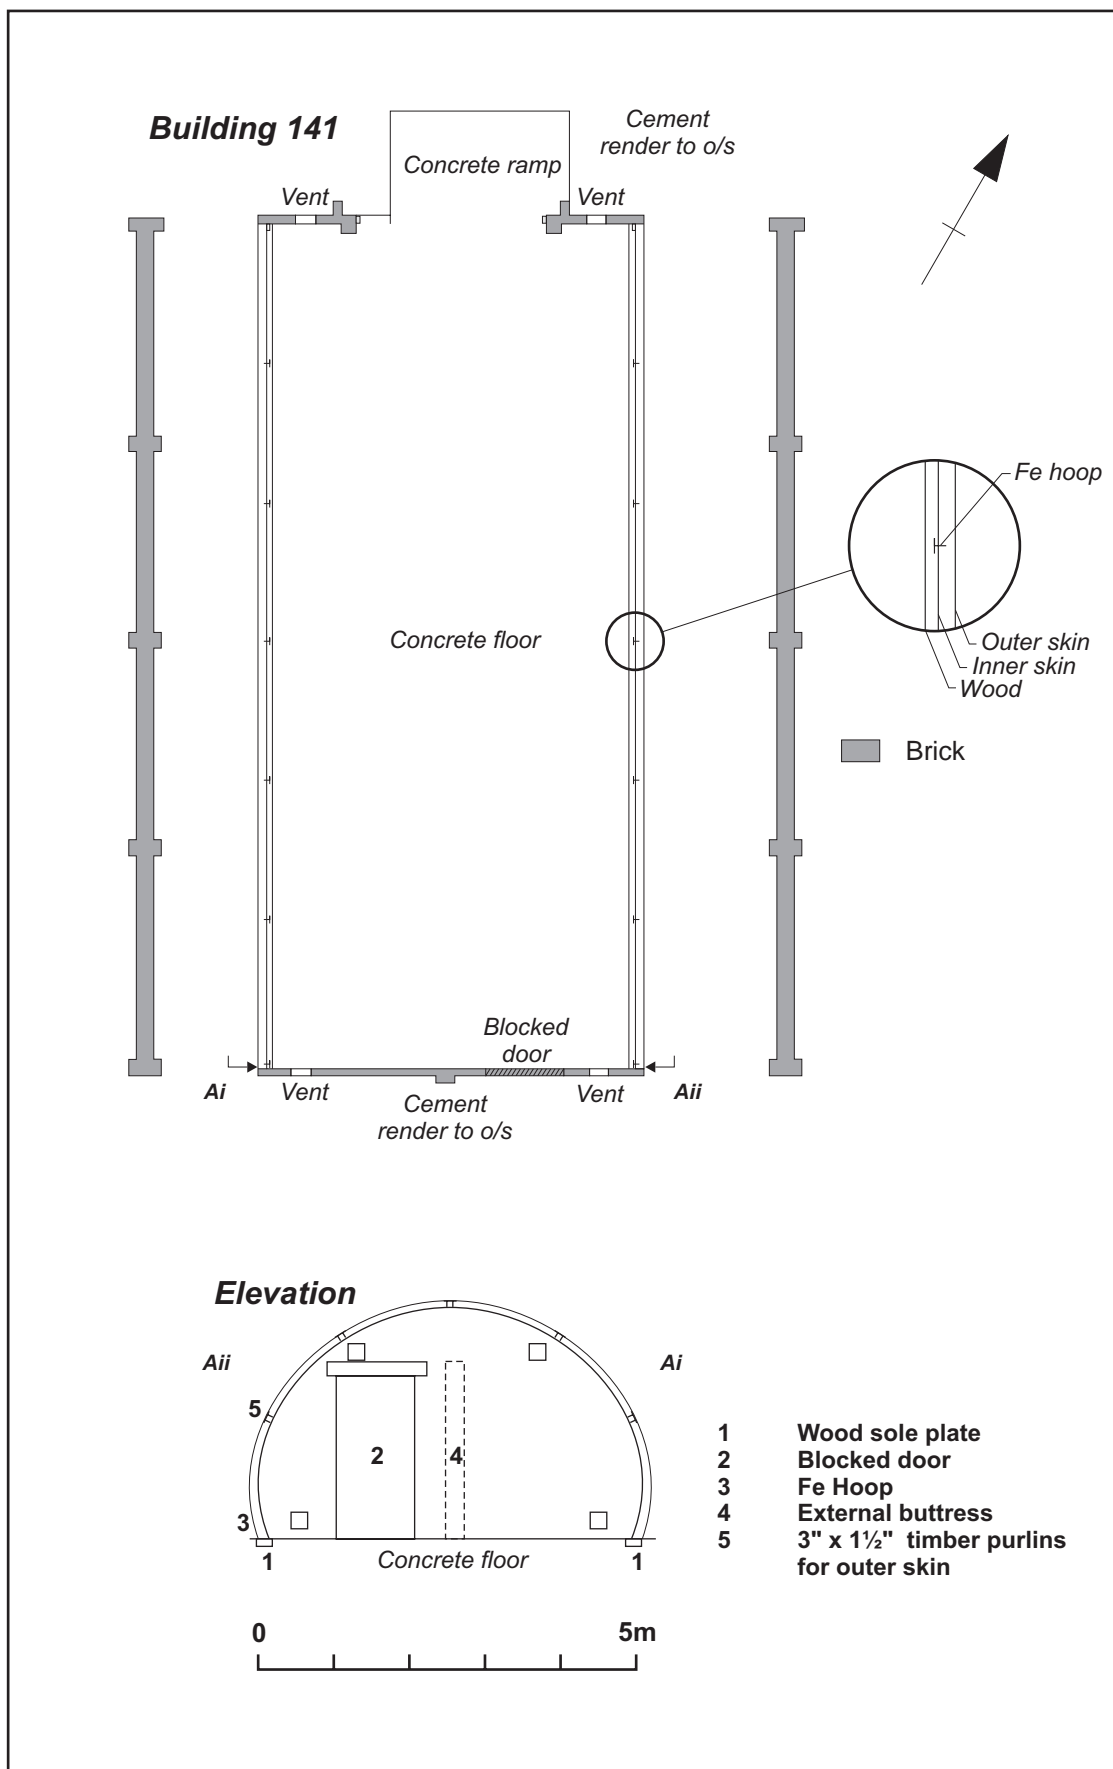
The two surveyed Nissen huts were to all intents and purposes the same and are described together. All four of the huts in the group are six-bay Nissen huts, with brick walls blocking either end (Fig 8). No windows were present in the huts. The rear walls of the two surveyed examples had originally had a door, which had been subsequently bricked up (Figs 10 and 11). The outside of the wall had been rendered in cement covering the bricked up doorway indicating that there was a change of function at some point in the use of the buildings. Four iron rungs were built into the back of the surveyed huts, the bottom pair were horizontal and the upper pair were vertical (Fig 11), but the function of these rungs was unclear.

Fig 8 Plan of Hut 141

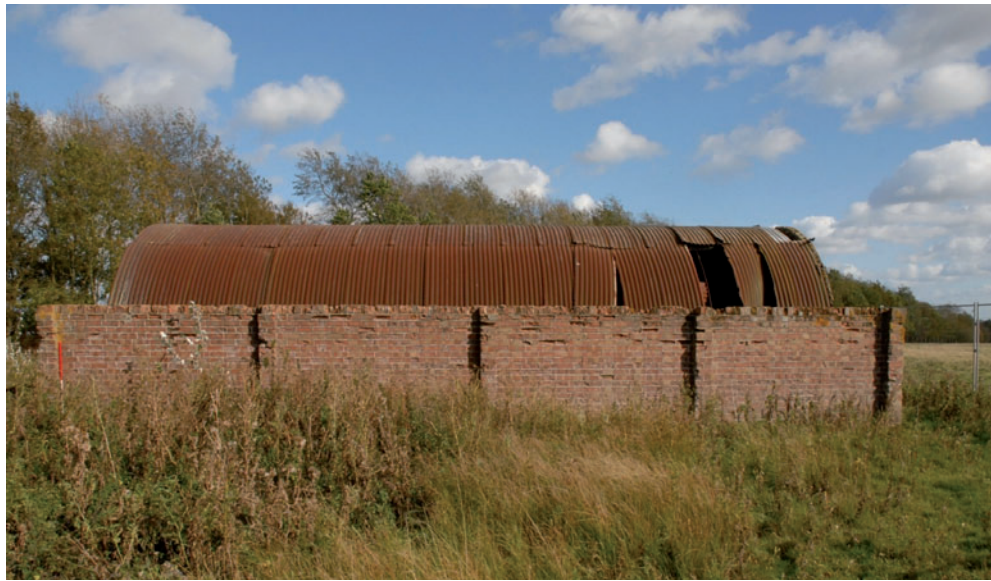
Fig 9 View of the brick wall, with Hut 141 behind, looking east

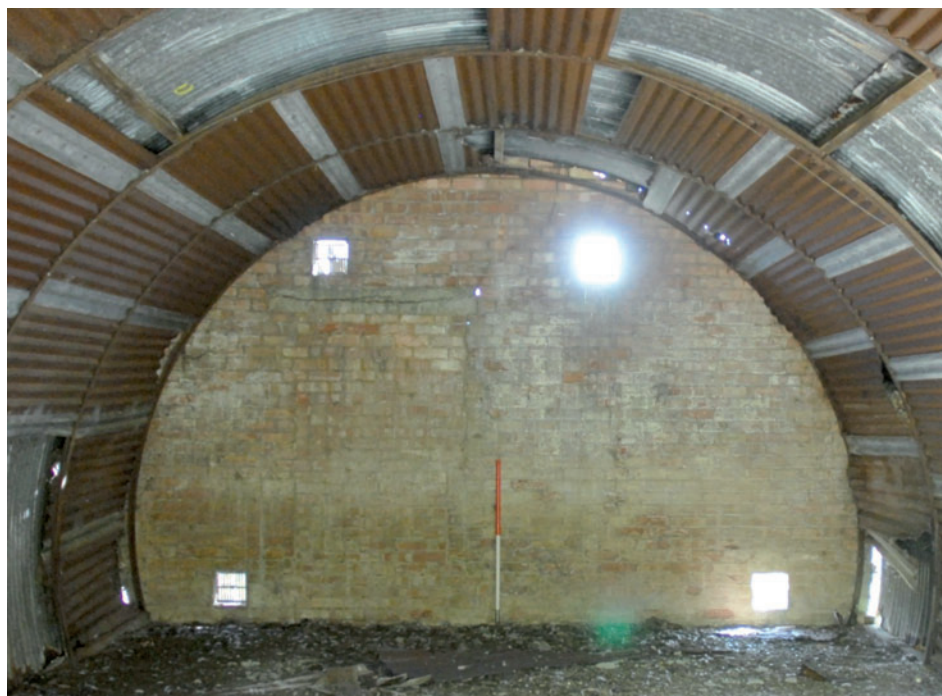
Fig 10 Interior of Hut 141, showing blocked door (left of the 1m ranging pole), looking south

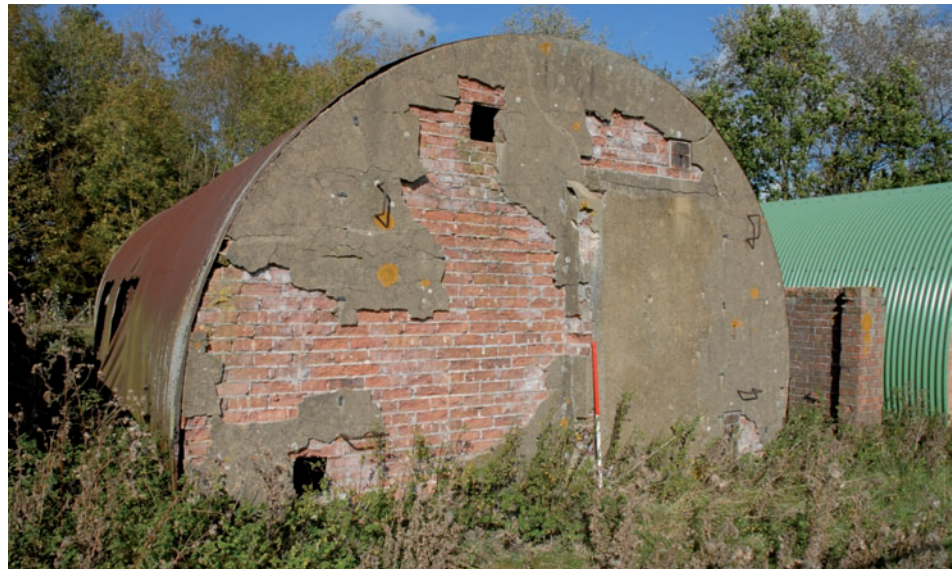
Fig 11 Back wall of Hut 141 showing concrete render over the blocked door, the vents and four iron rungs, looking north

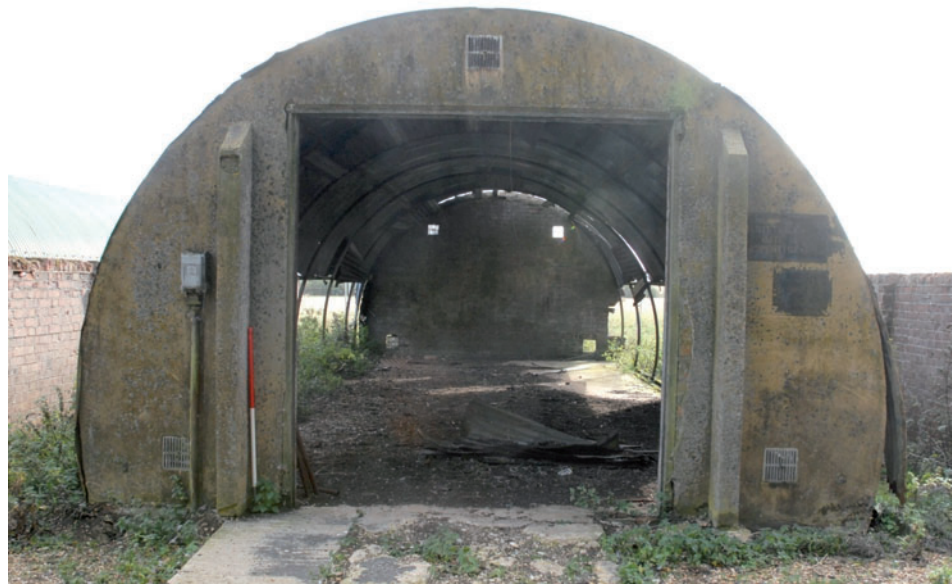
The front brick wall to each hut has a 2.4m wide opening, with doors (Fig 12).

The front walls were also cement rendered, and to the right of the doorway at head height each building had a small stencilled panel recording: Building No; Resistance-...Ohms; Date of inspection.

Fig 12 Front wall of Hut 143, looking south

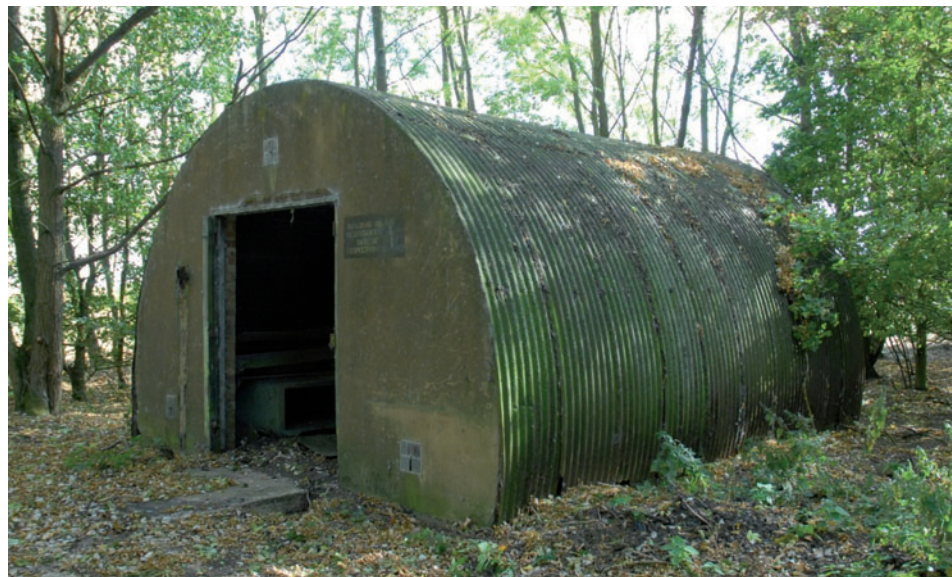
It was not possible to determine the date of inspection on the two huts which were surveyed, although Hut 140, which stood in the woods to the west, had a recorded inspection date of 22/11/63, indicating that the huts were rendered pre-1963 (Figs 13 and 14).

Fig 13 Hut 140, looking south-east

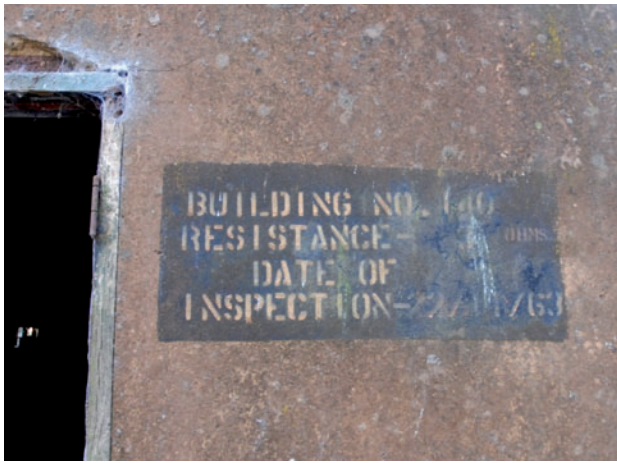
The resistance reading may relate to the building's earth, as it was a metal building used for storing munitions, where sparks would have been very undesirable.

Fig 14 Stenciled panel on Hut 140

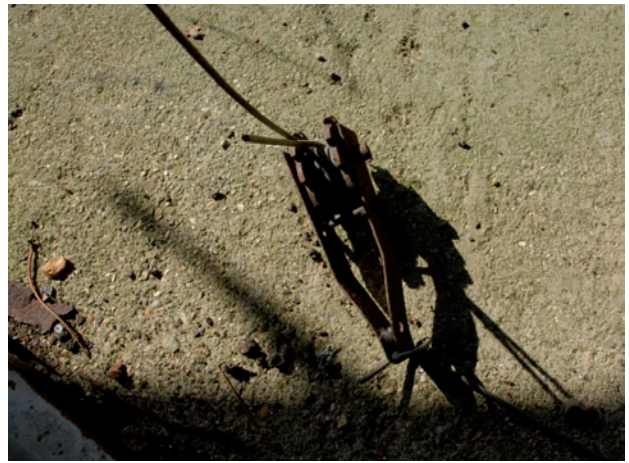
The purlins were attached to eight T-shaped ribs (1¾ × 1¾ × ⅛ inch / 45 × 45 × 5mm) set at 6 feet 0.5 inch (1.8m) centres. Each rib consisted of three sections bolted together using splice plates, and each end was bolted to the floor at the bearers. With each rib were two straining wires, one on each side and a straining ratchet (or in some cases a simple fencing wire strainer). The wires were strained during construction (see Fig 17). The straining wires do not appear in the original Nissen patent.

Various fittings were present on the brick and rendered end walls. There were simple metal ventilation grilles in the end walls of each hut, three in the front wall and four in the back (Fig 16). Air vents were often utilised to manage humidity levels and thereby help maintain the condition of some forms of stored munitions and fuses. On Hut 143, there was straining ratchet, used to tension the supporting wires during construction (Fig 17).

Fig 17 Straining ratchet on Hut 143

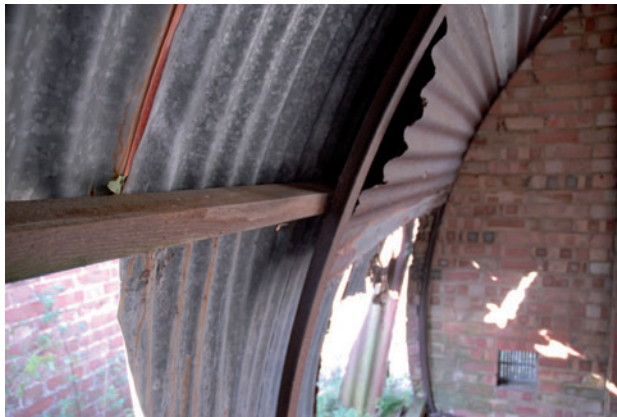
The huts were clad in corrugated iron sheeting, with the covering varying in its state of completeness and condition, allowing various details of internal construction and fittings to be viewed, such as the wooden purlins attached to the ribs (Figs 15).

Fig 15 Wooden purlin in Hut 143

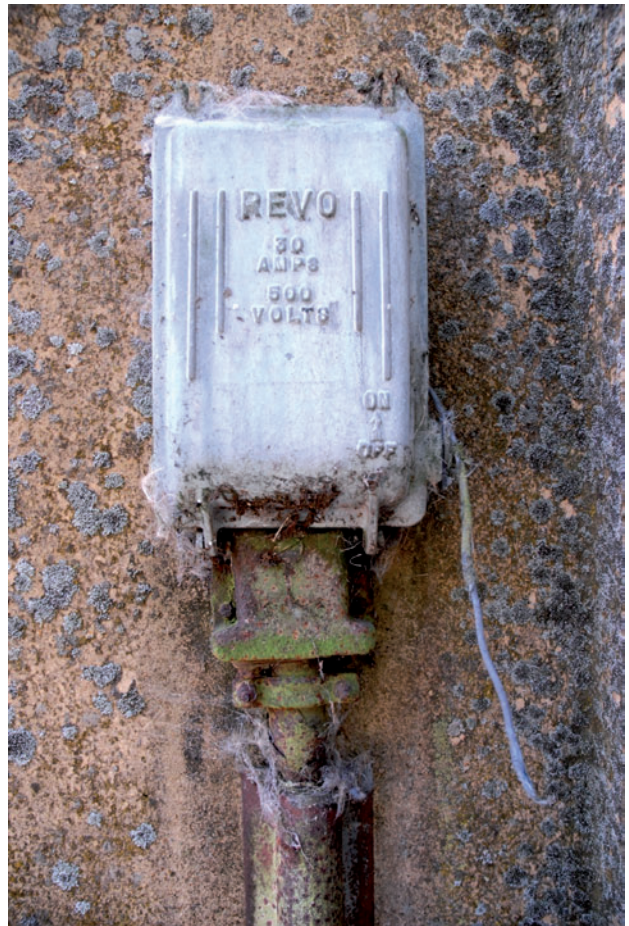
Each of the two surveyed huts had an electrical supply, with the junction boxes surviving on the front walls to the left side of the opening (Fig 18), but the associated internal wiring had been removed. No other internal fixtures or fittings were observed.

Fig 18 Electric junction box on Hut 141

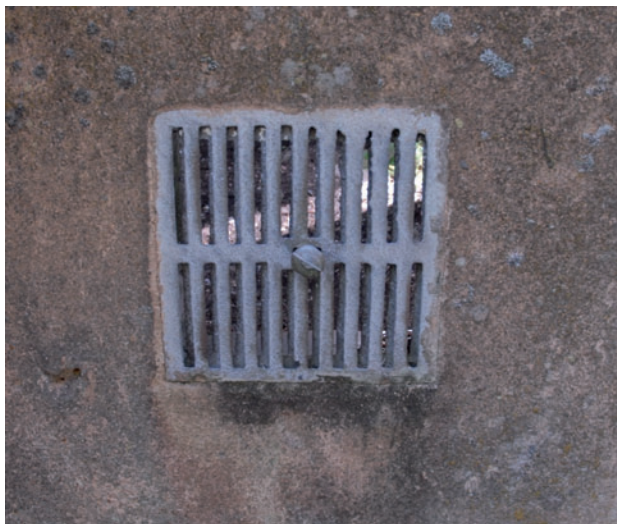
Fig 16 Detail of metal grille over wall vent

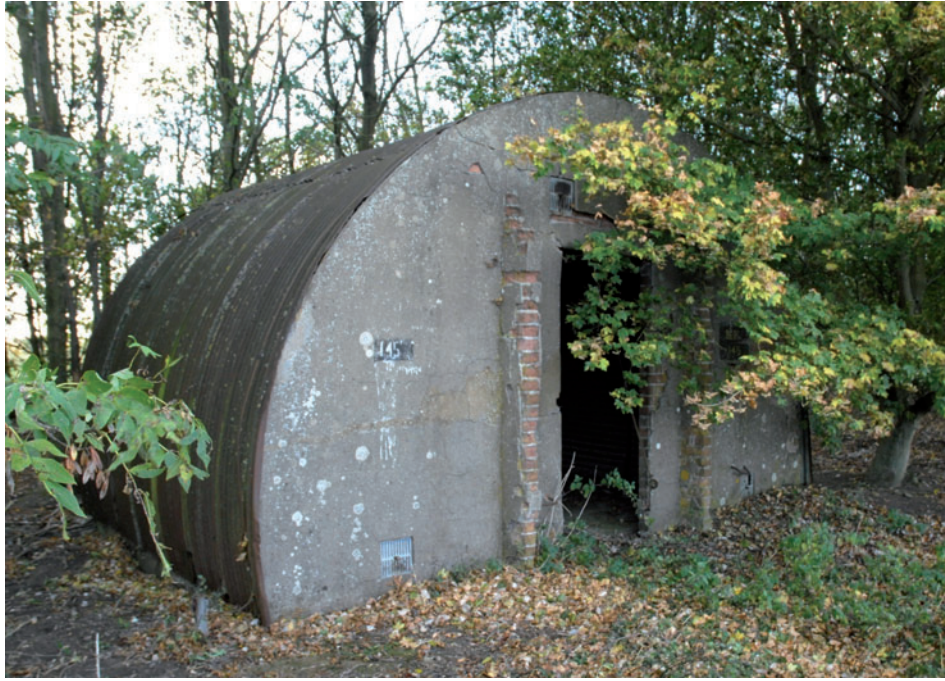
A further hut, 145, which was not subject to survey, lay to the east in the woods (Fig 19). This hut appeared to be in its Second World War condition, with no sign of the later stencilling, and with a steel-framed window in its back wall (Fig 20).

Fig 19 Hut 145, showing front wall and doorway, looking north-east

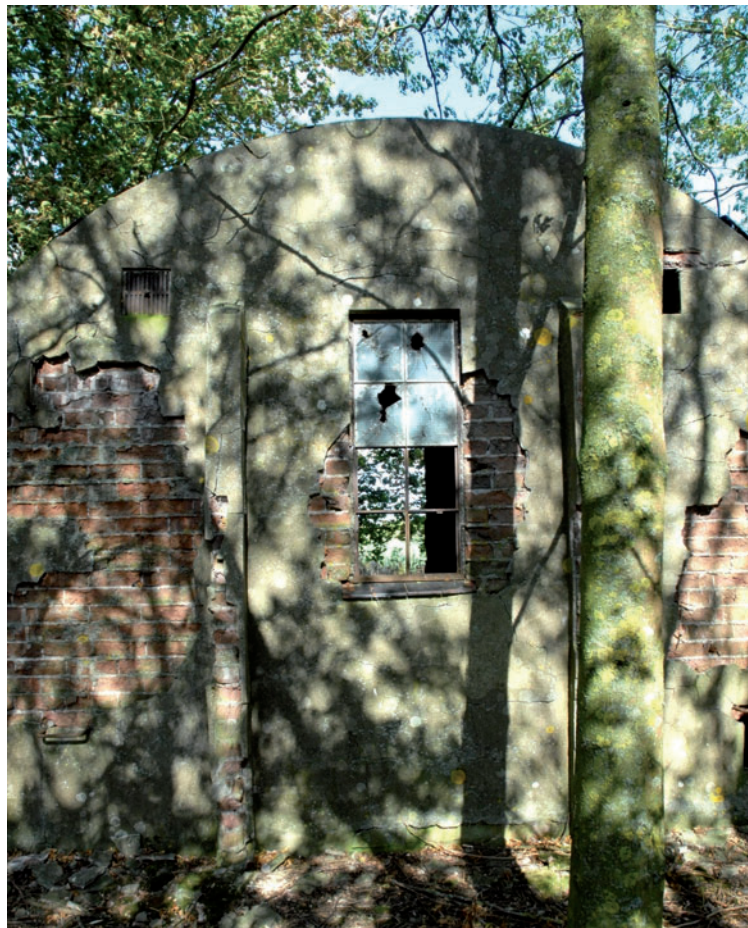
Fig 20 Hut 145, showing the steel-framed window

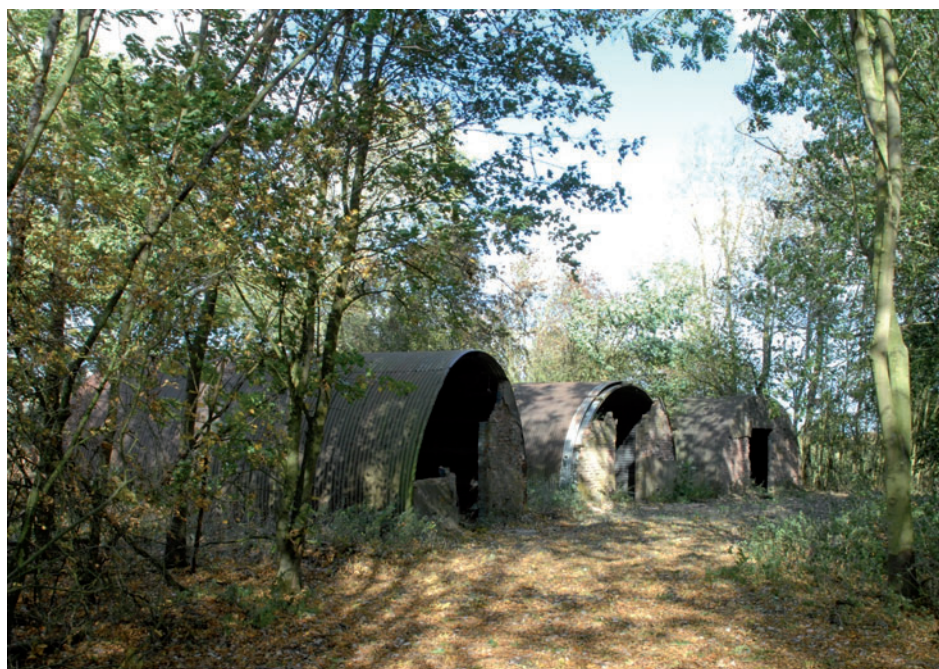
A further group of three huts lay in woods to the north-west of the surveyed group, but these were in a poor state of repair (Fig 21).

Fig 21 Group of three huts, 137-139, to the north-west of the surveyed group, looking north-east
