An Archaeological Assessment of land to the rear of 93 East St, Newton Abbot, Devon

Location: 93 East Street Newton Abbot (rear of)

Proposal: Part demolition of former builders /funeral directors yard and construction of two dwellings.

Date of Fieldwork: 15-16 Aug 2017

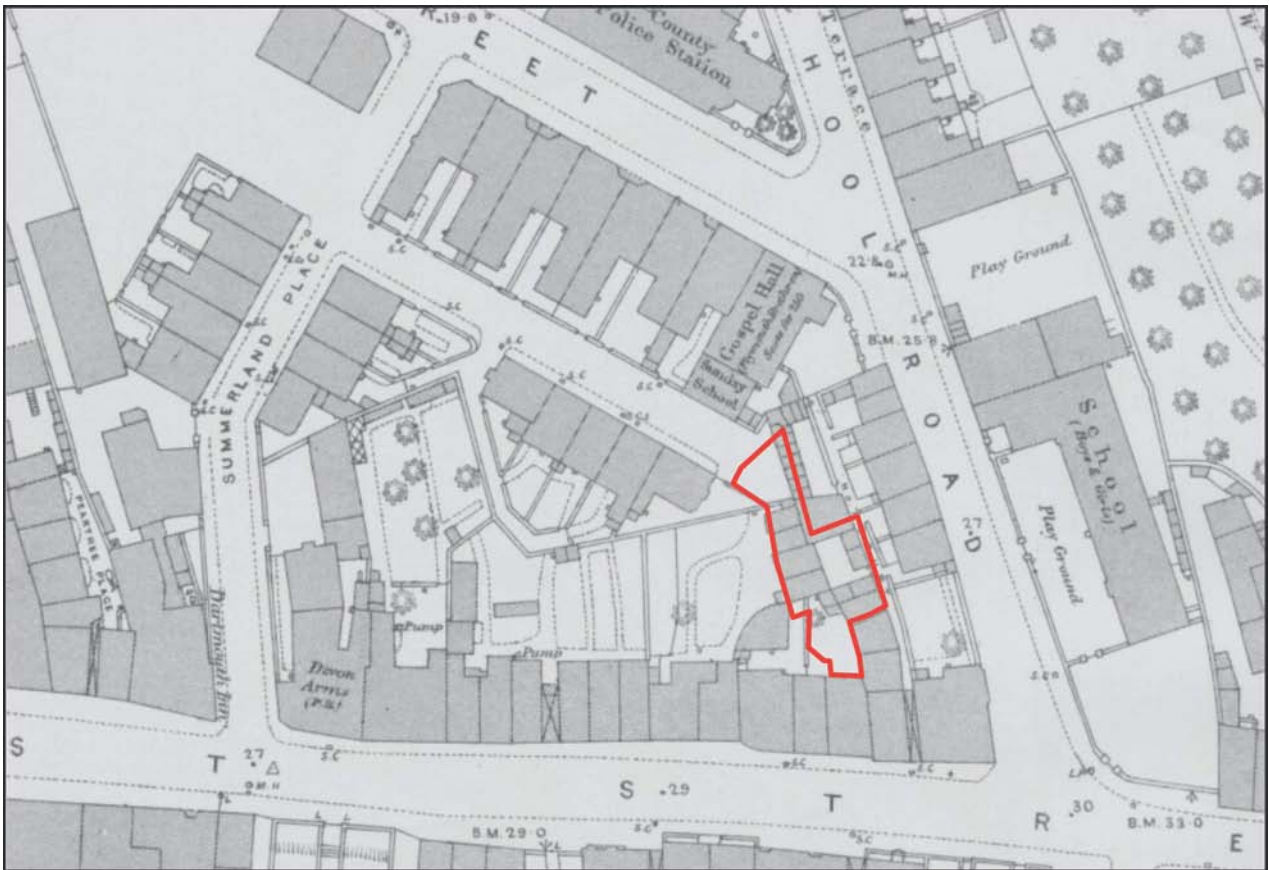
Fig. 1 Outline of the development in Newton Abbot, imposed on the Ordnance Survey 1:500 town plan of 1889-90, showing elements of what was probably a covered yard at that time.

By 1889, the adjoining terraced developments in Union Street and Summerlands Place were complete and the site contained some buildings, depicted at 1:500 scale on the OS town plan of that year (Fig. 1), but this may have been a covered yard rather than permanent buildings. The space was depicted as building free on the 1905 25-inch scale OS county series map (Fig. 4) and remained so on the 6-inch OS map revision of 1938. The builder's premises were first depicted on the OS 10,560 scale map of 1956. Once again this comprised a covered yard, which survived until 2017.

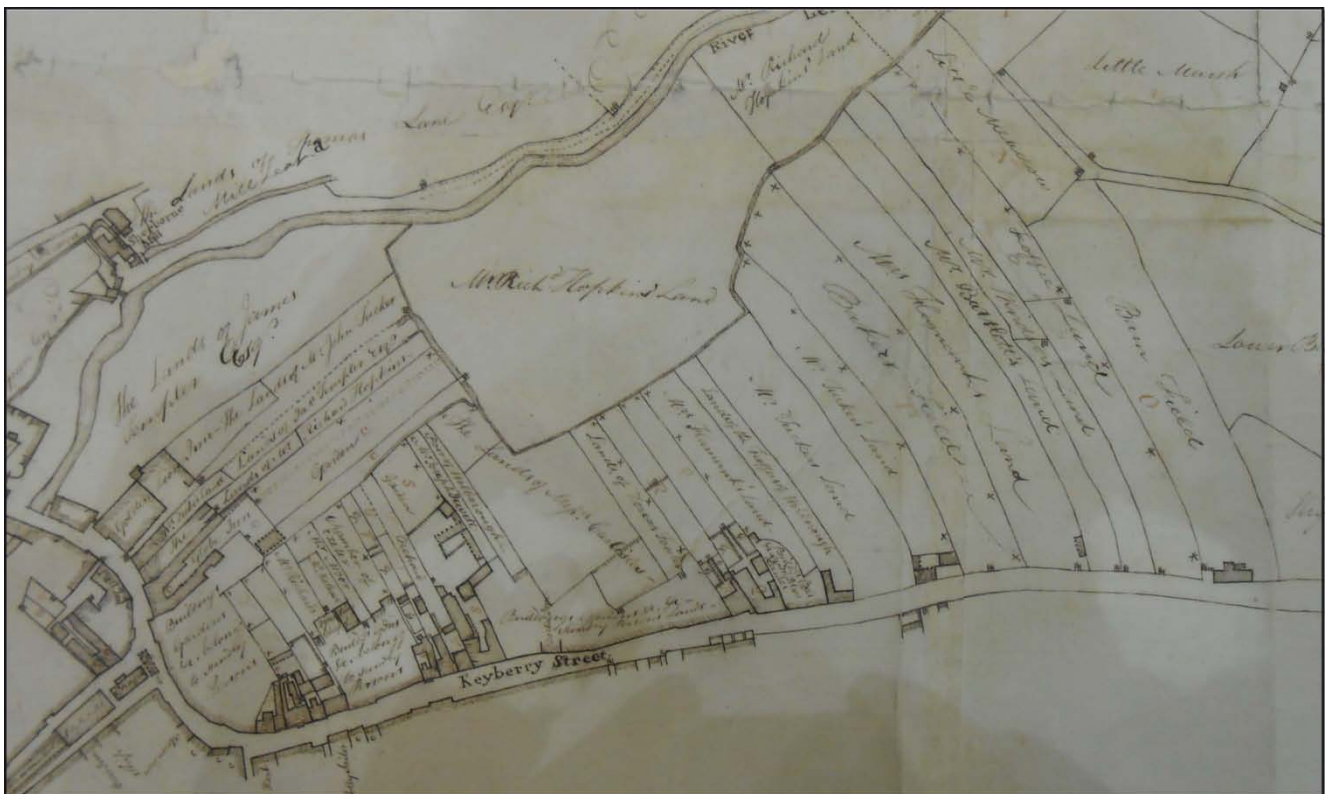
Fig. 2 Extract from a large scale map of Newton Abbot c.1803. (DRO 1508M/maps & plans/Newton Abbot/map/1)

On Donn's map of Devonshire, published in 1765, development along East Street had not extended as far as the location of modern Union Street, so the site was outside the built area of the town. The first edition Old Series OS map of 1802-4 depicts some of the street-front properties in East Street, though the area to the north was still undeveloped, and appears to have been occupied by several orchards. A large scale map of 1803 (Fig.2), similarly shows this area to be undeveloped (DRO 1508M/maps & plans/Newton Abbot/map/1).

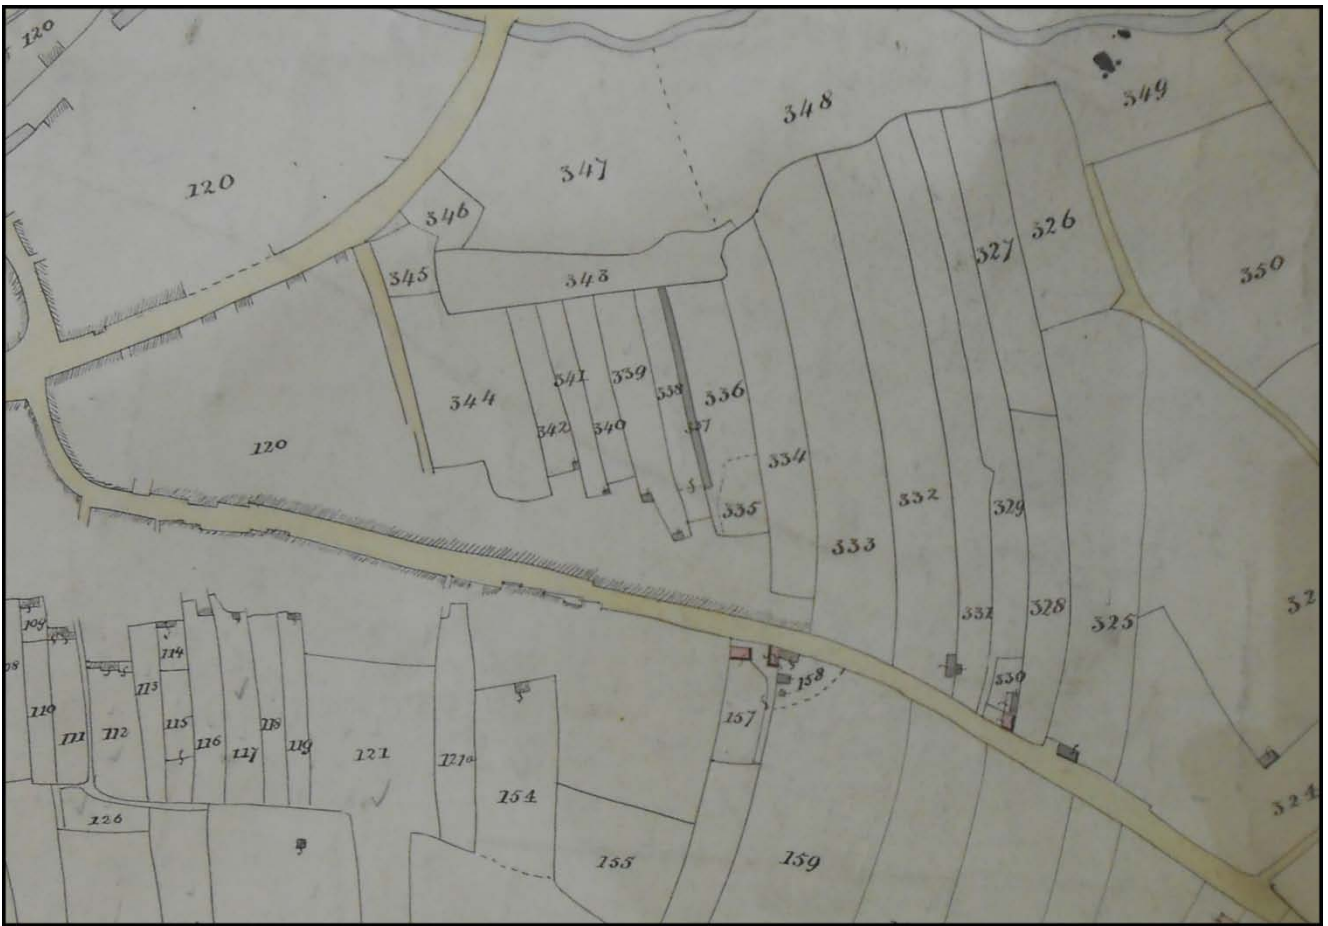
Fig. 3 Extract from the Wolborough Tithe Map of 1846 (DRO).

from old map sources including the Wolborough Tithe Map of 1846, on which the plots are clear (Fig. 4). Much building in Newton Abbot occurred after 1846, when many of these plots were effaced, but by 1889, when the OS 6-inch scale map was published, their alignment had clearly influenced the road layout and some had become fossilised into modern property boundaries. Although several documented plots around Wolborough Street were in existence by the 14th and 15th century, in East Street the earliest reference to any plot is 1640 (Weddell 1985, 99), though it may have had earlier origins.

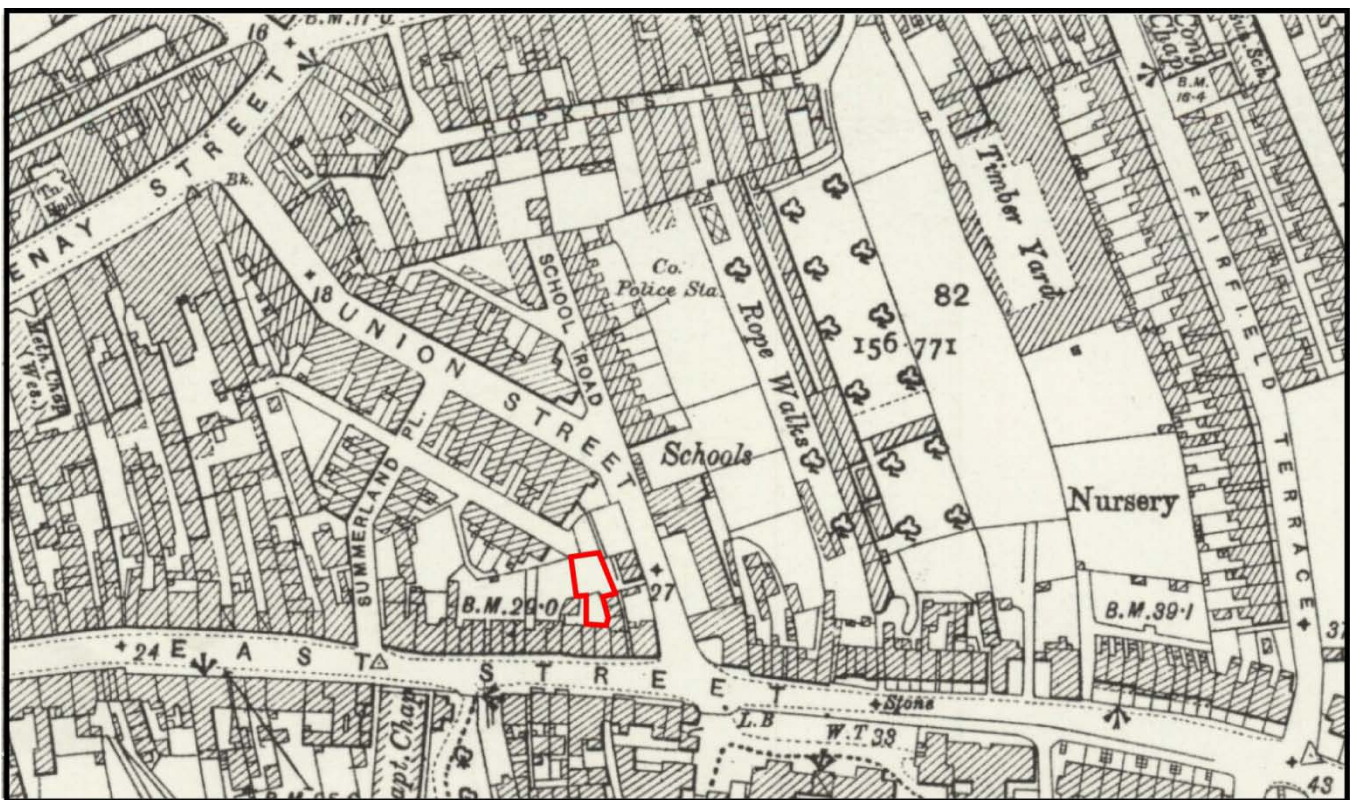
Fig. 4 Extract from OS 25-inch County Series of 1905, showing the plot without buildings.

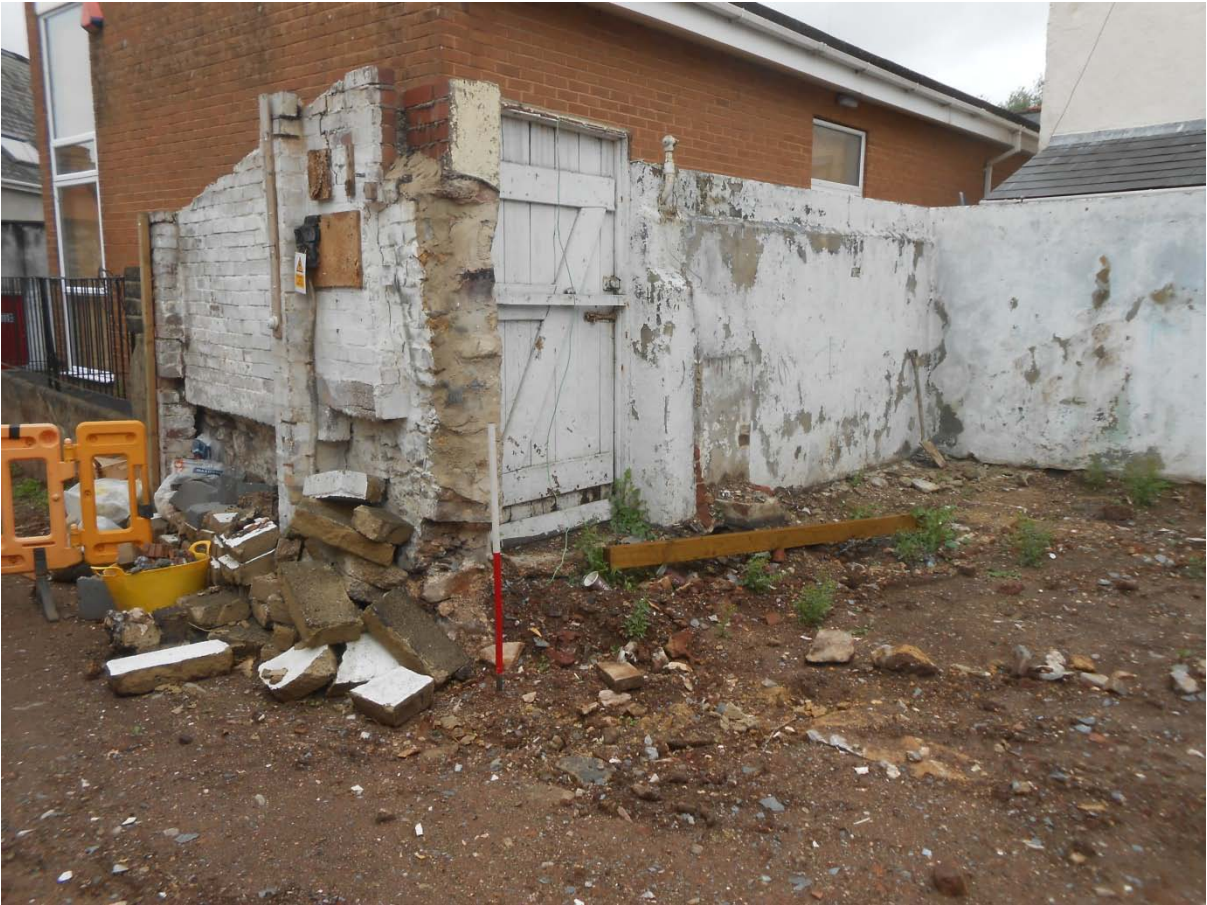
Fig. 7 View of the northern boundary wall before demolition.

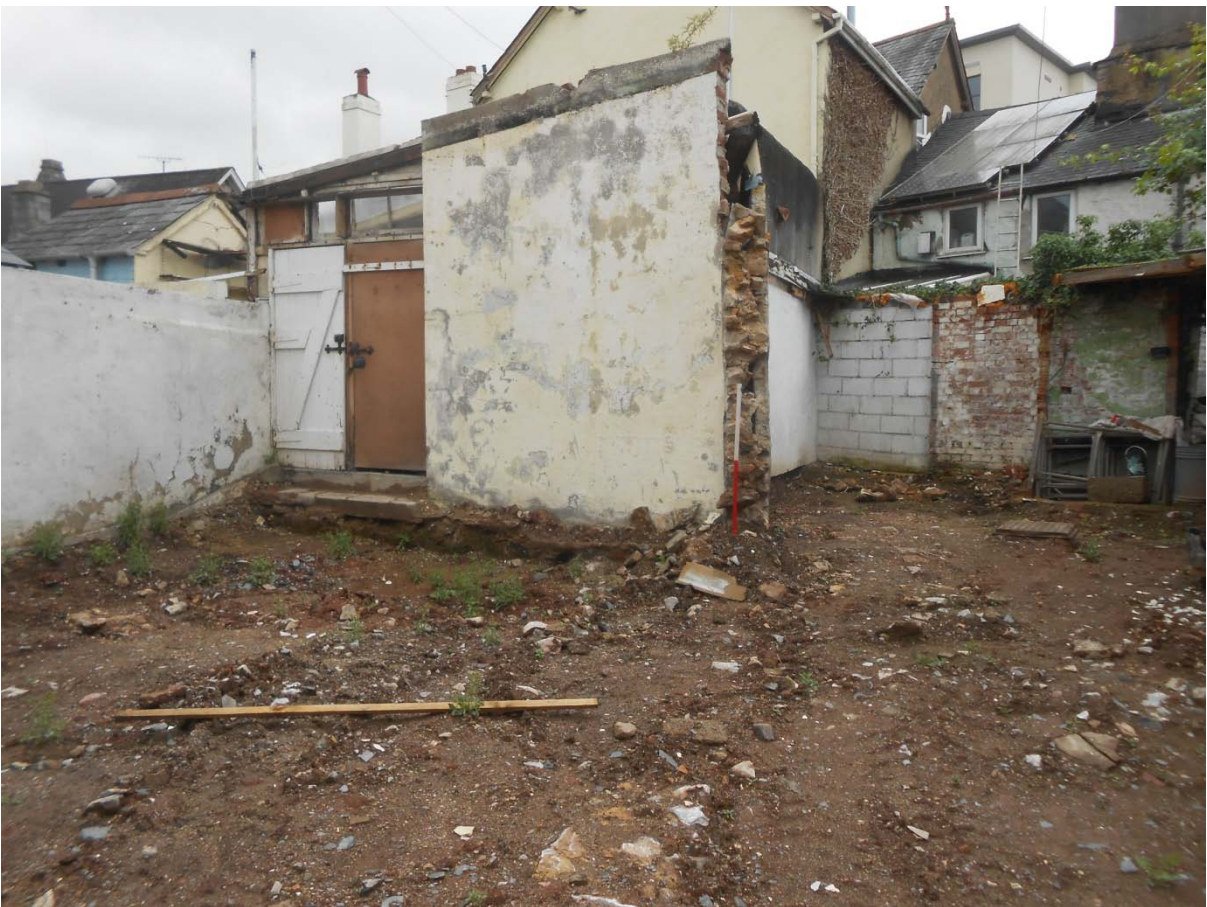
Fig. 8 view of the southern boundary wall before demolition.

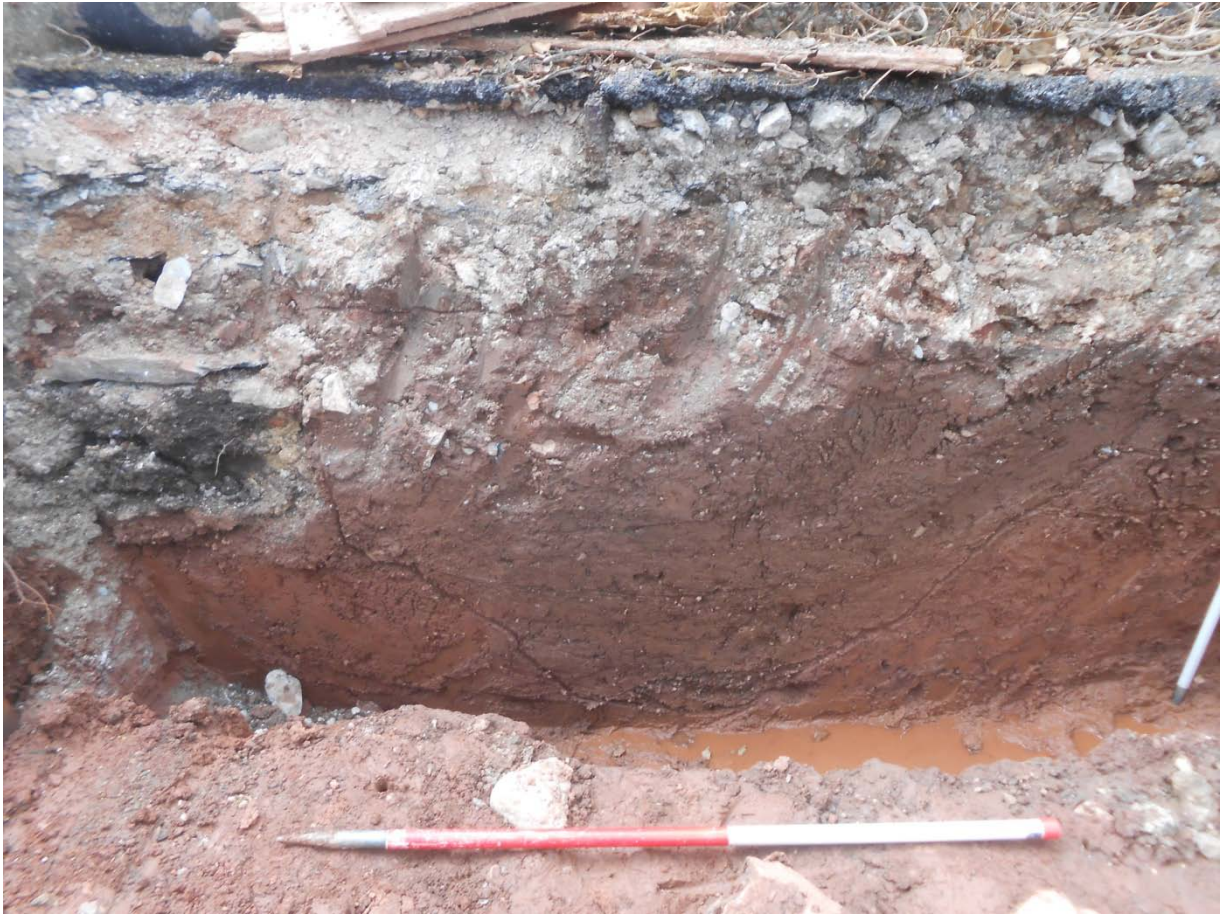
Fig. 9 The northern boundary section showing the cut ditch with rubble above.

No evidence of structures or of pits or similar features was encountered during the digging of the groundwork trenches. However, a fully backfilled ditch (F1) with a curved profile, could be seen in section, where the groundwork trench ran parallel with a neighbouring boundary on the northern edge of the plot (Fig. 6). The probable continuation of the ditch was visible in the southern boundary trench, confirming that it runs approximately north to south. The majority of this feature, between these two trenches (7.5m long in total) was not investigated due to it being unaffected by groundworks.

A backfilled ditch runs approximately north to south across the site and is coaxial with surviving property boundaries, which extend north from East Street. The latter are believed to represent fossilized medieval burgage plots, which are known from old maps. The ditch therefore was probably associated with a burgage boundary, acting either as a physical boundary or as drainage.

The ditch, which was already partly silted, was probably deliberately backfilled, though the date of this event is not known. Ceramic finds retrieved from the fill of the silt (104) confirm that backfilling was no earlier than the 17th century. However, the actual date of backfilling is more likely to have been in the mid 19th century when the streets around this site were first developed.

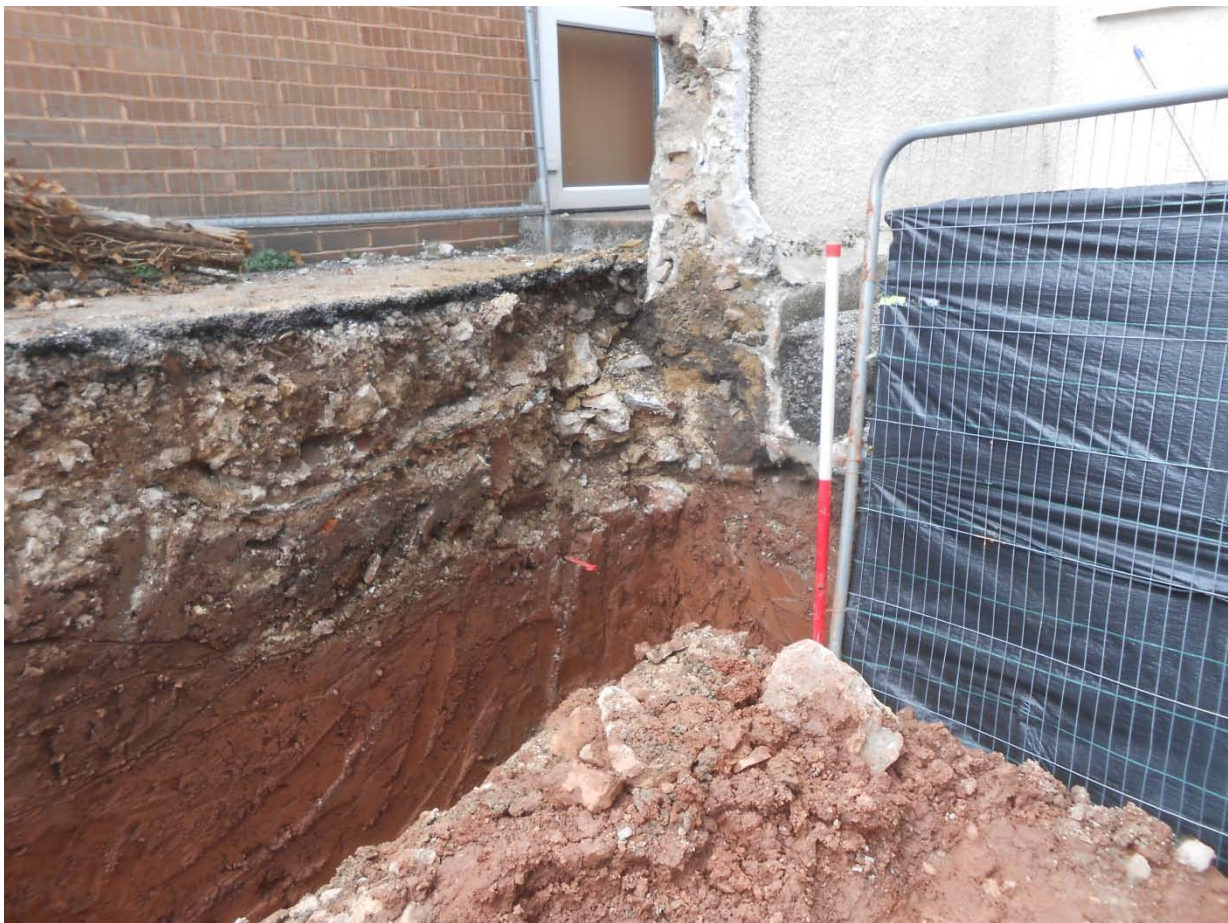
Fig. 10 corner of the north and east boundaries showing height difference with neighbouring properties.

Prior to the commencement of these groundworks, brick and stone revetments and walls surrounding the site were demolished and a concrete floor removed. With these features gone it was clear that the ground surface had been lowered in the past and levelled within the plot by up to 1 metre. This probably occurred when the covered yard was constructed in the 19th century, or when re-established in the 1950s, to accommodate the concrete base. With the boundary walls removed, the original soil levels were exposed to a higher level under neighbouring properties on the south, north and eastern boundaries, revealing the extent of this level change .

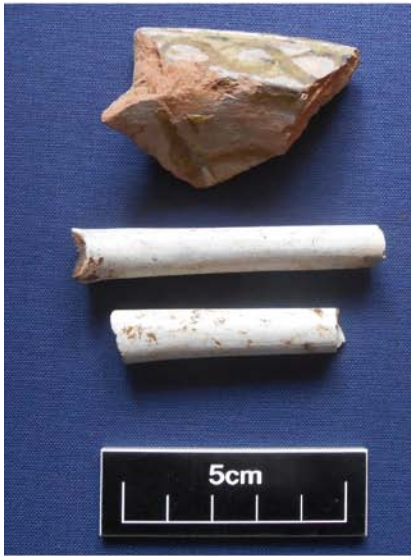
Fig. 11 Finds from Context 104.

1 rim sherd South Somerset flanged bowl or chamber pot with internal slip, and sgraffito line decoration with flecks of copper dated c.1580-1650.

2 thick tobacco pipe stem fragments, 45mm and 65mm long, with 3mm bore, c.17th-18th century.

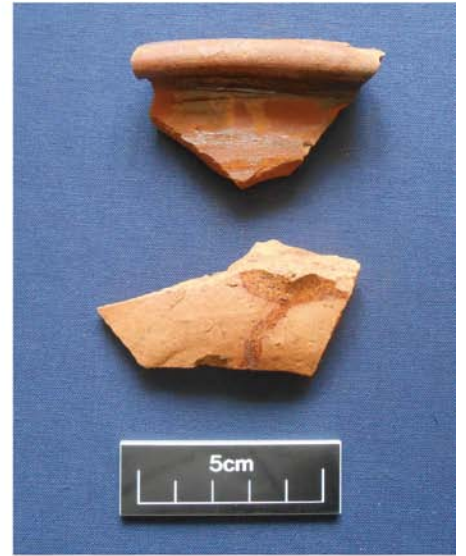
Fig. 13 Unstratified finds.

1 large chamber pot rim sherd. South Somerset ware, or a Devon copy of that style, using a pale clay. Trailed slip decoration with figure-8 scroll on the upper body and slip on top of rim. c.1720-1770.

1 South Somerset small dish with internal green glaze, 17th century.
