VII.—WARKWORTH CASTLE.

NOTES ON DISCOVERIES MADE DURING THE OFFICE OF
WORKS' OPERATIONS ENDING 1931 BY LIEUT.-COLONEL
G. REAVELL, F.R.I.B.A.

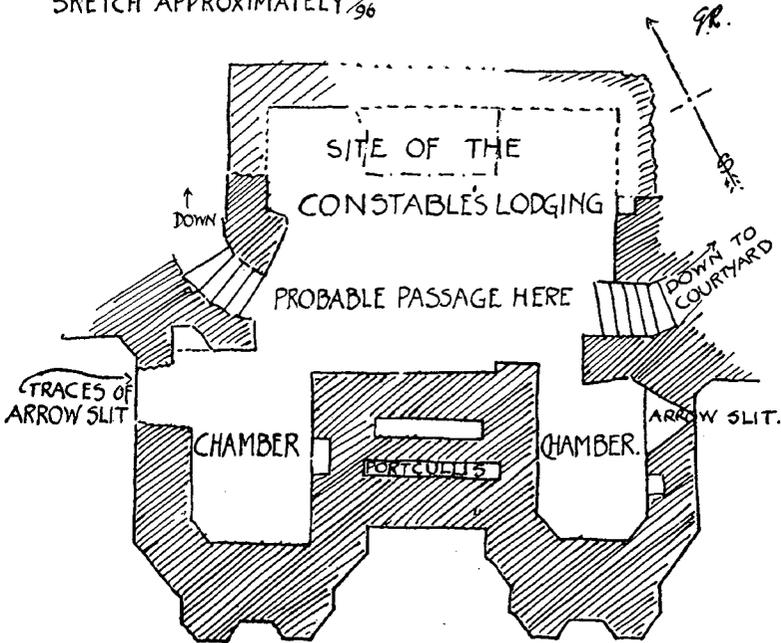
WARKWORTH CASTLE. FIRST FLOOR OF GATEWAY.
 SKETCH APPROXIMATELY $\frac{1}{36}$

lower steps of this staircase have been replaced in their original position and balance those on the other side of the gatehouse. This correction, obvious in itself, is verified by the drawing existing in Alnwick Castle made about 1850. The rubbish and filling on the first floor have been removed, leaving an arrangement as sketched above.

There are two chambers, still vaulted, with archery slits enfiling the south walls and a space in which would

have been the chamber referred to as the Constable's Lodging, behind which no doubt a passage connected the two staircases.

Behind the latter are the two spaces—one for the portcullis referred to in the *History of Northumberland* and the other the subject of speculation. May it have been for some system of balance weights for the portcullis?

The clearance of debris on the first floor west of the porter's lodge shows at the end of the wall passage the beginning of steps leading up to the battlement in the south curtain wall as inferred by Mr. Bates.

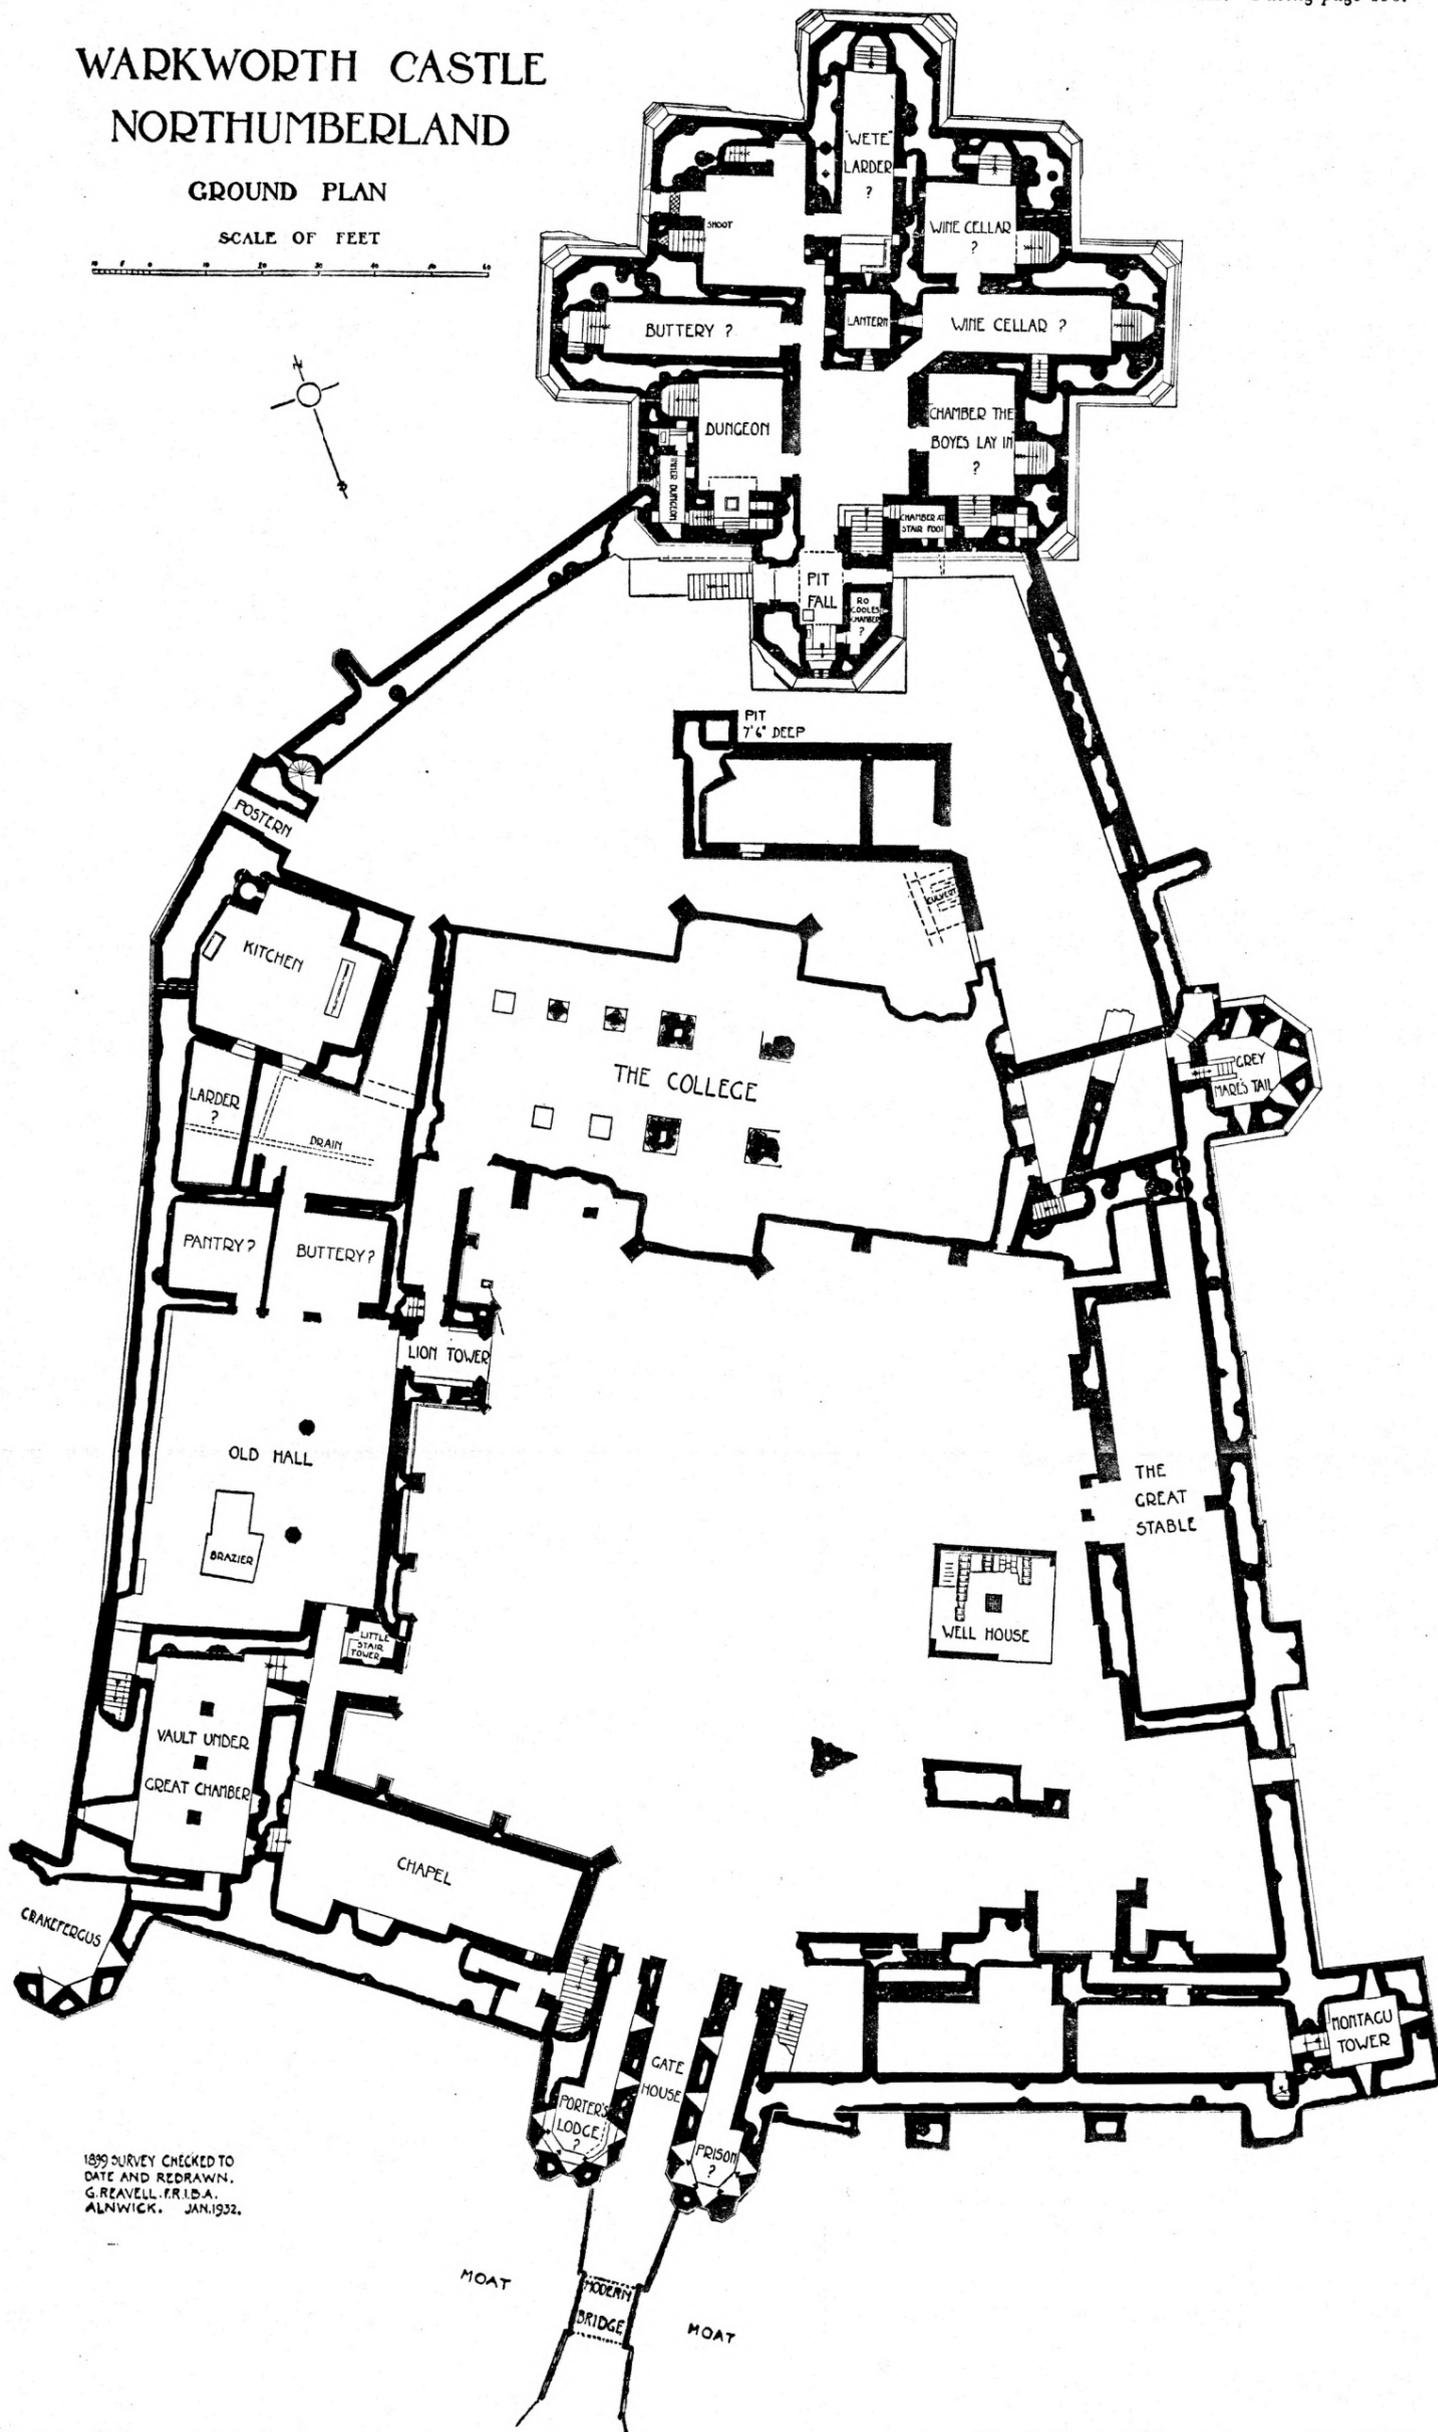
GROUND PLAN

1899 SURVEY CHECKED TO
DATE AND REDRAWN.
G. GRAVELL, F.R.I.B.A.
ALNWICK, JAN. 1932.

I have taken as a basis the ground plan prepared by my late father in 1899 at the cost of the Duke of Northumberland for the purpose of the description of the castle in the *History of Northumberland* (vol. V, pp. 18 ff.) by the late Cadwallader J. Bates. I have examined in detail all places where any new surfaces have been exposed and have embodied them in the new plan. The nomenclature of the original plan has been accepted throughout. (Plate xxii.)

Beginning at the gatehouse, it will be noticed that the moat which, as shown by the illustration in the *History of Northumberland*, vol. V, facing p. 84, had been filled up, has now been excavated disclosing stone approaches to the drawbridge as indicated on the new plan. (Plate xxii and plate xxiii, fig. 1.) That this stonework is not coeval with the gatehouse is clear though it is difficult to date it. There is no trace of the drawbridge itself nor has either the external excavation or the internal clearance thrown any light on the way in which the drawbridge was operated. The work was stopped without a thorough exploration being first made below ground at the gateway. I believe there is some hope that at a future date this may be resumed. In the meantime a wooden bridge and balustrade have been erected to serve present purposes, leaving the stonework exposed. (Plate xxiii, fig. 1.)

Near the well house, foundations of "The Great Stable" have been bared, and are shown correctly on the new plan. Between this stable and the Montagu Tower foundations, obviously modern and marked in the 1899 plan as the "Gardner's Chamber," have been removed.

Between the college and the donjon the building referred to by Mr. Bates as the brew house has been exposed and correctly shown.

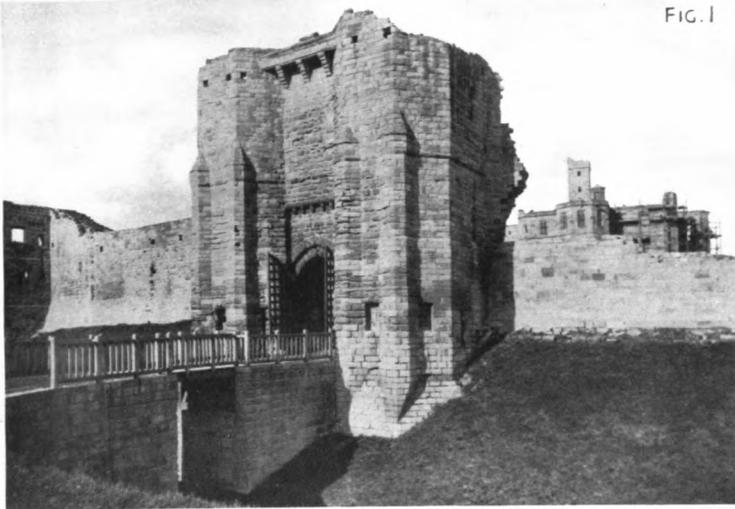
FIG. 1

1. GATEHOUSE EXTERIOR. 2. GATEHOUSE INTERIOR.
3. VIEW FROM N.E., TAKEN FROM TOP OF THE TOWER.

The windows, so crudely inserted into the gatehouse to form a porter's lodge, have, since the photograph was taken, been removed and the arrow slits have been restored, and inside the porter's lodge the partition and staircase, the latter leading to comparatively modern rooms above, have been removed together with the lean-to roofs and enclosure walls of the rooms themselves. The
