IV.—HOUSESTEADS MILECASTLE.

BY PETER HUNTER BLAIR.

[Read on 28th March, 1934.]

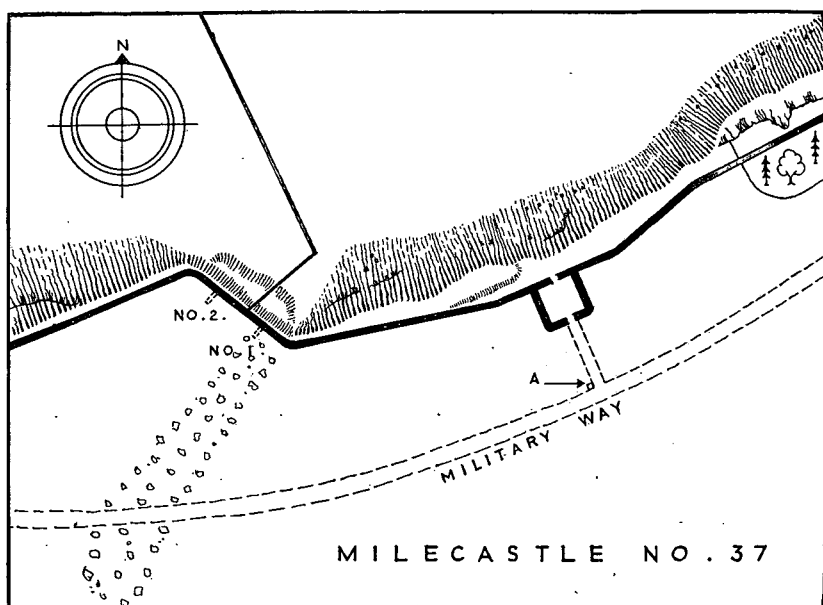
FIG. 1.

At a point about 85 feet to the south of the south gateway, two kerbstones were found set at right angles to the north kerb of the military way. These were all that remained of the road connecting the milecastle with the military way (see point A on site plan, fig. 1).

Three sections of the Wall footings in this area are shown in fig. 2; of these the site plan shows the positions of no. 1 and no. 2, where it was not possible to dig on the north side of the Wall, and the third is 20 feet west of Knag burn. At no. 1 the breadth from the foundation which projects 10 inches on the south side to the northern face of the Wall is 9 feet: above the foundation the Wall is reduced by four offsets of 8, 5, 3 and 7 inches to a final breadth of 6 feet 3 inches. At no. 2 the greatest measurable breadth was 7 feet 6 inches, the foundation projects 9 inches and one 6 inch offset reduces the Wall to a breadth of 6 feet 3 inches. At no. 3 both faces were exposed: the width of the foundation is 11 feet:

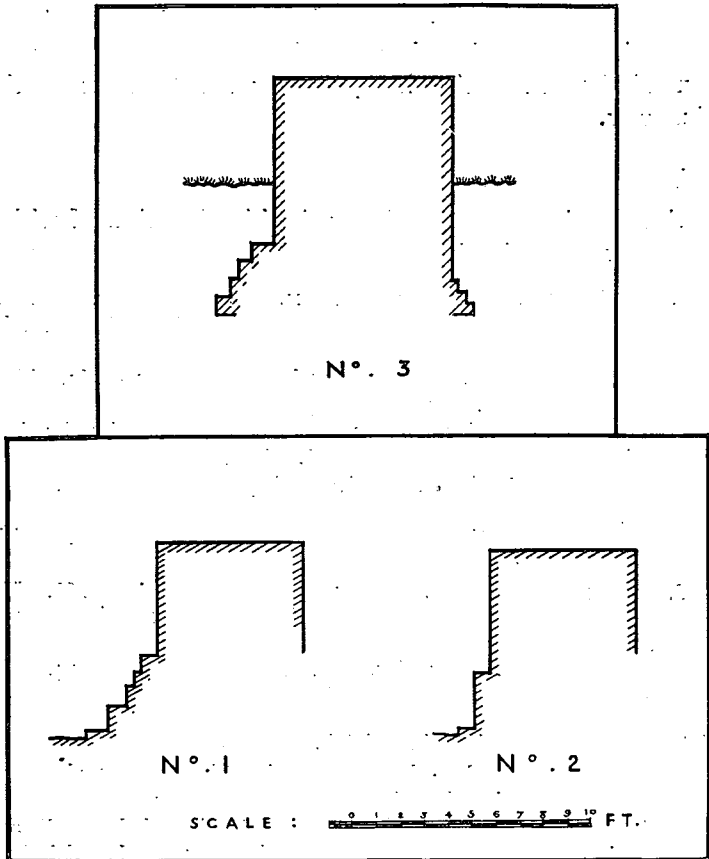
FIG. 2.

on the north side the foundation projects 4 inches and there are two offsets of 5 and 4 inches: on the south side the foundation projects 8 inches and there are three offsets of 3, 6 and 11 inches, leaving a final breadth of 7 feet 6 inches.

At no. 1 and no. 3 we meet the broad foundation carrying the narrow Wall, a combination usual in the gaps between the crags. The extreme narrowness of the Wall and the excessive number of offsets at no. 1 is perhaps to be explained by reconstruction during the Roman period. No. 2, whose position is on the upward slope rather than in the gap itself, reveals the narrow wall on the narrow foundation. A modern field drain passes through the Wall between no. 1 and no. 2 and the foundations there have been much disturbed.

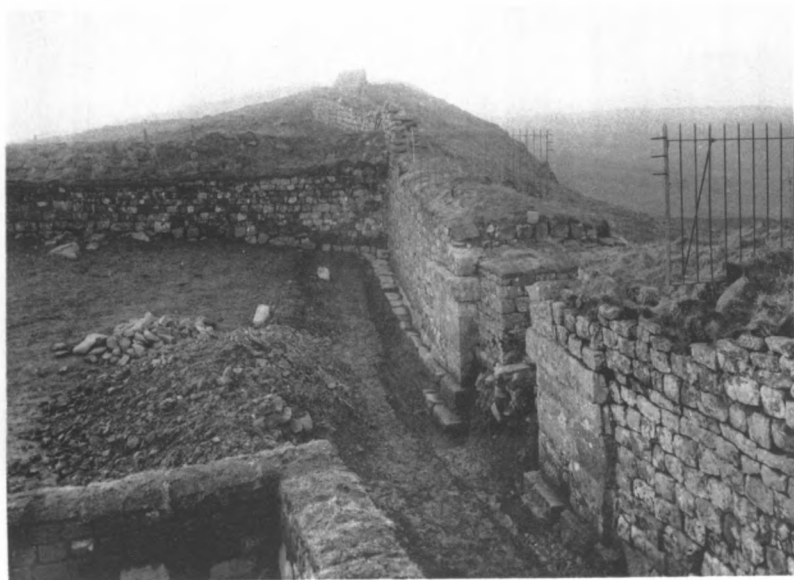
Fig. 1. HOUSESTEADS MILECASTLE, NORTH GATE FROM EAST.

Period 1. The gateways are built of massive and carefully tooled masonry (plate xv, fig. 1). They are similar in plan and conform to type 15,⁸ with arches at each end of the passage. The piers of the north gateway are standing complete to a height of 6 feet 6 inches above the foundations; both springers of the inner arch and one of the outer are still in position.⁹ The existing height of the passage walls suggests that they were originally taken up to the level of the rampart walk, which was probably carried over on wooden beams. The total length of the passage is 10 feet and exceeds the thickness of the wall only by a few inches; the width of the passage was originally 10 feet 6 inches, increasing to 12 feet between the inner and outer piers which project into the passage. The outer piers form the jambs of the doors. There are two pivot holes, one on each side of the passage at its outer end in the angles formed by the passage walls and the projecting gate piers. It is clear that at the end of the first period of occupation the north gate must have been violently overthrown. When Mr. Simpson cleared away the core of the secondary masonry so as to expose the original face of the passage walls, he found that on the west side, the whole northern pier had been tilted out of position so as to leave a crevice $2\frac{1}{2}$ inches wide at the bottom increasing to more than 6 inches at the level of

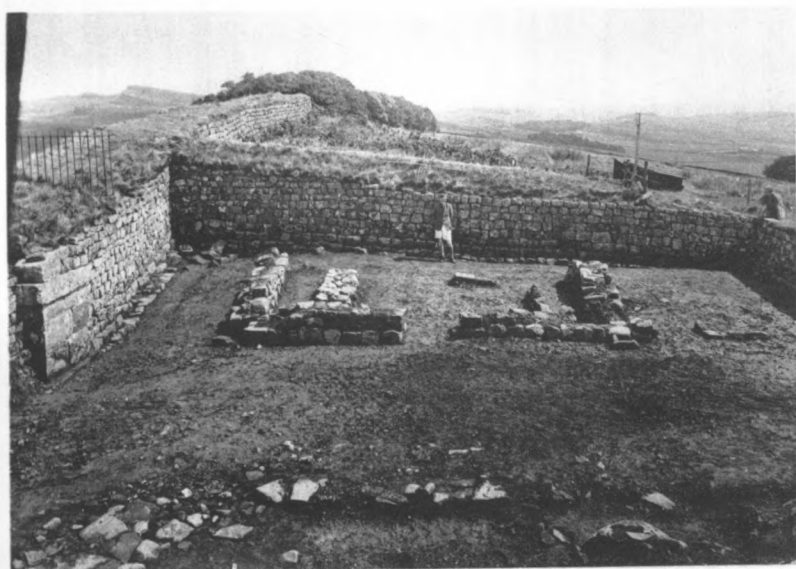
Fig. 2. HOUSESTEADS MILECASTLE, INTERIOR FROM WEST.

On the eastern side of the road, perhaps owing to the greater depth of soil, there was much more left (see plan, plate xvii and plate xv, fig. 2). There seems originally to have been a rectangular stone building with two rooms. Of this building there survived the remains of three walls, the north, the west, and the partition wall between the two rooms. There was no trace of east or south walls. The north wall, standing three courses high at its highest point with a breadth of 2 feet 6 inches, was broken off 3 feet 6 inches from the east wall of the milecastle. It appeared to have slipped from its original position. At its junction with the west wall of the building a number of stones were missing. The west wall, also standing at the most three courses high with a breadth of 3 feet 6 inches, was broken off 4 feet 6 inches from the south wall of the milecastle. There was no sign of any return to the east. Both these walls were built with a mixture of freestone and whinstone set in clay on top of a foundation of large whinstones. The partition wall was built of smaller stones; it was bonded in with the west wall and extended for a distance of 8 feet towards the east. The west wall was divided into three parts by doorways 3 feet 6 inches wide giving access to each room. Though no threshold remained both pivot holes were in position; that belonging to the northern room was against the southern jamb of its doorway, and that belonging to the southern room was against the northern jamb.

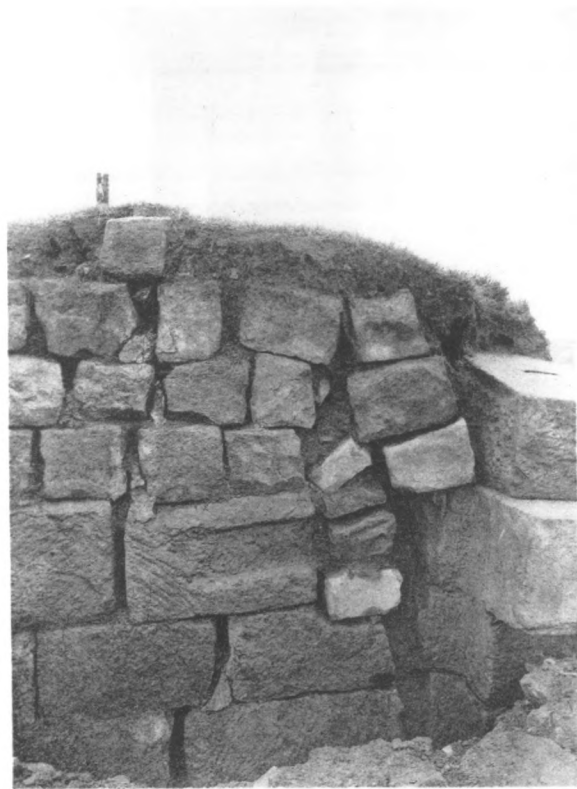
Fig. 2. N. GATE, SHOWING DISPLACEMENT OF N.W. PIER.

the impost. Such violence had been applied that the stone beneath the impost, which extended through the full thickness of the pier and 1 foot 10 inches from the pier into the passage wall, had been snapped in two. The stones at the northern end of the passage wall had been dragged from their original beds in such a way as to open the vertical joints to $1\frac{1}{2}$ inches. (Plate xvi, fig. 2.) On the east side the northern pier had been tilted $1\frac{1}{2}$ inches out of position. The springer of this pier is no longer in place and the outer face of the impost has been fractured. The form of the fracture suggests that it may have been caused at the moment when the arch had been tilted out of position and was on the point of collapse.¹⁰ The gates had been secured on the inside by a bar, probably of wood. On the east side of the passage wall at its northern end was a slot 6 inches deep, into which one end of the bar would be inserted; on the west side a gradually deepening groove was cut horizontally in the passage wall in such a way as to enable the bar to be swung into position behind the gates: when the bar had been so swung it then dropped downwards into a slot similar to that on the east side. (Plate xvi, fig. 2.)

Period 2. When the north gateway was restored the northern piers were not replaced in their original positions. The crevice on the west side was loosely packed with rough material (plate xvi, fig. 2). The passage was narrowed by masonry built out from both sides of the original passage walls, while at the same time the road level was raised by 2 feet 6 inches. The narrower passage is 8 feet long and 5 feet wide.¹¹ There is a pivot hole at its northern end on the west side. Bruce thought that the southern gateway had "evidently been diminished in width as well as the other,"¹² but there is now no evidence of this.

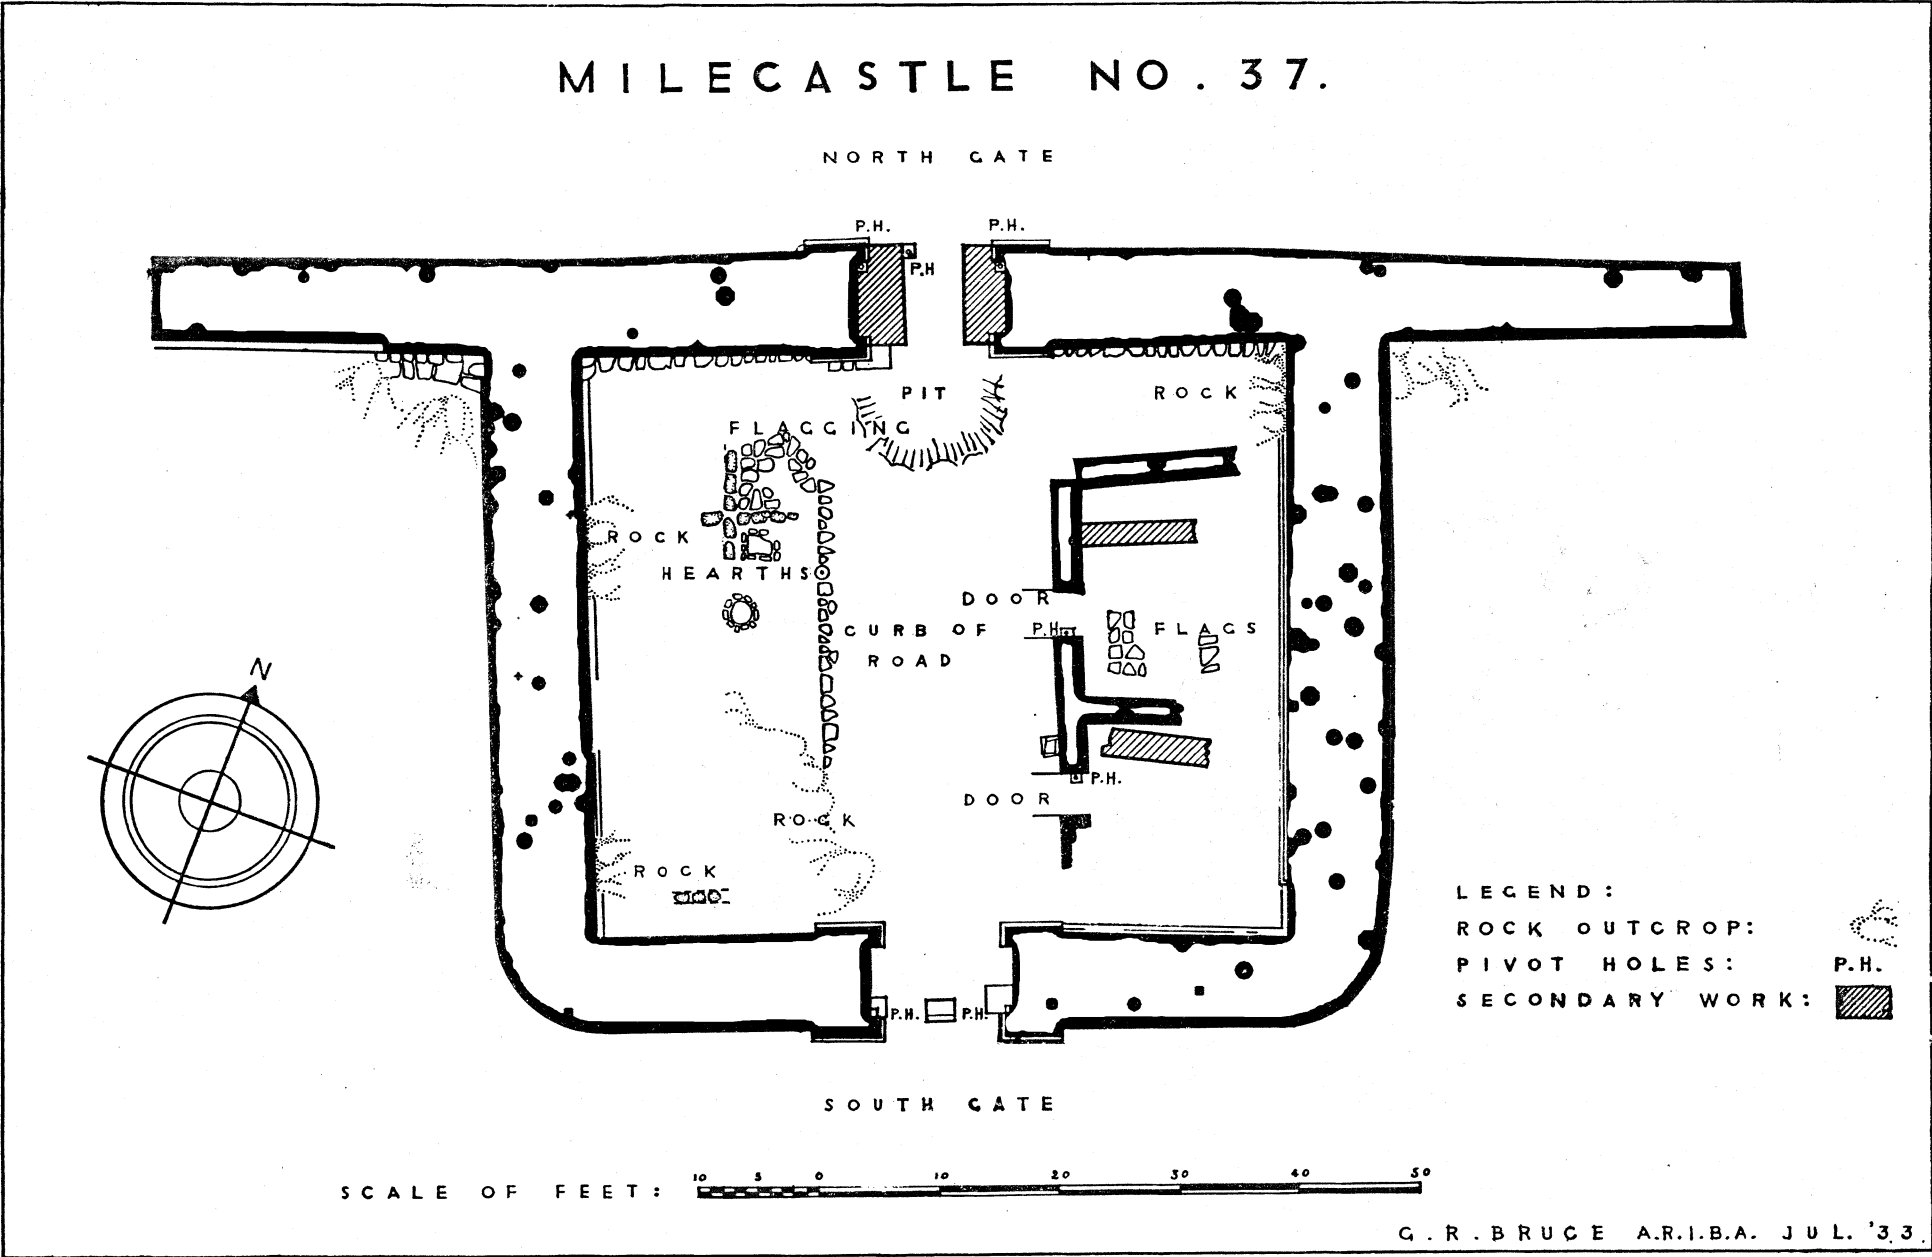
Structural remains in the western half of the milecastle were very slight (see plan, plate xvii). In the midst of a small patch of flagging near the northern end were a few roughly shaped whinstones set in line, one series parallel to the north wall and another parallel to the west wall, and cutting each other at right angles; these may have been the foundations for thin partition walls of wood or lathe and plaster, but they could hardly have borne the weight of anything more substantial. Underneath one of the flags in this area was found a worn legionary coin of Mark Antony. There were two small hearths, each consisting of a large central flag laid on a bed of clay and surrounded by a number of smaller flags set on edge. Both had been heavily burnt and both were slightly raised above the small patch of flagged floor which survived. The natural surface of the ground in the western half is very unlevel and much broken by outcrops of rock. At the southern end a quantity of mason's chippings was found in the interstices of the rock as if some attempt had been made to smooth out the irregularities of the surface. Close to the south wall were three whinstones set in line, similar to those nearer to the north wall. The western half divides itself roughly into two areas, of which the southern is about one foot above the level of the northern. There was a little evidence to suggest that this had been stepped; indeed if the whole area was occupied some such device must have been adopted. At its southern end the western kerb of the road is interrupted by the rock, which slopes across the area from north-west to south-east. A small triangular space between the kerb of the road and the edge of the rock was filled with clay packing as if it had been intended to give a straight edge to a downward step from south to north.

The piers of the gateways are founded on rock throughout or at most separated from it by an inch or so of clay. At the north gateway the rock dips sharply from east to west, the dip reaching its maximum depth beneath the western half of the gateway. To counteract the inequalities of the surface deeper foundations were laid for the western pier than for the eastern; the lowest course beneath the western pier has a maximum depth of 1 foot 9 inches on the east side, decreasing westwards as the level of the rock rises again, while it projects 1 foot 6 inches and 10 inches from the east and south faces respectively of the foundation course proper (see plan, plate xvii and elevation, plate xviii).
