XI.—THE FORT ON HADRIAN'S WALL AT HALTON.

BY F. G. SIMPSON AND I. A. RICHMOND.

[Read on 31st March 1937.]

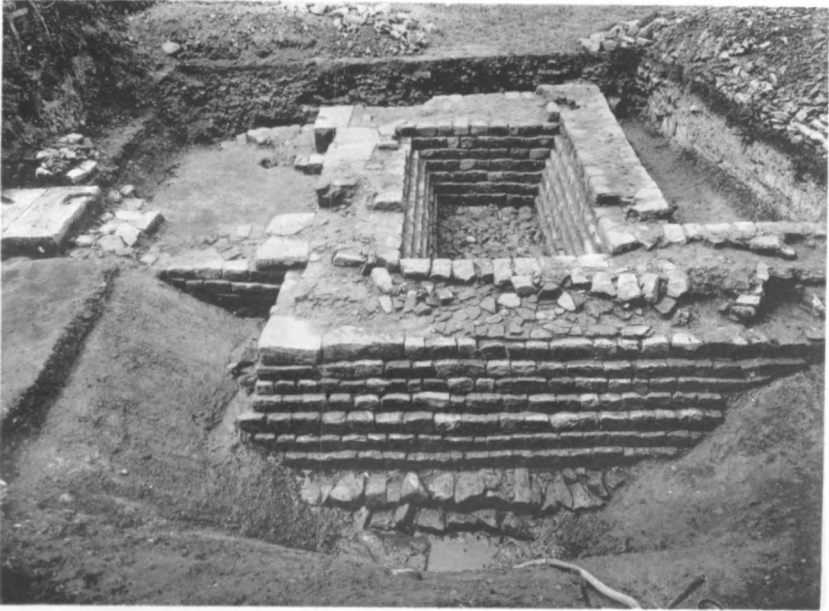
FIG. 2. HALTON CHESTERS: FOUNDATIONS OF MAIN EAST GATE.
BUILT ACROSS THE DITCH OF THE GREAT WALL.

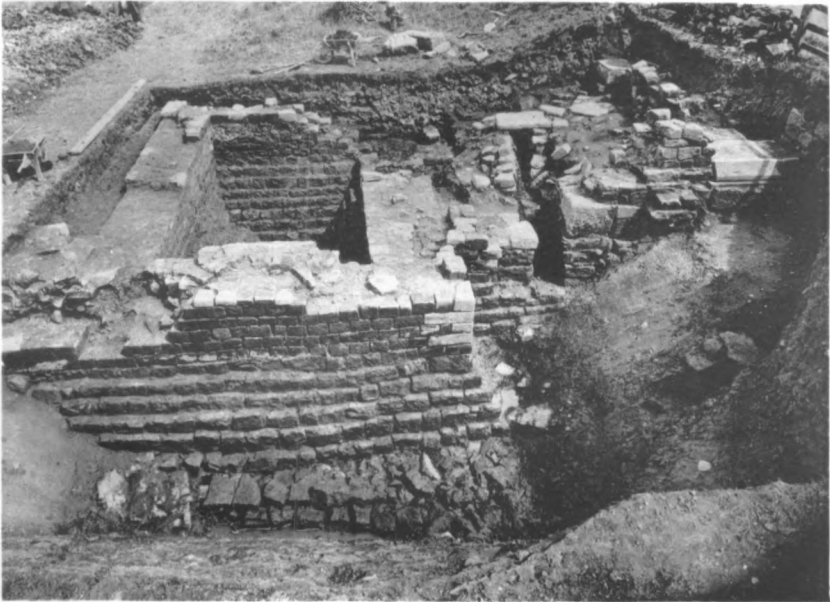
FIG. 1. HALTON CHESTERS: FOUNDATIONS OF MAIN WEST GATE.
BUILT ACROSS THE DITCH OF THE GREAT WALL.

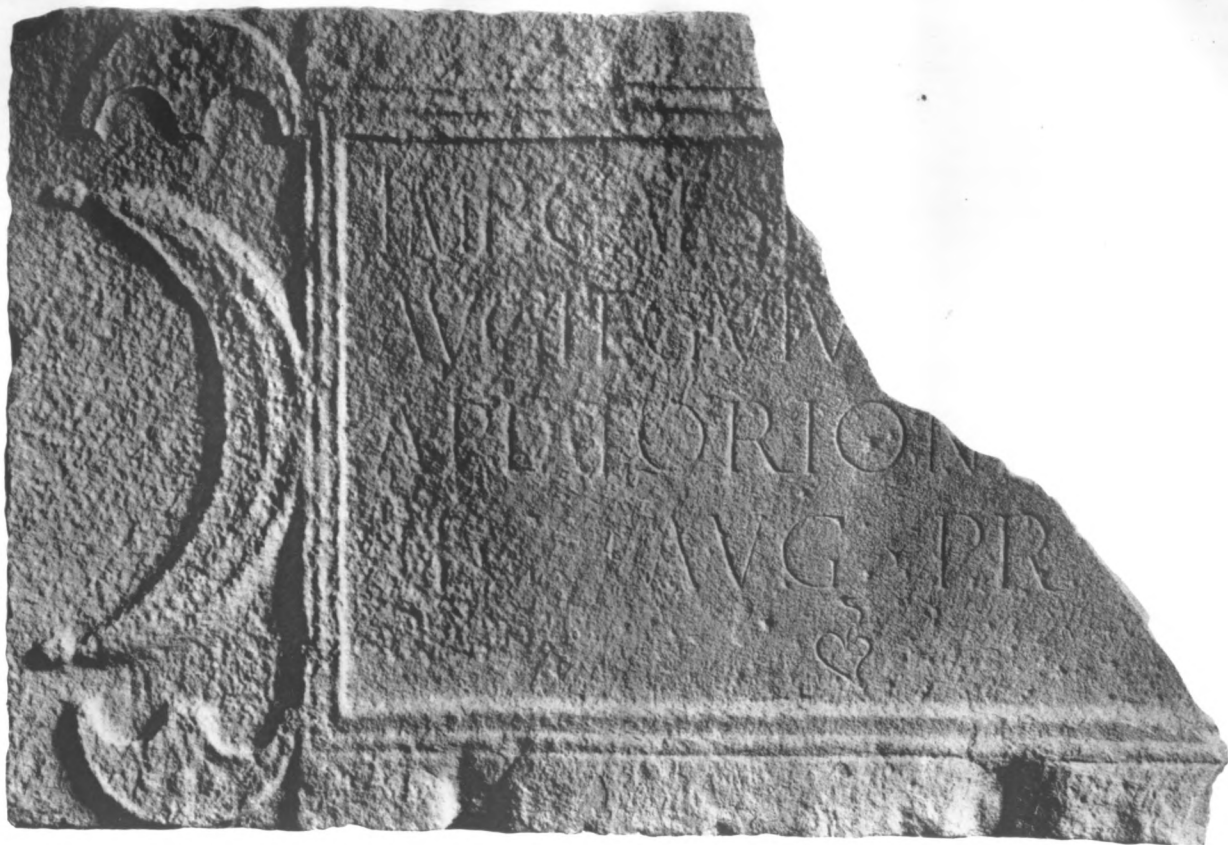
HALTON CHESTERS: DEDICATION-SLAB OF HADRIAN AND PLATORIUS NEPOS
FROM MAIN WEST GATE. A.D. 122—c. A.D. 126.

It is, however, clear that the main archways of the gate were erected. This may be inferred from the existence of the superstructure on the inner central pier and the gap from which stone-robbers have removed such masonry on the outer pier. Doubtless the archways, as in milecastle-gateways, would be among the first parts of the building to be erected. This must also be taken to account for the fact that the dedication-tablet of the gate was in position: for a broken half of the slab (pl. XXIII), exposed to heavy weathering before it fell, was found on the ground, face downwards, in front of the central pier. It had evidently fallen from the haunch above the pier, occupying the same position between the two arches as the sculptured slab once visible on the east gate¹¹ of Chester. The text, no less interesting than the other features, is given below.
