## II.—CASTLES OF NORTHUMBERLAND FROM THE AIR.

BY J. K. ST. JOSEPH.

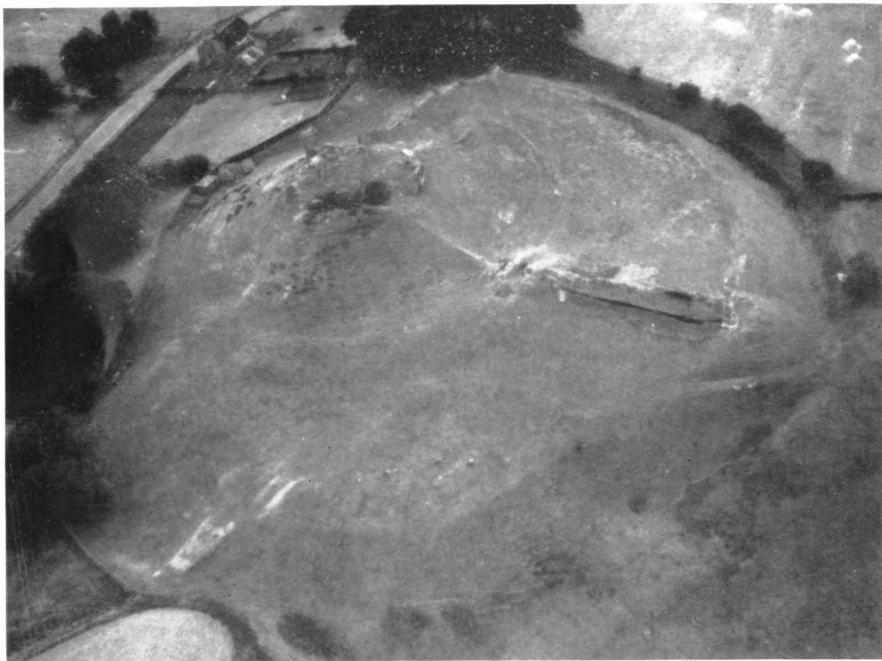
FIG. 2. HARBOTTLE.

As may be seen from the photograph (plate II, fig. 2), which was taken from the east, the sides of the mound have been steepened, and the summit levelled, while in the middle of the south side a circular motte has been thrown up, partly carved out of the mound, with which it is connected by a solid causeway on its west side. Few remains of this first castle or of two subsequent reconstructions in stone, about the beginning and end of the thirteenth century, now remain above ground. After withstanding more than one Scottish siege, it was ordered to be destroyed in 1321, under terms made with Robert Bruce. It was probably rebuilt towards the end of the fourteenth century, and about 1432 the defences were refashioned; most of the surviving walls are of these periods. The mound was divided by a cross-wall of which substantial remains exist, and the wall was continued westwards round the top of the slope, to surround a (reduced) bailey. This enclosure was entered by a gatehouse at the south end of the cross-wall, while towers protected its north and west angles. The massive stone wall, of which fragments can be seen crowning the motte, is probably also of early fifteenth-century date. The castle seems to have remained habitable for another century, for here in 1515 was born Margaret Tudor, grandmother of James VI of Scotland and I of England. The military needs that had led to the building of the castle had now passed, and its subsequent history seems to have been one of gradual decay in spite of efforts at repairs by wardens of the Middle March.

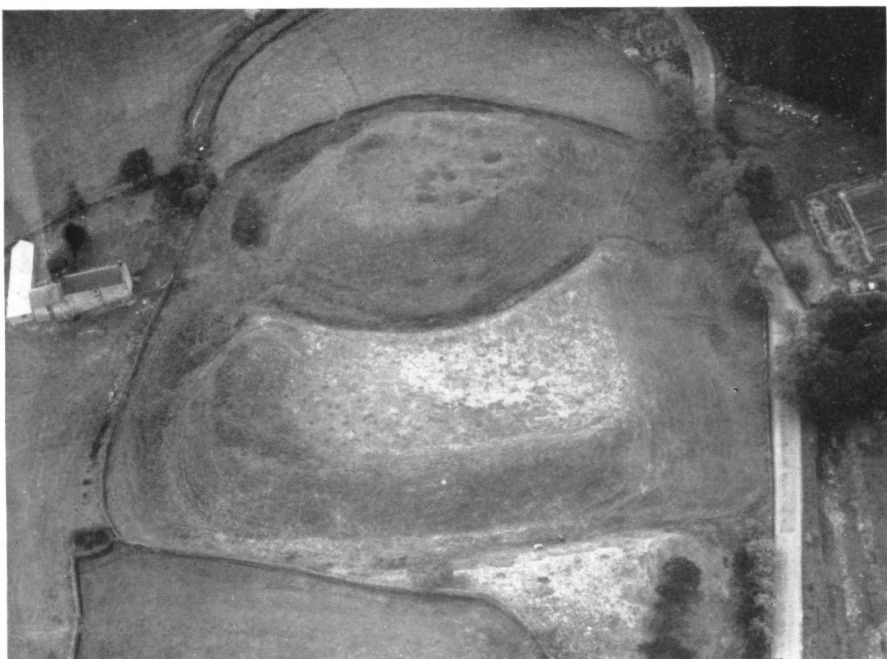
FIG. 1. ELSDON.

The earthwork known as the "Mote Hills", Elsdon, is an excellent example of an early Norman motte and bailey castle, unaltered by subsequent building. Constructed by Robert of Umfraville about 1080, on the east side of the Elsdon Burn, on an easy route between the valleys of Coquet and Rede, it was replaced about three-quarters of a century later by the castle at Harbottle, seven miles to the north, a more strategic centre from which to control the Middle March. The photograph (plate II, fig. 1) which faces south, shows the great circular mound, almost surrounded by a ditch. The bailey, on the north, nearly half an acre in area, is defended by a broad ditch and massive rampart on east and north; on the west, the steep slope of the ground may have been considered a sufficient defence. Originally there would have been access to the mound by a wooden bridge spanning the ditch between it and the bailey, while excavation might reveal the foundations of a stockade which is known from contemporary illustrations to have crowned the earthen defences of forts such as this.

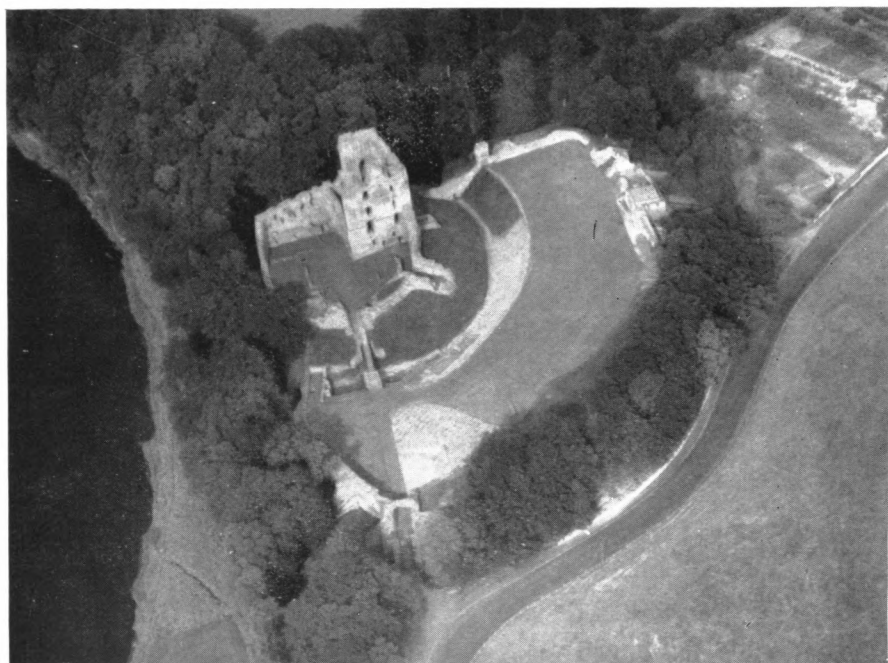
FIG. 2. NORHAM.

The photograph (plate III, fig. 2), which is taken from the west, shows the whole of the inner and outer wards; the main entrance to the outer ward was by "Marmion's Gate" at the north-west corner, just above the bend in the modern road. The core of this gate, the much damaged barbican gate directly behind giving access to the inner ward, the lower storeys of the keep, and the curtain-wall on the east side, are all twelfth-century work. The inner ward is surrounded by a deep ditch, originally crossed by a drawbridge, on the site of the present wooden bridge. To the left of this was the castle chapel: the walls of its undercroft, which was later converted into a stable, can be seen spanning the ditch.

In the inner ward, to the left of the gateway, lay the kitchen and butteries, then the hall and great chamber, beyond which were smaller rooms; all in their present form sixteenth-century building.

The square keep, which still stands to nearly 90 feet and forms so striking a feature of the ruins of Norham from whatever direction they are viewed on the ground, is rather dwarfed in the air photograph. The foundations of a narrow garderobe tower project from the south wall of the keep, and at a little distance along the berm of the inner ditch is the base of "Clapham's Tower", built in the early sixteenth century as a quadrangular bastion for artillery. A number of similar bastions with gun-ports were refashioned at the same time out of thirteenth-century turrets in the south wall of the outer ward. These are hidden by a belt of trees.

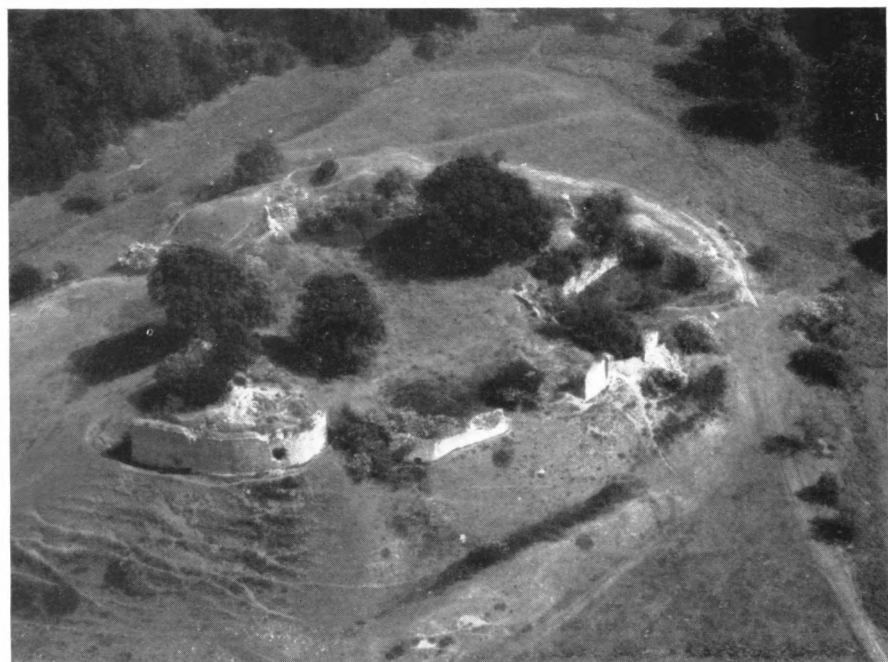
FIG. 1. MITFORD.

The castle lies two miles upstream from Morpeth, at an easy crossing of Wansbeck, between the existing channel of the river on the north, and an older abandoned channel, now occupied by a small stream, on the south and east. The mound so enclosed, seen in the photograph (plate III, fig. 1)

from the north-west, carries on its crest the main castle-wall. Below this wall, the slopes have been artificially steepened, while broad ditches form an additional defence to the south-east and west. The western ditch is clearly marked by a growth of dark vegetation.

Mitford castle was first held by the Bertrams. The motte, originally thrown up early in the twelfth century, can be seen above the steep slope in the foreground: it was the highest part of the enclosed area. No traces of the original defences (in wood) now survive, but they may have occupied much the same line as the existing stone curtain-wall which had been completed by 1138. Of this, the best preserved portion is that forming the west side of the inner ward. The wall round the bailey, probably built later in the same century, is more ruined, and at the south end of the mound it has been entirely destroyed by quarrying. Within the inner ward, the lower part of the walls of the pentagonal stone keep can be seen. This replaced in the early thirteenth century whatever structures had formerly stood upon the motte, but no trace of other internal buildings are now visible. More than once, Mitford was the headquarters from which rebel bands plundered the surrounding country, but by 1321, after a siege, the castle had become a ruin and was never restored, being subsequently used as a quarry for dressed stone. The ruins passed in 1666 to the Mitford family in whose possession they remain.

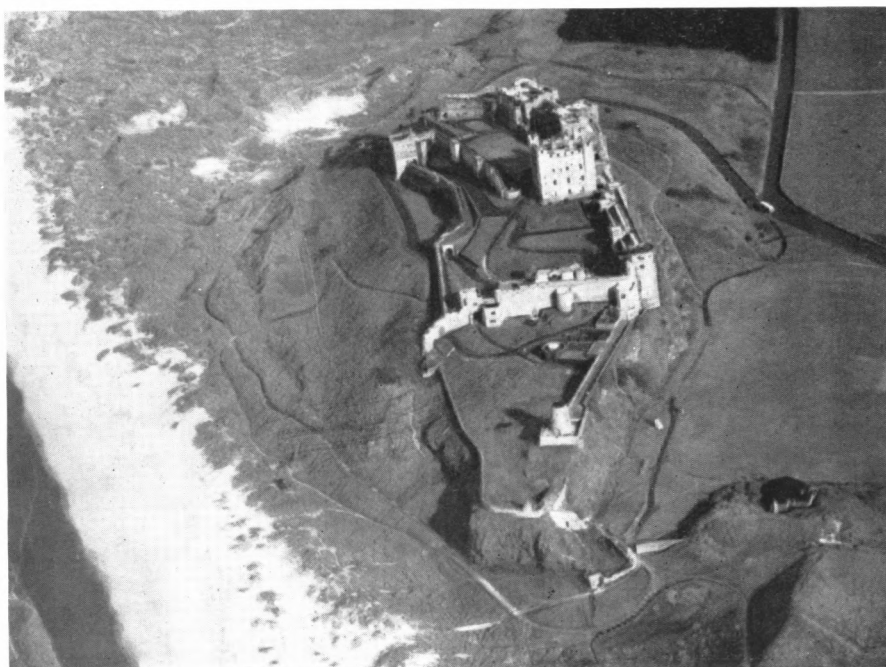
FIG. 1. BAMBURGH.

The view (plate IV, fig. 1) is taken from the north-west, looking along the length of the ridge. The original entrance was at this end, giving access to the outermost ward, and thence to the higher east ward, beyond which stands the square keep. Behind the keep, the domestic buildings of the castle are clustered along the west curtain, forming one side of the inner ward. On the opposite side, at the highest point of the rock, stood the chapel; its foundations are just visible. To the east of this again, and at a considerably lower level, is the barbican gateway, at the head of a winding approach.

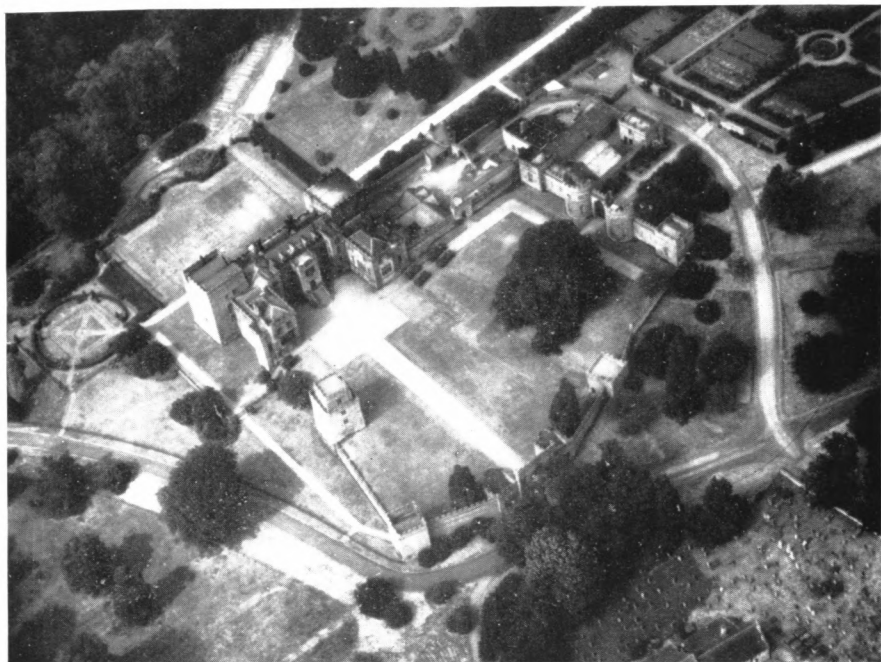
FIG. 2. FORD.

The buildings, which are viewed in plate VI, fig. 2 from the south-west, are seen now to be set in a park amongst trees and lawns. Of the fourteenth-century castle the principal portions that remain are the massive north-west tower and parts of the curtain-wall along the north and west fronts. The great hall and its offices probably lay to the north of the courtyard. Successive reconstructions by the Heron and

Carr families, to whom the castle belonged, gradually converted the place from a fortress to a mansion.

The present appearance of the castle is due to two further periods of reconstruction; the first in 1761, and the second a century later. The embattled wall and towers, enclosing a large area, is modern.

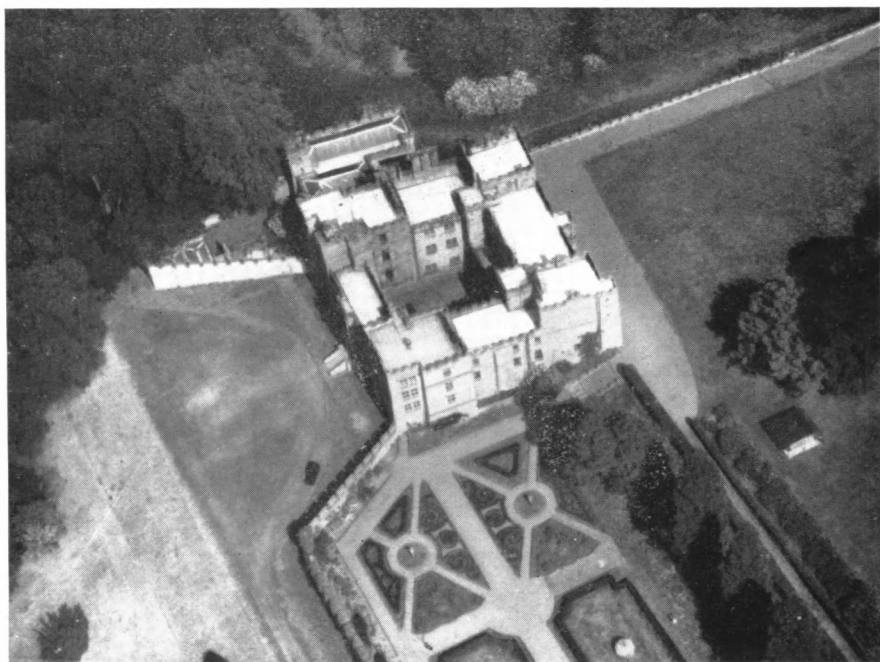
FIG. 1. CHILLINGHAM.

A manor-house had been built at Chillingham before the middle of the thirteenth century, and to judge from the fact that English kings stayed there on more than one occasion, it seems to have been a place of some pretensions. A century later, in 1344-8, this house was transformed into a castle, of which existing buildings preserve the general character though with many alterations and additions (plate vi, fig. 1). The castle stands in a wooded park, near the bottom of the slope below Roscastle, in the Till valley: in the plate, it is seen from the west. Like other fourteenth-century castles at Bolton, Raby, and Lumley, the plan is a rectangle, the buildings being grouped around the four sides of an open courtyard, their outer sides forming a curtain-wall, with a square tower at each corner of the structure. The photograph conveys well the angular appearance of the buildings and the rather constricted inner court. The castle was besieged

and damaged by rebels during the Pilgrimage of Grace. Great alterations were made at the beginning of the seventeenth century, when a walled fore-court was constructed on the north side. Again, about 1753 and in the nineteenth century, there were further alterations to both buildings and grounds. On the last occasion a new service-wing was added on the east side, the eighteenth-century fore-court was swept away, and the ornamental garden, part of which is seen at the bottom of the photograph, was laid out.
