VII.—EXCAVATIONS ON THE ROMAN SITE AT CORBRIDGE 1946-1949.

BY I. A. RICHMOND AND J. P. GILLAM.

The purpose of this report is to give an account of recent excavations of the granaries, aqueduct and fountain, and to record the discovery of the east rampart of the Antonine fort and the west rampart of the Flavian fort; also to publish an important large group of late second-century pottery found north of the granaries. All these studies have been carried out by the Durham University Excavation Committee since 1946. Treatment of the Antonine and earlier remains north of the granaries is reserved until a further season's work has been accomplished. The account of the structural remains is by I. A. Richmond and that of the pottery by J. P. Gillam.

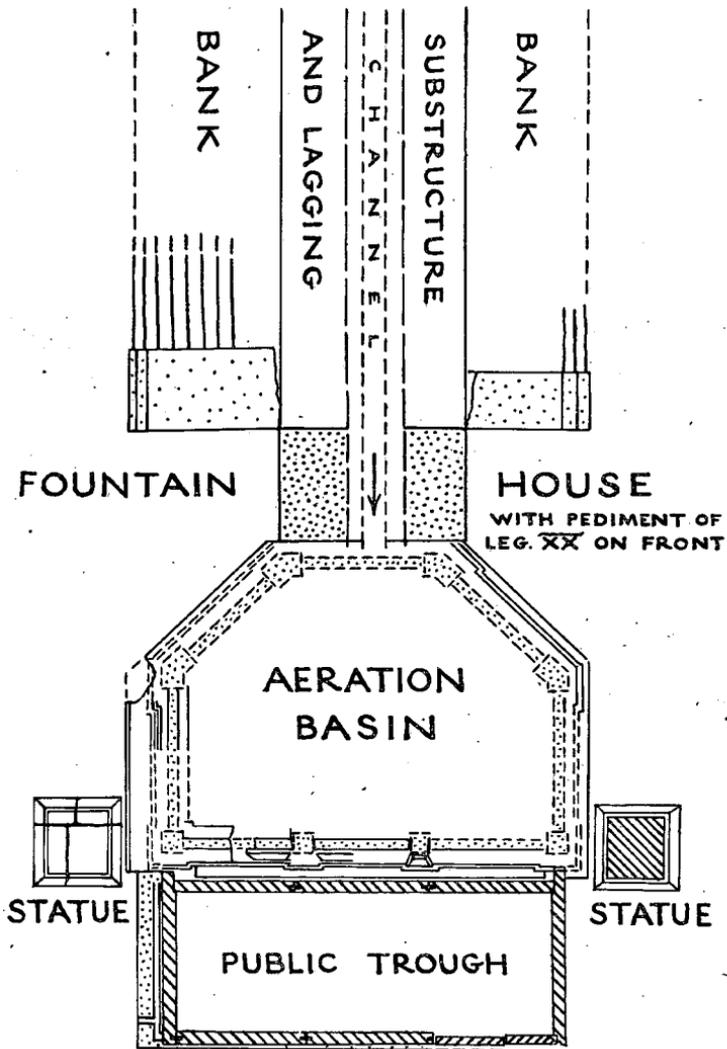
FIG. 1. CORBRIDGE, THE FOUNTAIN.

The fountain (fig. 1) comprises three portions: the fountain-house, the aeration-cistern and the drawing-tank. The fountain-house was the decorative façade which formed the terminal feature of the *substructio* and disguised its wholly utilitarian design. It rested upon a rectangular foundation which linked the butt-end of the *substructio* with the base of the cistern and measured 7 feet 8 inches across the front and 4 feet 8 inches in depth. None of the dressed masonry belonging to the little building remains in position to-day, but its pediment was smashed and discarded by stone-robbers, who evidently found it useless, and its fragments remain (Pl. XIII, 1). The tympanum was decorated with a wreathed roundel, upheld by winged Victories and containing the inscription¹⁸ LEG(io) XX V(aleria) V(ictrix) FECIT. A pediment so ornate must have crowned a richly treated front, and an Ionic cap and shaft found with it suit its proportions so well that it is difficult to dissociate them. This would imply a shrine-like treatment with distyle front and an inner façade framing the actual orifice of the supply. It may well be that the little fragment of attached baluster on the angle of a small screen-like panel fitted this part of the structure. Again, the two base-moulds, one of which very closely matches that of the aeration tank, while the other is enriched by foliage on the cyma, may very properly be assigned to the base of the monument. Thus, although we cannot now reconstruct this part of the fountain in detail, its general lines are beyond dispute. Immediately in front of the

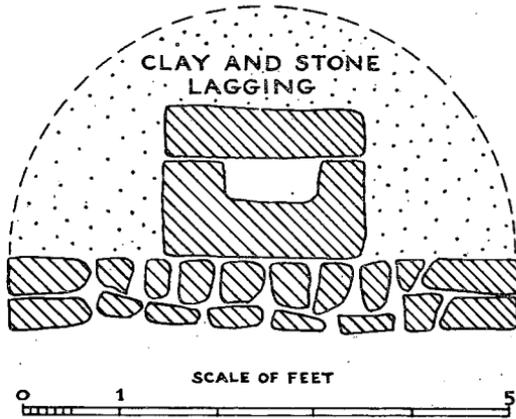
FIG. 2. SECTION OF AQUEDUCT, CORBRIDGE (RESTORED)

side in coursed masonry. Along the middle runs a channel, cut in large and carefully laid blocks of stone. This forms the basic element in the aqueduct, namely, the actual channel conveying the water, and it is matched¹⁷ by comparable channels at Chesters, Chesterholm and Birrens. At Corbridge, however, cover-slabs also remain, demonstrating that the channel was covered or enclosed. There is no sign that either the slabs or the conduit channel were set in mortar. The builders chose to use a liberal luting of clay, and their

choice explains the great width of the *substructio* in relation to the cross-section of the conduit which it carries. In order to keep the conduit free from leaks and safe from frost a considerable thickness of clay sheathing or lagging will have been required and this will have rested upon the *substructio*, covering the conduit with a protective mound.

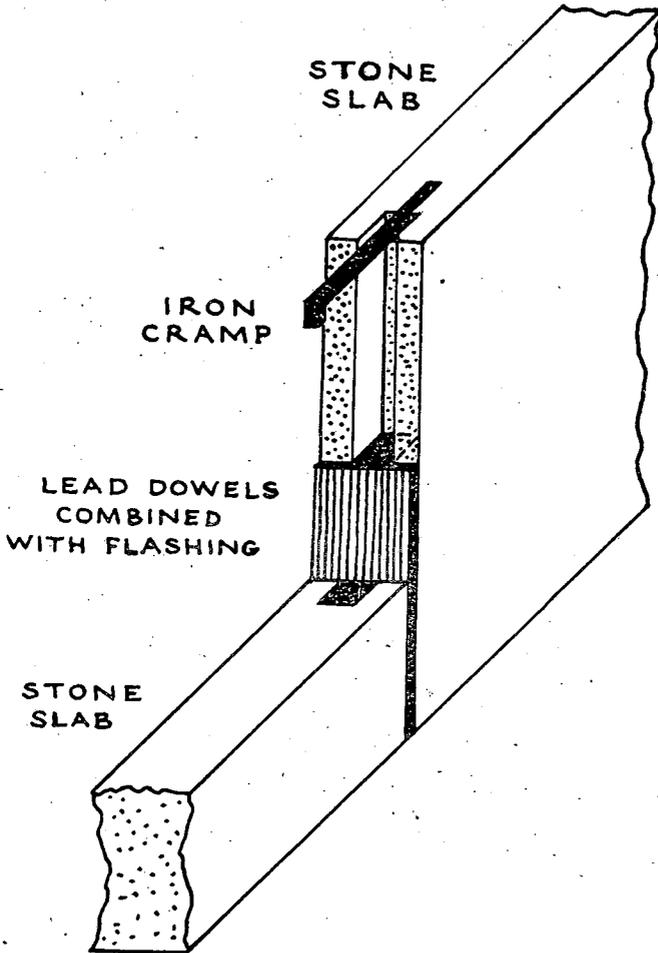
FIG. 3. DIAGRAM OF JOINTING FOR STONE TROUGH, THE FOUNTAIN, CORBRIDGE.

the east actually came within four inches of the bottom. No doubt the tank had been lead lined, like its counterpart at Housesteads, for the vertical grooves, on the juxtaposed lateral edges of each slab, which were intended to hold a lead dowel and flashing combined (fig. 3), are clearly visible. It is therefore plain that in course of time a fine piece of masonry and plumbing was so maltreated as to become completely useless—an early example of the attitude of the general public to its own property. The damage itself was inflicted by regular abrasion of the stone in a left-to-right and right-to-left movement which affected different stones differently, producing in some a slight abrasion only, while in others, as already observed, the wear is very severe. When all the effects are considered the explanation that most readily commends itself is that the stones were used for sharpening knives and weapons, particularly swords: for this was an operation which demanded not merely good smooth-grained stone but also a supply of water ready to hand.

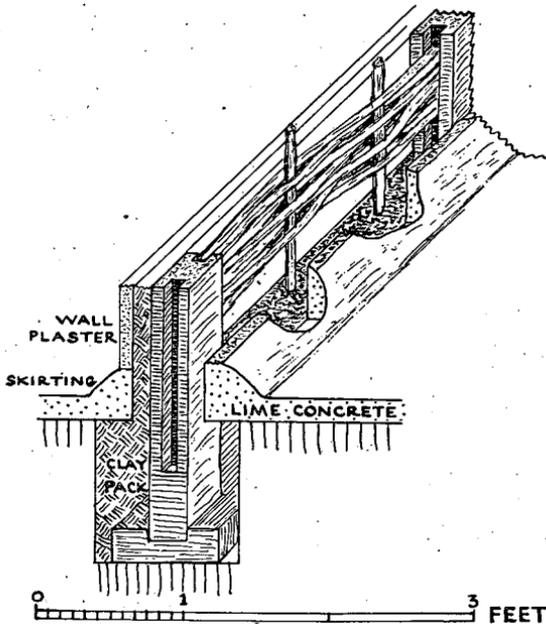
FIG. 4. DIAGRAM OF ANTONINE I TIMBER-FRAMED WALL.

The first feature to be discovered and explored was a well-laid red floor (Pl. xv, 1) of *opus signinum*, or cement with an aggregate of broken tile, below the later street in front of the headquarters building. The room to which it belonged measured 11 feet 6 inches from north to south and 13 feet 9 inches from east to west. All the walls had been timber-framed, and their lowest stage at least had been tightly packed with large and remarkably uniform blue cobbles set in tough clay which had collapsed when the wood had decayed. Holes were observed for both main uprights and intermediate supports, the latter flush with the face of the wall, as in half-timbering. There were also indications

of a doorway at the west end of the south wall. This was the first time that walling of this kind had been recognized at Corbridge; but it need not be doubted that the masses of clay and cobble encountered at the same level in 1937 and taken for foundation-work when seen in section did in fact represent remains of this kind of walling, and similar struc-

tural remains were again observed under temple I in 1947. In principle, this kind of building is very like the base of a clay wall in the clay-and-cob cottages or "clay daubins" surviving in West Cumberland to-day, though it is not intended here and now to suggest that there is any traceable connection between them.

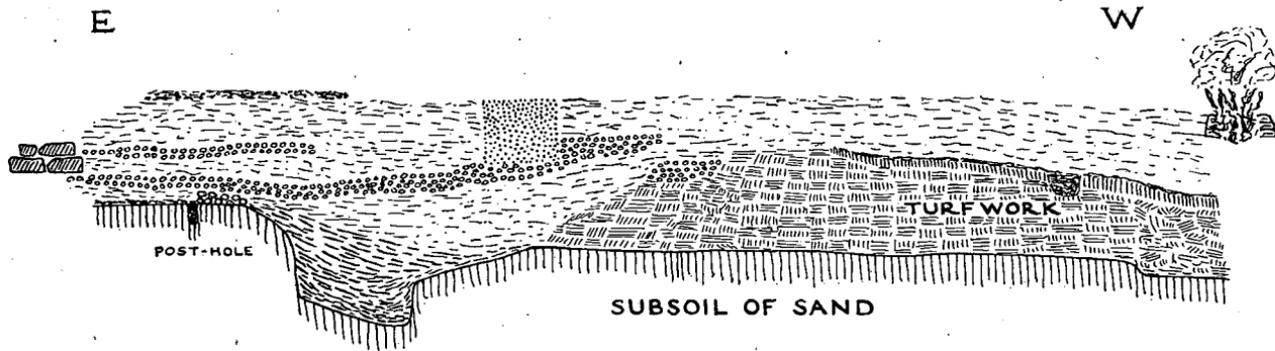
FIG 5.

SECTION OF FLAVIAN WEST RAMPART

The wall exhibited two courses, with a pronounced offset on the west side and was associated with a gravel road 10 feet wide. Below this lay another road-surface, underlying the foundations of the wall just mentioned, and this continued westwards for 26 feet. The levels above the roads had been thoroughly disturbed and no significant material came from the short and thin sealed layer between them. The layer below them, however, was rich in Flavian-Trajanic pottery, including the rim of a grey jar, two fragments of small orange-coloured jars with sharply everted rims, three mortaria and an orange carinated bowl with reeded rim and girth grooves. This scattered material was associated with an occupation-layer containing a small post-hole and a cobble foundation, both in contact with the gravel subsoil. Then came a deep pit, with vertical east end and stepped west end, which yielded fragments of thirteen vessels including two pieces of rustic ware in light grey and orange fabric, one fragment of Samian ware of Dragendorff's shape 18, a South-Gaulish cup of form 27, a dark grey jar of hard pre-Hadrianic fabric and two rims from orange-coloured vessels imitating Dragendorff's form 29. There is no doubt that this is a Flavian-Trajanic deposit, without admixture of later wares.

Almost immediately west of the pit occurred the heel of a well-preserved turf rampart, extending westwards for 24 feet. It still stands 4 feet high, and is in that respect com-

parable with the Flavian turf rampart⁴² 3 feet high, discovered in 1937 at the north end of the east wall of the west military compound. Like that rampart it has no bottoming, but is laid directly upon the undisturbed sandy subsoil. The front of the work was difficult to define, the turfwork having been squeezed forward under pressure from later superincumbent layers: and a tendency to collapse and to weather had in any case to be taken into account. But at 24 feet the characteristic lamination had ceased and there was a downward step in the subsoil, as if the berm had here begun and its surface had weathered off at the toe of the rampart. Beyond this point, however, there was no room to search for a ditch in the small interval between this feature and the hedge.

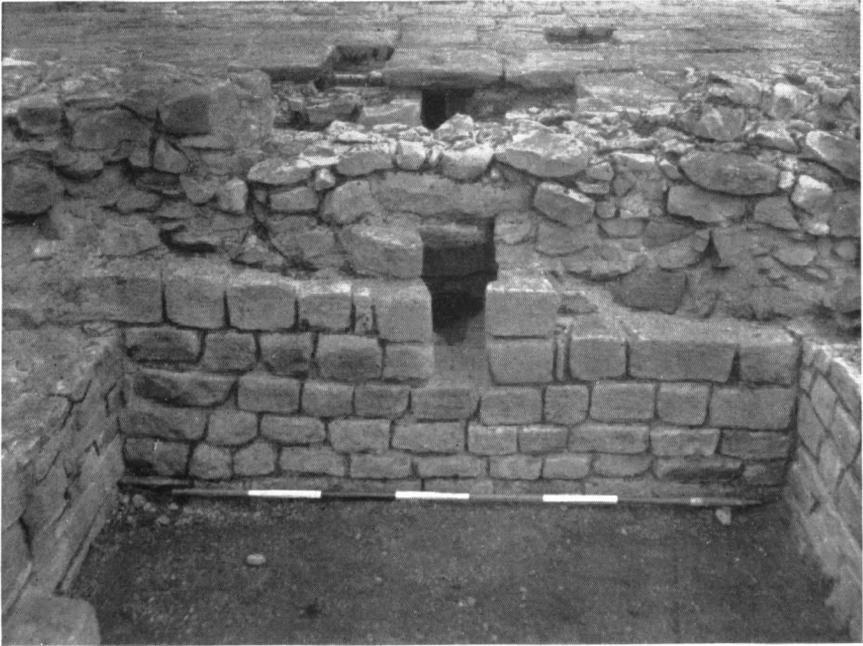
1. WEST GRANARY, CORBRIDGE: WEST WALL, WITH MASONRY AND VENTILATOR OF TWO PERIODS.

The west granary. This notable building still stands seven feet high, though stone robbers have dealt heavily with the upper part of its walls, leaving only their core, which is now consolidated by H.M. Ministry of Works. The distinctive plan (Pl. XI) of the building unhesitatingly declares its purpose and places it in the well-known series¹ of military *horrea* or storehouses. It has eight buttresses, with seven ventilators between them, on either side. The north wall has three buttresses but no ventilators. The south wall has neither buttresses nor ventilators, but is pierced at the west end by a small opening, once containing a wooden door-

frame and later² walled up, which gave access to the basement during building and will have been useful also as a shoot³ for removing material while the actual excavation of the basement was in progress. When the building was completed it could afford access to cleaners in the event of the ventilation channels becoming choked or obstructed.

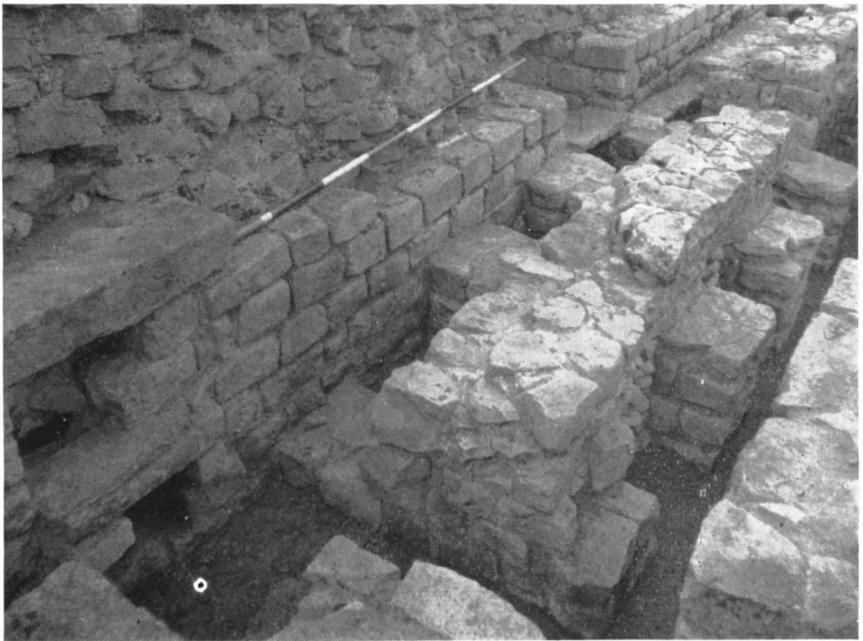
2. WEST GRANARY, CORBRIDGE: ANTONINE TRANSVERSE VENTILATION-SHAFTS, COVERED BY SEVERAN LONGITUDINAL SHAFTS; ALSO VENTILATORS OF SEVERAN AND CONSTANTIAN BUILDING SUPERIMPOSED, AT N.E. CORNER.

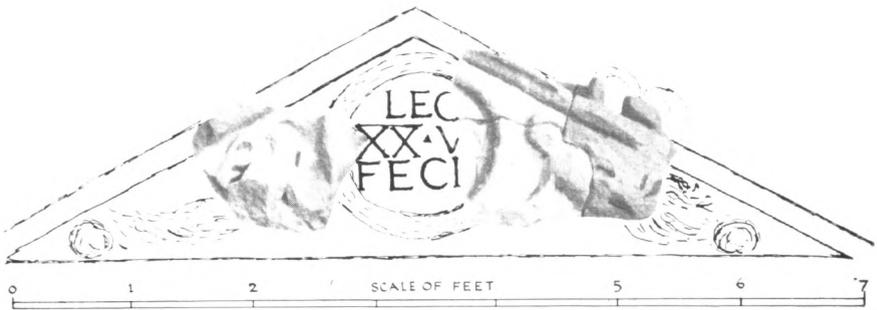
1. THE FOUNTAIN, CORBRIDGE: FRAGMENTS FROM PEDIMENT OF THE TWENTIETH LEGION, RESTORED.

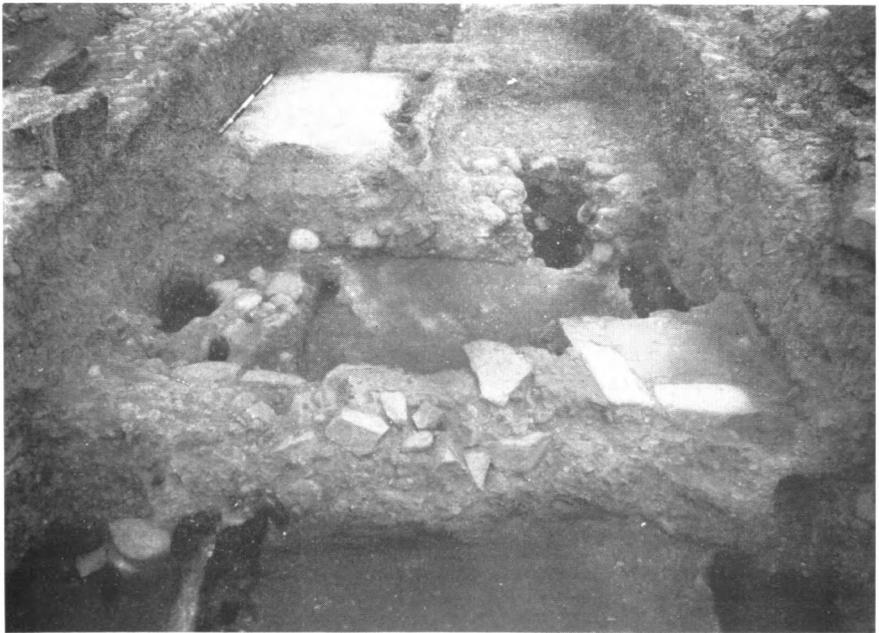
2. ANTONINE BARRACK-BLOCK, CORBRIDGE, LOOKING NORTH. TWO ANTONINE LEVELS, SUPERIMPOSED.

Two levels of Antonine buildings (Pl. xv, 2) were in fact found, but it is more convenient to describe the lower and earlier level first. Although only a small portion of the early building was examined, it was clear that the rooms discovered formed the north frontage of a long building running east and west, along the south side of an east-to-west street. The long buildings which occupied the north side of this street were discovered in 1937 to extend westwards for at least seventy feet.

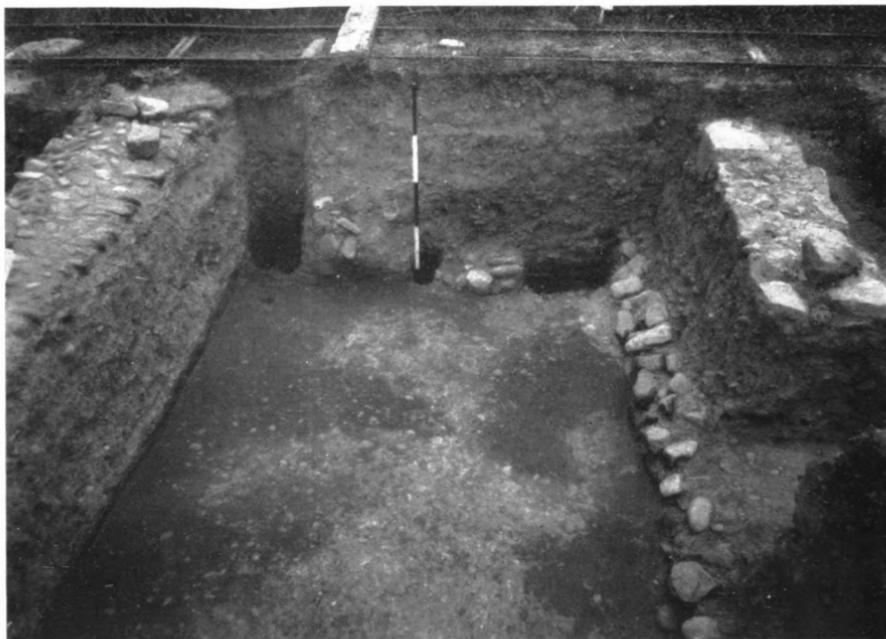
1. ANTONINE BARRACK-BLOCK, CORBRIDGE, LOOKING SOUTH. *Opus signinum* FLOOR, WITH CLAY-AND-COBBLE WALLS, PLASTER-FACED AND TIMBER-FRAMED.

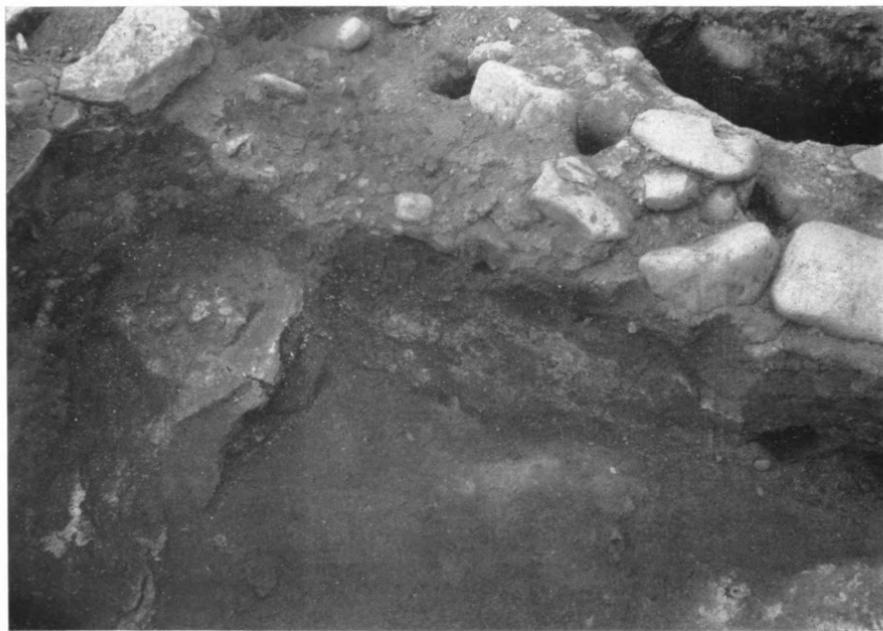
2. ANTONINE BARRACK-BLOCK, CORBRIDGE: CLAY-AND-COBBLE PARTITION, SHOWING PLASTER FACING (FALLEN AND *in situ*) AND HOLES FOR WATTLES.

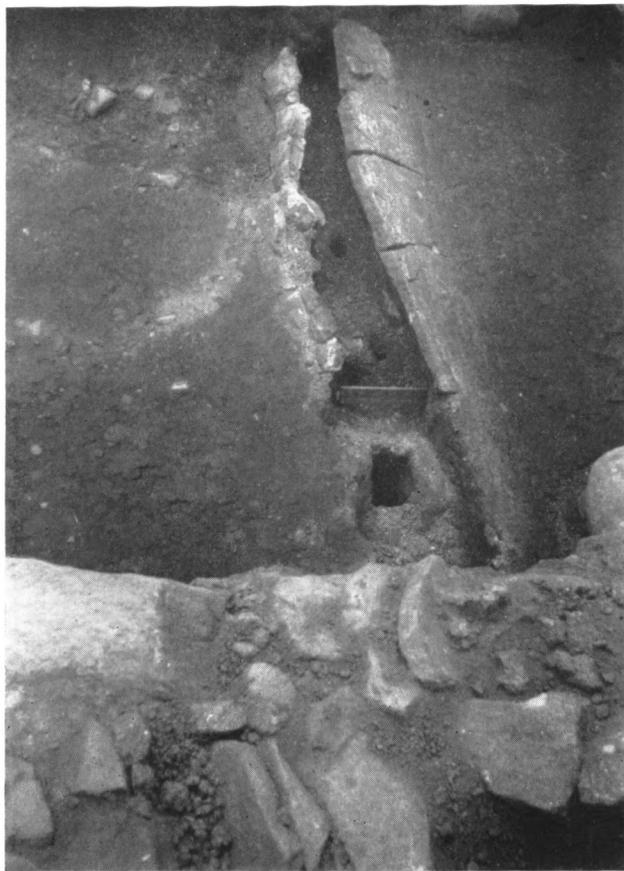
1. ANTONINE BARRACK, CORBRIDGE: W. PARTITION, LOOKING S., WITH HOLES FOR TIMBER-FRAMING AND WATTLES AND PLASTER SKIRTINGS.

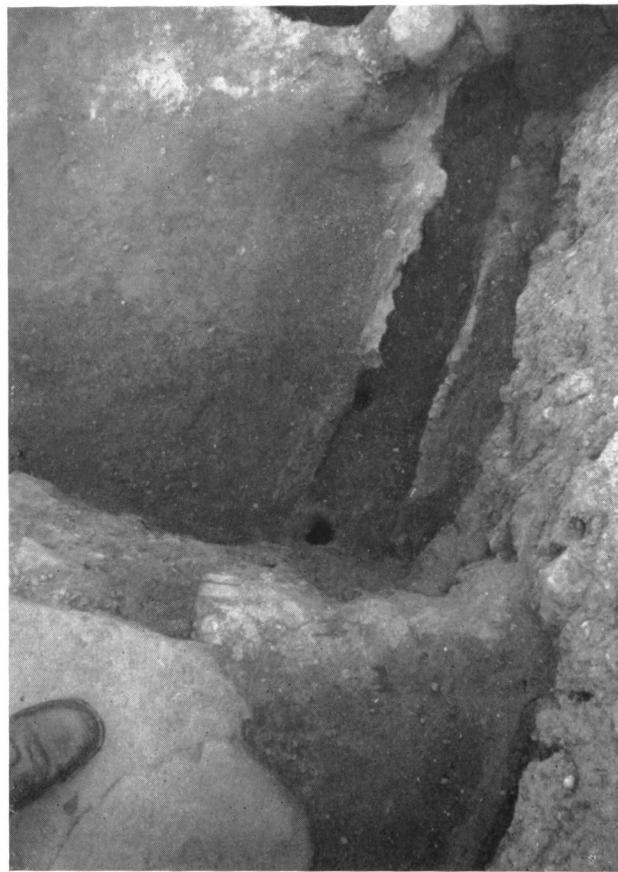
2. ANTONINE BARRACK, CORBRIDGE: E. PARTITION, LOOKING NORTH, SHOWING HOLES FOR WATTLES AND REMAINS OF PLASTER SKIRTINGS.

East of this partition lay a passage five feet wide, followed by a room 14 feet 6 inches wide, with remains of a lime-cement floor much decayed with damp. It was plain that these two units had been divided by a partition wall of similar character to the last. But the remains were here slighter and the skirtings had been reduced to the merest fragments. A main upright (Pl. XVI, 2) was detected south of the later cross-wall and four wattle-holes to north, at one-foot intervals. The spacing of the elements in the framework was thus not uniform as between the two partitions, but a reason for this did not appear. The effect of a doorway upon the regularity of spacing would be an obvious factor to take into consideration. The poorer remains of this wall afforded an opportunity to probe the trench for the foundation-beam or sill: this was 1 foot wide and 1½ feet deep, but whether the uprights³⁹ were simply placed in it and packed with earth, or were morticed to a horizontal beam, was not revealed, though the relative looseness of the packing was in favour of the latter arrangement.

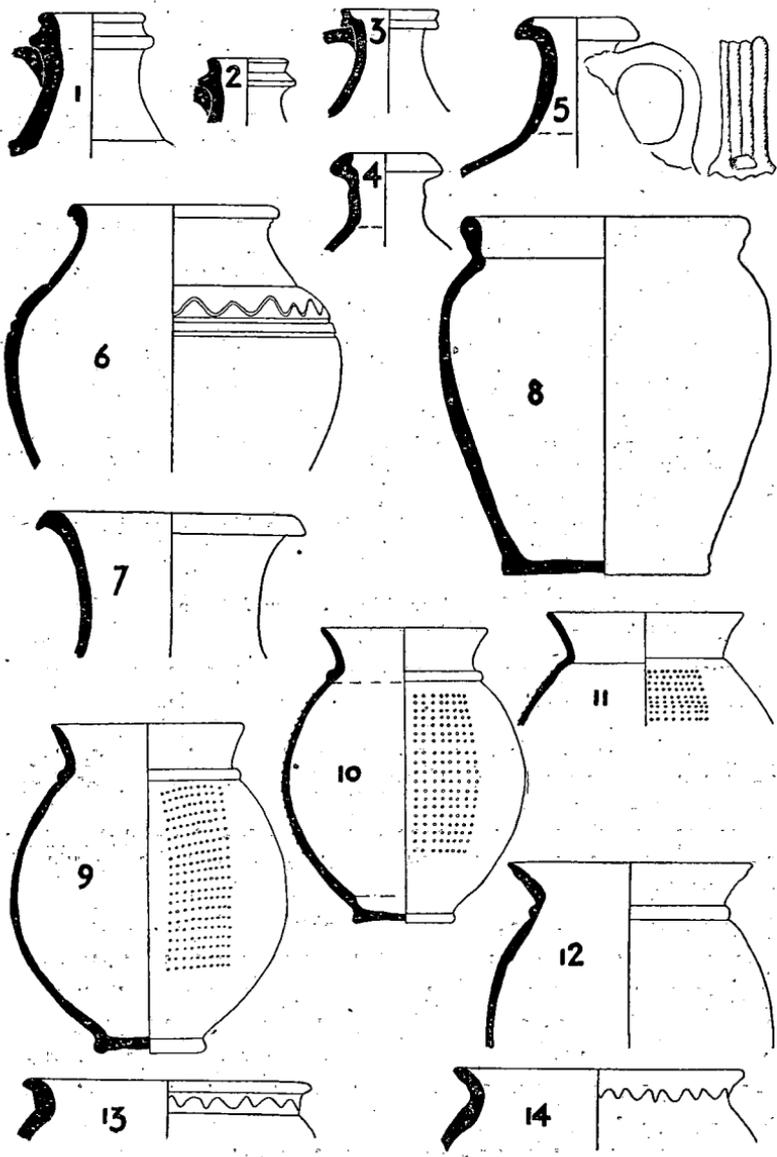
FIG. 6. (scale $\frac{1}{4}$)

1. Neck of flagon with flanged lip; a flat handle, now broken away, has joined below the flange. Course pinkish-buff fabric, similar to that of the locally-made mortaria⁴⁵ nos. 51-53 below. The piece is coated with a dark orange slip similar to that used above the stamps of the potters CUDRE and SATURNINUS (II). A fragment from a second vessel is identical in form but lacks the orange slip.

6. Rim and wall of a narrow-mouthed jar, with horizontal grooves and a lightly-scored wavy line on the shoulder, in a hard, fine, reddish-brown fabric, grey in fracture.
7. Rim of narrow-mouthed jar, with undercut overhanging lip, in a hard, smooth, unpolished grey fabric.

8. An almost complete jar, with rim ledged internally at the neck, in a hard, gritty, brick-red fabric, pinkish-grey in fracture. Both shape and fabric are slightly reminiscent of Derbyshire ware. The vessel is sooty and has been used as a cooking pot.

9. Poppy-head jar, decorated with regular rows of applied self-coloured dots, in fine blue-grey fabric, with black polished surface. It was found complete and unbroken.
10. Almost complete poppy-head jar, found broken, in a fabric similar to no. 9.
11. Rim and shoulder of poppy-head jar, in a fabric similar to no. 9.
12. Rim and shoulder of poppy-head jar, in a fabric similar to no. 9, but without decoration.

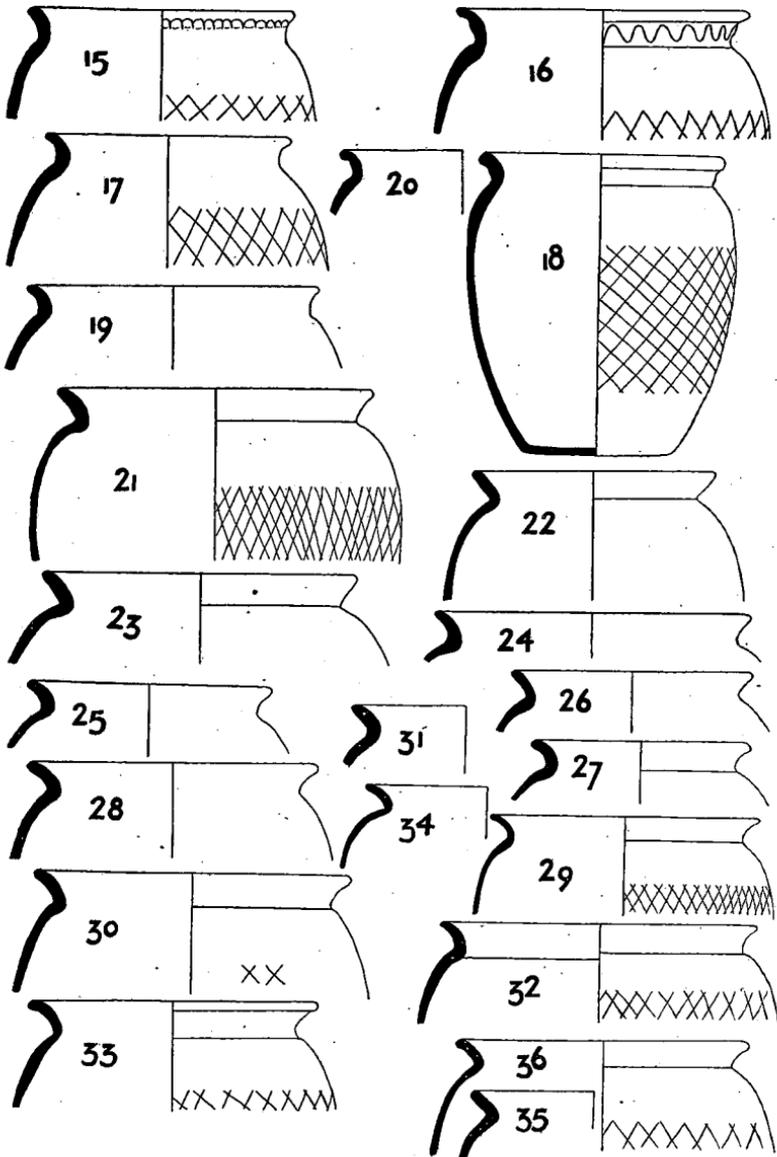
FIG. 7. (scale $\frac{1}{4}$)

The eleven vessels, nos. 21 to 31, represent the characteristic cooking pots of the deposit. The fabric is similar to that of the bulk of the associated bowls and platters; it differs from the dense black and slightly-gritty fabric of Hadrianic-Antonine cooking pots, bowls and platters, and from the soft grey fabric with darker surface of Trajanic-Hadrianic jars and carinated bowls.

(a) straight in section and without a bead, springing boldly out at about 45 degrees to the horizontal, and about 90 degrees to the shoulder, cf. no. 22;

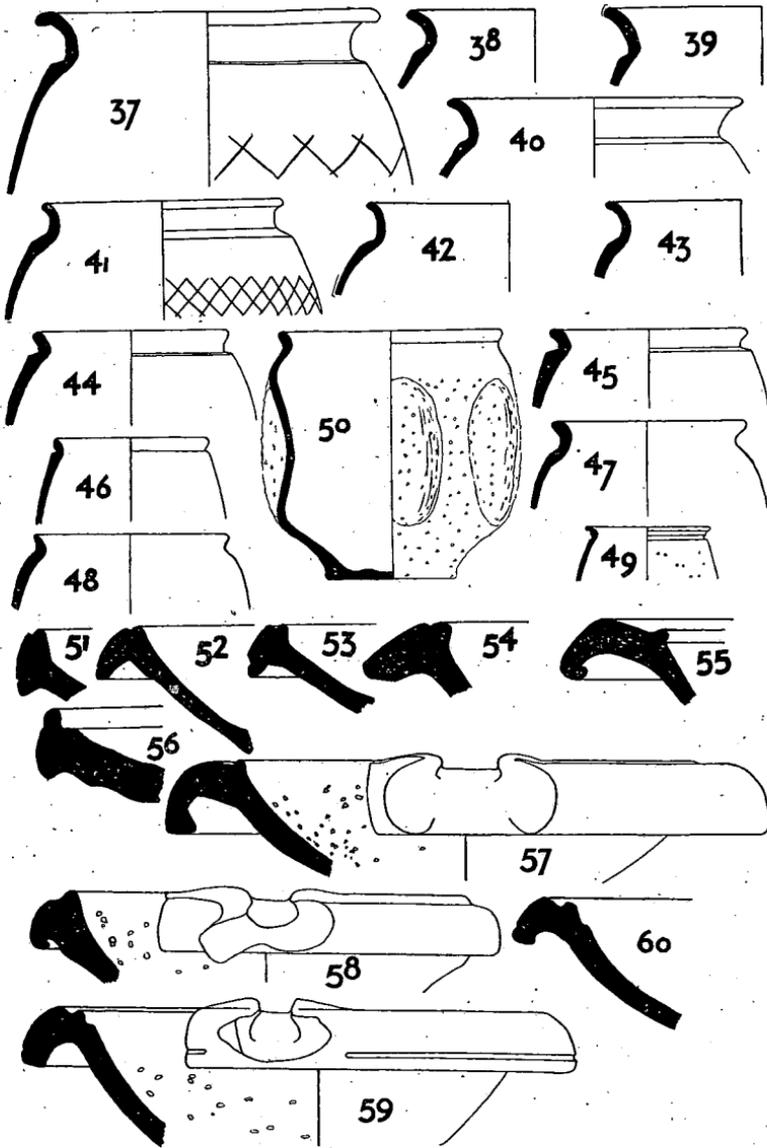
FIG. 8. (scale $\frac{1}{4}$)

44. Rim and shoulder of a beaker-*olla*, with high, sharply-stepped shoulder, in polished black-fumed ware.

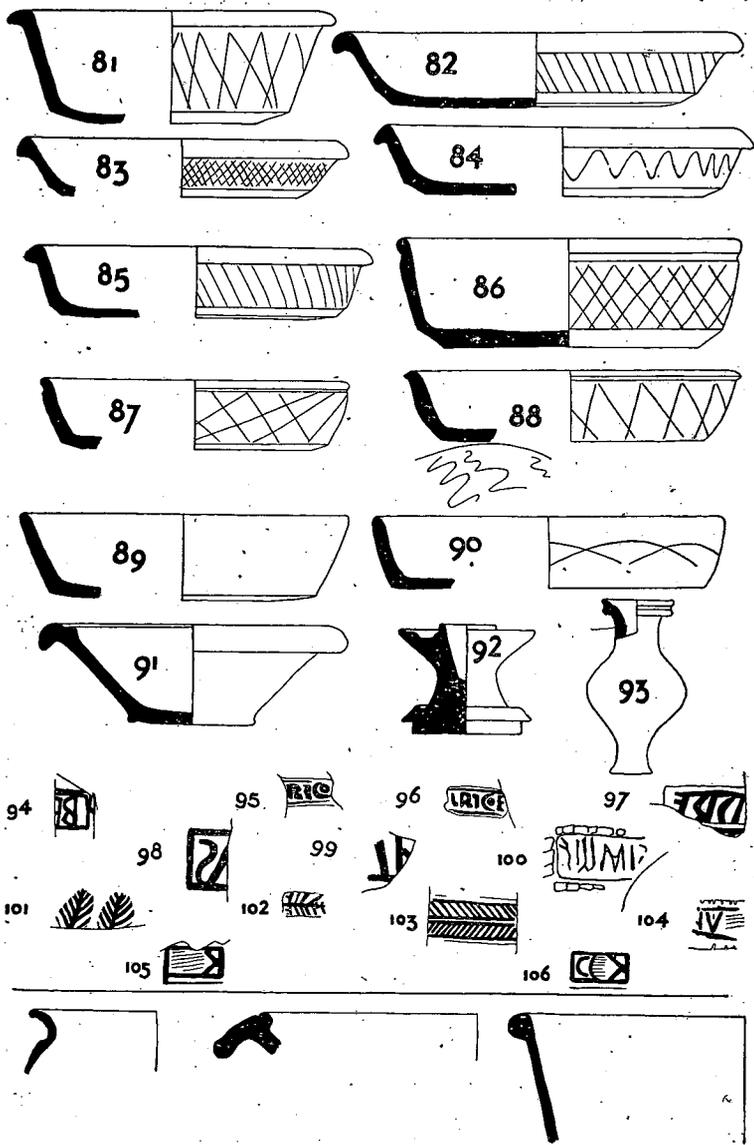
FIG. 10. (scale $\frac{1}{2}$)

The unnumbered fragments are from the west granary, see p. 155.
