## VI.—SECOND REPORT ON ROMAN BUILDINGS AT OLD DURHAM.

By R. P. WRIGHT AND J. P. GILLAM

(Read on 24th November, 1948.)

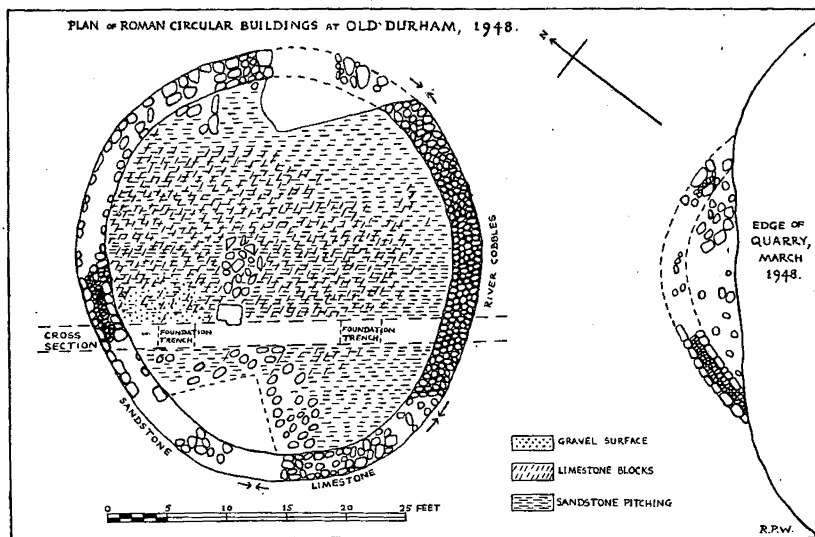
FIG. 2. GROUND-PLAN OF CIRCULAR BUILDINGS AT OLD DURHAM.

The site lay forty yards north-west of the cold bath of the bath-house, and proved to be the foundations of an almost circular building varying from 33 ft. 6 in. to 35 ft. 6 in. in diameter. Part of a second building, also roughly circular and obviously of much the same dimensions, was found at a distance of 15 feet farther south-east, but only a small segment of it could be recovered, as the main part had already been destroyed by the quarry. In the course of the spring all that remained of both buildings was quarried away.

The wall varied in width from 2 ft. to 2 ft. 4 in. and was composed of mixed material, described below. In general only the foundation course remained, but on the west side two blocks of an upper course lay near their original position from which they had been dislodged by the mechanical leveller. Material which must have come from this course was found on the spoil-heap accumulated by the leveller.

The south-east circular building had a well-laid circuit-wall, 2 ft. 4 in. wide, with a single course surviving. Large dressed sandstones formed the two faces of the wall with rubble packed in between. Again, there was no trace of mortar.

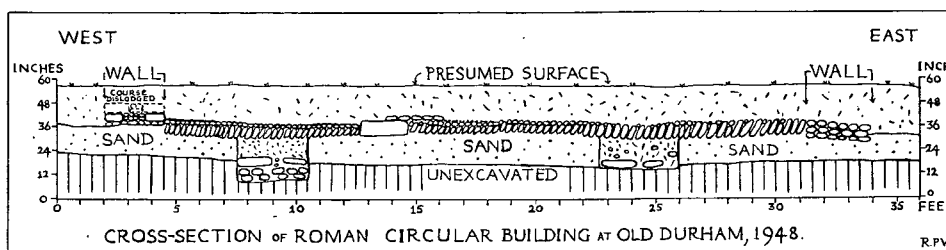
FIG. 3. CROSS-SECTION OF CIRCULAR BUILDING AT OLD DURHAM.

One full cross-section was cut through the building from south-east to north-west and showed traces of earlier work. The stone floor was on the average 9 in. thick and lay on undisturbed sand. But at two points the pitching had sunk slightly where it overlay a pair of earlier trenches which were 12 feet apart and ran nearly at right angles across the section. The east trench was 3 ft. 9 in. wide and had vertical sides cut 1 ft. 3 in. into the subsoil sand; it contained large sandstone slabs at the bottom and some mortar near the top. The west trench was 3 ft. wide, 1 ft. 8 in. deep

and had cobbles at the bottom, the sandstone slabs, and then a filling of earth and gravel. Unfortunately there was not time to follow out the course of the two trenches, but they seem clearly to have held foundations of earlier walls.

On the north side of the cross-section and sealed beneath the pitching lay a small area of sandstone slabs and beyond them a circular patch of slaked lime, 3 ft. 6 in. in diameter, standing 6 inches high on the east side, but scooped away elsewhere. It seems to have been a lime slurry, used by builders for providing lime for plastering, and can be matched by two examples from the Roman villa<sup>3</sup> at Park Street, Herts., where one such deposit was 12 inches deep and 2 ft. 9 in. in diameter. The Old Durham slurry yielded a stratified group of seven fragments of pottery and one roofing-tile, which are discussed below (items 1-4 and 10).

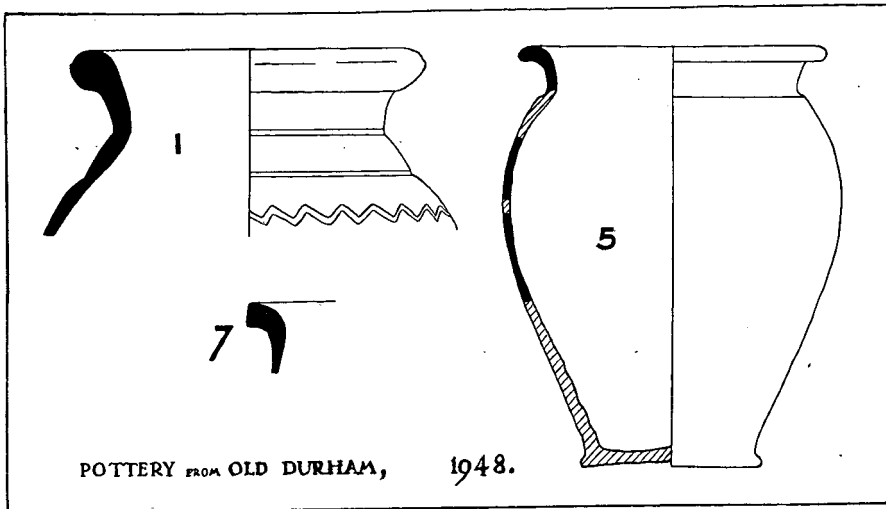
FIG. 4. POTTERY FOUND IN 1948 AT OLD DURHAM.

1. Three conjoined fragments from a narrow-mouthed jar with a deeply scored wavy line on the shoulder, and two lightly burnished horizontal lines on the neck; sandy buff fabric with light grey surface, smoothed but not burnished (fig. 4, no. 1).

In the drawing the vessel is restored after the Chesterholm example, and the surviving fragments are shown in section as solid black (fig. 4, no. 5).

This vessel is almost certainly medieval (fig. 4, no. 7).

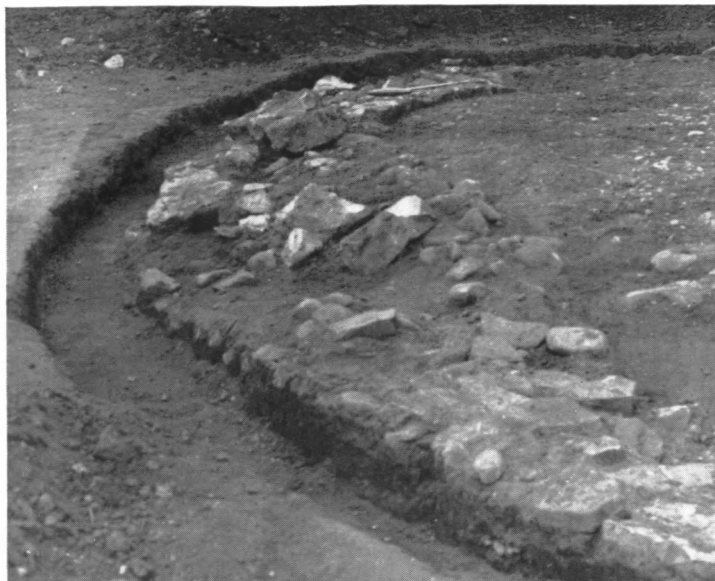
FIG. 1. NORTHERN PORTION OF PAVEMENT AT OLD DURHAM.

wall was sandstone, varying in size from the blocks described above down to smaller stones about 6 by 6 by 4 inches. The rubble used for the core and in the foundation was partly broken sandstone, partly a much weathered yellow limestone, and thirdly on the east side some water-worn cobbles. There was no trace of mortar in the walling. The area inside the wall was pitched with re-used building-stones set at an angle, or in places with cobbles. Smaller blocks of grey limestone had been used to fill the crevices, and on the western part of the pitching there remained a thin layer of gravel which had been spread to give a smooth

top surface. It is probable that the whole pavement had once had this thin layer of gravel. The whole building had thus been constructed with very varied material, much of it clearly re-used, as if drawn from previous structures near the site.

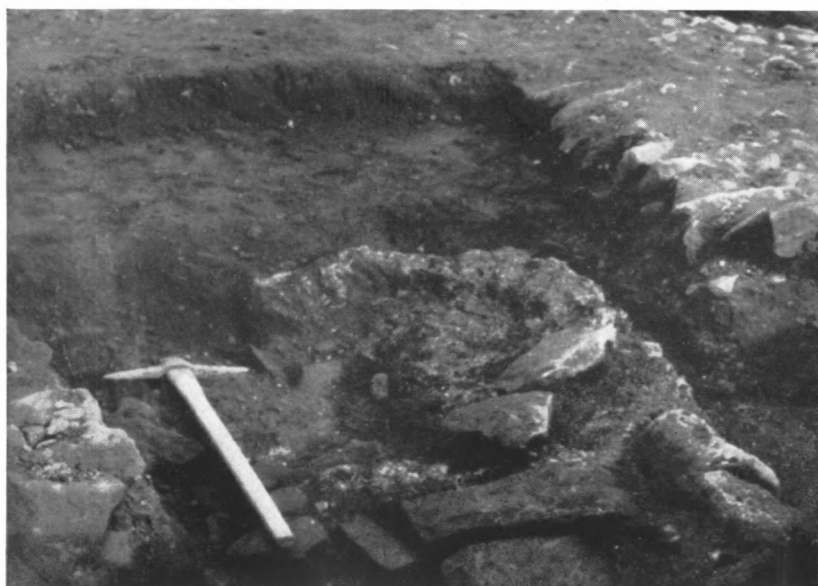
FIG. 2. LIME SLURRY AT OLD DURHAM.
