### III.—MITFORD CASTLE.

By H. L. HONEYMAN.

# MITFORD CASTLE:

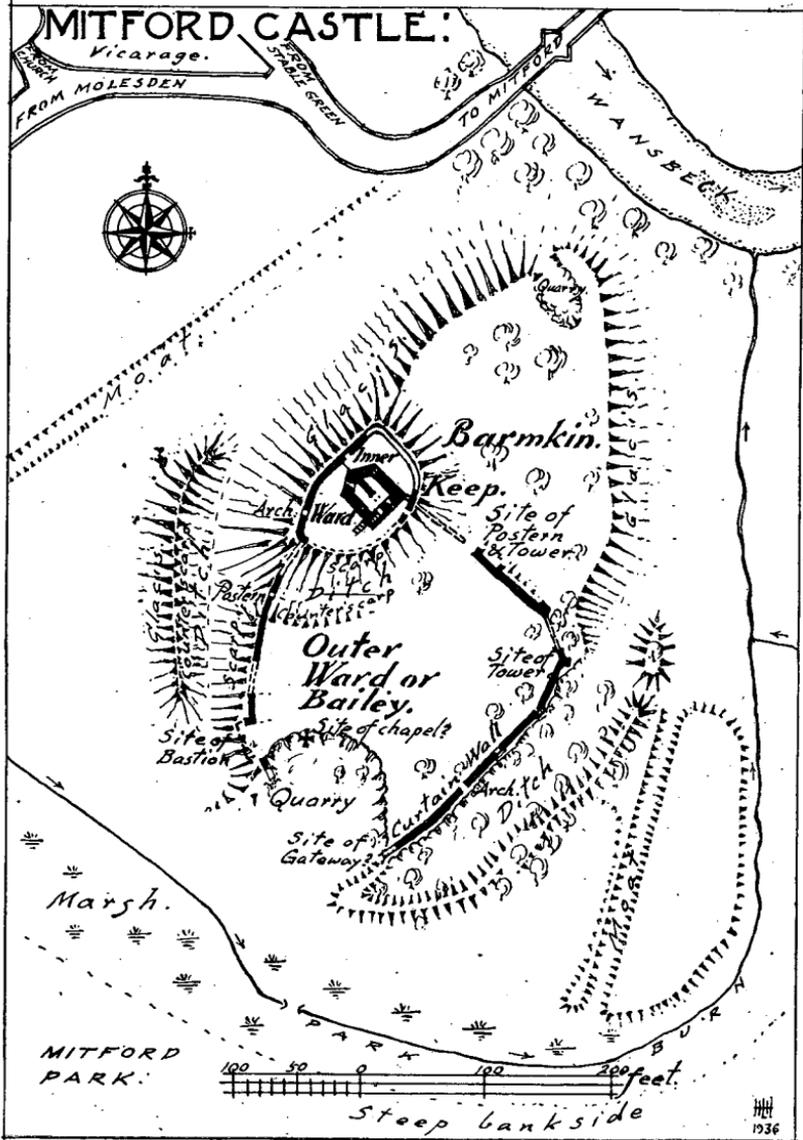
The castle, see sketch plan, consists of three parts. 1: A barmkin on the north protected, it would seem, only by a mud wall though a stone wall joined it to the north corner of the shell keep. 2: A bailey surrounded by a stone wall and with the main gate, destroyed by quarrying before 1810, at its south end. This bailey was crossed by a cruciform church somewhat on the lines of the "college" church at Warkworth and was surrounded by various buildings huddled against its curtain wall. 3: A mound or "motte" crowned by a "shell keep" within which stood a pentagonal great tower whose vaulted semi-basement still remains.

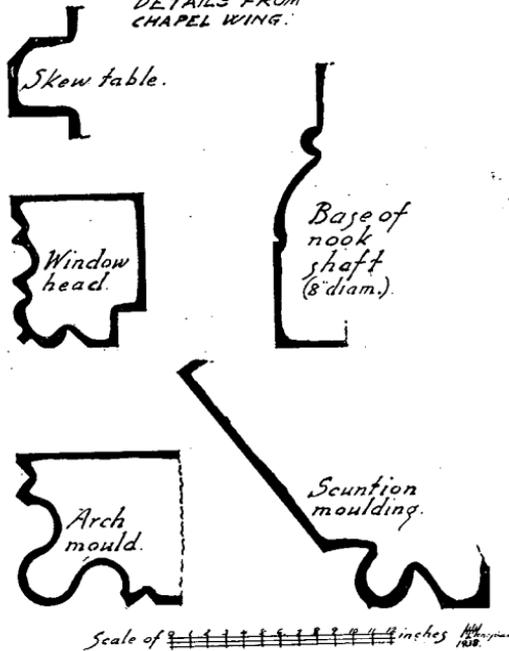
DETAILS FROM  
CHAPEL WING:

Fragments of a window (see details and plate X, fig. 5) and a well carved nook shaft capital (see plate XI, fig. 6) proved that the superstructure was of late twelfth century date and therefore that the graves were earlier, as indeed was indicated by their decoration. Some were mere stone boxes, little less

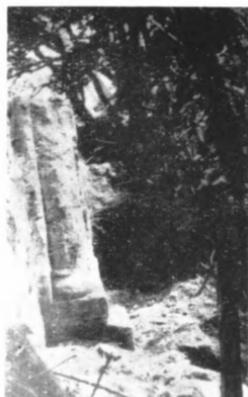
4.

5. The 1810 map shews "supposed chapel" in a mound of debris in the bailey and, although the expansion of the quarry to provide stone for John Dobson's new Mitford Hall in 1820 had encroached on the area indicated, it seemed worth while to excavate in the corner between the quarry edge and a part of the curtain wall which had obviously been the end of a two or three-storied building. It was found that the latter overlay the foundation walls of an earlier building, not parallel with it, one of a series extending eastwards across the bailey, and having mixed up with them either the north or south wall of a church. The church had been cruciform as the east respond of its north, or south, transept arch remains to some height with the moulded base (see plate X, fig. 4) of a nook shaft.

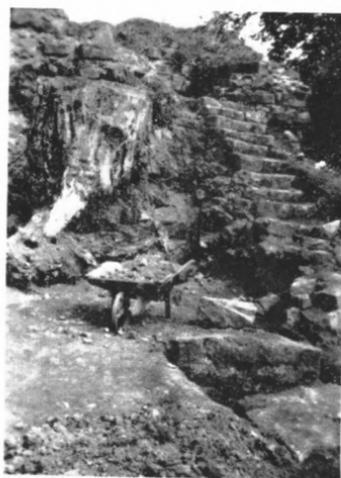
3.

2. The great tower or keep. This was examined but not interfered with. It was noticed that the two parallel barrel-vaulted chambers which form its semi-basement had been constructed as cisterns—there being no well on the motte—with inlet spouts for rainwater and an entrance door set well above floor level. But that they also served as places of confinement was indicated by the pathetic inscription *CAPTIVVS MORIOR 14-7* (plate X, fig. 2) cut on a stone of the innermost chamber. Note the Arabic numerals: I am informed that a date in the fifteenth century (unfortunately the third figure is indecipherable) is possible for their use, though not common. The main floor of the tower was reached by a flight of steps which may have been covered by some sort of fore-building (see plate X, fig. 3).

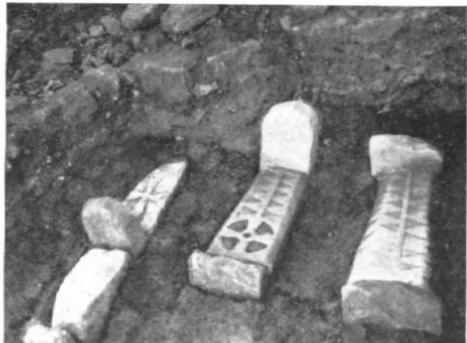
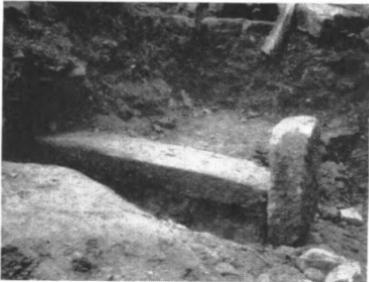
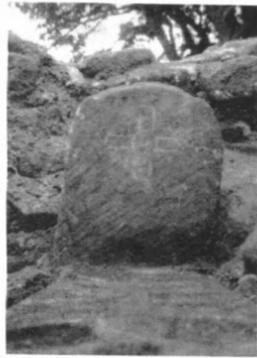
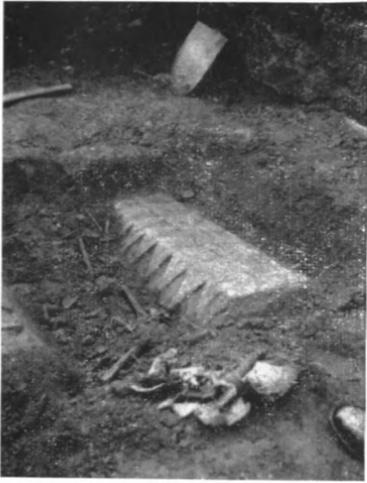
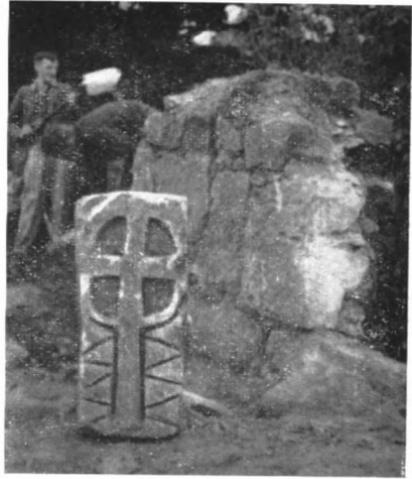
rude than pre-historic "cists", but most were protected by a headstone, a foot-stone, and a long heavy slab, sometimes plain, sometimes carved, tightly fitted between them (plate XI, figs. 6 to 11). They thus illustrate, what is not commonly known, the way in which early mediæval tombs were actually covered. The headstones which can be seen in such churches as Woodhorn were not meant to be used alone
