## IV.—THE ROMAN BATH HOUSE AT RED HOUSE, BEAUFRONT, NEAR CORBRIDGE.

BY C. M. DANIELS.

WITH CONTRIBUTIONS BY B. R. HARTLEY, J. P. GILLAM,  
DOROTHY CHARLESWORTH AND OTHERS.

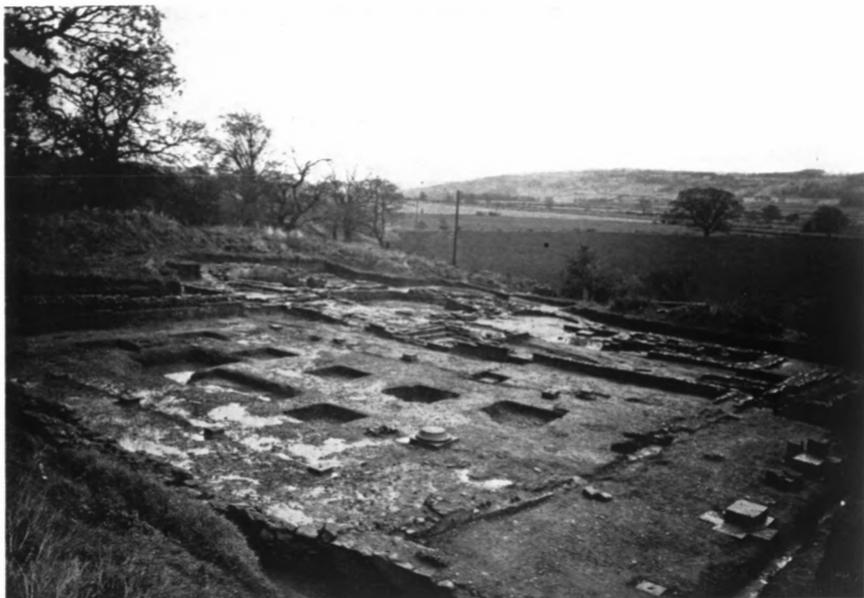
1. Bath House from north-west.

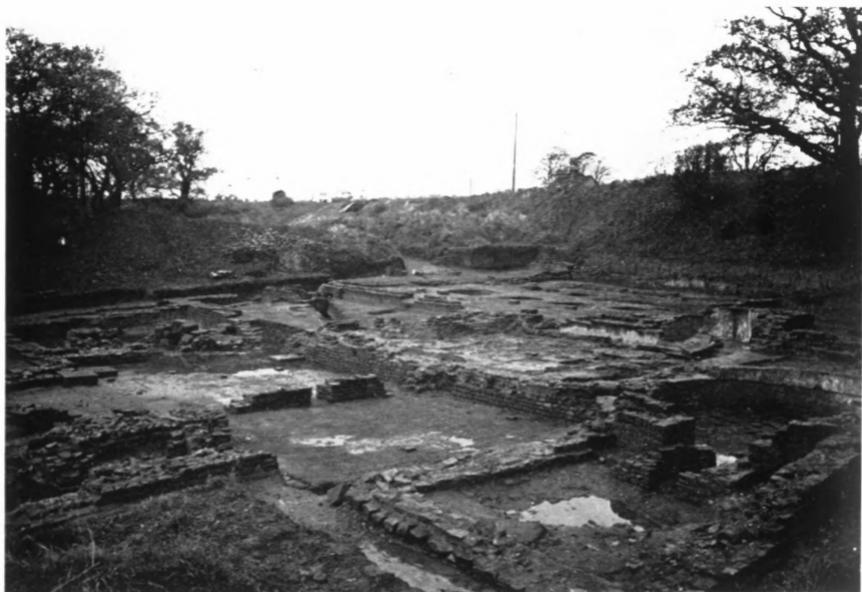
2. Bath House from south-east.

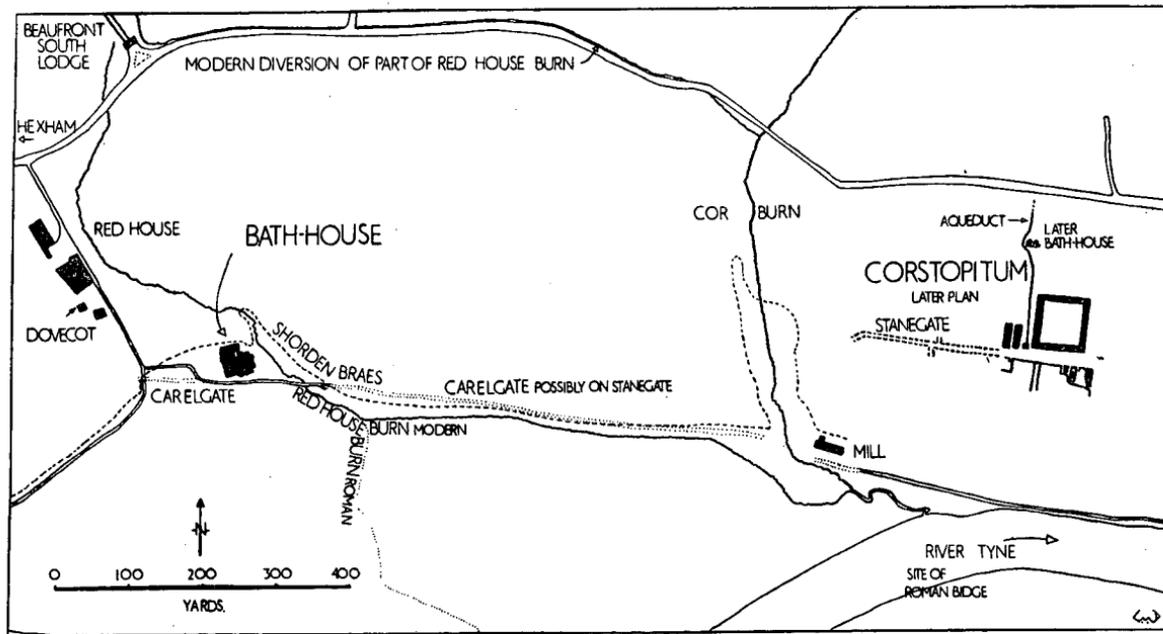
FIG. 1. THE SITE OF THE BATH HOUSE.

The bath house is situated 1,100 yards west of the Roman site at Corbridge and 200 yards south-east of Red House farm, Beaufront Castle.<sup>1</sup> The river-terrace which carries the Corbridge site continues westwards from the Cor Burn under the modern name of Shorden Brae, but where it is interrupted by the Red House Burn, also called Short Burn, it forms a sub-terrace several hundred feet long and some 160 feet wide from north to south, before continuing westwards at full-height behind the small house named Prior Thorns. This sub-terrace is high enough to be clear of the river floods which until recent times and the construction of an adequate floodbank, used to occur annually, but is low enough to be sheltered from the north, west and east.<sup>2</sup> To the east the stream has cut back into the river-terrace and formed a small valley, which could easily have been dammed to provide a water supply. There will have been no shortage of wood in the area; the site, therefore, possessed all the requirements necessary for a bath house in the eyes of a Roman planner (fig. 1).

As will appear, the bath house dates from the earliest Roman occupation of the Corbridge site. It lies unusually far away from the fort (fig. 1), but the reasons for this position are not difficult to decide. The first garrison was the *Ala Petriana*,<sup>3</sup> a cavalry unit which would require a considerable water supply. The most immediate source for this was the Cor Burn which runs just west of the site and could be tapped higher up its course and brought into the camp. Even if this were only a temporary measure, and the Cor Burn was ultimately replaced by a more carefully selected source, the problem of finding a water supply for the bath house would still have to be solved. The next nearest stream is the Red House Burn, 1,100 yards west of the fort, from which a sufficient supply could certainly be drawn by the damming

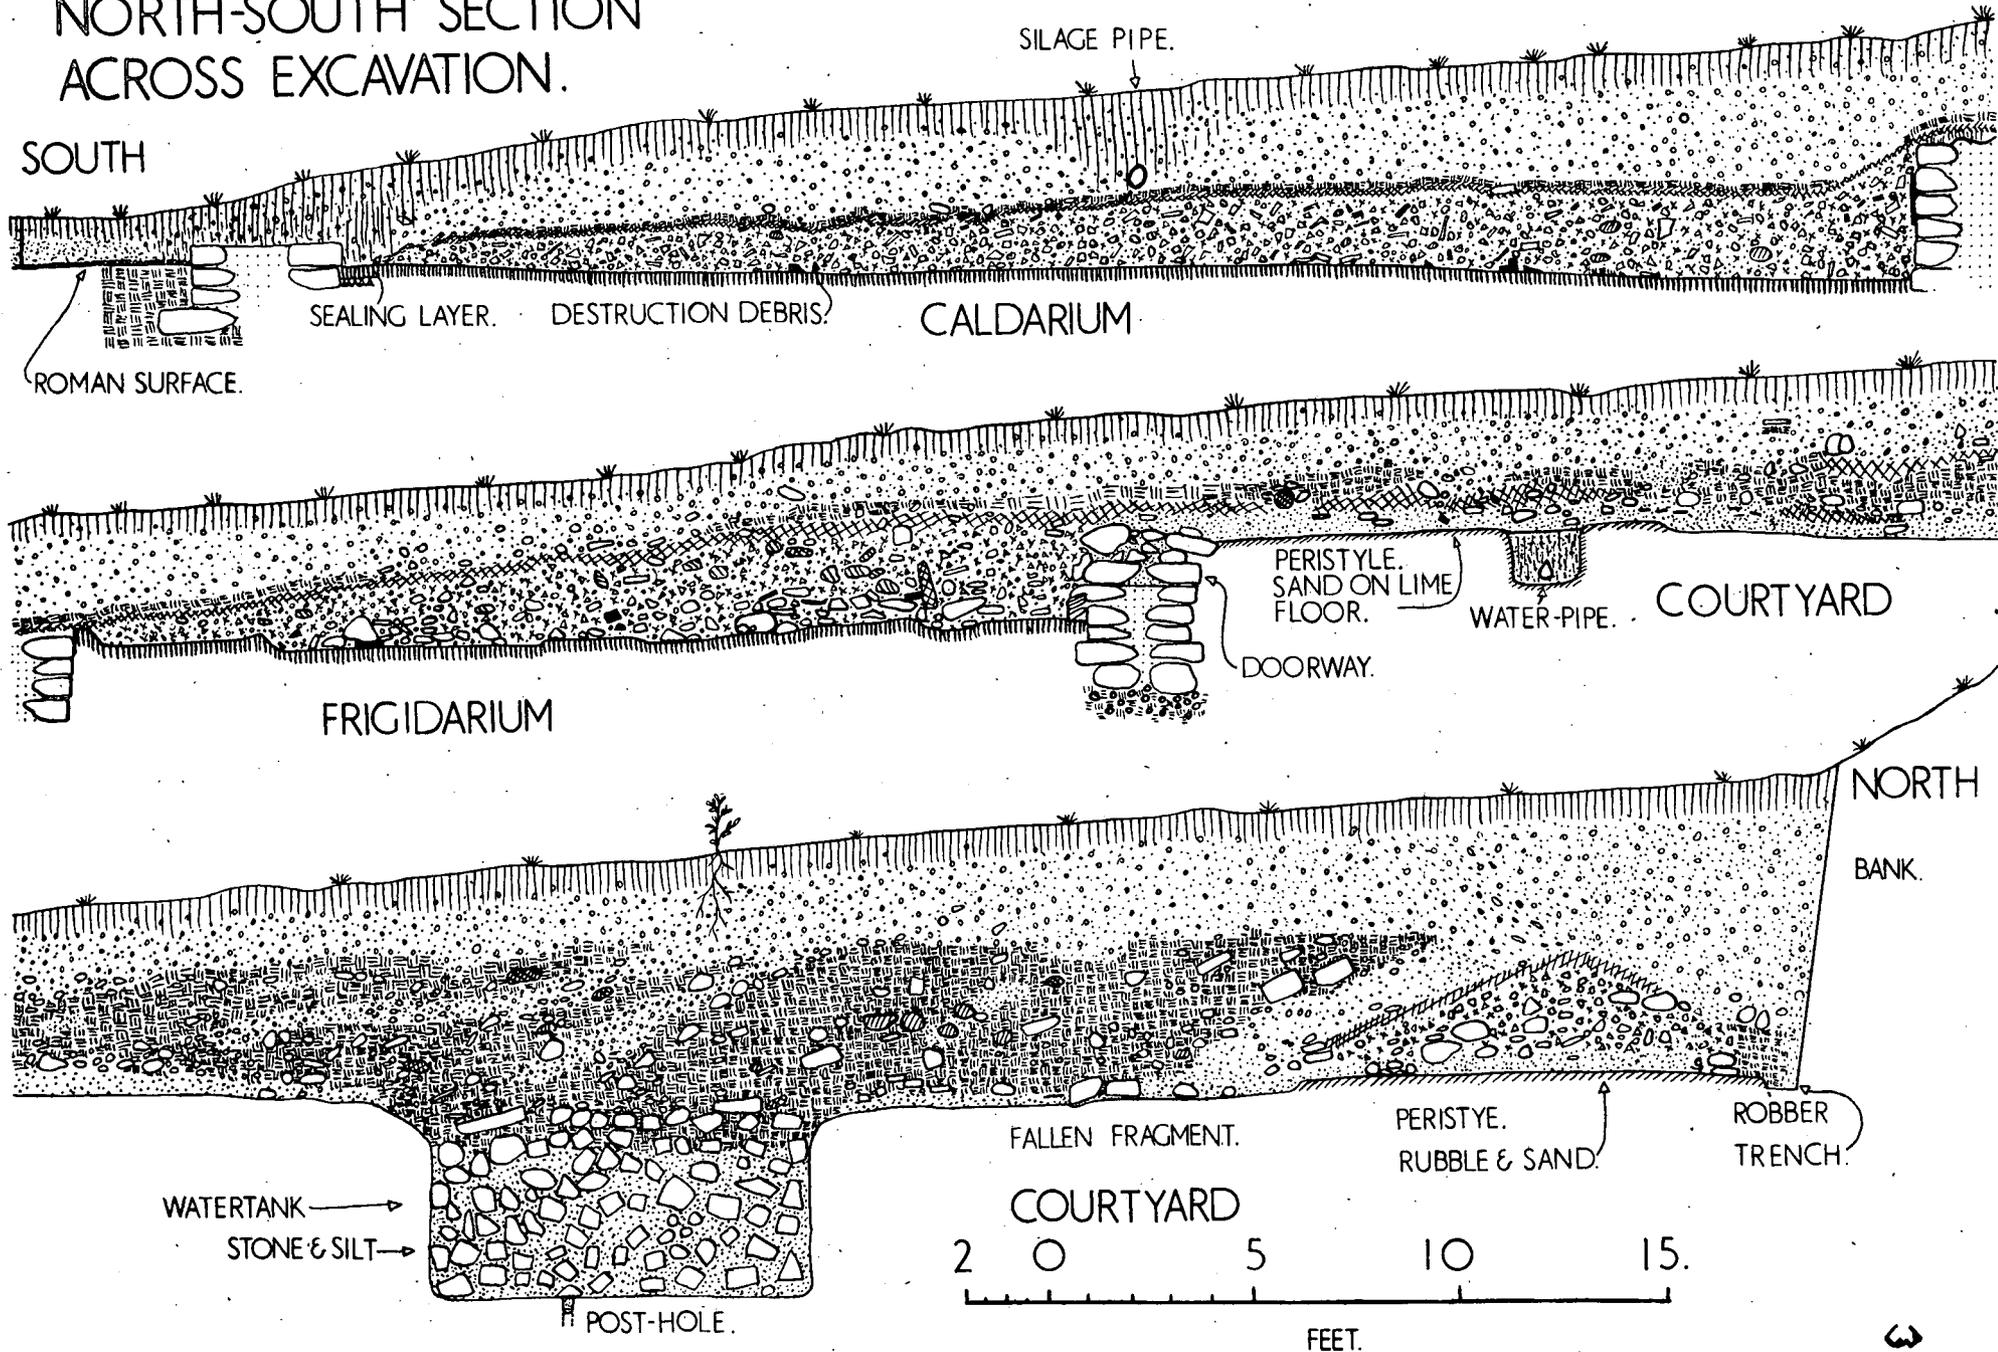
FIG. 3.

# NORTH-SOUTH SECTION ACROSS EXCAVATION.

When found, the whole area was covered to a depth varying from 4 to 8 feet, with a mixture of rubble, sand, clay and gravel (fig. 3). Most of the rubble lay close to the walls, and under it and stretching across the whole floor was a thin layer of sand, considerably disturbed in places, but remaining as a clear division between floor and rubble in the vicinity of the peristyle.

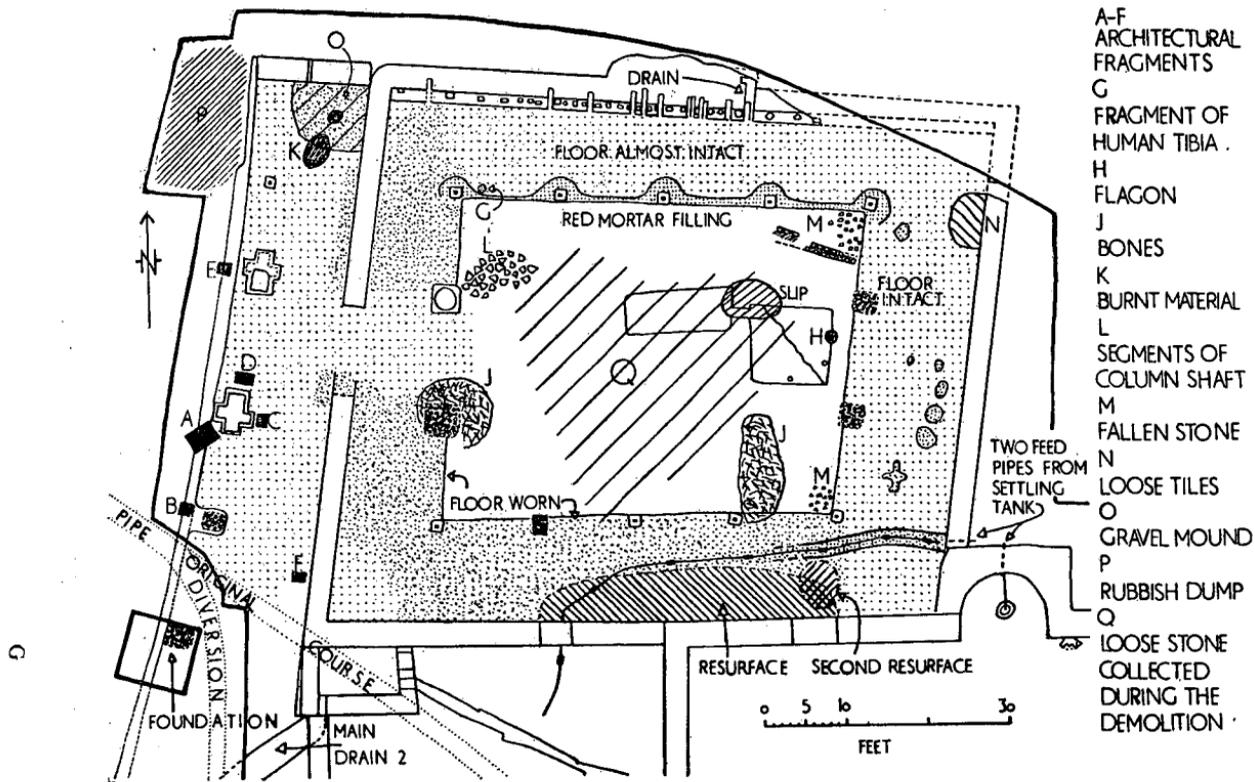
FIG. 4.

# PLAN OF PORTICO & COURTYARD AS EXCAVATED

The demolition debris in the portico was thickest along the north wall (where it lay on top of a mound of gravel), and between the main piers and the entrance to the courtyard. Here there was much stone and plaster (both loose and still sticking together), bones and nails. Several large building-stones were found (fig. 4):

the small yard (XII) suggestive of an end. Here, too, the portico was crossed by the modern silage drain which was carrying a constant flow in a wet summer, and had already been diverted to the maximum possible extent. Therefore the pipe was approached as closely as was possible on the north, and a new trial-hole put in to test for the presence of a south-west corner pillar. This, too, had been removed; but sufficient clay-and-cobble foundation was recovered to indicate its former presence, if not its size (fig. 4).

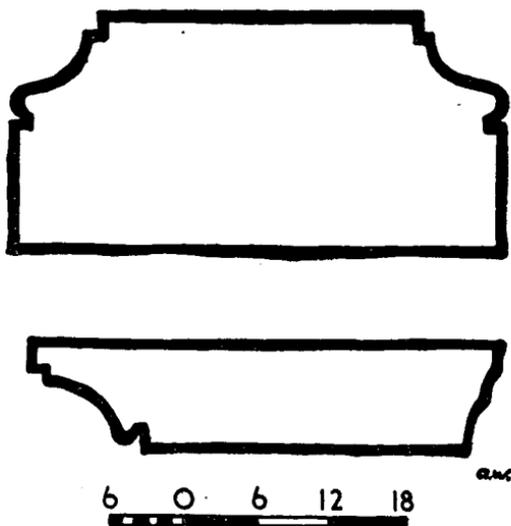
FIG. 5.

A. Cornice stone. A corner stone with an external cornice of cymer moulding (fig. 5) 42 inches by 30 inches overall and  $9\frac{1}{4}$  inches thick, retaining no trace of a plaster coating. Found lying against the south-west portion of the south pier. Does not appear in any of the photographs.<sup>22</sup>

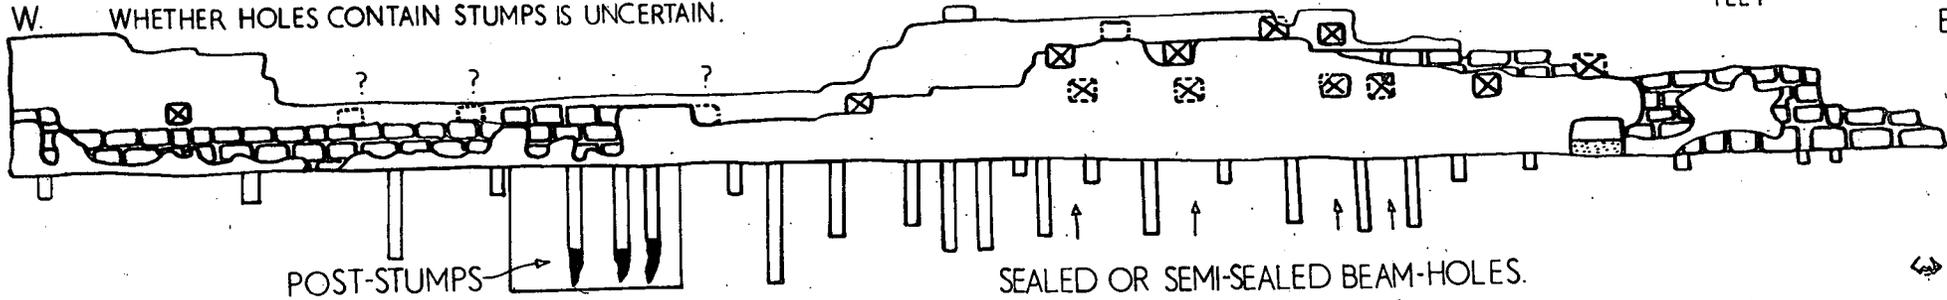
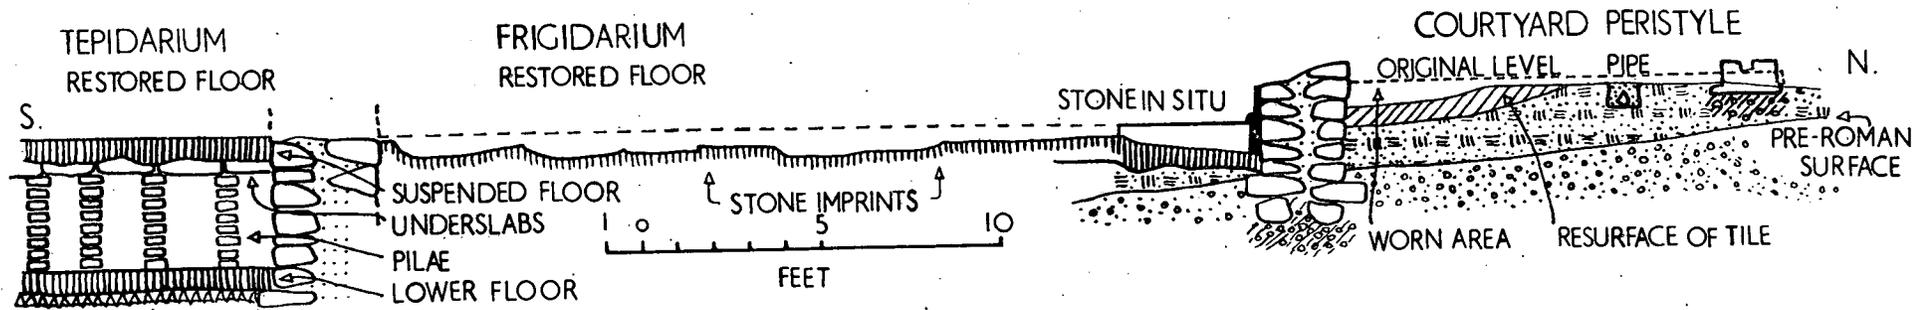
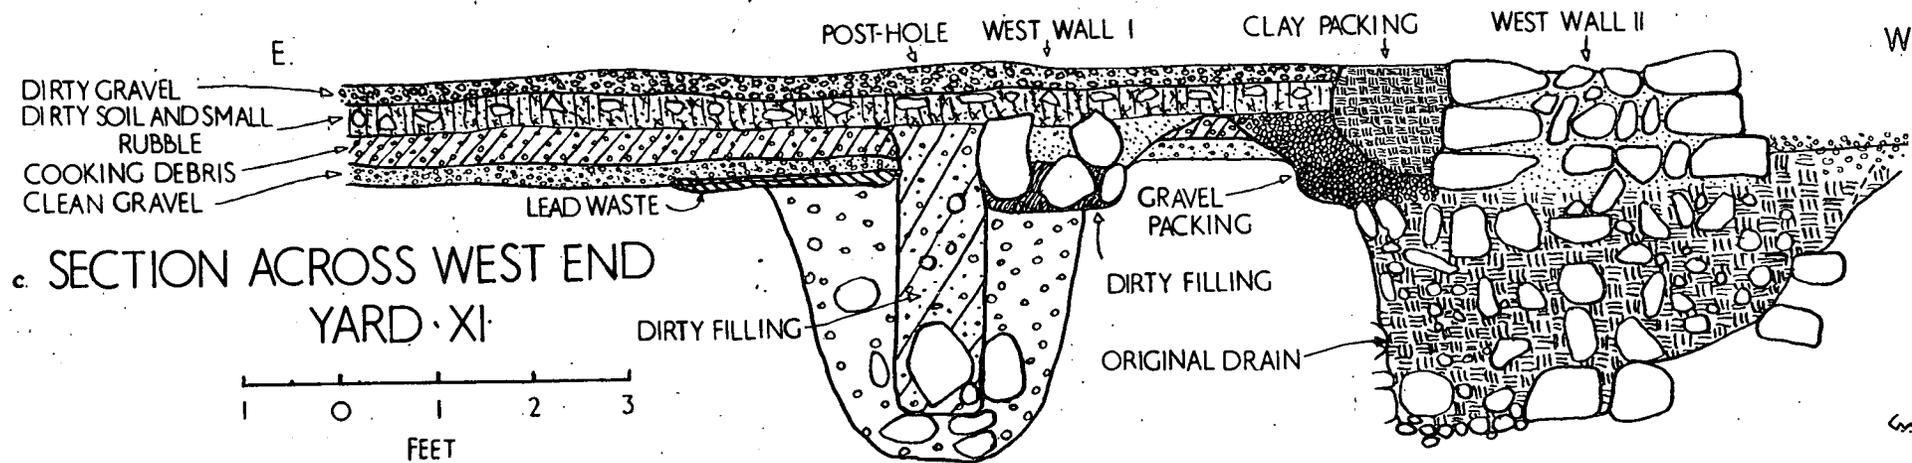
FIG. 6.

b. RESTORED SECTION ACROSS ROOMS II·III·IV

c. SECTION ACROSS WEST END YARD XI

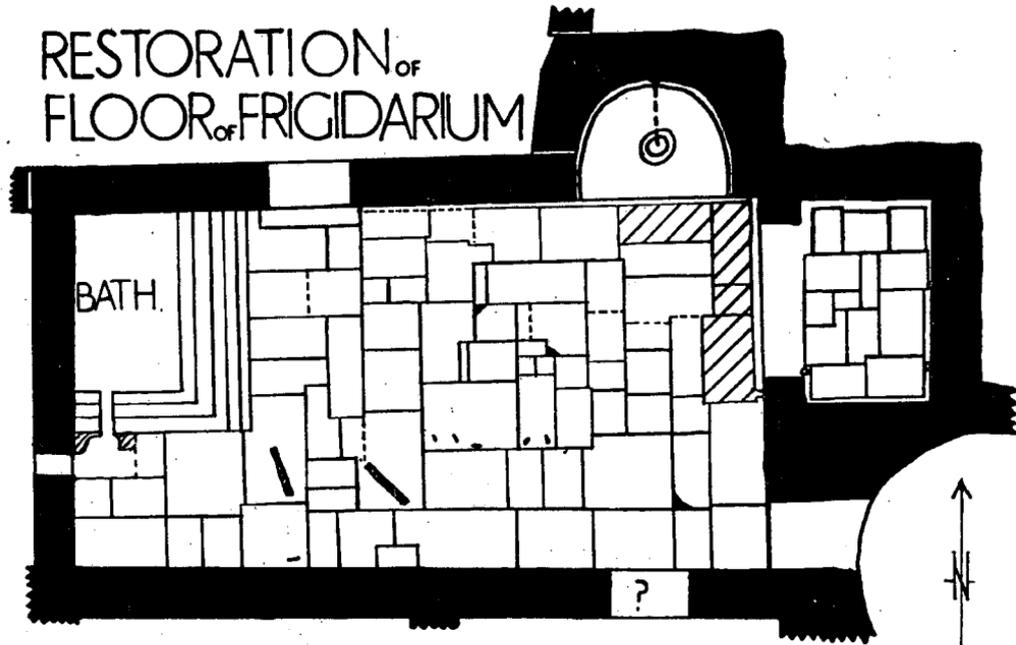
# RESTORATION OF FLOOR OF FRIGIDARIUM

IMPRINT OF WOOD & CORNERS  
STILL EMBEDDED IN MORTAR SHOWN  
IN BLACK

The floor of the *frigidarium* had been of freestone flags (fig. 8), some of considerable thickness.<sup>46</sup> The pattern was not a regular one, but the fitting together of squared slabs of different sizes was common enough in Roman floors.<sup>47</sup>

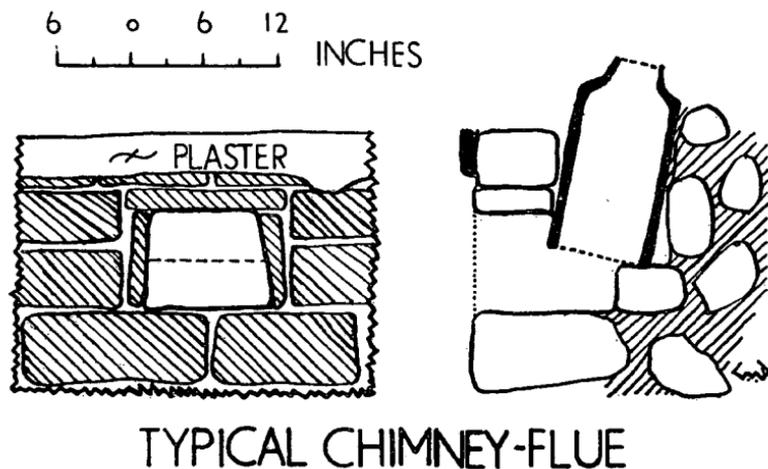
FIG. 14.

was covered with the usual plaster drip. Symmetrically placed in it were three chimney flues (fig. 14), akin to those in the *laconicum*: only the central flue was complete, though it was clear where the eastern one had been and the position of the western one could be estimated. The surviving flue opened 2 feet above the floor and was almost 8 inches square. A fragment of the tile pipe remained *in situ*. It is not known whether these flues were a device for regulating

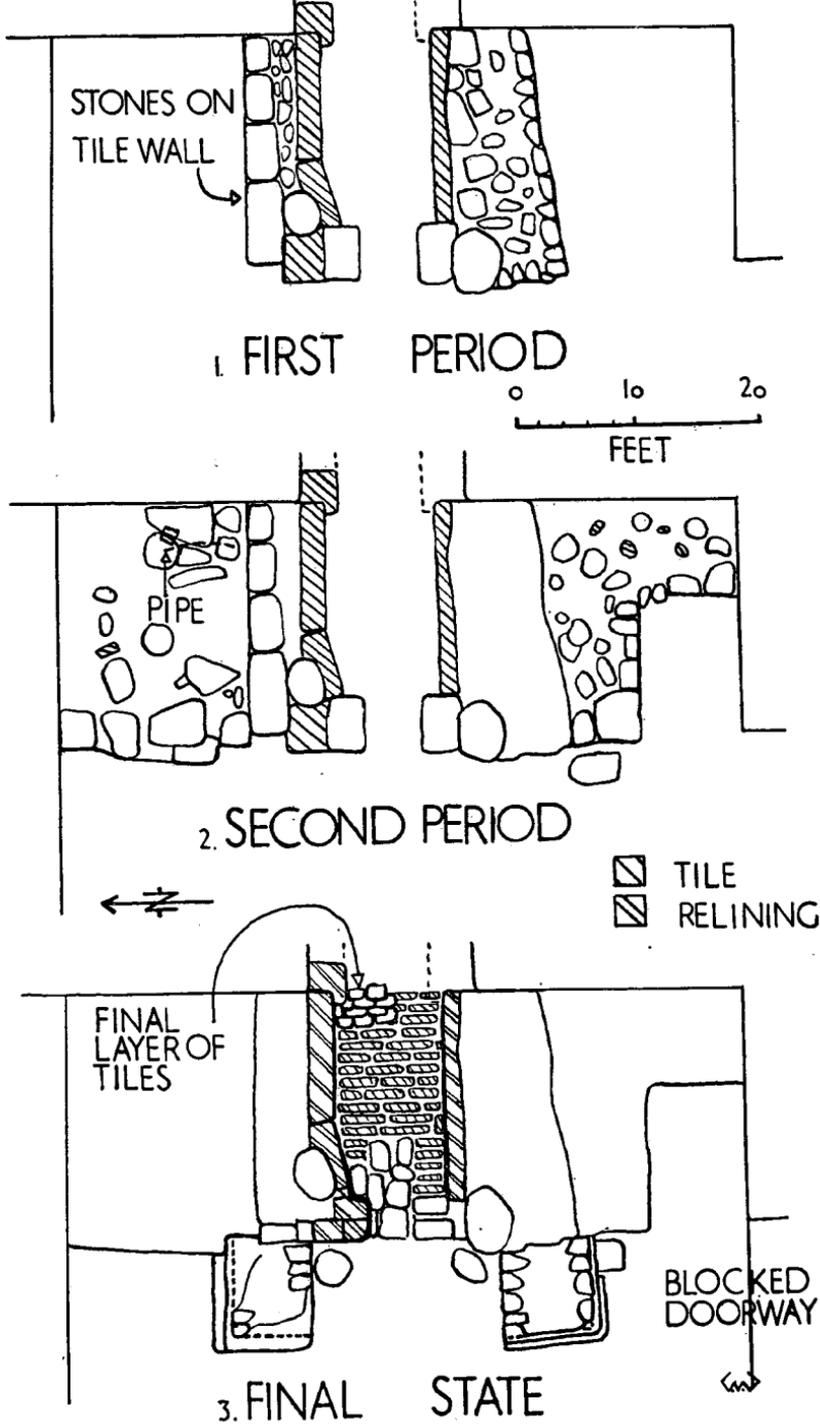
FIG. 15. PERIODS OF THE MAIN STOKEHOLE.

*First Addition.* The first change was the addition of an outer packing on both sides (fig. 15, 2). The southern lay on an inch of rakings, over which a layer of clay had been placed to bed the stones. The packing was again clay-bonded and faced with large stones. An amount of tile was incor-

porated as well as several calcined stones. The north pack was largely of dirty clay, with one or two stones in it, laid on a stone foundation and given a face of large, flattish slabs on its western side. In this packing, near its south-western corner, a length of lead pipe was found, similar to that already mentioned. It was 43 inches long and very battered. Whether it was *in situ* or not is difficult to say, but it must have been part of the cold feed to the boiler, and cannot have come from very far away. The layer of burning under this packing was thinner than that at the south, but this could be expected, as the obvious direction of the raking

*Re-lining.* The next event was the re-lining of the stokehole. Several inches of rakings had already collected on the furnace chamber floor, on to which the reddened clay and broken tiles of the old lining had been thrown. Although some had doubtless been removed much remained, indicating a thorough refitting. Whether there had been any change to the shape of the stokehole's face as a result of this is unknown, for no trace of the original lining remained.

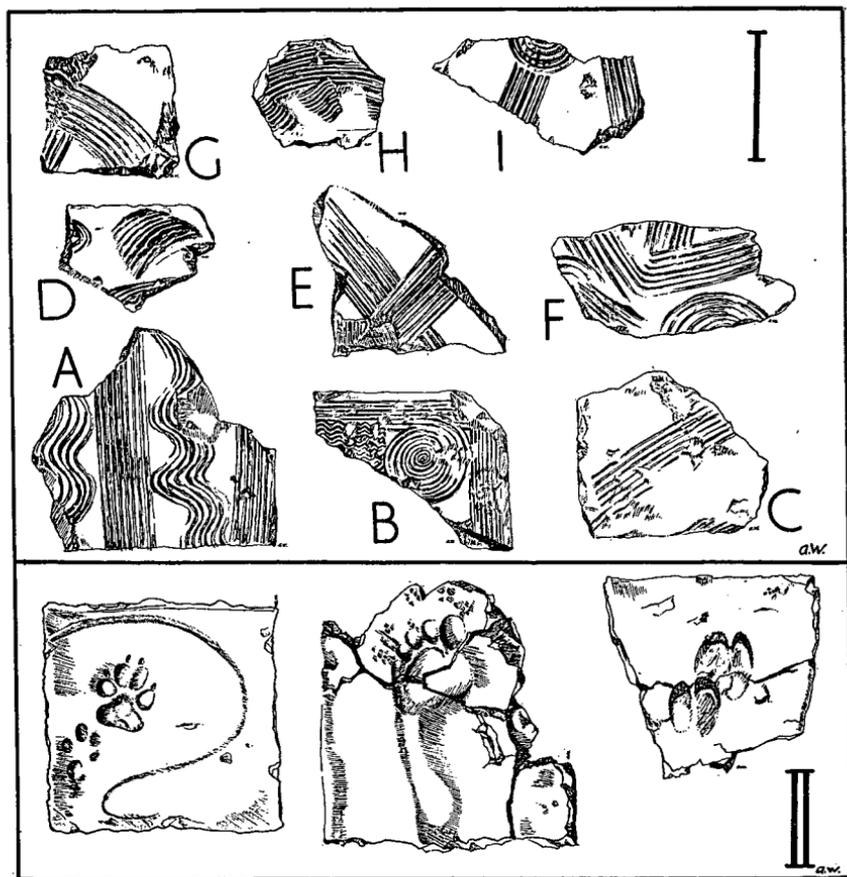
FIG. 23. TILE MARKS ( $\frac{1}{8}$ ).

Figure 23 shows the decoration on comb-marked tiles, and three

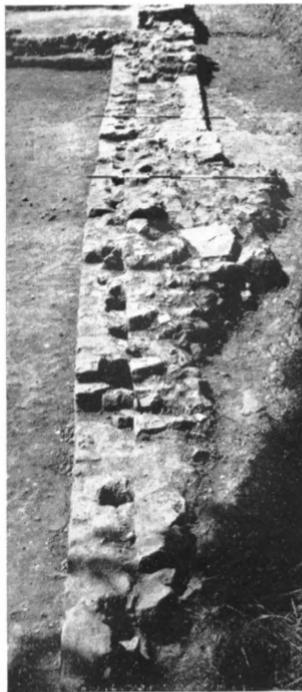
2. North wall of courtyard showing second face and bulge.

remained in every hole. In order to mask these posts a new face 15 inches thick had been added to the old wall, but merely rested on the peristyle floor (fig. 7). The posts must have been relied upon to do the retaining, the new face being intended to give unity of design. To tie the old and new walling together a series of horizontal beams ran through from the new face into the old wall, penetrating it to a depth of about 18 inches. Twelve of these were found for certainty and possibly another four, the majority being placed in two rows where the bulge was worst. The wall had then been plastered, and when found the plaster still completely covered two beam-holes and partly covered two more, though none of the wood remained (fig. 6a). This treatment seems to have been successful in retaining the bank, for only a slight belly was visible on the new face (plate VIII, 2).

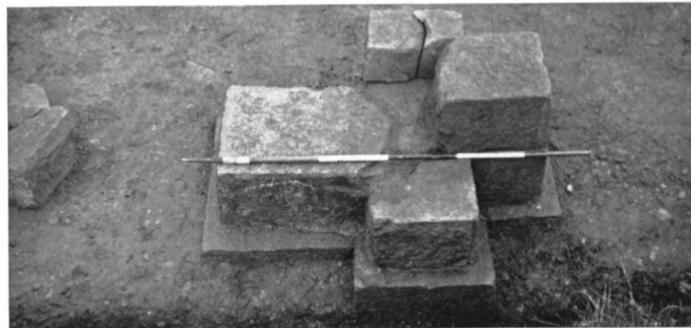
1. South pier of portico from west.

B. The stone appearing on the southern arm of the south pier (plate VIII, 1). Found in the drain where the south interval column should have been. It is 19 inches by  $17\frac{1}{2}$  inches by 1 foot high and worked on three sides. It probably came from a position similar to that in which it is seen.

C. The stone on the east arm of the south pier (plate VIII, 1). It was found immediately to the east of the east arm of the pier and measures  $9\frac{1}{2}$  inches by  $17\frac{1}{2}$  inches by  $7\frac{1}{2}$  inches in thickness. It had been cracked by its fall, but still retained plaster on three of its faces.

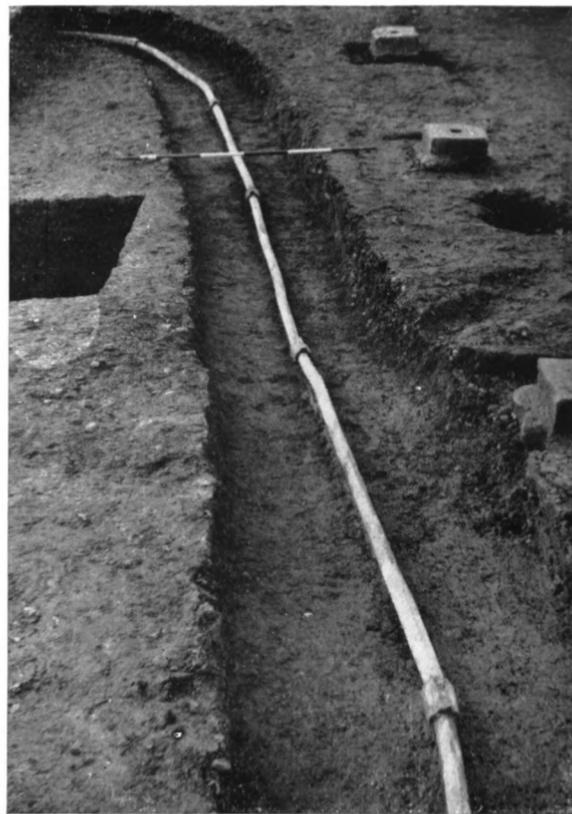
2. Water pipe from east.

The most interesting discovery was the main water pipe. This ran from the join in the east wall, along the south side of the walk, underneath the doorway to room XI, and ended on the edge of the main drain: 60 feet 9 inches in all (plates IX, 2, and X, 1; fig. 4). The pipe was of purified lead<sup>27</sup> in 10-foot lengths united by large box joints; unfortunately it was unstamped. The trench in which it had been laid had become indistinct where the wear had been hardest, but close to the east wall, where the lime surface remained intact, it was quite clear that the pipe had been laid in a prepared trench, with mortar sides and bottom. It had then been covered with a mixture of sand, lime and soil. At the east wall the pipe had run perpendicularly up the face of the wall cutting through it at a height approaching external ground level (plate X, 1). This upper portion of the pipe had been torn off, but no attempt had been made to remove the rest although its trench was unmistakable.

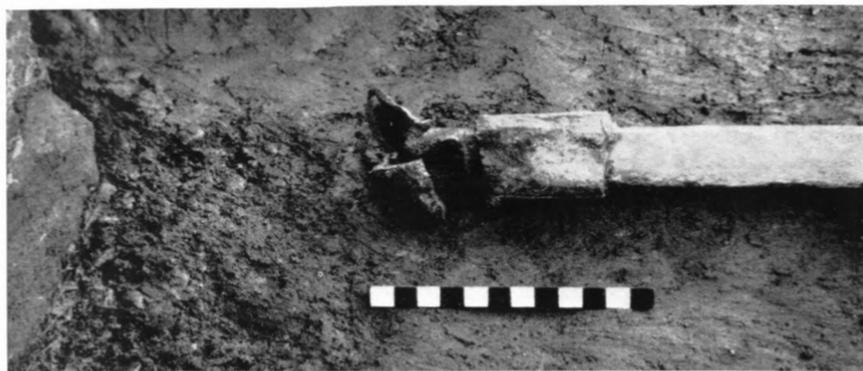
1. East end of pipe in courtyard.

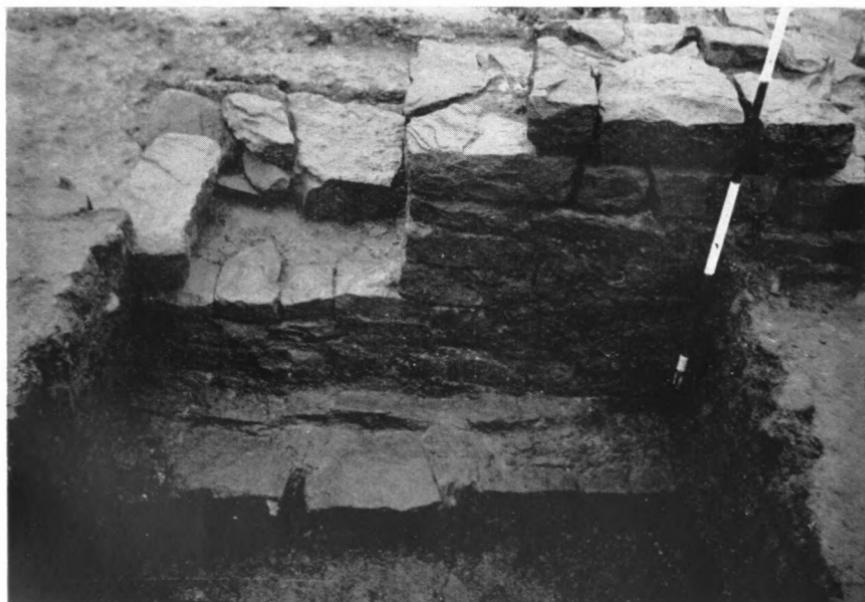
2. Doorway room II-III showing offset.

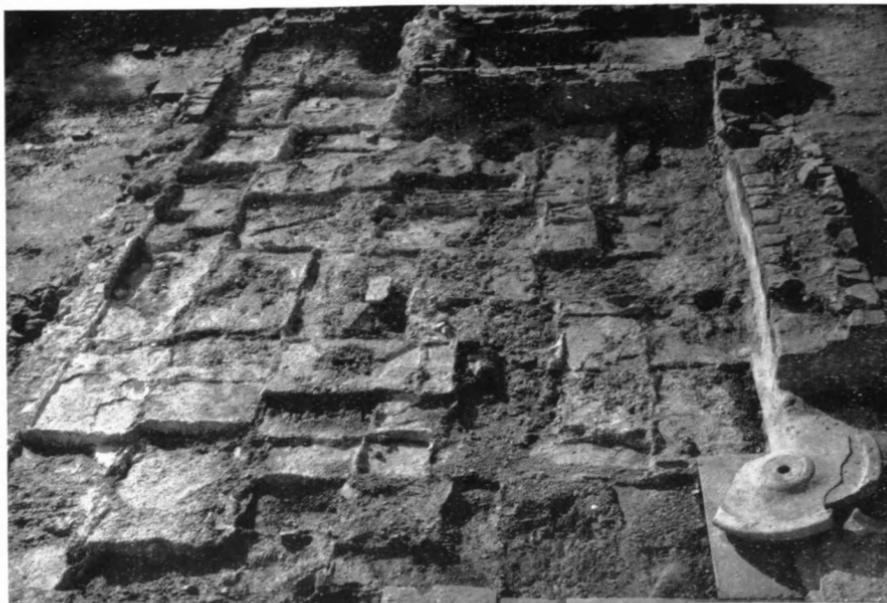
1. Matrices in *frigidarium* floor.

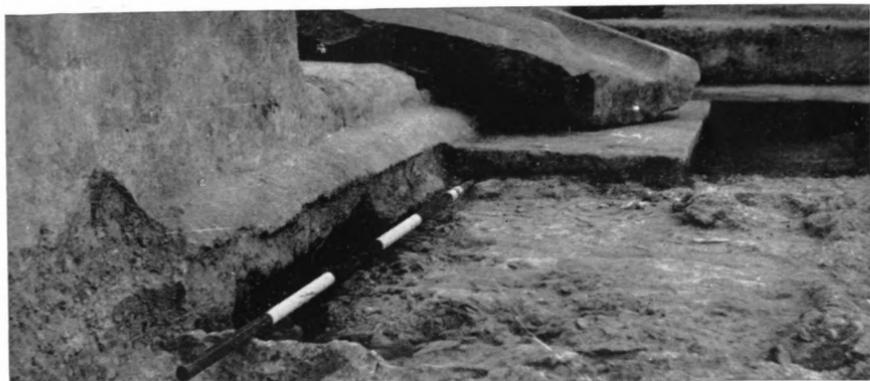
1. Moulding and pick marks: N. wall *frigidarium*.

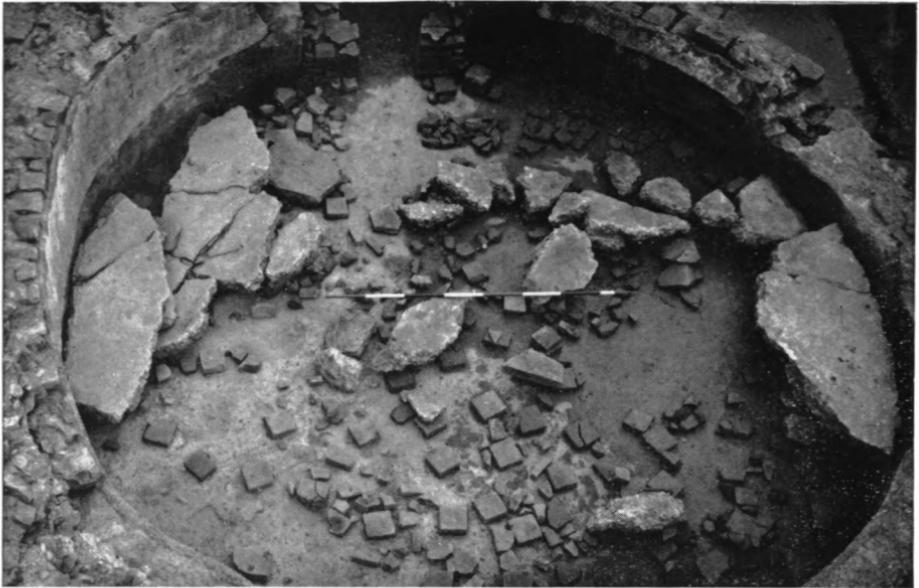
1. *Laconicum*, suspended floor and *pilae* fragments.

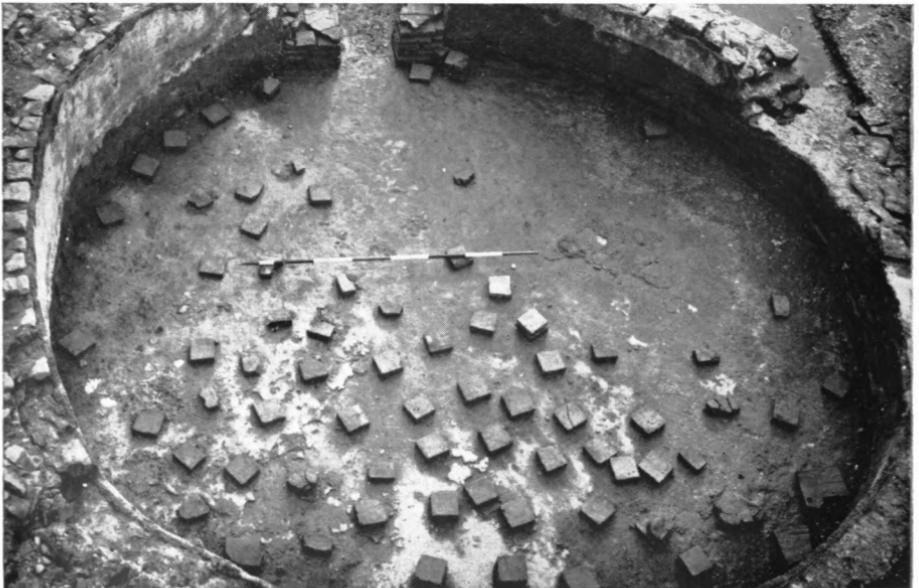
2. *Laconicum*, *pilae* bases *in situ*.

The *pilae*, at most 36 inches high,<sup>59</sup> had been built of square tiles, 2 inches thick and 9 inches wide. Clay had been used to set the two tiles remaining *in situ* and many traces of it remained on the floor.<sup>60</sup>

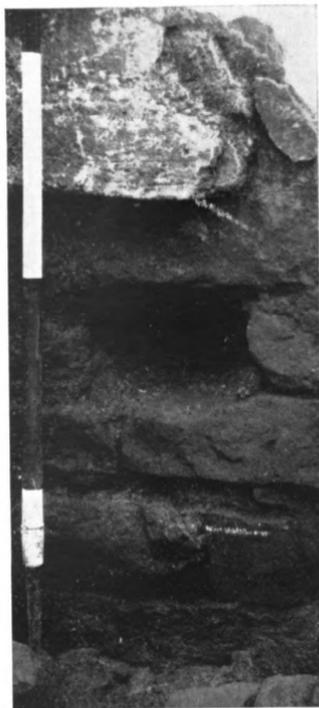
2. Chimney flue, *laconicum*.

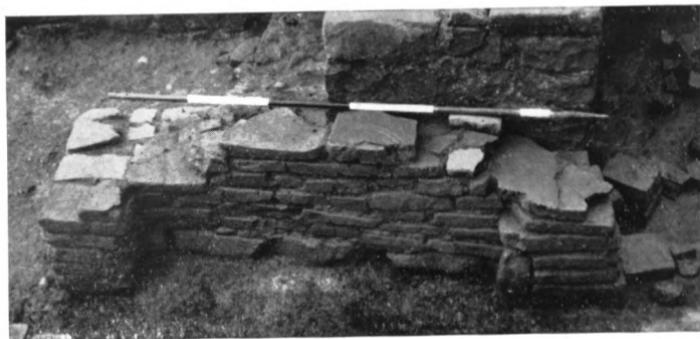
1. Level of suspended floor, stokehole *laconicum*.

The stokehole pierced the southern wall of the *laconicum* at basement floor level (plate XVII, 1), the size of the gap in the stone wall being 5 feet. The furnace itself was a small box-like construction (fig. 10) 7 feet by 7½ feet at maximum, built upon the bare subsoil. It had a stone foundation and outer face, forming a shell, inside which there was a pack of

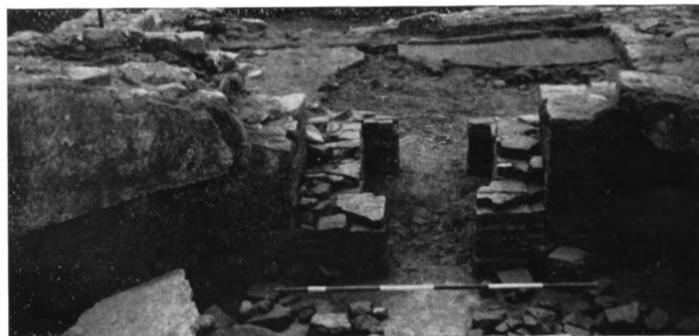
3. West cheek of *laconicum* stokehole.

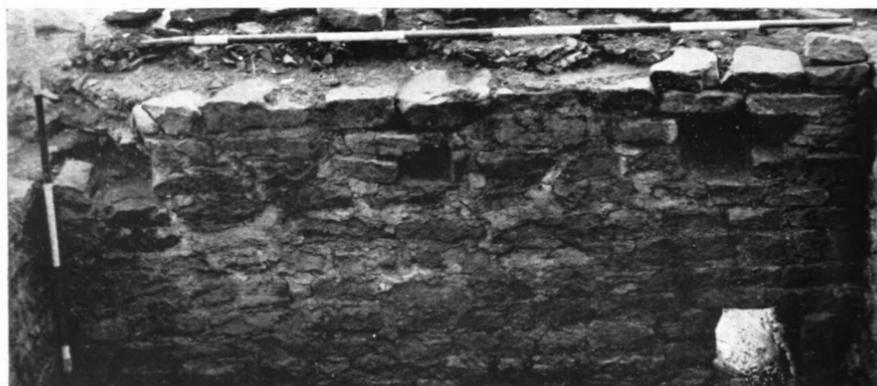
2. Latrine: Beam holes in south wall.

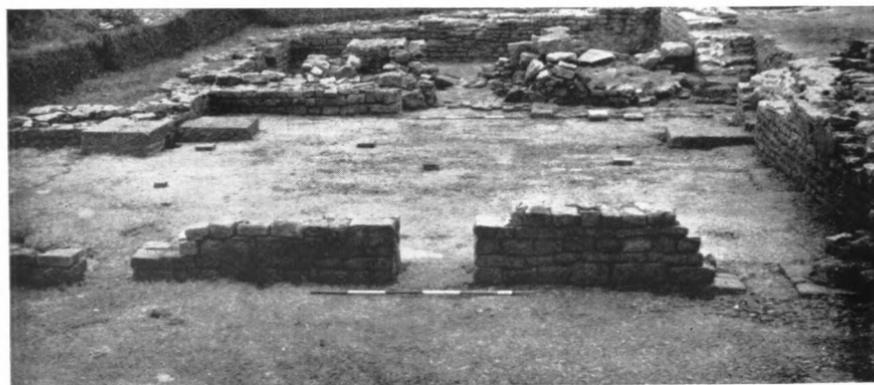
3. *Tepidarium-caldarium* wall from *tepidarium*.

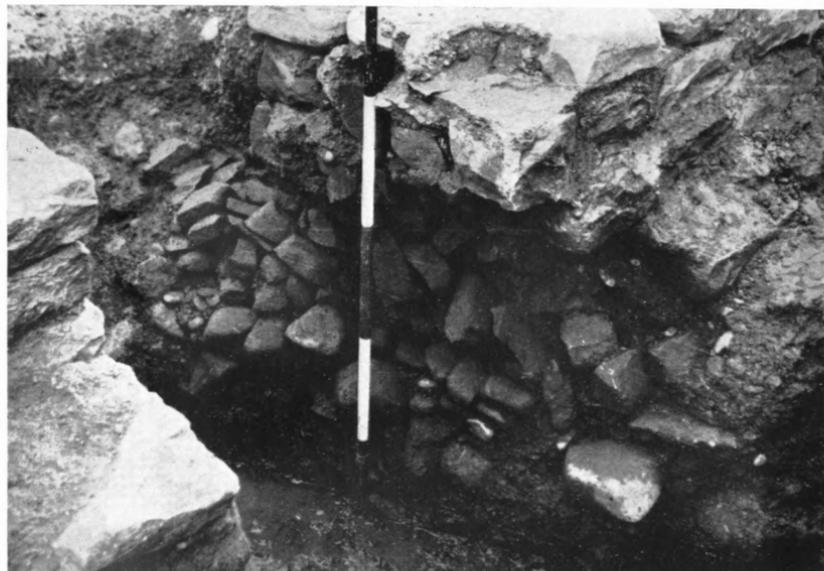
2. Main drain blocked by wall foundations.

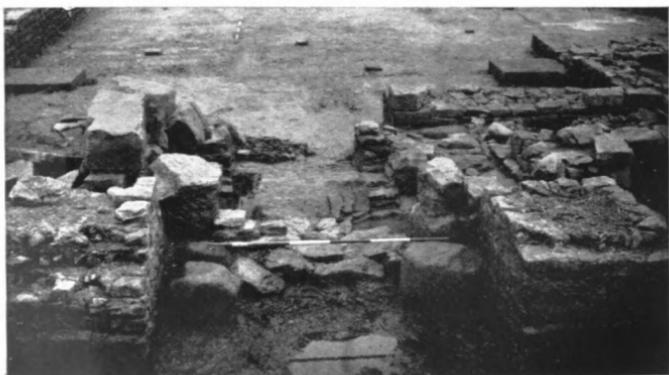
3. Main stokehole from west, final period.

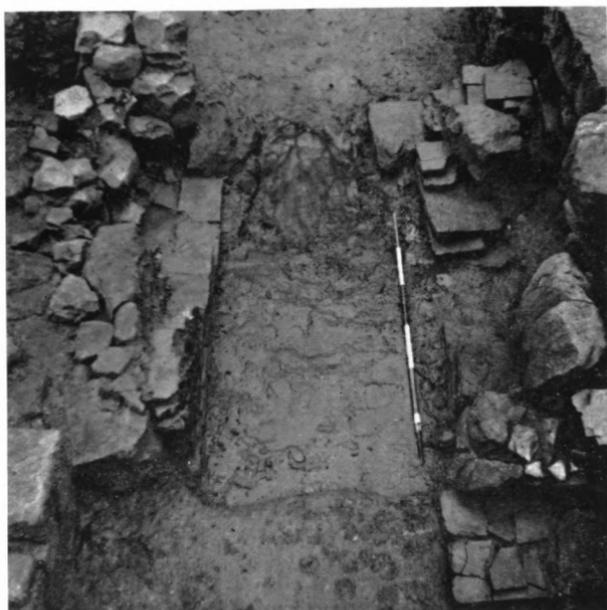
1. Main stokehole from east, earliest period.

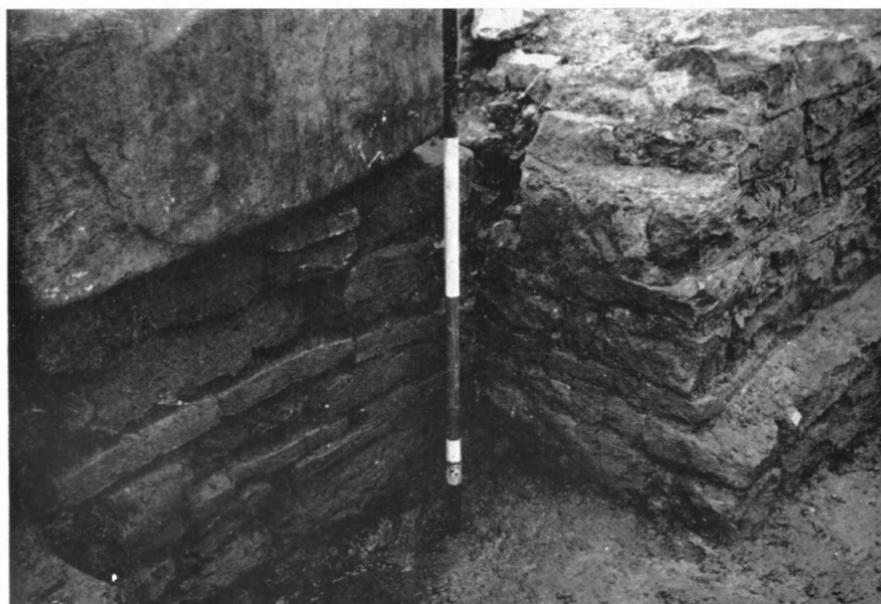
2. Main stokehole, period I. N. face, N. check.
