IV.—EXCAVATIONS AT NEWMINSTER ABBEY, NORTHUMBERLAND, 1961-1963

Barbara Harbottle and Peter Salway

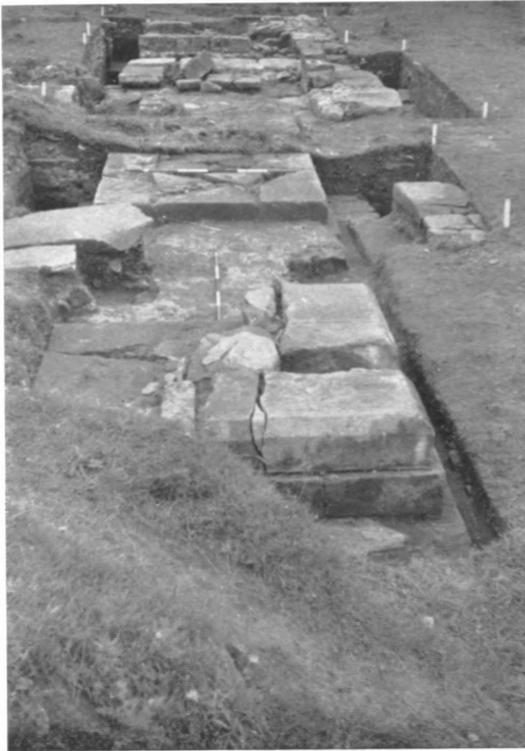
Fig. 1.
North Transept
piers from north

Only the bases of the northern and central piers of the aisle survived (pl. IV, fig. 1). Both had a bottom course of ashlar approximately 7 feet square, and on the northern there remained part of the second course, slightly less than 7 feet square and with a chamfered upper edge. The piers stood 10 feet apart on a continuous sleeper wall consisting of one course of ashlar $7\frac{1}{2}$ feet wide set on foundations $10\frac{1}{2}$ feet wide and $6\frac{1}{2}$ feet deep. The two bottom courses of these footings were river cobbles, the remainder rough sandstone blocks, and as there were virtually no traces of a foundation trench it seems clear that when the big blocks had been placed in position the sides of the trench were filled up with smaller stones. These tended to peel off during the excavation when the sand supporting them was removed.

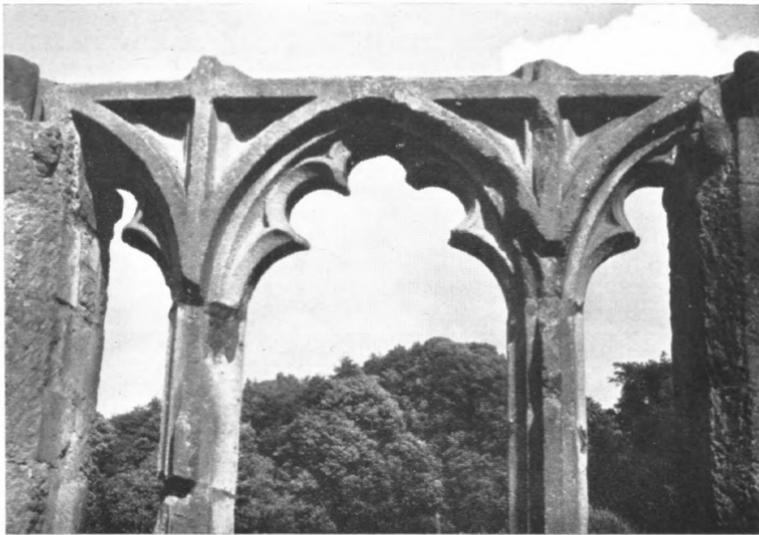
Fig. 1. Re-erected tracery in North Transept

This trench also served to confirm what was already obvious, that the fragment of a perpendicular window now standing within the transept is not *in situ* (pl. V, fig. 1). It is built on sand, with only one course below present ground level, and

Although the re-erected fragment of a window was not found *in situ*, it should be included in a consideration of later alterations to the outer walls of the transept. Woodman and Fowler recorded the discovery at the north end of the transept of "portions of the tracery of a very large perpendicular window . . . with an embattled transom". Renwick made a similar find in this area of presumably the same fragments (see p. 103), and it is reasonable to suggest that a fifteenth-century window was constructed in the north transept, perhaps in its north wall.

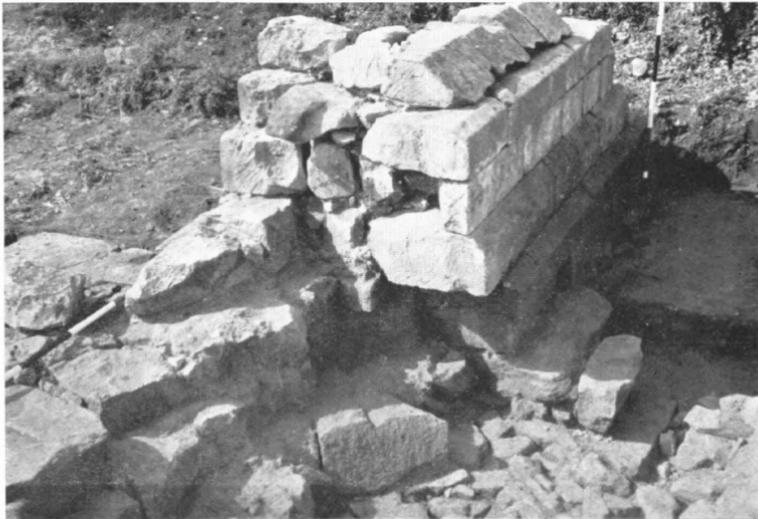
Fig. 2. North wall of Nave joining North Transept

wall was cleared down as far as the top of its foundations, and was found to be 5 feet thick at ground level (pl. V, fig. 2). Its north face stood six courses high above slightly projecting footings, and was relieved with four chamfered plinths. Two to three courses of the south face remained, and as not all the stones were ashlar it is possible that there has been some recent reconstruction here. These courses rested on a dressed course projecting 18 inches to the south, and below which were the rough foundations. It will be seen from the plan that masonry 6 feet in width projected $2\frac{1}{2}$ feet into the church from this junction of walls.

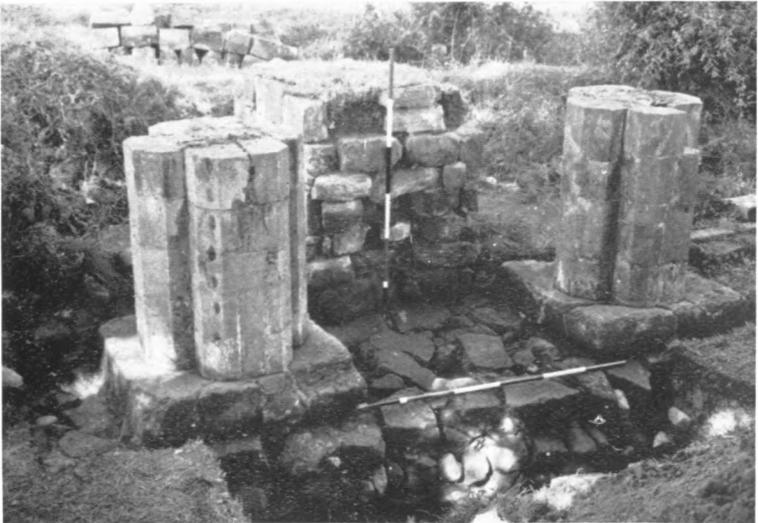
Fig. 2. Reredorter arcade and secondary buttress from south

Apart from indications that the arcade of the reredorter was later blocked up and buttressed (pl. X, fig. 2), and

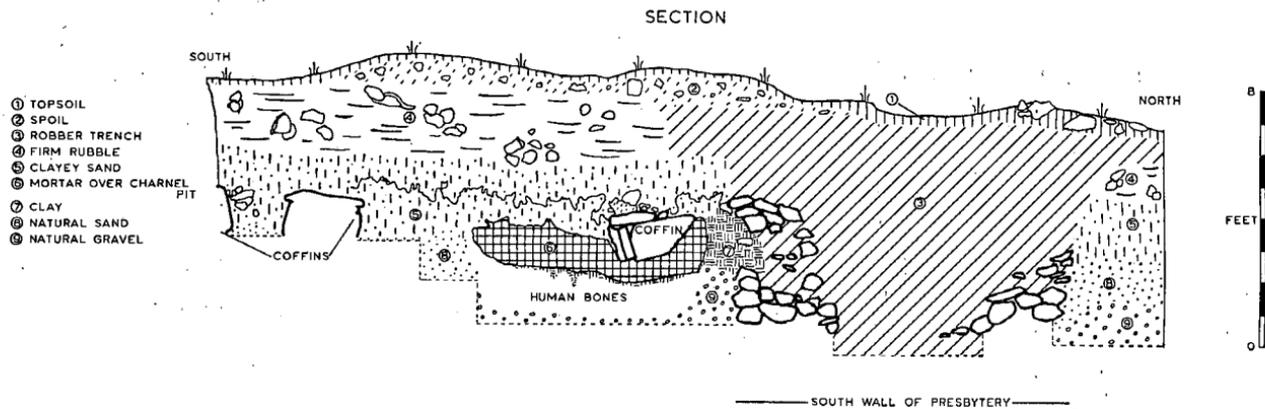
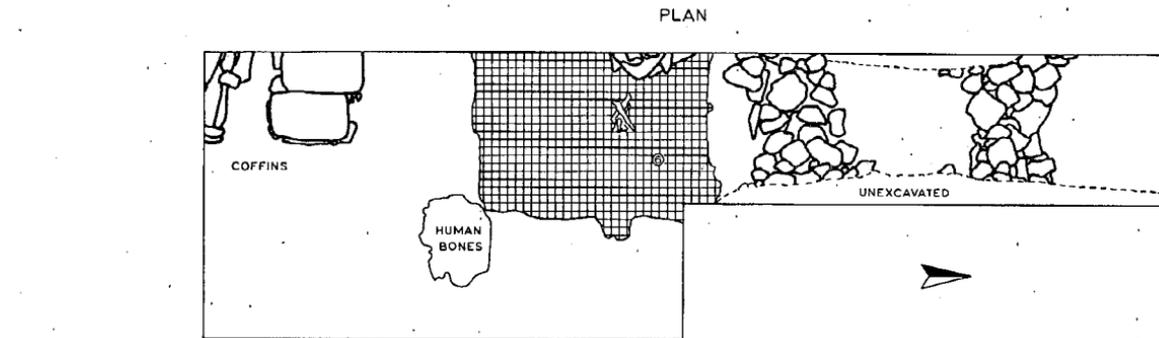
FIG. 4. SOUTH WALL OF PRESBYTERY (15)

in depth was found above laid river cobbles 9 feet across from north to south. South of the cobbles the sandy subsoil was overlaid by a thick level of brown clayey sand, in which were three stone coffins and a layer of hard mortar and stones covering a charnel pit. This contained a large quantity of human bones which, judging from their systematic arrangement, had been collected from other burial places in the abbey and deposited here. Above the clayey sand there was firm rubble, which was cut through by the loose rubble already described. Immediately below the topsoil was a slight mound of spoil from an earlier excavation.

In the northern half of **15** (fig. 4) loose rubble 7½ feet

which the stone robbers were so thorough that they removed not only the ashlar of the walls but also the greater part of the foundations. In **15** the robber trench had been dug through the firmer rubble, which may represent debris from the demolition of the abbey soon after the Dissolution. From the re-used stones incorporated in it the buttress is clearly secondary, and its angle would suggest that it was added at a comparatively late date. As it protrudes into the line of the wall provided by the evidence of the robber trench in **14** it must have been bonded into the wall, hence part at least of the north-east angle of the presbytery must have been rebuilt.

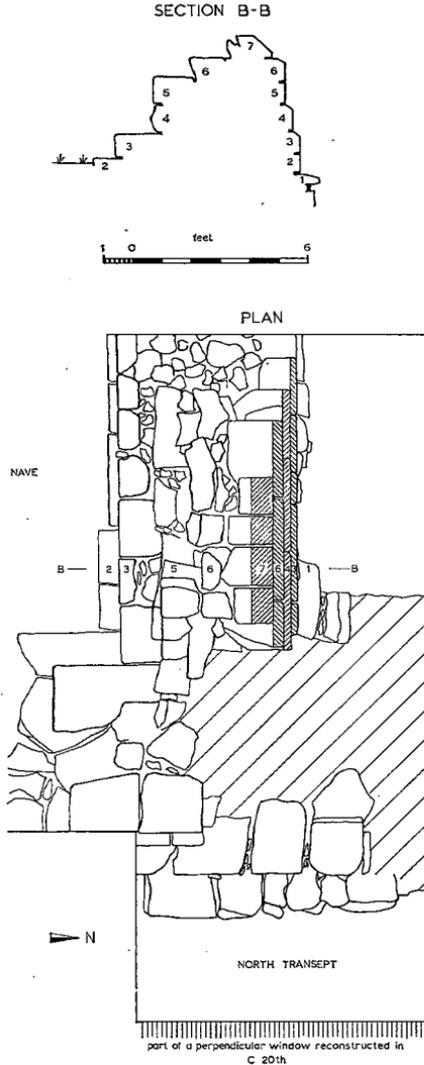
FIG. 6. JUNCTION OF NORTH WALL OF NAVE WITH WEST WALL OF NORTH TRANSEPT (7)

The removal of the rubble overlying much of **7** (fig. 6) exposed foundations of rough sandstone running from north to south. These footings, which were 11 feet wide and had particularly large blocks in their east face, ran under the extreme east end of the north wall of the nave. The nave

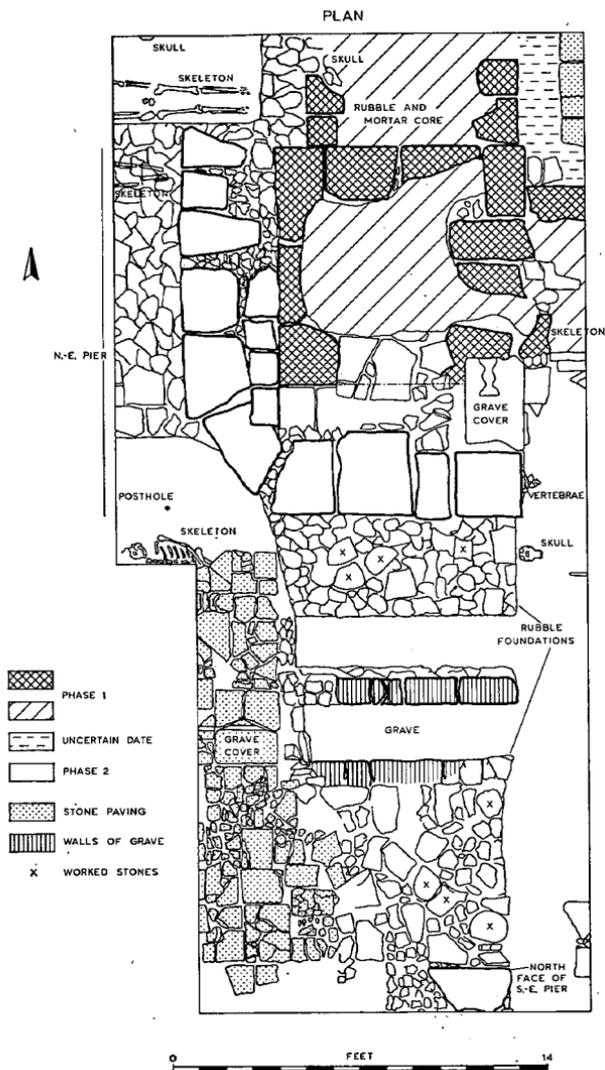
FIG. 9. THE CROSSING: NORTH-EAST AND SOUTH-EAST
PIERS (11)

At the north end of **11** (fig. 9, and pl. III (fig. 2), and beneath laid rubble which carried a few flat stones, some 4 feet of the sleeper wall were revealed. Here the wall consisted of a rubble and mortar core faced on either side with one course of well-dressed but unchamfered blocks of ashlar, and was found to abut a line of similar stones forming a straight face $9\frac{1}{2}$ feet long from east to west. After the removal of a thin covering of topsoil it became apparent that this face was the north edge of a large stone platform, which could be nothing else but the base of the north-east crossing pier. The base, which measured 13 feet from east to west and 14 feet from north to south, had a rounded south-west corner, and west and south faces of very large but rough stones, with their greatest dimension in depth from face to core. These stones projected outwards from ashlar faces which showed as straight joints in the core of the pier, and which were partially obscured by other stones, including the fragment of a grave cover. When a covering of clayey sand had been removed, the rough stones of the south and west edges of the base were found to rest on rubble, among which were a number of re-used stones. The pier had no true east face, for large stones lying on rubble were found projecting jaggedly from its core, but it should be noted that this rubble had a north face of ashlar.

foundations to the south and west, and placing on top the large rough blocks which now form the edges. This increased the basal area of the pier from about 85 to nearly 180 square feet. The evidence which remains suggests that the south-east pier underwent the same treatment, but an old excavation trench between the north face of the pier and the central pier in the south transept has made it impossible to obtain further proof. It is possible, perhaps even likely, that the western piers of the crossing were also enlarged, but in the case of the north-west pier the evidence for such enlargement has been destroyed.

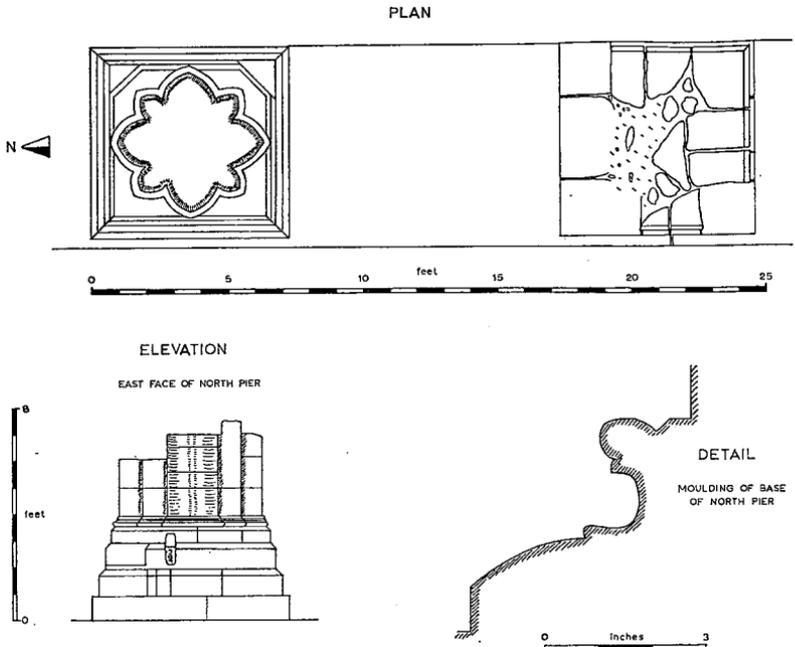
FIG. 10. PIERS OF SOUTH TRANSEPT

Some fragments of masonry stood above ground in the south transept before excavation began. The line of the east wall was indicated by the lower part of a buttress, 6 feet wide by 8 feet long, and six courses high with a chamfered plinth on the third course. It lay opposite the southern of two pier bases, 7 feet square and standing 10 feet apart on a sleeper wall, which could be traced from the northern pier to a point some 10 feet south of the southern one (fig. 10). The northern pier, which was the more complete of the two, had a square base four courses high with chamfered plinths on the three upper courses, and bevelled angles on the east side of the top course. In its east and north faces there were vertical

slots, so rough as to suggest they had been cut after the pier had been built, and presumably intended to support wooden screens. Above its base, the pier was in the form of a compound column composed of four large and four small keeled shafts, and it is quite certain that this upper portion was one of Renwick's restorations.²² The probable position of the south wall of the transept was indicated by foundations showing through the turf, and of the west wall by a slight mound.

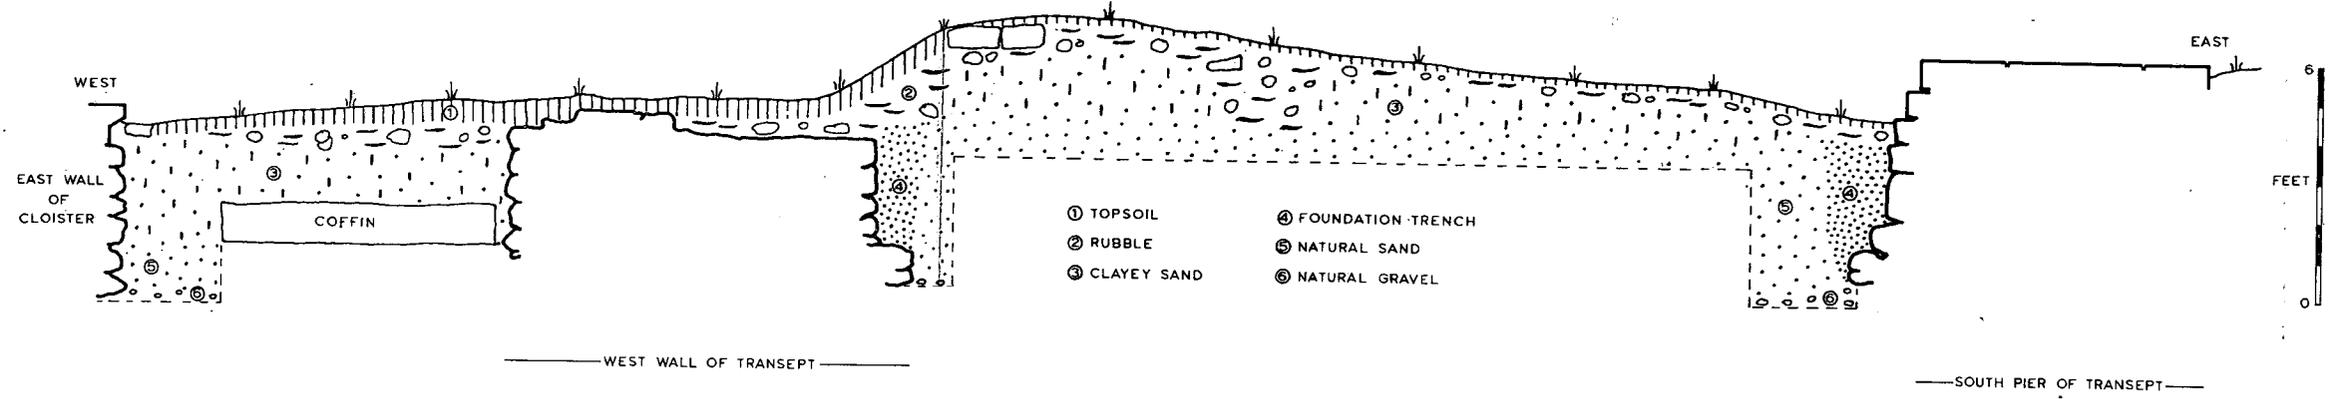
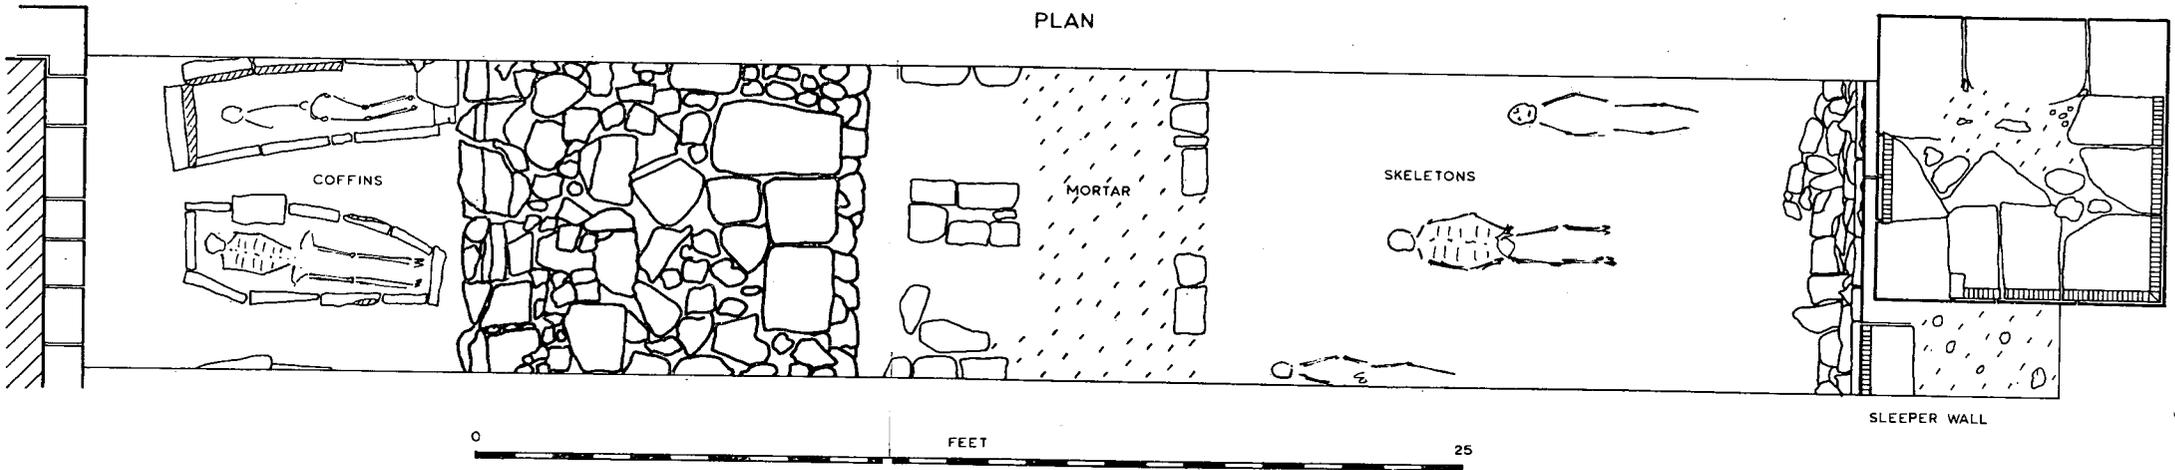
FIG. 11. NEWMINSTER ABBEY 1961. SOUTH TRANSEPT (17)

At the west end of **17** (fig. 11) the east face of the footings of the cloister wall was fully exposed, and was found to consist of 3 feet of river cobbles, one course of large rough stones, one dressed course and a projecting plinth chamfered on the underside. This plinth presumably indicated the level of the floor in the cloister walk, though no trace of tiles or stone flagging remained. On the upper surface of the corner stone of the plinth there were a number of small holes, and it is possible that these were connected with the original setting out of the plan of the abbey.

The foundations of the west wall of the transept lay $9\frac{1}{2}$ feet east of the cloister wall. Two courses of river cobbles had been placed at the bottom of a trench $10\frac{1}{2}$ feet wide, and rough sandstone blocks laid on the cobbles at a reduced width of 9 feet leaving cobbles projecting on the east side only. This side of the trench had then been filled up with dark brown sand.

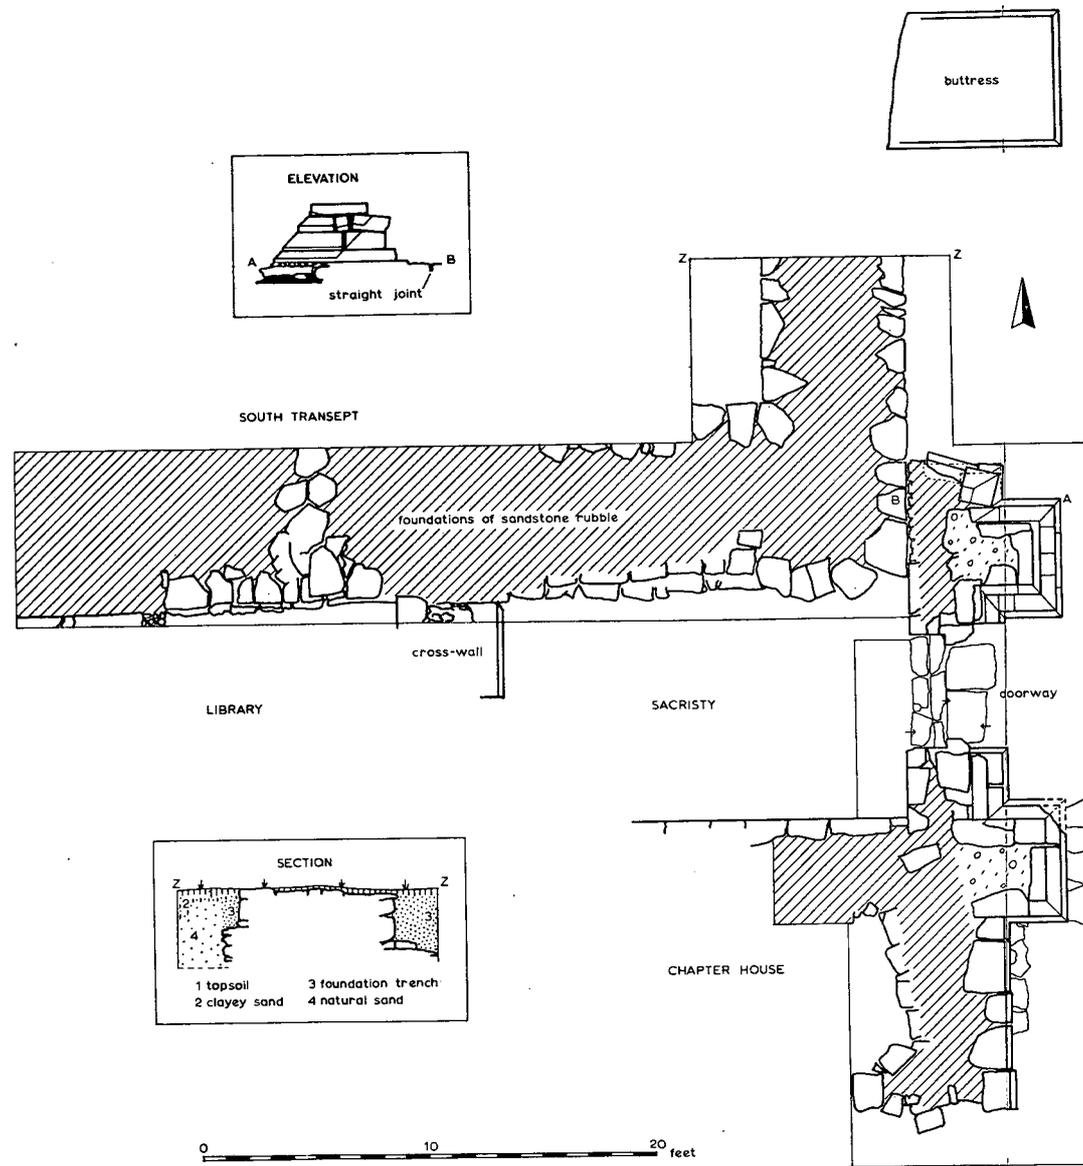
FIG. 13. SOUTH TRANSEPT AND SACRISTY (20)

several places the dark filling of the trench could be clearly seen. The transept wall, of which only the foundation stones remained, was over 8 feet wide, and from its south face projected the east wall of the library. The lowest part of the foundations of the latter wall merely abutted the transept wall, but the upper part appeared to be intended to bond into it. Towards the west end of the south face of the transept wall there was another projection, which was more fully investigated in **22** (p. 127), and it need only be added here that **19** established that there was no similar feature built out from the opposite face on the transept wall.

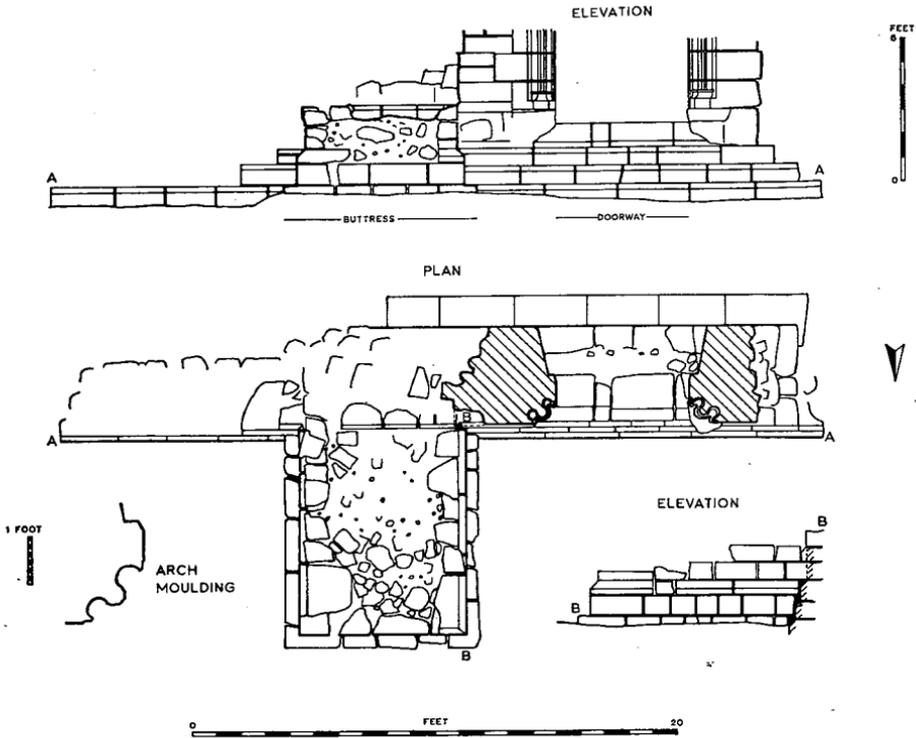
FIG. 14. WEST END OF NORTH WALL OF NAVE

At the west end of the nave there remained a short stretch of its north wall standing four courses above modern ground level. On this wall was a complete arch, and against the outer face of the wall and east of the arch a large buttress (fig. 14). The wall itself was similar in width and character to the other end of the same wall found close to the north transept (fig. 6). The buttress, $8\frac{1}{2}$ feet long by 7 feet wide, was clearly later than the wall. There was one chamfered plinth on the buttress and four on the outer face of the wall, and the two were only raggedly bonded together. The face of the wall within the buttress retained the remains of a chamfered plinth, but as this was higher than the equivalent course outside it is probable that it had been moved when the buttress was added. An attempt was made to discover if an earlier buttress was embedded in the later, but no trace of one was found.

The arch remained a mystery. It had the appearance of a door, with two hollow mouldings outside, and splayed and rebated jambs inside, but a door in this position in a Cistercian church would be unusual. It was badly seated, being found to overhang slightly the uppermost chamfer on the wall, and on its east side there was no provision for bonding into the nave wall proper. Being 3 feet above ground level, it would have to have been entered up steps, but neither the inner nor the outer face of the wall on which it rested showed any sign of such a feature. The only evidence for steps was unconvincing, consisting as it did of a single semi-circular line of stones both within and without the church. On the whole it seems probable that the arch was reconstructed in this position after the Middle Ages, perhaps as a Gothick folly of the eighteenth century, for it was certainly standing in 1792 (p. 88). It is unlikely that it would survive the demolition of the church, or be consistently ignored by stone robbers when the remainder of the abbey had disappeared beneath the grass.

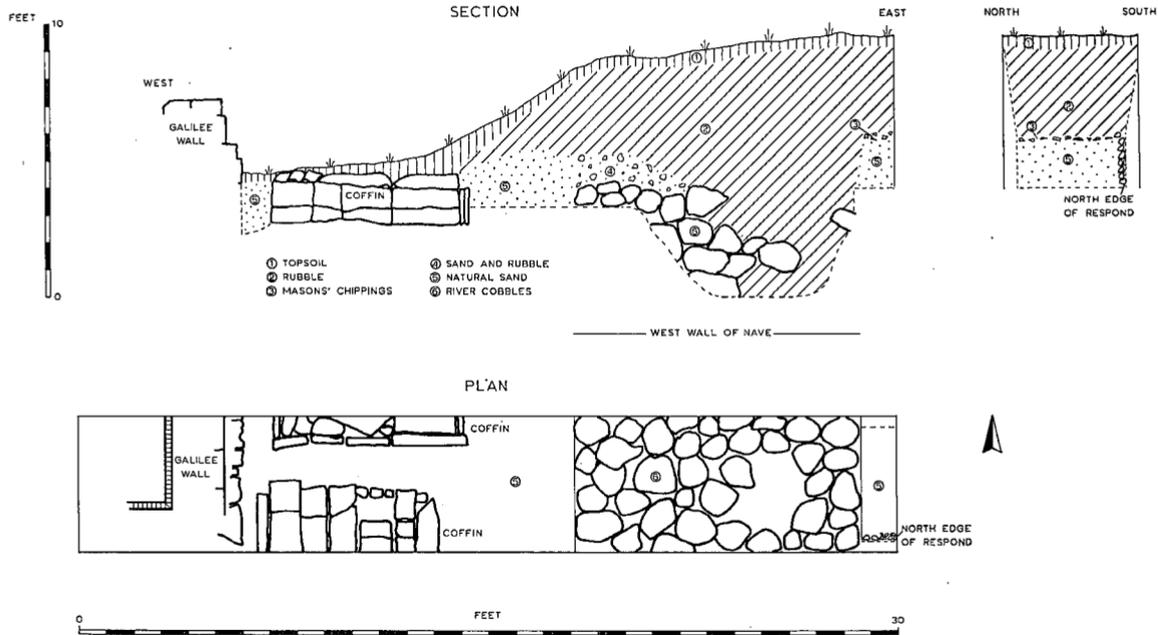
FIG. 16. WEST END OF NAVE (2)

The eastern part of **2** (fig. 16) was also filled with loose rubble, which was found to cover large river cobbles $10\frac{1}{2}$ feet across from east to west between undisturbed sand on either side. On the west edge of the cobbles and below the rubble there was a layer of sand and stones over 1 foot in depth, and on top of the natural sand east of the cobbles was a thin spread of small broken stones. Rubble was also found to project from the south section east of the cobbles. At the west end of the trench and close to the galilee wall there were two stone-built coffins.

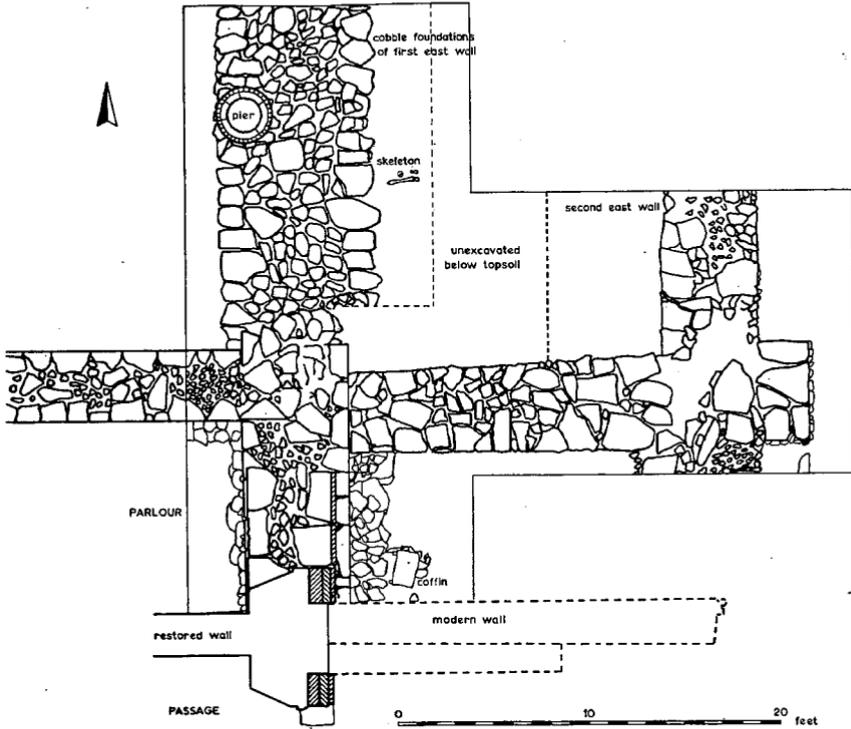
FIG. 19. CHAPTER HOUSE (24)

In **24** (fig. 19) the south jamb of the east door of the parlour was found to stand five courses above the threshold,

and to have its original splay, door-check and bar-hole. The lower part of its outer face was relieved by two chamfered plinths, and the outer edge of the threshold was also chamfered. The course which formed the threshold was $4\frac{1}{2}$ feet in width, and was set on the single course of ashlar $5\frac{1}{2}$ feet wide described above. Half an empty stone coffin was found east of this wall, and had probably been damaged when the foundations were laid.

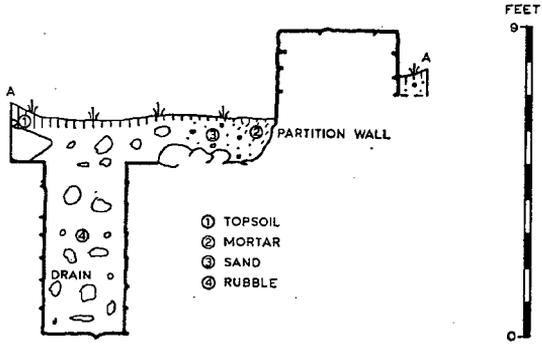
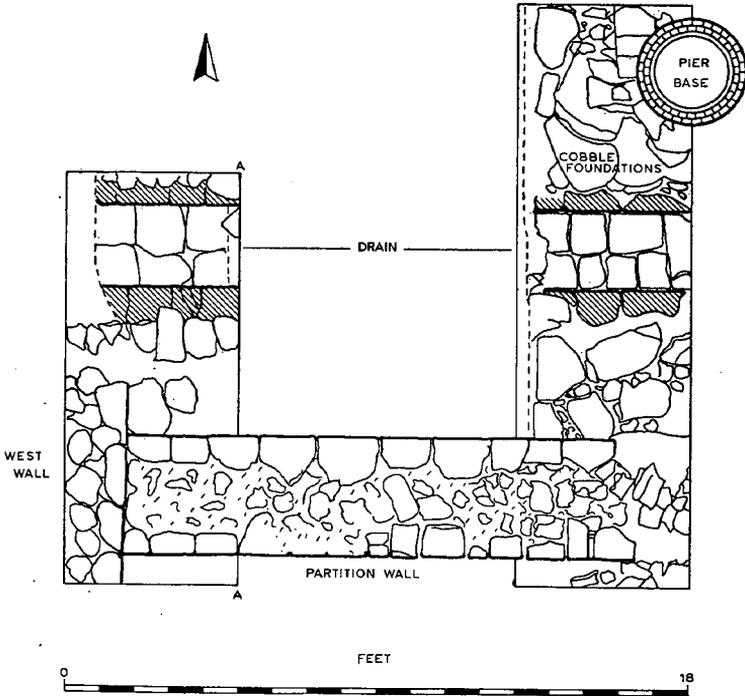
FIG. 20. DORTER UNDERCROFT (30, 31)

Although the wall was not as well-preserved in **31** (fig. 20), it was quite clear that it did not incorporate the base of a pier. Large river cobbles projected from its north face, and lay beneath the pier base some 9 feet to the north, and though their line was broken by another stretch of the drain described above it seems certain that they had once formed a continuous foundation down the centre of the undercroft. From the rubble filling the drain came a number of fragments of pottery (p. 164, and fig. 28, nos. 63-64), and one section of vaulting-rib similar to those found in the west range (p. 153, and fig. 25, no. 7).

On the whole it seems likely that this south wall was of primary rather than secondary construction. If the latter, it would have entailed the removal of a pier before the wall could be erected, and this in turn would have meant some form of temporary support for the vaulting. The usual way of adding a partition wall was to leave the pier in position and build the wall up to each side of it, as was done further north in the undercroft.

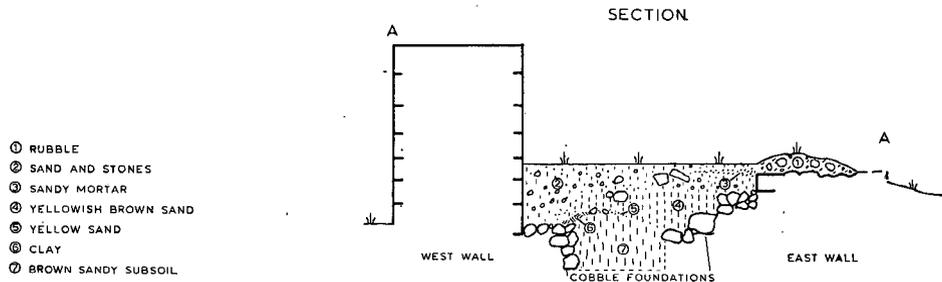
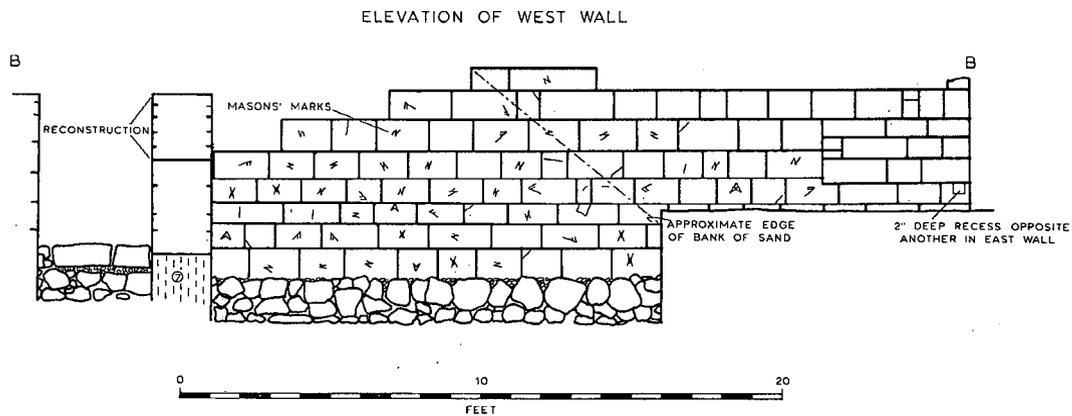
FIG. 23 THE DAY STAIRS (27, 28).

The wall which contained the mound on its south side was very different in construction (pl. X, fig. 1). Only 2 feet wide, it was built on sand without footings, and did not bond into the west wall of the dorter. The stones of its north face were much rougher than the ashlar of dorter and warming house, and the joints between them were so heavily smeared with mortar that much of the detail was obscured. Nevertheless, it was clear that the courses of this end wall did not match those of the east wall of the warming house, though the two were found to bond in one or two places. Its five uppermost courses were just as obviously a modern

replacement. They had been built up from the south side against the mound of sand, and modern white cement had oozed out of the joints to congeal in ugly lumps against the north face.
