VI.—THE EXCAVATION OF ONE HOUSE SITE IN THE DESERTED VILLAGE OF WEST HARTBURN, CO. DURHAM

*L. Still and A. Pallister*¹

West Hartburn

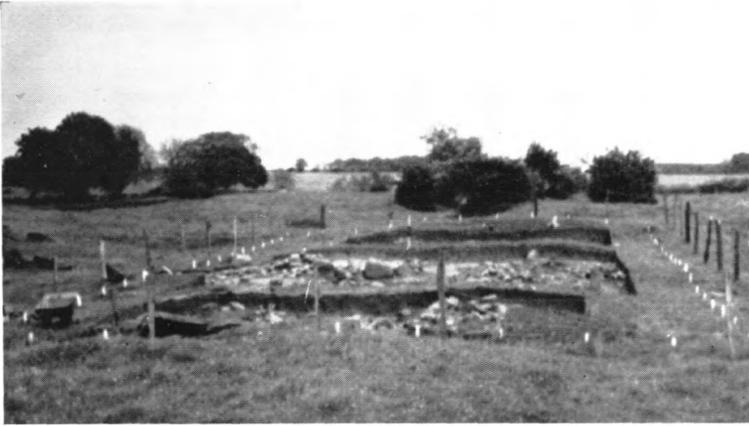
Fig. 1. View east along line of sunk road

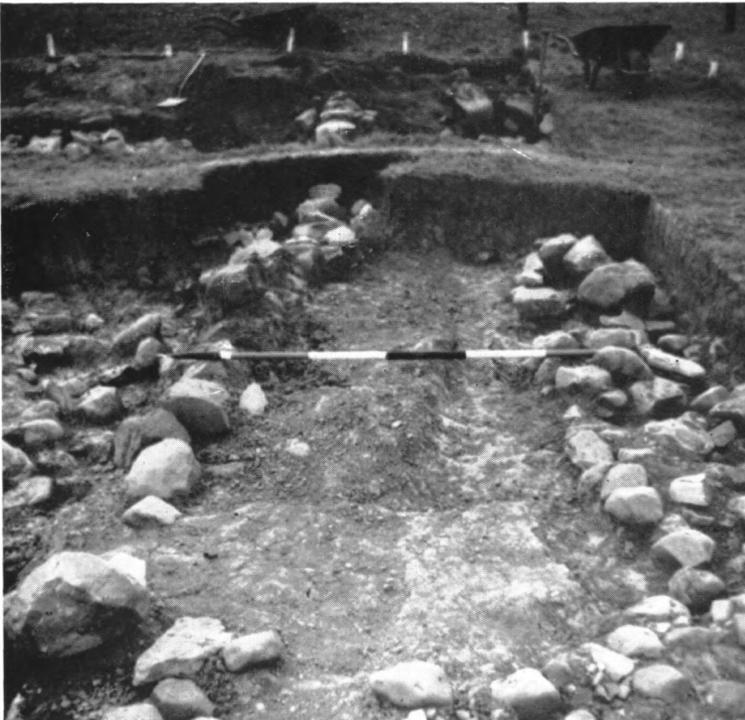
Fig. 2. Clay core of north wall looking W.

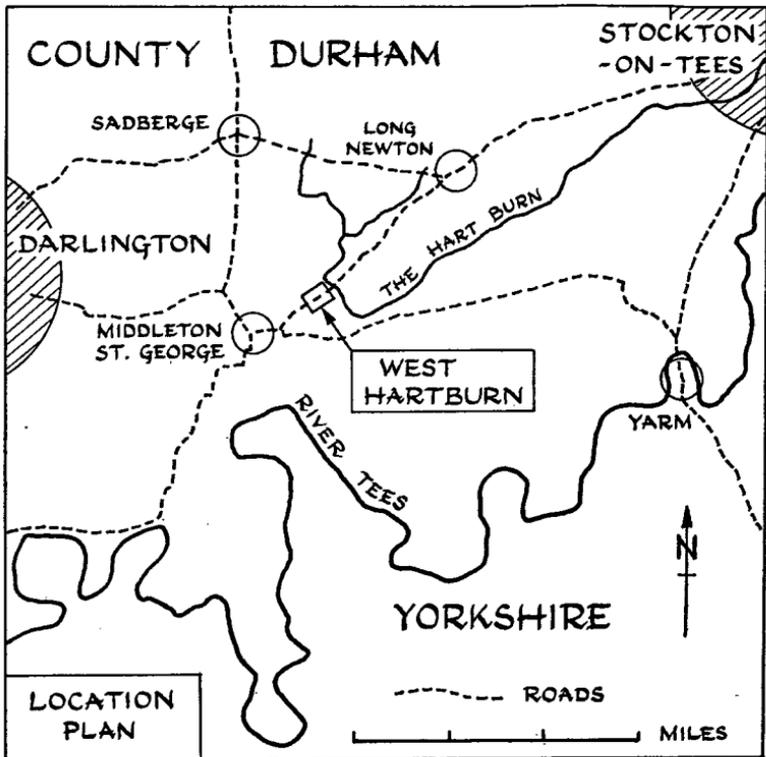
FIG. 1

WEST HARTBURN

VILLAGE PLAN

MAIN FEATURES ONLY SHOWN.
 GROUND SLOPES GENTLY TO STREAM.
 P.....DRIED-UP POND.
 W.....DITTO - SITE OF WELL?
 RF.....BOLD RIDGE & FURROW.
 FRF....FAINT RIDGE & FURROW.
 A.....HOUSE 'A' - EXC. 1962.

The site of the village lies principally in the fields of Foster House Farm, to the east of the present farm house although some traces lie to the north of the present Long Newton-Middleton St. George road in a field belonging to West Hartburn Farm. Remains on the ground suggest a long narrow village green with houses on both north and south sides, each row of cottages possibly having its own roadway. One sunken roadway is still very obvious running the length of the southern side of the village, but that on the northern side is probably obscured by the modern road and hedges. (See sketch plan of village.)

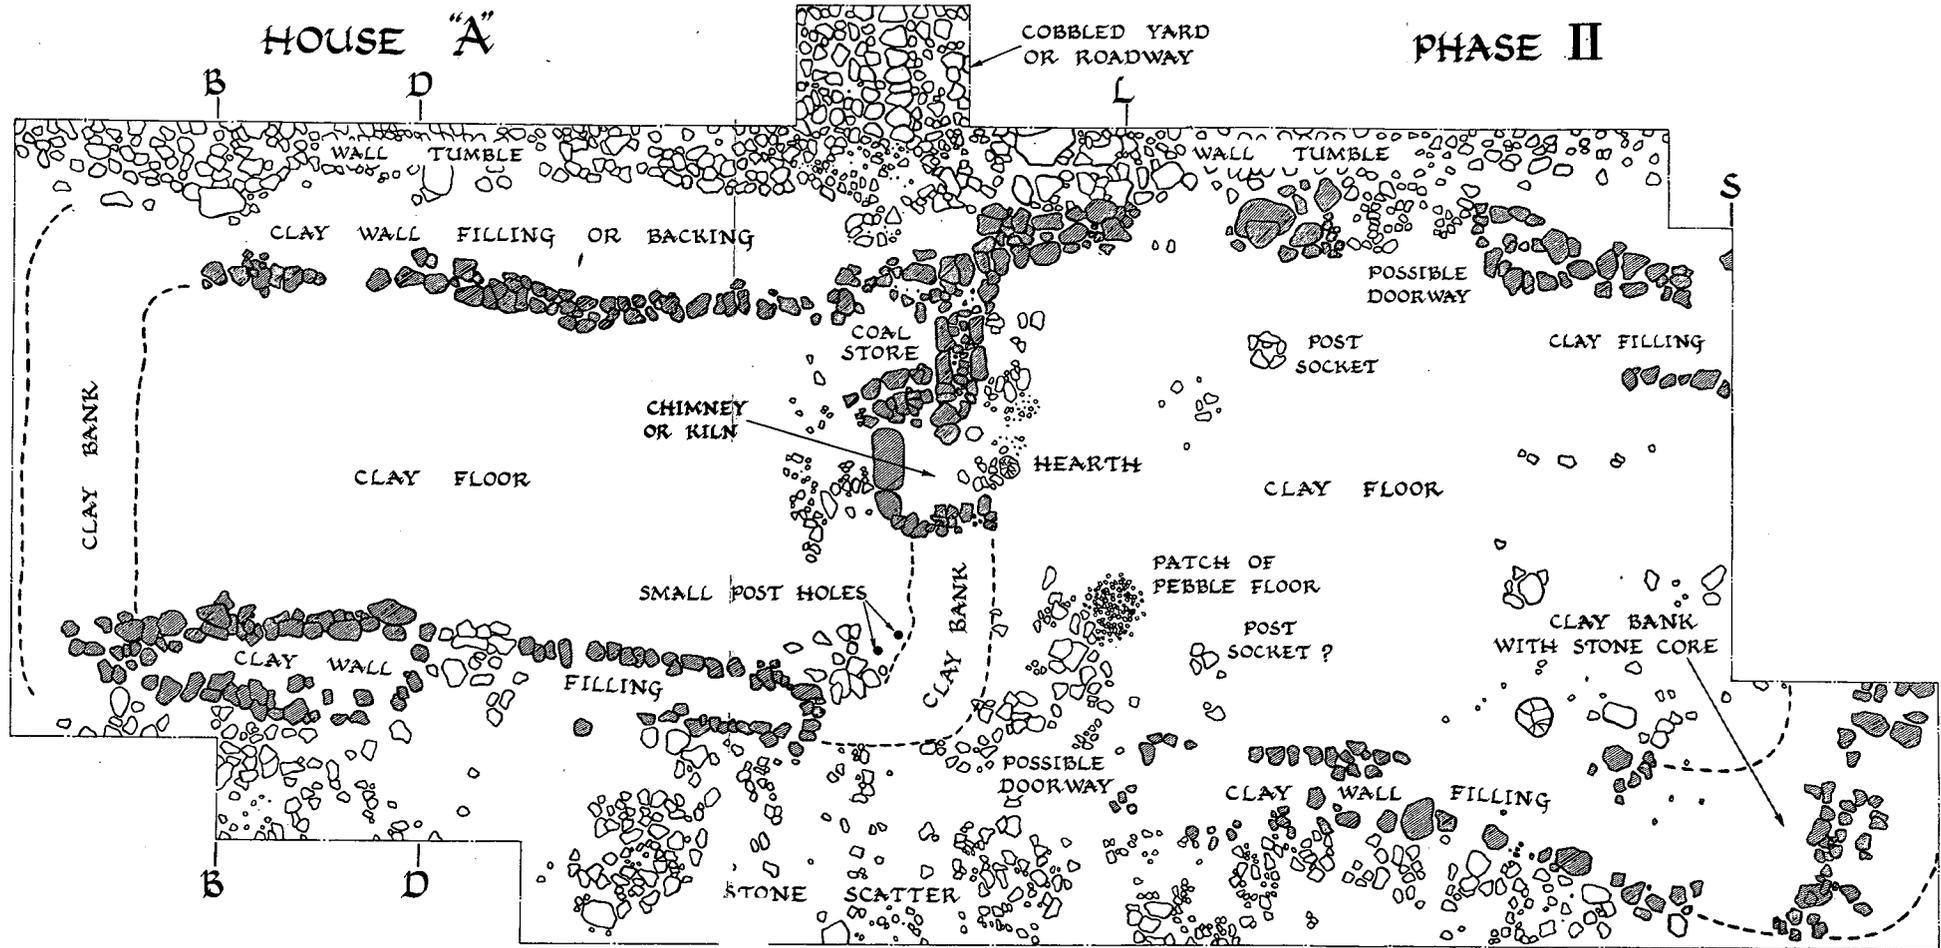
FIG. 3

WEST HARTBURN 1962

PLAN I

FEATURES SHOWN AS FOUND ON EXCAVATION.
WALL STONES FOUND IN POSITION, OR NEARLY
SO, SHOWN SHADED.

Phase II—see Plan no. 1

Plan no. 1 represents the building as seen after all turf, topsoil and loose stones had been removed. The stones in dark shading are those set firmly in hard clay and show the foundations of the walls. These wall footings were examined carefully and sectioned in places and it would appear that the method of construction was that of a clay core between 2 feet and 3 feet thick, faced on both sides by undressed river boulders. The clay of the wall interiors had been worked, it was free from the gravel and small stones found in the local clay, and had a texture and colour quite distinct from the natural layer. The clay interior of each wall was examined for signs of post holes, wattle hurdles, etc., but nothing was found. This suggests that no posts were set in the wall clay as evidence of the use of posts was clearly seen elsewhere on the site. A wall with a core of clay and outer and inner faces of stone, wide at the base and receding towards the top, is a reasonable form of construction, particularly if, as may have been the case, the weight of the roof was taken by other supports. The interior dimensions of the whole building at this stage were 62 feet long and between 12 feet and 18 feet wide. A cross wall divided the structure into two rooms, a small western half 28 feet by 12 feet and a wider eastern half 29 feet by 18 feet approximately. Internal evidence suggests that the western half was a storeroom and possible animal house whilst the eastern half was for human occupation. The evidence for this assumption is (a) a hearth, situated against the cross wall, faced into the eastern end, (b) the eastern half was relatively free from finds and rub-

The cross wall itself existed as a projection from the north wall, 5 feet long and 2 feet wide, made of two parallel lines of well laid stones with a filling of clay and smaller stones. It was then enlarged by an apse-like structure, 4 feet wide, projecting westwards and situated behind the hearth, indicated by calcined stones and much burnt clay and ash. This apse-like structure is taken to be either the base of a chimney or a small corn drying kiln.

To the south of this assumed kiln the cross wall was continued as a clay bank, its line on the westward face being clearly indicated by the abrupt cessation of a layer of coal dust which was present in the western section of the house floor at this level. In addition, two small post holes 2 inches in diameter and circular in cross section were seen in such a position as to suggest supports for a wattle hurdle against a clay wall. This cross wall curved westward at its junction with the south wall of the house and formed a corner without any apparent break. East of this junction neither stones nor clay bank were apparent and this gap may represent a doorway.

Measuring approximately 28 feet by 12 feet this part of the building had well defined north and south walls and a floor of hard clay. The soil immediately above the floor contained a great number of animal bones, the jaw bones of pigs being most common, much broken pottery and one silver coin, a penny of Bishop Ruthall (1509-23), found on top of the collapsed south wall. This coin and its position is discussed in Appendix 2 to this report.

The western wall appeared as a very noticeable bank of worked clay. No stone facing was in position, but tumbled stones had to be cleared from the interior and could be felt through turf to the westward of the exterior, suggesting the

use of facing stones in a manner similar to the long walls. In the north-east corner of this room there was a heap of small coal, several inches in depth. This coal appeared as surface scatter over most of the clay floor of this western room. Fragments were taken for examination and the report appears as an appendix.

This end of the building is assumed to have been for human habitation—a beaten clay floor, an absence of small finds and a scatter of plaster fragments from the inner face of the east wall supports this view. The internal dimensions were 29 feet by 18 feet, extra width being obtained at the expense of wall thickness. Two groups of stones on the surface of the clay floor suggested post sockets and a roof supported on internal timber uprights. The hearth was very obvious, against the cross wall and marked by cinders and ash upon burnt stones. The south wall was a continuation, both in line and form, of that of the western room; it was fragmentary in places but sufficiently well marked by its clay filling. The eastern wall had possessed some plaster on its inner face which had fallen forwards into the house. No large pieces of plaster were preserved but there was a general scatter of small particles, indicating by their presence the original floor level. This eastern wall could not be examined in its entirety as an Air Ministry road crossed one corner of the site. In the north-east corner a double line of stones (4 feet long) with clay filling suggests that the original line of the north wall was at some period rebuilt to make a larger room. This is admittedly a puzzling feature and no explanation of why that short section of wall remains is offered.

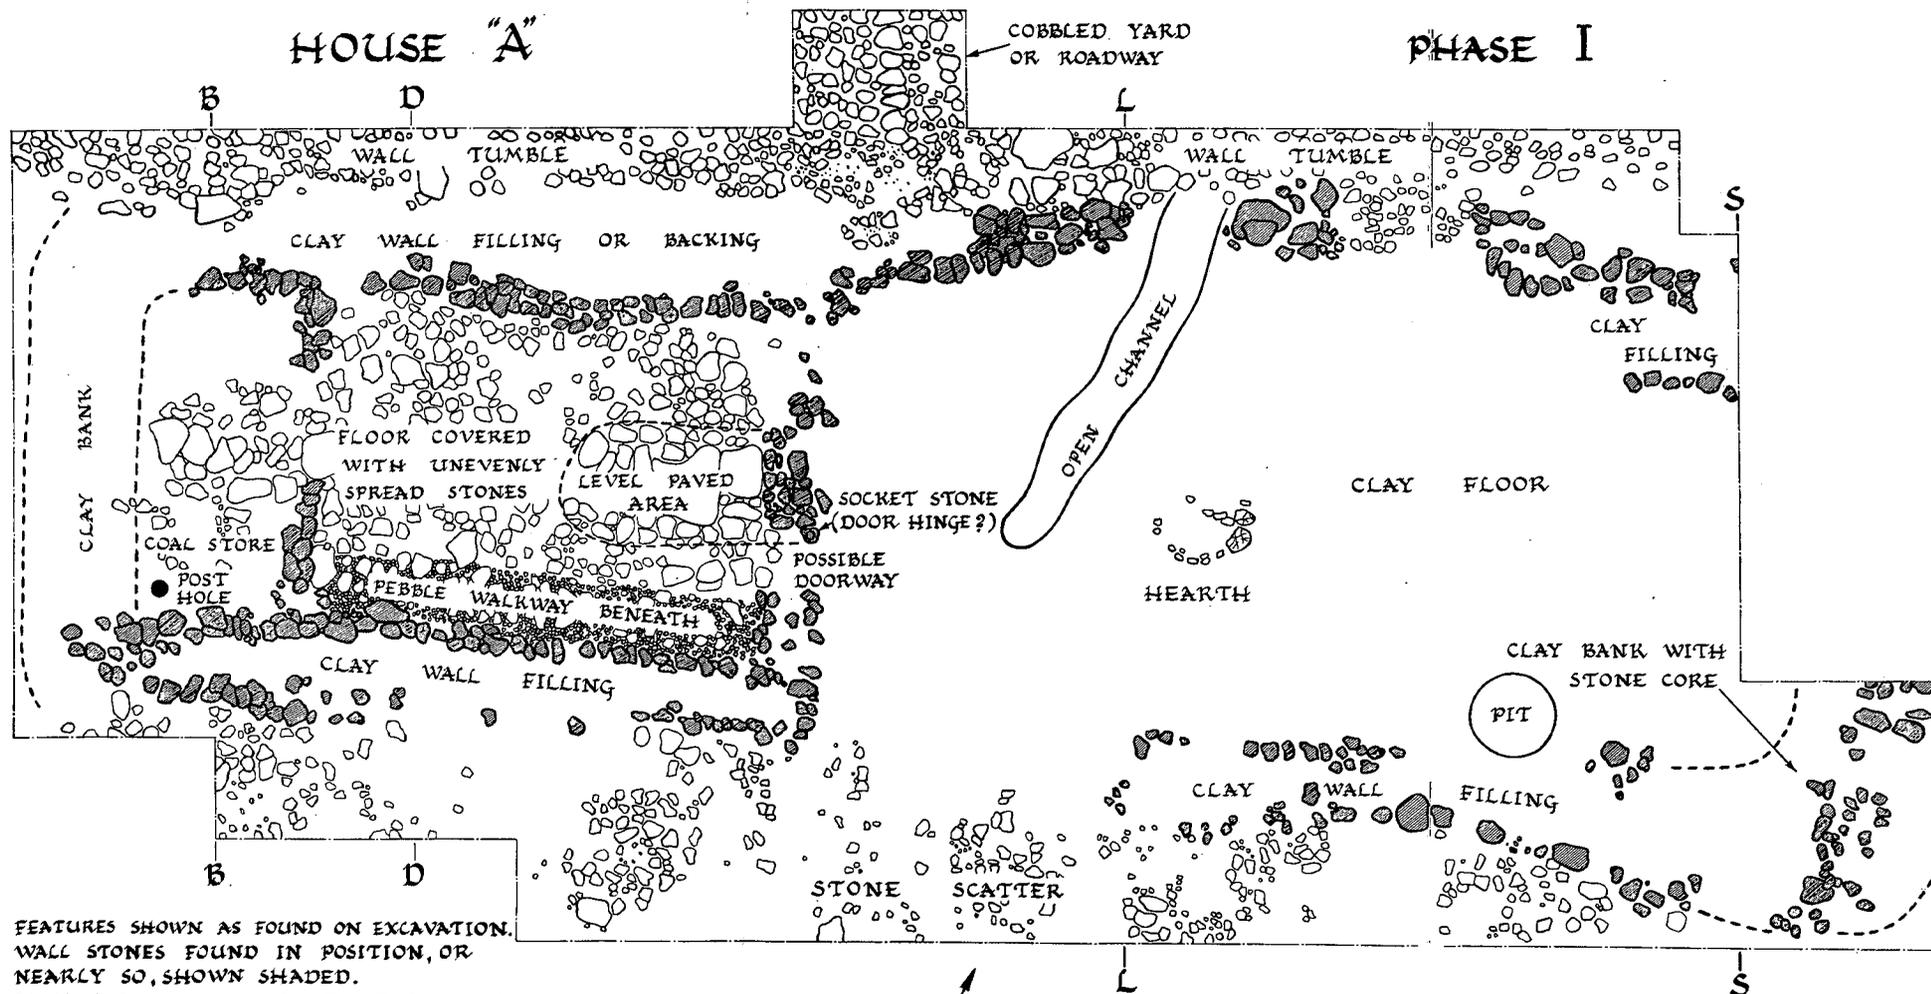
FIG. 4

WEST HARTBURN 1962

FEATURES SHOWN AS FOUND ON EXCAVATION. WALL STONES FOUND IN POSITION, OR NEARLY SO, SHOWN SHADED. IT IS NOT CLEAR WHETHER THE OUTSIDE WALLS OF PHASE I DIFFERED SIGNIFICANTLY FROM THOSE OF PHASE II. THESE WALLS ARE THEREFORE SHOWN GENERALLY THE SAME FOR BOTH PHASES.

Phase I—see Plan no. 2

The level clay floor of this half of the building was completely removed to reveal a lower floor in part properly paved and in part clay reinforced with stones. Bones and pottery were recovered from the surface of this floor and from between the stones. The jaw bones of pigs, some with tusks, were the commonest finds. At the eastern end of this half an attempt had been made to construct a level floor, large flat stones being used. This level area occupied only a small proportion of the total floor area; complete paving may have been impossible owing to a shortage of suitable stone. Along the south wall a walk-way of pebbles set in clay was obvious, the remainder of the floor was of clay in which stones were set. Some of these stones were wall tumble, others appeared to have been set in the floor and the general impression was of a reinforced floor level. The walls for Phase I were similar to those of Phase II with the addition of the footing of two short internal projections from both north and south walls near to the west end. These projections form the retaining walls of a small room and the limits of the southern half of this room were marked by another store of coal dust. In the south-western corner there was a post hole, not in the wall but rather in the junction of the south and west walls.

This hole was filled with soil and coal dust and had at the bottom two pieces of pottery. The presence of this post hole suggested a roof supported by wooden posts, and an attempt was made to find another in the north-western corner without success, as disturbance of the site there in earlier years had removed that area in which such a post might have been expected.

The cross wall dividing the building was again present but located to the west of the later wall above it. The western room was now 24 feet long instead of 28 feet as previously. This cross wall was indicated by stones set in a clay bank broken only by a gap a little south of centre. It is thought that this gap represented a door, particularly so as at the north side of the gap there was set a stone having a conical socket cut into it in which a post could have turned.

At this early stage 38 feet long and between the same north and south walls, this room possessed a second, lower clay floor at a depth of approximately 3 inches below the first. The clay broke away easily at this level and particularly so near the centre of the room, where the remains of an earlier hearth showed as an area of burnt red clay partly surrounded by small burnt stones. This hearth had been covered by the laying of a second clay floor.

In the south-east corner a large flat piece of red sandstone partly covered the mouth of a circular pit 3 feet wide and 3 feet 6 inches deep, filled with soft black mud containing large pieces of very coarse hand built pottery of an unfamiliar type. The mouth of this pit was invisible at Phase II level but could have been dug and sealed at any time during the history of the house.

The only other feature observed in this room was a trench or gulley, 14 feet long and previously covered by the clay floor of Phase II date. This gulley had a soft filling containing pottery fragments. It is difficult to account for

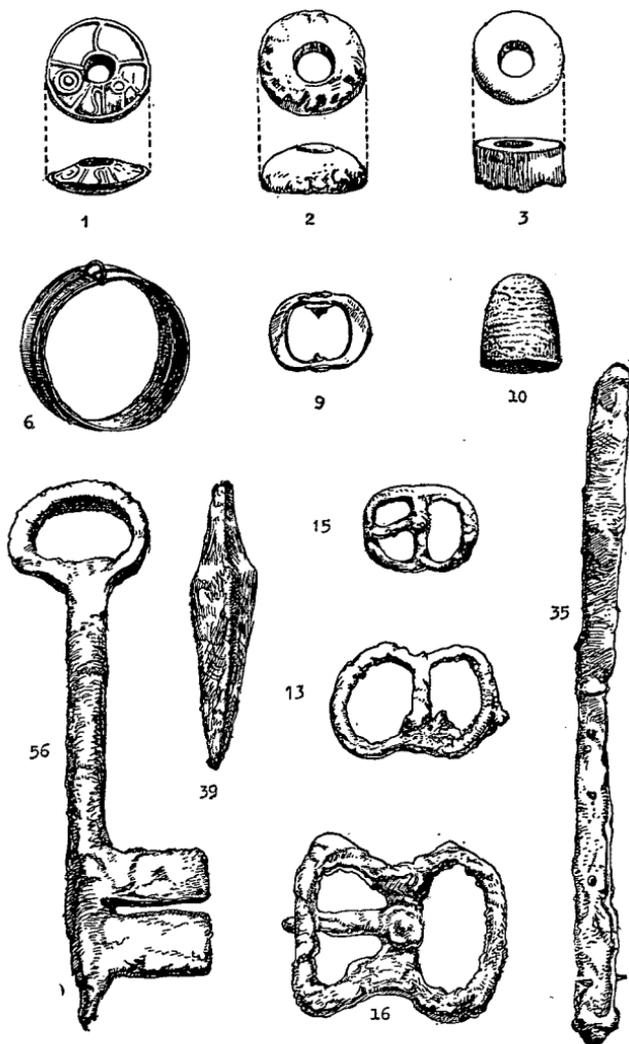
FIG. 5. METAL OBJECTS (½)

- *1-5. Spindle whorls, lead. The first has the letters RNO in reverse. (1-3 only illustrated)
- *6. Bronze double ring having two small loops diametrically opposite. Diameter $1\frac{1}{2}$ ".
- 7 & 8. Iron needles, length 4" and $2\frac{1}{4}$ ".
- *9. Bronze buckle.
- *10. Bronze thimble.
- *11-19. Iron buckles. (13, 15, 16 illustrated.)
- *20. Iron stirrup, width $4\frac{1}{2}$ ", height 5".

All metal objects reproduced half size with the exception of numbers 20, 21, 22, 26 and 27, which are one-third size.

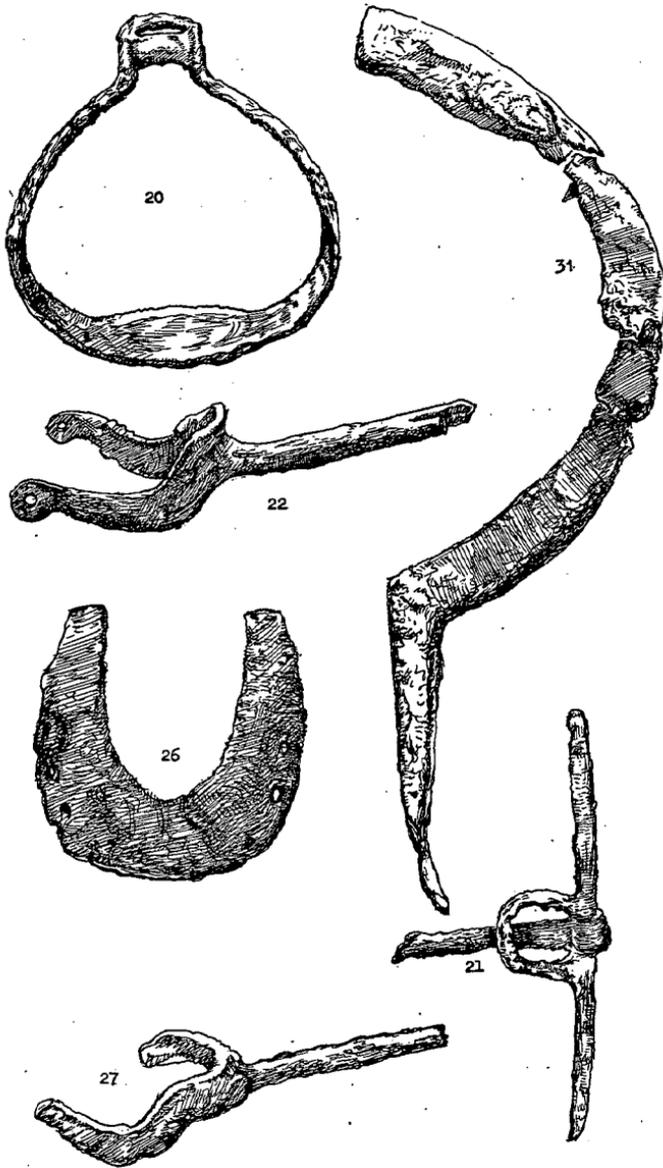
FIG. 6. METAL OBJECTS (1/2) NO. 31 (1/2)

- *21. Iron snaffle bit (fragment).
- *22. Iron spur, length $7\frac{1}{2}$ ". Rowel socket present but rowel missing.
- 23-25. Iron fragments, possibly purse frames, approximately 6" long.

- *26. Iron horse-shoe, no calkins.
- *27. Iron spur fragment, length 6". Rowel socket missing.
- 28. Iron fragment, possibly prick spur.
- 29. Iron knife-blade, single edge, handle missing, length $9\frac{1}{2}$ ".

- 30. Iron blade, 5" long, possibly razor.
- *31. Iron sickle, incomplete.
- *32-38. Iron knife-blades, some with handles still showing rivets for securing cheek-pieces. Lengths of blades 3"-5". (35 illustrated.)

- *39 & 40. Iron objects, square in cross-section and tapering to a point, possibly blacksmith's sets. (39 illustrated.)
- 41. Section of iron chain.
- 42. Iron spike, $9\frac{1}{2}$ " long.

- *56. Iron door-key, length $5\frac{1}{2}$ ".
- 57. Door-bolt, iron, length 7".
- 58. Iron fragment, possibly from agricultural implement.
- 59. Iron bracket, incomplete.

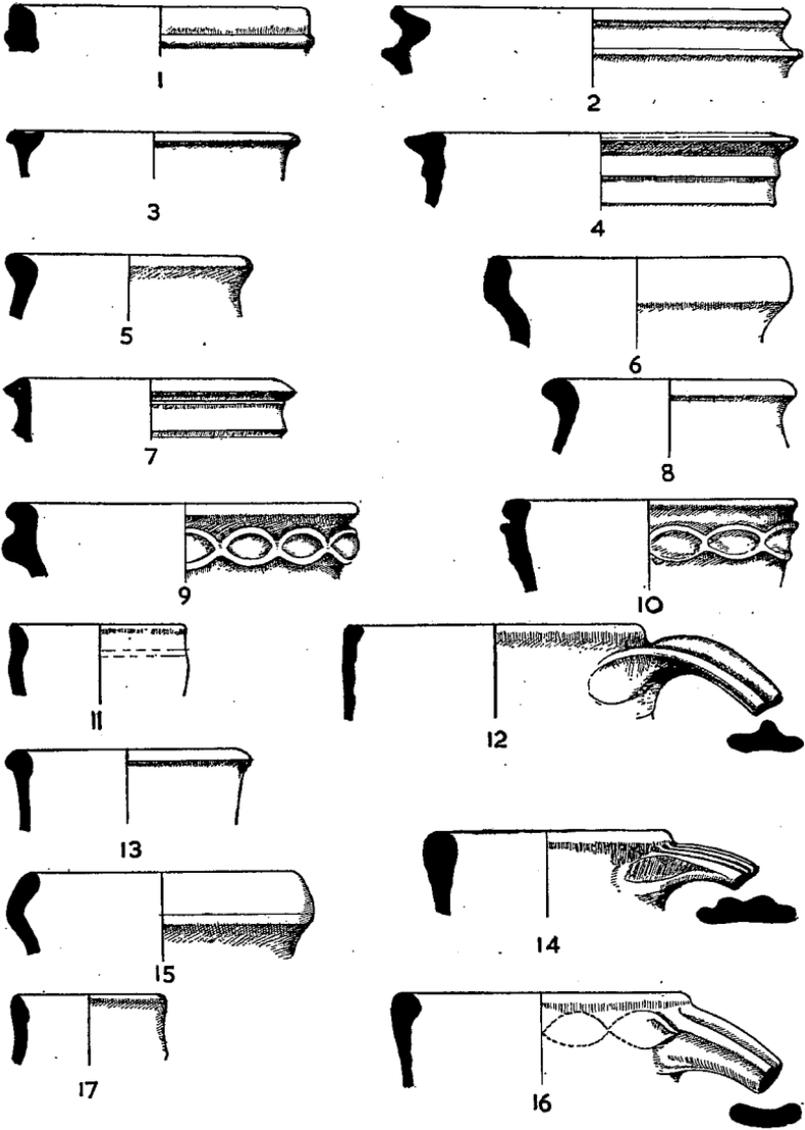
FIG. 7. POTTERY (4)

- *1. Rim of vessel in coarse buff fabric, aperture $5\frac{1}{2}$ ". No evidence of glaze.
- *2. Rim of vessel in pinky buff fabric, flanged below rim. Aperture $7\frac{1}{2}$ ". No evidence of glaze.
- *3. Rim of vessel in pinky buff fabric with grey interior, reduced and re-oxidized in cooling. Aperture $4\frac{1}{2}$ ". Lid seated, no glaze.
- *4. Rim of vessel in pink fabric, aperture $6\frac{1}{4}$ ". No evidence of glaze.
- *5. Rim of jug in grey fabric, re-oxidized to pink on inside surface. Aperture $4\frac{1}{2}$ ". Lead glaze stained by ferric oxide on edge of rim only.

- *6. Rim of grey jug. Aperture $5\frac{1}{2}$ " , completely reduced fabric. Green lead glaze coloured at upper edge by iron stains from the body of the pot.

- *7. Rim of jug in pink gritty fabric, aperture 5". No evidence of glaze.
- *8. Rim of jug in grey fabric, aperture $4\frac{1}{2}$ ". Evidence of decayed glaze on upper surface of rim only. Outer face of jug fully reduced and apparently free from glaze.

- *9. Rim of jug in grey fabric, aperture $6\frac{1}{2}$ ". Pie crust moulding around neck, green glaze.
- *10. Rim of jug, aperture 5". Grey fabric with heavy pie crust moulding below rim. Green glaze, some iron staining.

- *11. Rim of jug in grey fabric, aperture $3\frac{1}{4}$ ". Green lead glaze.
- *12. Rim and handle of jug in pink fabric, aperture $5\frac{1}{2}$ ". Strap handle joins neck of jug with thumb print on each side. Green glaze with russet brown iron stains.

- *13. Rim of jug in dark grey fabric, aperture $4\frac{1}{4}$ ". Green/brown glaze, slightly pitted.
- *14. Rim and handle of jug in grey fabric, aperture 4". Broad strap handle has three grooves, emerges straight from rim with finger pressings on each side at joint. Pale green glaze.

- *15. Rim of vessel in grey fabric, aperture 5". Pale yellow glaze with brown staining, oxidized-lead glaze.
- *16. Rim and handle of jug in grey fabric, aperture 5". Thick thumb groove down centre of handle which has been pulled to the left on being mounted on pot. Pie crust moulding below rim. Good dark olive green glaze heavily stained with brown.

- *17. Rim of jug in grey fabric, aperture $2\frac{1}{4}$ ". Smooth green glaze.
- *18. Large vessel in grey fabric, uneven double rim turned inside. Handle mounted sideways, probably twin handles although only one shown in reconstruction. Height not known. Probably thrown on wheel, but appearance suggests poor centering. Smooth green glaze.

- *19. Base of jug in buff fabric, base diameter 3". Heavy throwing rings in interior. Poorly made specimen, green glaze.
- 20. Base and lower half of large jar in grey fabric, base diameter $6\frac{1}{2}$ ". Patchy green glaze heavily stained with brown.

- *21. Lower half of well-made storage jar in fine grey fabric with external green to brown glaze. Bung hole 1" in diameter in centre $1\frac{1}{2}$ " above interior base.

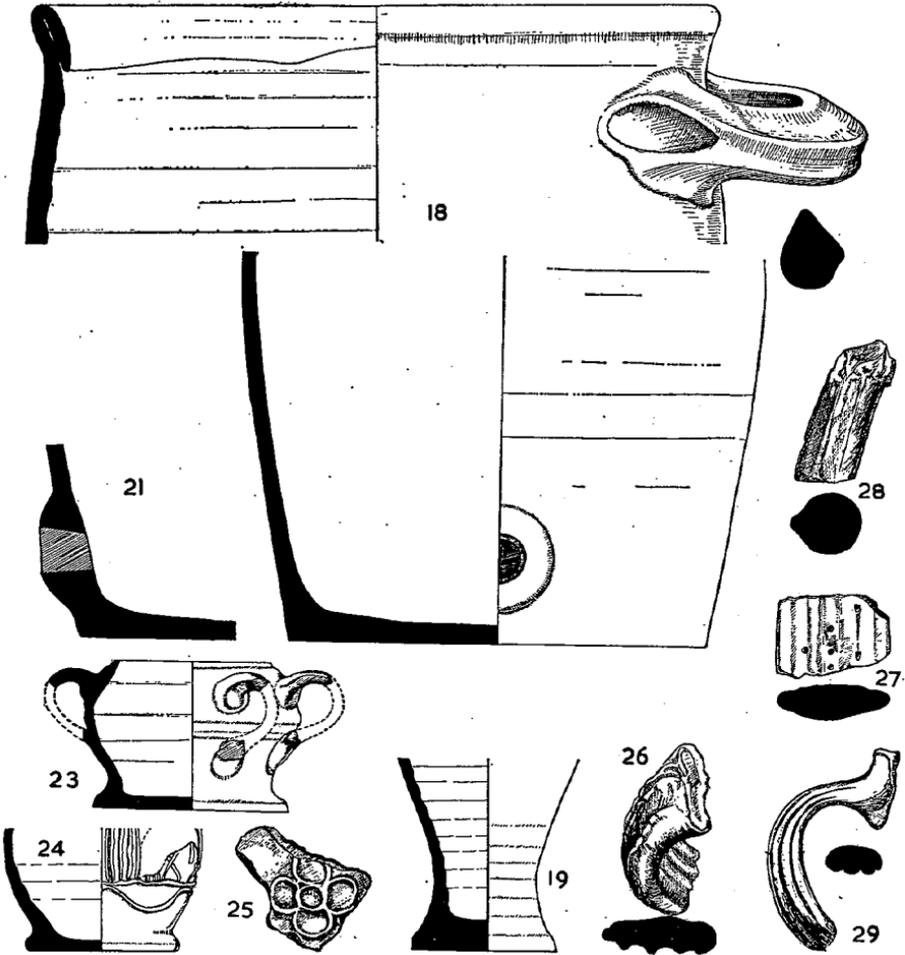
FIG. 8. POTTERY (4)

*23. Eight handled cup in thin hard red fabric. Aperture diameter 3", maximum 4", base 3".

*24. Part of small vessel in hard red fabric with white slip trailed decoration under glaze, general chestnut brown body colour.

- *25. Applied four leaf decoration on pot of grey fabric with pale green glaze.
- *26. Large strap handle, width $2\frac{1}{2}$ " , with three grooves running lengthwise. Yellow glaze.

- *27. Fragment of strap handle with five shallow and irregularly spaced grooves and three rows of regularly spaced holes made with a sharp pointed instrument.

- *28. Section of handle in pink fabric, central ridge with thumb print at one end. Yellow glaze.
- *29. Handle in pink fabric, poorly formed, three incised grooves, vestiges of green glaze.
