## VII.—WEST HARTBURN 1965. SITE “C”

*L. Still & A. Pallister*

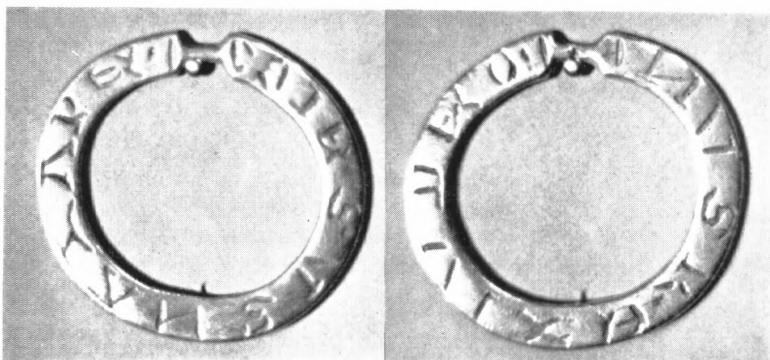
Fig. 1. Silver brooch, outside diameter 1·2".

Inscription—"IESUS NAZARET/HUS REX Iudeo". c. 1300

1. From the soil over a collapsed wall, a rather worn silver sixpence, Queen Elizabeth, 1570.
2. From beside the hearth and covered with a second layer of clay flooring—a small silver brooch. Approximately 1" in diameter, it is a simple flattened ring, one sixth inch in cross section, with a narrow segment where the pin, now missing, must once have been fitted. Both sides of the brooch bear roughly incised letters making the phrase IESUS NAZARET/

HUS REX IUEDEO. Dr. Kent informs us that this is a talismanic inscription of a kind found from time to time on brooches and purse frames of thirteenth to fifteenth century dates and that he would suggest c. 1300 for this specimen. This adds little to the dating of the site, a presumably valued object could have a long life.

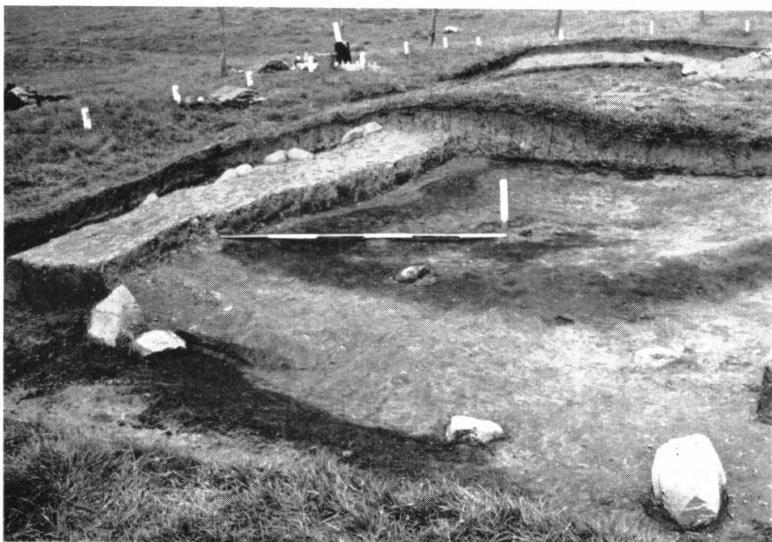
Fig. 2. West end of house showing wall thickness outlined by fallen burnt thatch (foreground) and burnt material on floor inside. The charred stump of a roof support can be seen beside the white peg in the floor area

burnt material were successively removed until the building was left almost as a print upon the ground. The interior of the structure was outlined in black ash contained between yellow clay walls whose edges could be determined with certainty. In particular the west end of the house showed both outer and inner faces of the wall very clearly as well preserved clumps of burnt thatch, falling from the roof, had lain along the outer wall edge, remaining as a thick black layer. All walls were 3' thick at the base and contained surprisingly few stones, and those few were located mainly in the north wall; no real wall footings of stones were seen and it must be concluded that these walls were of clay only, reinforced on the interior by a wattle framework. No evidence was seen of any straw binding having been added to the clay.

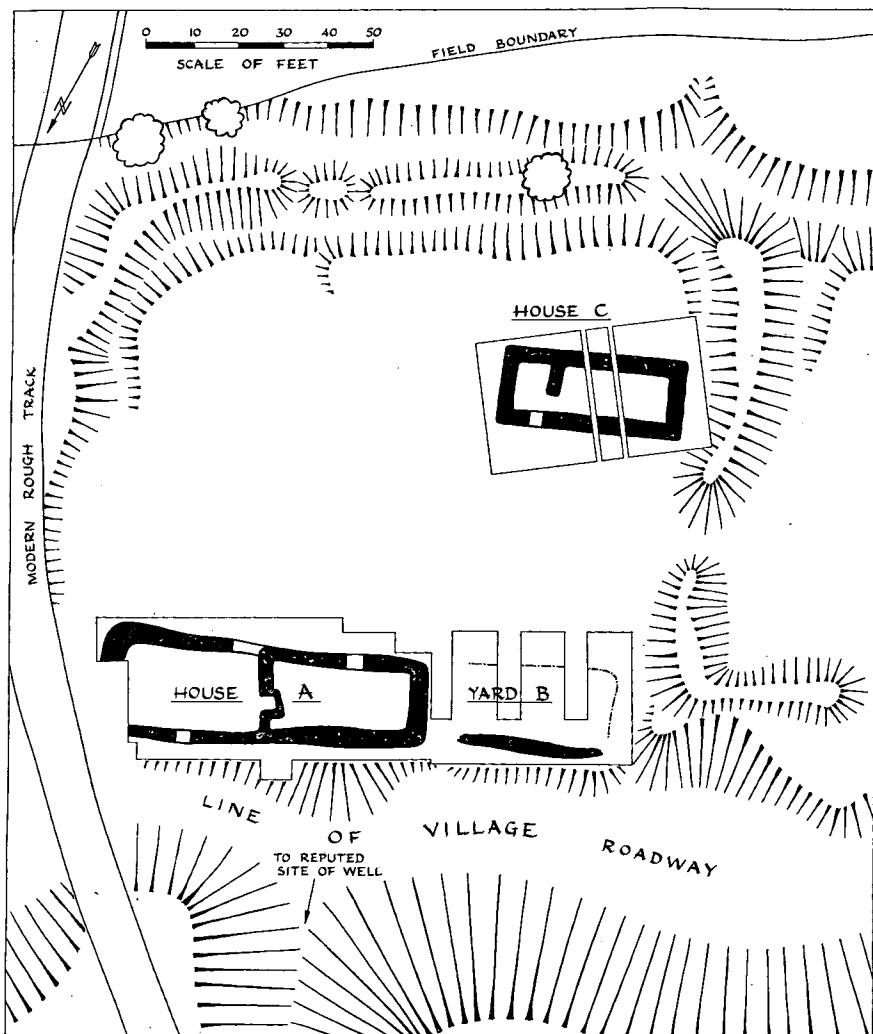
FIG. 1. PLAN SHOWING ENCLOSING CROFT WALLS AND THE RELATIVE POSITIONS  
OF THE TWO HOUSES

Work continued at West Hartburn in the early summer of 1965 upon a building outlined by turf banks and first noticed during the previous excavations. Known as site “C” it lies inside the walls of the croft belonging to site “A” (*A.A.* 4, Vol. XLII (1964), pp. 187-206), parallel to the village street but some yards behind the first long house. Complete excavation revealed the ground plan of a wattle and daub hut which, having been destroyed by fire, left a print of its outline in the ground.

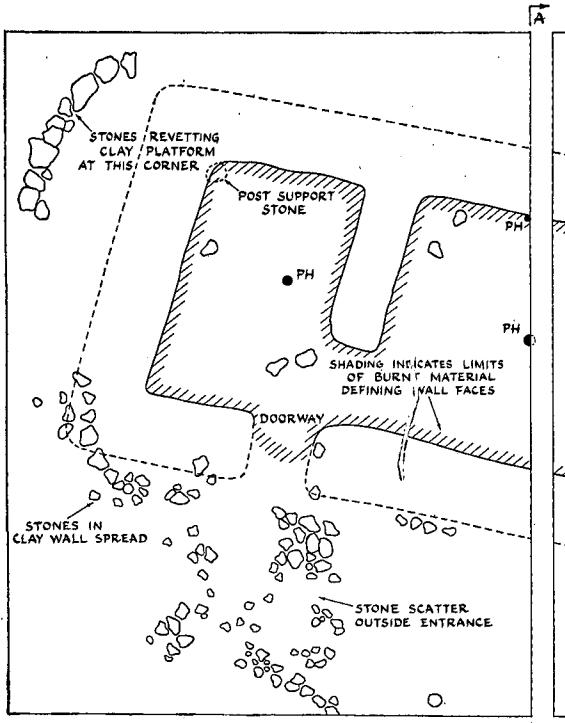
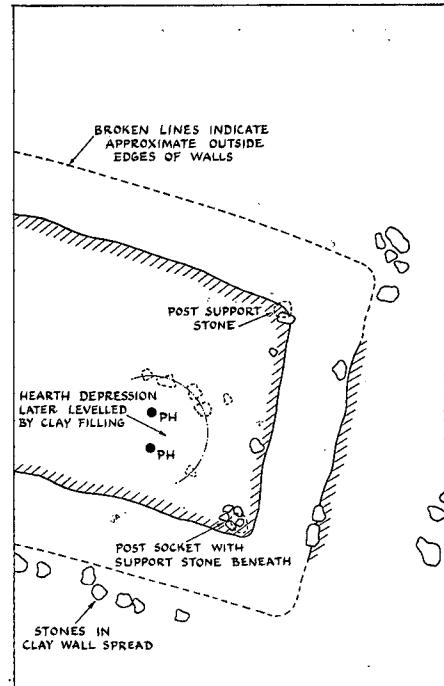
# HOUSE "C"

PH INDICATES POST HOLE

- ① TOPSOIL
- ② CLAY WALL SPREAD
- ③ CURTAIN MATERIAL
- ④ NATURAL CLAY
- ⑤ THIN LAYER OF BURNT MATERIAL
- ⑥ COAL & CHARCOAL INCLUSIONS
- ⑦ FINE SCATTER OF BURNT MATERIAL

SECTION A-A ACROSS HOUSE

Following the initial section the site was completely stripped, revealing a building of long house proportions, external measurements 41'×17', standing on a slightly larger clay platform. As with site “A” turf and topsoil had been removed and a level clay platform made which had been reinforced at the corners of the east end with very large stones set in clay. The top layers of turf, topsoil (in which a silver sixpence of 1570 was found), fallen clay walls and

The doorway was situated 5' from the east end of the north wall; 3' wide, it was marked by an absence of the clay wall and by the outward spread of the burnt material from the interior of the house. The charred remains of the wooden door and door frame were found inside the house, complete with a pair of iron hinges. This doorway led into a small end room, 11'×7', separated from the remaining large room by a cross wall projecting 7' into the building from the south wall, leaving a 4' gap as a doorway into the main room; there was no trace of door or doorframe here.

neath. No post hole was found in the fourth corner. Small post holes in the interior of the house no doubt relate to internal fixtures, the three post holes in a straight line along the centre of the house probably supported a ridge pole. The most westerly of these three posts remained as a burnt stump in the centre of what had been the earlier hearth. This points to a re-roofing after the hearth had become disused, the earliest form of roof structure must remain conjectural.

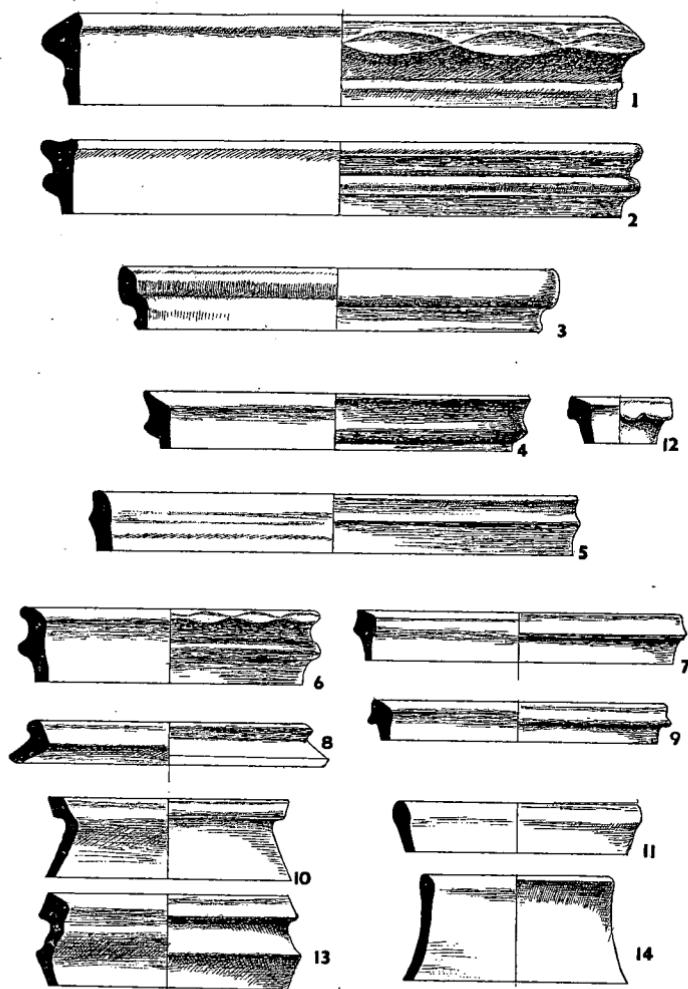
FIG. 3. POTTERY RIM SECTIONS ( $\frac{1}{4}$ )

1. Heavy rim of vessel in hard pinkish fabric, "wavy" design. No glaze. Aperture 11".
2. Bifid rim in soft buff fabric, possibly lid seated. No trace of glaze. Aperture 11".
3. Rim of vessel in gritty buff fabric, lid seated. No glaze. Aperture 8½".
4. Bifid rim in hard pink fabric, no glaze. Indications that rim was brought up and turned outwards to produce double thickness. Aperture 8".

5. Simple rim in buff fabric, oxidised yellow lead glaze. Aperture 10".
6. Rim of vessel in gritty buff fabric, no glaze. Finger pressings along upper rim to produce "wavy" effect. Aperture 5½".

7. Simple square rim form in reduced grey fabric re-oxidised to pink on cooling. Aperture 6".
8. Simple rim in pinkish fabric, no glaze. Aperture 5½".
9. Angular rim in buff fabric, no glaze. Aperture 5½".

10. Well thrown pot in gritty buff fabric, slightly reduced, highly fired compared with other pieces from this site. No glaze; aperture 4½".
11. Very simple rim in pink/buff fabric. No glaze. Aperture 4½".

12. Rim of small vessel with "wavy" decoration along lower edge. Yellow lead glaze below rim. Aperture 1½".
13. Rim of coarse buff fabric, rim brought up and reversed. Patchy oxidised yellow lead glaze. Aperture 5".

14. Rim in coarse grey fabric, completely reduced. Blistered lead glaze on exterior. Aperture 3½". From burnt layer in west end of building.
15. Rim and base fragments of grey and brown mottled stoneware were found on floor of eastern end of building. Not illustrated.

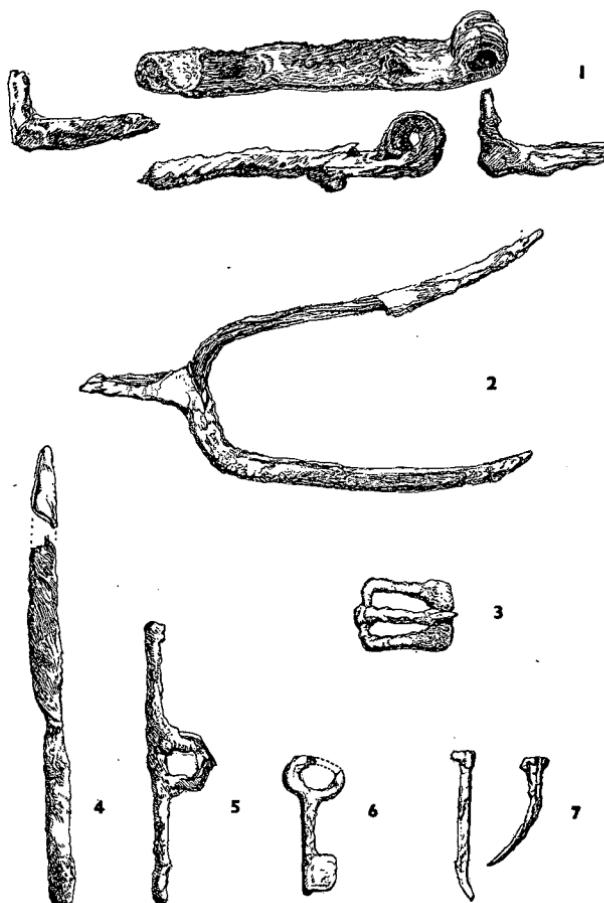
FIG. 4. METAL OBJECTS (1/4)

1. Two simple iron hinges found adhering to the charred fragments of the door.
2. Iron hayfork.
3. Iron buckle.
4. Iron knife.
5. Cheek-piece of snaffle-bit, iron.
6. Small iron key.
7. Two iron nails.
