EXCAVATIONS OVER ST. WILFRID'S CRYPT AT HEXHAM, 1978

Richard N. Bailey and Deirdre O'Sullivan
with a contribution by D. J. Rackham

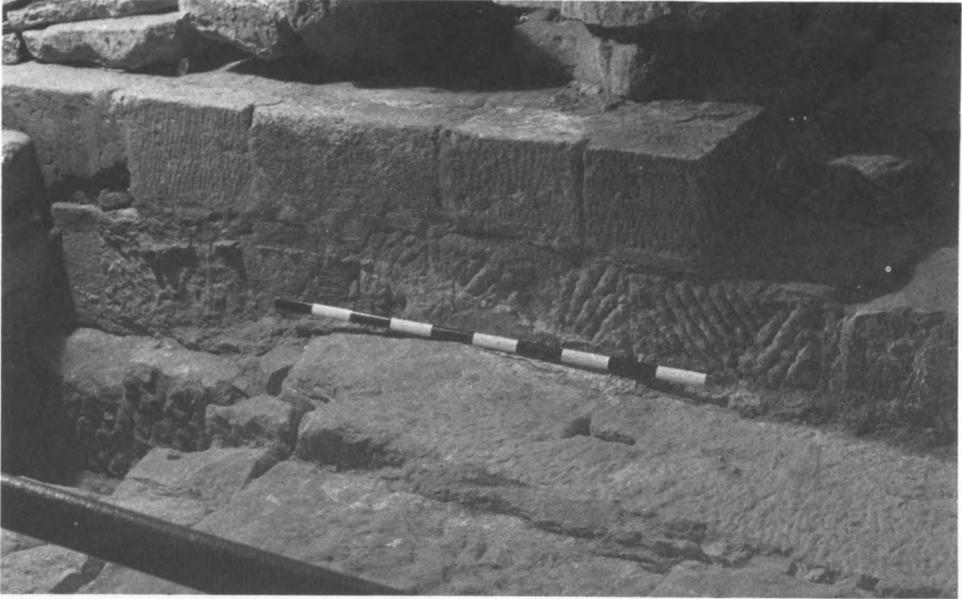
a. The north side of the Saxon wall underlying the later screen-platform. Note plaster adhering to the tooled face of the wall stone which bridges the passage and the lewis hole on the adjacent cover stone.

Three of the roofing slabs of the south passage were revealed within the excavated area (fig. 2 feature 6 and pl. XII, a). One of these slabs covers the turn between the easterly and southerly legs of the passage and was surrounded on two sides by small mortared packing-stones lying on top of the passage wall (feature 8 of fig. 2). The adjacent slab on the south side was marked by a lewis hole. The third roofing slab, set against the lowest course of the screen-platform, also carried a lewis hole but differed from the others in having a convex upper surface which rose some 5 cm to the top of the curve; its eastern edge had been fractured in antiquity.

In the western part of the excavation the wall rested on an offset stone (with a lewis hole) which extended 11 cm north from the line of the wall (pl. XII, b). No equivalent offset was found on the south side: here the wall was set directly on massive mortared foundations (fig. 2 feature 9). At the point where the wall passed under the screen-platform these large foundation stones were not only set *under* the wall but were also packed *against* it and spread southwards: it is likely that this can be explained as reinforcement around the turn of the crypt-passage between its southerly leg and its eastern exit.

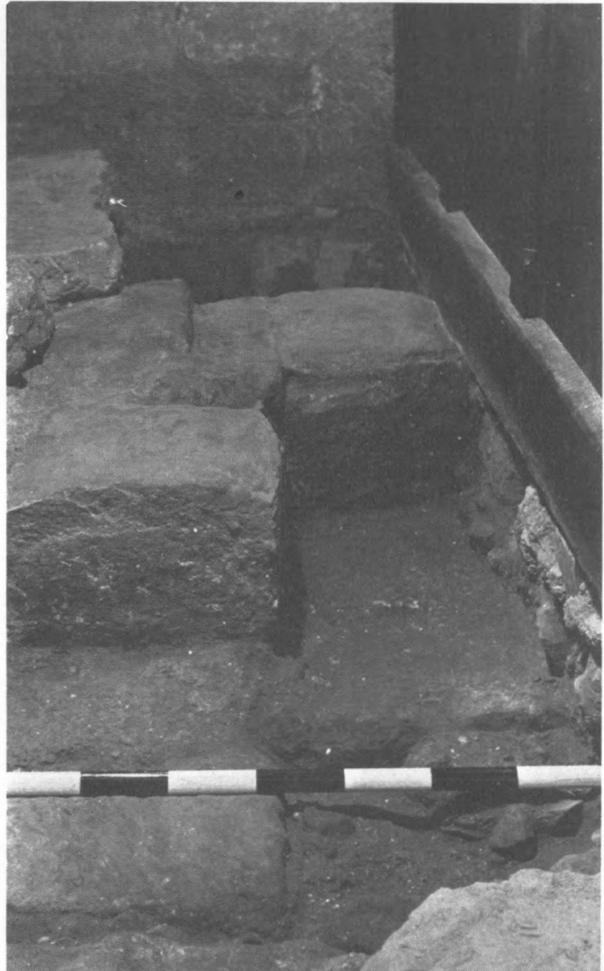
b. The Saxon wall in the south-west corner of the excavation. In the foreground is the offset underlying the wall and the mortared rubble between the crypt-passage and the wall.

The surviving course of the new east/west wall formed part of the paving which was visible when the excavation began (fig. 3 and pl. XII, b). This suggests that the rest of the paving found and photographed in 1907 belonged to a phase later than the crypt-passage and its accompanying wall. We have, however, two possible interpretations. The first is that the surviving section of wall was the threshold of a doorway flush with the contemporary paving adjacent to it. But if this were the case then it would be difficult to explain its highly uneven surface and the lack of wear one would expect if it had served this function. Our first explanation is thus more attractive: the paving *is* later than the wall. The remains of a floor-level which preceded the paving may have been preserved to us in the underlying mortar shown in the section as 21 (fig. 4).

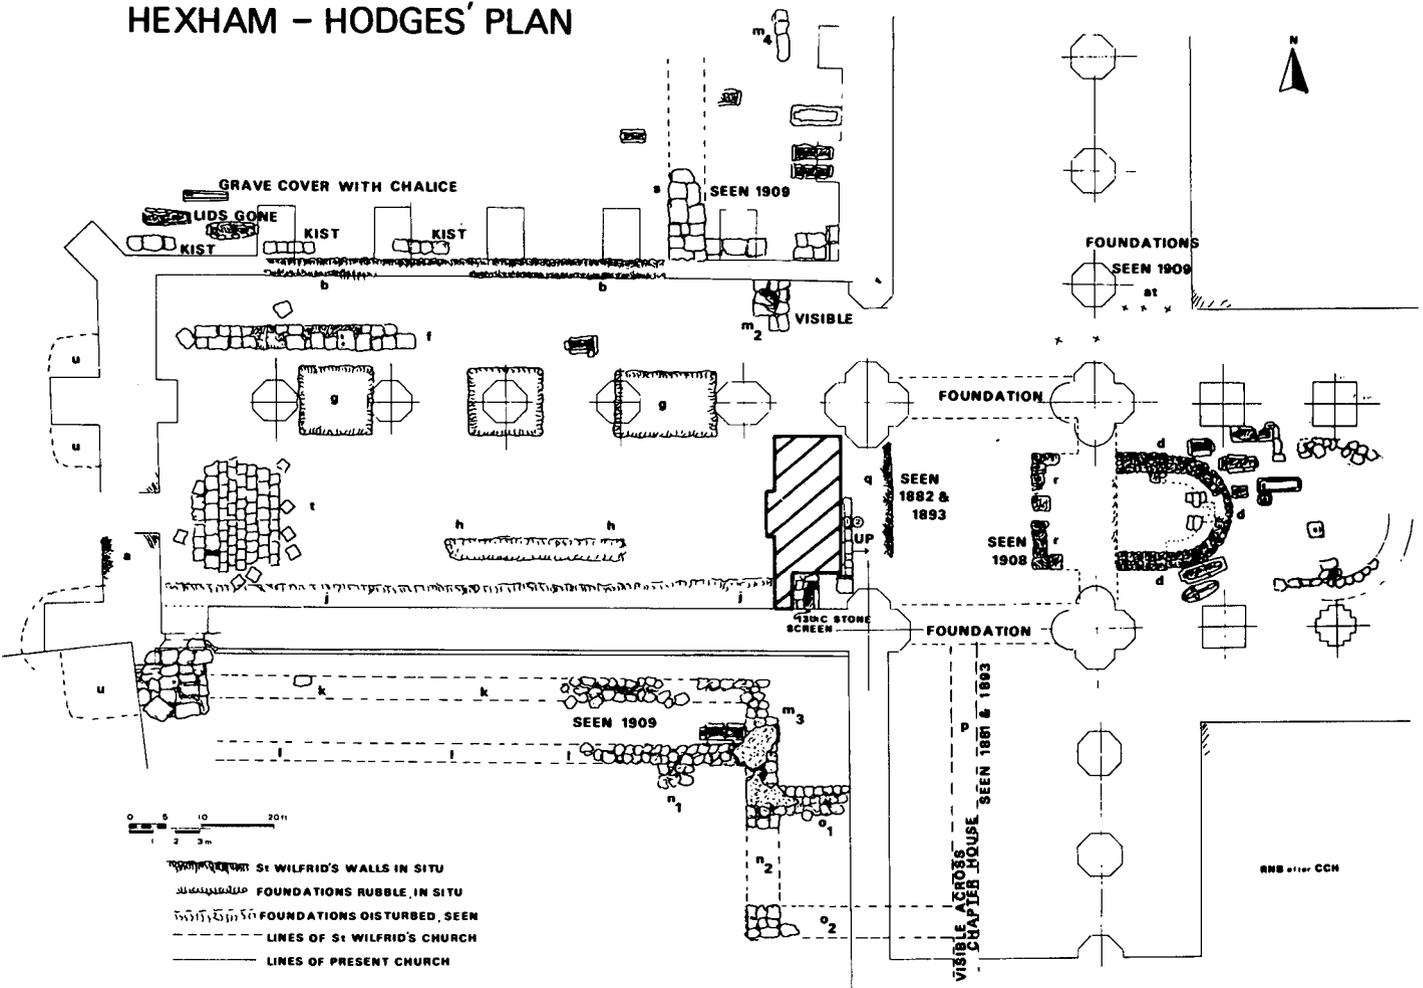
HEXHAM - HODGES' PLAN

Fig. 1. St. Andrew's Hexham: the excavated area (hatched) in relation to the standing structure and the foundations recorded by Hodges.

The area investigated is shown as hachured in fig. 1 where it has been plotted in relation to the standing structures and the features recorded in the composite plan of 1923.⁴ Effectively the work involved stripping an area across the entire width of the nave between the crossing-step and the front pew. Our excavation was necessarily subject to two limitations which were agreed with the architect: (a) the need to avoid undermining standing walls and piers in a part of the church which has a worrying history of structural failure and (b) the desire to avoid disturbance or destruction of medieval work, both above and below the present ground level. These entirely reasonable restrictions must be borne in mind when reading the following account.

The Saxon wall is 0.9 m wide and its foundations are quite distinct from those of the present nave wall. The position of the foundations suggest that they can be identified with foundation "j" of Hodges plan (fig. 1). If this is the case then we are faced with two alternatives: either this foundation took a more northerly line at its eastern end (since the lewis-hole offset extends beyond the north side of "j" as plotted by Hodges) or, more worryingly, Hodges' plotting in 1923 was inaccurate. We suspect that Hodges was in error and Mr. Cambridge has pointed to other anomalies in the traced plan which suggest that it is not completely reliable in its details.

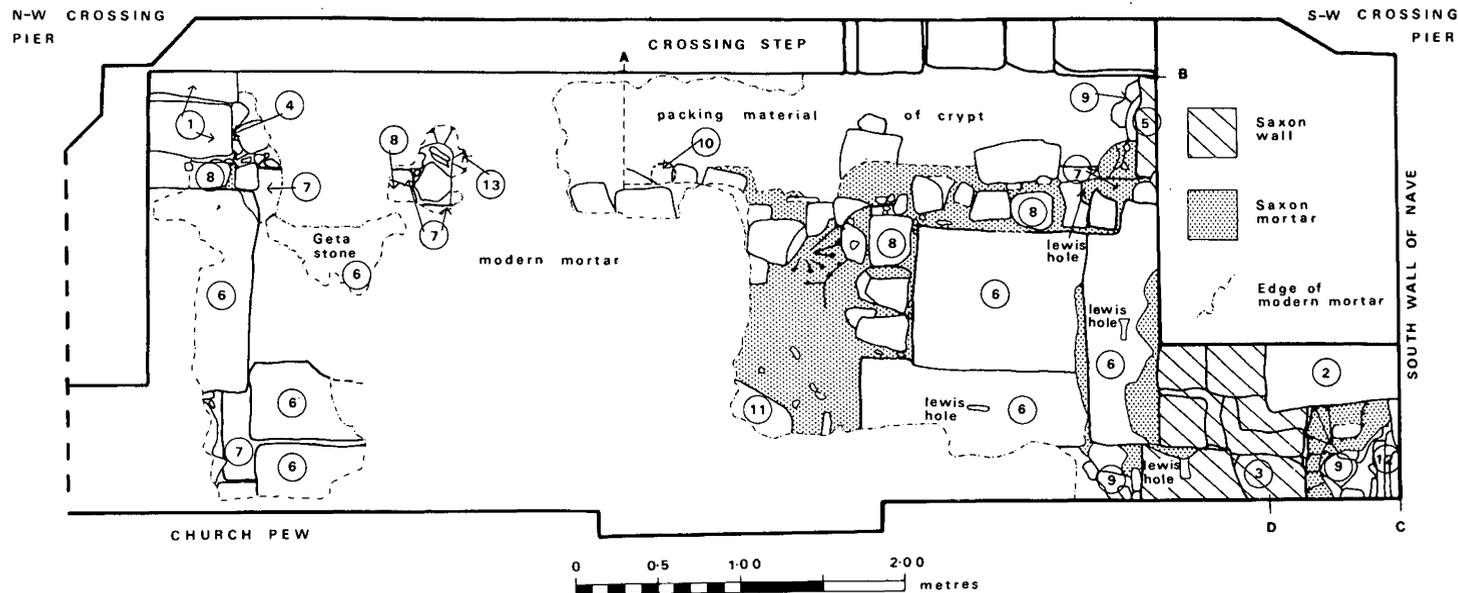
HEXHAM 1978

Fig. 2. General plan of excavation.

Key: 1. Roman decorated stones; 2. part of the medieval screen-platform; 3. Saxon wall; 4. foundations of crossing-pier; 5. offset of Saxon wall; 6. roofing slabs of passages; 7. passage walls; 8. mortared packing of roofing slabs; 9. foundations of Saxon wall; 10. post-hole; 11. exposed curve of vault; 12. footings of nave wall.

As can be seen from fig. 2 much of the excavated area was covered by a thick raft of modern mortar which incorporated the footings of the 1908 pews.⁵ This raft could not be removed without threatening the stability of the crypt below but it was, nevertheless, possible to investigate on its north side where the mortar thinned and where it has already been cut through in 1974 during repairs to protect the "Geta" inscription.⁶ More important, the raft did not extend to the east of the main crypt-chamber nor to the south of the centre-line of the church: excavation in these sections was naturally more fruitful.

The most unexpected discovery came with the removal of paving slabs 1, 2 and 3 (fig. 3). It then became apparent that the northern part of the medieval screen-platform was standing on the remains of an earlier stone wall, 0.9 m broad, which ran east-west through the whole of the excavated area (see fig. 2 feature 3, fig. 3 and pl. XII). Where visible the southern face of this wall lay 0.55 m north of the present nave wall. Its sole surviving course had formed part of the paving between the screen and the front pew whilst its north face (still carrying its Roman tooling) had acted as the lower course of the north side of the screen-platform.¹¹

The mortar of the buttressing merged westwards with a thick creamy mortar which filled the space between the curving vault of the crypt and the north wall of the south passage. A small section of the top of the vault was visible where it had been exposed by the builders in 1908 (feature 11 of fig. 2).

One final discovery should be highlighted. This is the post-hole, marked 10 on fig. 2, which penetrated some 26 cm from the top of the yellow-brown packing. It could be interpreted as the remains of a scaffolding pole which had once been set against a (hypothetical) east wall. If so, it is strange that no others were found on the same line. Lack of associated holes might also be felt to rule out the possibility of its being part of a ciborium.²⁰ Since the hole is on the centre line of the crypt, and thus presumably also on the centre-line of Wilfrid's church, it seems reasonable to suggest that it once held the shaft of a cross placed behind the altar. The altar would, of course, most fittingly have stood directly over the relics in the crypt and thus to the west of this hole.²¹

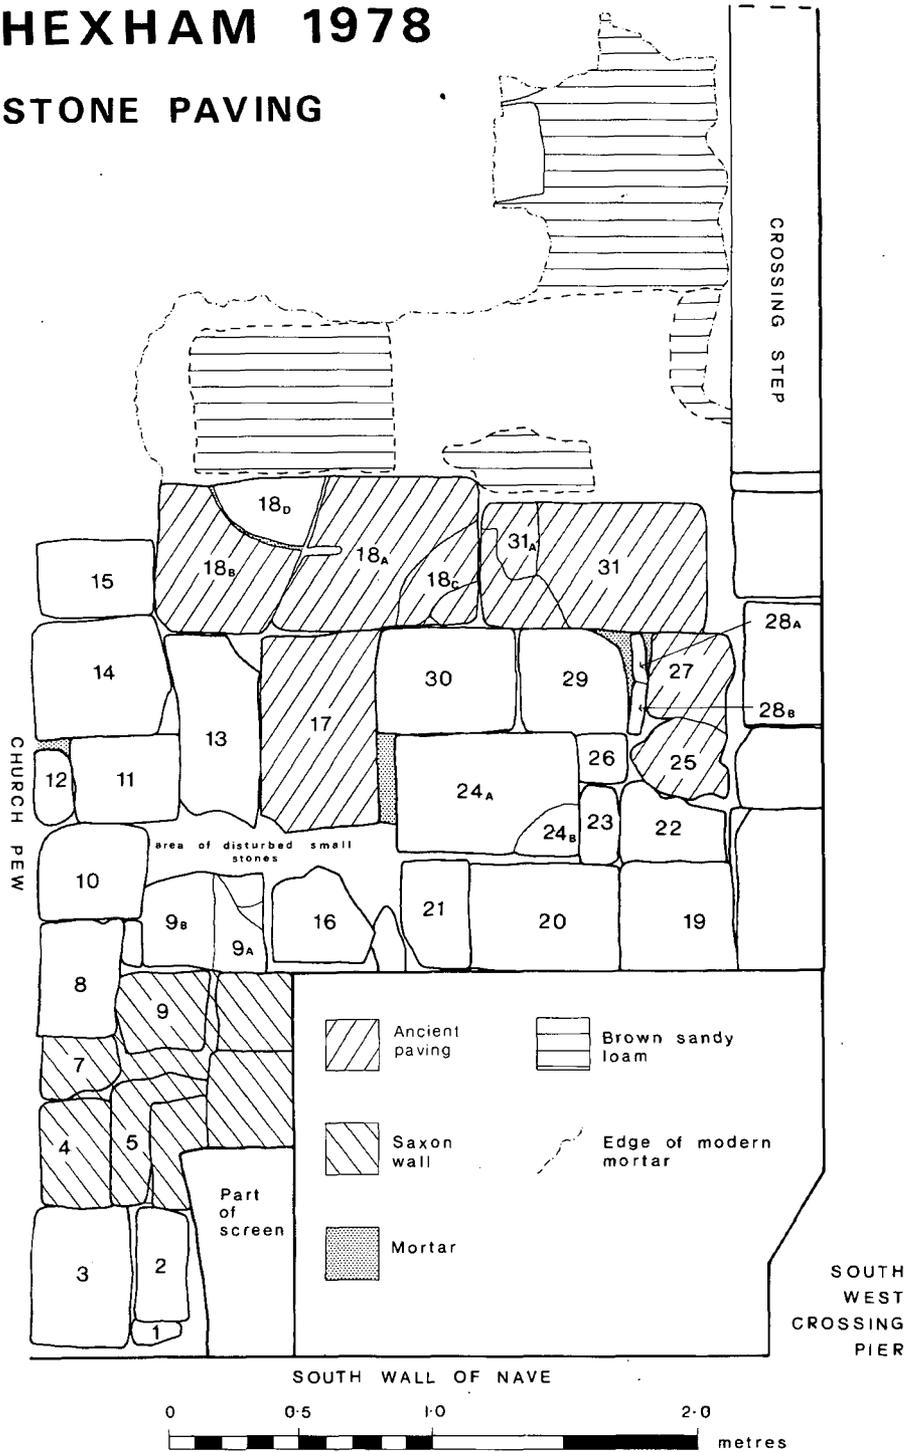
Fig. 3.

STONE PAVING

As explained above, the initial reason for excavation was the condition of the paving stones lying around the thirteenth-century screen platform. This paving was generally believed to be of seventh-century date.⁷ After they had been numbered, planned and lifted it was possible to see that the slabs had lain on two distinct types of bedding material (fig. 3). Most of them were set in a fine yellow sand containing modern glass and nails but those marked "ancient paving" on fig. 3 rested on a fine medium brown sandy loam containing mortar and both human and animal bones. This latter group could be identified with the slabs discovered and photographed during the building of the nave in 1907;⁸ the other stones represented modern infilling.

The sandy loam bedding extended to the north of the ancient paving (fig. 3) though here it had been disturbed by the insertion of a modern gas-pipe and covered with recent mortar and rubble. The same bedding appears in the section (fig. 4) as level 19 and some of its associated paving is also preserved there, marked as the heavily hachured 20. The isolated rectangle of sandy loam bedding adjacent to stone 18 marks the position of a large paving stone which is visible in the photograph of 1907.⁹ This slab was presumably preserved in the 1908 floor, enclosed within an angle of

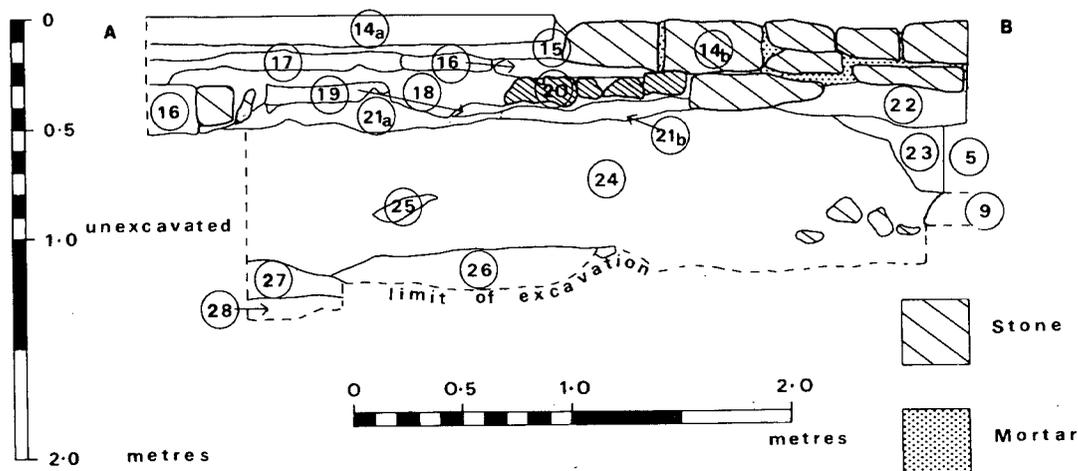
Fig. 4.

section A-B under crossing

Key: 5. offset of Saxon wall; 9. foundations of Saxon wall; 14a. crossing-step, modern; 14b. crossing-step, medieval; 15. concrete facing/bedding; 16. modern concrete; 17. loose modern mortar; 18. loose modern mortar and rubble; 19. fine light/medium brown sandy loam with mortar and bones; 20. paving stones; 21a. loose grey/brown mortar; 21b. loose grey/light brown mortar; 22. light brown sandy loam with small stones and mortar flecks; 23. chocolate-brown sandy loam; 24. stony yellow-brown loamy sand and gravel with mortar; 25. lens of medium brown soft clayey silt; 26. pack of compact medium brown loam, mortar and stones; 27. slightly stony yellow-brown sandy silt loam with mortar; 28. yellow-brown stony sand and gravel.

The area to the east of the south passage could be excavated to a depth just below the foundations of the new wall. Between the passage wall and the crossing-step there was a deep layer of packing material (feature 24 of fig. 4) consisting of a stony, yellow-brown, loamy sand and gravel containing mortar and sandstone chippings.

- (a) The offset (5) of the wall was set on foundation stones (9) which rested on the yellow-brown packing (24). The offset butted against the wall of the crypt-passage and was mortared to it by a layer of mortar which passed between the two, over the top of the passage wall (7), beneath and around the packing stones (8) and under the curved roofing slab (6).
- (b) The foundation stones (9) ran against the top course of the passage wall but penetrated below the overhang between this course and the one immediately below.
- (c) A stone-free cut (23) reached from the top of the yellow-brown packing to the top of the foundations (9).

Some earlier interpretations of the crossing-step must now be abandoned. The section (fig. 4) shows that the northern part of the step is modern. The southern half is clearly older but nevertheless post-dates the paving (20) and its associated loam bedding (21). We have seen that this paving does not belong to the first phase of building at Hexham: it might be attributed to Eilaf's eleventh-century activity but all we can say with certainty is that it belongs to a period when burials were disturbed in the course of obtaining bedding material. This does not help greatly in dating the older part of the crossing-step but it cannot be part of the seventh-century church¹⁸ and it can certainly never have formed the eastern wall of Wilfrid's building:¹⁹ this must lie somewhere under the crossing.

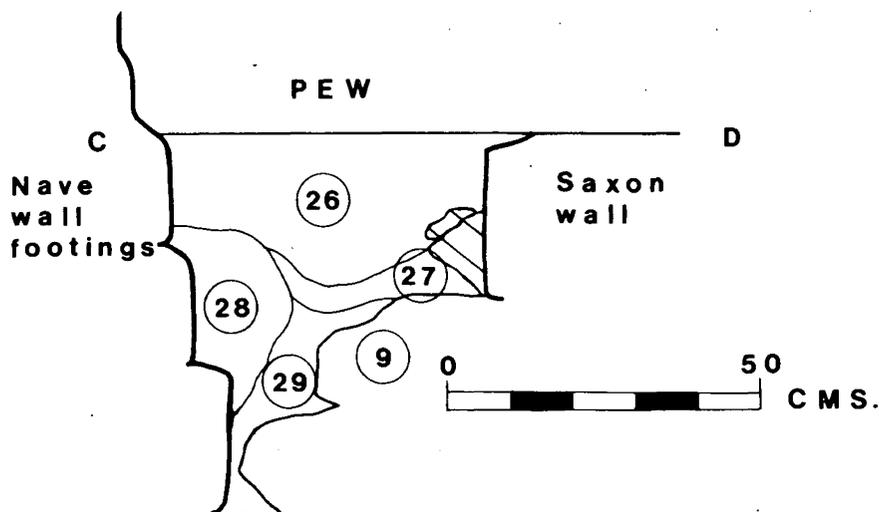
section C-D between wall footings

Fig. 5. Section looking west—footings of Saxon wall marked as 9

Because of the restrictions on excavation outlined in the introduction only two areas were available for a deeper investigation of this new wall and of its relationship to the surrounding structures: (a) between the excavated wall and the present nave wall (whose lower courses are medieval) and (b) between the crossing-step, screen-platform and passage. In the former area the modern nave wall was found to rest on three plinth-courses set above foundation stones (fig. 5). These plinths and founda-
