BACK SILVER STREET, DURHAM 1975-6 EXCAVATIONS

I. Introduction

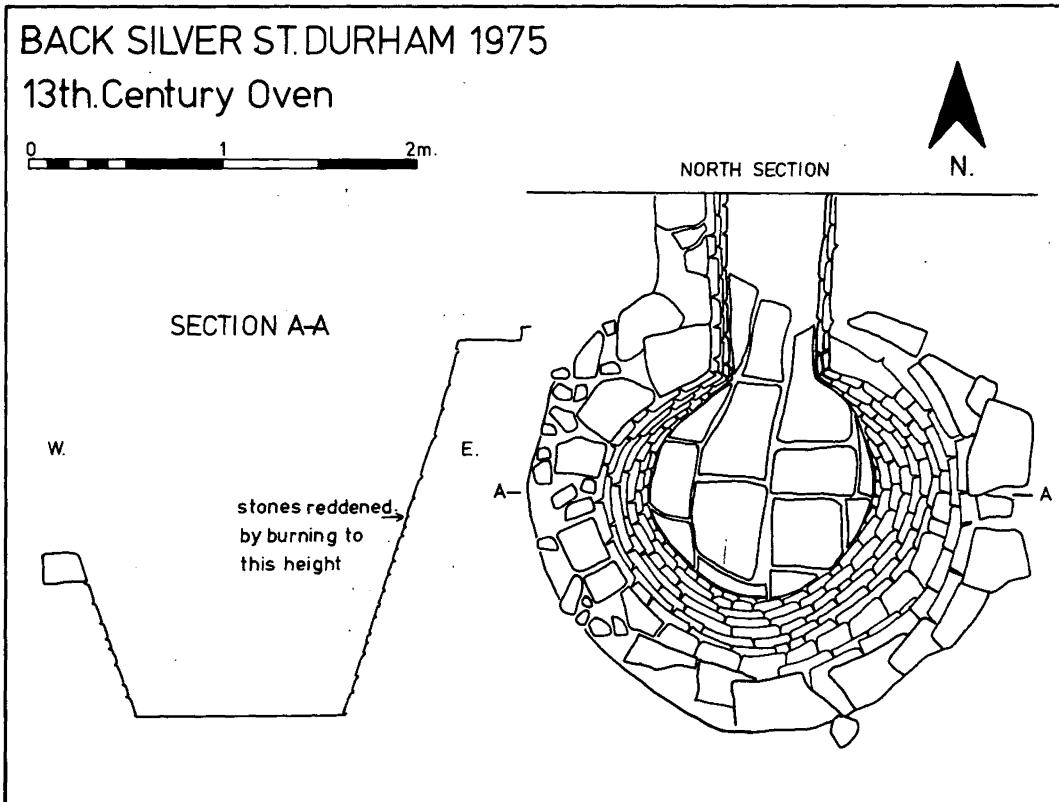
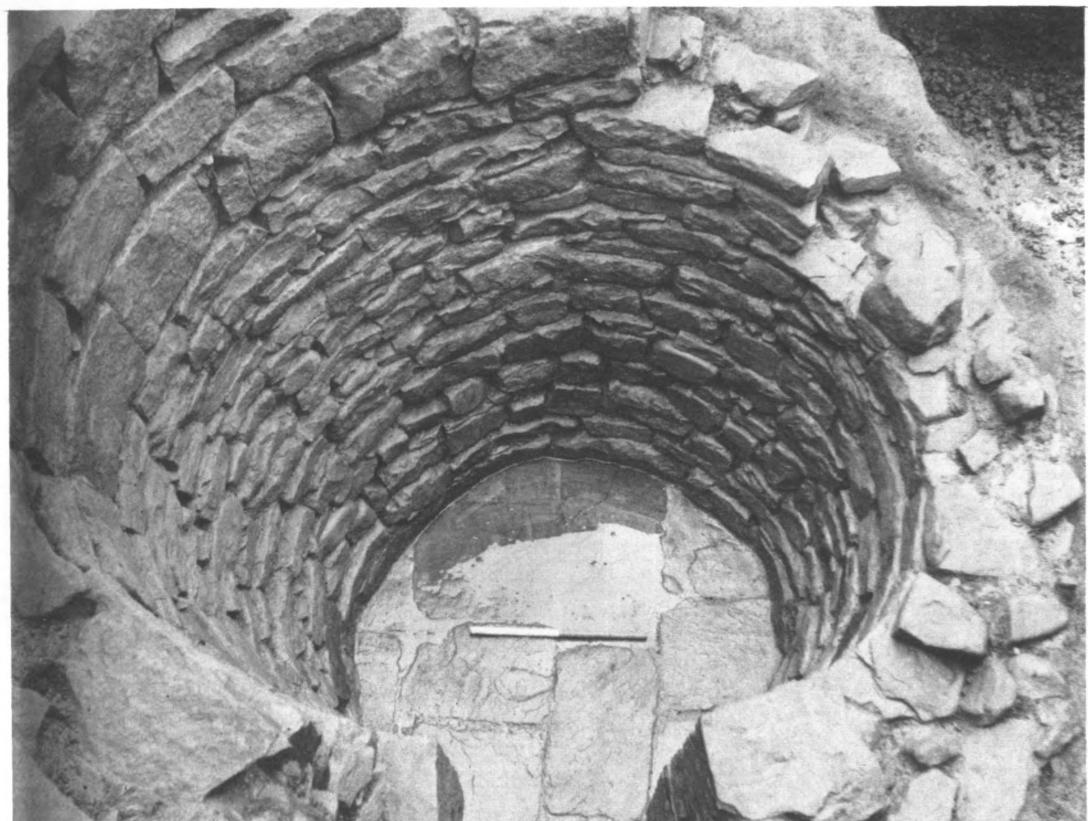
Fig. 2.

This mid-thirteenth century structure was located some six metres to the east of the City wall and was constructed of mortar-bonded sandstone blocks, possibly in two separate phases. It was approximately circular, but sloped outwards from a diameter of 1·40 m at the base to 2·50 m at the top. The northern segment of the circle was broken by a 0·50 m wide flue or entrance which extended at least 0·75 m beyond the structure. The flue was not completely excavated because it extended beyond the limits of excavation. To the East of the flue the main wall of the structure stood to a maximum

Back Silver Street, Durham: drying kiln

height of 2·00 m. The lower 1·25 m of this wall consisted of much smaller stones (10 × 15 cm) than those above (40 × 20 cm). The lower stones were slightly reddened by the effects of heat. Above 1·25 m, there were two courses of long, flat stones overlain by a maximum of four courses of larger, more square-shaped blocks, which only survived on the eastern, uphill, side of the structure and showed no evidence of heat discolouration. Associated with these upper courses was a shallow trench 0·25 m deep × 0·50 m wide following the top perimeter of the wall, and filled with rammed clay and small flat stones standing on end. Whether this represents an original construction trench for the whole structure or a repair trench enabling the insertion of the upper larger blocks was not clear.

Within the structure below the demolition rubble, which included many long, flat, slightly burnt stones and clay, were two layers of charcoal and organic material (see Appendix III). These covered a complex of flatstones, possibly the fallen remains of small stone pillars at the base. In turn those lay over a stone floor consisting of several large flagstones (*c.* 20 × 50 cm) covering all of the base of the structure and extending 0·50 m into the flue.

Despite the excellent preservation of this structure there was no clear evidence of its original function. Its general shape, the presence of charcoal, and the reddening of the lower courses of stones, all seem to indicate that it was either an oven or drying kiln for grain.

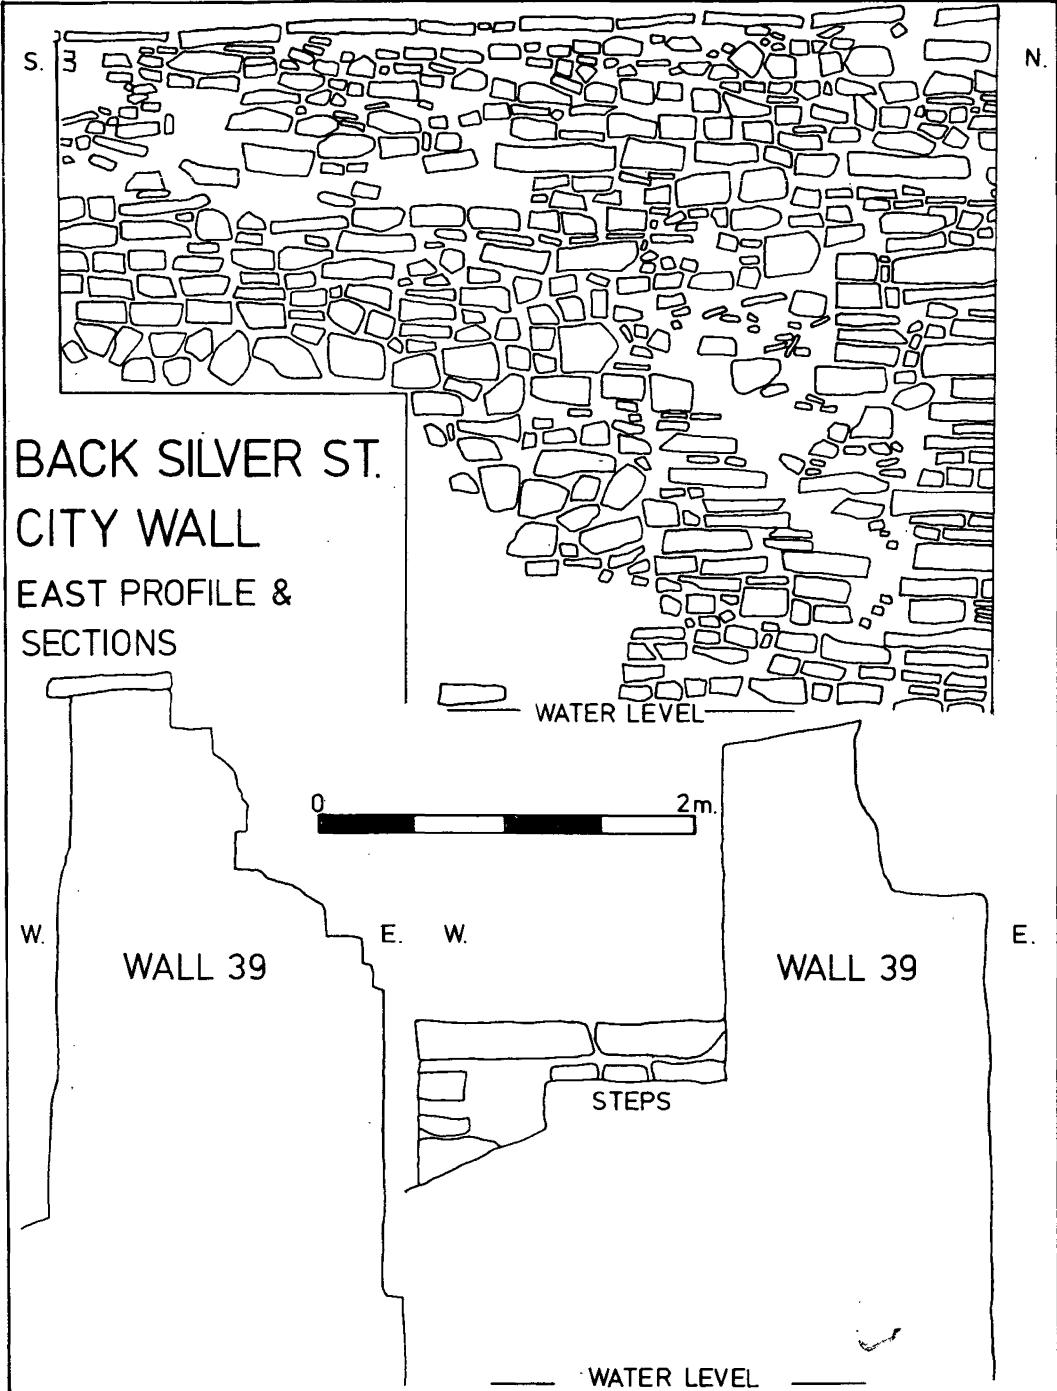
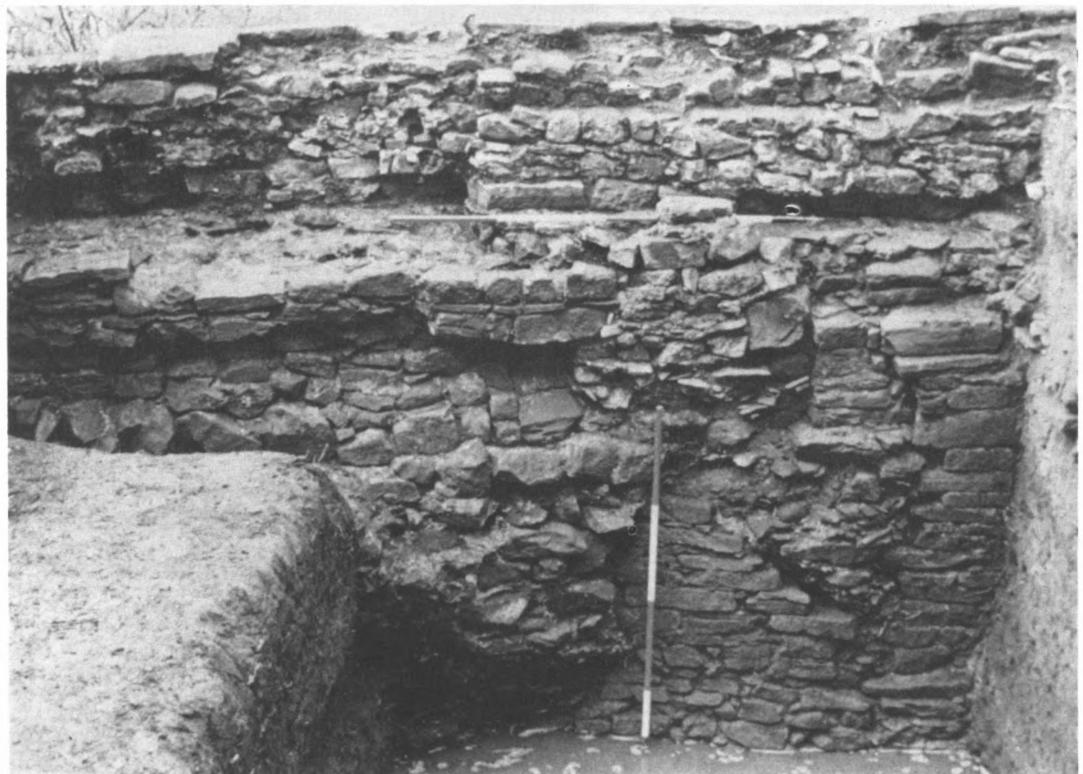
Fig. 3.

This wall was located running north-south at the extreme western end of the trench and was excavated to a depth of 3·70 m on its inner eastern face, before flooding from the river made further excavation impossible. Two distinct phases were detectable. First the upper, later section standing to a height of 1·00 m, 1·25 m wide, and mortar bonded. This section was built of small irregular sandstone blocks, with facing stones on both sides of the wall, but extant on the inner face only at the northern end. Pottery finds from the construction trench for this phase indicate a sixteenth century date. Flagstones running parallel to the wall level with the bottom of the wall suggest a contemporary walkway.

Secondly, below this construction was a much wider, 1·85 m, more solidly built wall consisting of larger sandstone blocks covering a rubble core. Many repairs and alterations were visible in this phase and the only section surviving reasonably intact was that at the extreme northern end. Here, the facing blocks were approximately 0·50 m long × 0·20 m deep × 0·35 m wide and clay bonded. South of this was a large "bulge" of rubble mortared into the wall and presumably representing some major repair. It was not clear from the excavations whether the wall was cut into the bank, or if it was built freestanding and subsequently soil accumulated behind it.

Back Silver Street, Durham: wall

This wall, or at least its lower sections is probably the City wall, recorded as being constructed around the lower peninsular in about 1315, after a plea from the citizens of Durham to the Bishop for the erection of walls "for the protection of the merchants and inhabitants from bands of murderers and marauders" (Reg. Polat. Dunelm. Rolls Series ii, 1071). The pottery evidence certainly seems to support this early fourteenth-century construction date.

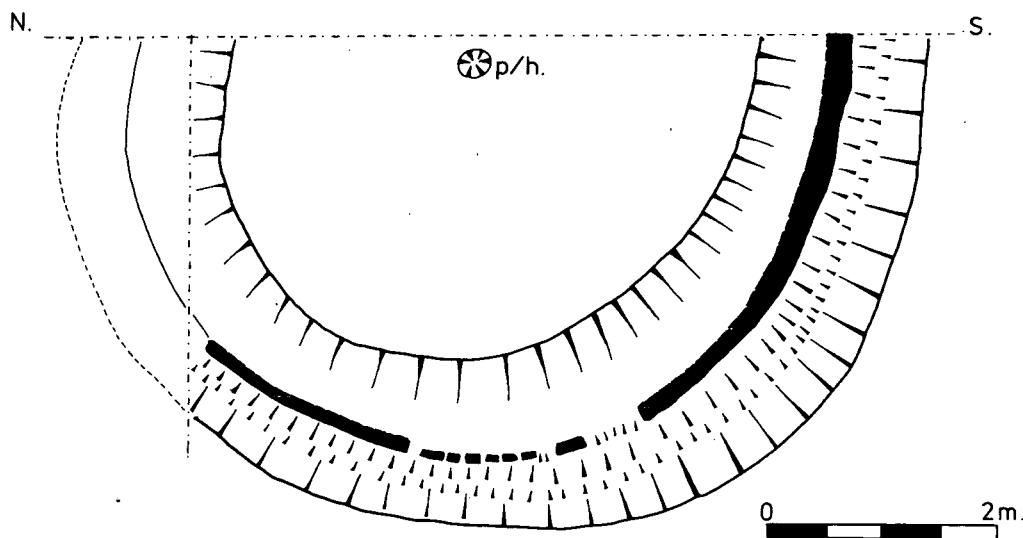
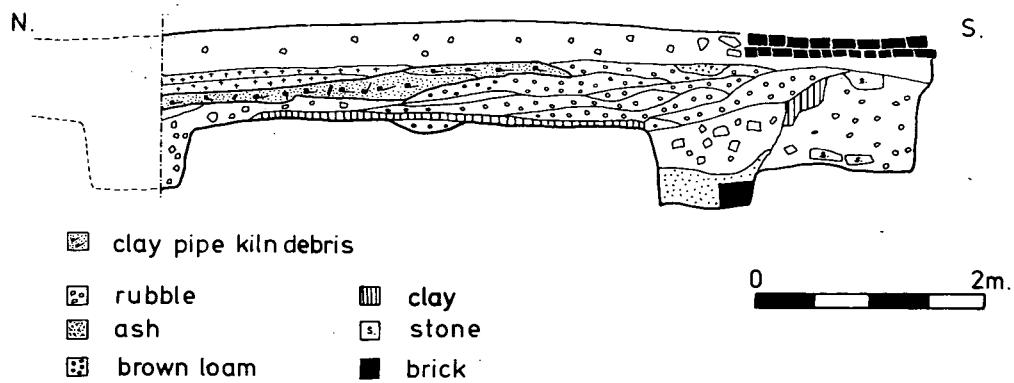
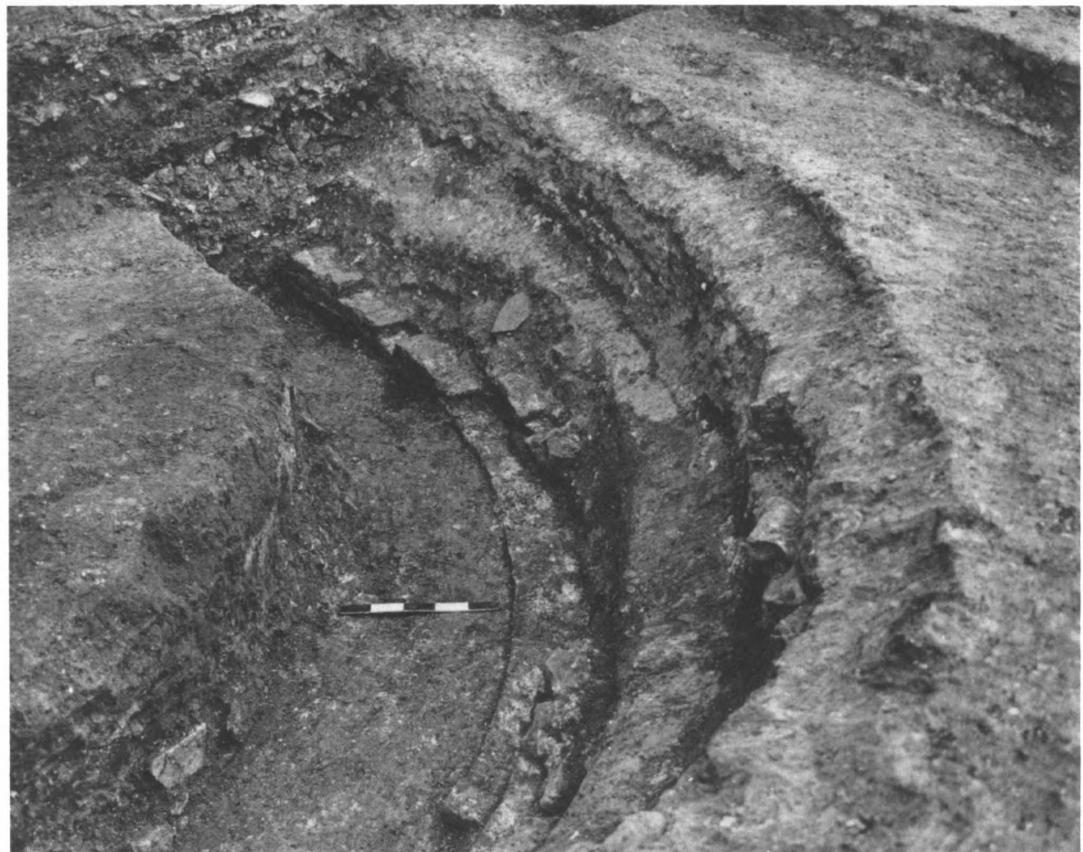
Fig. 4.

It was only possible to excavate half of this feature as it extended beyond the eastern limit of excavation. The foundation walls were the main surviving structural features. They were located in the bottom of a 0·90 m deep trench and survived to heights varying between 0·10 m and 0·20 m. Foundation construction was of nine by two hand-made bricks (see Appendix V).

Assuming that the unexcavated half was the same as the one excavated, the structure would have been circular, with an overall diameter of 5·50 m. The large number of dutch pantiles found in the robber trench of the foundation wall suggest these were the roofing material and the presence of a 0·40 m × 0·35 m posthole in the centre suggests a central supporting post. Thus one can envisage a round building with brick external walls and a pitched tiled roof, rising to a central support. No evidence was forthcoming of its function. Most of the material contained within it was debris from early nineteenth century clay pipe manufacture. This is clearly later material as shown in the eastern section (fig. 4b) and also by the other finds, evidence which suggests a late seventeenth-/early eighteenth-century construction date.

Late 17th.Century Brick Structure

Eastern Section - showing clay pipe kiln debris

Back Silver Street, Durham: circular brick structure

Overlying the demolition material of the circular brick structure was a 0·25 m thick layer of "slag type" material containing large quantities of decorated clay pipes, which have been interpreted (see Appendix I) as the debris from clay pipe manufacture. No structural evidence was found, however, for the location of the kiln.

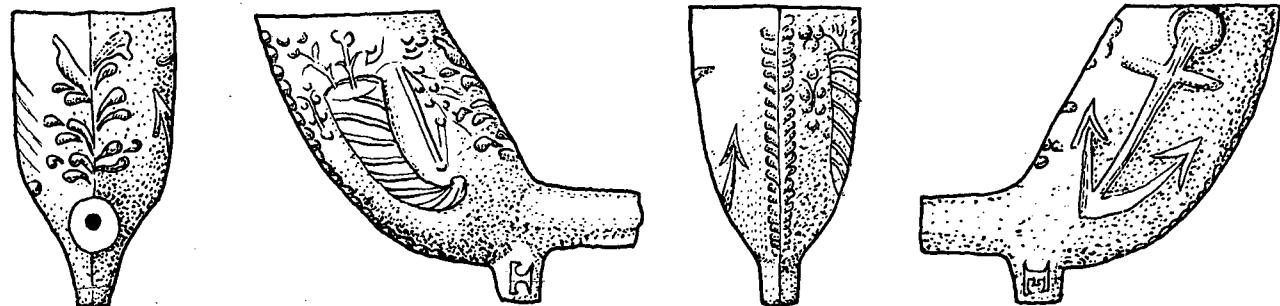
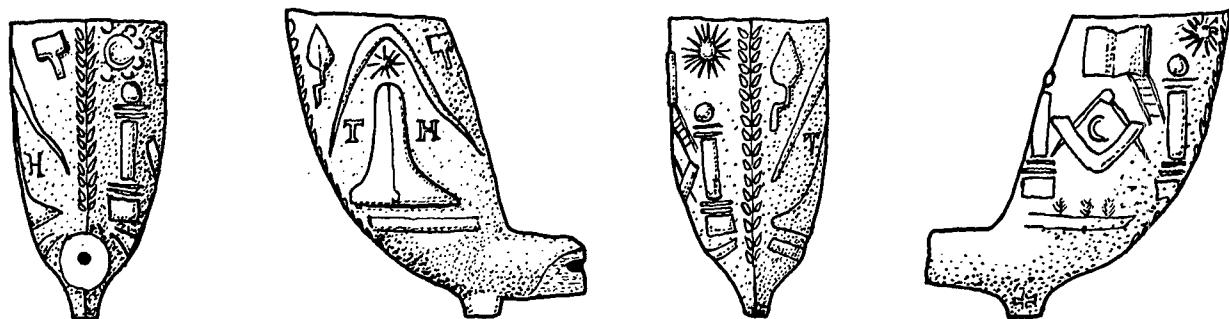
Fig. 5a. Off-set overflowing cornucopia on left hand side and anchor on right hand side. Initials T E (Thomas Elsdon) appear on spur
Fig. 5b. Decorated bowls showing freemason symbols

Eighteen distinct types of decorated pipes, all from separate moulds were recovered. All are of hard, thin fabric and show the same individual mould characteristics with untrimmed spurs. Most of the bowls vary in firing colour from white through light grey to reddish brown. Some are distorted and some have adhering slag. Four types are illustrated.

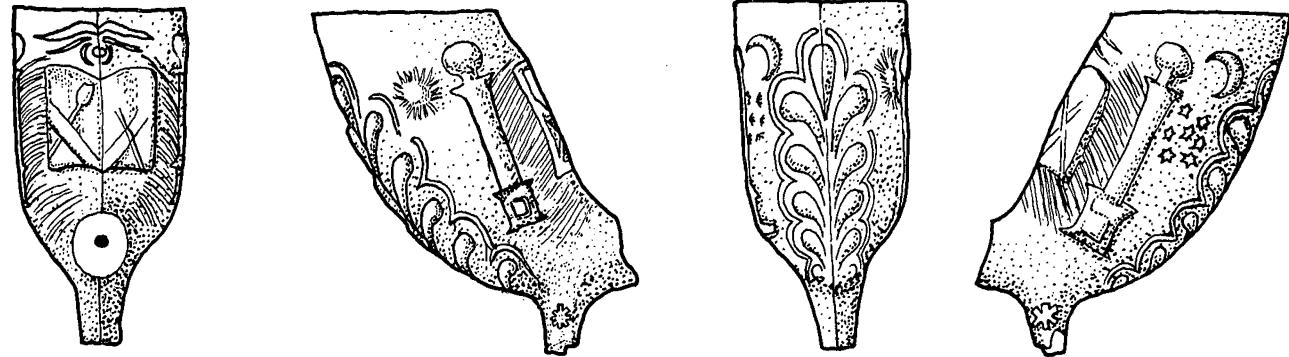
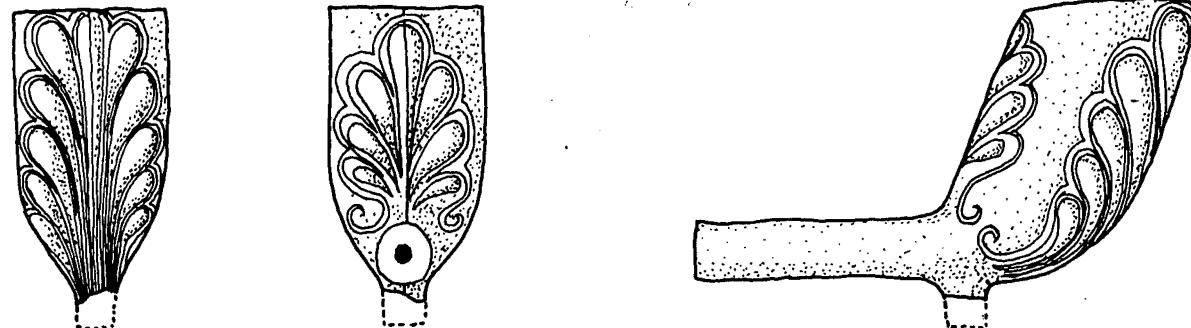
Fig. 6a. Decorated bowl showing freemason symbols

Fig. 6b. Spurred pipe with large fluting decorations extending from the mould lines

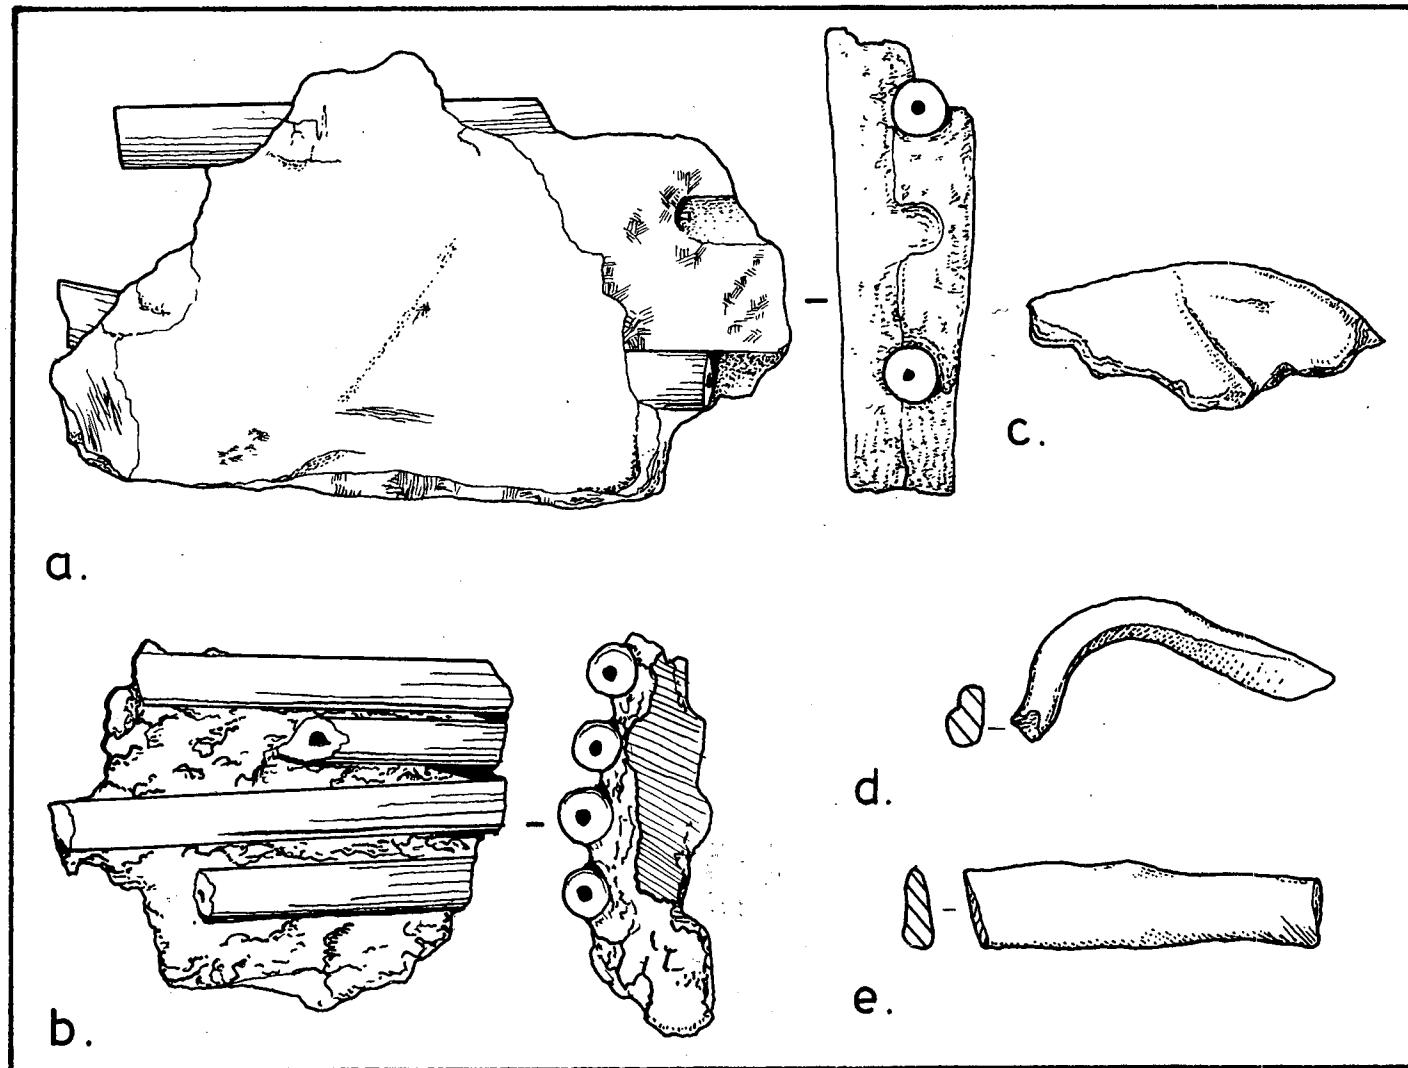
Fig. 7.

Examples of kiln evidence material are shown in fig. 7.

This is the first report from the North of England to include evidence of a clay pipe kiln site, as shown by the pieces of muffle, saggar fragments and distorted pipes with attached slag, all from context (10). The archaeological evidence for the pipe manufacture is also complemented to a certain extent by documentary sources. These documents record the presence of a William Dryden, pipe maker, working in Silver Street Lane (Back Silver Street) from 1827–34. However, a vast majority of the pipes recovered during the excavation bear the initials of Thomas Elsdon, pipemaker in Gateshead from 1811–51. Two possible solutions help explain this apparent dichotomy, either Dryden could have been apprenticed to Elsdon and have been supplied with one of his master's moulds to set up in business, or Elsdon may have sold-off surplus moulds within the trade.
