The Medieval Town Defences of Newcastle upon Tyne: Excavation and Survey 1986–87

J. Nolan, R. Fraser, Barbara Harbottle and F. C. Burton

INTRODUCTION

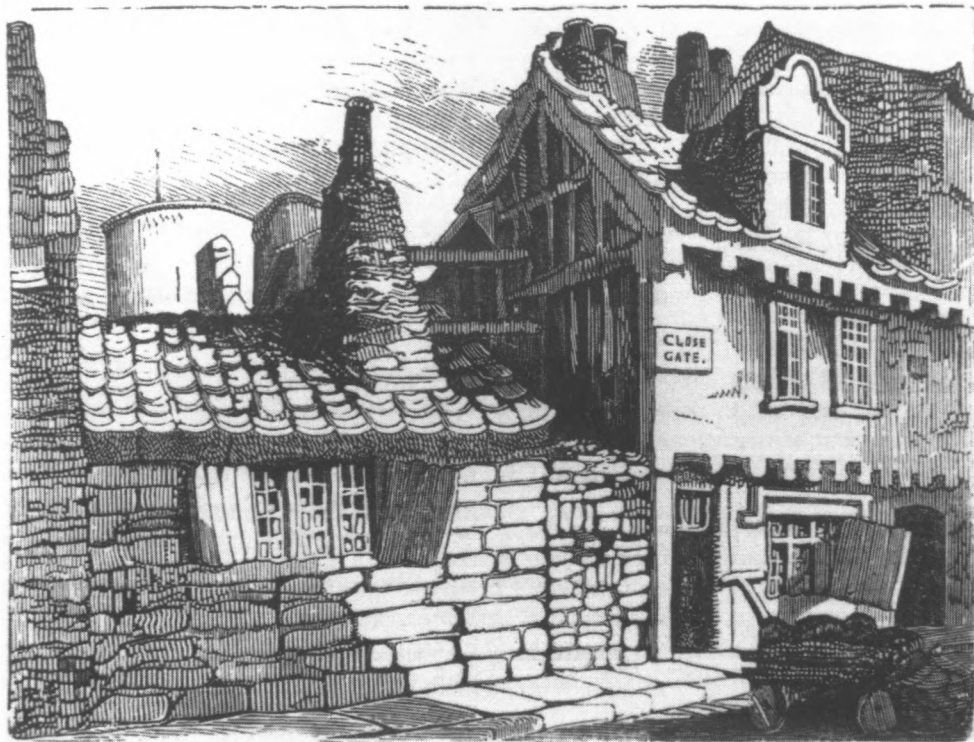
The Closegate in 1826, showing the building described in Phase 10.

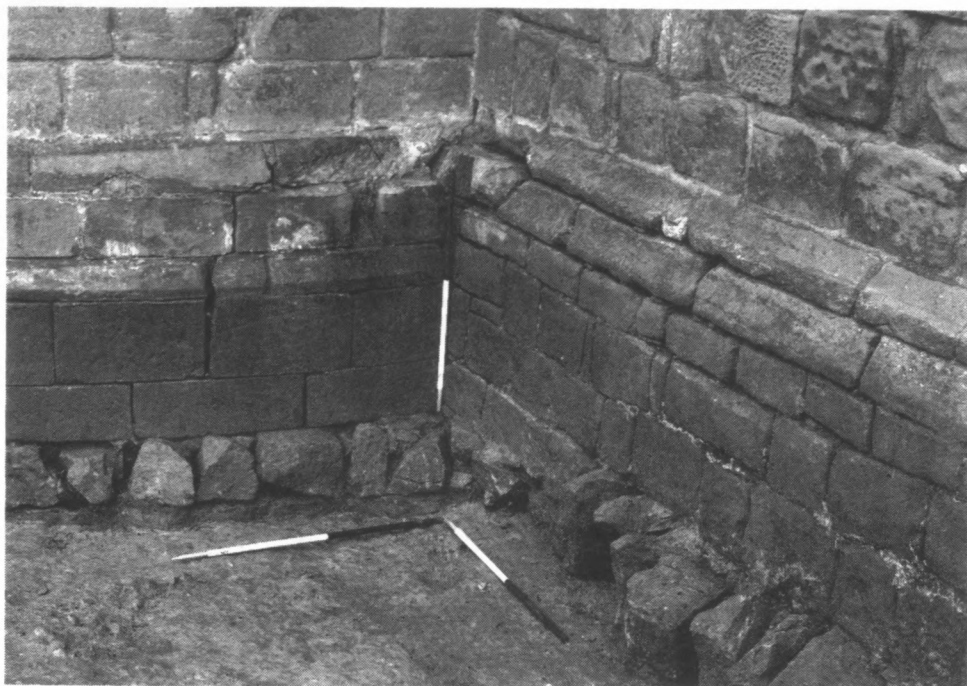
Junction between Morden Tower (left) and Curtain Wall to south (right).

The footings of Morden Tower were square in section and relatively shallow. As such, they were quite different in character from those of the town wall (Plate III), although both were unmortared. Two courses above the footings were two chamfer courses, which were separated by an intermediate ashlar course. At the junction between wall and tower, the tower footings turned through 90 degrees, and ran south-west for 1.00 m beneath the town wall. Above this, alternate courses on the tower overlapped the line of the wall, but the different depths of the courses on the town wall meant that, with one or two exceptions, the bed joints did not coincide.
