The Gatehouse of Morpeth Castle, Northumberland

Peter F. Ryder

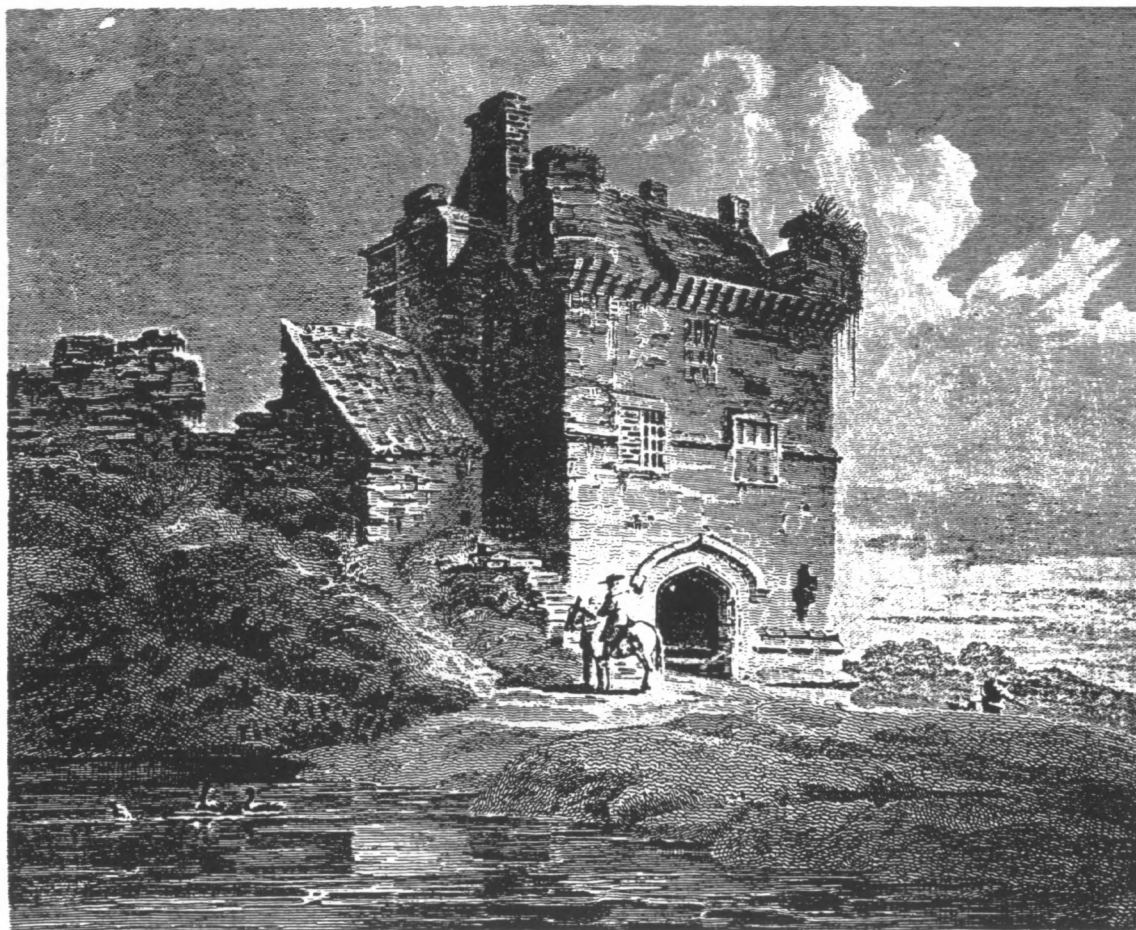
Fig. 2 Morpeth Gatehouse from a sketch by Luke Clennell, c 1810
