# Excavations at Newcastle Quayside: Waterfront Development at the Swirle

Summary: Excavations on the riverside in Newcastle upon Tyne by the confluence of the Tyne with the Swirle showed that after the foreshore had been consolidated behind an artificial embankment in the 13th century, a limeburning industry was established which flourished during the 14th century. After the end of the medieval period the land was divided into a set of parallel plots; buildings were constructed on top of landfill beside the Swirle during the 17th century, and later across the whole site. The context of this site on the Newcastle waterfront is considered, the technology of the kilns is reviewed and compared with other examples known from the medieval period. The sources of raw material were not local, and it is suggested that the limeburning industry was linked with the coal trade.

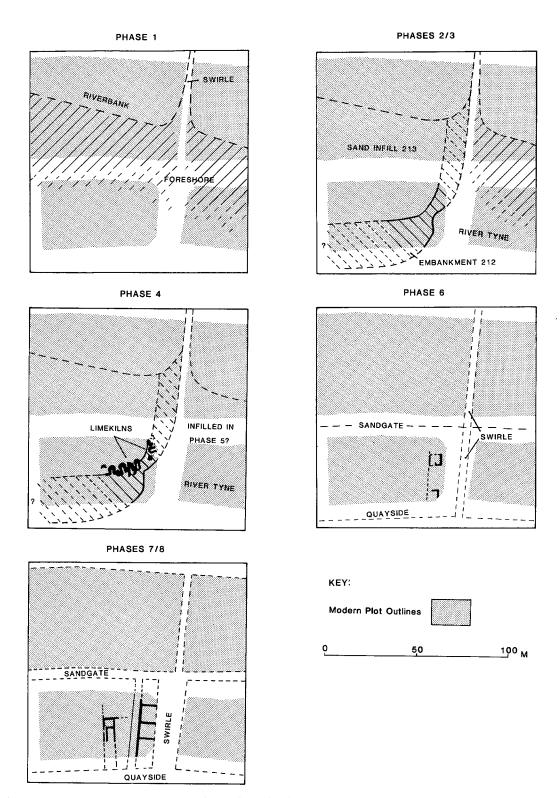
Fig. 26 Schematic view of the stages of waterfront development.
