IV Recording the Roman Wall

Alan Whitworth

THE RECENT RECORDING PROGRAMME

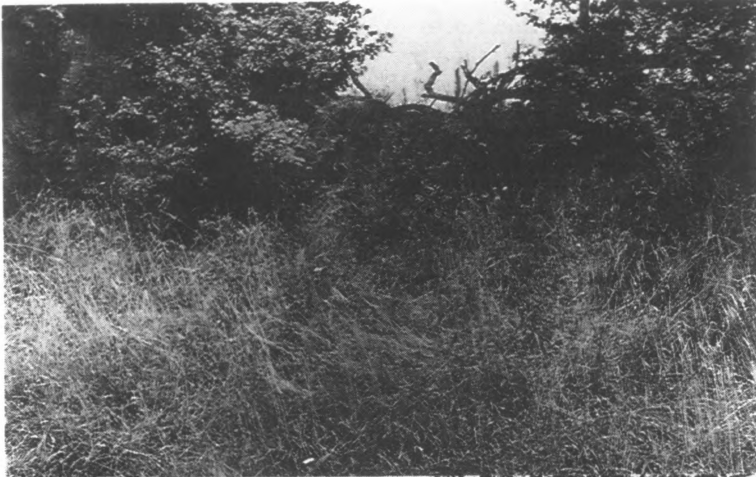
(a) Before exposure.

Fig 1 Consolidation work between Willowford farm and the River Irthing, 1955.

In Mr. Anderson's day it was not envisaged that the wall would be consolidated in its state of ruinous collapse. Where the wall face had fallen away from the inner core this was straightened and rebbed by dismantling some sections of face and replacing them in their original vertical position. The joints between the facing stones, where no Roman mortar survived, were cut out and repointed with new lime mortar mix with a little cement added for strength. To indicate that this was new work, the pointing mortar was usually left slightly recessed from the stone face. A waterproof core capping of cement rich mortar was also added to protect the inner core and shed rain water.

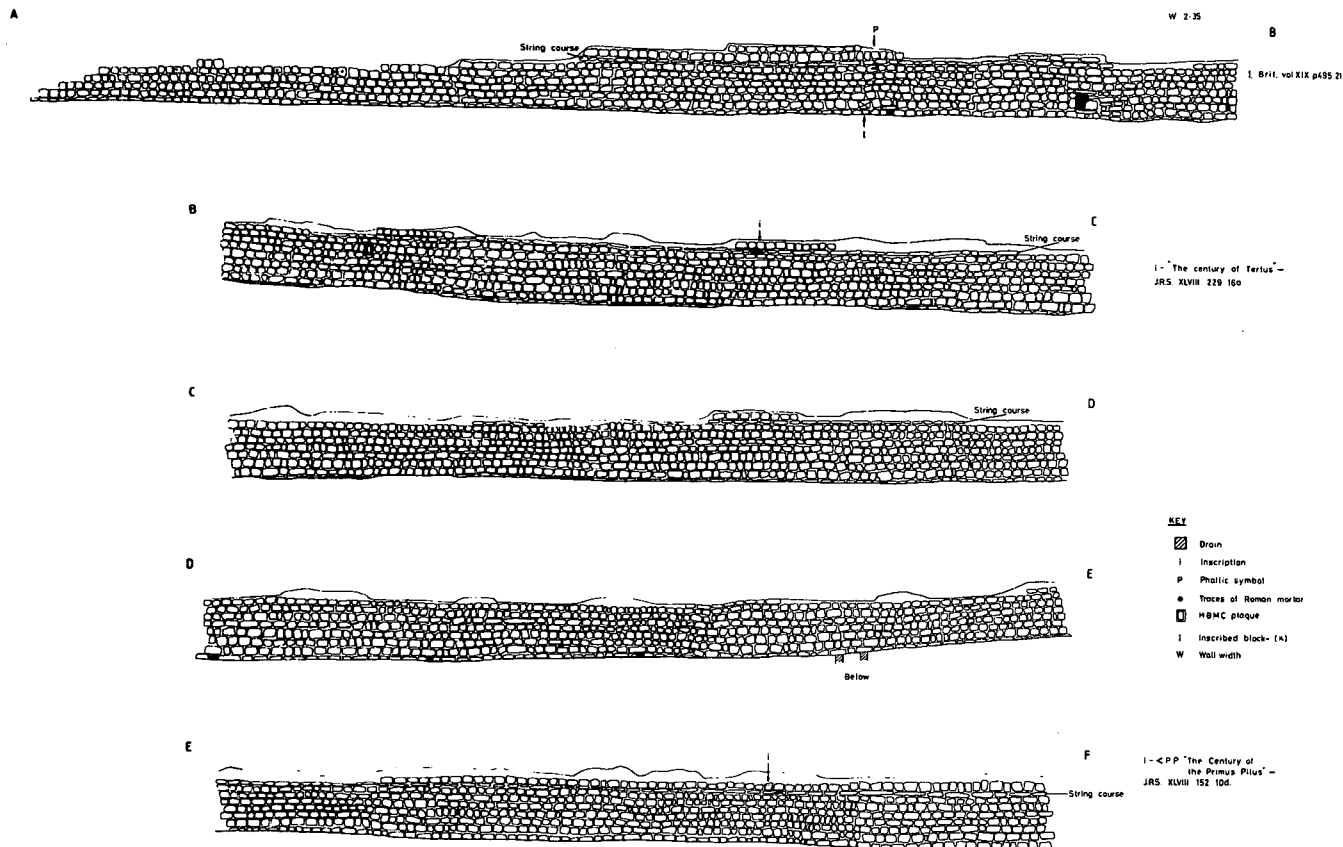
Site. HADRIANS WALL EAST OF BIRDOSWALD		code.	date. JULY 86	Sheet
Site Sub Division. South Face (1 of 4)	Drawing Number.	1:50	metres	56

Fig 2 Example of recent record drawings. South face of Curtain Wall east of Birdoswald (part of Sheet No. 56, reduced).

The rectified photographs were traced on to waterproof draughting film to enable them to be used on site in all weather. Every facing stone was checked and any missing ones that had been obscured in the photographs by vegetation etc. were added, to ensure that every stone in the fabric of the wall or associated structures was accounted for. The on-site enhancement of the rectified photographs also included indicating sections of horizontal offset courses and their widths together with any vertically offset or inset courses. It has been suggested (Bruce 1863, 20) that the vertically offset/inset courses seen only on the south face of the Wall are where the sections of various work gangs joined. These variations in wall thickness are not considered to be of original Hadrianic build (Birley 1961, 87) and can now be seen as a rebuilding of wall face which had collapsed during the Roman period. Drains and water culverts through the wall have been recorded. In the Birdoswald sector the drains are fairly evenly spaced every six metres, presumably as the natural drainage is from the south towards the wall. Further to the east, in the central sector, where the Wall follows the line of the Whin Sill escarpment, the drainage is generally away from the wall and drainage channels through the Wall are not so frequent. Areas of the surviving Roman lime-rich mor-

In areas where the Narrow Wall is built on top of the Broad Wall, the facing stones of both Wall gauges have been recorded. The width of the Wall face at various selected intervals is also recorded on the archival drawings.
