Excavation Adjacent to Close Gate, Newcastle, 1988–9

R. Fraser, R. Maxwell and J. E. Vaughan

SUMMARY

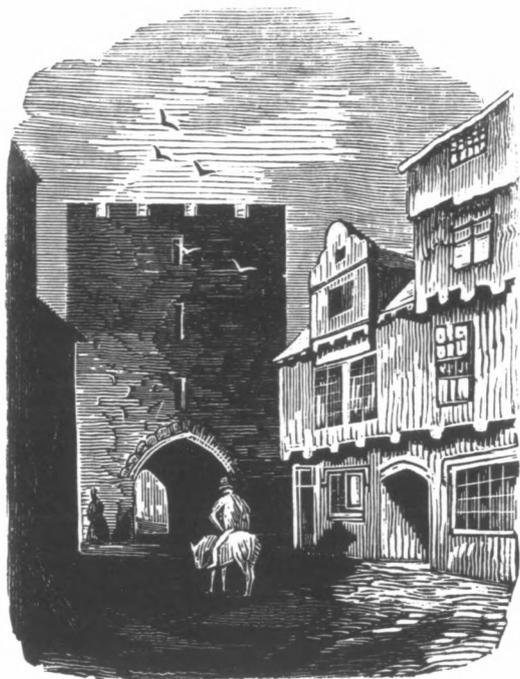
Fig. 3 A 19th-century view of Close Gate, compiled "from various sources". (The gate was demolished in 1797).

sources" (Richardson 1842) several years after the gate was demolished in 1797 (Mackenzie 1827). It depicts a three-storey rectangular structure over a central archway, but lacking either a flanking guardroom or a pedestrian passageway. From 1771, until its demolition, the gate served as a gaol. The fact that there appear to have been three chambers available for this purpose would suggest that the gate may have been of three storeys. The gate had previously been used as a store; in 1564 there were "remanynge at the Clos yaitt 24 great troys that is of the town" (TWAS Chamberlains Accounts 1561-4, fl. 11). A document of 1574 (Welford, Vol. 2, p. 462) records the purchase of a rope for the drawbridge at Close Gate, so it is likely that there was a ditch or drawbridge pit immediately to the west of the gate itself. It is probable that the gate did not have flanking guard chambers since during the English Civil War an adjacent house was leased as a guardhouse.

The only view of the Close Gate to have survived is a somewhat unreliable 19th-century engraving (fig.3), compiled "from various

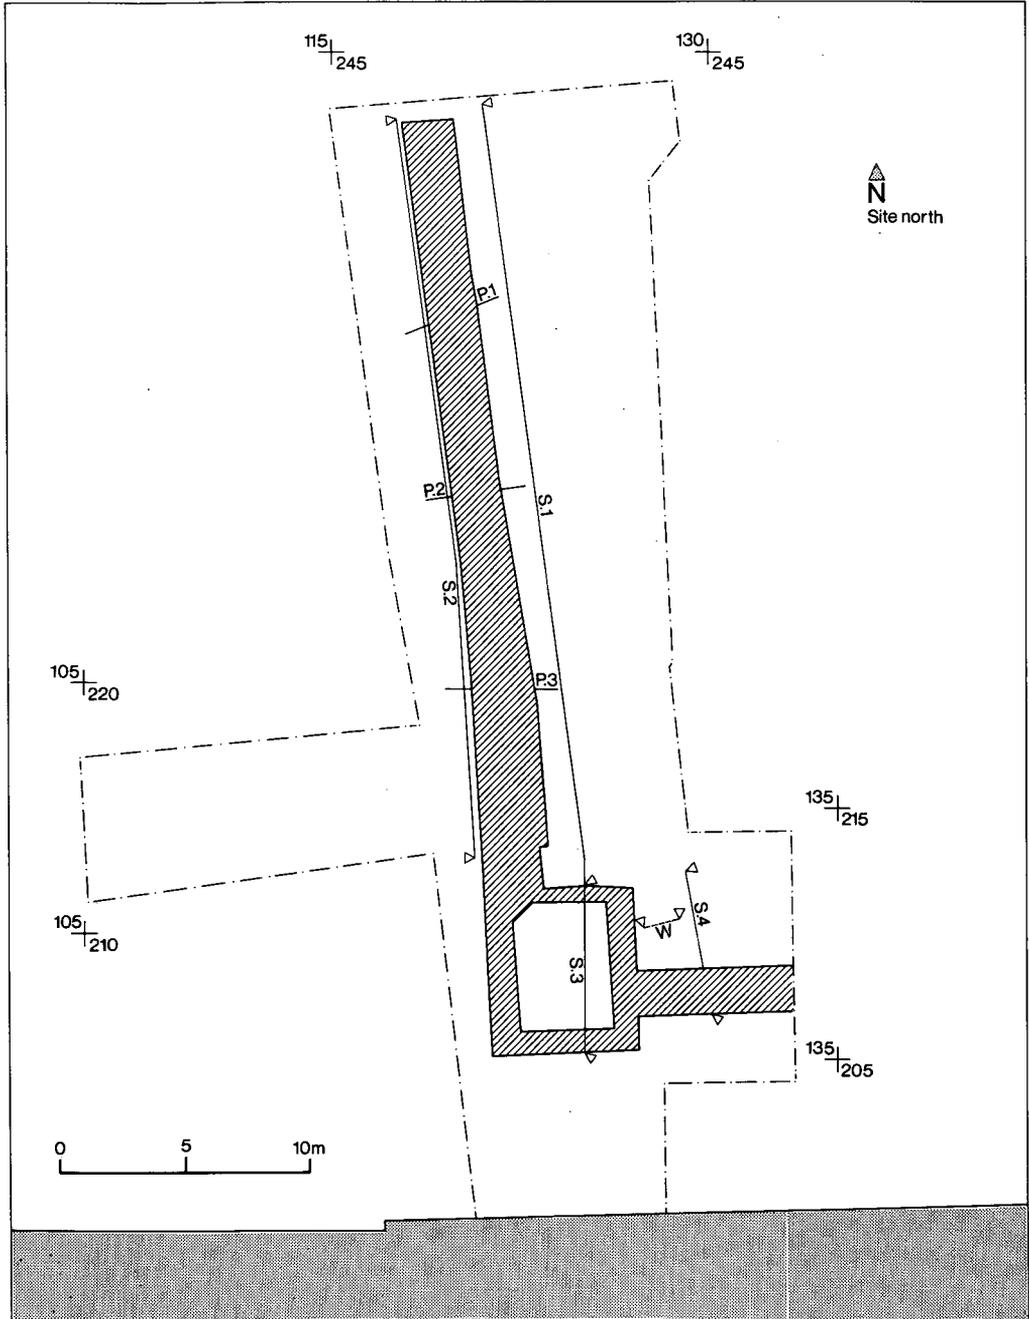
Fig. 7 Site plan indicating location of principal sections in relation to the Town Wall.

The main area of excavation measured approximately 45m long by 14m wide and extended from the road to the river edge (fig. 7). The trench encompassed the scheduled area of the town wall and tower and only a small margin of ground to the east and west. It was extended to the east in the area of the tower and the river wall and in one section to the west to test for the presence of a ditch.

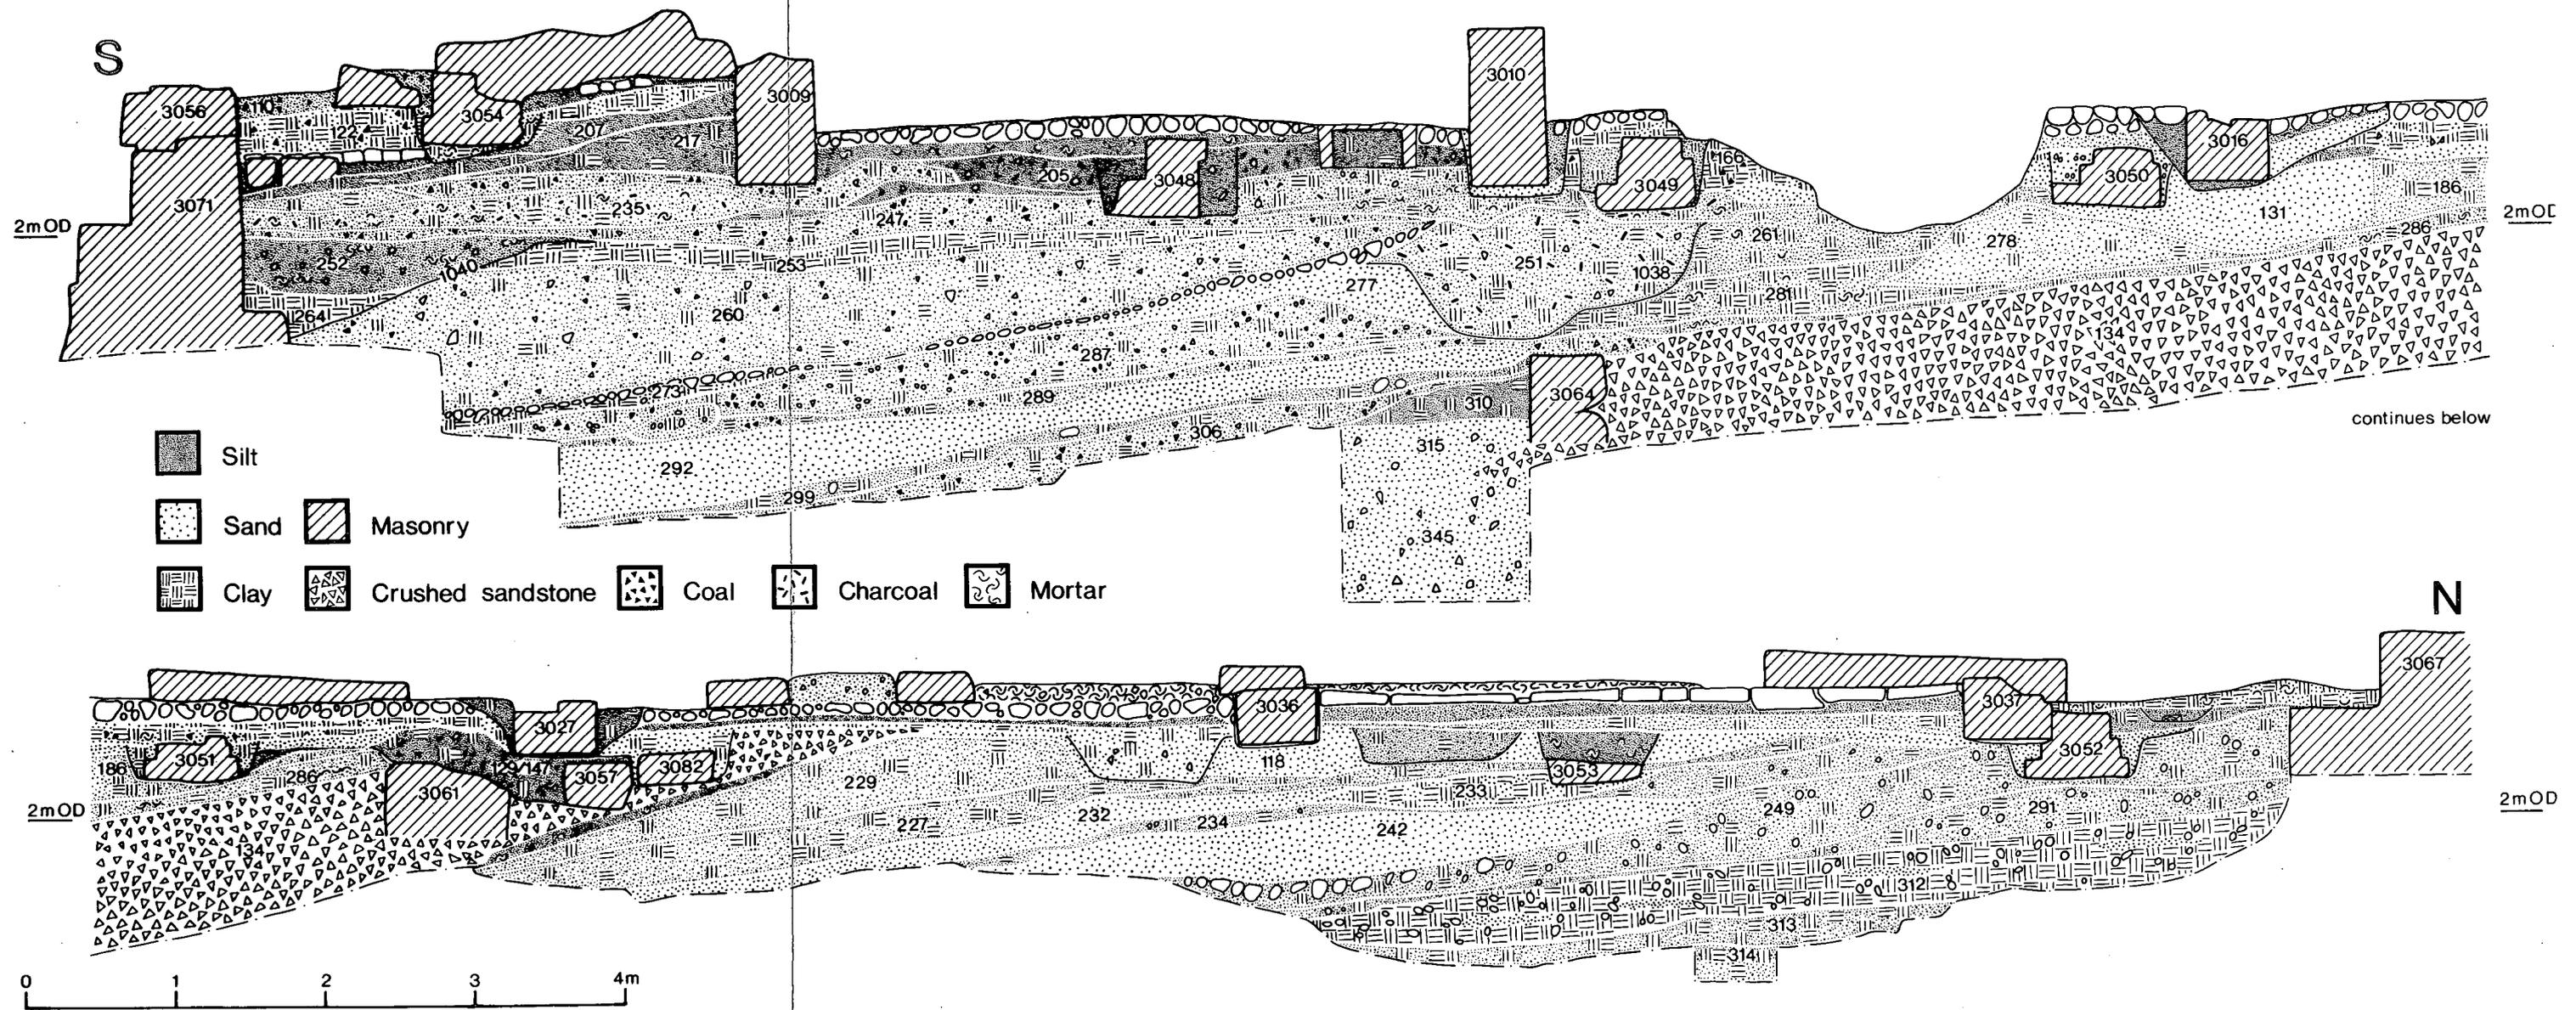
Fig. 8 North-South section east of the Town Wall.

platform. Sections excavated against both the eastern and western sides of the town wall revealed the wall footings, not in a foundation trench, but laid directly on top of a sandy surface, which was presumably the top of the river bed. It seems likely, therefore, that a foundation trench was dug on dry ground and where the wall entered the river a trench was both unnecessary and impossible to excavate. Certainly the very uneven settlement of the structure together with the marked displacement of joints would tend to confirm the observations that the wall was constructed directly on river sand.

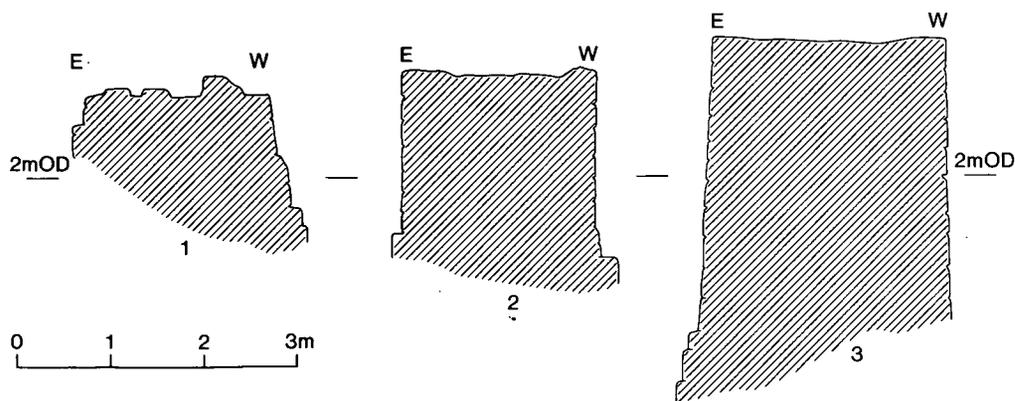
Fig. 9 Profiles 1-3 across the Town Wall.

The town wall (3000), constructed in local sandstone, was traced south over a distance of 36.7m. The wall measured 2.05m wide at the northern end, broadening out to 2.8m north of the tower (see profiles 1-3, fig.9). The course of the wall changed slightly between 7.5m and 12.5m north of the tower, coinciding with this expansion in width. Its footings comprised roughly dressed, irregular blocks although no trace of a bonding matrix survived in the elements that were exposed. The wall above the footings was faced on both sides with finely dressed, rectangular ashlars, and had a rubble core bonded with a light brown, coarse, sandy mortar. Although pointing did survive in places, generally the mortar had been washed out of the joints. There was a single chamfered

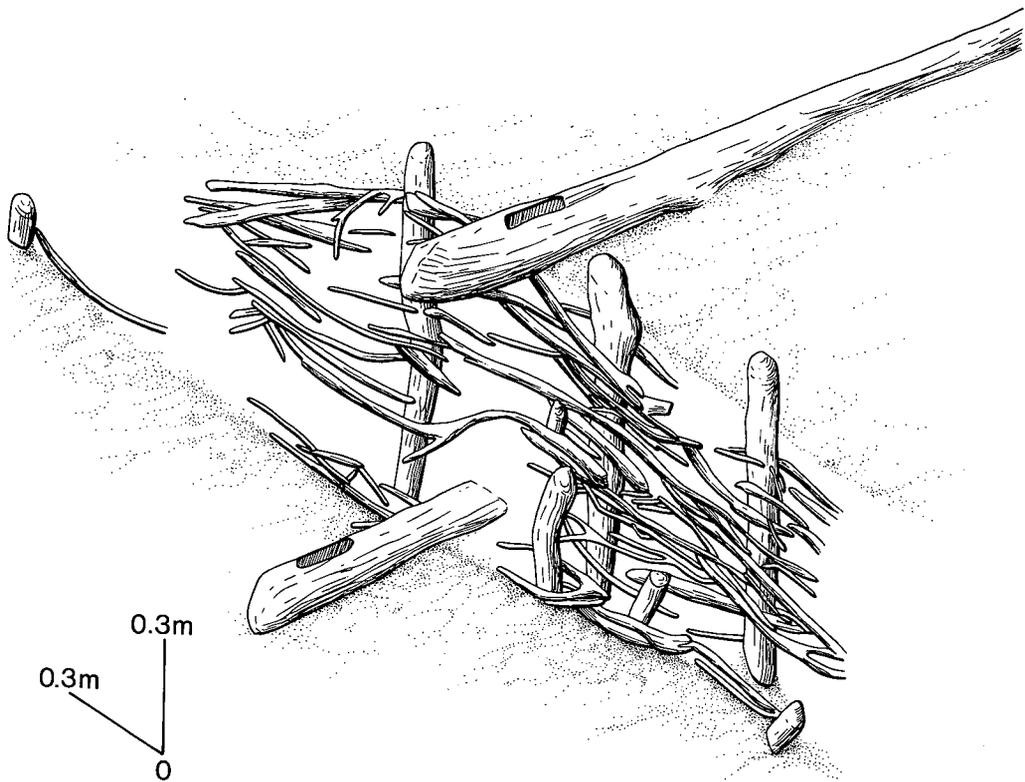
Fig. 10 Axonometric drawing of timber revetment.

Although the timber structure cannot be satisfactorily linked to layers lying to the north, it seems likely that this waterfront was constructed only slightly later than the phase 2 revetment walls, 3061 and 3064. As such it was probably constructed shortly after the town wall, possibly as a later element of the general reclamation of the area to its east. The original western end of the waterfront must have butted the east side of the town wall (in the area subsequently covered by the Tower) but still

some distance north of the southern end. It is impossible to estimate the original height of the waterfront since it was truncated by the construction trench (1043) for the new stone-built river wall (3046). Its eastern extent could not be established as the structure continued beyond the limit of excavation.

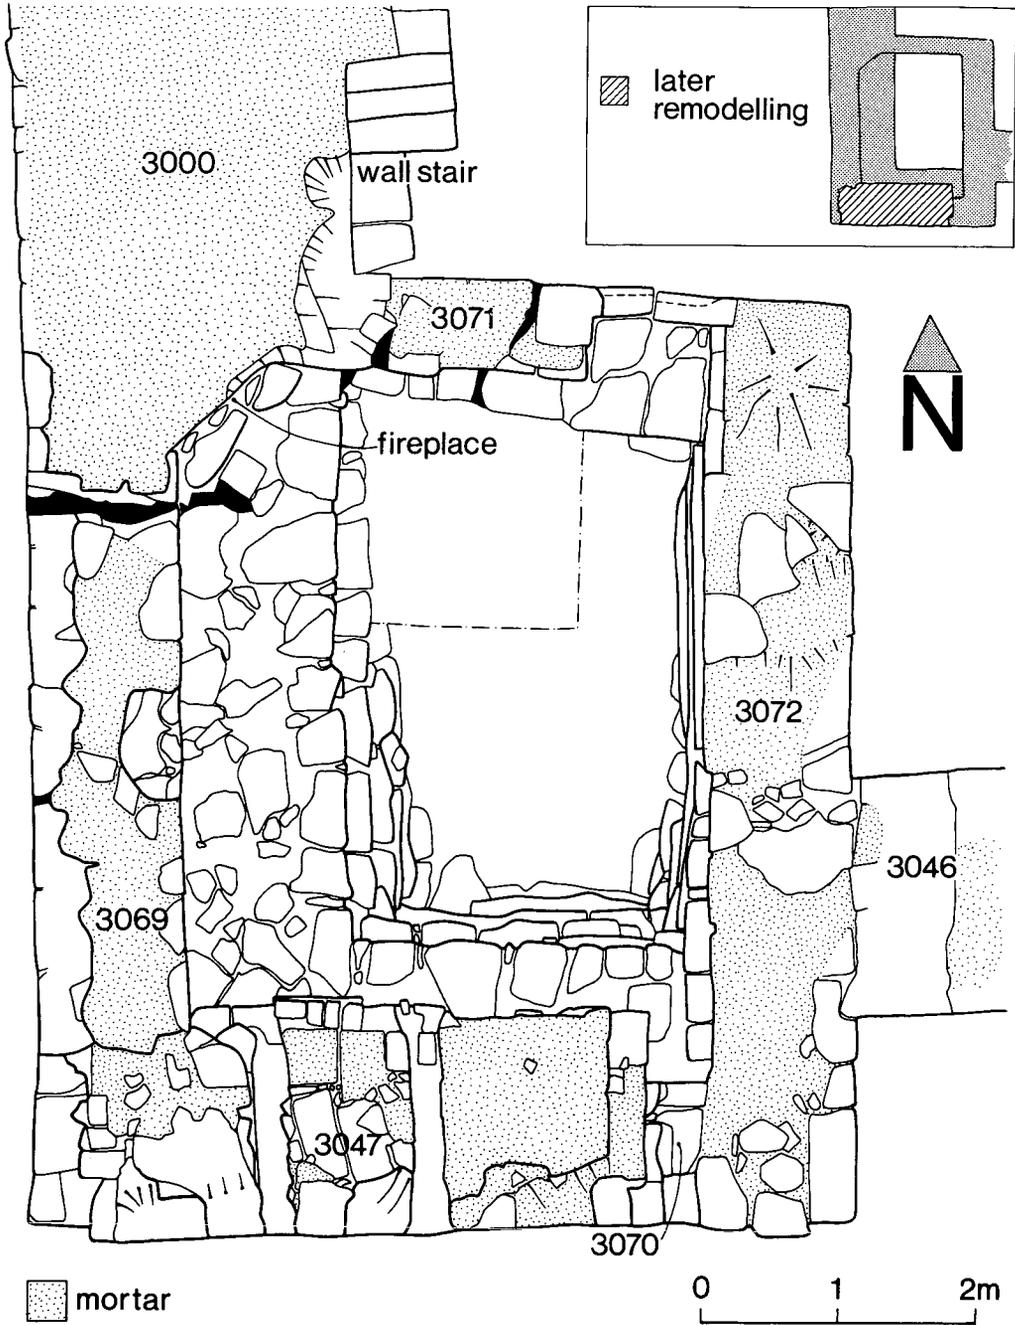
Fig. 11 Plan of Riverside Tower.

The tower was rectangular in plan, measuring 6.54m (north-south) by 6.00m (east-west) externally. The walls of the tower, above foundation level, averaged between 1.02-1.10m wide, although the north wall was considerably thinner (0.74m). The south and west walls were set on very broad foundations (2.1-2.3m wide) which are offset internally a further 0.6m towards the base. The foundations to the north and east walls were considerably thinner (1.20m wide) although the latter did offset to 1.6m wide at the base. At foundation level both the north and south walls of the tower

At its west end, the north wall of the tower had fractured away from the west wall mainly as a result of settlement caused largely by the insubstantial nature of its foundation. At its east end the wall was pierced by a doorway, of which the sill and the western jamb survived. Both elements had plain chamfers externally while internally the sill formed a raised threshold and the west jamb was splayed with a square rebate. The eastern jamb, although largely robbed away can be positioned in the angle between the north and east walls of the tower. The door was hinged on the eastern jamb and opened into a shallow recess which survived in the face of the east wall.

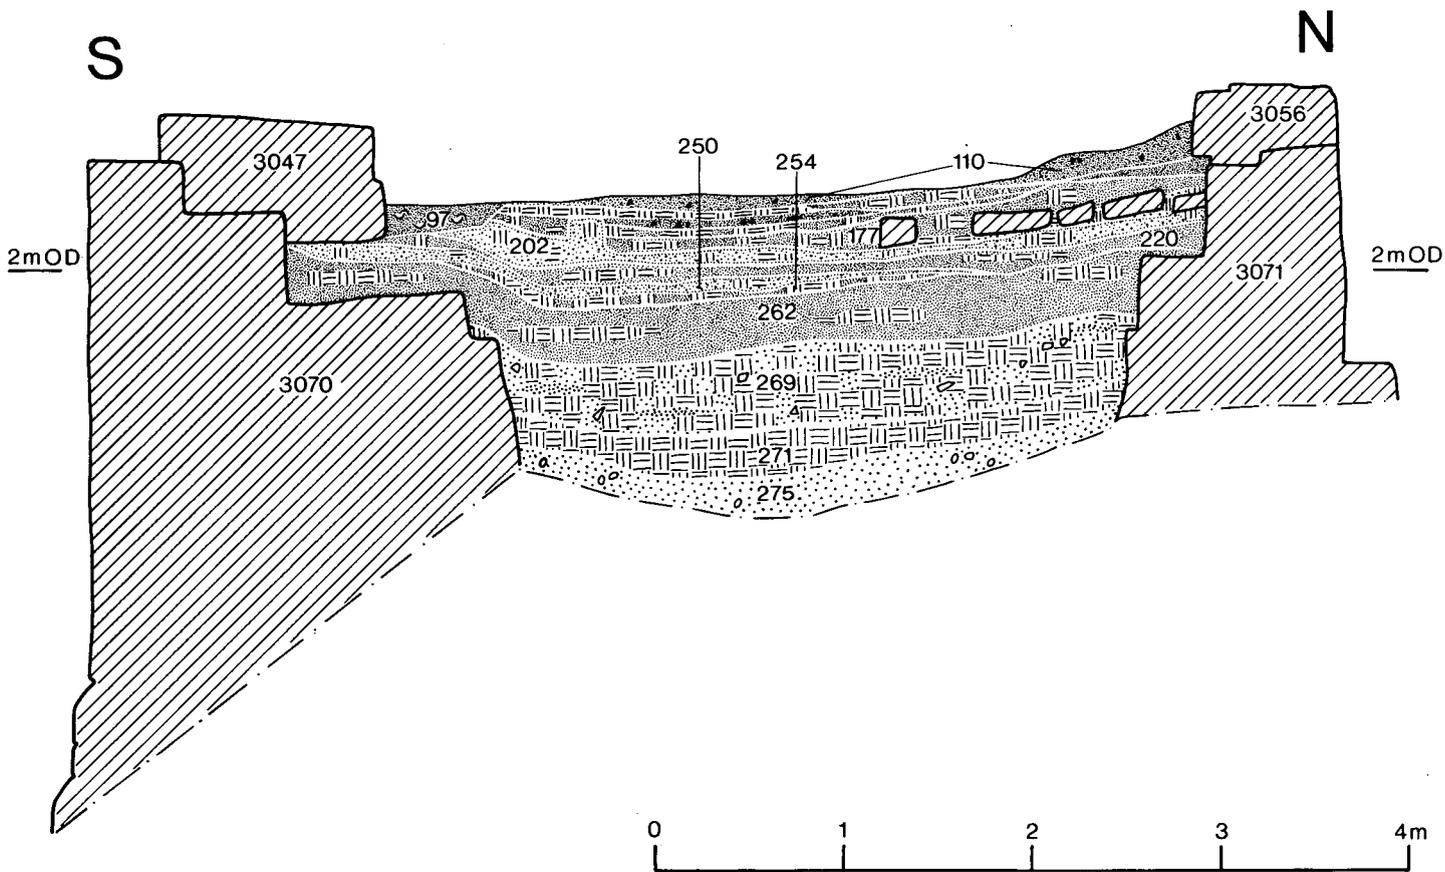
Fig. 13 North-South section through tower.

Within the tower lay a sequence of thin and often patchy layers (250, 220, 202) which may represent occupation deposits (fig. 13). They

overlay, but also reflected the dished shape of the earlier fill deposits, and extended into the doorway area. The central area of layer **202** also formed a marked depression and may have been the remains of a heavily worn surface. A sandy clay containing flat sandstone fragments, **197**, lay in the north-east corner of the depression and may represent the remains of a flagged floor. Above much of **197** and covering most of the flagging were four other thin deposits (**177**, **184**, **178** and **174**).

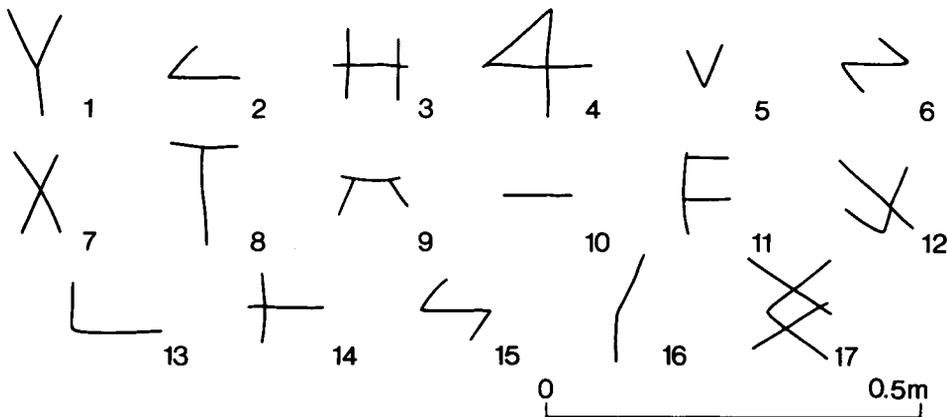
Fig. 27 *Masons' marks.*

Of the sixteen different marks recorded, nine were very common while three occurred only once and one mark (Y) represented almost a quarter of the total (23%). As has been discussed earlier, six main sections could be discerned in the building of the wall and

Table 3 illustrates the occurrence of the different marks within each section; section 1 being at the north end of the wall. While it can be seen that the proportions vary in the different sections, the repeated occurrence of certain marks in adjacent sections suggests that the first five sections were all built within a relatively short time scale.

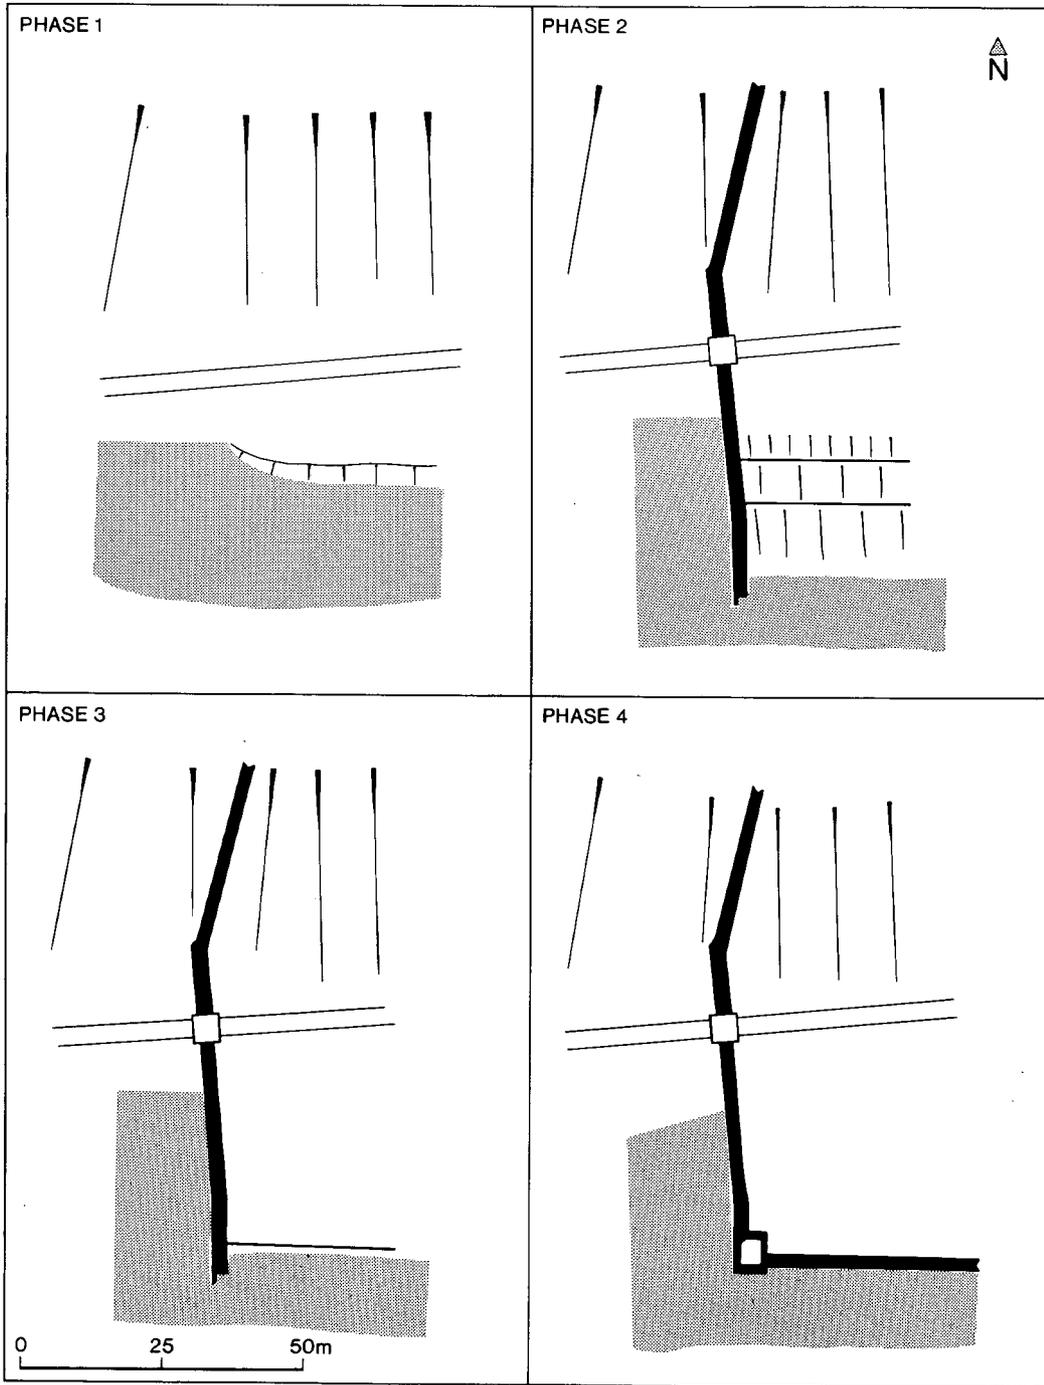
The material used to construct the platform in phase 1 differed substantially from that deposited after the construction of the wall. The initial deposits were predominantly mixed clays and sands containing only a small quantity of rubbish and waste material. Although a wall was seen on the north side of the road (Nolan 1989), no revetting or retaining structures were seen within the pre-Town Wall deposits to the south, and the ground simply sloped down to the water's edge. No structural remains were recorded on top of the early platform, however, any evidence is likely to

Fig. 28 Stylized sequence of development through first four phases. 1: early 14th century, 2: mid-14th century, 3: late 14th/early 15th century, 4: 15th century.

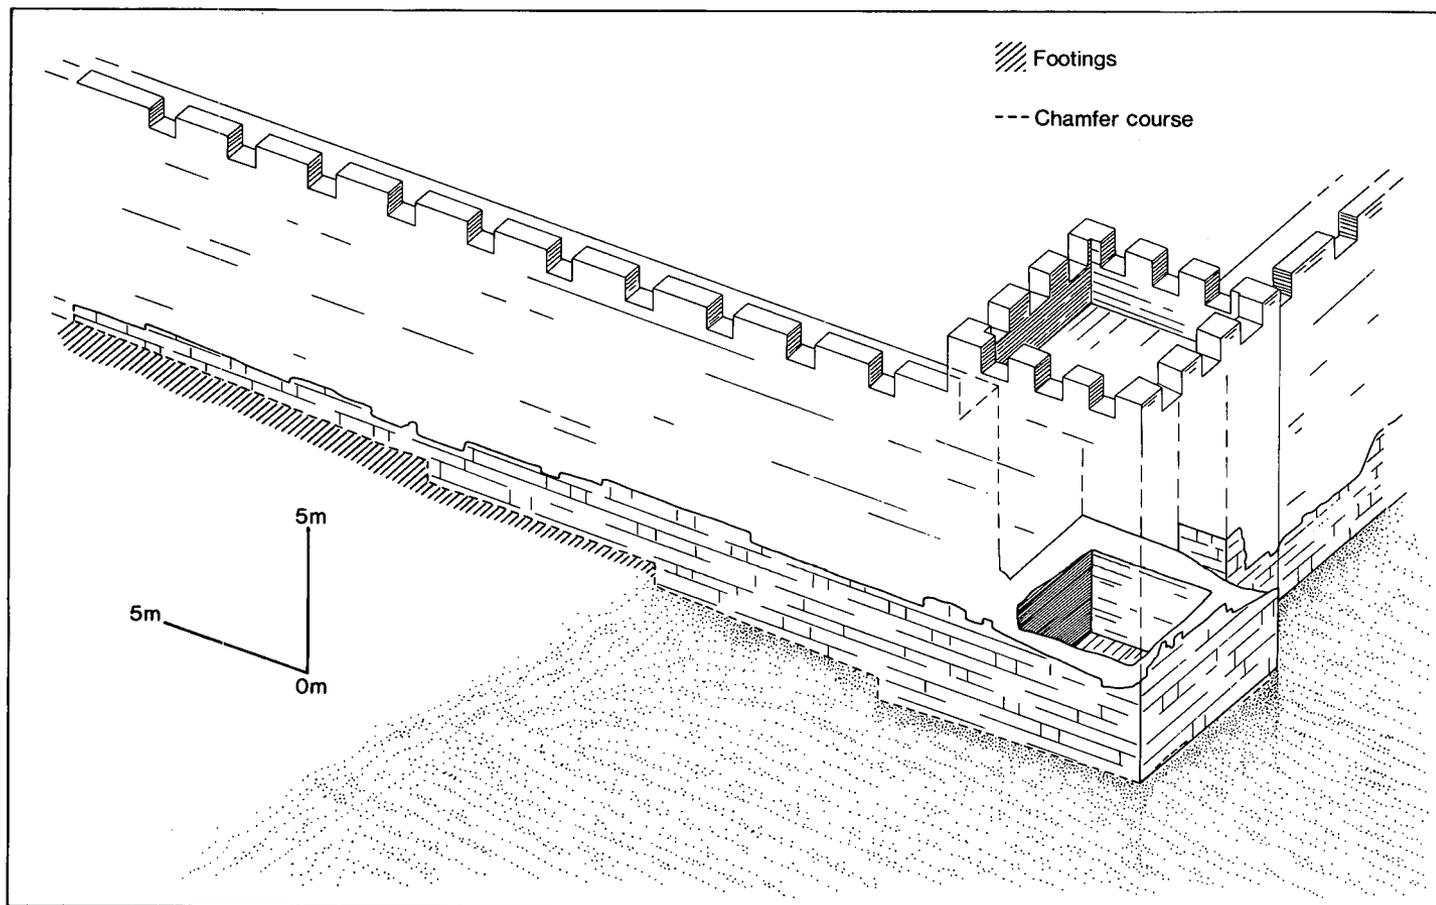
Fig. 29 Axonometric reconstruction drawing of the Town Wall and Tower.

The Riverside Tower is the only tower on the wall circuit which is square in plan (fig. 29).

Given that this tower belongs to a significantly later phase of construction, this plan form is not unusual and must reflect the change in military styles which by the 14th century had moved away from semi-circular towers. At Hartlepool, two types of tower are known to have existed on the circuit and the square towers were interpreted as forming part of a later remodelling of the defences in the late 14th-early 15th century (Daniels 1986, p.71). Other later medieval rectangular towers also occur at Dunstanburgh, Alnwick and Ravensworth Castles.
