Excavation on the Site of the Mansion House, Newcastle, 1990

R. Fraser, C. Jamfrey and J. Vaughan

SUMMARY

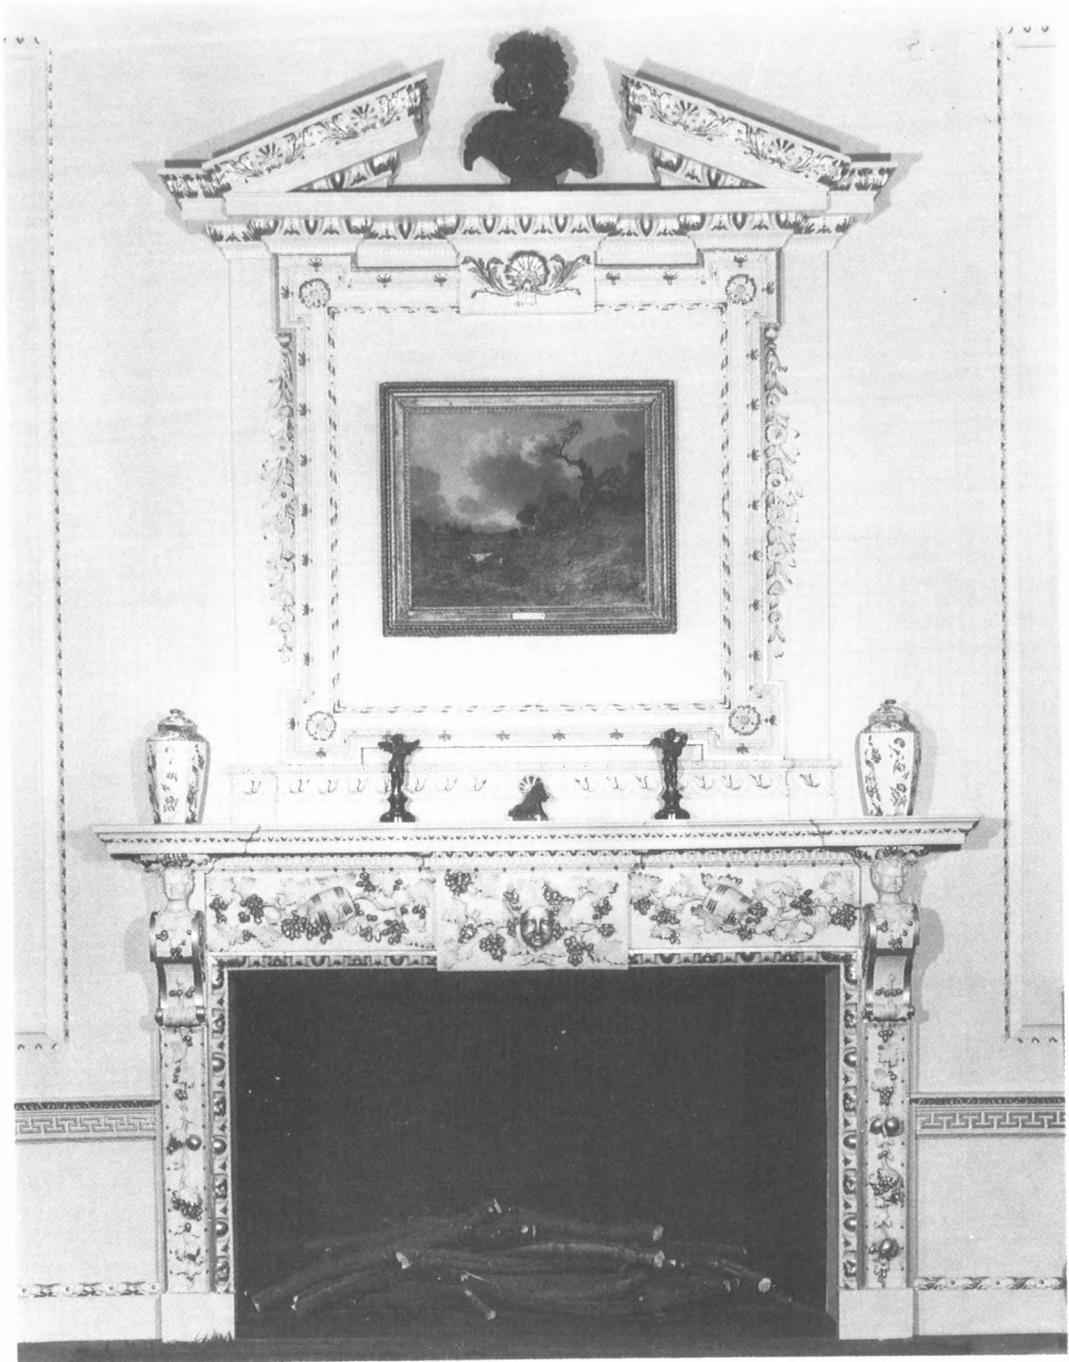
Fig. 4 *Ornate mantelpiece from the Mansion House (© Bowes Museum).*

Castle, Croft, N. Yorkshire, which was demolished in 1950 (Waterson and Meadows 1990, p. 36) and a mantelpiece now at the Bowes Museum (fig. 4) may also have been removed from the Mansion House (pers. comm. S. Medlam), although this cannot be verified.

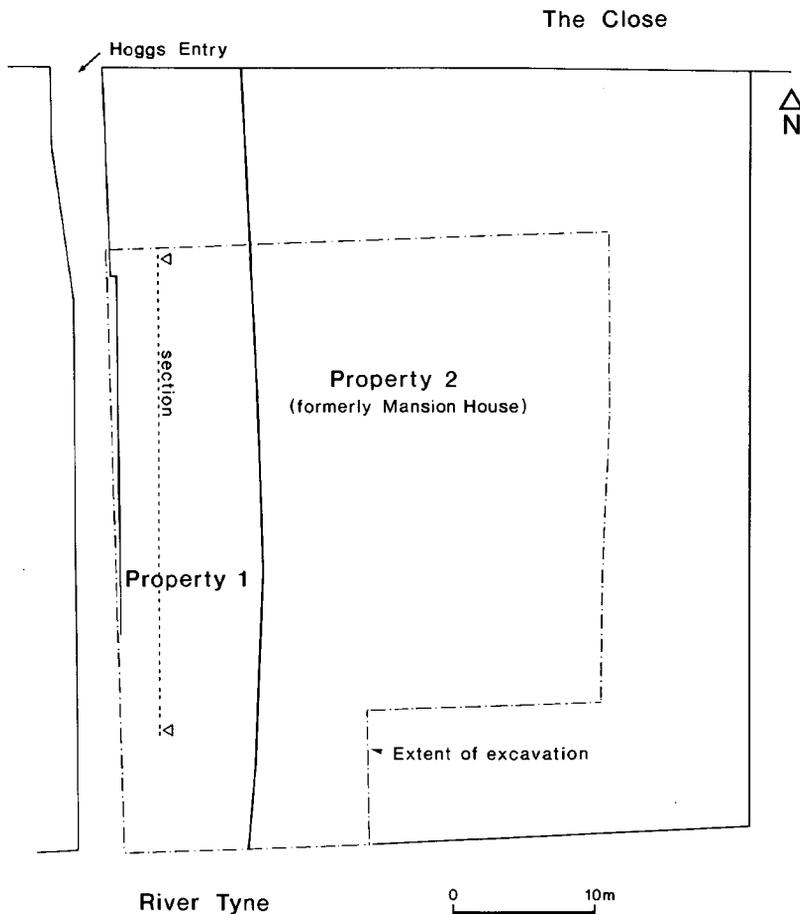
Fig. 6 Area of excavation and location of principal section.

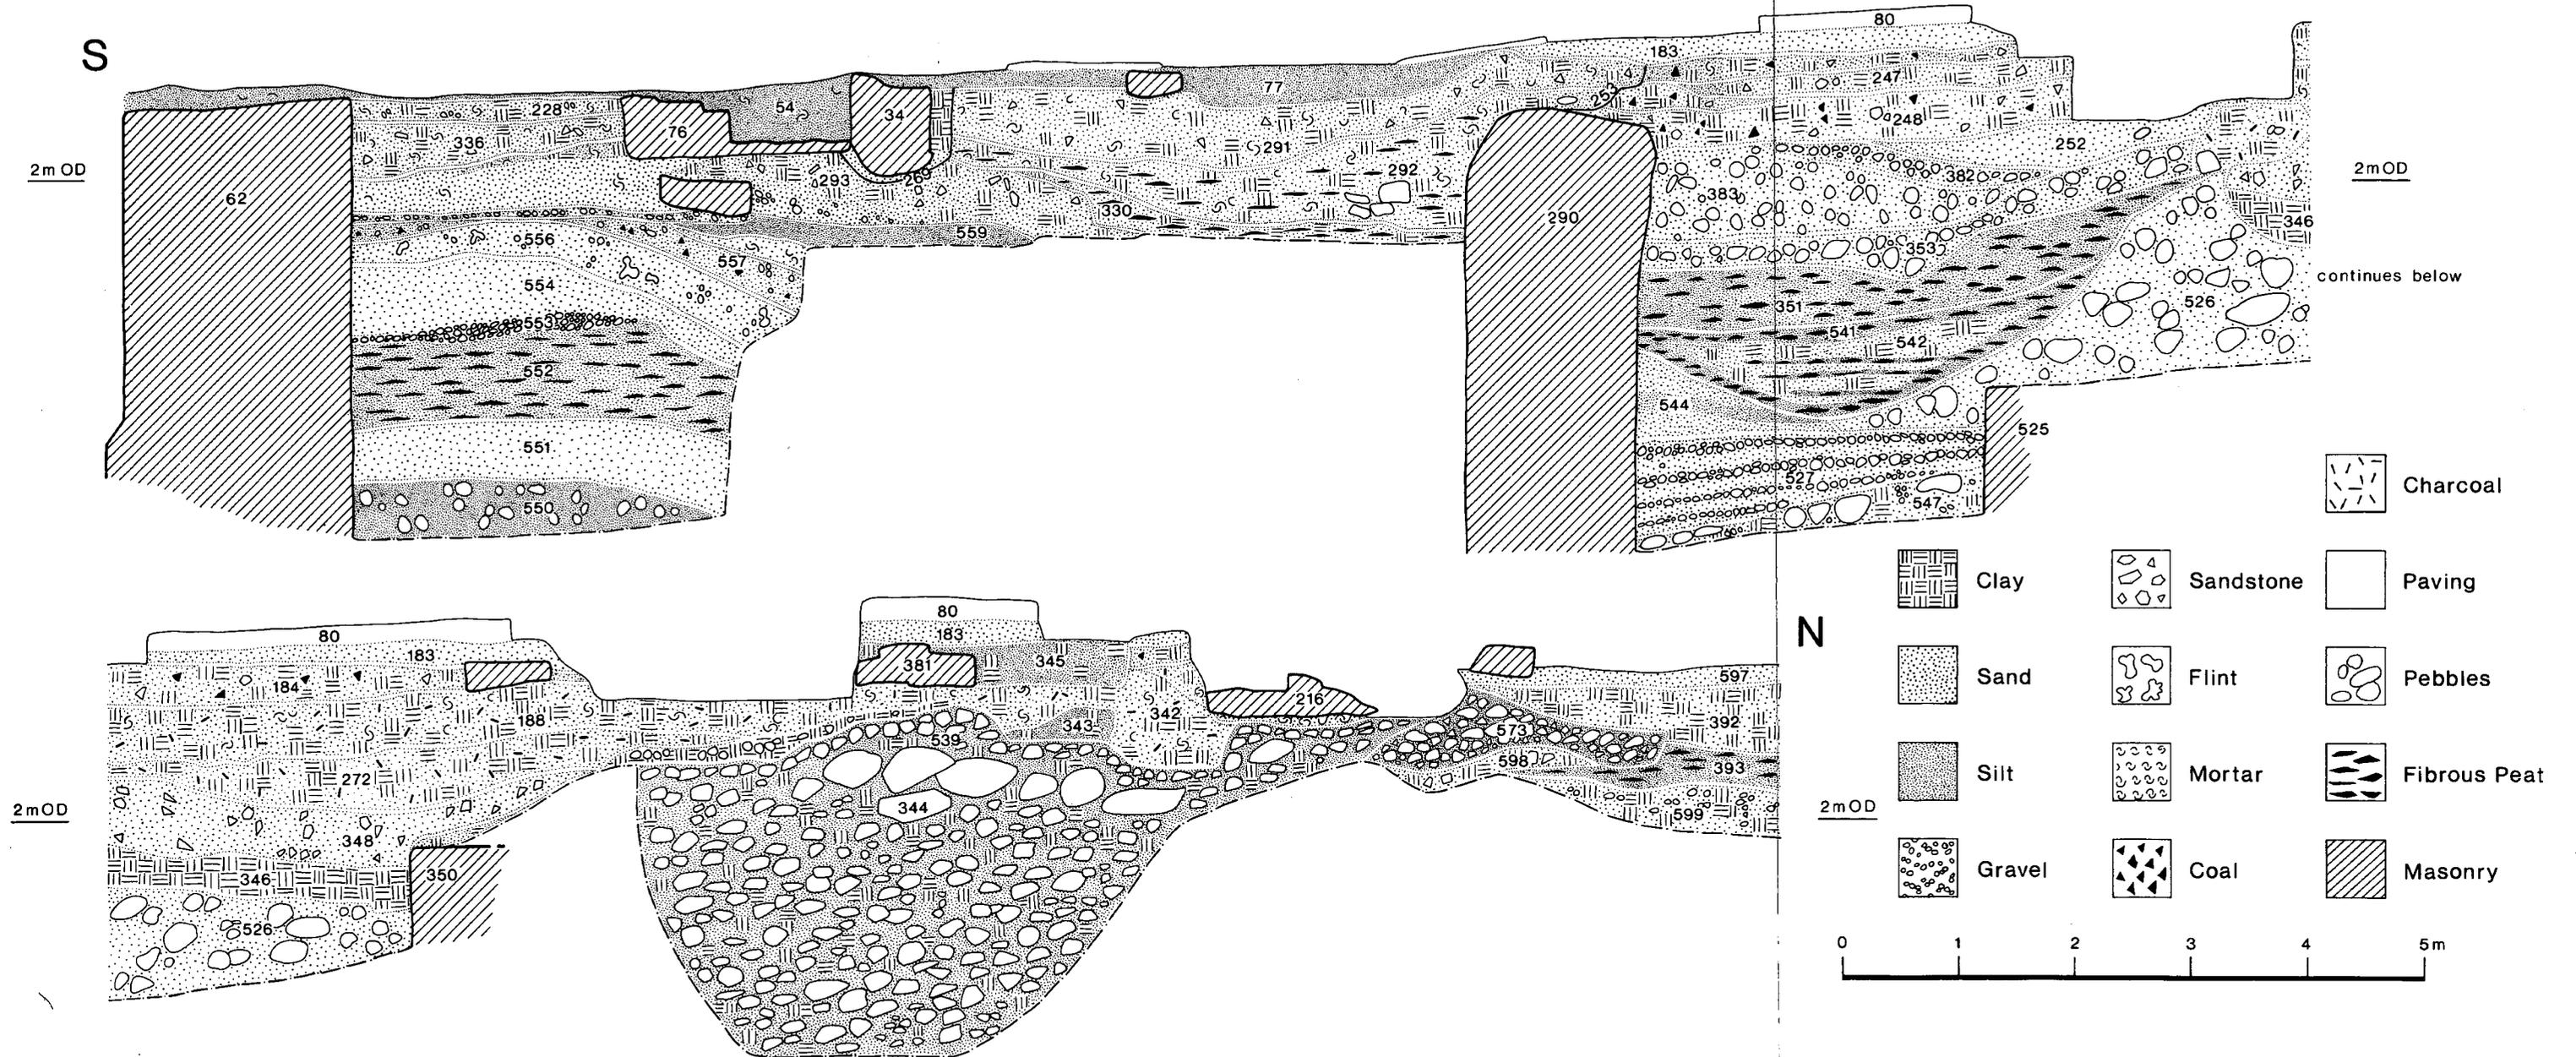
Fig. 7 North-South section through reclamation deposits in property 1.

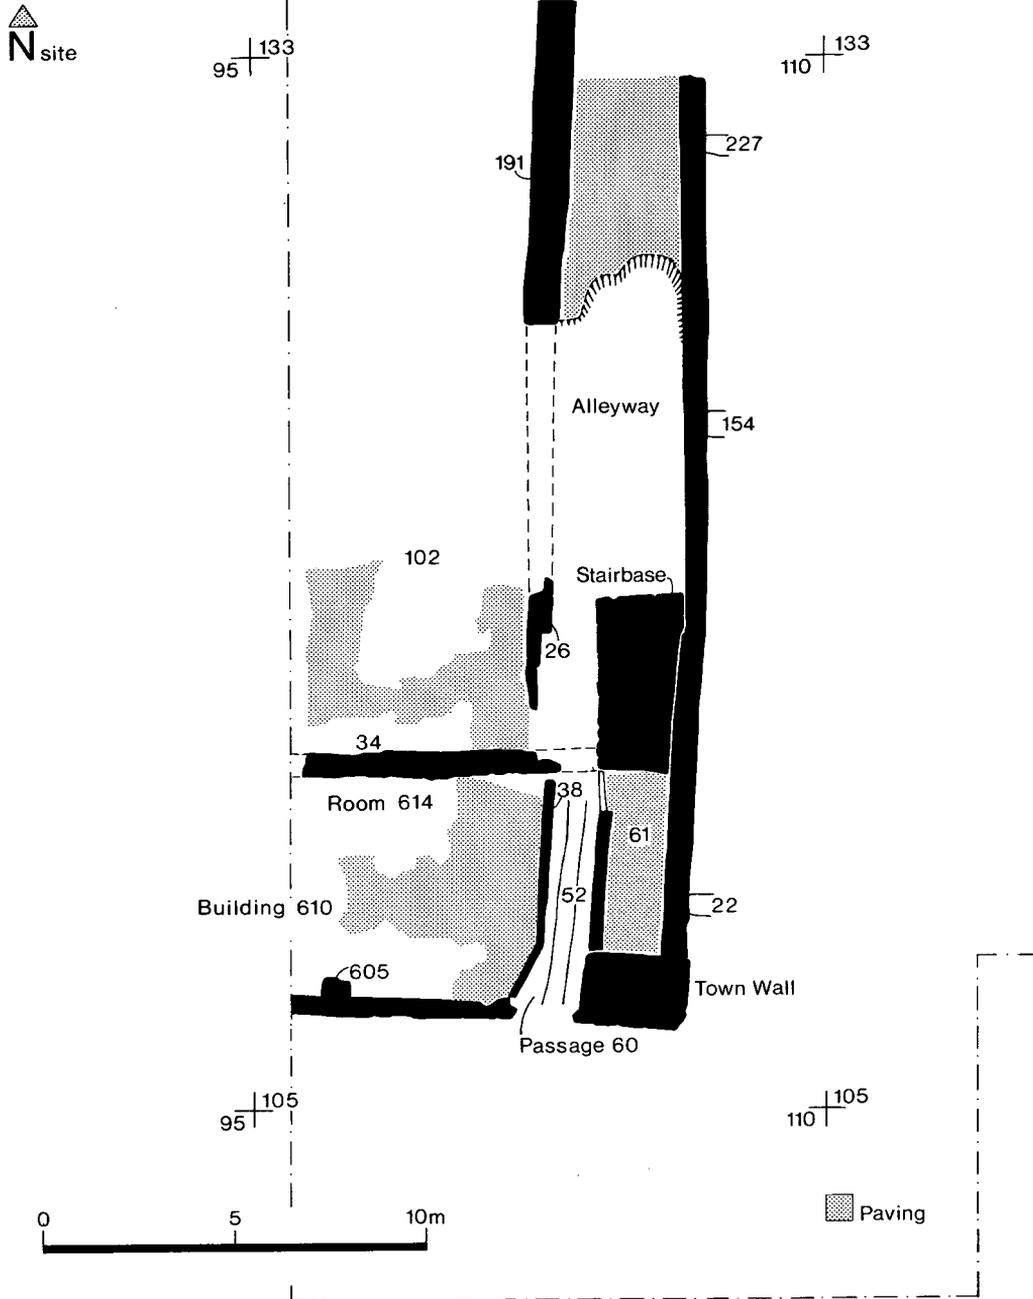
Fig. 8 Structures on property 1 in period 9.

Following the demolition of the town wall, a building (604) was erected over the town wall at the south end of the property (fig. 8). This structure measured 7 m wide and over 10 m long. It was truncated on the west by a later wall foundation and it abutted building 39 to the east. The south wall (605) was constructed on the southern edge of the town wall and as a result the building directly abutted the river. The building was divided into two rooms on the ground floor by a passage which ran north–south. Its elevation is recorded in the 1745 Buck engraving.

Room 614 was located on the west side of the passageway (60) and measured 6 m long and over 5.4 m wide. It was truncated on the west side by a later wall foundation, and the remainder of the walls survived only at floor level. The north and south walls (34 and 605 respectively) were constructed of sandstone, while the east wall (38) consisted of a thin brick partition two bricks wide. The room had a flagged floor which survived partially intact and which extended over the top of the demolished town wall. Part of the floor sealed a cesspit which had a wattle lining and contained early 18th century bottles, clay-pipe and pottery. To the east of the cesspit the floor was cut by a later brick-lined pit which abutted the south face of wall 34.

To the east of the passageway was a room (61) with a stone flagged floor which measured 5.86 m long and 1.56 m wide. At the south end it incorporated the only upstanding section of the town wall to survive the demolition. The east wall was constructed of sandstone and had been largely built as part of building 39 to the east. The west wall had a stone foundation and a brick superstructure which incorporated a blocked doorway at the north end. The north wall of the room was constructed in sandstone and had been remodelled to incorporate an adjoining stairbase on the north side.

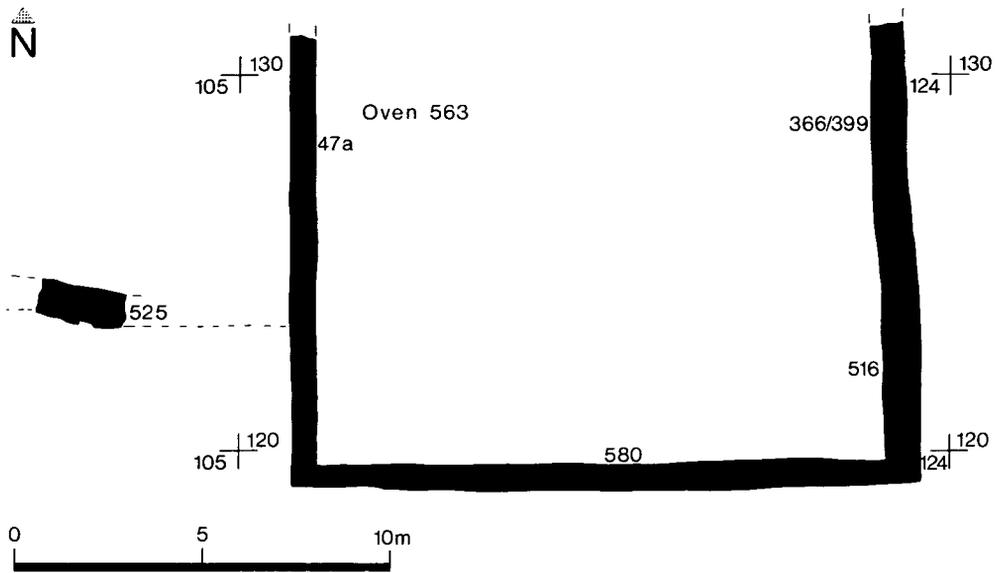
Fig. 9 Extent of property 2 in periods 2 and 3.

Both the eastern and western walls of the property appeared to have been constructed in a series of stages southwards towards the river (fig. 9). These different builds appeared to reflect a number of phases in the reclamation of the property from the river. The northern end of the later "dock" wall, comprising elements 366 and 399, appeared to be part of an early arrangement of the property where the

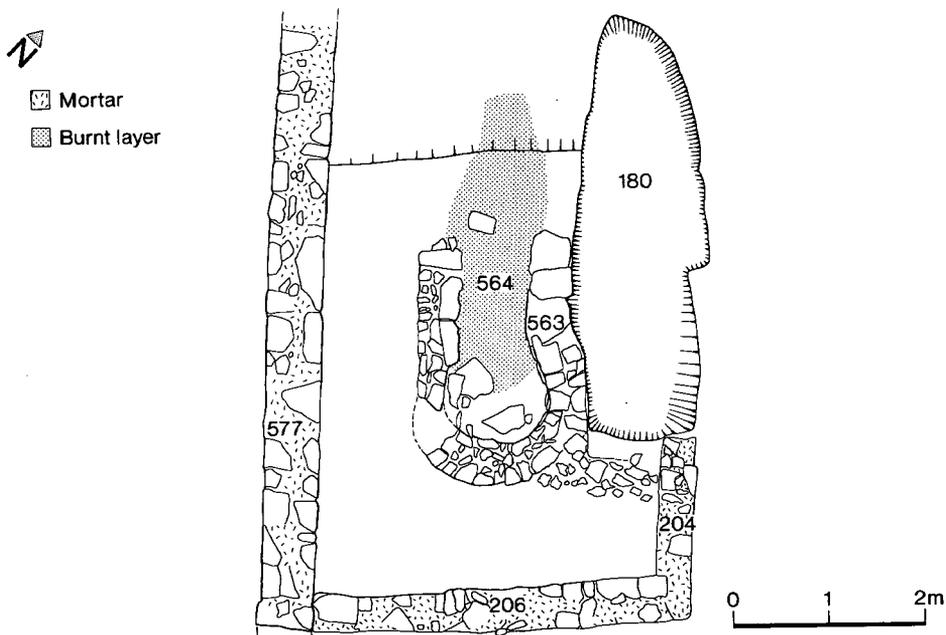
Fig. 10 Detail of oven 563 on property 2 in period 2.

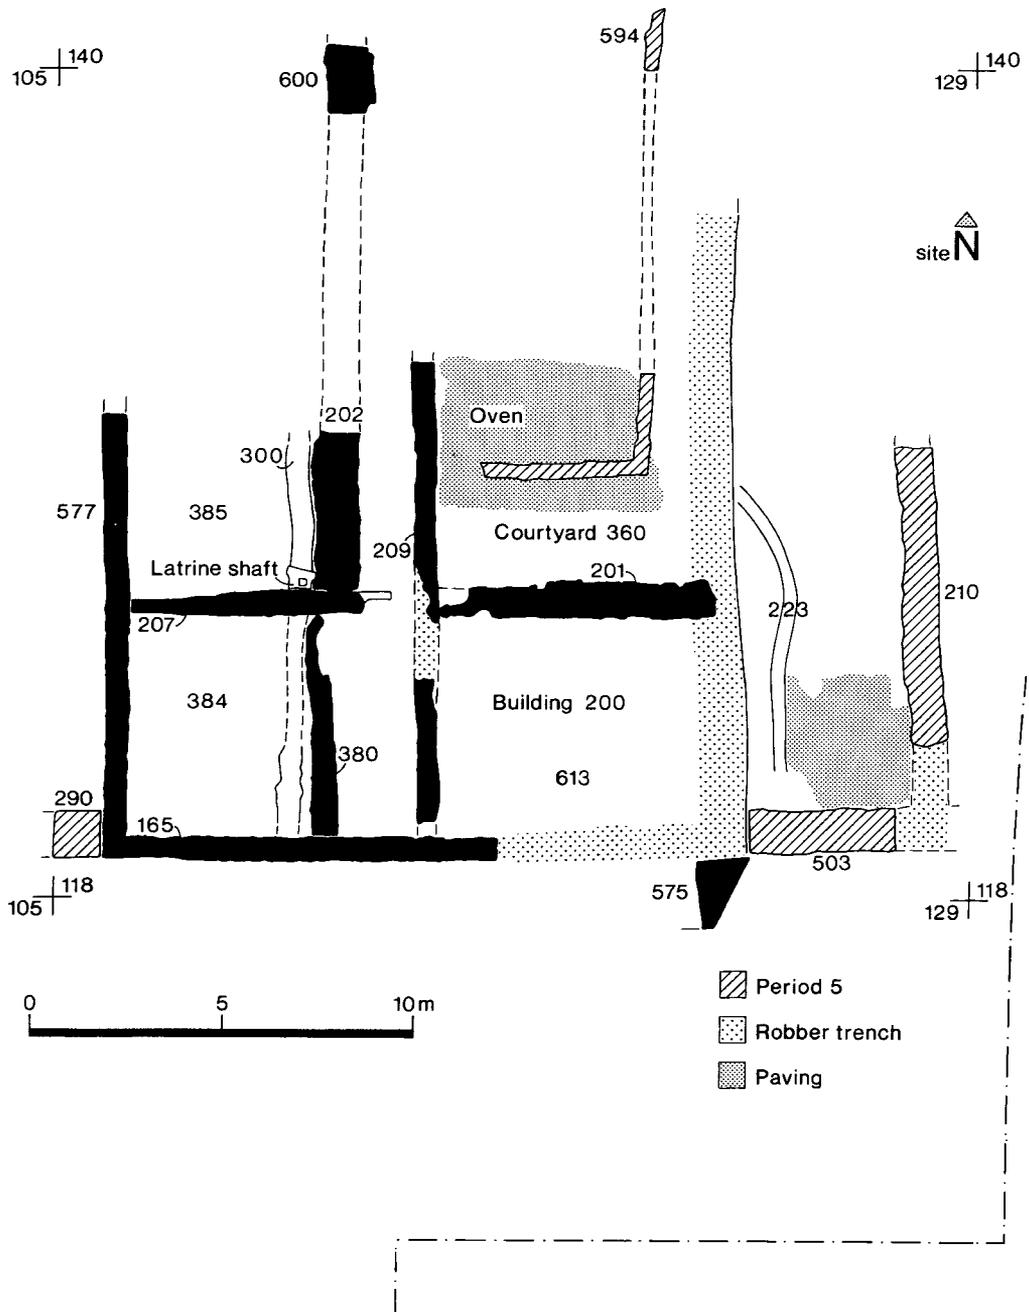
Fig. 11 Structures on property 2 in periods 4 and 5.

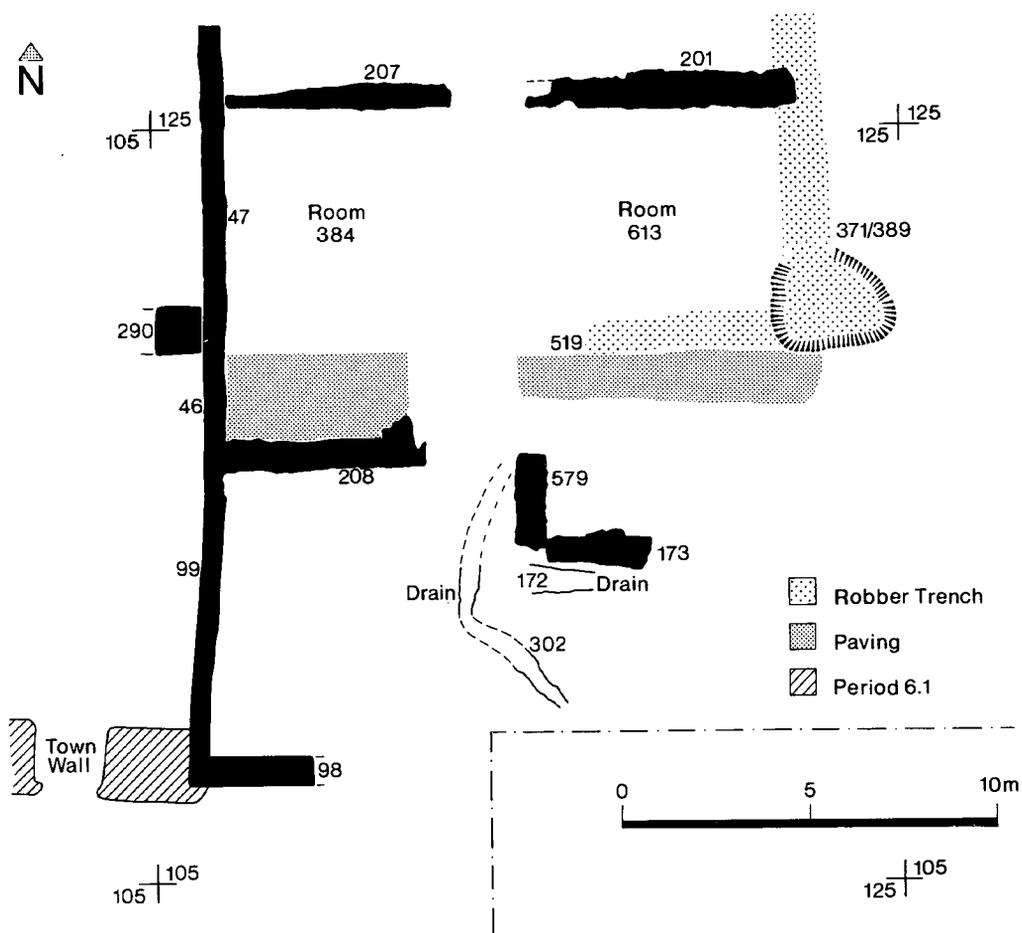
Fig. 12 Structures on property 2 in period 6.

The wall incorporated a postern gate or watergate at the east end with a culvert set 0.5 m below it. The watergate closely resembled the postern visible in the Bath Lane section of the Town Wall (Nolan et al. 1989 p. 55). The aperture was closed by a doorway which shut against chamfered stops on the riverward side. The postern was splayed towards the landward side. The eastern end terminated in a chamfered corner, the wall being bonded into the angle with walls 98 and 99 (fig. 12).

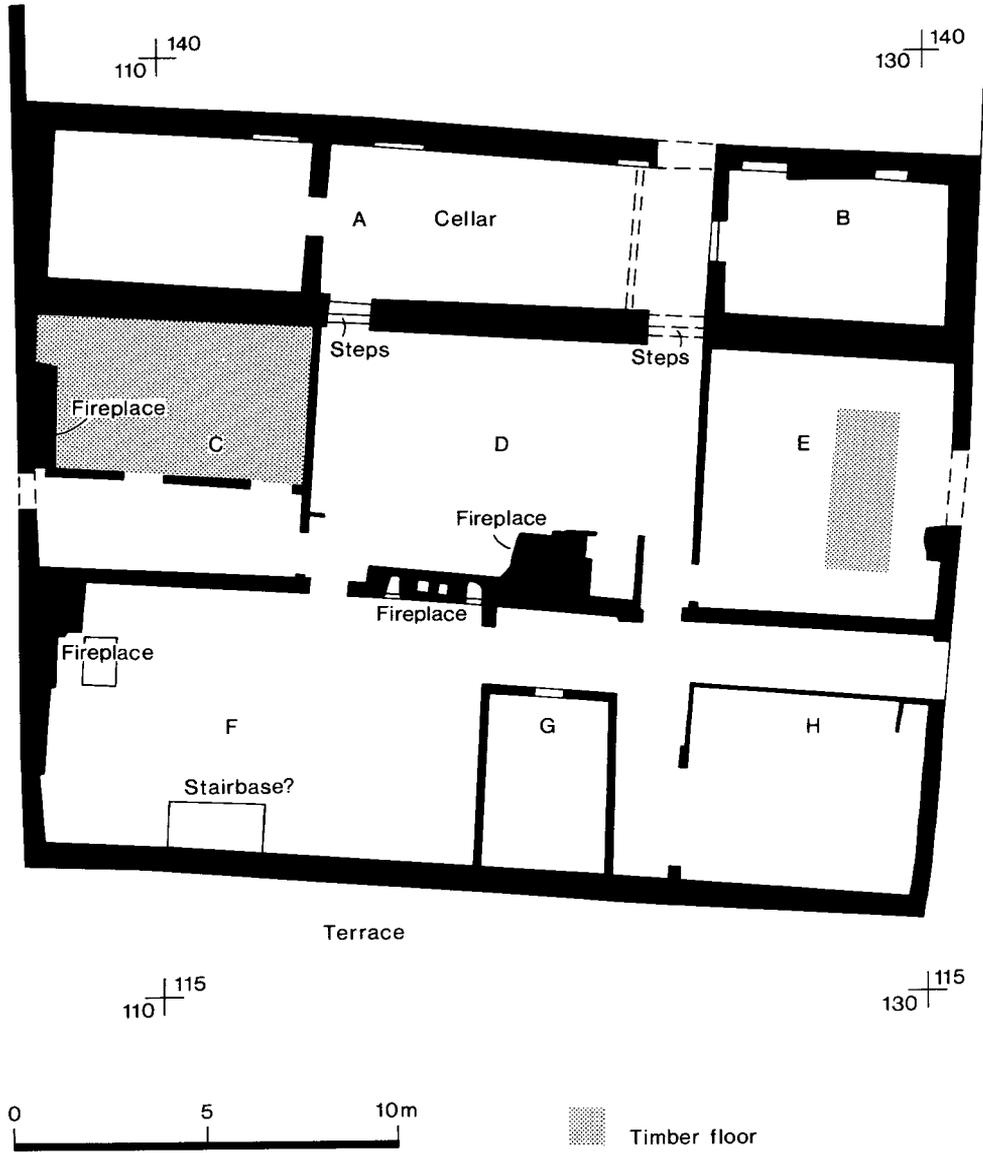
Fig. 14 The Mansion House, period 9.

Room E measured 6.28 m long and 6.87 m wide. The floor was predominantly of flagstones but in the centre of the room they were missing or removed and replaced with timber joists, although there was no evidence for planking surviving above. There was evidence for a possible fireplace against the east wall and of a blocked doorway at the west end of the south wall.

Room F was the largest on the ground floor. It measured 11.3 m long and 7.0 m wide and had a flagstone floor. It was connected through a doorway in its north wall to room D and in its east wall to room G. There was evidence of a fireplace in the north-west corner of the room against wall 4, with some indication of the position of the grate and the dog-irons preserved in the floor. Against the south wall 5, a small rectangular area was unflagged and this

may have been a stairbase. In the northeast corner, set in the south face of wall 109, were a series of grates and stokeholes, which were presumably for heating water.

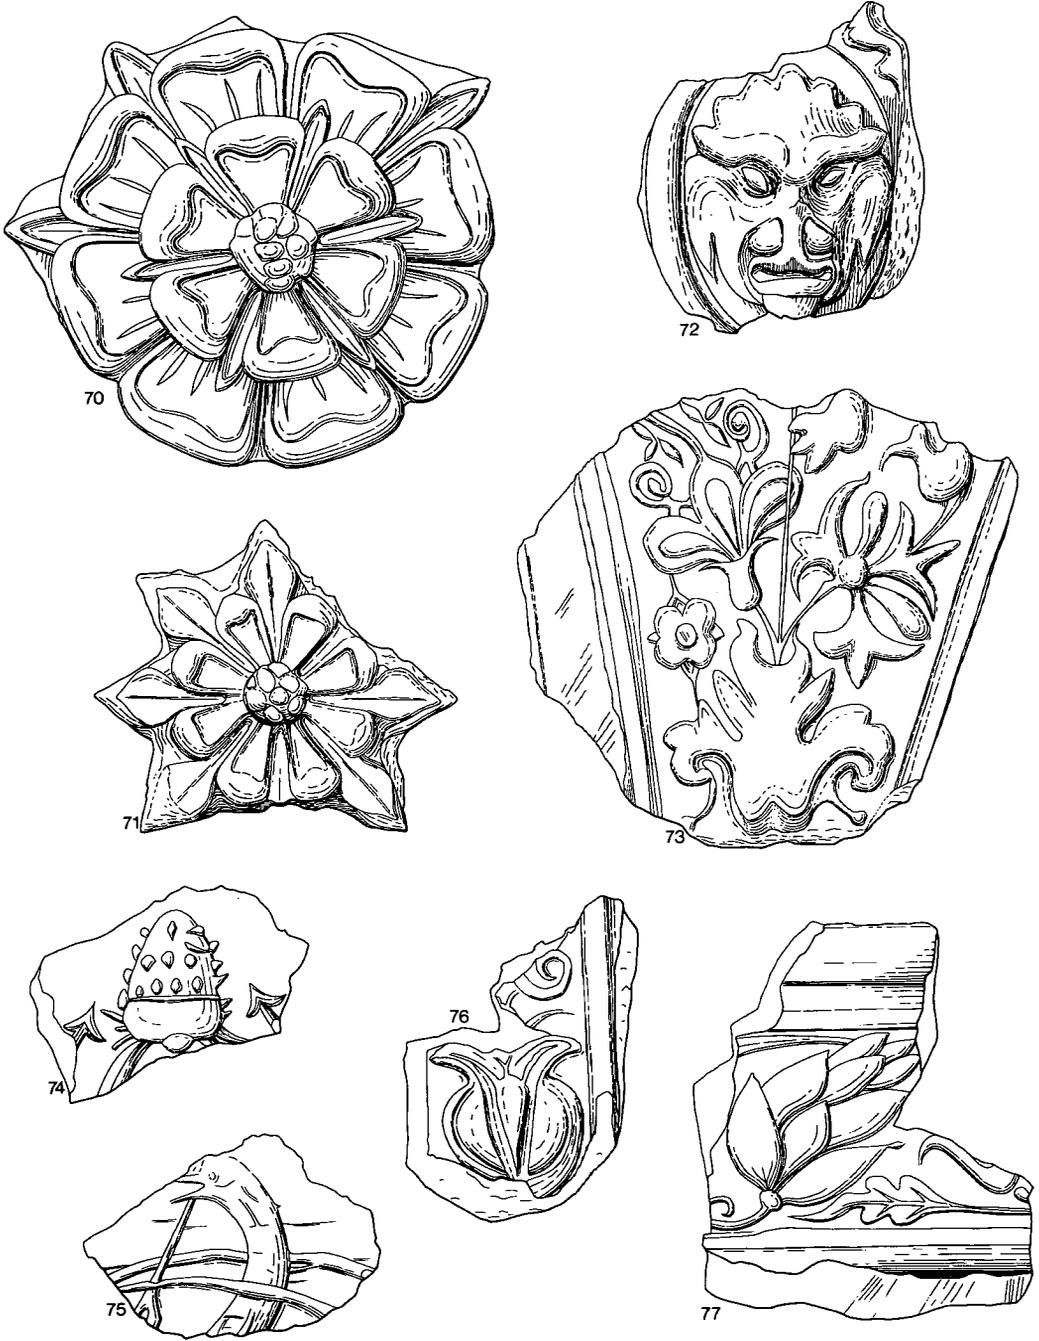
Fig. 21 Moulded plaster: nos 70-77 (1/4 scale).

- 70 Large Tudor rose, 6 inner petals, 8 outer petals. Very similar to a rose set in the centre of 4 palmettes within the ceiling of the Mayor's Parlour in the Guildhall. Similar to rose used in spaces between rib-work infill, Bessie Surtees. The Bessie Surtees example lacks the outer "leaves". 8 fragments.
- 71 Tudor rose, 8 inner petals, 8 outer petals.
- 72 Mask, simple moulding on left side.

- 73 Base of palmette shaped? decorative panel. Flowers and foliage around central stem. 11 fragments.
- 74 Exotic? fruit.
- 75 Bird head between 2 tendrils with foliage strand in its beak. This motif appears in full as part of a bird and foliage frieze in the recesses between the beam soffits of a ceiling in 28–30 The Close.

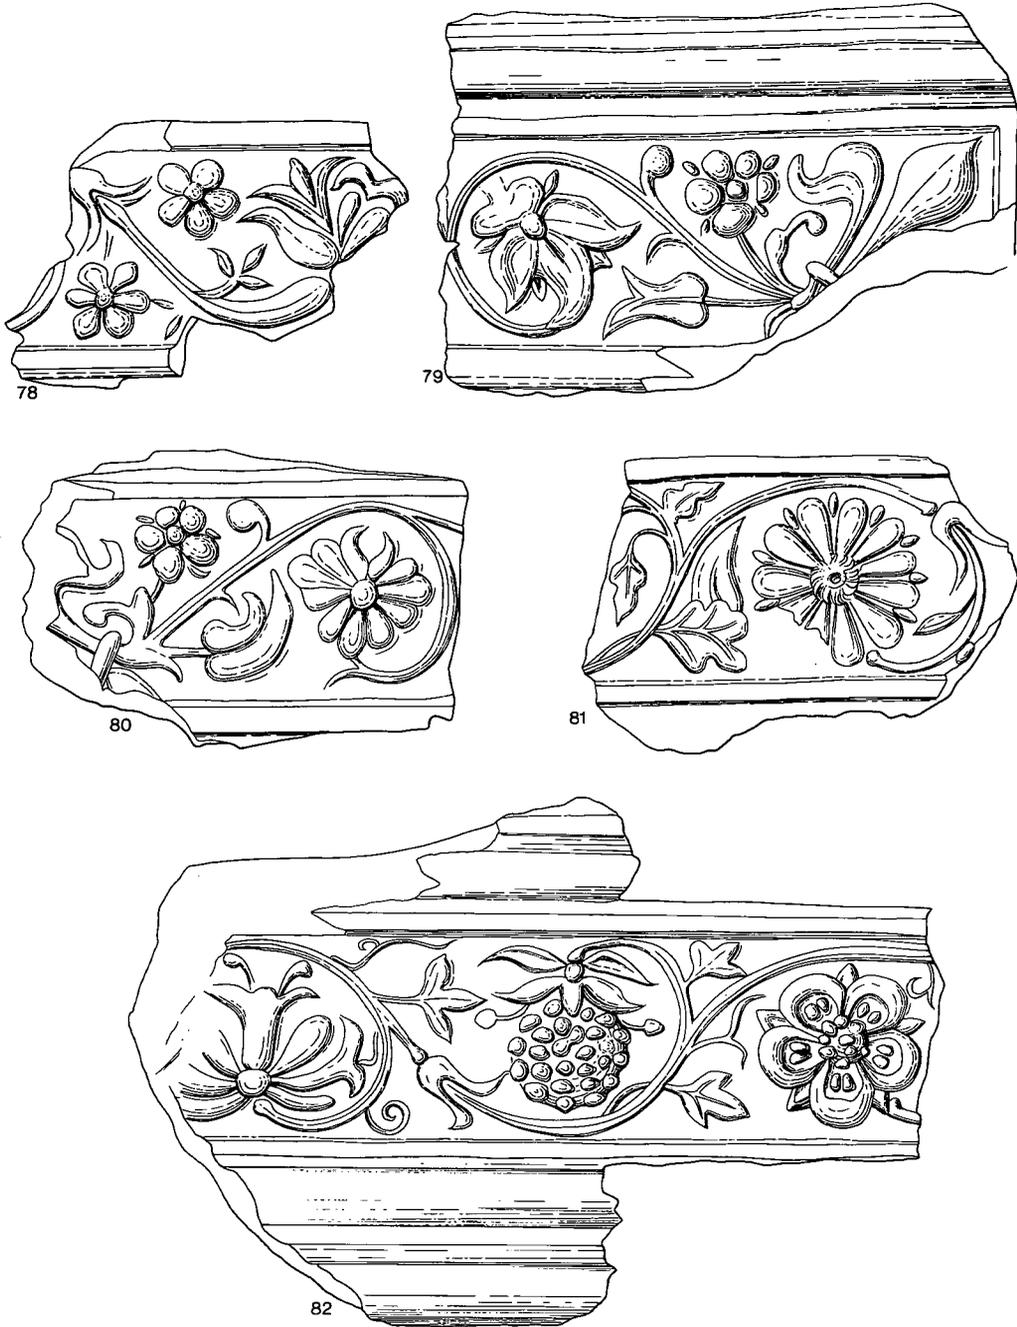
Fig. 22 Moulded plaster: nos 78-82 ($\frac{1}{4}$ scale).

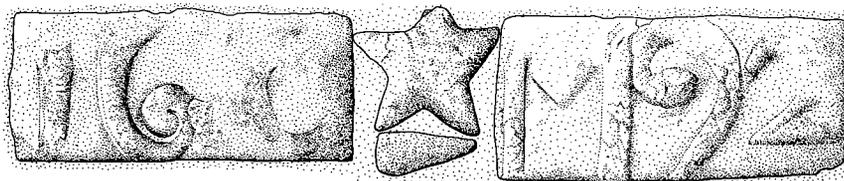
Fig. 24 Moulded brick plaque.

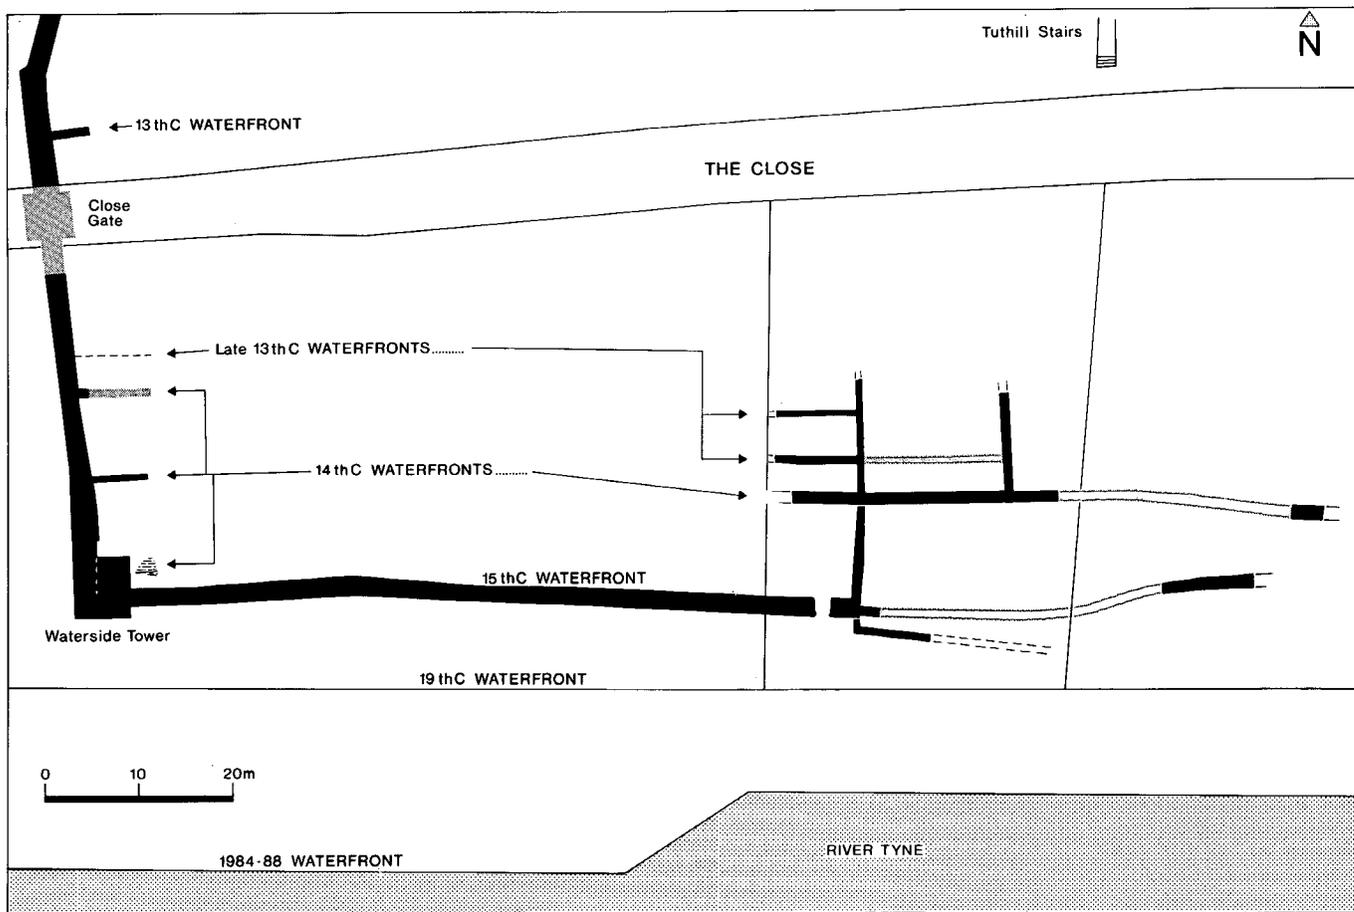
Fig. 26 Waterfronts identified during excavation on The Close.

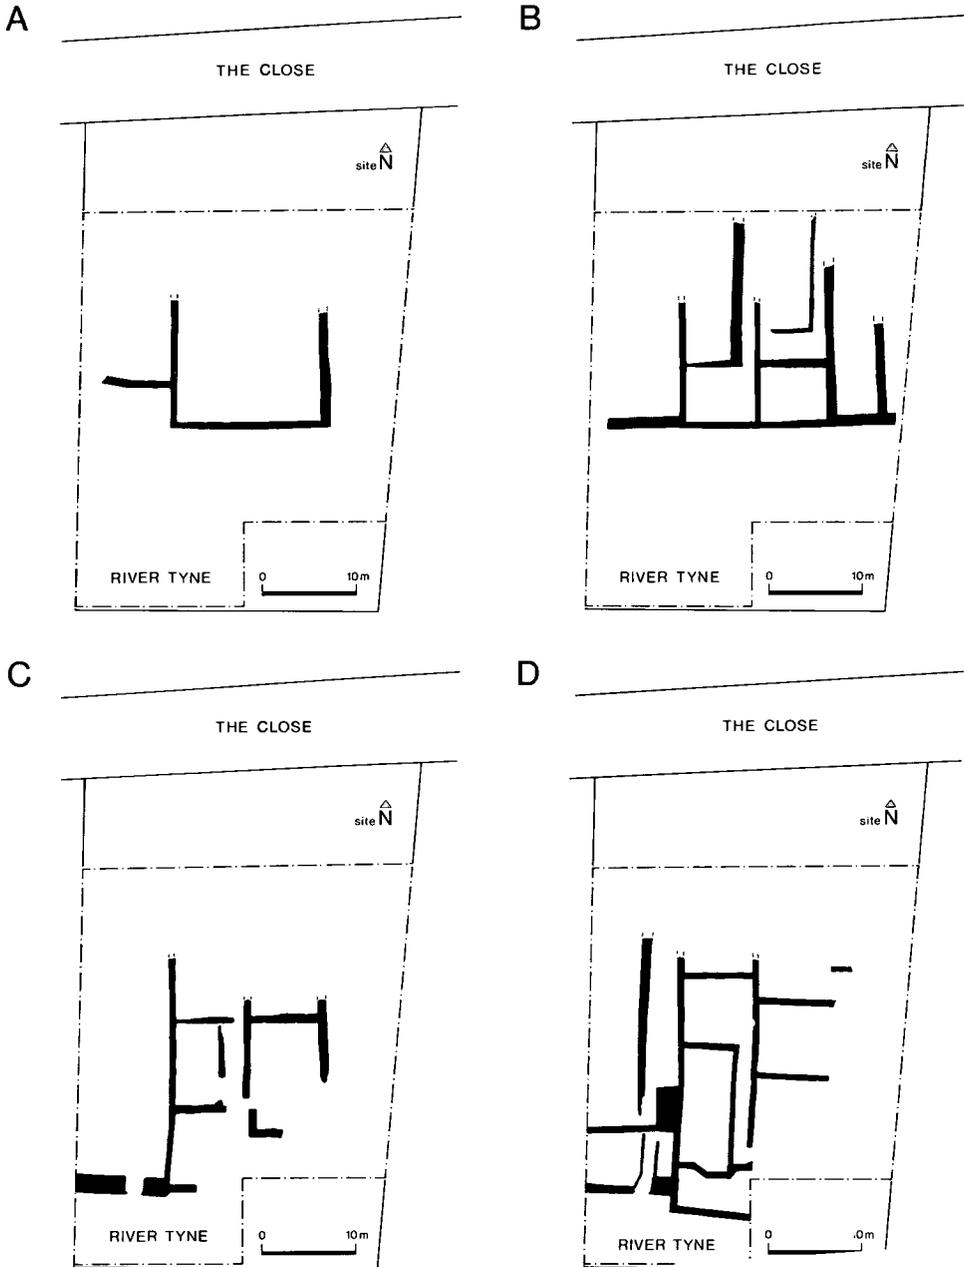
*Fig. 27 Building development on property 2.
(A—13th century; B—14th century; C—15th century; D—17th century).*

Following a further 11.5 m advance of the waterfront in the early 15th century the western and southern ranges were extended further south, although they no longer abutted the river (C). There is also circumstantial evidence that at this time the east range either collapsed or was demolished. These buildings then remained intact until the site was redeveloped in the early 17th century (D).

The redevelopment of the buildings on property 2 in the early 17th century appears again to be linked to a revision of the waterfront. The buildings consisted of an eastern, southern and western range set back from the waterfront, although only the west range utilized foundations from buildings in the earlier period. This latter range was bay-fronted and evidence from the demolition of the site suggests that both this building and the south range may have been used for domestic occupation since large quantities of decorative moulded plaster were recovered.
