# Excavation of the Town Wall in the Milk Market Newcastle Upon Tyne

*D. H. Heslop, L. Truman and J. E. Vaughan*

### SUMMARY

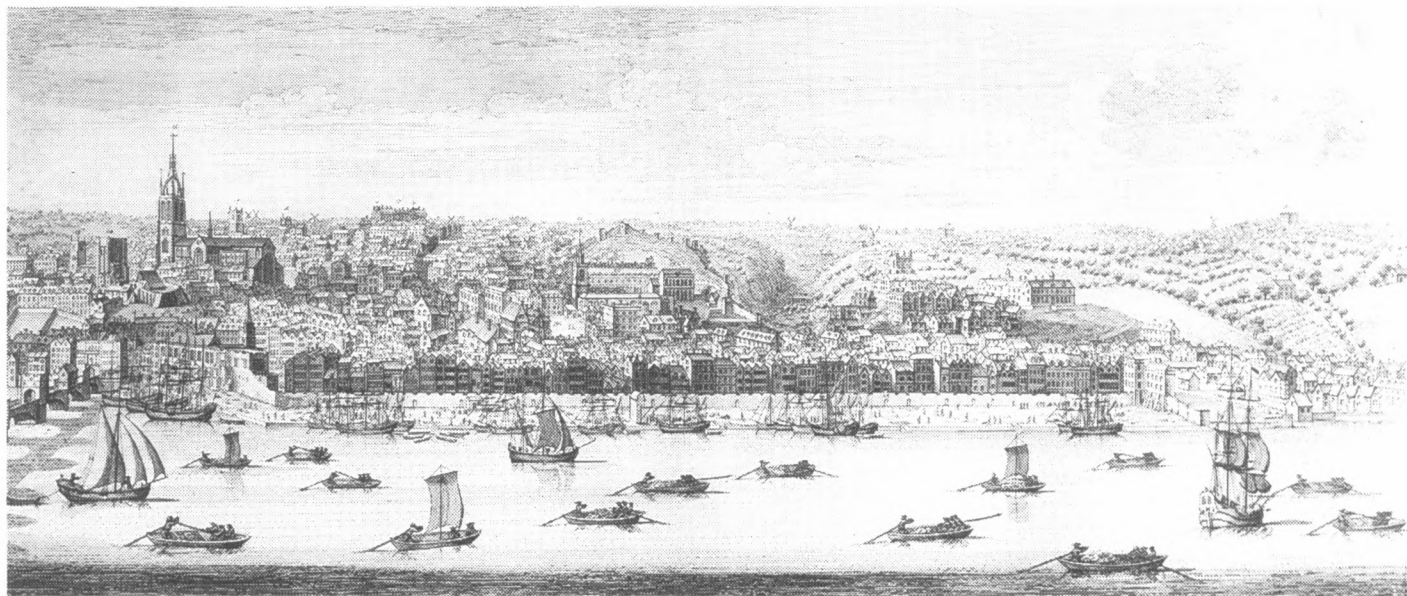
Fig. 3 N. and S. Buck, *Detail from "The South-East Prospect of Newcastle"*, 1745.

The wall is well illustrated in Buck’s “The South-East Prospect of Newcastle” of 1745 (fig. 3). The Quayside stretch is largely unencumbered, but the angle has buildings of four storeys, heavily buttressed on the river side. The length that runs to the river’s edge is

clearly of more than one build, and changes alignment as it approaches the terminal (see below). The butt-end is thicker than the wall width, suggesting a strengthening of the terminal, which may represent an end bastion, the “Sylverles towre” of 1567, repaired without the extra parapet.

There is no direct documentary evidence to help in dating this structure, but the ceramic assemblage would point to a late sixteenth or early seventeenth century date. It is not shown on the Buck view of 1745 (fig. 3).

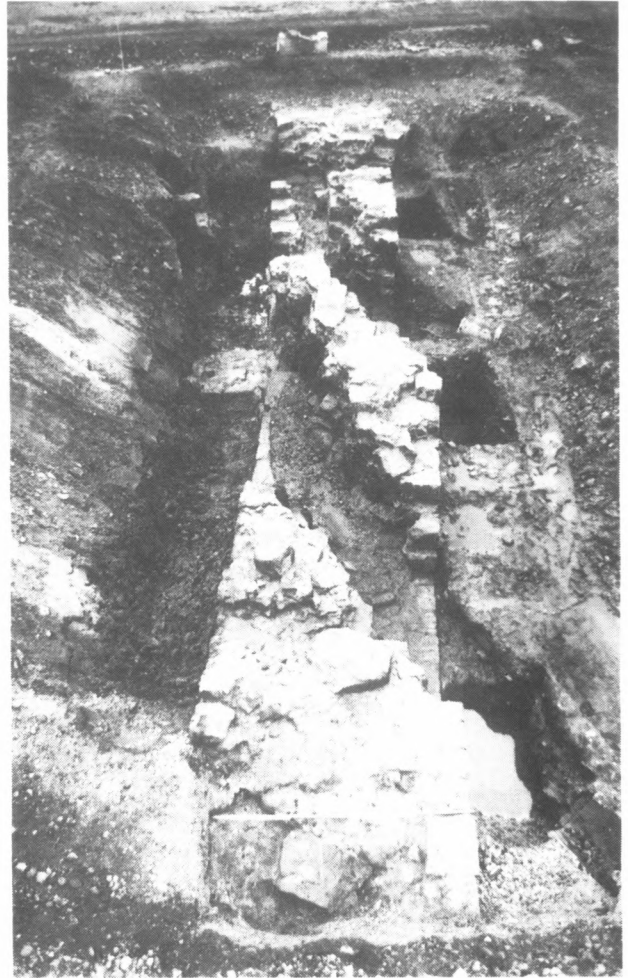
*Fig. 5 Walls 32, 33 and 34 from the north.*

ern end of the eastern stretch of the circuit (fig. 5).

Wall 034 was built against the western face of wall 033 to bring it to the same width as 032. The stonework was of comparable style and quality, and the foundation sequence of three offsets, none chamfered, resembled the outer face of 033. The southern end of this stretch was imperfectly recorded (being at some dis-

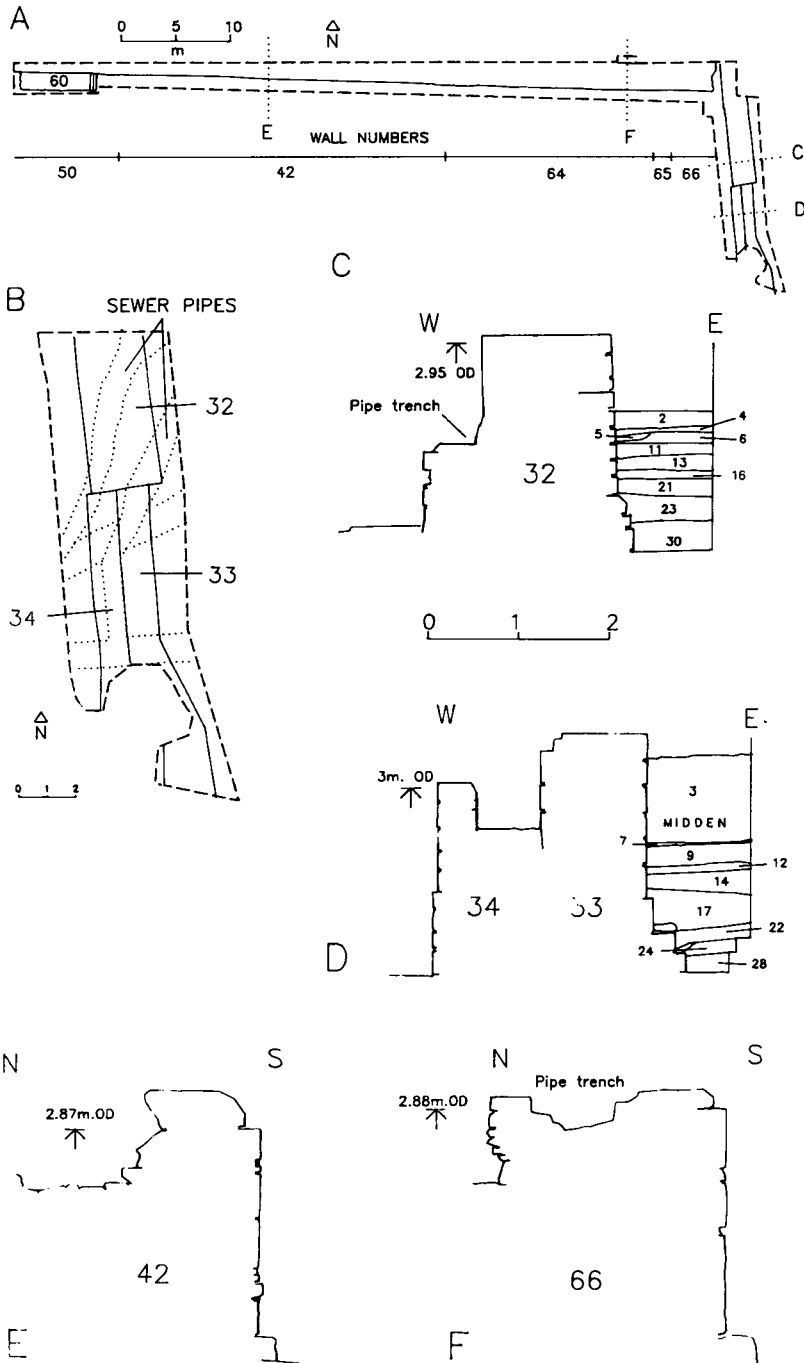
Fig. 6 The Town Wall:

- a) Plan of trenches with principal features.
- b) Walls 32, 33 and 34, with pipe trenches.
- c) Section, Wall 32

- d) Section, Walls 33 and 34
- e) Section, Wall 42
- f) Section, Wall 64.

The plan of the surviving stretch, (fig. 6, B) shows the extent of nineteenth and twentieth century damage when sewerage and drainage outlets were knocked through the masonry to debouch into the Tyne. This concentration of outfalls represents the direct line for the services running from the upper town (e.g. along Tower and Argyll Streets) down Milk Market bank to the river.

The upstanding facework was of good quality ashlar sandstone, in regular courses of differing thicknesses. A maximum of twelve courses were observed where the foundations were exposed (fig. 6, Section C). The wall was 2.40 m wide with no perceptible batter above the foundation courses. On the outer (eastern) face the foundations consisted of a well crafted chamfered course above two slightly offset undressed courses. As elsewhere on the town wall, the inner (western) face lacked the chamfer, having three slight offsets at the same level.

The layer immediately above the foundation raft was clay (Layer 23—fig. 6, C) its surface roughly corresponding to the height of the 3rd offset of wall 032. Large cobbles and sandstone fragments had been incorporated into the surface of the clay and may have stabilized the ground, perhaps serving as part of a beaching surface. Above this, a gritty sand (21) had been deposited, and was cut on the east side of the trench by a sub-rectangular feature with a depth of 23 cm. Its fill of decayed wood and irregular stone fragments is perhaps indicative of a post and its packing stones. It is possible that this feature supported a mooring post or some other structure associated with the riverside. The six overlying layers (16, 13, 11, 6, 5, 4) represent continuing riverine deposition, and consist of sands containing interleaved lenses of material. Organic material was present, including a large piece of drift wood in 11. All of these deposits slope downwards towards the river. At the top of the sequence a cobbled surface (4) was uncovered and appears to have compensated for the gentle incline of the underlying sediments. It would, therefore, have provided a stable surface on which riverside activities could have been carried out.

A trench was excavated 3 m to the south of the above, and while the deposit sequence (fig. 6, D) was similar it was by no means identical, the principal difference being that the upper layer (3) contained material derived from the Sandgate midden. It formed a homogeneous band 70 cm thick, but appears to have been disturbed, having been redeposited when the nineteenth century sewers were constructed, and containing material of that date. It was dark grey in colour, and of a mixed composition, containing fragments of charcoal, shell and coal, as well as stones and cobbles.

The overall width was established at one point where the concrete surround of the interceptor sewer had not spread onto the wall (fig. 6, F). The northern face of walling was not faced at this height because the ground level on the inner side of the wall would have been several feet above the foundation chamfer on the riverside (fig. 9).

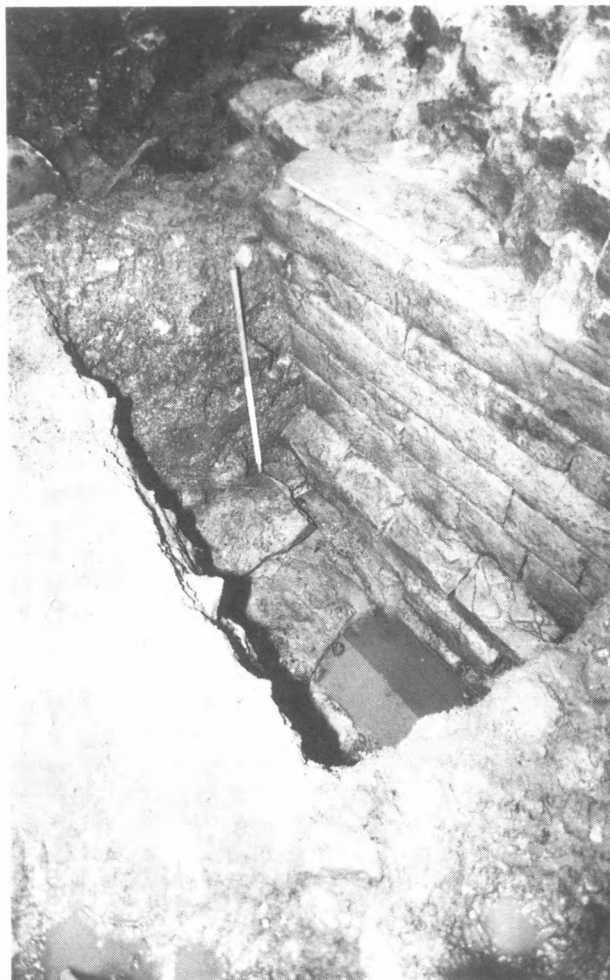
Fig. 7 Foundation raft and wall footings, Wall 32.

sandstone blocks cemented together with mortar which had become stained yellow with age. The arrangement of the stones implies that care was taken to produce an even surface, though a gentle slope down to the river's edge was perceptible. The full width of the raft could not be resolved in the area available for excavation; it extended at least 2 m on either side of the wall for an unknown depth.

The wall (fig. 7) was constructed on a foundation raft consisting of angular and rounded

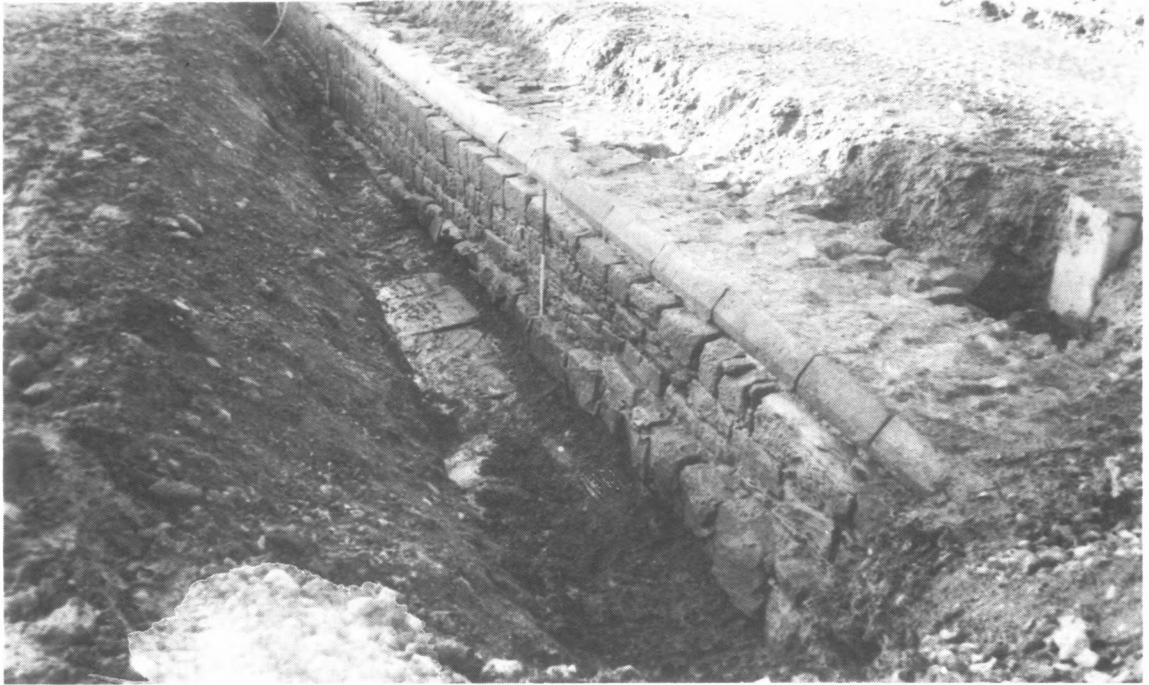
Fig. 8 *The Quayside wall, central section.*

The wall (fig. 8) was found to consist of one main phase, in which could be distinguished five clear breaks in the coursing or foundation treatment, but all beneath a continuous and, as far as can be distinguished, single phase chamfer course. These changes perhaps represent halts that took place during construction, or they may show that the riverside stretch was divided into sections, each worked on by a different gang. Stepping in the coursing, where extant (64/66) suggests that the wall progressed from west to east, but this may not reflect the situation elsewhere along the riverside wall, and the coursing breaks on either side of 65 might hint that 66 predated, or was contemporary with, 65.

The foundations were broadly consistent along the length, differences only being noted in the extent of the offset of the bottom course, which varied from over 25 cm (91) to less than 10 cm (42). The upper courses of the masonry were dressed with coarse pecking in diagonal lines, while much of the lower walling, and

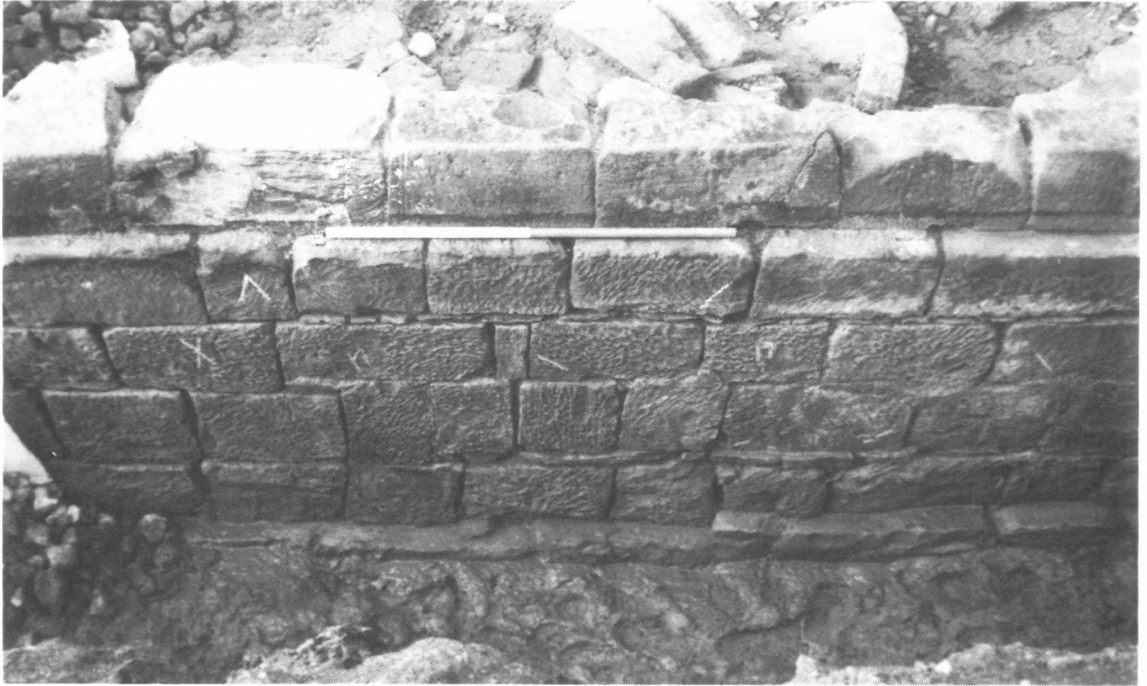
Fig. 10 Wall 42, showing masons' marks.

Masons' marks were frequent along this length, usually consisting of groups of two or three marks on adjacent blocks (fig. 10). Their location did not tally with the changes in build phases, but they do seem to reflect a numerical sequence or system of some kind, and may

perform the function usually suggested for such marks, to identify the work of individual masons, journeymen or labourers for the information of the paymaster (Salzman 1952, 129).

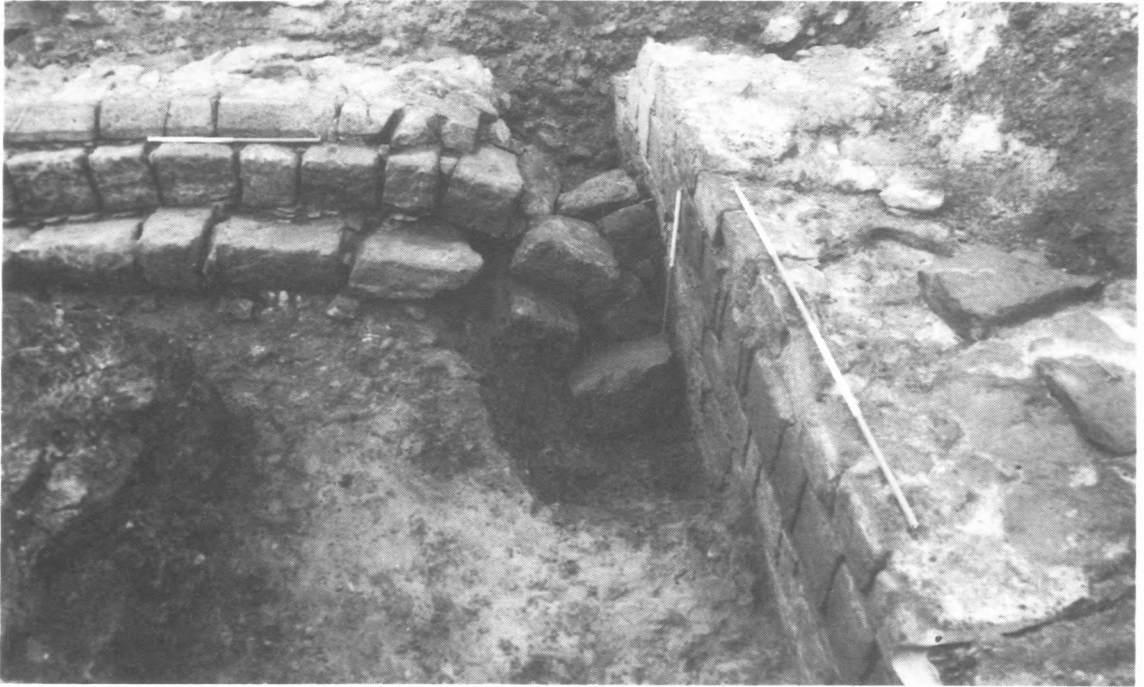
Fig. 12 The junction of the north-south stretch (Wall 32) and the riverside stretch (Wall 66) showing the collapse resulting from the modern pit.

in the angle of the junction were cut by a large pit which had undermined the wall and caused the collapse seen in Fig. 12. The inescapable conclusion is that this must have been dug on the instruction of Knowles to examine the relationship of the foundation of the walls at the junction. The trenches dug in the 1992 excavation were backfilled with aggregate and the wall was covered with a protective membrane before careful backfilling.

The junction between the eastern and southern walls was exposed during the last major phase of road engineering, in 1905, and recorded in *PSAN* of that year by W. H. Knowles (*PSAN* 3, II, 62–3). The work involved lowering the road way by 10 feet, which revealed seven courses of north–south wall upstanding for a length of 56 feet (18 m), and approximately 10 feet (3.1 m) of the riverside stretch. These are drawn in elevation, and the north–south wall is shown in section. Individual blocks are recorded and offsets noted. The only other architectural features shown is a triangular niche or wall cupboard in the inner face of the riverside length. The walling is shown to be well preserved, and the junction shows no sign of the collapse recorded in 1992 (see fig. 12, and below).

the wall at the east end of the Quayside. The junction of the north-south wall with the riverside stretch was in a collapsed state when excavated in 1992. This is in flat contradiction with Knowles' account and survey of 1905 (see above). The riverine deposits against the wall

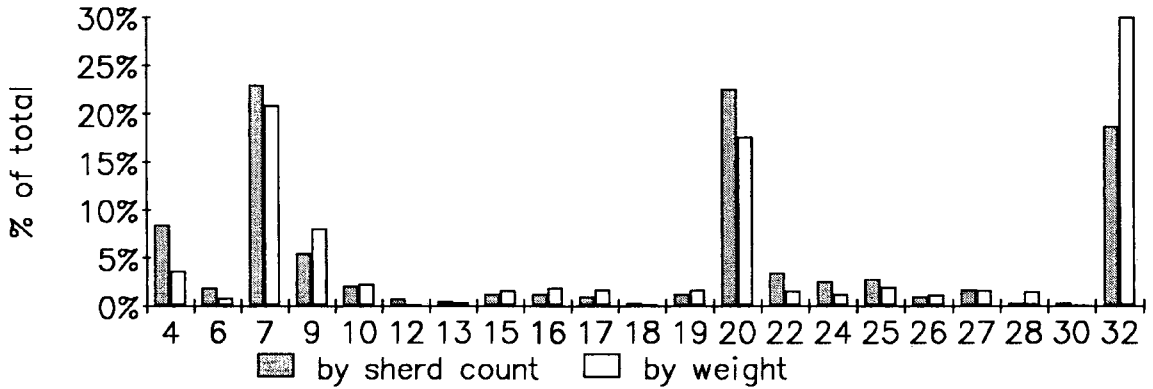
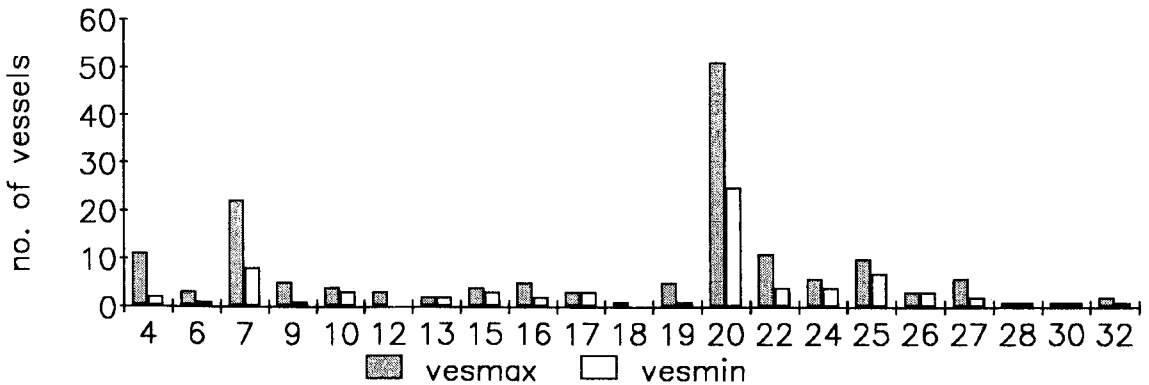
Fig. 13 Pottery charts: Chart 1, sherd count and weight; Chart 2, vessel maximum and vessel minimum.

the two bar charts in which the material is represented as from a single phase. The numbers refer to the fabric groups listed below. In Chart 1 each pair of columns represents the percentage of the total number of sherds/total weight for the fabric type. In Chart 2 maximum and minimum vessel counts are represented. "Vesmin" was arrived at by counting only vessels represented by a form element (rim, base etc.) or groups of elements; "vesmax" by counting all sherd "families" (groups of joining sherds or sherds estimated to be from the same vessel) whether form elements were present or not. The number sequence used is not specific to this site.

The two largest groups of material are the locally produced reduced greenwares (groups 7 and 9) and the imported redwares (20) although, as the charts show, different ways of quantifying produce different patterns. Both these groups occur from the 14th century up to the late 16th century in the Castle Ditch assemblage (*Ditch* 1981, fig. 6) with the redwares reaching a peak in the 16th century and the reduced greenwares in the 15th century.

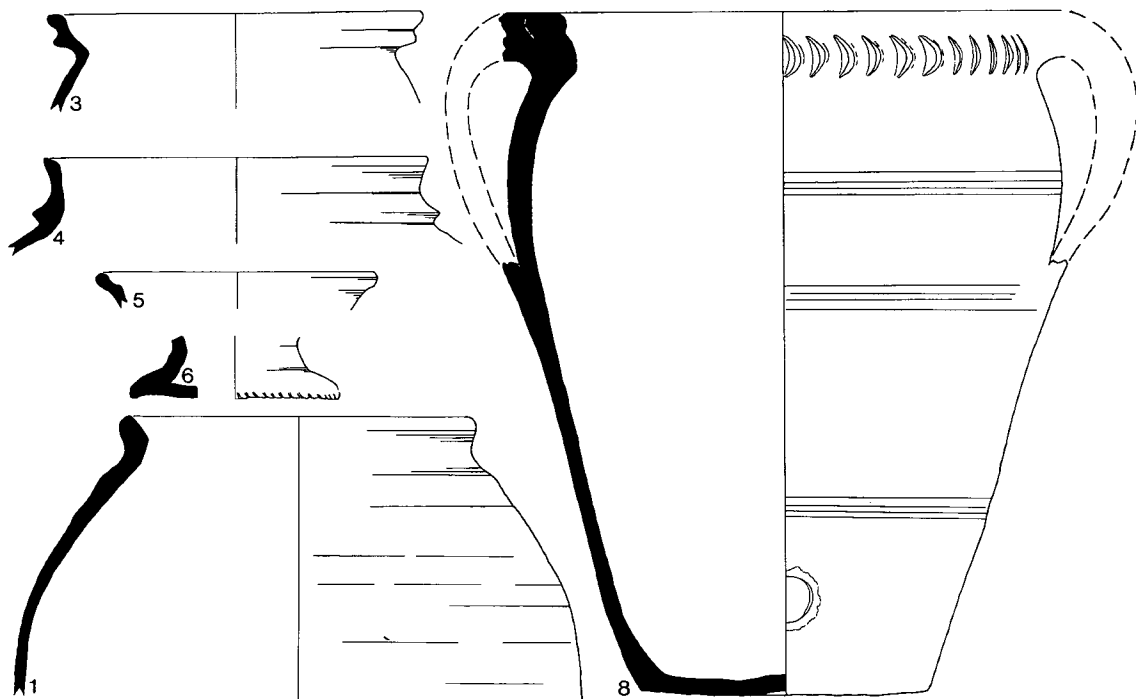
Fig. 14 Pottery—Scale 1:4.

8. Almost complete large storage type jar with wide mouth, flat topped rim, a spigot/bung hole and two handles at right angles to it. Form is not medieval nor has it been

recorded amongst the 17th century assemblages from Newcastle. The fabric is typical neither of 17th century redwares nor the later (18th–19th c.) local “brown” wares. Most probably an eighteenth century vessel. Cisterns were noted as being very rare amongst the post-medieval glazed red earthenwares from Norwich. One is illustrated with another large jar of a similar form (Jennings 1981, fig. 80 nos. 1354 and 1342, respectively). Another example (not redware) is illustrated from an 18th century well at Bishops Waltham (Barton 1969 no. 60 fig. 68 and p. 183). V. 62 [37].

The peak on number 32 represents the large cistern (illustrated below, fig. 14, 8) broken into 81 sherds. This underlines the discrepancies which can arise when using statistics to illustrate a small assemblage like this.

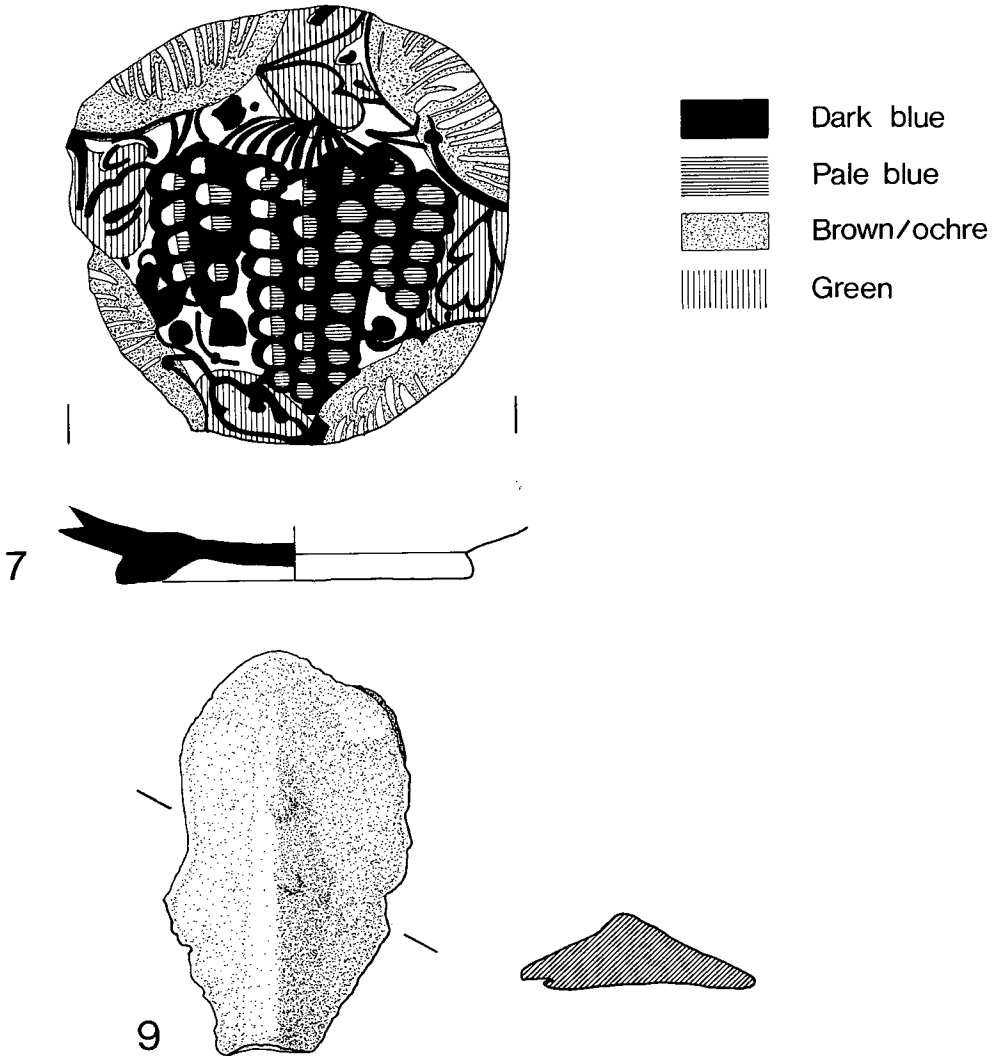
Fig. 15 Pottery and small finds—Scale 1:2.

**Roof tile:** 26 mainly small fragments, some joining, included a few pantile fragments and others with small spots and traces of glaze. All were in oxidized iron rich fabrics—red, red-brown—with grey reduction in parts (fig. 15, 9).

A nail with domed head and a fragment of a buckle came from the general clearance. Other objects were a rim fragment of a copper alloy vessel with iron suspension loop and the object illustrated (fig. 15, no. 9) which was possibly a fishing weight.
