## Excavations on Hadrian's Wall at Denton, Newcastle upon Tyne, 1986–89

*P. T. Bidwell and M. Watson with contributions by C. Batey, R. Brickstock,  
A. Croom, G. Morgan and R. Payton*

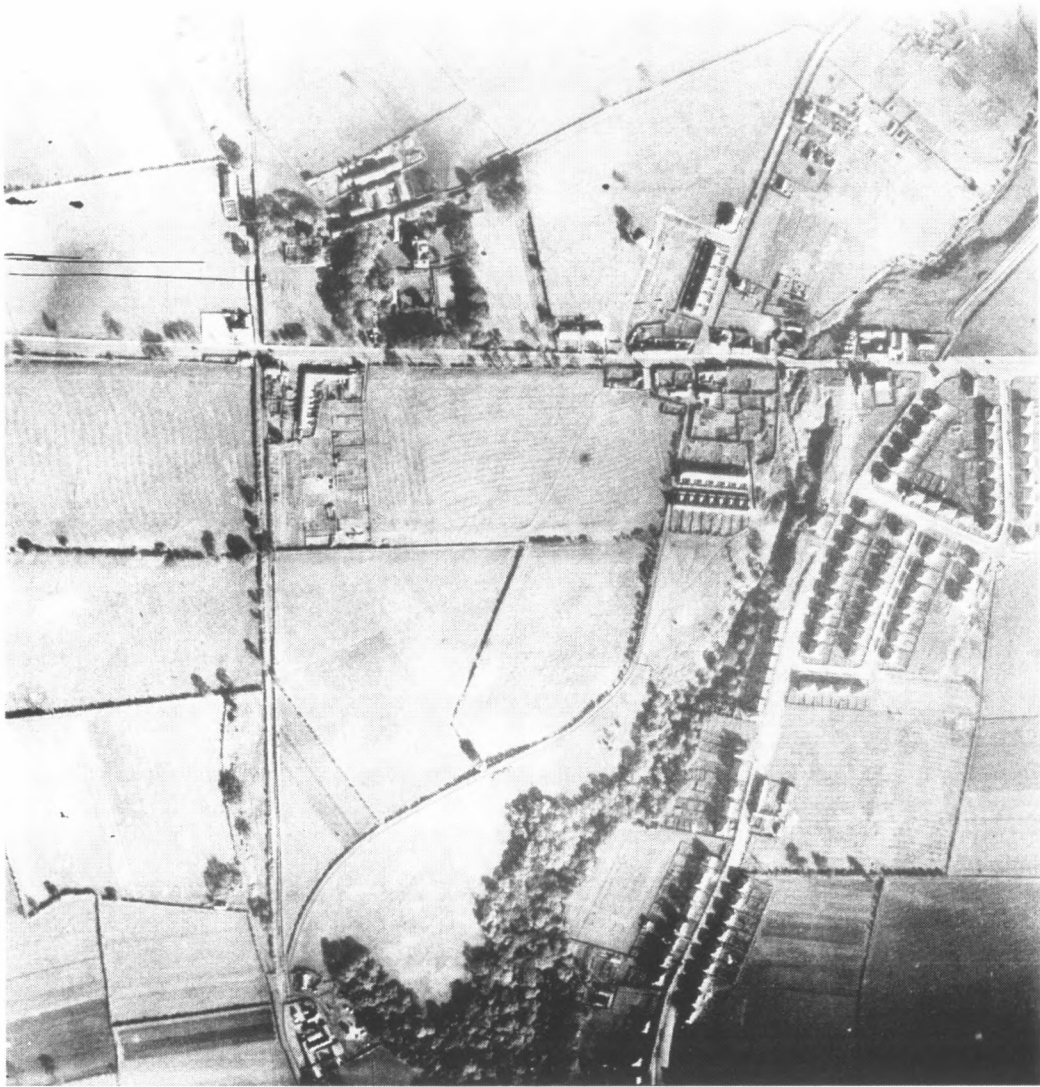
*Fig. 5 Vertical aerial photograph of the Denton area taken by the RAF on 22 October 1930. The Military Road (A69) crosses the top of the photo horizontally; the line of the Wall is represented by a lighter line south of the road, interrupted due south of Denton Hall by a lighter patch where the excavation trench for turret 7b, dug in 1929, has been backfilled. The buildings at the bottom of the photograph on the left are Dentonwood House (thus labelled on the 1897 OS map), where RIB 1360, a building stone of cohors viii, legio II Augusta, was built into the garden wall (Bruce 1875, no 37). It is now lost. The entry in RIB equates the site of Dentonwood House with that of the later Howlett Hall, a public house at the junction of Denton Road and Whickham View; but this identification is wrong, for Howlett Hall stands on the site of Denton Woodside House, an isolated group of buildings visible on the photo on the right-hand side of Denton Road which is the major road running south from the Military Road. Reproduced by courtesy of the Aitchison Collection, Museum of Antiquities, University of Newcastle upon Tyne.*

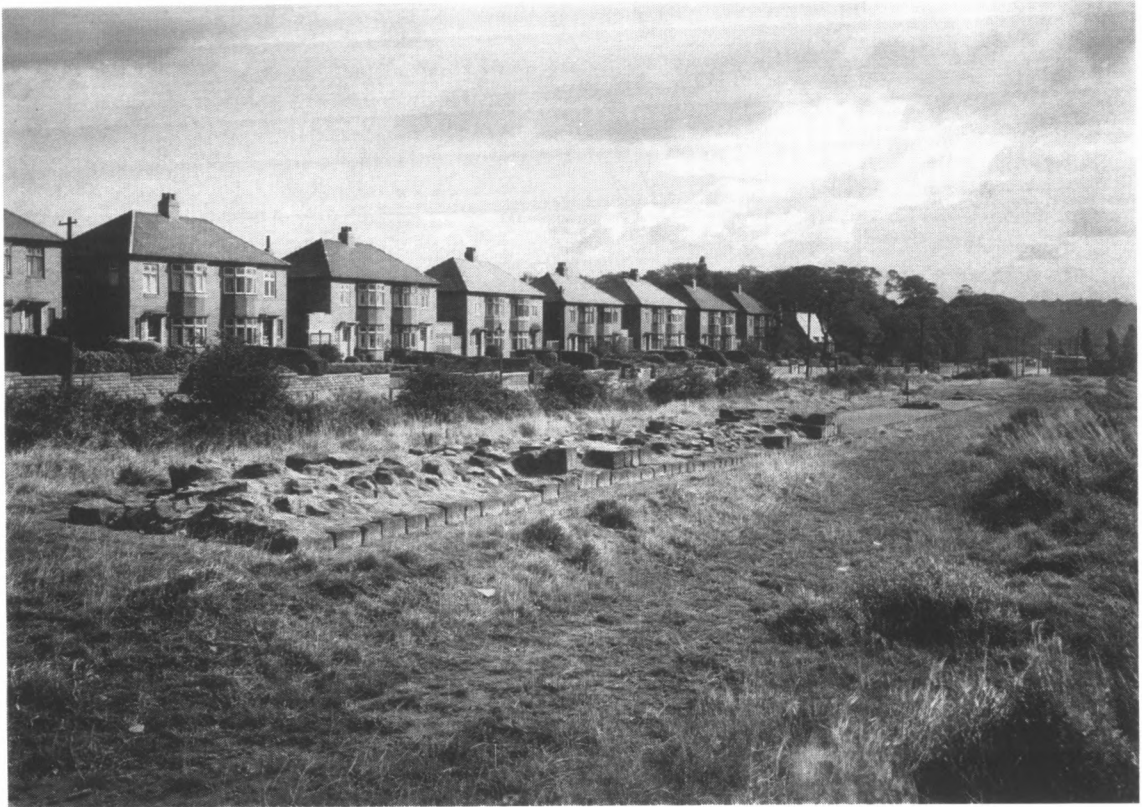
Fig. 6 Consolidated section of Wall between Areas I and IV, view from south-west, taken 23 September 1954. Photo: English Heritage (A3389/4).

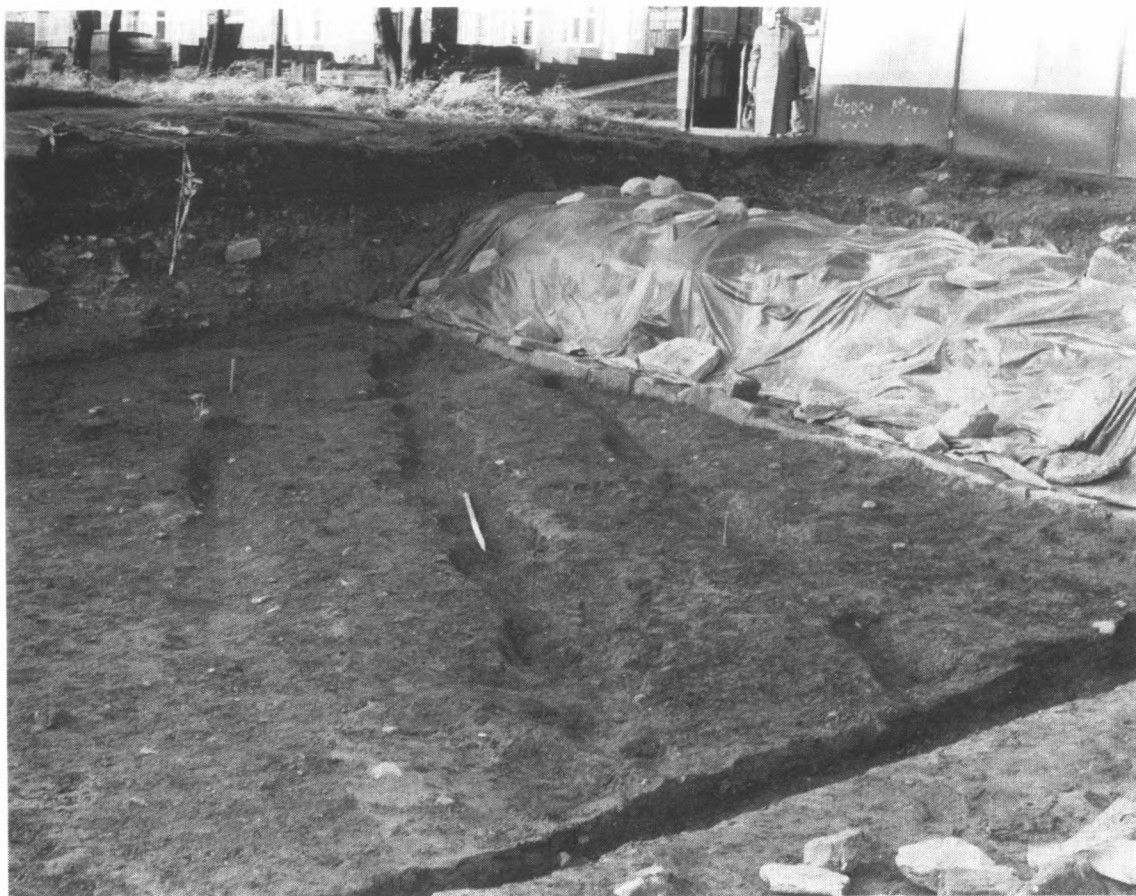
*Fig. 11 Furrows in surface of soil pre-dating Wall, looking north-west. 1 m scale.*

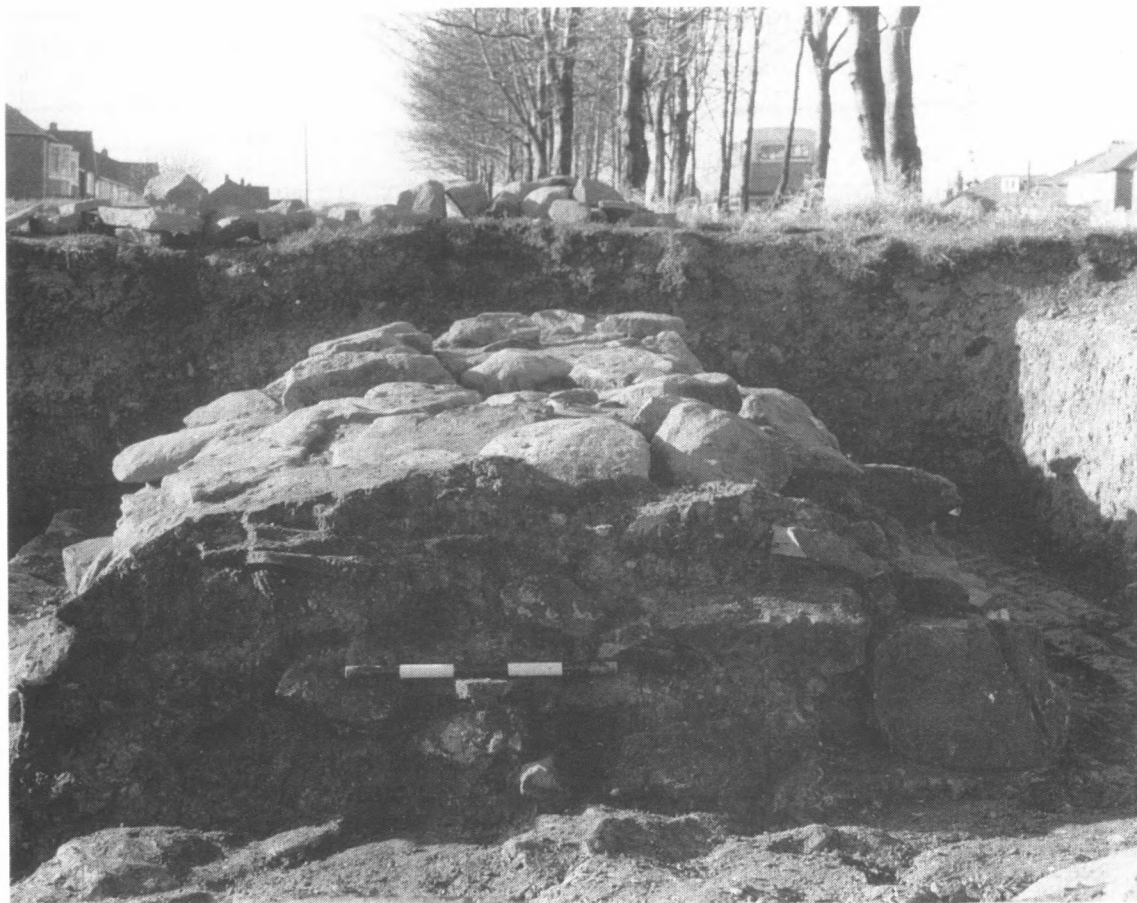
*Fig. 13 Section through Wall core, looking west. 0.5 m scale.*

The core of the Broad Wall at Denton can thus be described neither as a clay core nor as a rubble core set in clay. It is a clay and rubble core with the clay, compacted perhaps by treading but not puddled, providing the body of the core; the rubble, probably derived from digging the Wall ditch, was inserted as a filler.

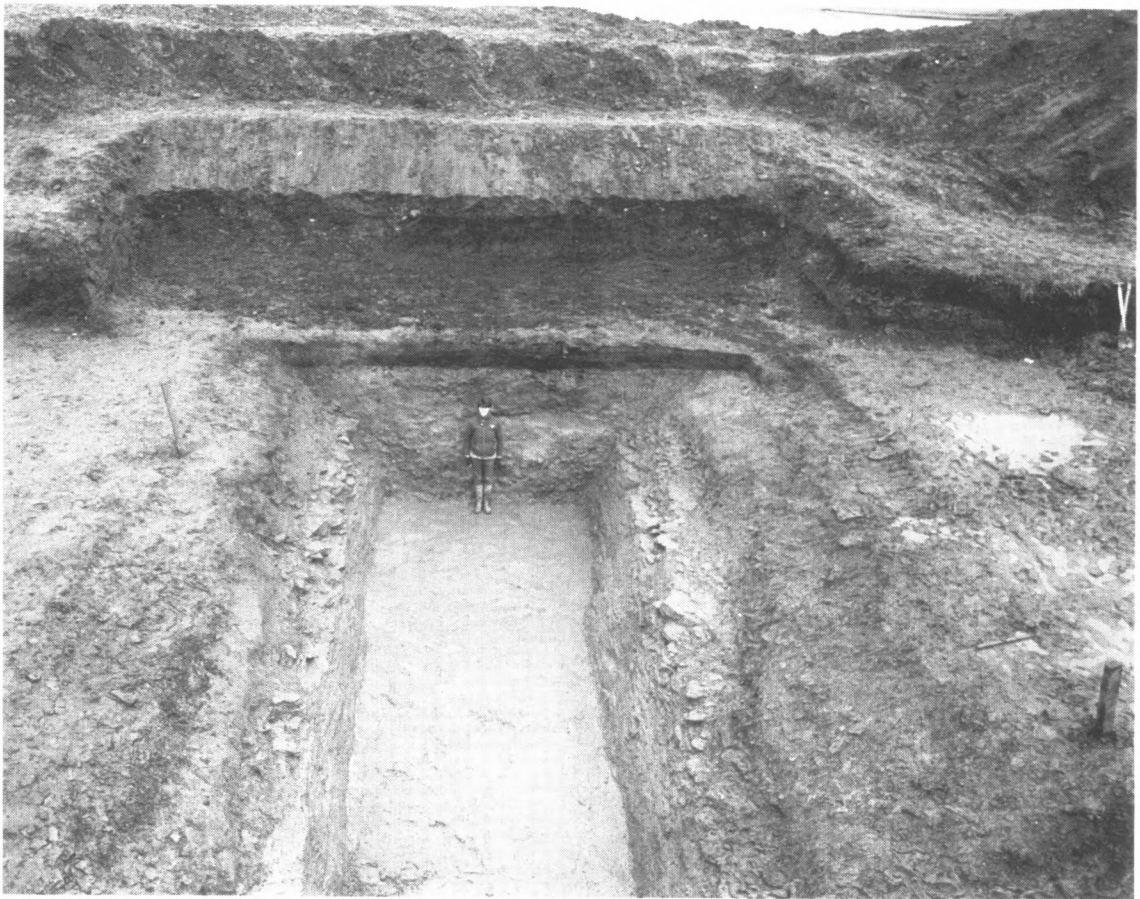
Fig. 26 Vallum ditch looking east. 2 m scale.

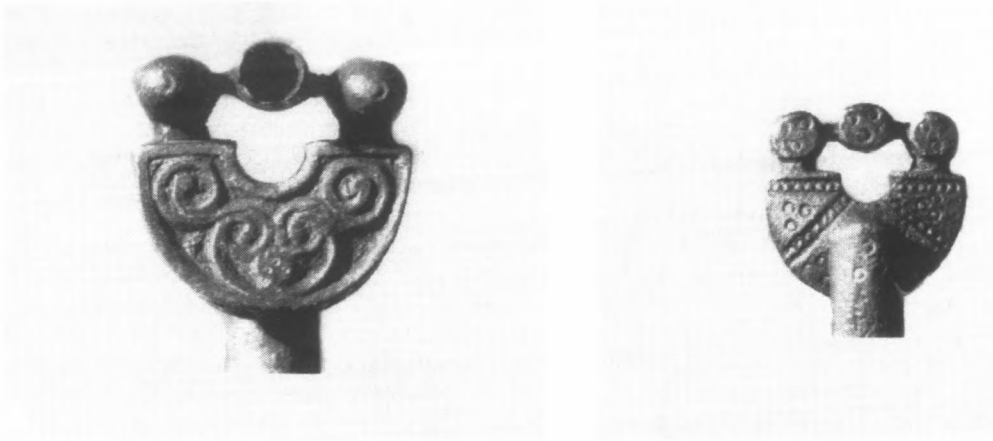
Fig. 29 Silver hand pin: enlargements of front (left) and rear (right) of head.

#### SILVER HAND PIN FRAGMENT

Figs 28–30
