Alnmouth Old Church

A. Aspinall, F. Bettess and R. B. Connell

SUMMARY

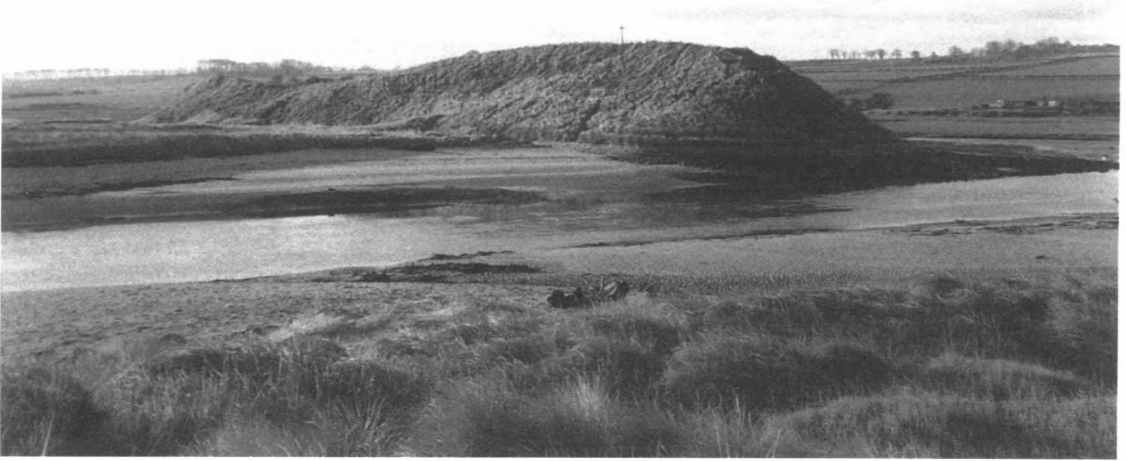
Fig. 2 Church Hill from village.

river, directly opposite the southern tip of the Village. It is a whale-backed narrow ridge running approximately north and south and falling away sharply to both east and west. At its northern end it rises steeply from an encircling retaining wall to reach the highest point from which it descends with a more gentle slope to the south (fig. 2).

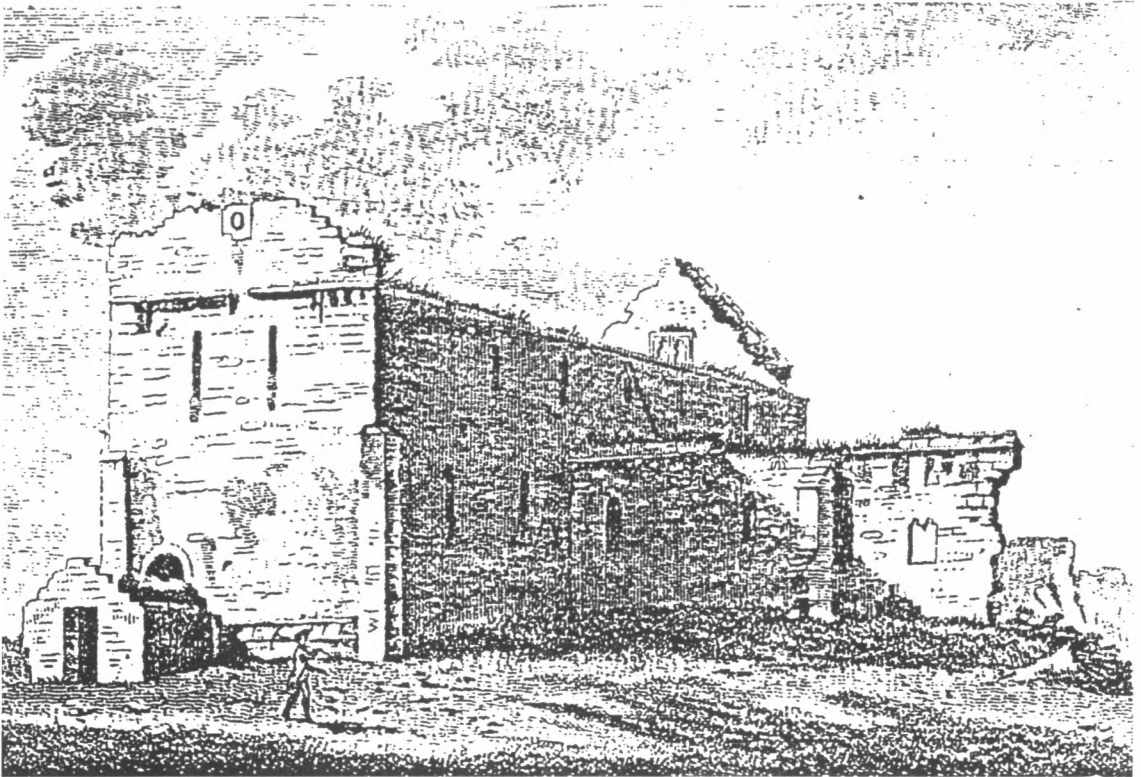
Fig. 4 View from SE 1783.

Pictorial evidence for the physical appearance of the original Church comes from two prints of 1771, another of 1783 (fig. 4), and a sketch of 1804 (NCH 1895, II, 489–95), all made within a comparatively short period before the final destruction of the building. These illustrations show a cruciform church, with a chancel two bays long and a two aisled nave with a length of at least three bays and probably more (Betts G 1994). The transept had a clerestory, and both it and the nave appear to have been of considerable height. There is no evidence for or against the presence of a tower. Thomas Wilkin's map of 1791 (NRO MSM 15), when the village and hill were still connected, shows the transept and the stub of the chancel, and agrees well with the prints and sketch mentioned above. A comparison of the south east views of the church made in 1771 and 1783 (mentioned above), shows that there was a considerable amount of erosion in the 12 year period between them.
