A Building at Steel, Hexhamshire, Northumberland

Peter Ryder

DESCRIPTION (figs. 1–6)

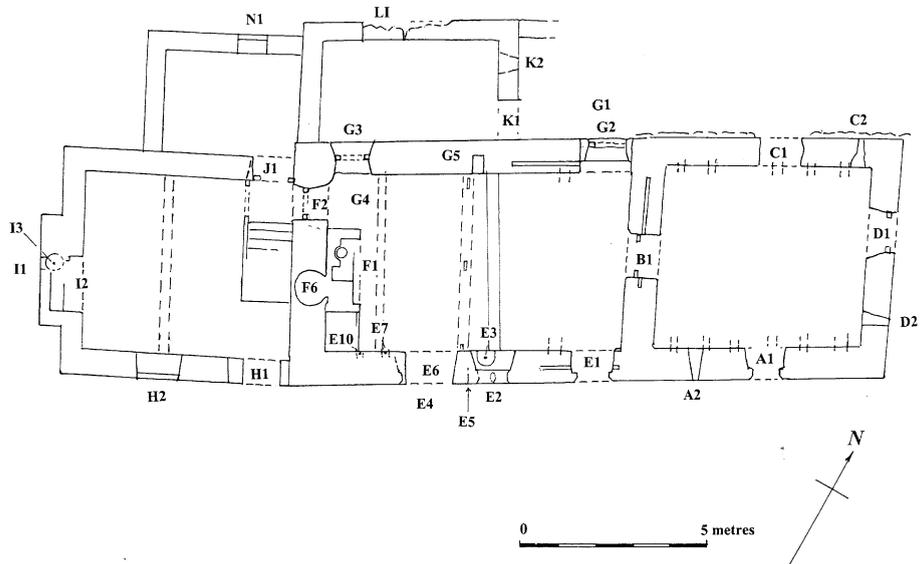
Fig. 1 Steel, 'The Tenement' Ground Floor Plan (1:200). P. F. Ryder, 1994/9. For key see text.

The range is built of rubble, much of it heavily mortared; the western part had a roof of stone slates whilst the central and eastern parts were covered in asbestos sheeting. Straight joints and quoining made three successive constructional phases, starting at the east end, easily recognisable, as is apparent from the plans (figs. 1 and 2; see also figs. 3 and 7).

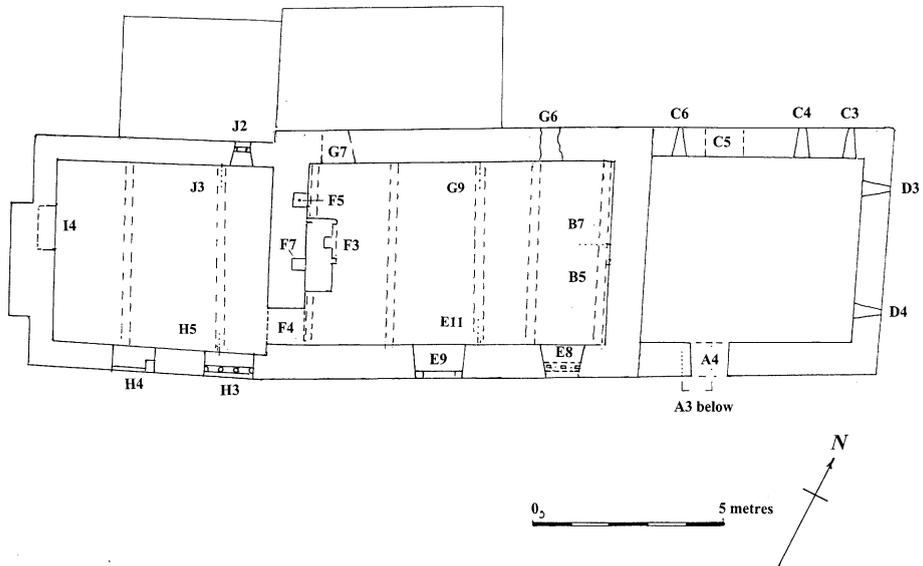
Fig. 2 Steel, 'The Tenement' First Floor Plan (1:200). P. F. Ryder, 1994/9. For key see text.

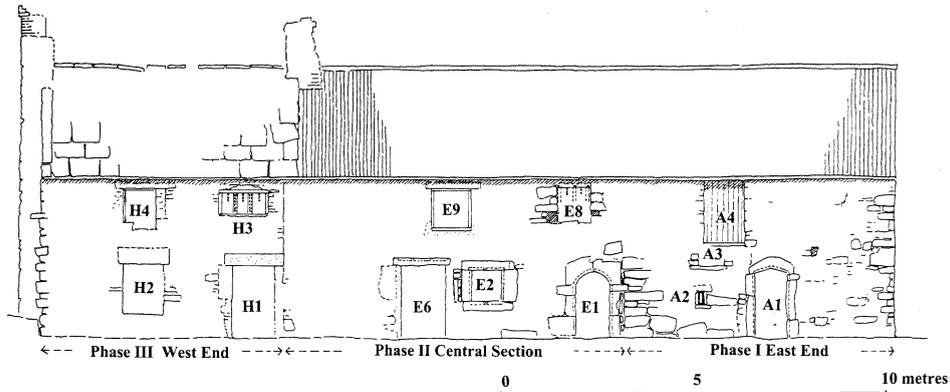
Fig. 3 Steel, 'The Tenement'. South Elevation (1:200; after a drawing by Gordon Currie Associates) For key see text.

In the south wall (see fig. 3) is a doorway (A1), with a chamfered flat-pointed monolithic head, sixteenth/seventeenth century in style but apparently a re-used piece. To the west of it is a slit vent (A2), which may be original. Above is a long block forming the external sill of the former window (A3), which must have been carried up as a dormer; the remains of its *in-situ* wooden sill were found and recorded during the building works.¹ Set in the early nineteenth century (?) masonry of the upper section of the wall is the pitching door (A4).

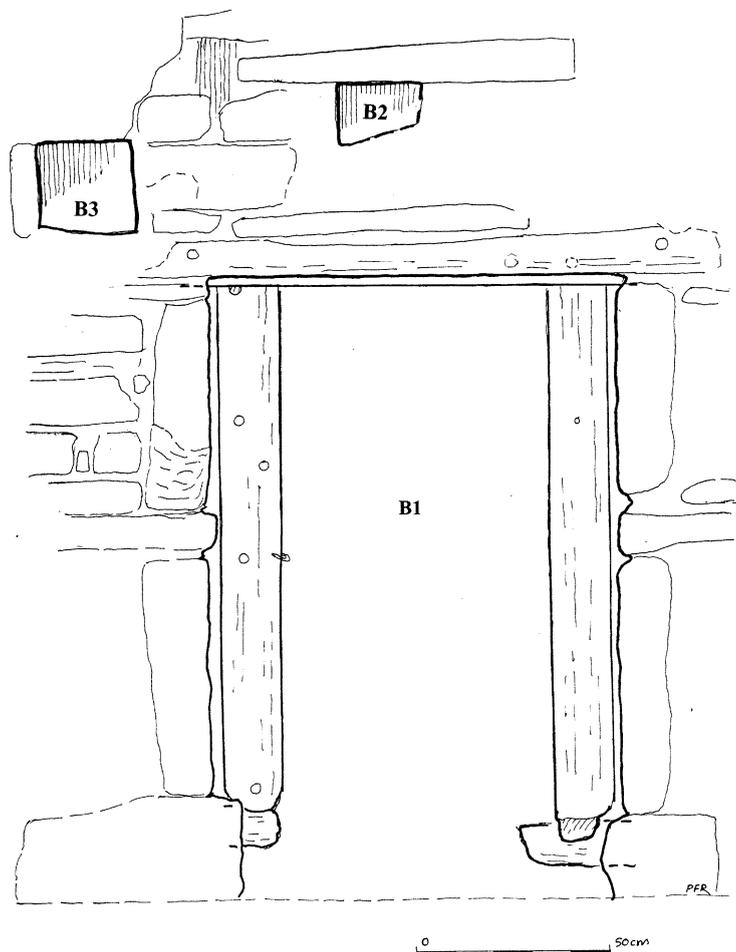
Fig. 4 Steel, 'The Tenement'. External Elevation of Doorway (B1) (1:20).

In the centre of the west wall of the Phase I building, now internal, is an extremely interesting doorway (B1), blocked for many years but now re-opened (see fig. 4). The opening has jambs of megalithic slabs, one at mid-height set horizontally with those above and below set upright (rather in the manner of Anglo-Saxon 'long-and-short' work); these jambs carry a series of timber lintels. The heavy oak door-frame is set midway through the wall, without any stone rebate, and is protected by a drawbar tunnel and socket on the east. The jambs have been mortised into a timber sill, only the ends of which survive. The door itself has been harr hung; a socket for the head of the harr-post is cut into the lintel but the base socket, perhaps cut into a stone block, has been lost.

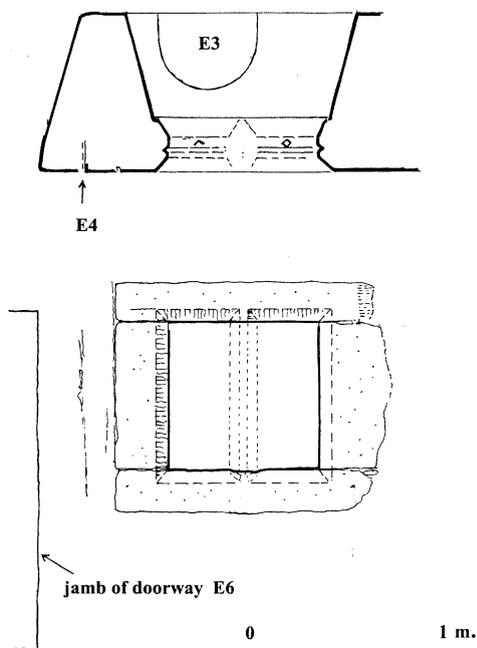
Fig. 5 Steel, 'The Tenement'. Details of Window (E2) and associated features (1:40).

At the east end of the south wall is doorway (E1) with massive gritstone dressings and a hollow-chamfered arched head of segmental-pointed form, of very 'medieval' appearance. There is a drawbar tunnel in the west jamb. Some features of this doorway, notably the way in which the dressings of at least the east jamb seem to be thicker than the wall, suggest that it too is a re-used piece, although perhaps brought from elsewhere when this part of the house was built, rather than being inserted after construction. West of this was a blocked two-light mullioned window (E2) with a chamfered surround, of later seventeenth-century character (see fig. 5) and then a plain doorway (E6).

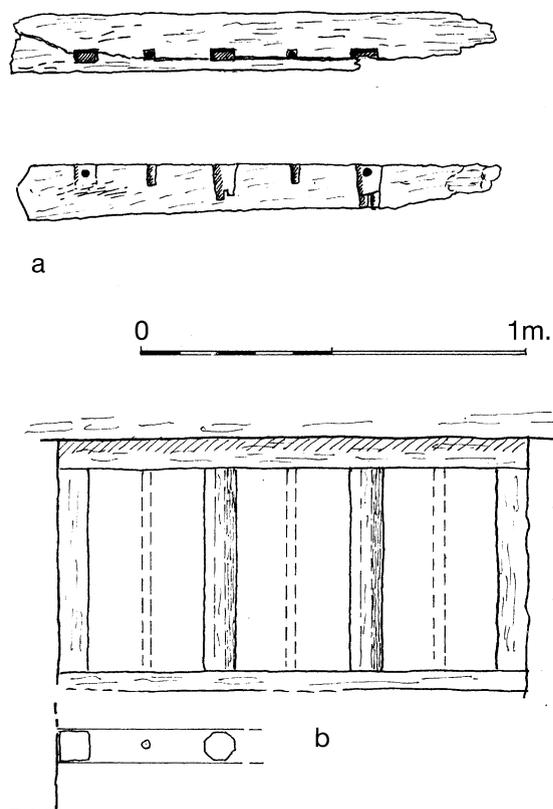
Fig. 6 Steel, 'The Tenement'. Details of timber windows (1:20).

a. Sill of window (A3) (Phase I) Plan/Section
b. Window (H3) (Phase III). Elevation/Part Plan

¹ This had split in two lengthwise; its section demonstrated the manner in which drill holes were enlarged by chisel to produce mortises (see fig. 6).

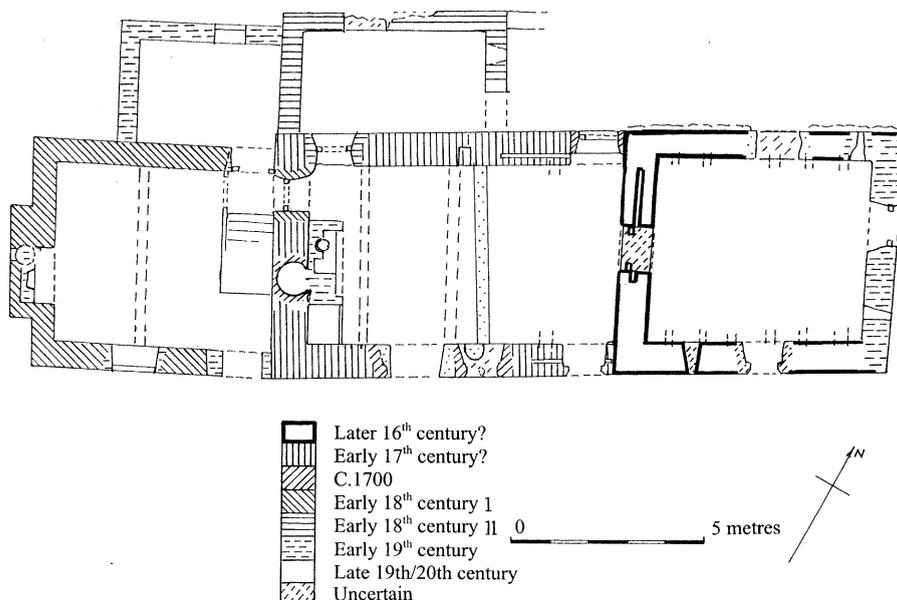
Fig. 7 Steel, 'The Tenement'. Provisional Phased Ground Plan (1:200).

The earliest part of the range represents a small but intriguing structure (figs. 7, 9). The doorway with its draw-bar tunnel implies that it was a domestic building, but its low eaves show it was not a conventional two-storeyed bastle, of which there are a number in this area.⁷ It may have been a defensible house, of two low storeys, of a type seen at Tow House, Bardon Mill, and again at Whitlees near Elsdon (fig. 8). Both of these seem to be buildings of the 'bastle period' (i.e. late sixteenth or more probably early-seventeenth century) but to have had domestic accommodation on the ground floor. They were clearly defensible structures, but it is difficult to know what to call them. One shrinks from adding another term to the already-confused nomenclature of defensible structures in the area to cover structures like this. 'Strong Houses' might be appropriate, except that its recent applications seem to have primarily been to larger buildings built

There is similarly little stylistic evidence to date the second phase of construction, when the central section of the range was built (figs. 7, 9). The great similarity between doorways (B1) of Phase I and (G1) of the Phase II suggests that no great time interval elapsed between the two. The south doorway (E1) looks 'late medieval' in character, but almost certainly is a re-used piece, although it should be noted that a variety of arched door types do persist well into the seventeenth century hereabouts, as seen in local bastles.

It is a little difficult to date the Phase III extension (figs. 7, 10) in relation to this remodelling of the centre section of the range, as here rather more vernacular timber mullioned windows are being used, although the roof was of sandstone flags. It could have taken place twenty or thirty years later, possibly into the

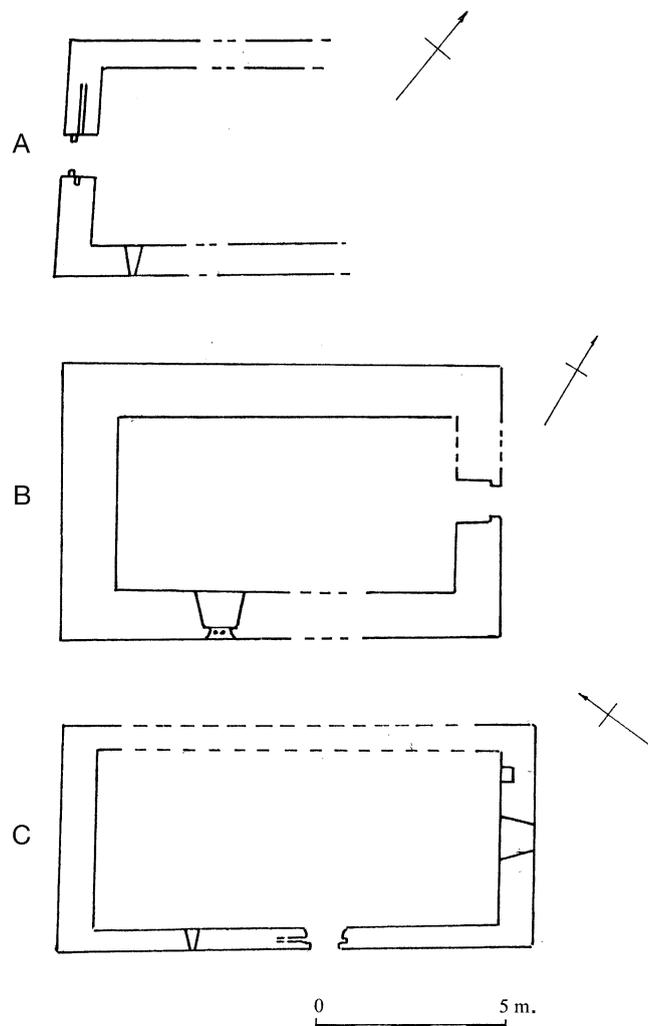
Fig. 8 Comparative Plans of Three Defensible Single-Storey Houses

A. 'The Tenement'. Steel. Phase I

B. Whitlees (Elsdon). In the heart of bastle country, a thicker-walled house. The principal evidence of its form is the grilled window on the south, in contrast to the smaller slits of the loft/floor above.

C. The Old Workshop (Tow House). Survey 1990 by Tynedale Vernacular Buildings Study Group. A three-bay cruck building of two low storeys; small windows with stout oak frames and a door provided with a drawbar tunnel shows that there was still some intention of defensibility.

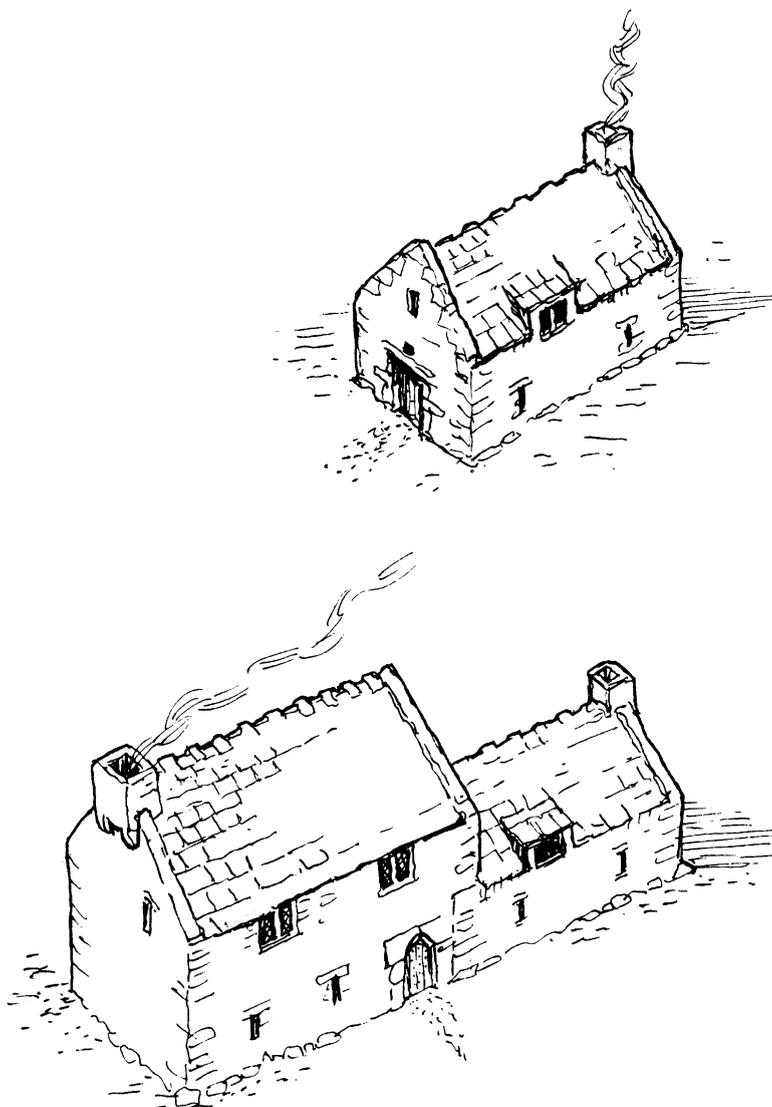
Fig. 9 Steel, 'The Tenement'. Reconstruction of defensible house, Phases I & II. (upper) Phase I. Late Sixteenth Century? (lower) Phase II. Early Seventeenth Century.

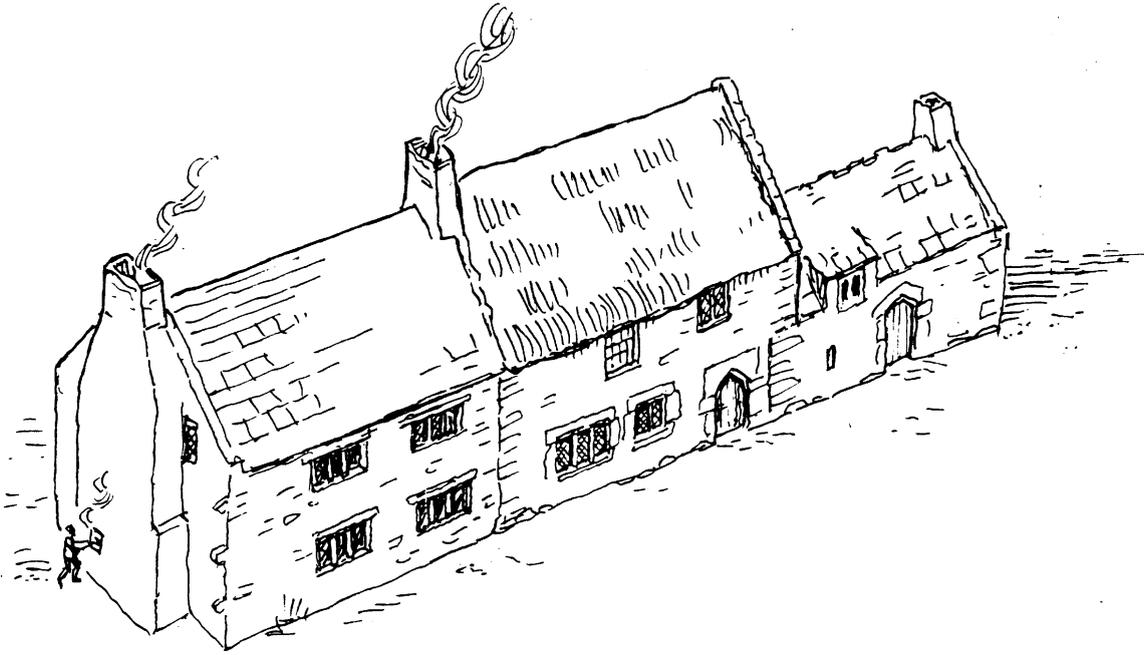
Fig. 10 Steel, 'The Tenement'. Reconstruction of the house as it might have appeared c. 1720.

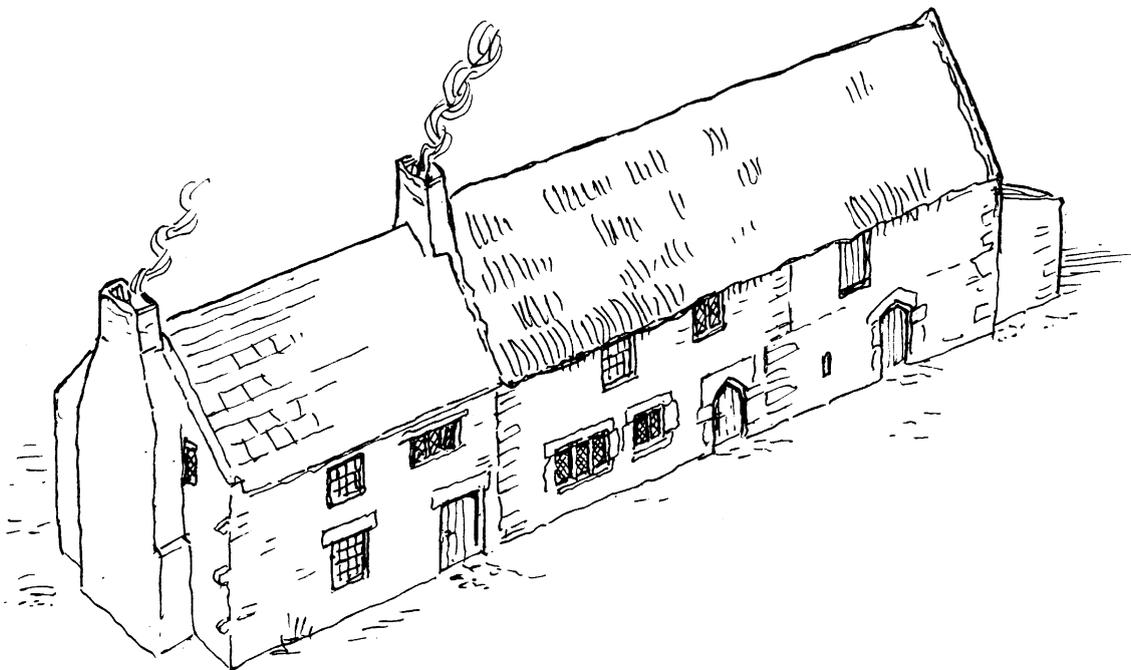
Fig. 11 Steel, 'The Tenement'. Reconstruction of the house as it might have appeared c. 1820.

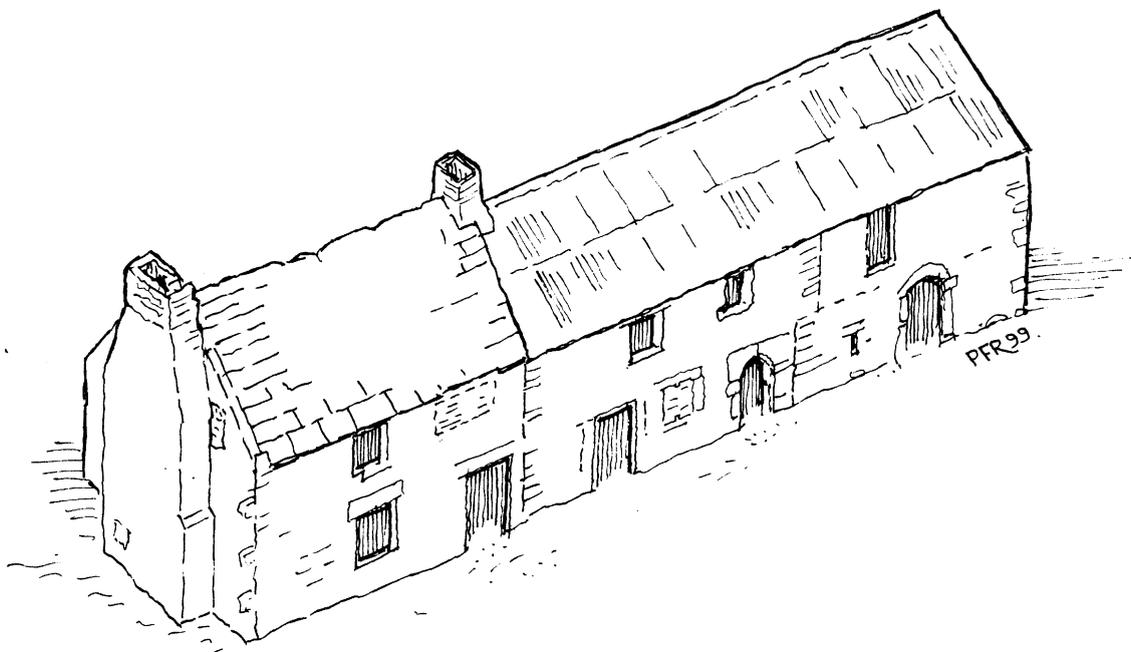
Fig. 12 Steel, 'The Tenement'. The range before restoration.

was inserted, and the asbestos sheet roof of the eastern and central parts replaced thatch. Over the last twenty years or so the building had been abandoned, and was in very poor structural condition (fig. 12) before the recent refurbishment returned the whole range to domestic use. Historic fabric was retained wherever possible, although sections of walling (including much of the front elevation of the eastern and central parts, above first-floor level) had to be taken down and rebuilt. The three-light mulled window (E4) and the original fenestration of the west part of the range have been reinstated. The rear outshuts have been completely rebuilt and extended, doorway (G1) being re-opened to give access to them.
