6. The West Granary

INTRODUCTION

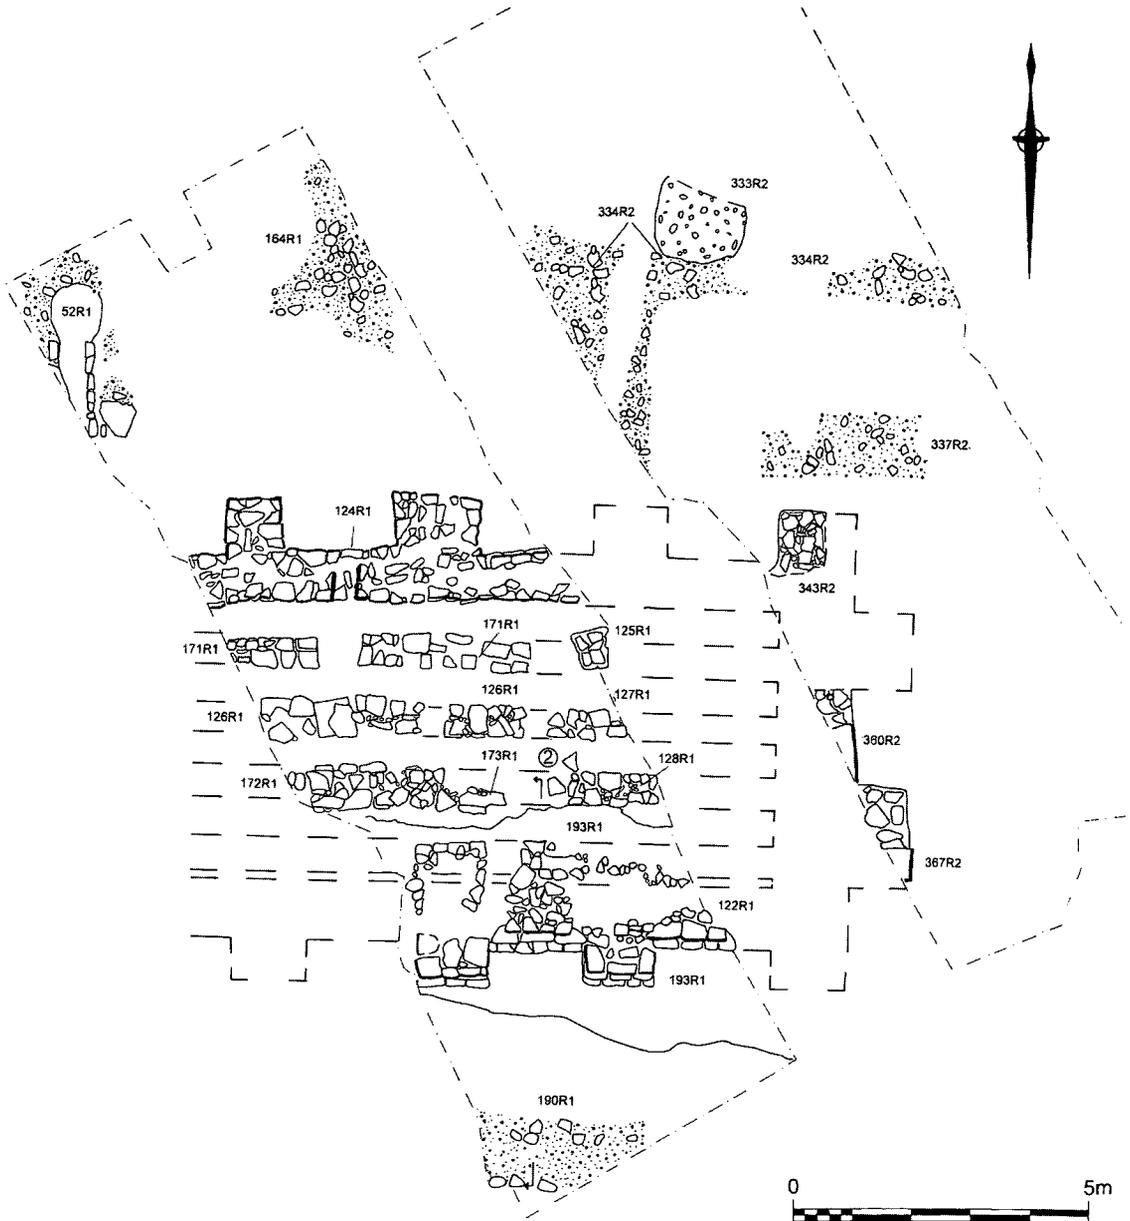
Fig. 6.1 The remains of the primary west granary, with wide foundations for the south and east walls. Also shown is part of the primary 'via principalis' (190R1) and a broad street to the north of the granary. For the position of the primary drains, see fig. 6.6. Section 2 is shown on fig. 6.2. The trench hearth to the north of the granary may belong to pre-construction phases. Scale 1:125.

To the north of the west granary, on an upstand left by later intrusions, was a feature (52R1) (fig. 6.1), with a stone-lined flue and a bowl-shaped pit, *c.* 0.90m in diameter, constructed of grey clay (51R1*), topped by pebbles (53R1*). The base of the bowl was a thin compact layer of green clay and there was a fill of coal and ash (50R1*).

(193R1) (figs 6.1, 6.3 and 6.4). The depth of the foundation is shown in section (fig. 6.2). The wall (122R1) was of mortared yellow sandstone with a rubble core, and the external face had two offset courses. At first sight, the south wall appears to have been exceptionally wide, but this was probably not the case. It is more likely that the remains as found represent an amalgamation of several features, as described below. The two surviving buttresses of the south wall were also strongly constructed with two offsets.

the external wall there was a gap in the sleeper wall. Both plans (fig. 6.1) and photographs (fig. 6.8) show two distinct butt ends of walling, the space between being *c.* 0.60m. The two dressed blocks partially filling this space, and the row of stones abutting the south side of the sleeper wall represent a later feature (see below).

Fig. 6.1 shows the suggested layout of the east end wall of the granary, assuming the buttresses were all of approximately the same size and spacing, *cf.* Type 1 granaries at South Shields (Bidwell and Speak 1994, 23, fig. 2.6). It seems impossible to reconstruct this as South Shields Type 2 (*ibid.*, 23–4, fig. 2.7) without either shortening the space between the first two buttresses of the long walls, or projecting the east end wall and its buttresses beyond the known extent of the foundations. The surviving buttresses of the north wall would be the third and fourth from the *via praetoria*, and those on the south wall would be the second and third. It is unlikely that the loading bays of either granary would have been situated on the *via praetoria* immediately in front of the *principia*. There is some evidence to support this assumption. There are no remains of a loading bay at the east (*via praetoria*) end of the west granary, and the spacing between the two buttresses there is the same as that for the buttresses on the long walls. This contrasts with the east

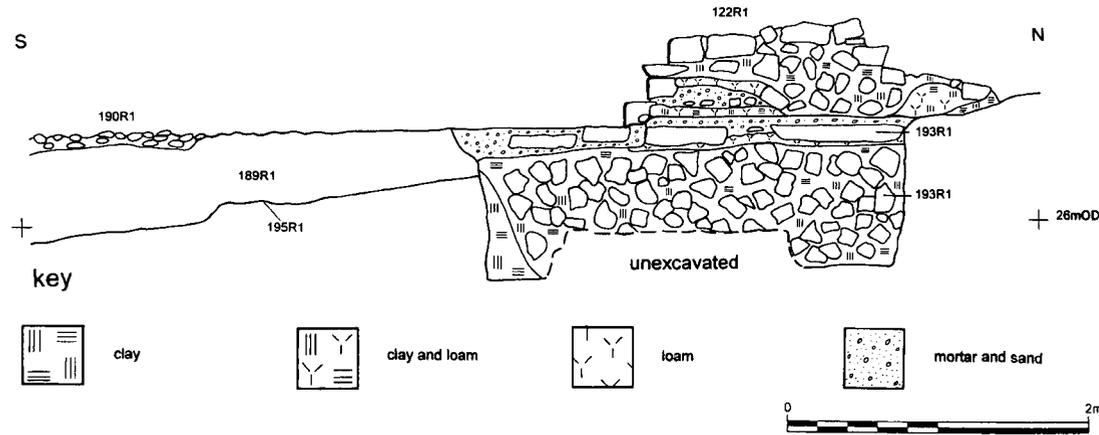
Fig. 6.2 Section 2, through the south wall and southernmost sleeper wall of the west granary, also showing some of the primary 'via principalis' pressed into the fill of a pre-fort ditch. Position of section shown on fig. 6.1. Scale 1:50.

It is possible that there was a fourth sleeper wall, the remains of which became amalgamated with the remains of the south external wall, giving a false impression that the latter had the exceptional width of 1.50m above the offsets. A section through the south wall (fig. 6.2) suggests an external wall 1.10m wide at the base and *c.* 0.80m wide above the offsets, with a core consisting of regularly banded clay and mortar.

Further evidence of industrial use in the west granary at Newcastle is seen in the composition of the layer overlying the filling between the sleeper walls, and the sleeper walls themselves. This was a dark soil (123R1), with clay and mortar patches, containing some burnt material in places, charcoal, reddened clay and lumps of coal (fig. 6.2).

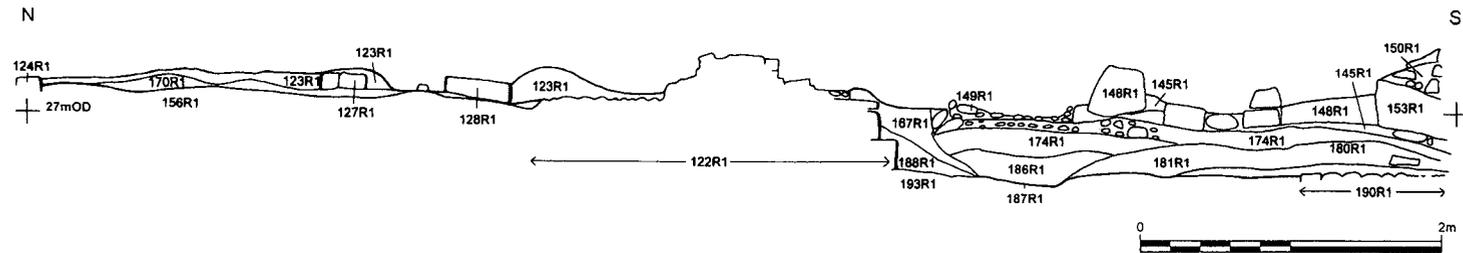
Fig. 6.3 Section 3, through the west granary and part of the 'via principalis'. Position of section shown on fig. 12.1. Scale 1:50.

A levelling layer of mortar, stone chips and clay (170R1) had been laid over the whole interior of the excavated building, overlying the stakeholes mentioned above, and just overlapping the wide foundations of the 'south' wall (193R1). The sleeper walls were then built on top of this levelling layer (fig. 6.3).

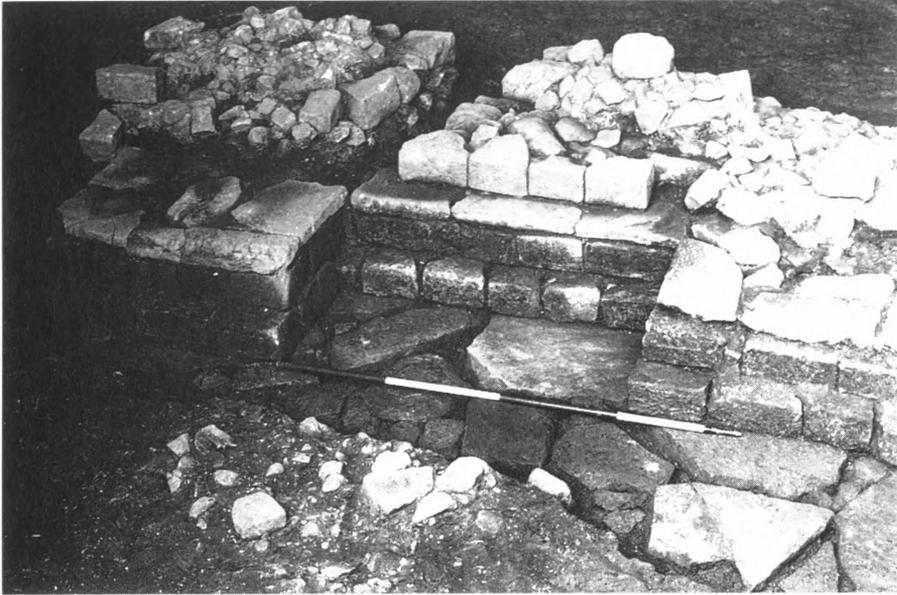
Fig. 6.4 Broad foundations of the south wall of the west granary viewed from the south.

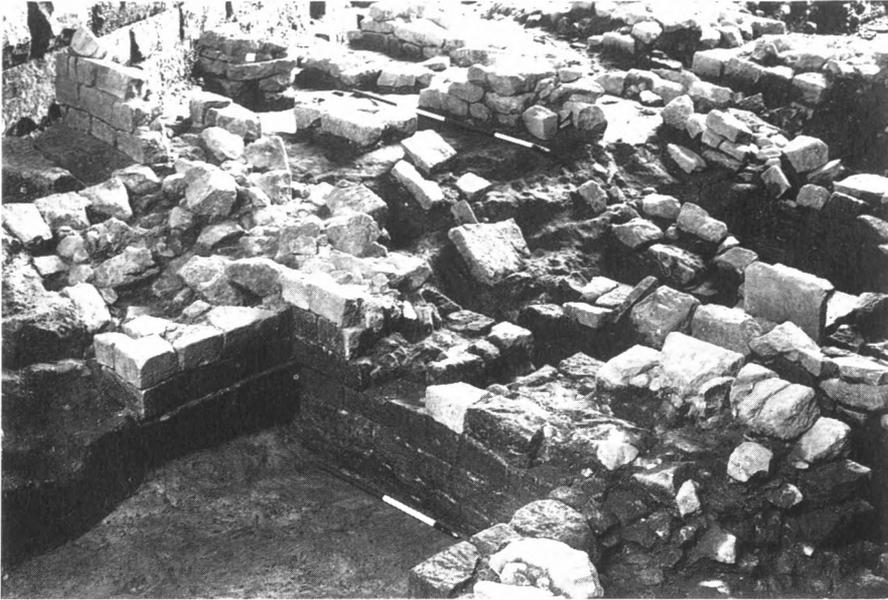
Fig. 6.5 West granary seen from the north-west, showing subsidence into the pre-fort scarp.

unaware of the existence of the north/south scarp or terrace related to the earlier agricultural activity (fig. 2.2). Consequently a striking feature of the archaeology of the west granary area is the considerable subsidence into this scarp which took place throughout the Roman period (fig. 6.5) and after.

Two further evenly-spaced sleeper walls (126/127R1 and 172/173/128R1) lay to the south. These two sleeper walls in the west granary were originally continuous (*cf.* granaries at Wallsend (Hodgson forthcoming)), the breaks in the lines here being the result of later disturbances and subsidence into the north/south scarp (fig. 6.5).

The granary lost its original raised floor and the sleeper walls were reduced in height. Photographs (fig. 6.5) show some standing to a maximum of four courses (*c.* 0.50m), and

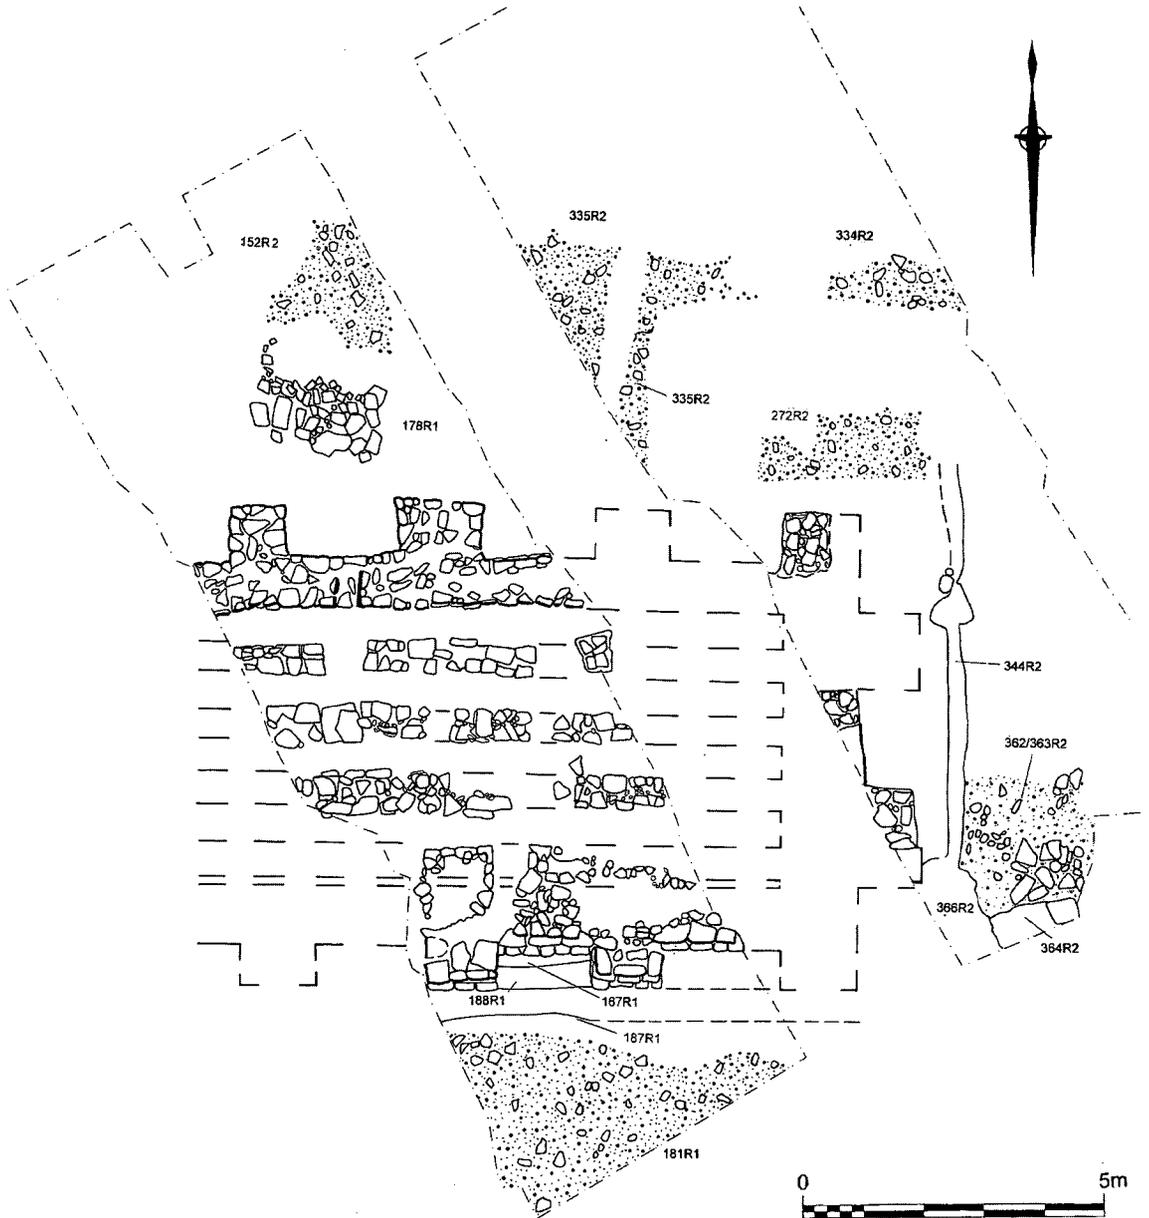
Fig. 6.6 The west granary and remains of later street surfaces, also showing robber trenches for the primary drains. Scale 1:125.

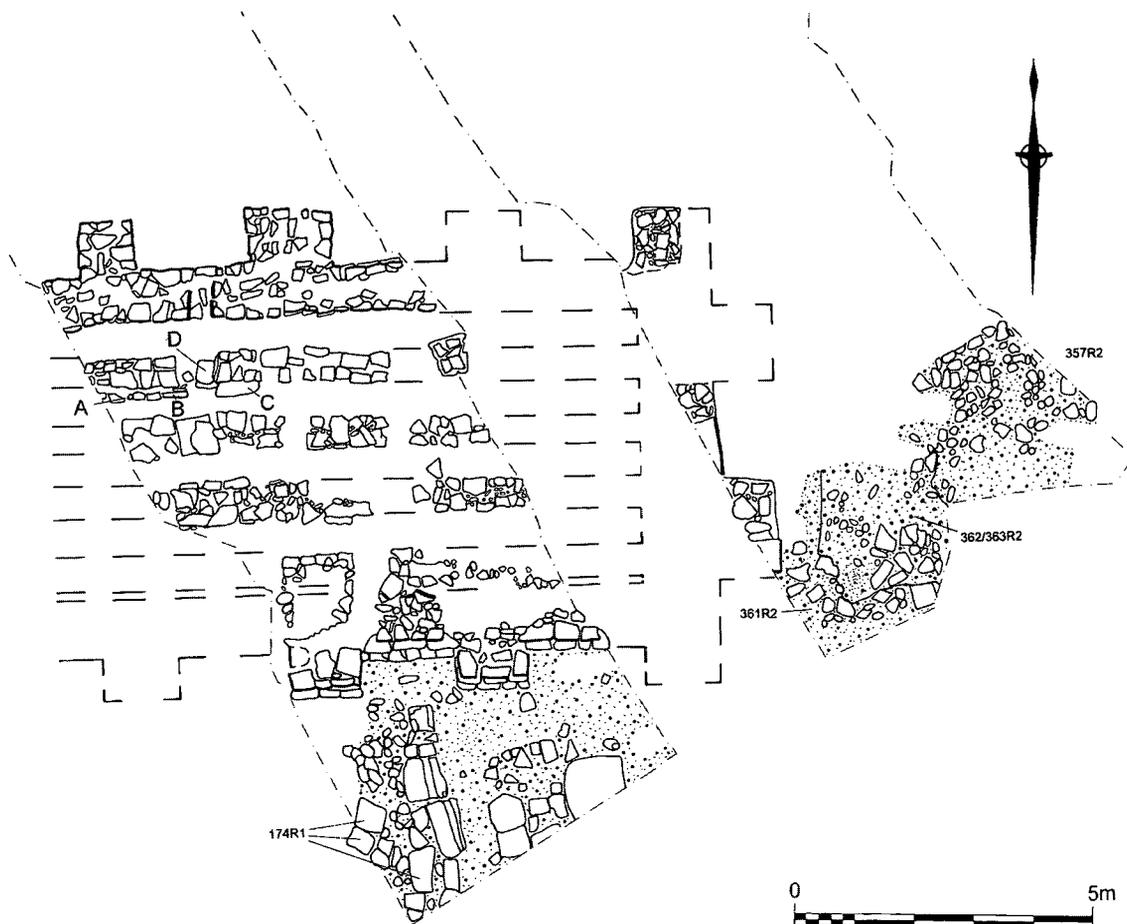
Fig. 6.7 The west granary in the second half of the fourth century. The stone feature at A, B, C and D may be the remains of a trench hearth inserted after the spaces between the sleeper walls had been filled in and the granary had undergone a change of use. The latest metalling of the 'via principalis' and via praetoria includes large re-used blocks, some of which are architectural fragments, suggesting the robbing of buildings. Scale 1:125.

At the western edge of the excavated area the remains of a stone feature were found abutting the south side of the northern sleeper wall (171R1). This consisted of an alignment of four small dressed blocks (A on fig. 6.7), set on a layer of soil rather than on the subfloor of the building, and terminating in a large, carefully-dressed slab (B on fig. 6.7), set on edge (fig. 6.8). The postulated gap in the primary sleeper wall was partially blocked by two dressed blocks (D on fig. 6.7), which also appear to be standing on a layer of soil, and some smaller stones. To the east of the alignment was a long, flat stone (C on fig. 6.7). It is

likely that this represents the remains of a trench hearth inserted into the space between sleeper walls.

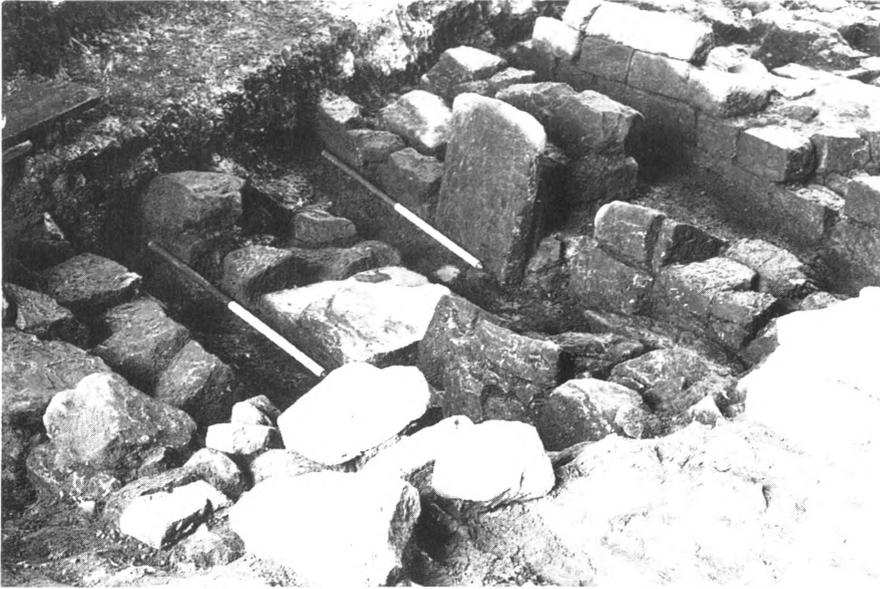
Fig. 6.8 Stone alignment, possibly a trench hearth, abutting the south face of the northern sleeper wall of the west granary. At upper centre, there is a large upright slab, heavily worn on top; the stone alignment can be seen to the left, and to the right there are two courses of dressed stones blocking the gap in the sleeper wall. Viewed from the south-east.
