9. The Northern End of the *Via Praetoria*

FOURTH CENTURY – REMETALLING OF THE *VIA PRAETORIA* (figs. 8.6 and 9.1)

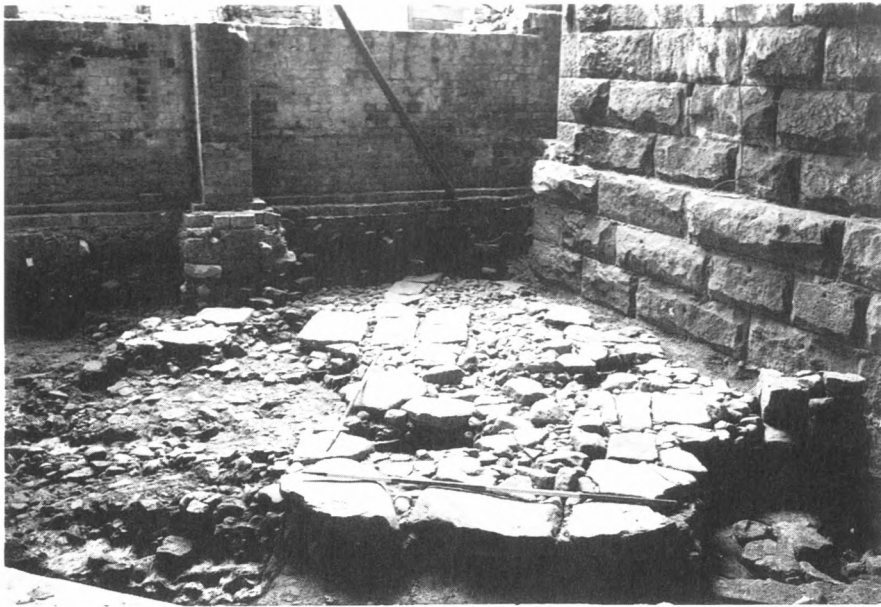
Fig. 9.1 Remetalling of the *via praetoria* in the second half of the fourth century incorporating heavy blocks and re-used stones. Viewed from the south.

Further south there was patching (154R3*) over the hollow in the street caused by subsidence into the earlier pit mentioned above. This was overlain by a metalling (147R3) of large slabs and cobbles (fig. 9.1) similar to the metalling (557) to the north, also covering the roadside drains. Plans (fig. 8.6) and photographs (fig. 9.1) suggest that re-used Roman facing stones and larger dressed blocks were incorporated. Compacted brown soil (148R3*) filled hollows in the metalling. This metalling

closely resembles in character the latest metalling of the '*via principalis*', in that both incorporate many large slabs and both ignore and overlie the roadside drains of previous periods (see Part 5). The metalling of the *via praetoria* similarly overlay the patching of a hollow (154R3*) which contained Local Traditional Ware, while the latest metalling of the '*via principalis*' (290C) also contained Local Traditional Ware.
