12. The Fort in the Post-Roman Period and During the Earliest Anglo-Saxon Occupation

INTRODUCTION (FIG. 1.6)

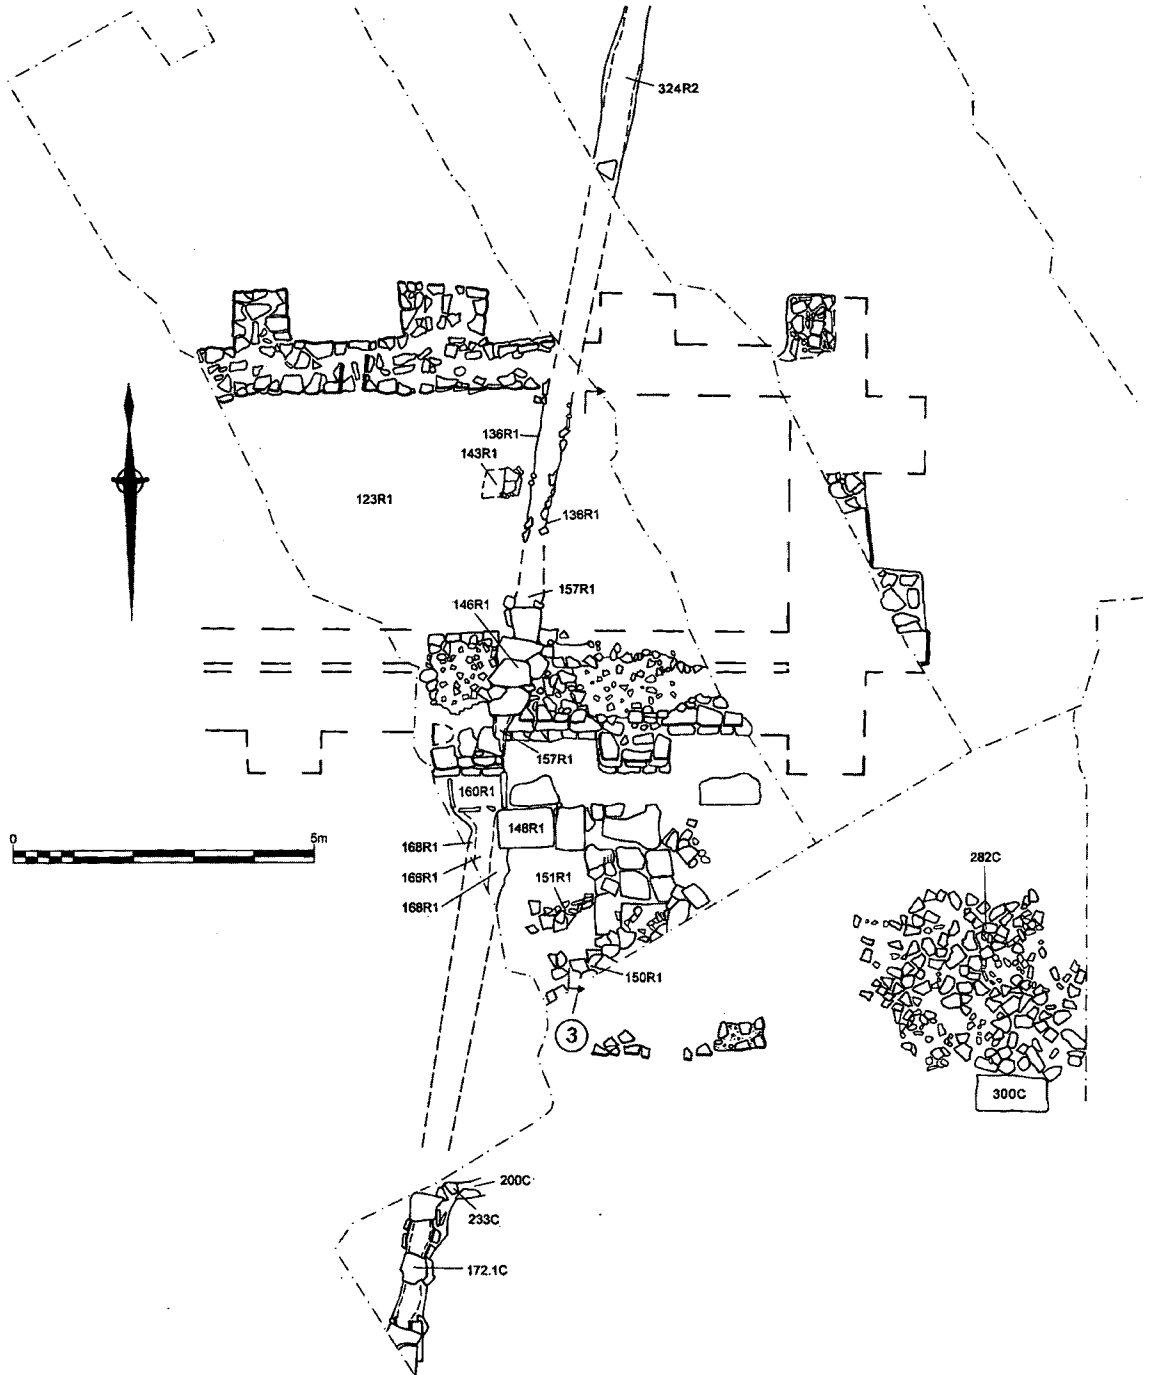
Fig. 12.1 The earliest Anglo-Saxon features, pre-dating the cemetery, including a water tank and a drain cutting through the remains of the west granary and the north-east corner of the praetorium. The former street surface was overlain by large stone blocks, a fragment of mortared wall and a raft of laid rubble. Section 3 is shown on fig. 6.3. Scale 1:125.

The drain survived as several discontinuous lengths, interrupted by modern features. The most northerly length of the main channel was represented by a robber trench (324R2) cut through the metalling (335R2) to the north of the granary. Immediately inside the granary north wall was another length of channel (136R1). A possible trace of a substantial stone lining survived; running parallel to the east side of the drain was a short length of construction trench containing dressed facing stones (143R1), with rubble packing behind.

A third length of drain (also contexted as 136R1) survived where it cut through the south wall of the granary, to the east of the third buttress. The construction of the channel had removed dressed stones from the inner face of the wall and had cut through the rubble core. The sides of the cut had been lined with large cobblestones and there was also a lining of orange clay (155R1* and 157R1), the latter spread out over the stones of the buttress (shown on slides in the archive). The large drain cover slabs (146R1) survived intact. When it reached the outer edge of the wall, the drain forked. A side channel running west had been cut across the buttress foundation; no lining or cover stones survived on this branch.

The main channel appears to have run over the top of the surviving facing stones of the buttress and through the north-east corner of a stone-lined tank (160R1), which was 0.80m by 0.50m in size (fig. 12.2). The construction pit for the tank cut the latest metalling of the 'via principalis' (174R1, 154R1*, 149R1*) (see Part 5, p. 53 and fig. 6.7). The slabs forming the one long side of the tank rested on the lowest offset course of the buttress, and the rest of the tank projected out into the street. The bottom of the tank was lined with orange clay (169R1*), and similar clay (168R1) lined the sides (fig. 12.1). From the southern edge of the tank, a continuation of the main drain channel (166R1) was seen to cut the street metalling for a short distance before being truncated. The cover slabs and lining stones had been robbed, but

Wall and rubble surface over the former '*via principalis*' (fig. 12.1)

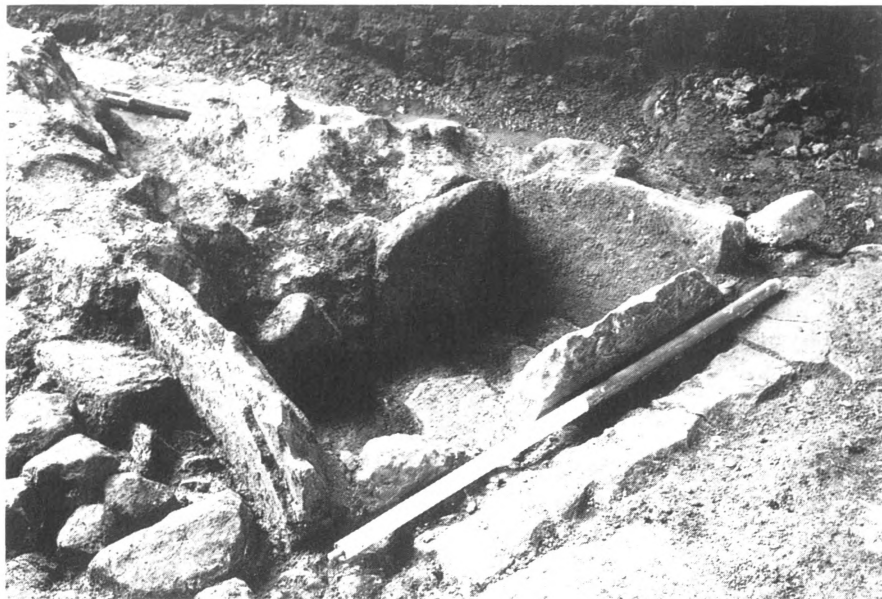
Fig. 12.2 Water tank belonging to the earliest Anglo-Saxon activity, abutting remains of west granary wall. Viewed from the north-east.

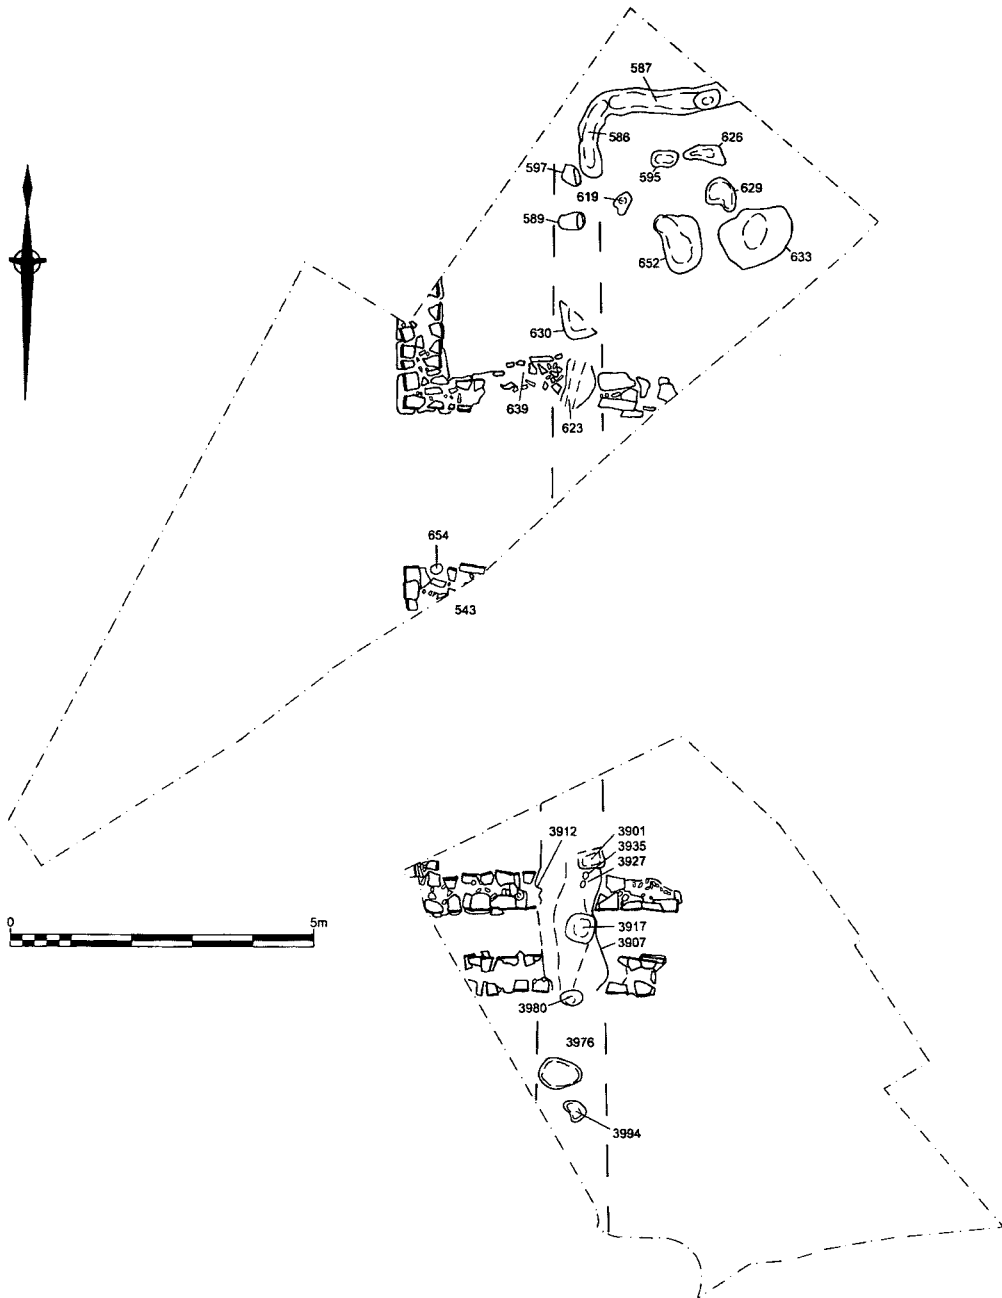
Fig. 12.3 The north-eastern area in the earliest period of Anglo-Saxon activity, showing a north/south alignment of post holes set in a V-shaped slot cut through the remains of Buildings I, III and IV. Scale 1:125.

which could represent either a fence or a timber structure (fig. 12.3). The post holes lay within a slot cutting through the remains of Buildings I, III and IV. Because of the build-up of debris and soil layers, it is unlikely that the remains of the walls would have been visible by this stage; their outlines are shown on fig. 12.3 purely in order to locate the later features in relation to them. It is significant that the slot cut a layer of disturbed masonry (4006*) containing human bone, suggesting that the alignment was of Anglo-Saxon rather than sub-Roman date.

In the area of former Buildings III and IV, a slot of V-shaped profile running north/south (3907/3912) (figs. 8.1 and 12.3) cut through the remains of the north wall of Building IV, the south wall of Building II, the south wall of Building III, and the accumulation of material (3915*/ 3955*) which between the buildings and contained fallen sandstone roofing slates and red deer antlers. It also cut two stake holes (3935, fill 3934* and 3927, fill 3926*), which themselves cut the footings of the wall of Building III. The slot could not be traced to the north or south, possibly because it ran through deposits heavily disturbed by grave cuts. The fill of the slot was clay and ash with stone fragments (3906*/3897*). This in turn was cut by two post holes (3901, fill 3899*, and 3917, fill 3916*); a third post hole (3980*, fill 3979*) lay just beyond the surviving southern end of the slot, with a fourth (3976, fill 3977*) further south. The four were equidistant and in line north/south, suggesting they were part of the same feature. A truncated fifth post hole (3994, fill 3993*), adjacent to 3976, may also be associated. The line is *c.* 3m east of the eastern edge of the Roman *via praetoria*, which raises the question of whether the street was still usable by that time, or entirely covered by soil accumulations.

In the area of the former Building I there was also an alignment of features similar to those cutting the remains of Buildings IV and III (fig. 12.3). A pit or slot (623) cut through the remains of the south wall of Building I, and to the north of it was part of a pit (630), which could have been an extraction pit for a post hole. Beyond that were two post holes (597 and 589) both containing packing stones. These two post holes cut the late ashy layer (583*); the other two features on the same line apparently did not have a direct relation to it.

Cutting the metallurgy to the north of Building I were two features which appeared to be post trenches (fig. 12.3). One trench (587) aligned east/west, contained a post hole at the eastern end. Adjoining the western end was a shallower trench (586) running north/south, which petered out after a length of *c.* 1.50m. It was not quite aligned with the row of post holes described above, but in view of the disturbed nature of features in this area, it is certainly possible that these trenches represent the truncated continuation of the north/south alignment, and its east/west return. At the southern end of the excavation area, a small post hole (654) cut the north wall (543) of Building III.

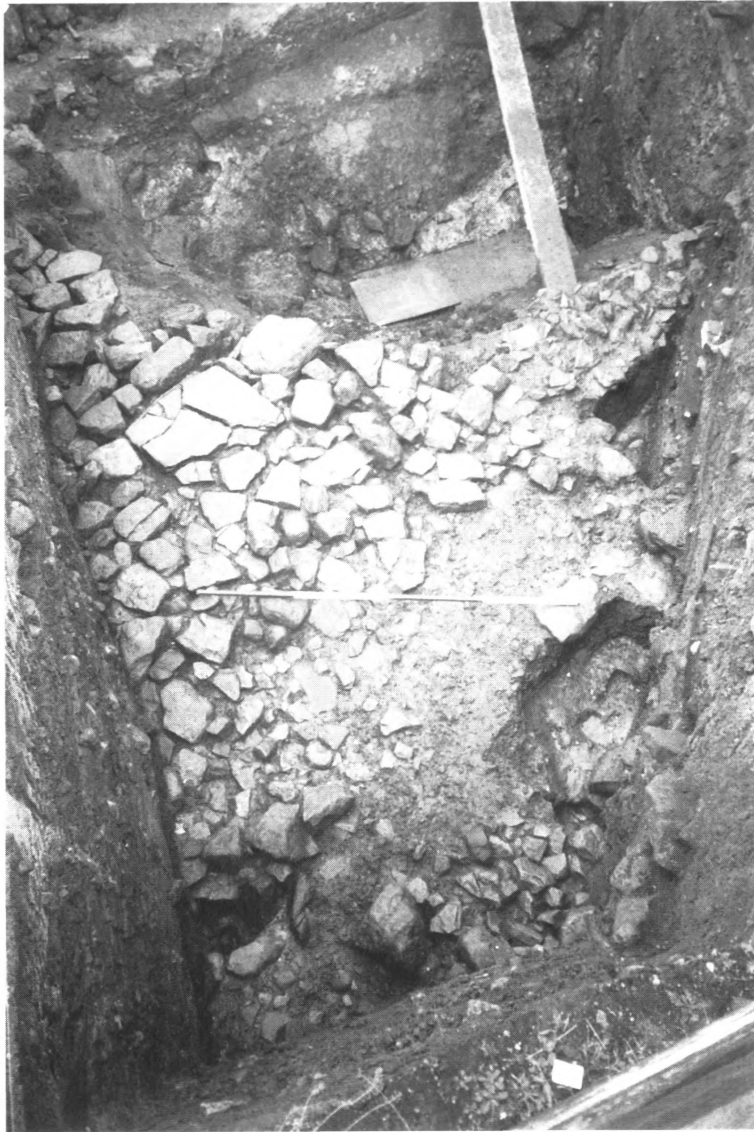
Fig. 12.5 Remains of the earlier of two layers of paving (2470/2487) overlying a demolished sector of the northern fort wall. Post holes and pits at right and lower left. Viewed from the south-west.

Fort wall, west. This part of the fort wall was demolished. The layer immediately overlying the remains consisted of demolition material (2499*) of broken stones and mortar. A surface of large stones (2470/2487), Paving 1, was deposited over the demolition material of the fort wall and the remains of the latest Roman street and disused drain (fig. 12.5). Plans and photographs show that this paving, a second layer above it, and two layers of paving found in the extra-mural area (see below) were not quite the same in character and appearance as the street surfaces of large slabs and cobbles found in the fort in the second half of the fourth century.

Just appearing at the southern edge of excavation were parts of two large square or rectangular pits (fig. 12.5). One pit (2457) filled with loose rubble (2459*) measured 0.90m by at least 0.70m; one edge was cut by a smaller post hole (2466) filled with gravel (2467*). Another pit (2461) measured 1.30m by at least 0.50m and was cut by a smaller post hole (2465) filled with compacted clay and stones (2462*). The pits were sealed by clay layers said in the archive to be Anglo-Saxon or Norman.

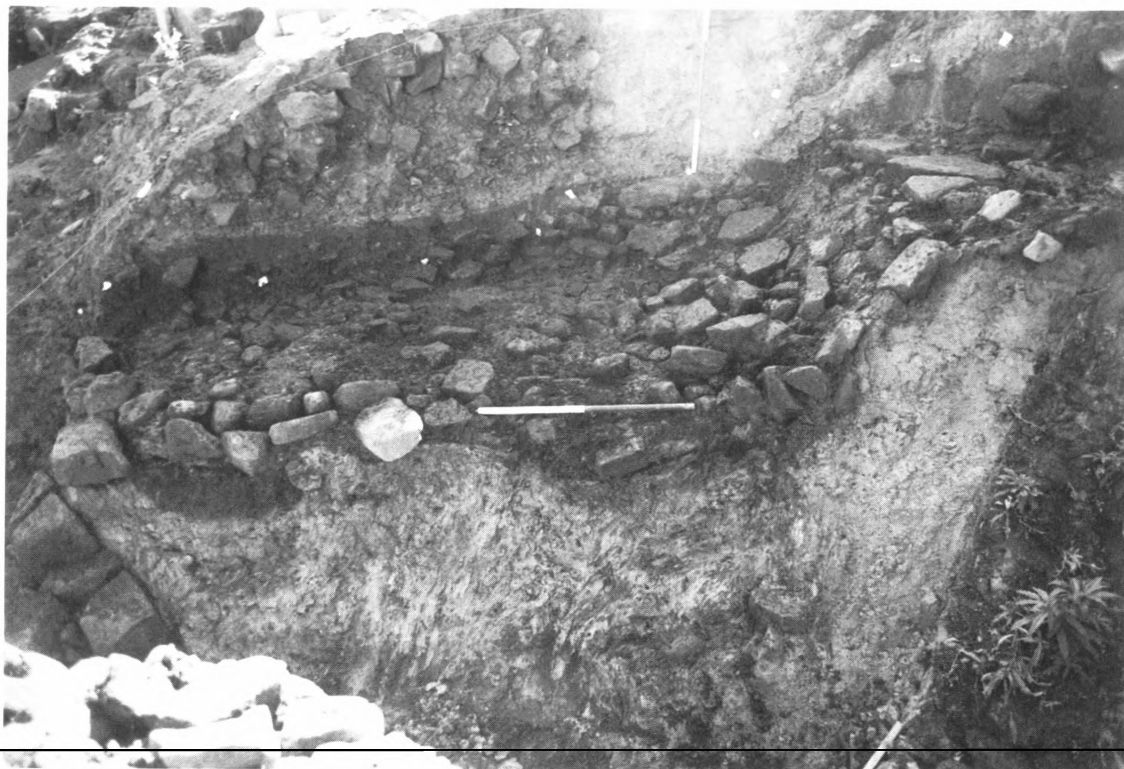
Fig. 12.6 Earlier of two layers of paving (2200) in the extra-mural area. The steep drop in this layer, at the upper right, suggests a landslip at some time in the post-Roman period. Viewed from the north-west.

A surface formed of rubble (2200), Paving 1, was found on top of the eastern end of the narrow surviving strip of ground and extended further east over the flat triangular upstand (fig. 12.4). The paving fell in a sharp drop of more than 1m from the top of the strip down onto this triangular area (figs. 12.6 and 12.7A), suggesting a landslide at a later period (see below).

Another surface of rubble paving (2174) occupied the same area as the previous paving (2200). Like its predecessor, it fell down a steep drop, likely to have been caused by a landslide later in the post-Roman period (figs. 12.6 and
