Variation in the form of the Ditch, and of its equivalents, on Hadrian's Wall

Humphrey Welfare

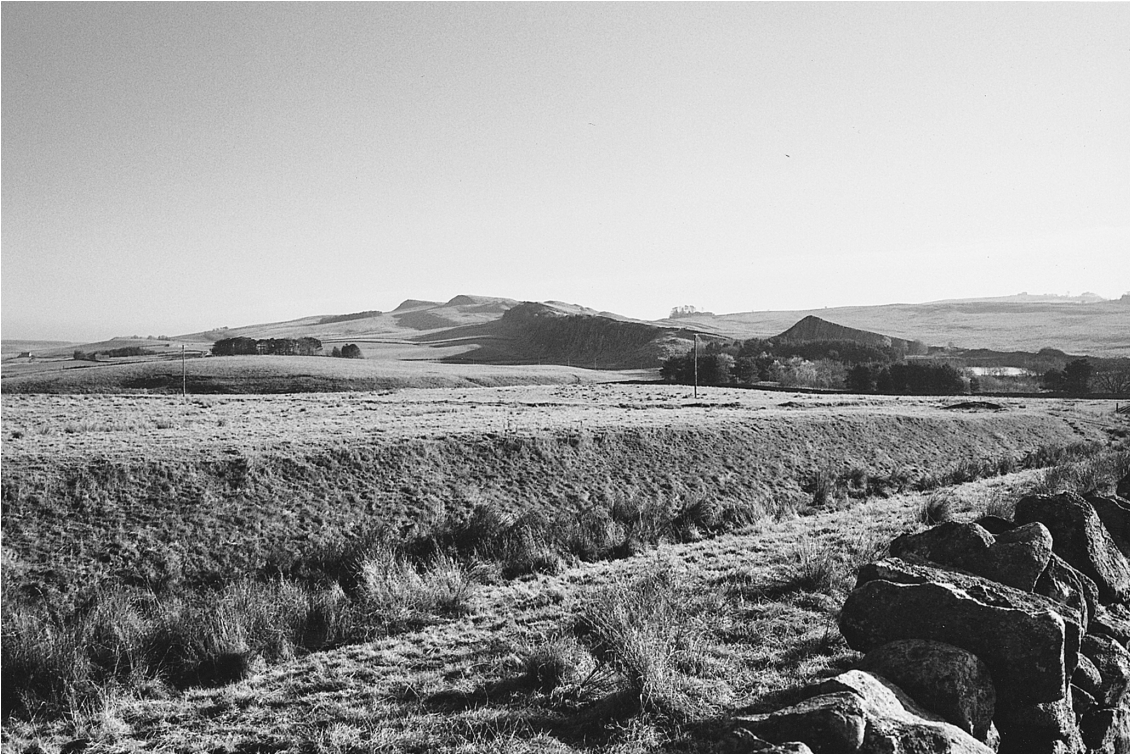
Fig. 1 The Ditch, with its smooth Glacis on the far side, immediately to the W of Burnhead.

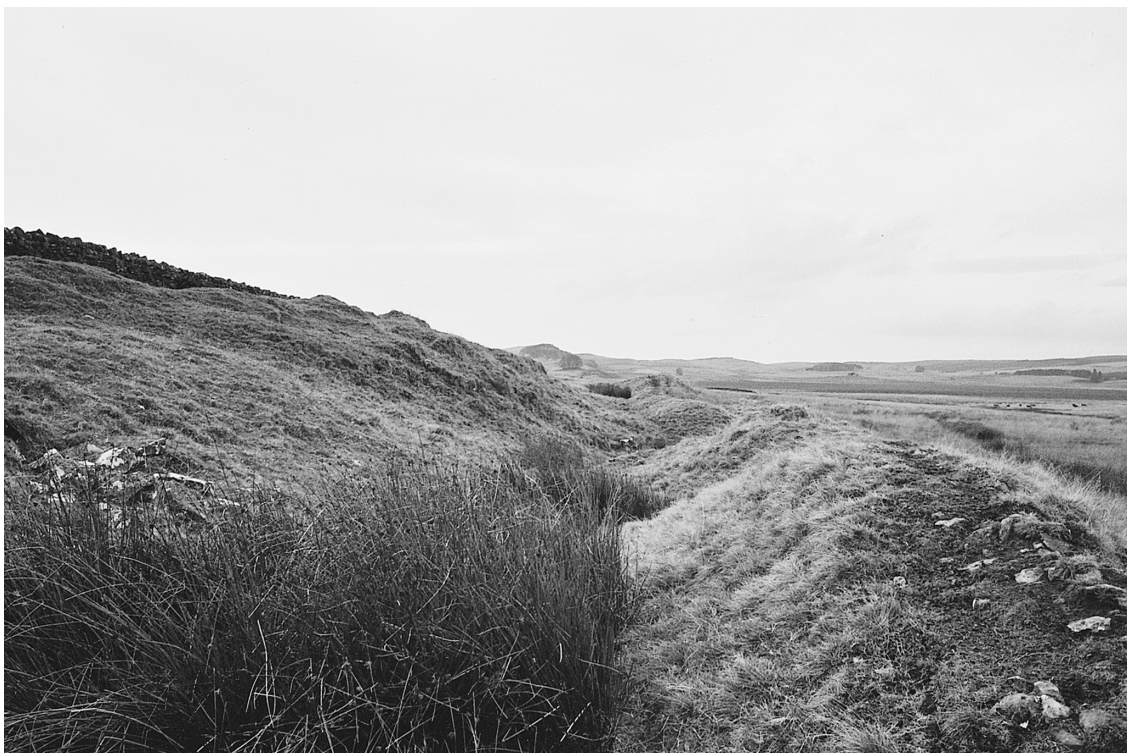
Fig. 2 The pronounced Counterscarp Bank to the W of Milecastle 33; its inner scarp here is 1.5m high. Hadrian's Wall lies under the field-wall on the left.

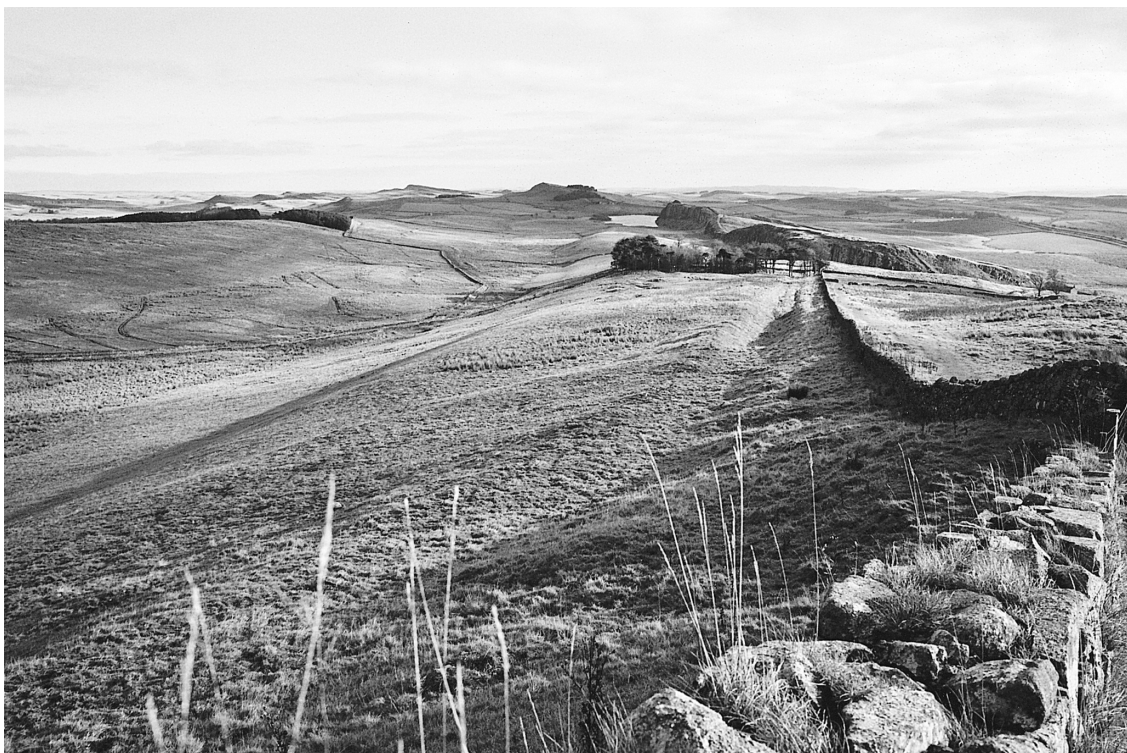
Fig. 4 The view E from Milecastle 40. The Ditch of the Wall, and the Glacis, end suddenly in the middle distance; they are replaced by the Counterscarp Bank (consisting of scraped-up overburden from the 'Minimal Ditch') and then by a single extended scarp.

An example of the first of these two types may be seen (fig. 4) on the eastern flank of

Winshields (NY 746675), approaching Milecastle 40. Here the Glacis is suddenly replaced by the Counterscarp Bank, composed mainly of rubble and standing up to 3 m high externally. This extends for 120 m before it is reduced to a simple outer scarp for a further 35 m. At this last point, 100 m up the slope from the butt-end of the Ditch, opposite Milecastle 40, the slopes of the Whin Sill are once again sufficiently steep that no further artificial defence was necessary. To the W of the butt-end, inside these outer defences, the line of the Ditch survives as a terrace about 4 m wide, its southern edge formed by the North-facing scarp of the Berm, 1 m high. Only the overburden, and nothing more, was removed by the Roman engineers (*cf* Birley 1961, 80). Less than two miles to the E, in Crag Lough Wood (NY 769679), where the ground rises westward to Highshield Crags, the same general design

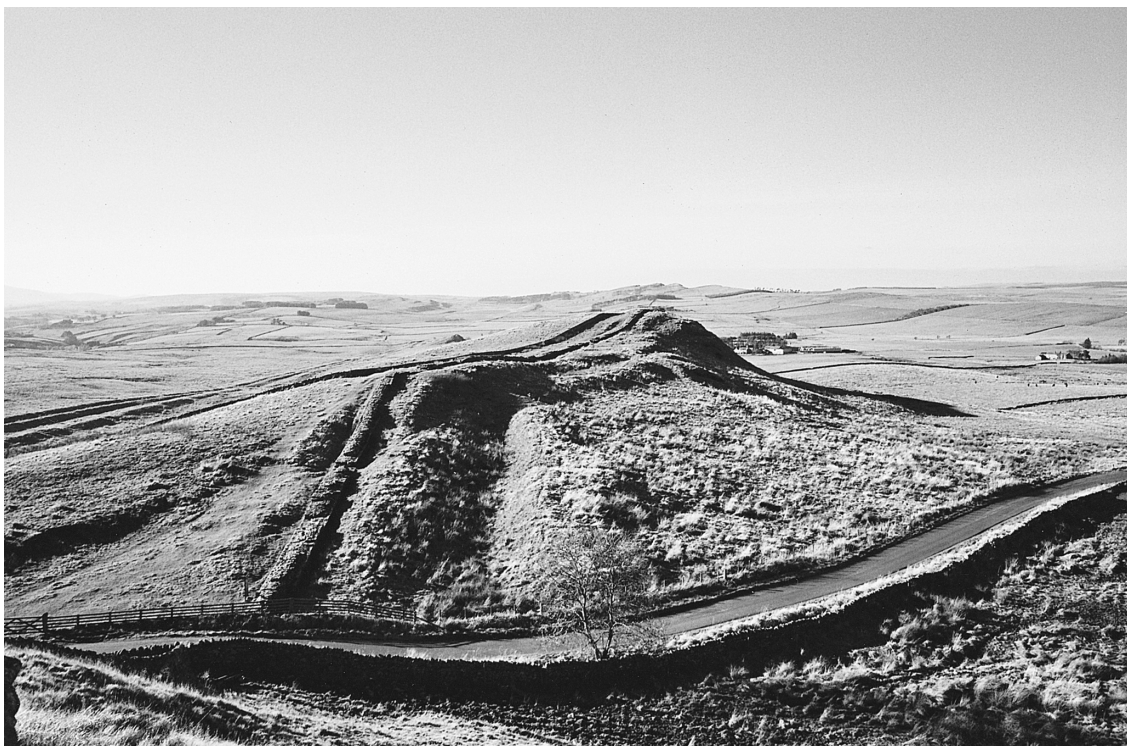
Fig. 6 The eastern side of Caw Gap where the Ditch becomes a terrace before this merges with the steeper slopes of the crags in the middle distance.

A further example of this combination of scarps can be seen immediately to the E of Caw Gap (fig. 3; fig. 6) where two short segments of the Ditch (NY 725668; 726668), each with neat butt-ends, were provided with a Counterscarp

Bank. Between these two segments there is an unexcavated boss of rock that seems to have been the pivot of a minor re-alignment. The Roman engineers appear to have baulked at driving the Ditch through this solid obstacle. The Berm here is 4 m wide; its outer scarp, 3.5 m high, forms the forward face of the outcrop. Lower down the slope, beyond a terrace 4.6 m wide (which represents the line of the Ditch), the outer scarp of the Counterscarp Bank (1.5 m high) also continues. At the western end of the more westerly Ditch segment the N-facing scarp of the Ditch and that of the Counterscarp Bank, still divided by a terrace, fade into the rising crags. It is noteworthy that to the S of this segment of the Ditch the Berm has been widened appreciably, to 14 m – i.e. the Wall and the earthworks of the Ditch are diverging in another pragmatic response to the topography.

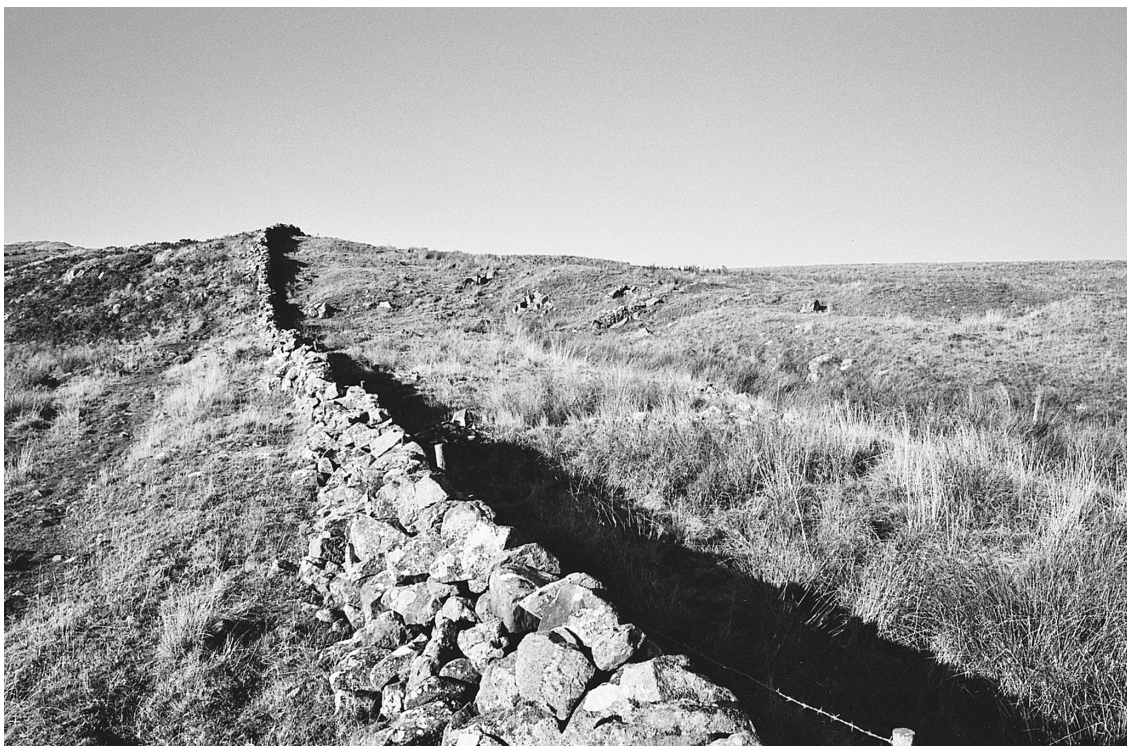
Fig. 7 The Ditch, on Allolee Rigg, ends at an outcrop of the Whin Sill. On the right, the attempt to flatten a hillock on the line of the Glacis was abandoned. The N face of Hadrian's Wall forms the base of the field-wall.

These instances of the absence of the Ditch do not appear in the literature. The textbook example is that on Allolee Rigg (NY 690669), to the W of Cockmount Hill, where the line of the Wall closely follows the northern edge of the Whin Sill; here the sudden geological changes ensured that the pragmatism of the Roman construction was more complex than is usually implied. One Roman mile to the E, between Burnhead (NY 711666) and the fort at Great Chesters, the Ditch and the Glacis are well preserved (fig. 1); this state of survival diminishes (as one would expect, given so much later activity) in the immediate vicinity of Great Chesters farm itself. To the W (NY 699668) there is now no more than a slight scarp on the N crest of the Ditch, and at a point about 200 m to the E of Cockmount Hill the earthworks have disappeared altogether. Clearly some of this can be attributed to cultivation but the absence of the earthworks must also beg the question whether the Ditch was ever dug here, for geological fieldwork has demonstrated that the dolerite of the Whin Sill meets the line of the Wall again just to the E of Turret 43A (Johnson 1997, 34). The engineers may have been caught unawares for in this stretch the Whin has not formed any crags; as far W as Milecastle 44 there are no steep slopes and the presence of such an intractable rock would not have been suspected. Between Burnhead and Cockmount Hill the partial absence of the Ditch may not have been considered critical as the land to the N dips gently, maximising visibility and providing no dead ground, before rising to the next ridge about 400 m away.
