The Gates of Prudhoe Castle

Robin Dower, Jane Geddes and David Sherlock

SUMMARY

The late medieval gates of Prudhoe Castle were restored and re-hung in 2003. During this work the complex history of their repairs and alterations was examined and samples of wood taken for dendrochronological dating. One of the trees used was felled in AD 1459–1484. The paper describes the ironwork and carpentry techniques employed, and sets the gates in their historical context.

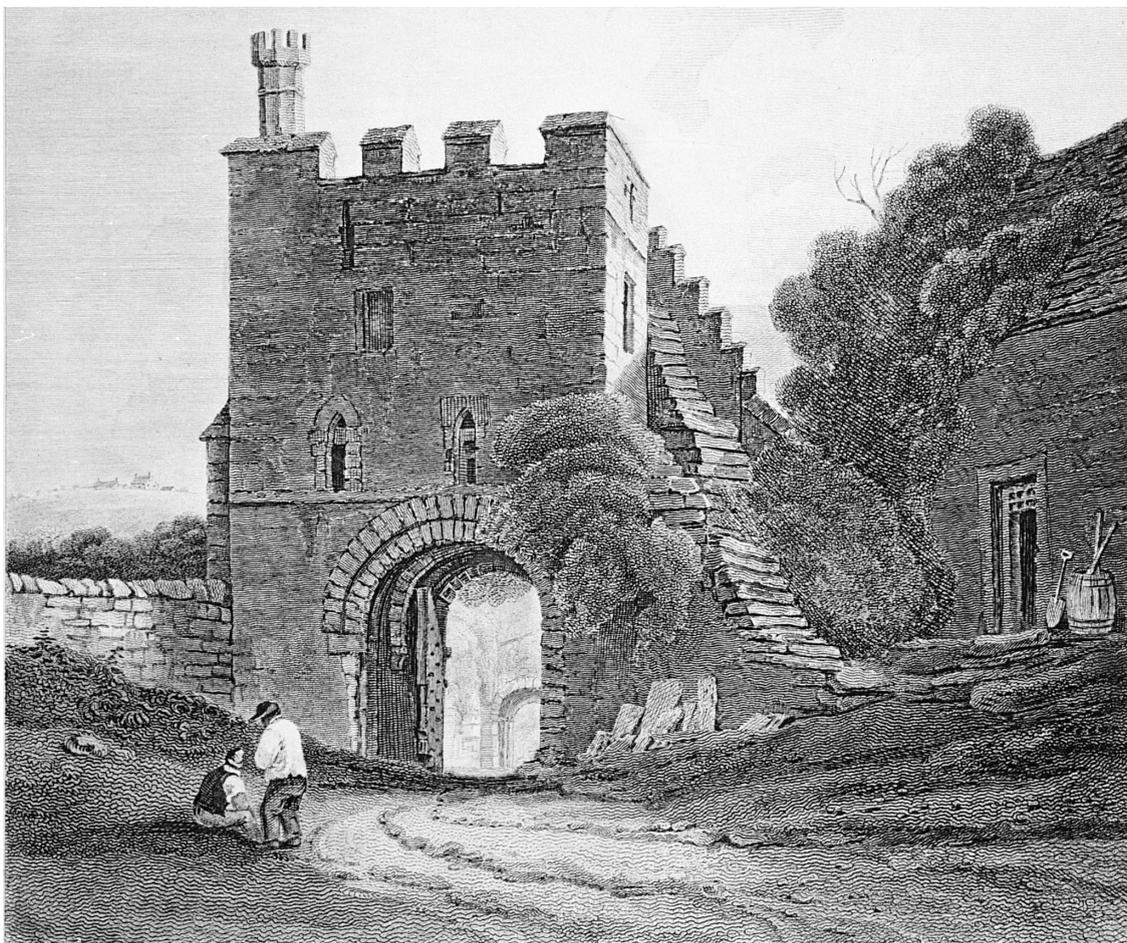
Fig. 1 The gatehouse from the north, showing gate or probably gates open, from an engraving published in Scott 1814.

There are no early antiquarian drawings of the gates themselves. The Buck brothers' 1728 engraving of Prudhoe (reproduced in Saunders 1993) shows the archway in shadow, which might imply that they were then hanging and closed. The engraving published in 1814 shows the right-hand gate open (fig. 1), but Walter Scott's accompanying text rather implies that the gates had lost their frontal boards because he wrote 'a lattice or open gate still remains, joined with studs of iron' (Scott 1814, 91–92), copying exactly the words of Hutchinson in 1778 (1778, 124). About a decade later Anthony Salvin's drawing of the top corner of one gate (fig. 2) may or may not indicate the boards are missing. Salvin, the fourth duke's architect, restored parts of Prudhoe and was probably responsible for the insertion of the massive iron tie-bars in the upper walls of the gatehouse (fig. 4b, below), but it is not known if he worked on the gates. The earliest photograph we can find, taken in 1944, shows the gates hanging, but open so there are no details of their construction visible (National Monuments Record, A44/10748).

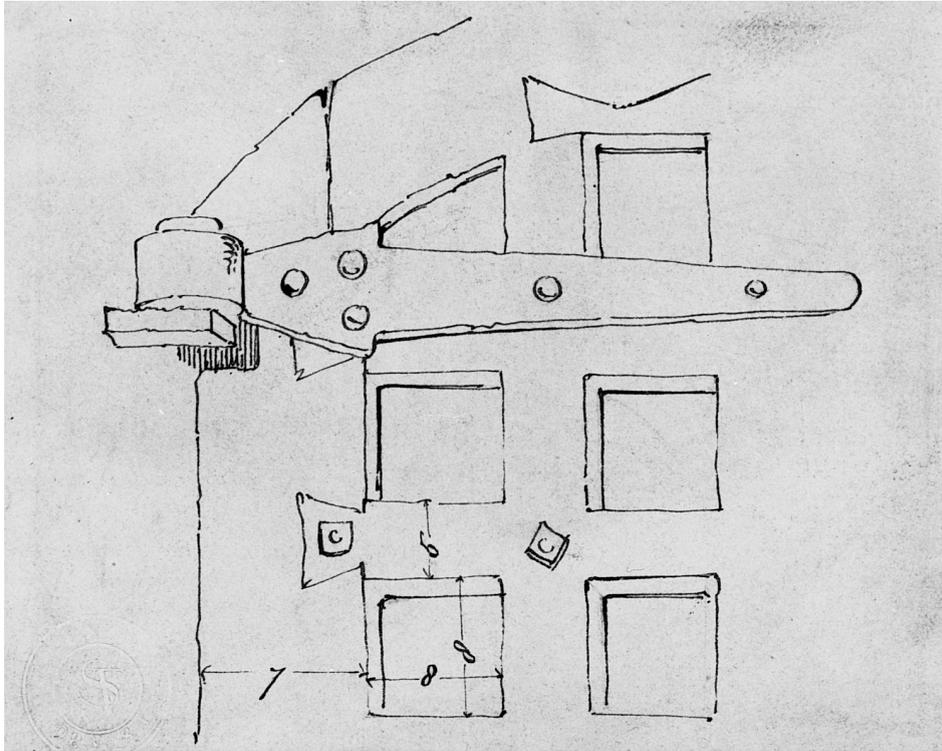
Fig. 2 Drawing of inside top of hinge-stile of the right gate, by Anthony Salvin, n.d. but c.1824. Copyright RIBA Library Drawings Collection.

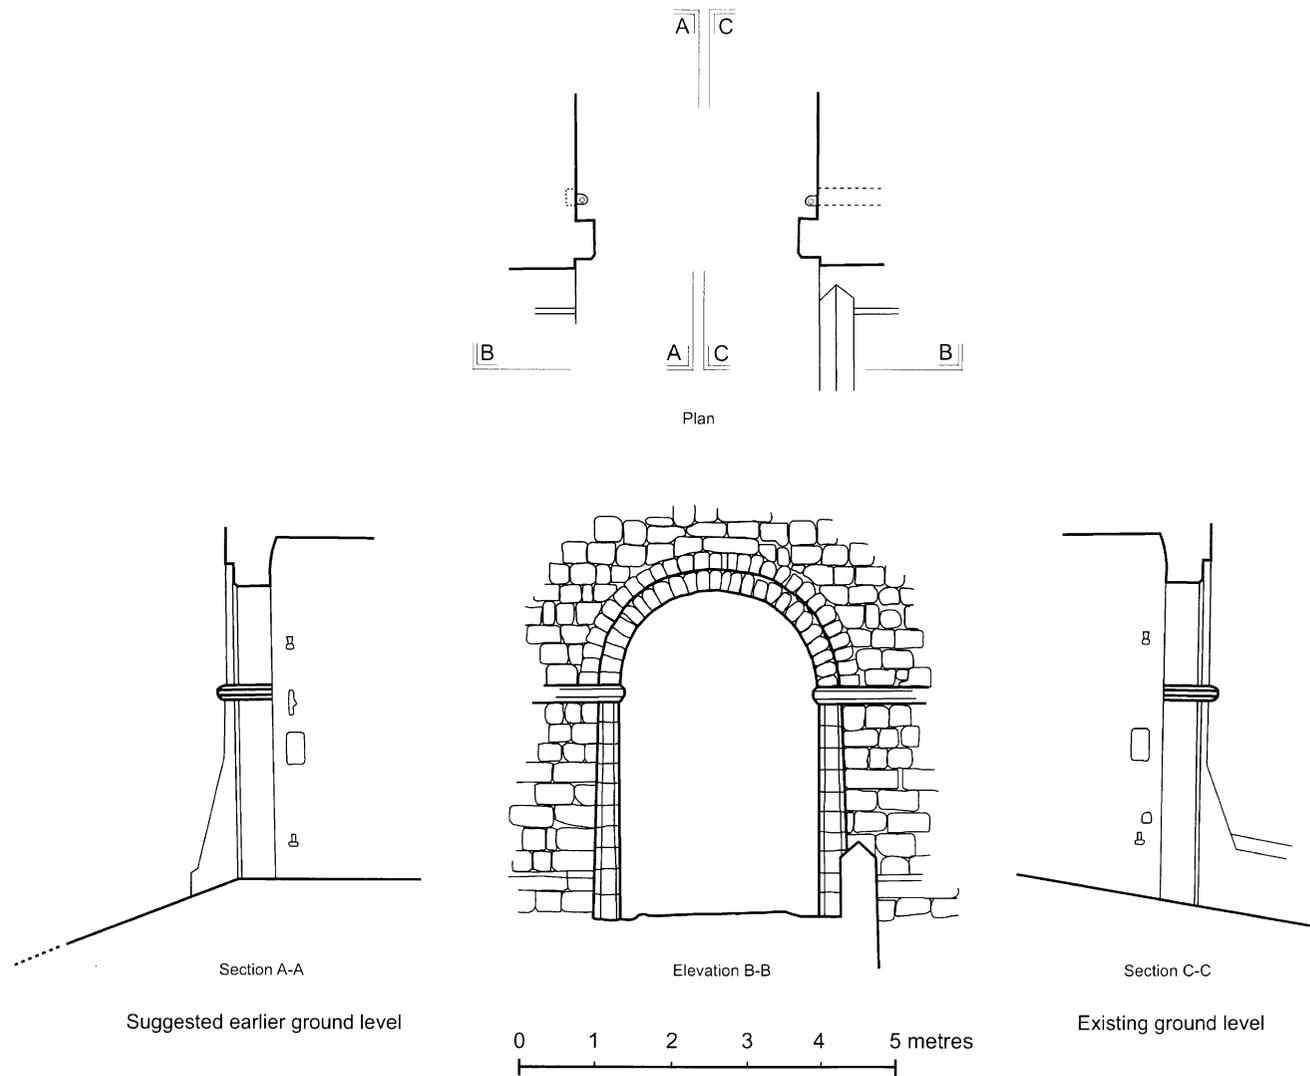
Fig. 3 Plan and cross-section of the gatehouse southern arch and jambs where the gates now hang (1:100).

It is apparent that the present cobbled surface of the gateway is modern because there is a gap beneath the gates wide enough for a person to slide under. The original surface would have been higher here and then fallen more steeply outside the gates (fig. 3, section A-A). Dodds adds 'the gateway has no portcullis, and is an early example of its class, the date of which

very common from the second half of the fourteenth century onwards, but begin as early as *c.* 1330 (Geddes 1999, 28, 7). By contrast, coach bolts with a standard screw thread were only invented in 1841 when Sir Joseph Whitworth refined the machinery that was needed for cutting accurately angled threads in metal. Although screw threads were clearly understood and used before this date, the mass production of standard bolts only began in the mid-nineteenth century. The main repairs to the gates, judging from the coach bolts are therefore later than *c.* 1841. That may be the time when the gradient of the passage floor was altered to the present steady rise (fig. 3, section C–C). Careful adjustments on the hinges were

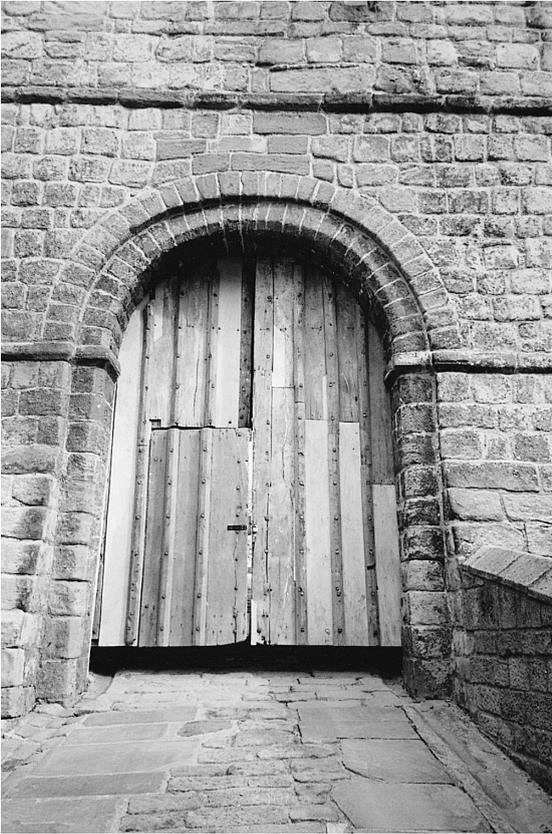
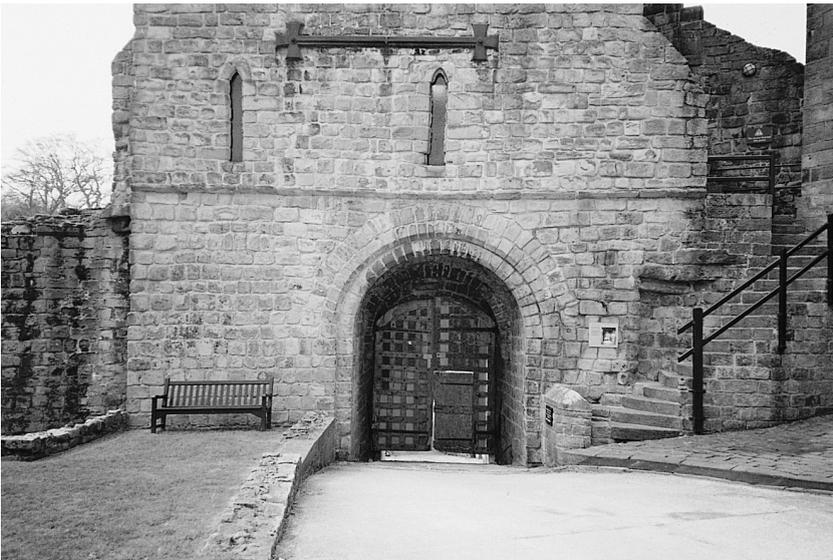
Fig. 4 The newly repaired and re-hung gates, a. from the outside, b. from the inside.

DESCRIPTION (figs. 4 and 5)

Both gates are basically portcullis-braced with ledges dovetailed to the hanging and opening stiles. The curved top member of the frame is morticed and pegged into the stiles. The frame is covered with flat boards on the front, with moulded ribs covering the joints of the boards, except in the centre where the gates meet. The hanging and opening stiles are 25 mm thicker than the ledges and uprights of the frame so that the front of the boards finishes flush with the front of the stiles. The gates measure 3.77 m high and their combined width is 3.04 m. They hang on two pairs of pintles within an archway which is 3.17 m wide.

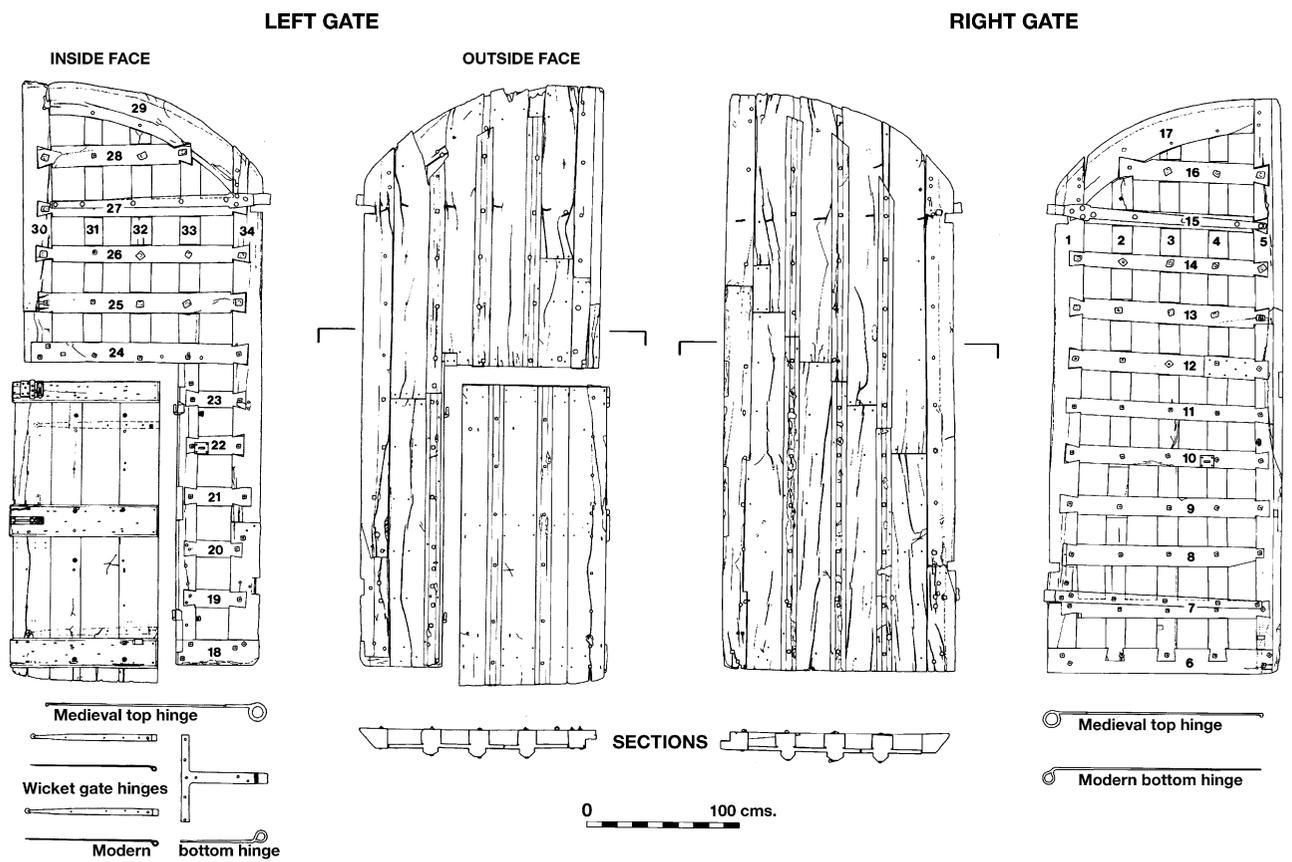
Fig. 5 Survey of the gatehouse gates in 1986, from an original drawing at 1:10 by Mark Fenton for English Heritage, reproduced here at 1:50.

The frame has already undergone some repairs. There is a scarf joint on the opening stile under 13 (see drawing, fig. 5). The angle of the scarf rebate is such that the lower end of the stile has to be secondary and it was slipped under the dovetail at 13. The bottom of stile 1 is also replaced between 6 and 7. The ledges 6–11 are replacements. Ledge 8 is a re-used piece of wood: on the hanging side it has a square, not dovetailed, tenon and on the other end the ledge tapers to produce a very small tenon. The right end of 12 is a scarfed repair.

The upper ledges 24–29 are original. The stile 33, from which the wicket hangs, has a scarf joint at the top of the wicket, and all the lower ledges, 23–18, are replacements. The hanging stile is original down to 20.

Once again the iron corroborates the evidence of the carpentry. All the new work is attached by round-headed coach bolts (on 18–24), rectangular medieval roves are used on 25–29 but two modern coach bolts attach 25 and 26 to 31. The portcullis frames were assembled and bolted to the stiles and head before the boards were nailed; ribs were attached by longer bolts which also secured the cross joints to the frame.

Hinges and other ironwork (figs 5 and 6)

The top hinge on each door is a plain strap with an enlargement at the hanging end and a raised nib at the tip. These hinges are original. The bottom hinges are plain straps with smaller eyes than those at the top. They appear to be replacements. The T strap reinforces the lower left hinge which is shorter than the others since the wicket occupies much of the width of the door leaf. It appears from the pattern of redundant holes that this T strap has been reversed in order to off-set the door slightly from the timber post fixed into the original masonry rebate on this side. This adjustment has the benefit that the bottom edge of the door rises to clear the steeply sloping cobbled passage floor as the door opens inwards over it. The wicket hinges are plain straps with a flattened disc at their tip.

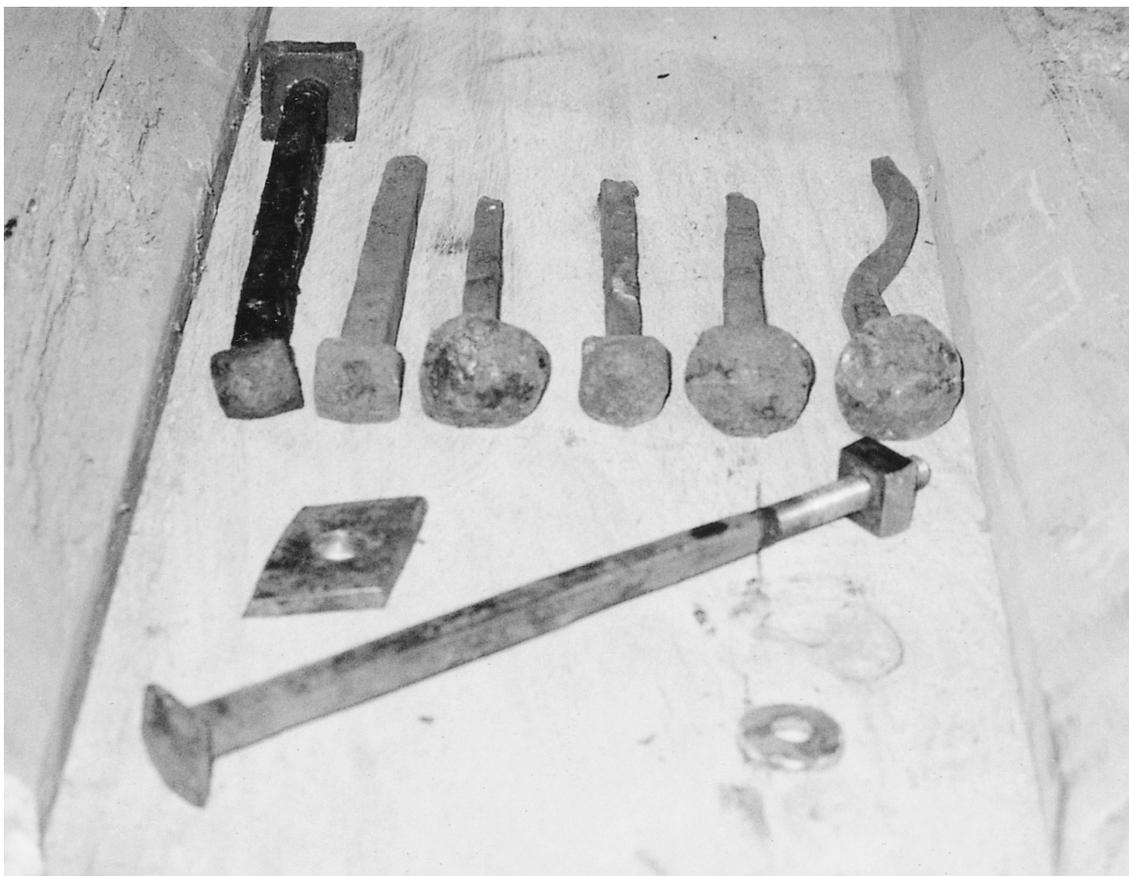
Fig. 6 Examples of the various iron bolts and nails used in the gates.

counter-sunk hole on the front of the door frame. The nail projected slightly beyond the rear plane of the door, a rectangular rove was threaded over it, and then the tip of the nail was hot-hammered (up set) into the rove to produce a tight fit. During the process of dismantling, the original nail heads became detached, so the rove and shank of the nail survive independently from the head. The medieval roves are of irregular size but rectangular. The modern roves are circular and are attached to coach bolts with screw threads.

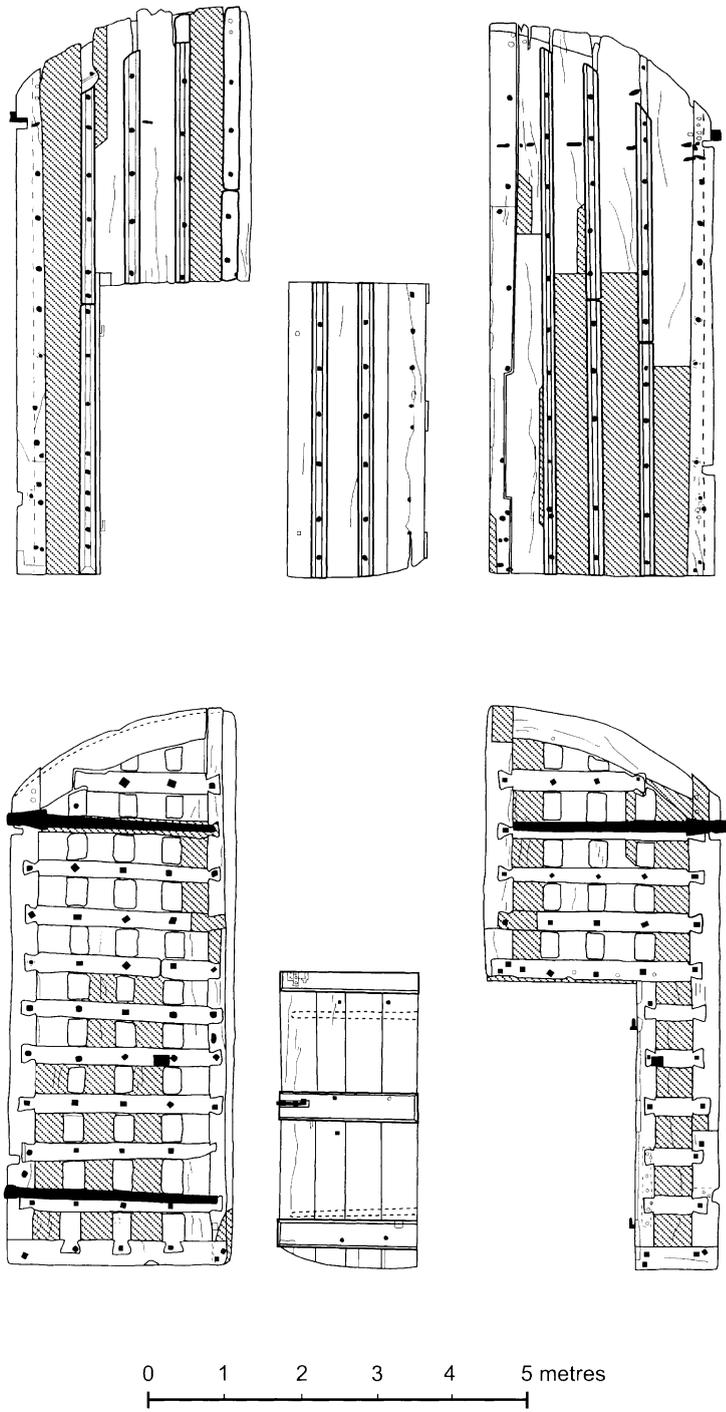
Physical damage to the timber of the gates was widespread. A number of the facing boards were severely split and large areas were missing particularly from the lower boards added in the nineteenth century when extensive repairs had evidently been necessary. Dovetails on the frame ledges were damaged or broken off and old scarf joint repairs formed in animal glues had opened up with weathering and relied only on nails to hold them together. Luckily very little "natural" decay from fungal or insect attack had been sustained though shrinkage cracks and shakes were extensive.

Fig. 7 The gates showing timber replaced in 2003. The new boards have not been treated or painted and should tone down to match the original wood in a few years' time. (1:100)

The fact that the gates had been dismantled allowed an approach to conservation which might not have been attempted had they been fully assembled. Each piece of timber could be separately handled and repaired before the whole gate was re-assembled, missing and damaged dovetails could be pieced in and scarf joints were all re-opened and glued afresh. For this work it was considered appropriate to use modern epoxy based wood glues so that each repaired piece could be restored to long-term full strength.

However, epoxy resin glues are too strong and unforgiving to use in assembly joining; so, where needed, in mortice and tenon joints traditional animal glues were used. Other halved cross-joints and the dovetail joints were re-assembled and bolted using animal glue. This approach will allow easy dismantling should future repairs ever be necessary.

The most difficult problem created by the dismantling was that so many of the bolts and rivets which held the gates together had to be cut to free them, with the result that most were too short for re-use. They had been bagged up but all had suffered some degree of rusting, the nineteenth-century bolts as much as the medieval rivets. Some of the longer bolts were re-used in the stiles where the original bolts had been shorter but new hand-forged wrought iron bolts with threaded ends and nuts were supplied for the rib through-frame positions. All the original roves (the rectangular flat plate washers on the inside face of the gates) were retained.

The gates have not been treated in any way. The new green oak boards are expected to weather quickly to the colour of the original
