Excavations at Vallum Causeways on
Hadrian's Wall in the 1950s*Brenda Heywood and David J. Breeze*

SUMMARY

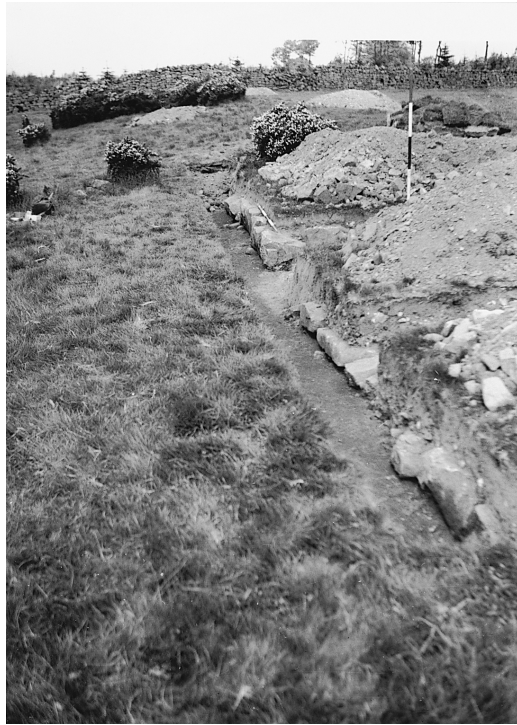
Fig. 3 (left) MC 23. Stone revetment on the south side of the north mound in Trench VIII looking west.

A thorough investigation of the north mound produced the necessary, though rather slender, evidence for the presumed original state of affairs. Trenches cut across the north mound revealed a most unusual feature which had already been found connected with the southern. Precisely where a gap in the mound had been expected there was a single course of masonry revetting either side of the virtually demolished north mound, representing a clearly continuous mound over which no sign of metalling could be discovered. The revetment continued on the south side of the north mound for some 13.4 m (44 ft), and seemed plainly original work (fig. 3).

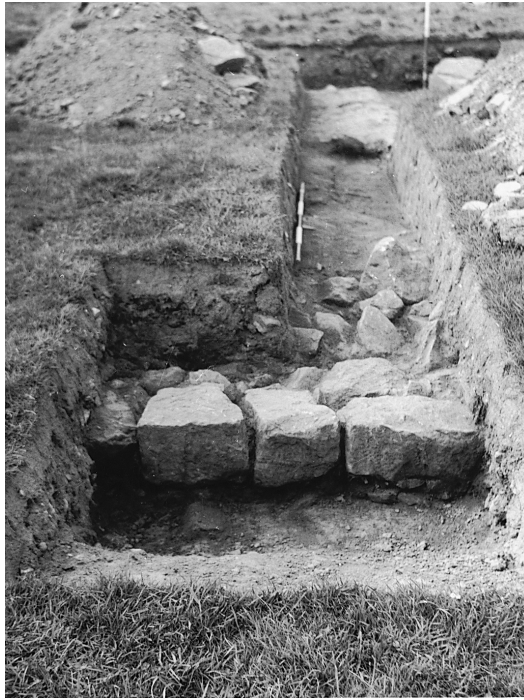
Fig. 5 MC 23. Stone revetment on the north side of the north mound in Trench IX looking south: the south revetment here had been ploughed away (see fig. 2)

The question of the relative date of the stone revetment of the north mound was further investigated (fig. 5). The existence of the turf cross-kerbs in the north mound proved the stone revetment, representing a continuous north mound, to be secondary work. Five small trenches were dug to confirm this evidence. Some 22 m (24 yds) to the west of the causeway site small trenches were cut over the north and south edges of the north mound. The northern

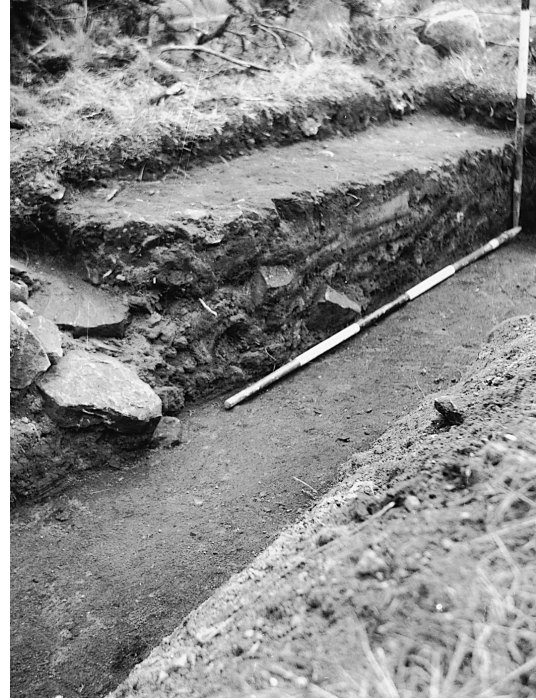
Fig. 6 MC 23. The south mound of the Vallum in Trench I showing the turf revetment on the south edge.

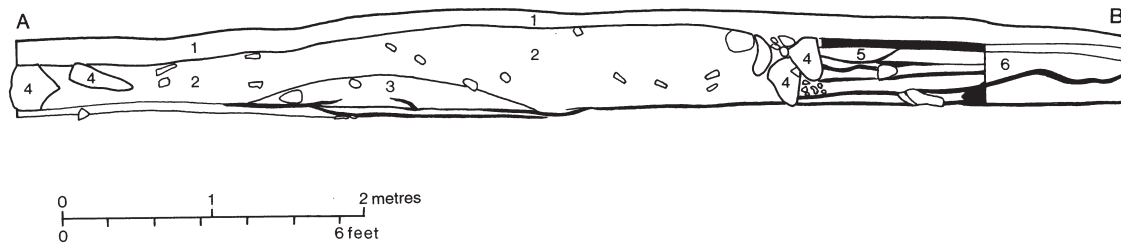
Fig. 7 MC 23. Section across the south mound looking east showing the two revetments in Trench I. (1:50)

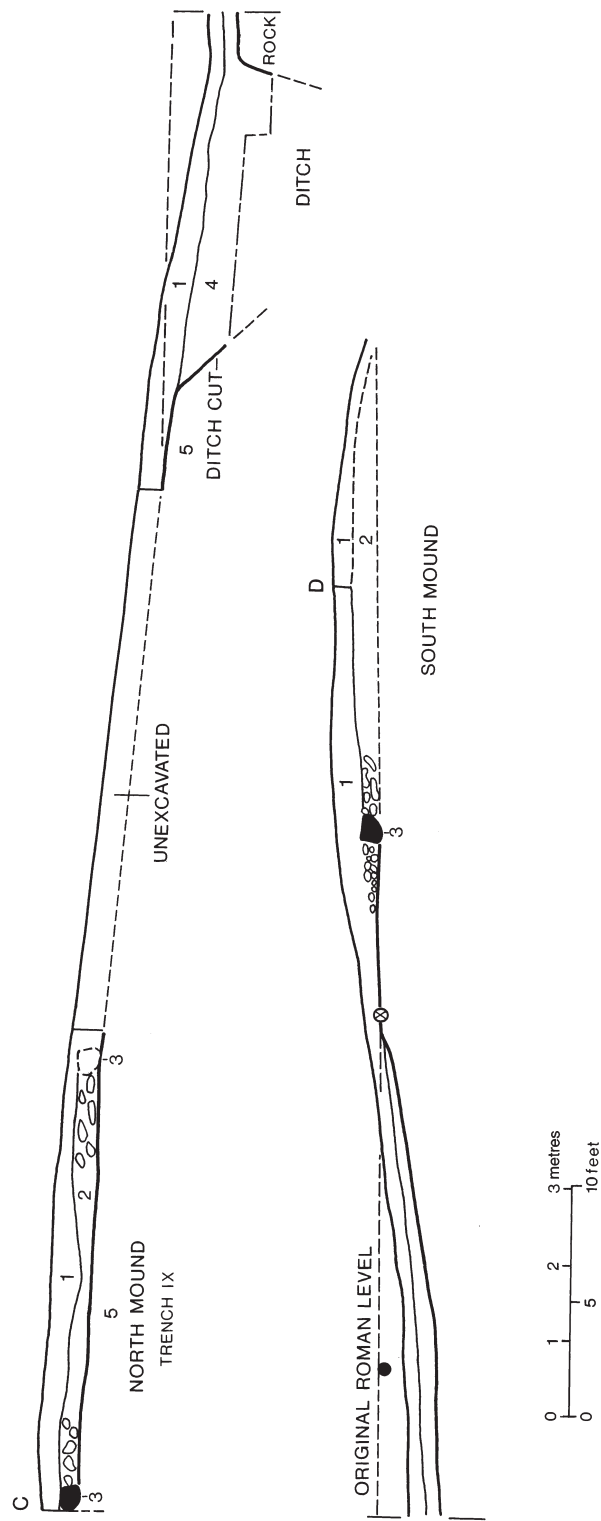
Fig. 8 MC 23. North-south section across the excavation. (1:100)

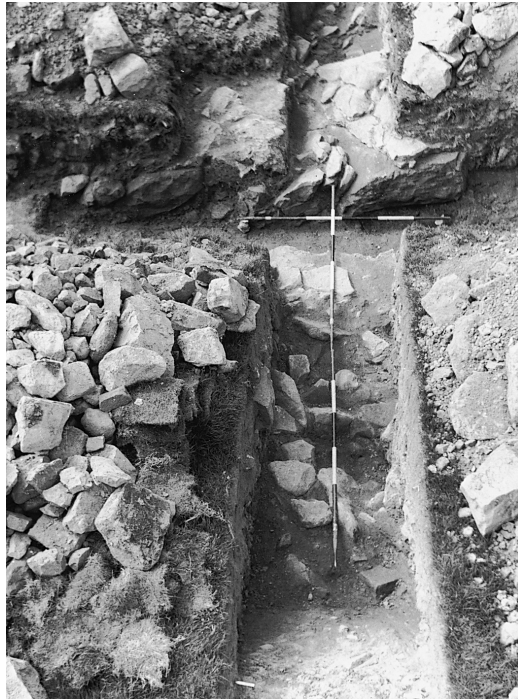
Fig. 9 MC 23. Vallum ditch looking south, showing the rock-cut south lip and secondary filling of the causeway.

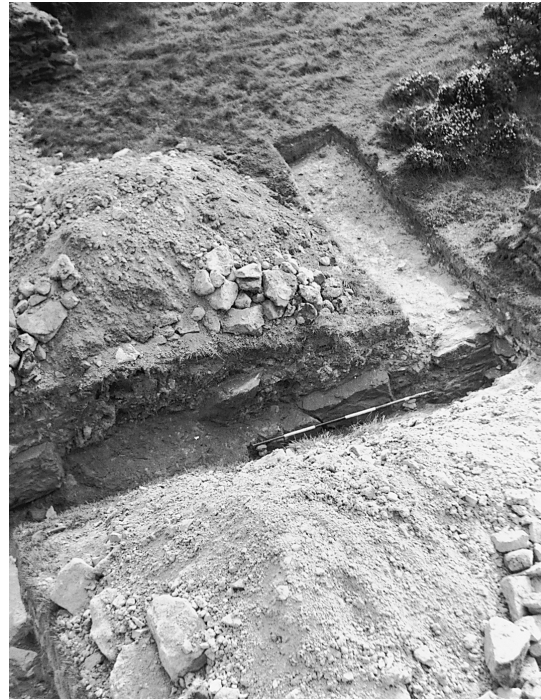
Fig. 10 MC 23. Vallum ditch at the west side of the centre trench showing the rock-cut south slope of the ditch.

The stump of boulder clay, clearly visible in the photograph (fig. 10) projecting slightly in front of the southern rock-cut slope of the ditch, was partially cut away, and was found to overlie dark material explicable as ditch silt. Beneath this the rock continued in line with that on either side. Yet the clay is quite different from the normal causeway filling and similar to natural subsoil. It may be explained as the clay from the south berm shovelled just over the ditch lip when the berm was depressed.

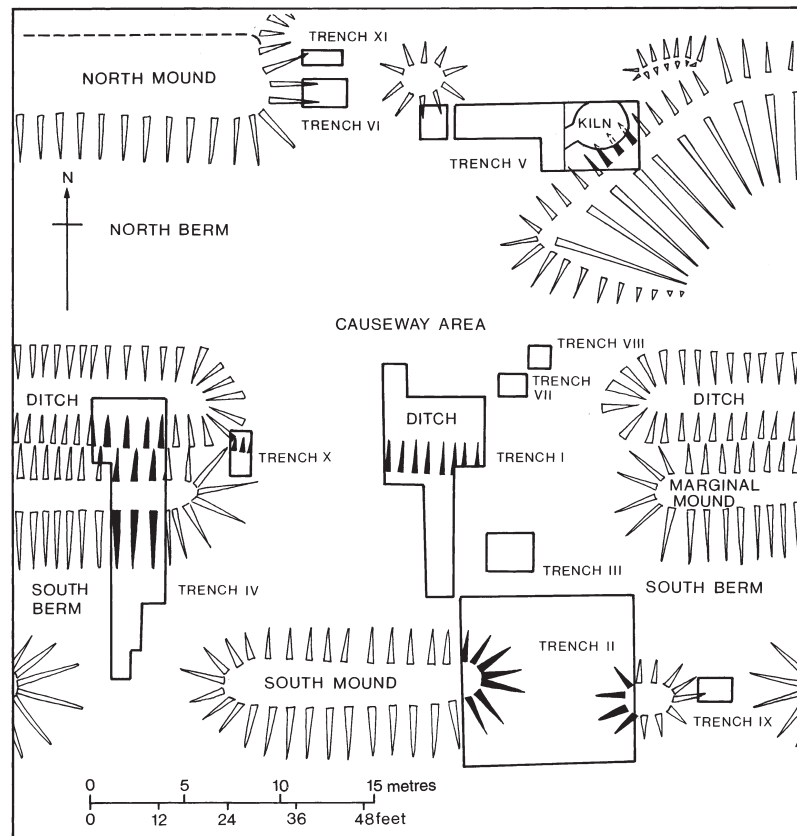
Fig. 11 MC 42. Composite plan showing the visible features (Vallum mounds and ditch), trenches, and, in Trenches I and X, the eroded edge of the Vallum ditch. (1:400)

The Cawfields area had been studied by F. G. Simpson as early as 1908 when the gaps in the north and south mounds representing secondary crossings had been recognised but before causeways over the Vallum ditch at milecastles had been regarded as significant. Simpson's excavations were all to the west of MC 42 causeway and revealed excellent examples of the turf-kerbing of the north mound. Dr Grace Simpson has since published her father's work in the Cawfields area (Simpson 1976, 116–119, Plates IX and X and Figs. 29–40). One complete section, no 6, across the whole Vallum showed remarkable treatment of the ditch and was first published in 1940 (*JRS* 30 (1940) 164). 'It was found that the sides of the ditch had been cut back almost vertically in the bad sandy ground and were then retained by turf-work capped with clayey sand and resting on a solid base of stone four courses high' (Simpson 1976, 119, Plate X, Fig. 32). The marginal mound, at that time believed to represent the recutting of the Vallum ditch, was shown to overlie this unusual revetment of the ditch. It was thought that this condition 'extends from the farm-track leading to MC 42 as far as the macadam road to Cawfields quarry' (*JRS* 30 (1940) 164). It was hoped that the turf revetment of the Vallum ditch, based on coursed flagging might have continued eastwards to the milecastle causeway to be investigated in 1958. It was always intended to concentrate on bottoming the Vallum ditch to look for any trace of an original causeway, and on the composition of the marginal mound. This mound did not extend across the secondary causeway, as shown in fig. 11.

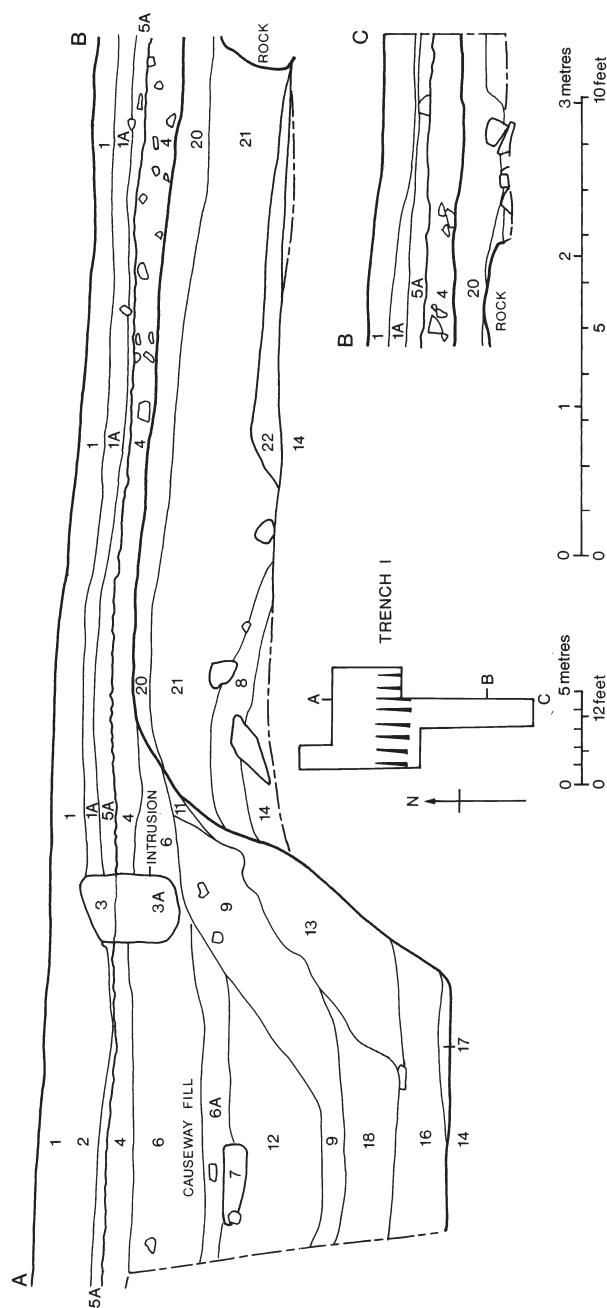
Fig. 12 MC 42. Section of the east face of Trench I. (1:50)

Both the east and west sections across the ditch in Trench I and the north section linking the two show a 3-stage filling of the ditch (fig. 12). The lowest deposit was a peaty band (17), overlying the bottom of the ditch in all three sections; above that was coarse silt, reddish brown with some peat (16), about 300 mm (1 ft) thick (pp. 122–3). Then grey gravel (13) accumulated in a triangle over the south ditch-slope, as well as over (16) in the east section, whilst in the west section blue-grey silt (10) replaced (13). Next, (18) fine grey silt sometimes over 300 mm (1 ft) deep, accumulated in all three sections. These gravelly and silty deposits have the appearance of natural wash from the subsoil (14) through which the ditch had been dug originally.

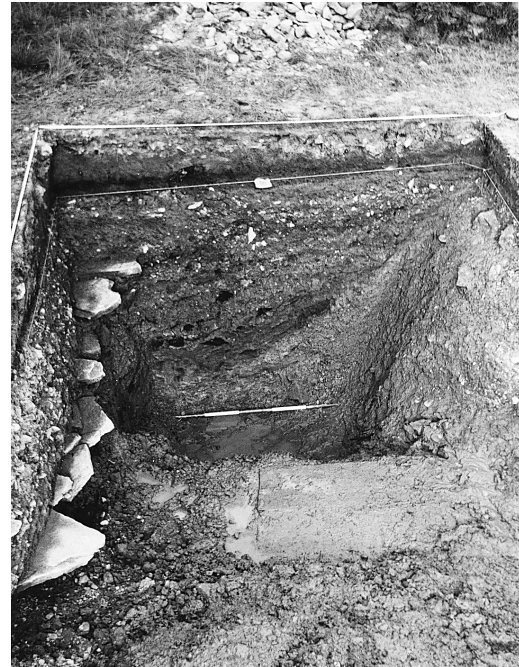
Fig. 13 MC 42. The Vallum ditch in Trench I looking east showing the steep slope of the ditch (slightly overcut), gravelly silt, peat blocks and miscellaneous soils below the metalling.

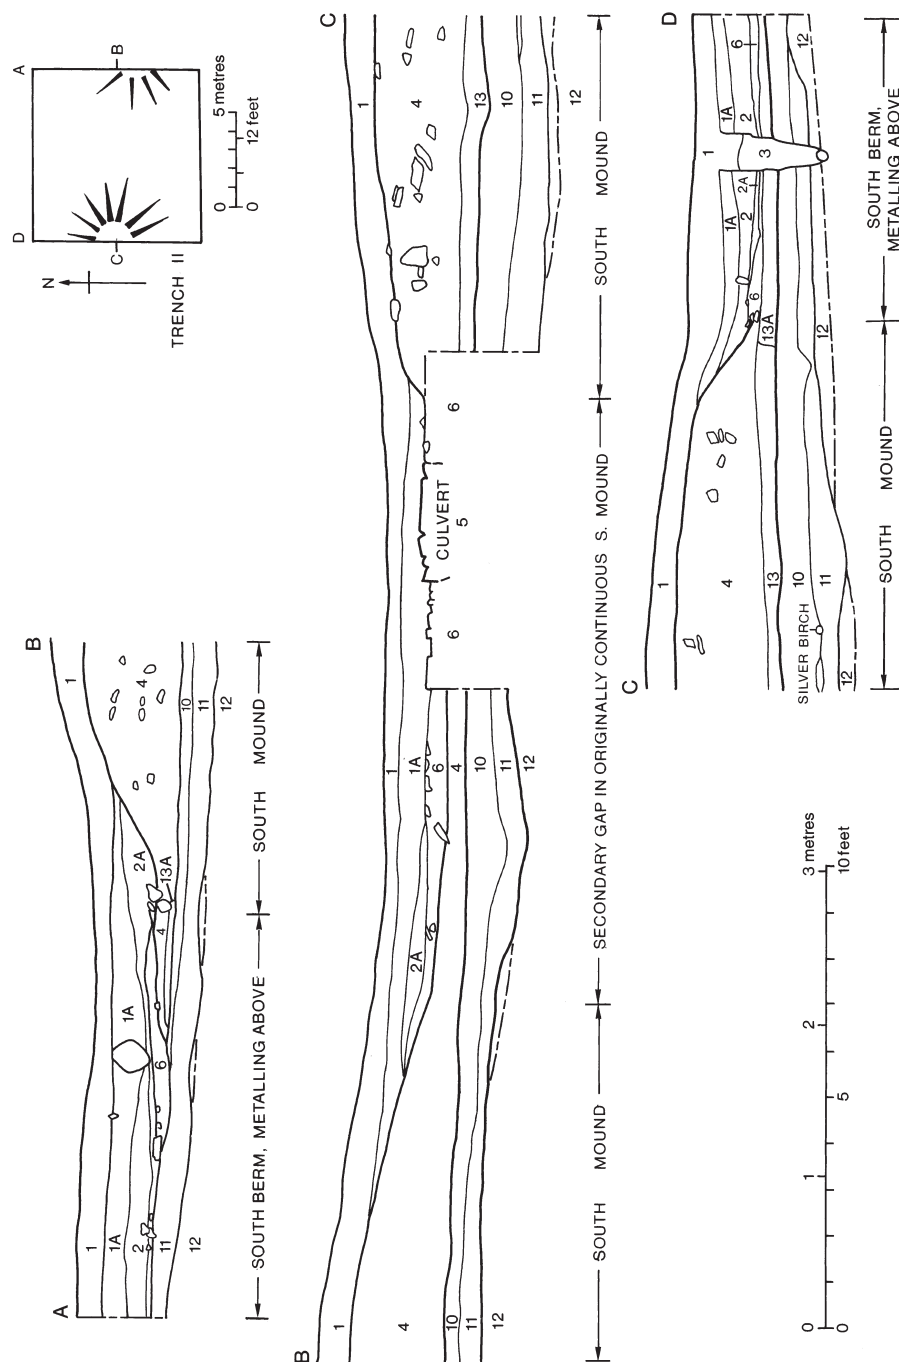
Fig. 14 MC 42. Section of the east, south and west faces of the northern half of Trench II. (1:50)

It is by no means certain how much time elapsed before the next positive phase in the use of the Vallum. In Trench I we have seen that a secondary causeway was thrown across the ditch, its surface metallised by road surface A (4). This metallising continued across the south berm, and into Trench II as road surface A (6). It covered a large part of the trench, including the depression in the south mound but not the higher portions of the mound on either side, and thinned out to virtually nothing south of the mound (fig. 14). This metallised surface had been

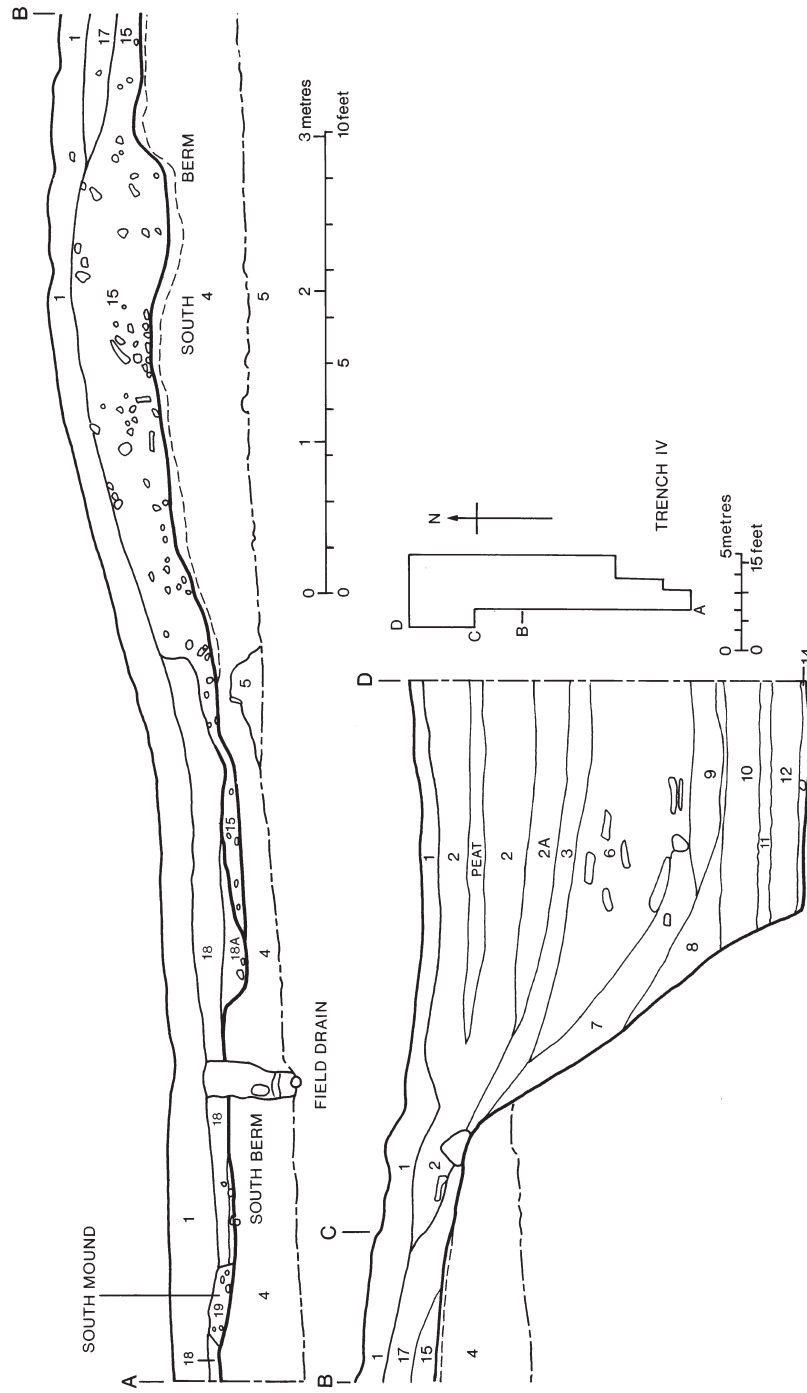
Fig. 15 MC 42. Section of west face of Trench IV. (1:50)

Trench IV was placed 15.24 m (50 ft) to the west of Trench I (point A) and was initially 3.05 m (10 ft) wide covering the south portion of the Vallum ditch (which had resumed beyond the western limit of the secondary causeway of Trench I) but narrowed to 1.5 m (5 ft) wide across the south berm to the start of the south mound, to a total length of 13.72 m (45 ft). It was intended to gain a complete section across the south berm and of the marginal mound as well as of the southern half of the ditch. In the event the west section of the ditch was taken back a further 600 mm (2 ft) because of subsidence (fig. 15).

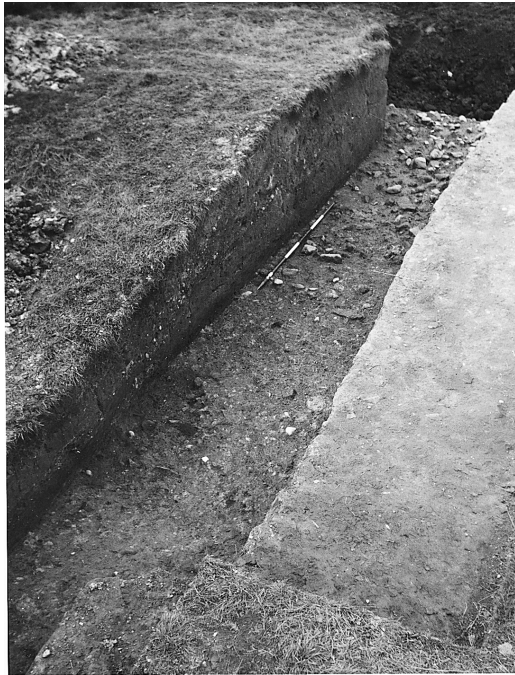
Fig. 16 MC 42. The trench through the marginal mound in Trench IV looking north-west and showing the stony surface on the south berm, contemporary with it.

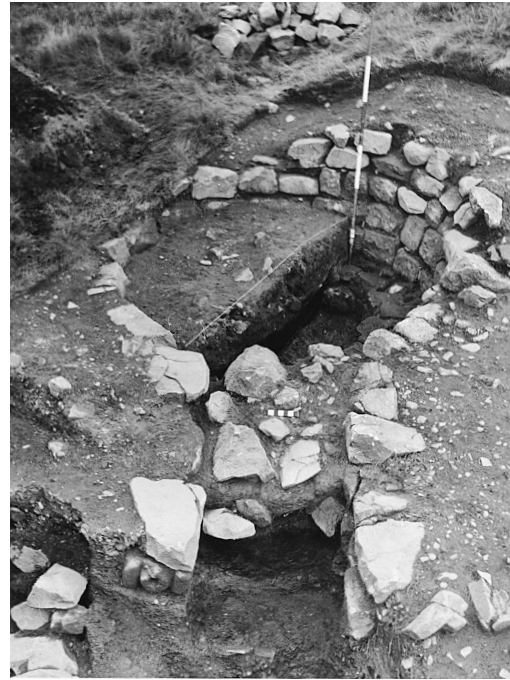
Fig. 18 MC 42. The kiln: the *focus* of the altar is visible to the left of the flue.

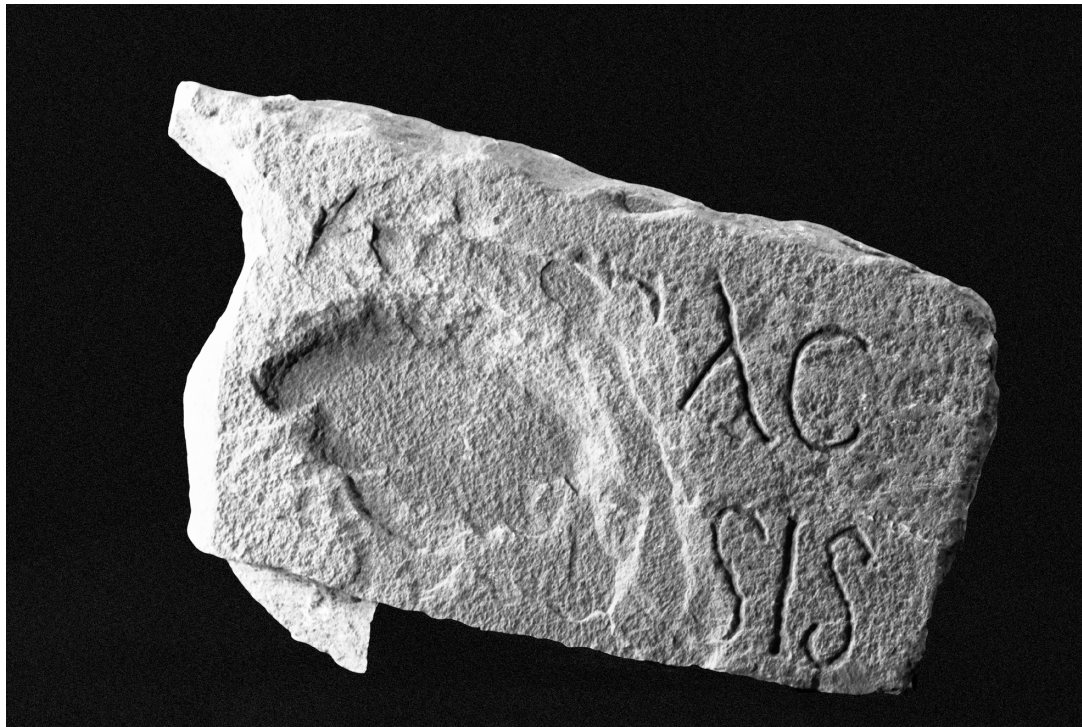
Fig. 19 MC 42. The inscription.

Phase 3 No further structural changes were found in Trenches I, III, VII and VIII with only topsoil and turf accumulating over the metalling of Phase 2. Three post-Roman features were present in Trench II. In Trench IV the Vallum ditch exhibited a gradual, natural filling, including a few fragments of wood and leather to attain the profile still visible today. In Trench V a kiln, built of Roman stones was set into the north mound, heavily disturbing earlier features and dating probably to the medieval or even later period. It did produce two interesting finds, the *focus* of a small Roman altar and a fragmentary inscription thought to be a Vallum stone marking a length of the north mound when originally constructed (fig. 19).
