Excavations at 119–125 Marygate, Berwick-upon-Tweed

Erlend Hindmarch

SUMMARY

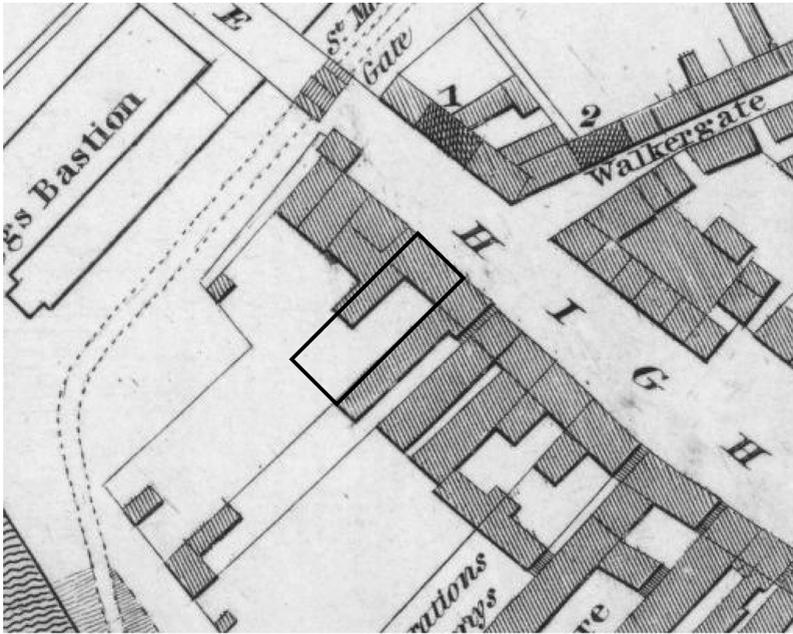
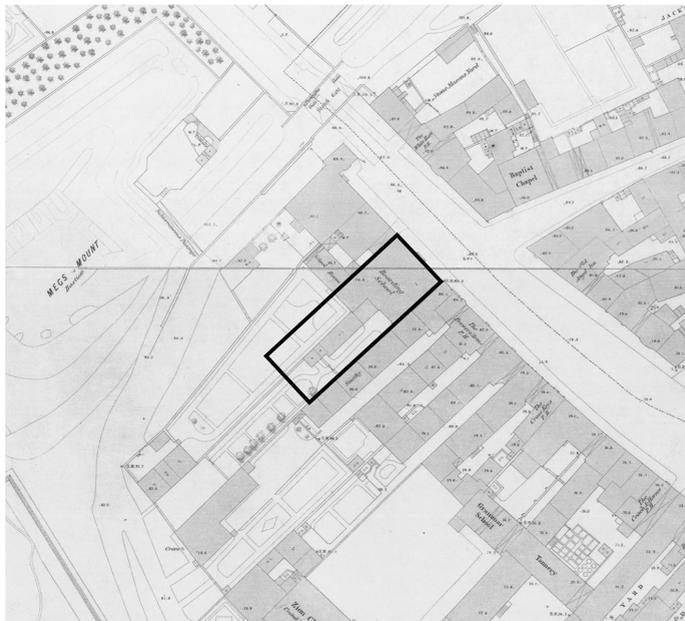
Fig. 2 a. John Wood's map of 1822 showing the location of the property.
 b. The 1855 1:528 OS map showing the location of the property.

By 1855, when the 1:528 OS map was published, St Mary Gate had become Scotch Gate, and High Street had been renamed Marygate. Buildings now extended back from the 119–125 Marygate frontage covering much of the plot behind (fig. 2b). The building complex was a boarding school at this time.

During this phase the footprint of the building was extended further into the burgage plot in successive stages. Some of these structures are depicted on the 1855 OS map (fig 2b).

Wall 12 is also depicted on the 1855 OS map (fig. 2b); the entrance shown on the map is represented by two large sandstone flags on the ground. A midden deposit containing fragments of pottery, glass and clay pipes built up in the open area bounded by Walls 10 and 12, but did extend south-west beyond Wall 12. The ceramic assemblage recovered from this deposit contained an element of residual medieval and early post-medieval pottery but was dominated by eighteenth- and nineteenth-century types. Two pipe bowls of mid to late seventeenth century date were found, but given the dominance of later pottery they are likely to be residual. A very small amount of food debris was also present.

previous centuries. The south-western end of the site was still undeveloped in 1822 (fig. 2a) and the original plot appears to be undivided. However, by 1855 the land behind the building fronting onto Marygate appears to have been divided in two (fig. 2b). By then the Marygate building had become a boarding school, and a washhouse and septic tank, presumably part of the school's facilities, had been built along the western edge of the property. The construction of the septic tank reflected improved civic hygiene and suggests that Berwick-upon-Tweed may have been somewhat advanced in this respect. Septic tanks were first designed in France by John Louis Mouras in 1860 and first patented in Britain in 1881 (Stanbridge 1976, 42), but there was clearly a septic tank on the property in Marygate by 1855, whilst the presence of pottery mainly from the first half of the nineteenth century suggests that it went out of use soon after this date. The prosperity of the proprietors of the school is perhaps reflected in the porcelain and the grape seeds recovered from the septic tank.

By this period, Area 2 lay in the adjoining property where it remained in use as a garden (fig. 2b). Similar features to the wide, shallow ditch-like features observed in this area (fig. 6) were found during the excavations in Walkergate where they were interpreted as the impressions of a timber floor (Hunter 1982). However, as Area 2 remained in use as a garden it is more likely that they relate to horticultural activity, the depressions perhaps being created by walking between rows of canes supporting fruitbearing bushes such as raspberries.

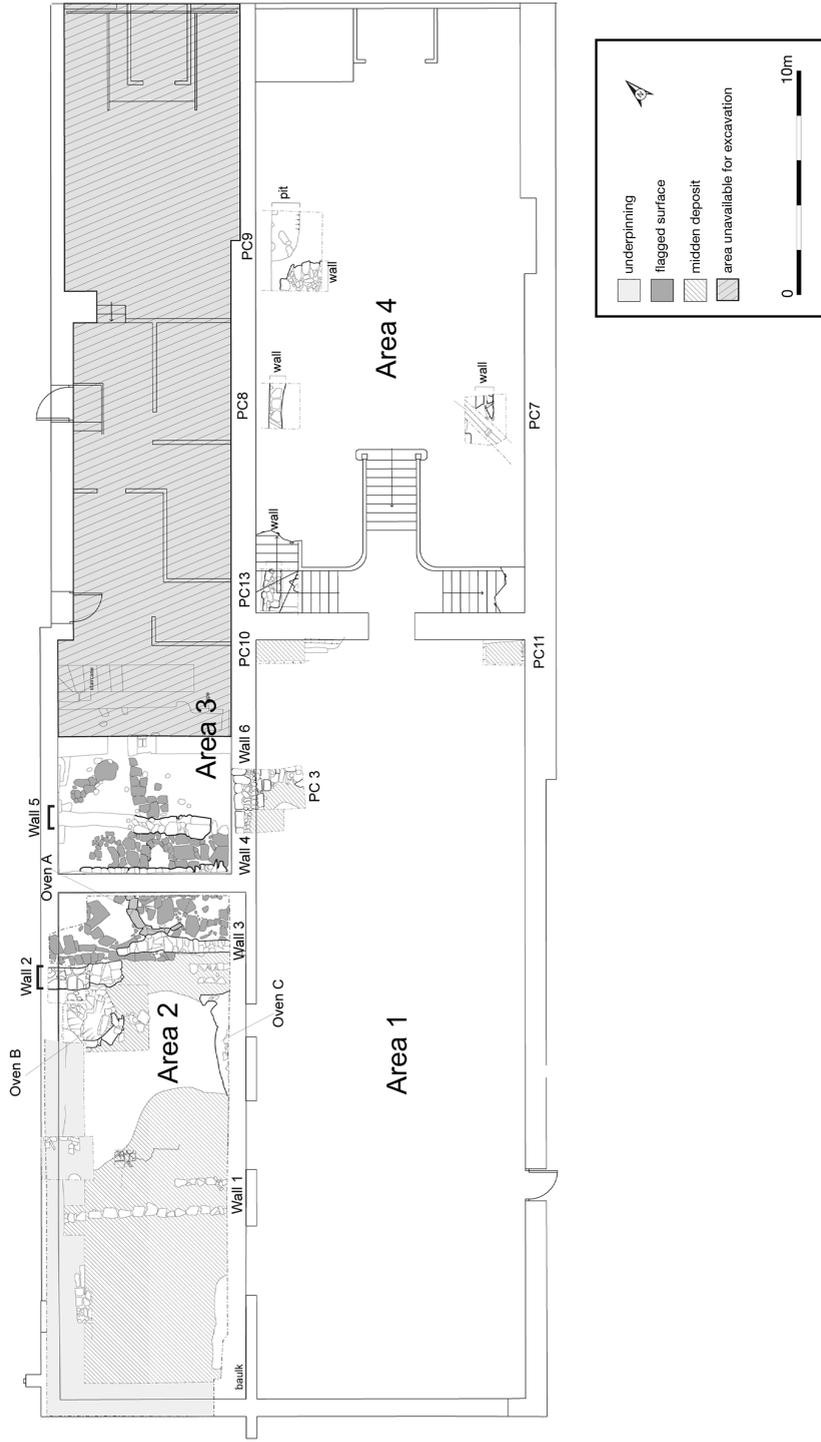
Fig. 3 Phase 1 features.

A surface of flat irregular sandstone slabs covered the northern end of Area 2 (figs. 3 and 4) and extended into Area 3. Although more patchy in Area 3 it seems likely that the whole excavated surface here was once floored in this way. Large sandstone flags were also found in the base of PC3 which may represent an extension of the flagged floor to the east. The southern extent of the flagged floor appears to be defined by Wall 2.

Oven A consisted of an incomplete circular wall built from unworked and roughly worked stones 0.5 m high and 0.3 m wide, and bonded with clay (figs. 3 and 4). Within the oven a thin layer of black ashy silt, 0.01 m thick, lay directly over the flagged base and was in turn buried by a scorched orange clay, 0.3 m thick, which contained large angular stones and may represent collapse from the demolition of the oven. A deposit of brown silty clay up to 0.4 m deep sealed some of the stone slabs outside the oven. This was in turn sealed by a layer of scorched pink/red clay which may represent further demolition debris and which in turn was sealed by the later Phase 2 midden. Fragments of Later Reduced Greenware pottery were recovered from these demolition layers suggesting disuse by the mid fourteenth century.

Oven B was sub-circular in plan (fig. 3). It differed from Oven A in that it had a concave base comprising a single layer of pink sandstone slabs. The superstructure consisted of a wall of large sandstone cobbles bonded with clay; only one incomplete course remained which had been laid around the upper edge of the oven cut. There were three layers within the oven. A thin layer of compact dark orange clay covered the entire base of the oven and this was

A spread of rubble associated with a patch of red scorched clay on the eastern edge of the area may mark the location of another oven (fig. 3). As these features lay at formation depth they were not investigated any further.

In Areas 2 and 3 there were multiple fragments of walling all aligned NW–SE (fig. 3). Wall 1 survived as two parallel lines of un-bonded, unworked stone, one course high and 1 m wide, built directly over the midden deposits. As described above, Wall 2 appears to define the southern extent of the flagged surface. It was a double-faced wall with rubble fill and extended across the entire width of Area 2, although it was more poorly preserved at its south-eastern end. It abutted Oven B.

Clay-bonded, rubble-built walls were also recorded in Area 4 in PC7, PC8, PC9 and PC13 (fig. 3). These could feasibly be part of the same structure, with the wall in PC9 forming part of the north-eastern gable. This stretch of wall had been built directly onto the boulder clay, although the walls seen in the other pile caps were built over anthropic deposits, those in PC13 containing thirteenth or fourteenth century pottery. A fragment of twelfth to fourteenth century Scottish White Grittyware (SWG) was recovered from the bonding material of the wall in PC13 and the wall was in turn sealed by clay which contained thirteenth- or fourteenth-century ceramics similar to Northumberland Buff Sandy ware.

The quadrant of a large pit cut into the boulder clay was uncovered in PC9 (fig. 3). The pit contained charcoal, several large stones, charred cereal grains (again dominated by oats with smaller amounts of barley), and a small quantity of unidentifiable fragments of large mammal bone. Pottery fragments derived from a large portion of a coarse Later Reduced Greenware cistern (fig. 7b) were also recovered. This type of pottery is hard to date but is believed to be a fossil type of the later fourteenth to sixteenth centuries.

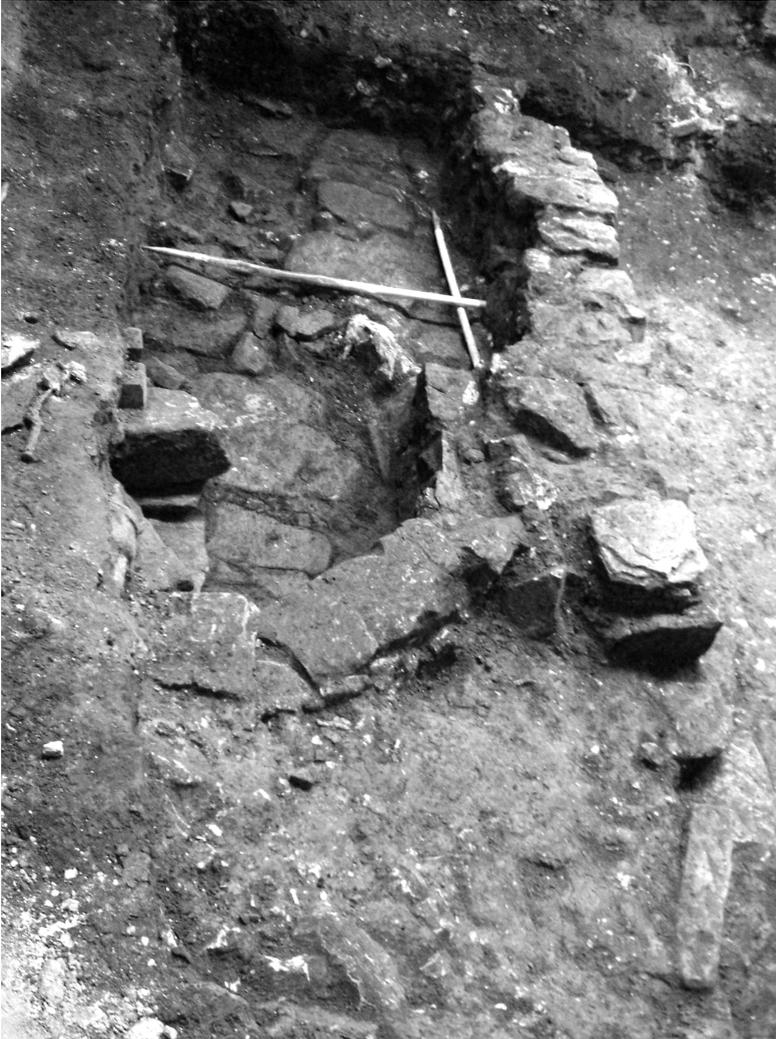
Fig. 4 Oven A looking south-east. Wall 3 abuts it to the south and the flagged surface is just visible beyond the oven.

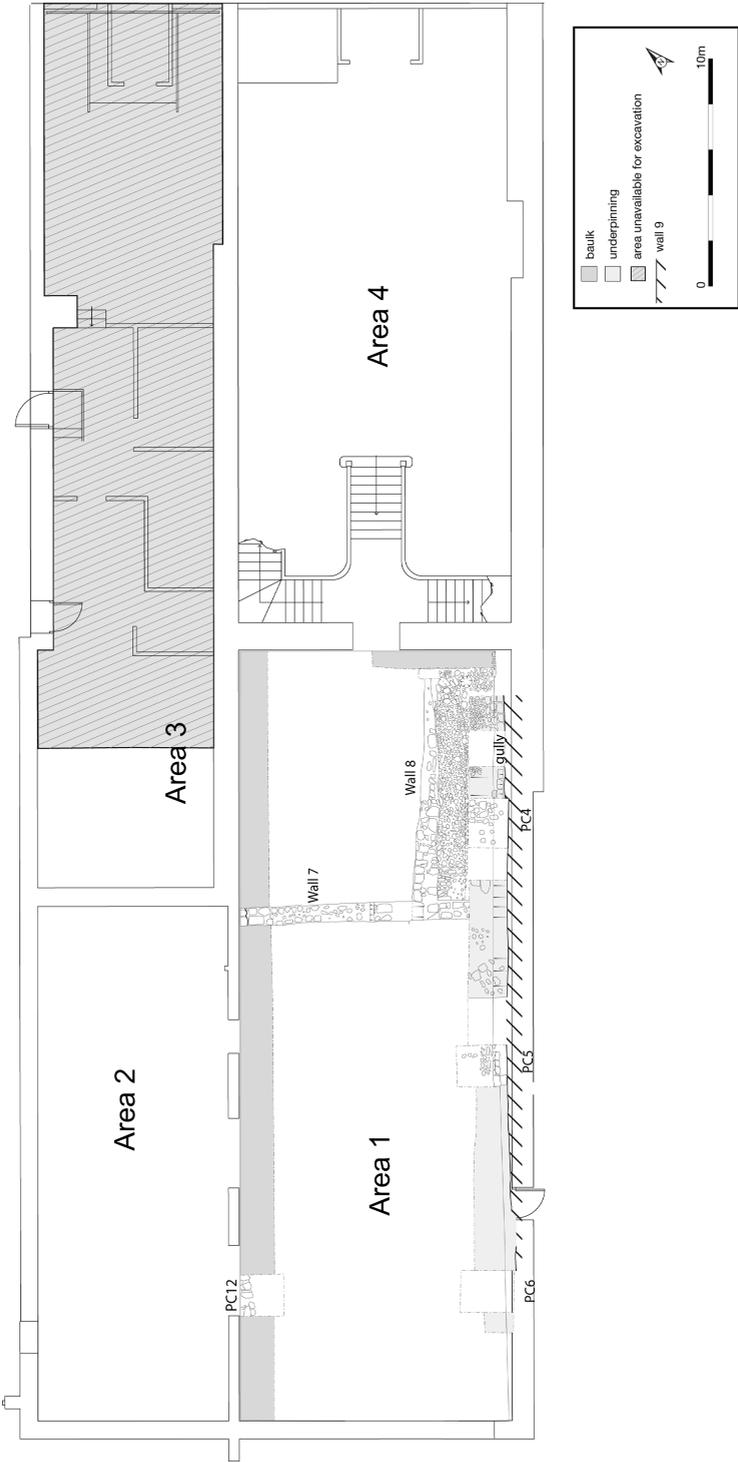
Fig. 5 Phase 3 features.

Phase 3 activity was only observed in Area 1 and relates to the construction of a new building or, more probably, to the extension of the building fronting onto Marygate. The structure excavated consisted of two walls, one of which, Wall 7, ran across the width of the current building while the second wall, Wall 8, was tied into it just over halfway along its length, thus forming a 'T' shape. Both walls were built from partially worked, clay-bonded stone laid in

random courses. A fragment of late sixteenth- to early seventeenth-century Weser ware was found within the bonding material of the NW-SE aligned wall providing a *terminus post quem* date for its construction.

To the east of Wall 8 and bounded by both Walls 7 and 8 was a surface of tightly packed stone cobbles; this surface had been laid directly over a bedding layer which contained pottery of seventeenth-century date. The remnants of an earlier stone surface were observed under the bedding layer during the excavation of the pile caps and underpinning. To the east, the cobbled surface butted against the remains of a shallow gully or open drain built from large flat unworked stones. The gully butted up against the remains of a clay-bonded wall, Wall 9, which extended along the whole length of the standing building. No floor deposits were encountered to the north-west of Wall 8. The features suggest a cobbled yard or a stable with a drain, and an open area or garden bounded by Walls 7 and 8.

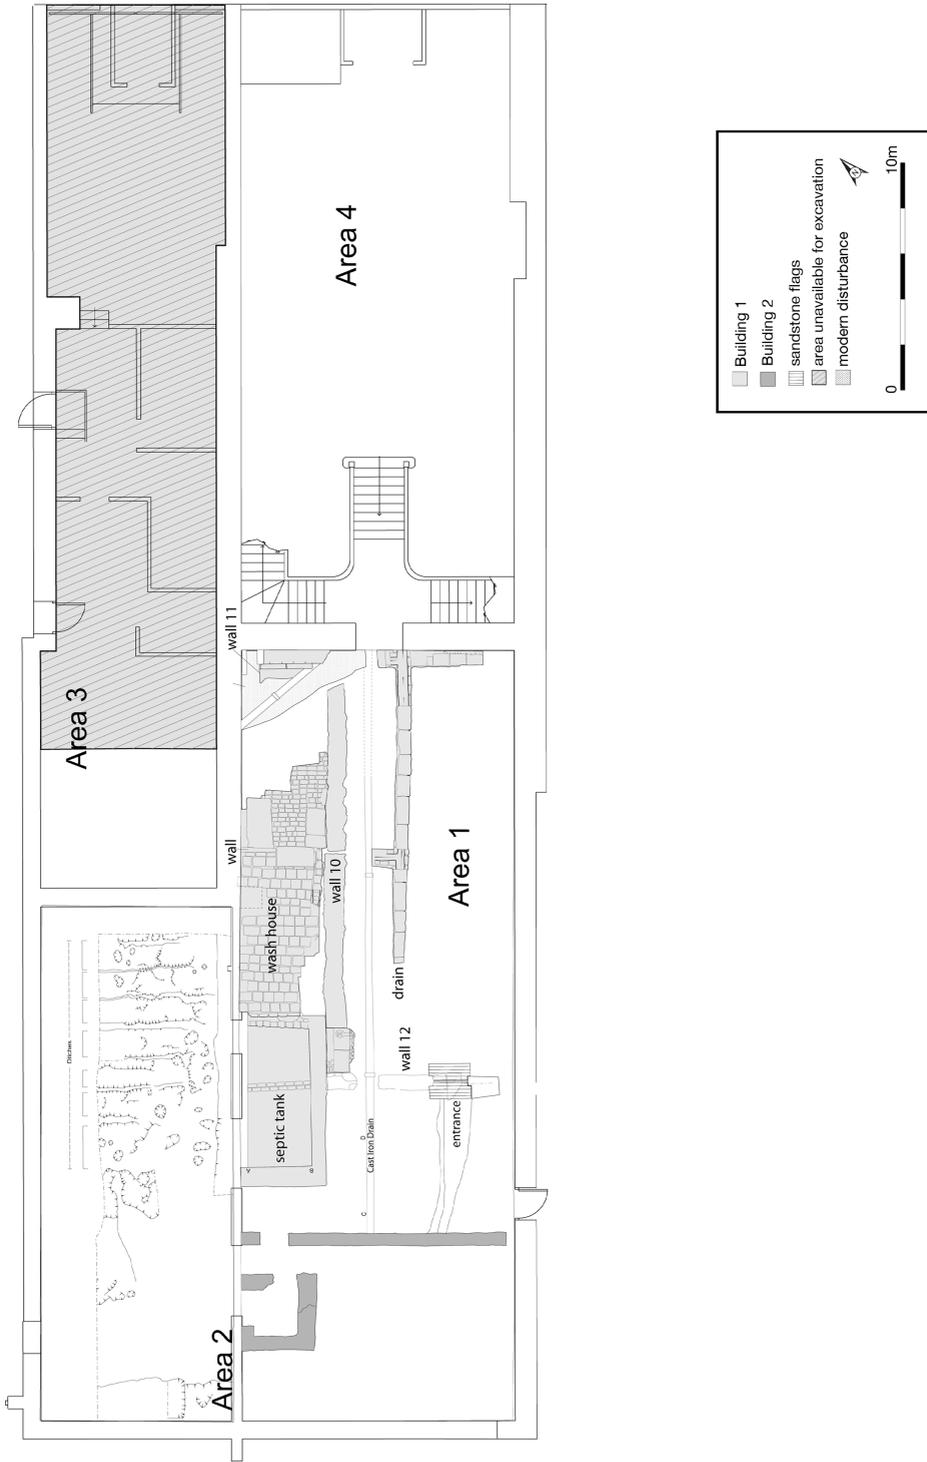
Fig. 6 Phase 4 features.

Building 1 consisted of a washhouse and septic tank built along the north-western side of the plot. Walls 10 and 11 are the walls of the washhouse, within which there was a tiled floor and a brick floor separated by a single brick wall. Several large sandstone slabs were set into the brick floor; these lay over two brick-built drains which ran into a larger drain that took waste downslope towards the Tweed. Post-medieval red earthenware was recovered from the cut for this drain. Two of the sandstone slabs displayed an arrangement of five drilled holes in bowl-shaped depression, presumably to facilitate surface drainage in the washhouse.

The septic tank lay at the very end of the washhouse. It consisted of a rectangular subterranean structure at least 2 m deep, covered by two arched brick sprung roofs. The walls of the tank were built from large worked stones of various sizes, laid in random mortared courses with deliberate voids left at irregular intervals. The tank had been split into two by the construction of a brick wall which had not been tied into the main walls suggesting that it may be a later addition; this division is depicted on the 1855 OS map (fig. 2b). This wall also contained small voids and a single large void in its centre.

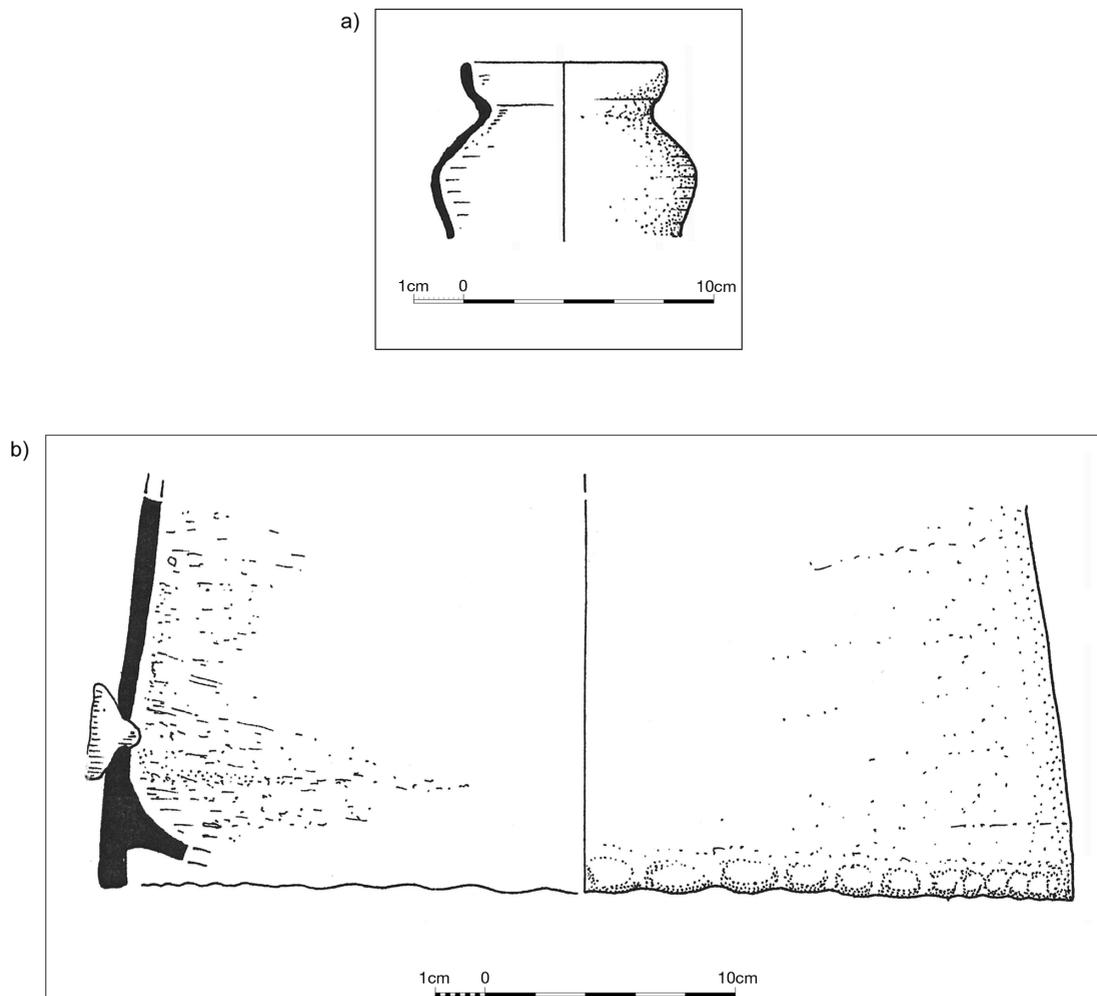
Fig. 7 a. Northumbrian Buff Sandy ware from the Phase 1 midden deposit: small squat jar with simple upright clubbed lid-seated rim; thirteenth to mid or late fourteenth century.
 b. Later Reduced Greenware from pit in pile-cap 9: pie-crust base of cistern with lead bung in side of vessel; fourteenth to sixteenth century.

The earliest deposits on the site were middens containing animal bone, fish bone and pottery of thirteenth or fourteenth century date including Northumbrian Buff Sandy ware (fig. 7a). The deposits were deepest in Area 2 where they may represent the dumping of domestic waste to level the sloping ground. In this area the boundaries between the midden layers were quite distinct, suggesting that there had been no cultivation here which would have led to mixing of the soils. In Area 3 the earliest deposit was a more homogenous soil over 0.4 m in depth which also contained Northumbrian Buff Sandy ware as well as charred cereal grain (predominantly oats — *Avena* sp.); this soil may have been cultivated.

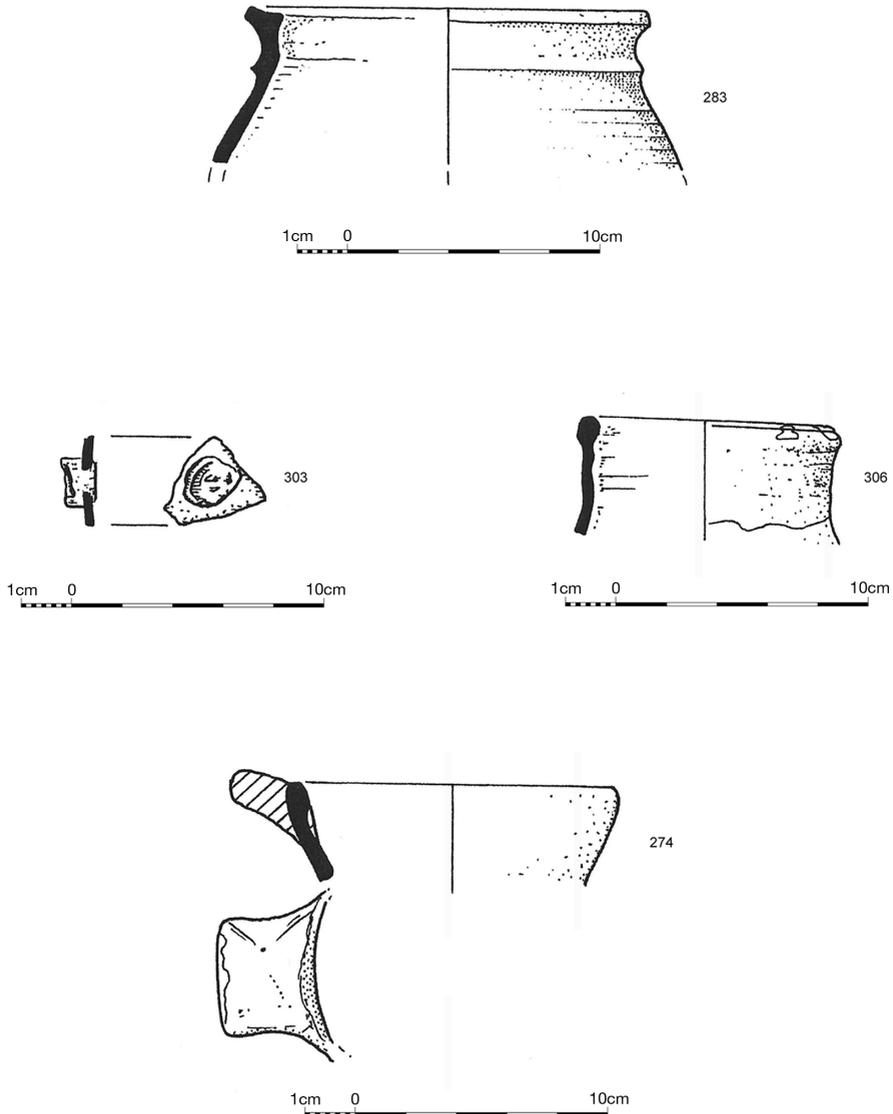
Fig. 8 Pottery from the Phase 2 midden deposit:

- 303, early glazed ware: hole through wall with lead plug repair; twelfth to thirteenth century.
 283, Northumbrian Buff Sandy ware jar: thirteenth to mid fourteenth century.
 306, Reduced Greenware jar with unusual upright thickened or clubbed rim with groove round outer angle. This has some similarity with Tyneside buff or white wares; mid fourteenth to sixteenth century.
 274, Scarborough Ware type 1 bowl with a simple upright clubbed rim and a short straight strap handle similar to a porringer handle; thirteenth to fourteenth century.
