Excavations on Hadrian's Wall at Melbourne Street, Newcastle upon Tyne

A. C. Platell

SUMMARY

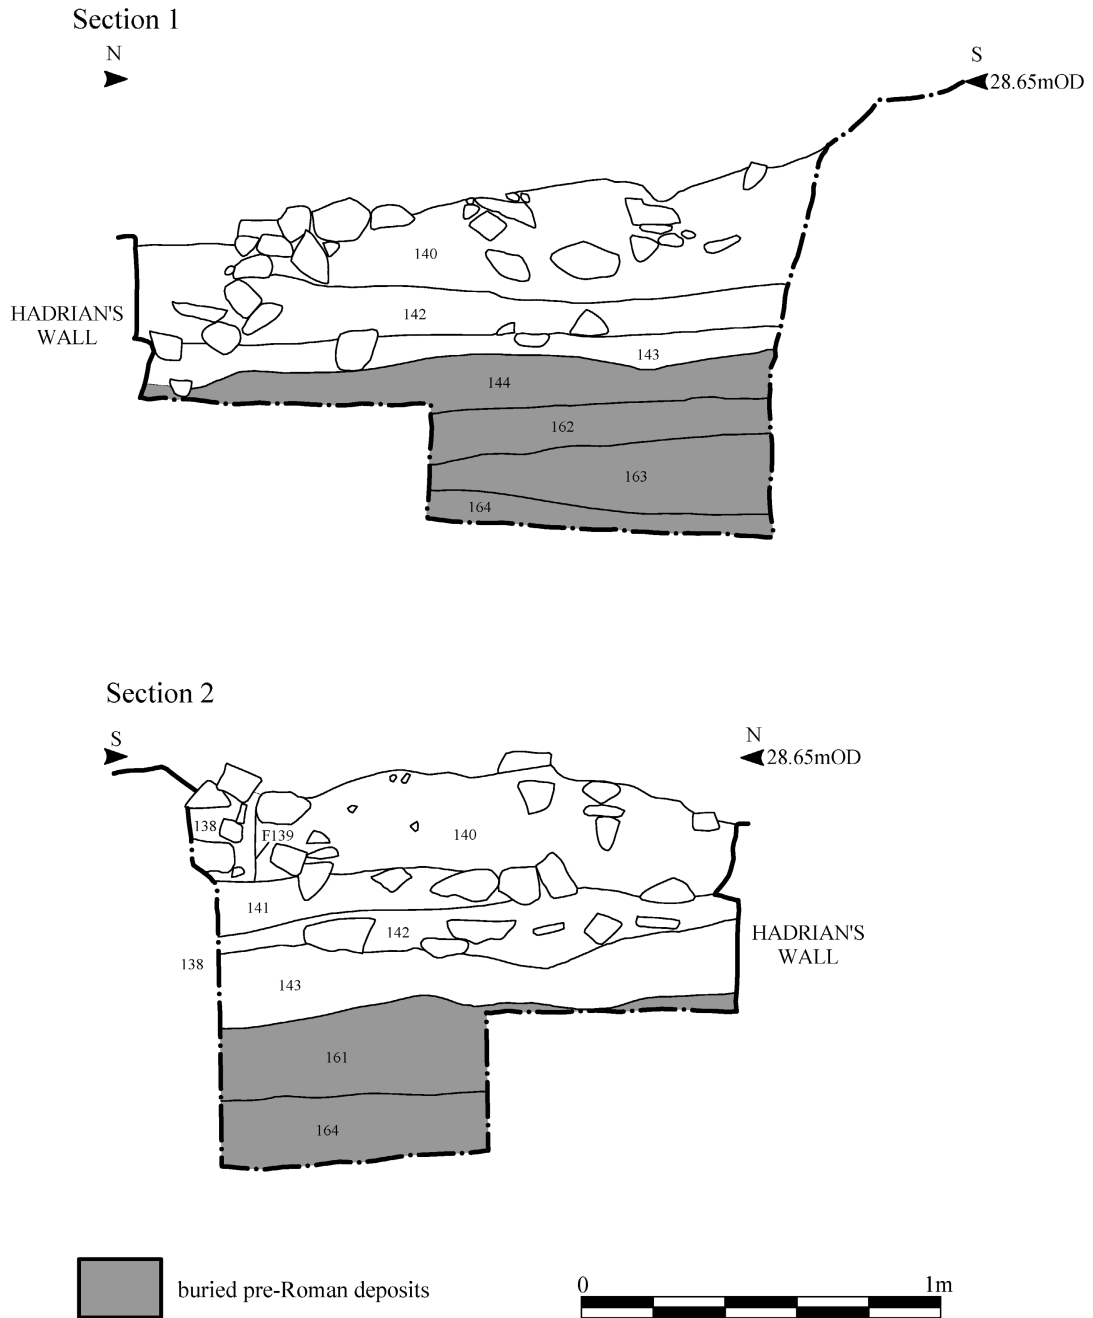
Fig. 4 Sections through the sondage to the south of the Wall. The positions of the sections are shown on figs. 5 and 6.

Several pre-Hadrianic deposits were exposed in the sondage to the south of the Wall (fig. 4). The earliest, a reddish-brown sandy silt [164], was possibly natural, although this could not be proven as it was not fully investigated. Above were various clays and then a mid-grey sand [161] (and then a light grey silty clay in part of the sondage). Hadrian's Wall was built directly on top of this latter deposit. In the northern sondage the Wall was built directly on top of a grey sand [80] that was thought to be a continuation of context 161 to the south. Clay beneath this, sloping steeply towards the centre of the stream channel, was thought to be its sides.

and [142], separated by a thin band of black to dark grey silty sand [141] (see figs. 4 and 8). This latter deposit was only present in a localised area in the south-west corner of the sondage.

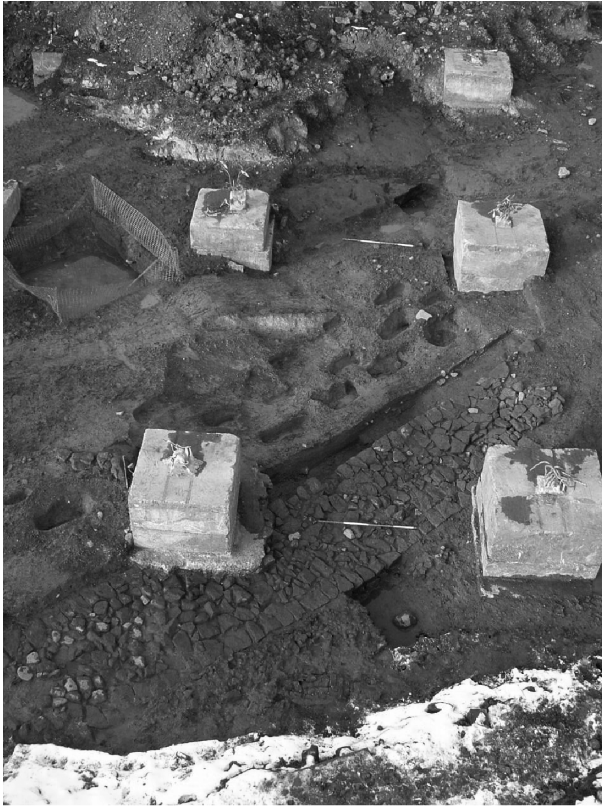
Fig. 7 The Wall and the defensive pits, as excavated. Wall ditch section at top left.

A short section of the foundation to Hadrian's Wall survived within the former stream channel (figs. 5, 6 and 7). It measured 13.3 m in length and 2.44 m (8 ft) in width; since the foundation is typically slightly wider than the curtain, the masonry above is likely to have been around 2.33–2.35 m wide. The foundation consisted of two courses of stonework in the centre of the stream channel, reducing to one course at either end. This two-course foundation is unusual for the Narrow Wall between Wallsend and Newcastle; it presumably relates to the depression of the stream channel. The western end of the surviving fabric was terminated by a twentieth-century drain and then by nineteenth-century cellars. Towards the east it ended fairly abruptly at the top of the slope of the former channel. From here, a shallow robber trench was intermittently present, with a single stone from the northern edge of the foundation remaining *in situ*.

The defensive pits (figs. 5, 6, 7, 10, 11 and 12)

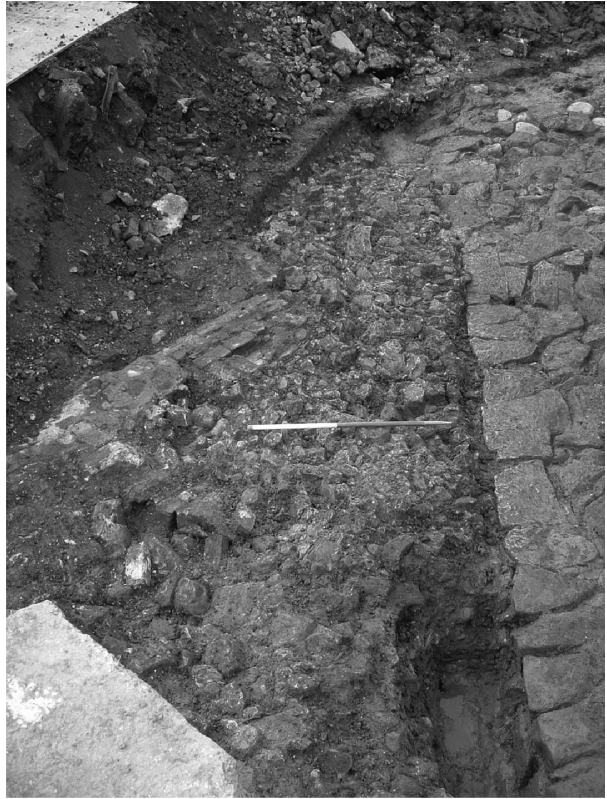
Fig. 8 Stone packing to the south of the Wall.

The stone packing was at least 2.1m wide. (It was cut by nineteenth-century cellars towards the south so its original width could not be determined.) It was only present within the former stream channel and appears to have been placed there as a reinforcing buttress to the southern side of the Wall foundations. These had slumped downwards immediately to the west of the stone deposit, indicating the necessity for such reinforcement.

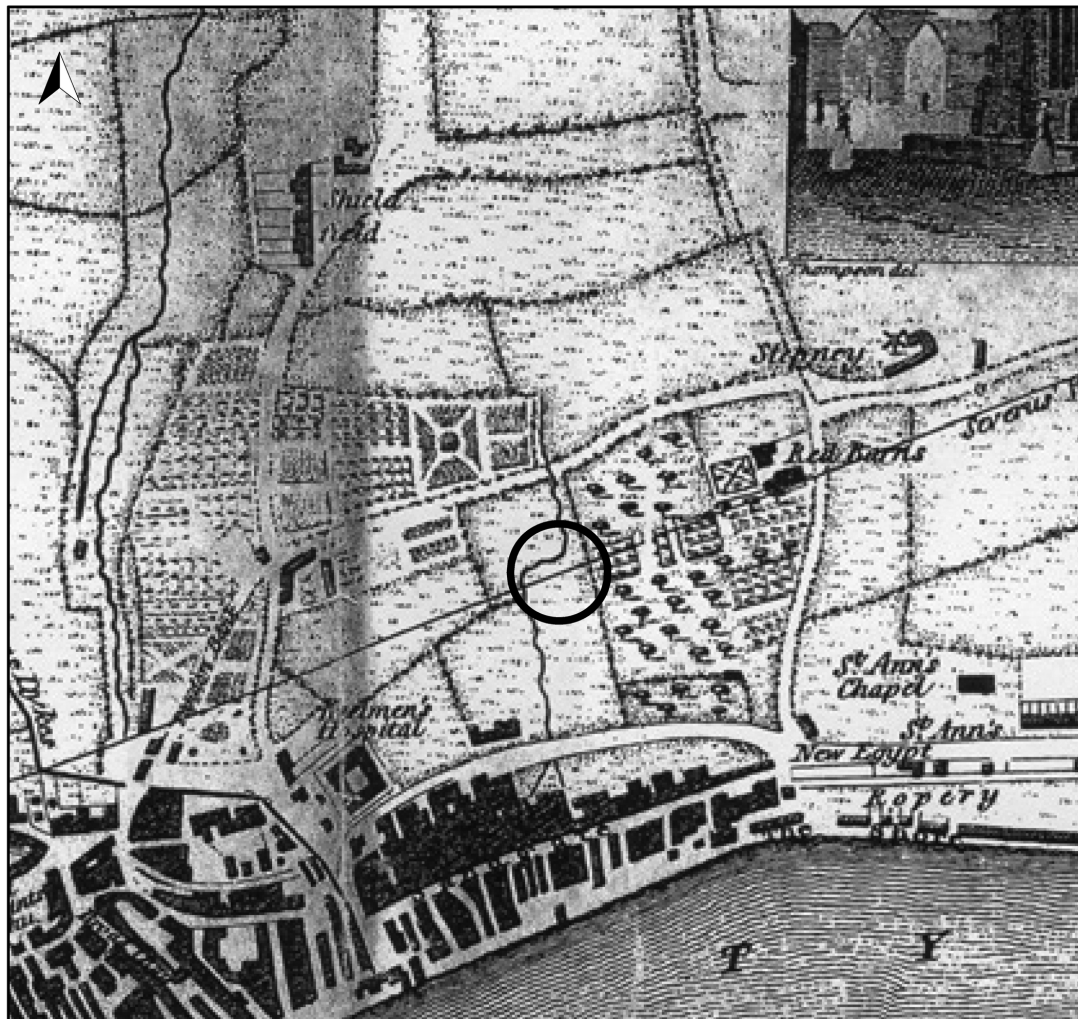
Fig. 9 Location of the site, as shown on Roper and Cole's map of 1808. The right-angle turns in the course of the stream are clearly depicted.

As the ground surface has been modified by later development, it is not clear from the topography today whether water would have flowed westwards or eastwards along the ditch. However early maps, from Hutton's plan of 1770 to Wood's plan of 1827, all show a stream (The Swirle) in this area, flowing southwards until just north of the Wall, making a right-angle turn to the west and then shortly afterwards making another right-angle turn back towards the south (fig. 9).

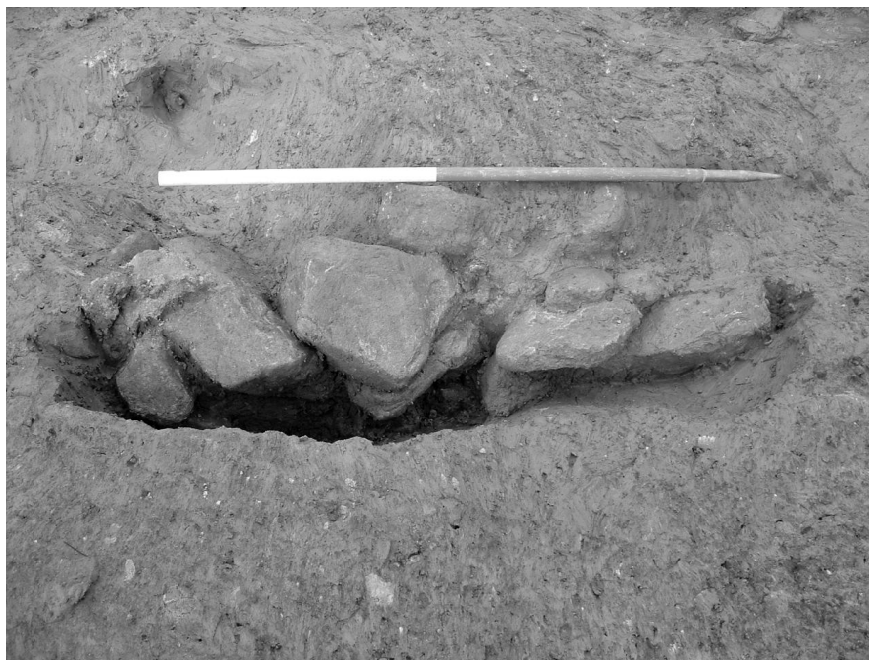
Fig. 11 Section through pit F86.

(see, for example, fig. 11). The mixed nature of both the fills and of the material that the pits were cut into would make the identification of any postholes very difficult, so it is perhaps wise to leave undetermined the exact nature of the defensive pits at Melbourne Street.

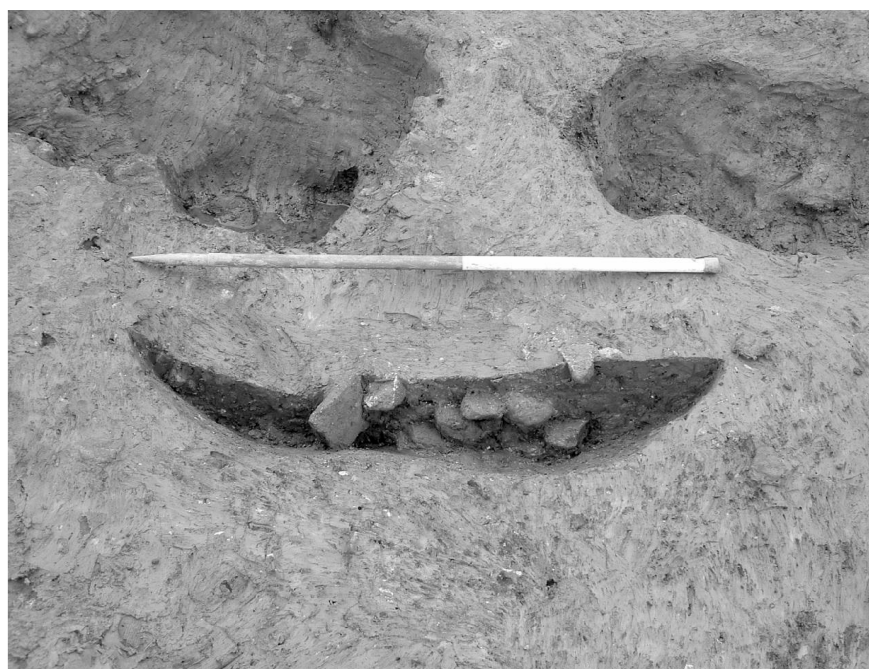
Fig. 12 Section through pit F112.

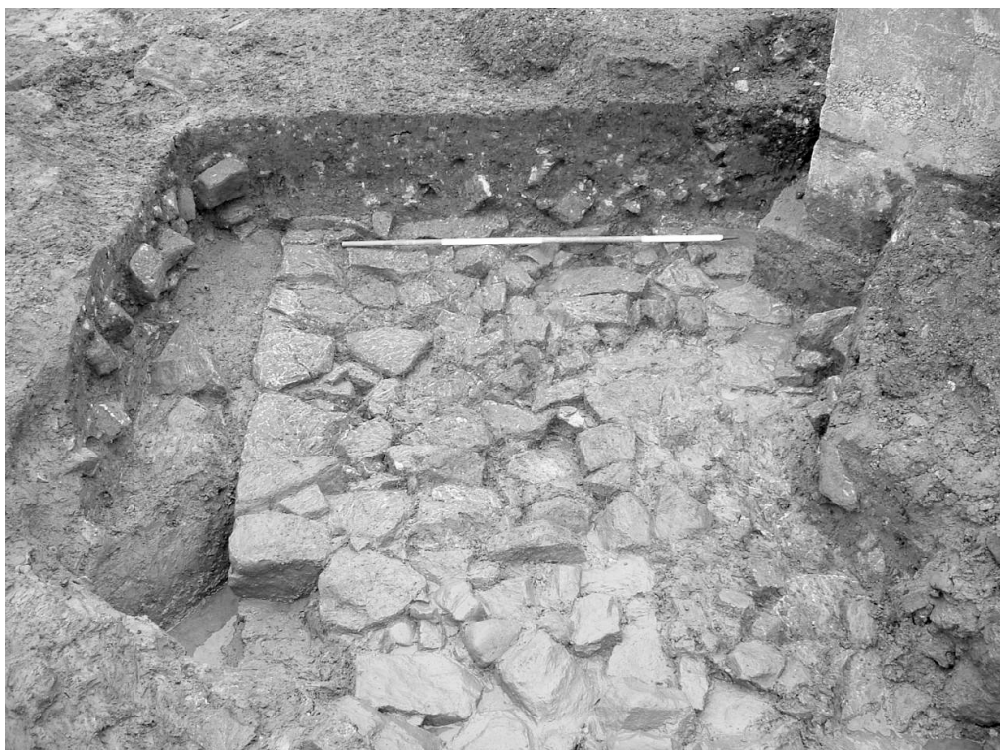
Fig. 13 Deposits overlying the Wall, looking east.

Several layers of clay had built up against the northern edge of the Wall, one of which contained large angular stones that were likely to be tumble from it. Above was another clay that contained many concentrations of stone. These did not form distinct features and were interpreted as stony patches within one generally mixed fill. However, following excavation, it was found that one such concentration directly overlay pit F96. Given its location and the fact that underlying pit F96 was atypical in form (see above), it is possible that this had been the fill of a later pit. A small area of (possibly related) fill, separated from the main deposit by a later intrusion, produced a single sherd of medieval pottery. Otherwise these deposits were notable for their lack of finds. Above was a distinctive reddish-brown clay containing frequent small sandstone pebbles. This overlapped the Wall and increased in thickness towards the south (fig. 13). A robber trench was visible to the east of the stream channel and was filled with a very similar deposit. This robber trench was deeper and more clearly defined along its northern than its southern edge, and was cut by a shallow gully.

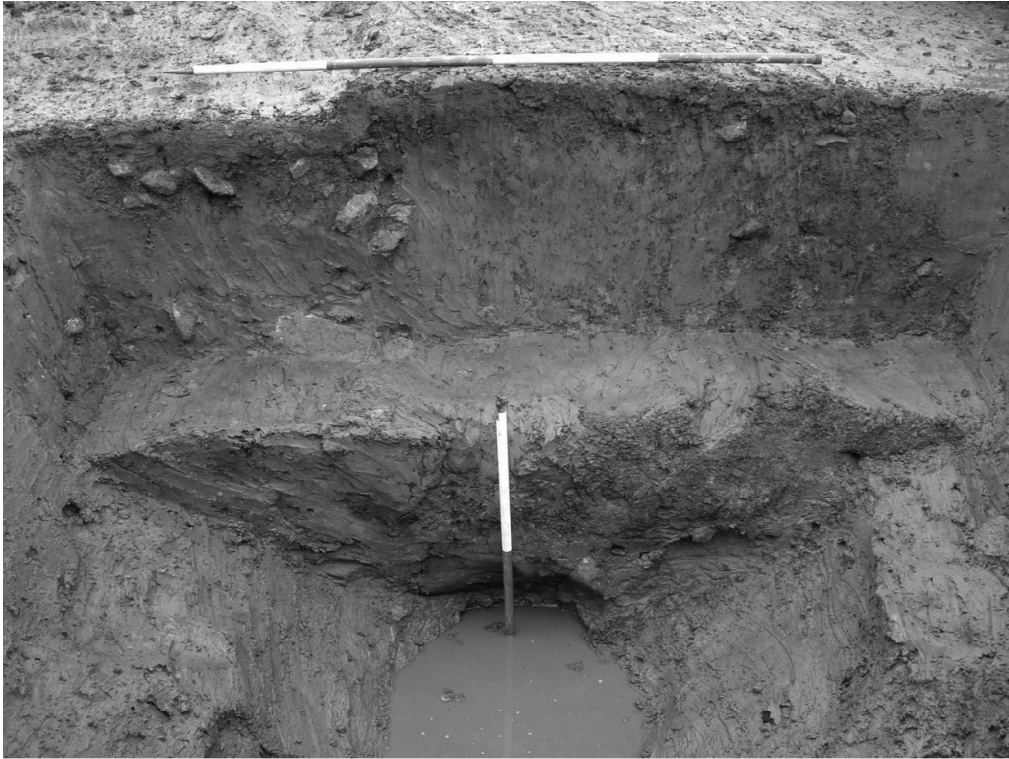
Fig. 15 South-western section through the ditch of the Wall, fully excavated.

Two sections were excavated across the fills of the Wall ditch; one towards the western end of the site and one towards the east (figs. 14 and 15). In addition, a partial section was excavated to the north of foundation pad G to investigate a possible entrapment pit against the edge of the ditch. Excavation of this latter section was discontinued when it became clear that it was not a discrete feature and had been formed by slumping of the ditch sides. The lowest deposit in all sections was a light grey fine sand [59/172]. Since this was remarkably free from silt or other impurities, and geologically very different from the clay that formed the ditch sides, it may have been a deliberate deposit, possibly to reduce the depth and steepness of the ditch following abandonment of its defensive use. The difference in composition between this deposit and the natural clay allowed a shallow but distinct slot to be identified in the eastern ditch section (see above). Above this sand in the easternmost section was a thin band of black sand [171], interpreted as a former turf layer then, in all sections, a grey silty clay [58/147] that thickened eastwards from 0.2 m to 0.5 m and may have been deposited over some time. In the eastern section, a number of pieces of wood and a piece of worked leather were collected from the top of this deposit. Since it is not permanently waterlogged, this indicates that the upper part, at least, is of fairly recent date.

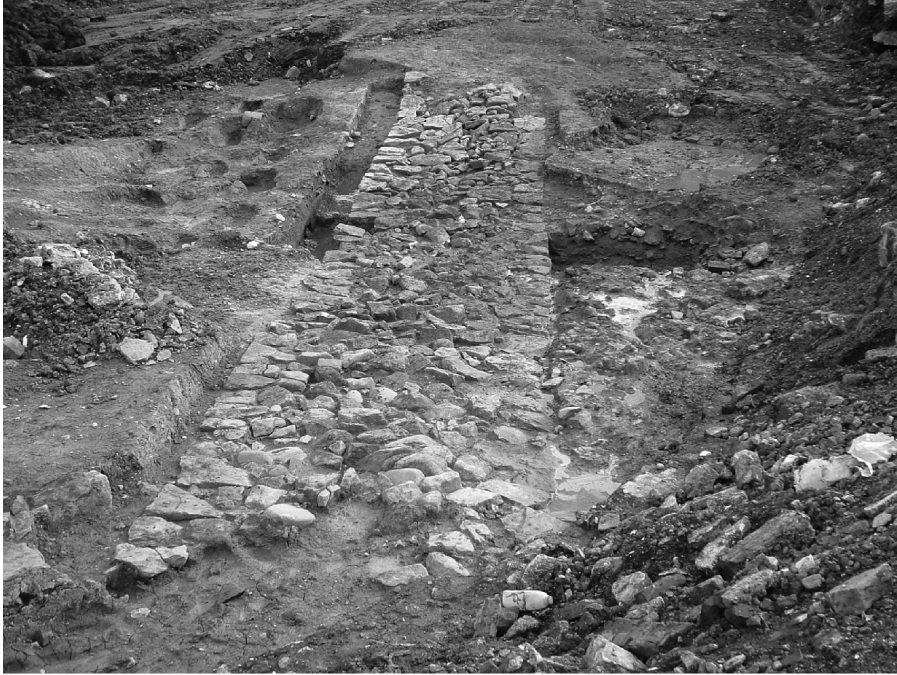
Fig. 16 The Wall after removal of the foundation pads.

During excavation the concrete foundation blocks from the former car showroom were left *in situ* because they were thought to be pile caps and their removal would be likely to cause unacceptable damage to archaeological remains. However, at the end of archaeological works, one block was removed from a non-sensitive part of the site and proved to be a square pad (approximately 1.2m thick) rather than a pile cap, and it was lifted cleanly. Subsequently the remainder of the pads were removed by machine under archaeological supervision. This fully exposed the Wall without causing any damage to it (fig. 16). The surviving remains of the Wall together with the defensive pits and surrounding berm, the ditch adjacent to this and the stone bank south of the Wall were covered with geotextile and backfilled with fine material. This area is preserved *in situ* within the development. Full details about the extent of this preserved area and the nature of the backfill are provided in the archive report.
