# Waggonways and brickworks: insights into the industrial heritage of Walker

Jennifer Proctor

## SUMMARY

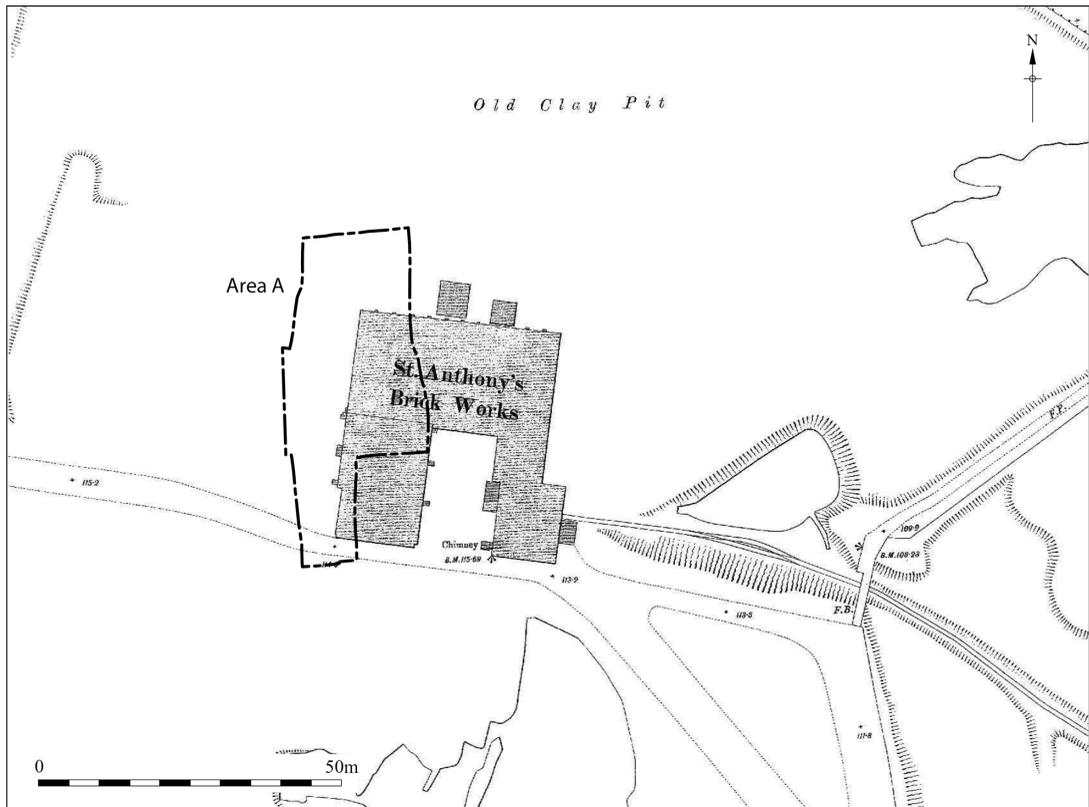
Fig. 5 Ordnance Survey map of 1907, 1:500 scale edition: detail of St Anthony's Brickworks.

and Wear Museums and Archives (T186/11858A), shows plans and elevations of two buildings to be constructed at 'Grant and Watsons Brick Works Saint Anthony's' (see fig. 20). The 2nd edition Ordnance Survey map of 1898 shows a building annotated as 'St. Anthony's Brick Works' (fig. 4). The brickworks had been completely rebuilt by 1907 (fig. 5) and were demolished sometime between the 1940 and 1951 editions of the map.

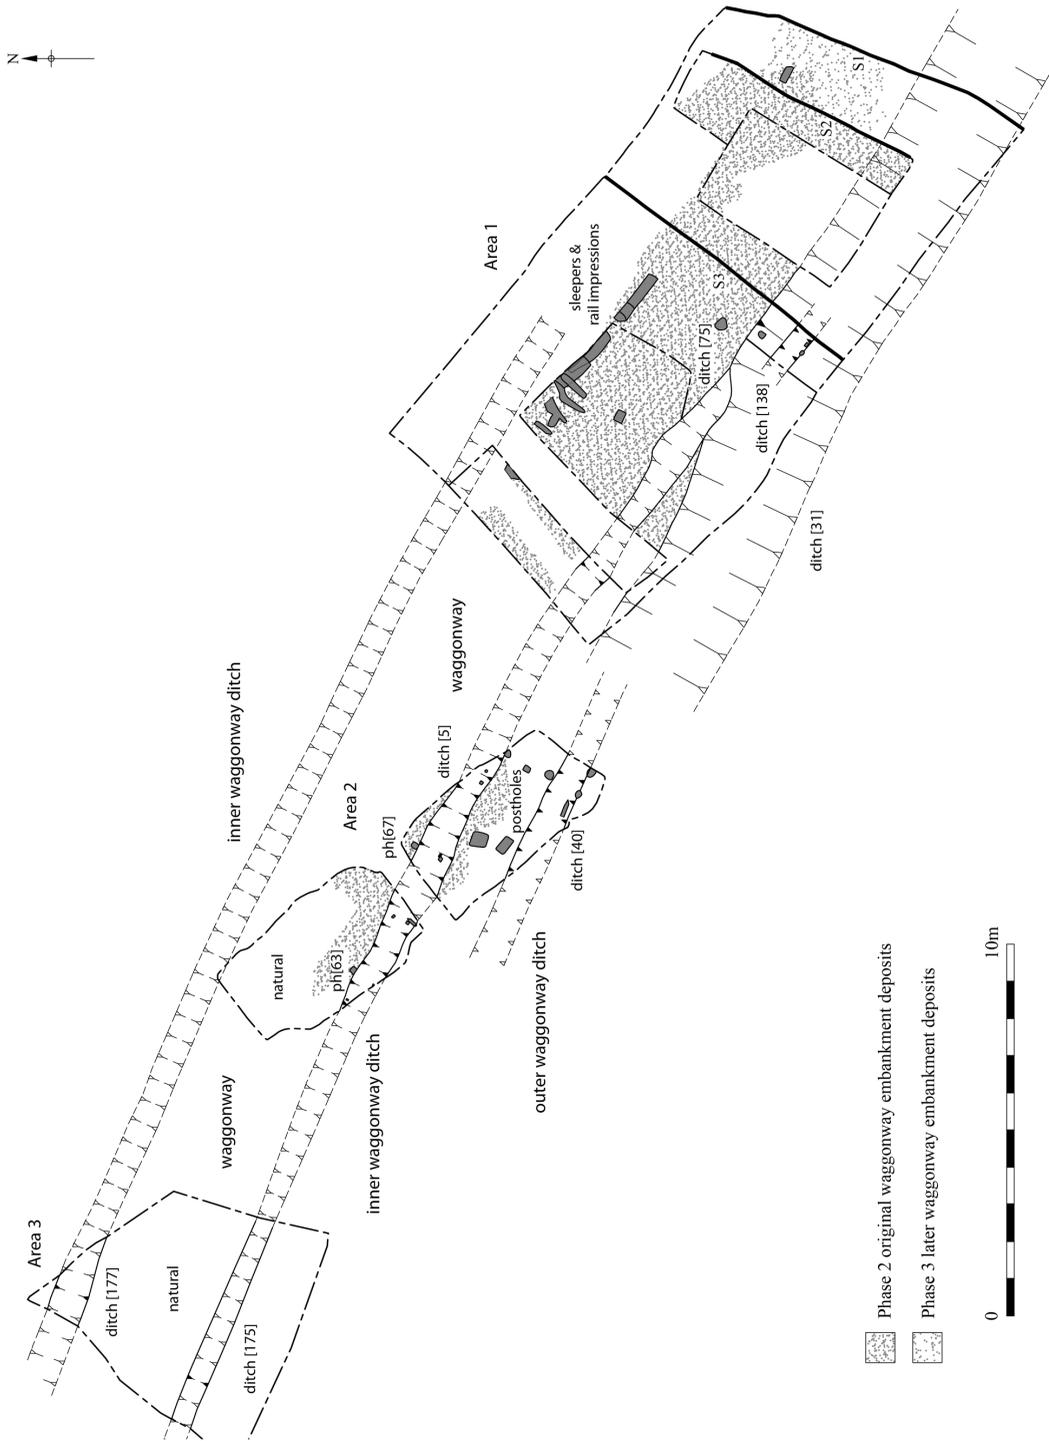
Fig. 6 Sir Charles Parsons School: plan of wagonway across Areas 1-3.

that had been removed. Four irregular sleeper impressions, up to 0.28m wide, survived for a maximum length of 1.17m; four rail impressions running along the north-eastern side of the embankment varied in width from 0.20m to 0.35m and were up to 1.70m long (fig. 6).

the alignment of this ditch shows that its course lay beyond the limits of investigation in Area 2, and within Area 3 it had been truncated by later activity (fig. 6). Traces of the original ditch along the south-western side of the waggonway were recorded in Area 2; the base, which was steep-sided and flat, was recorded in section due to a later recut. In Area 3, all traces of this original ditch were truncated by a later reinstatement [175].

The latest ditch in this area was ditch [31], which had an irregular broadly U-shaped profile, and was up to 2.5 m wide and 0.7 m deep (fig. 6; sections 1, 2 and 3, fig. 9). This produced a small assemblage of finds dating from the eighteenth to nineteenth century.

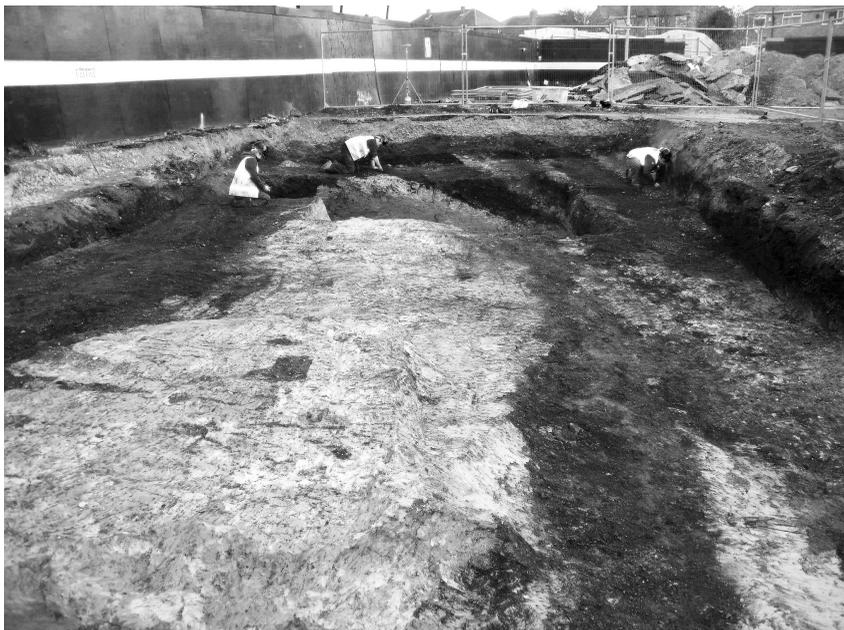
Fig. 7 Sir Charles Parsons School: waggonway embankment in Area 1, looking south-east, with trackside ditches to right of picture.

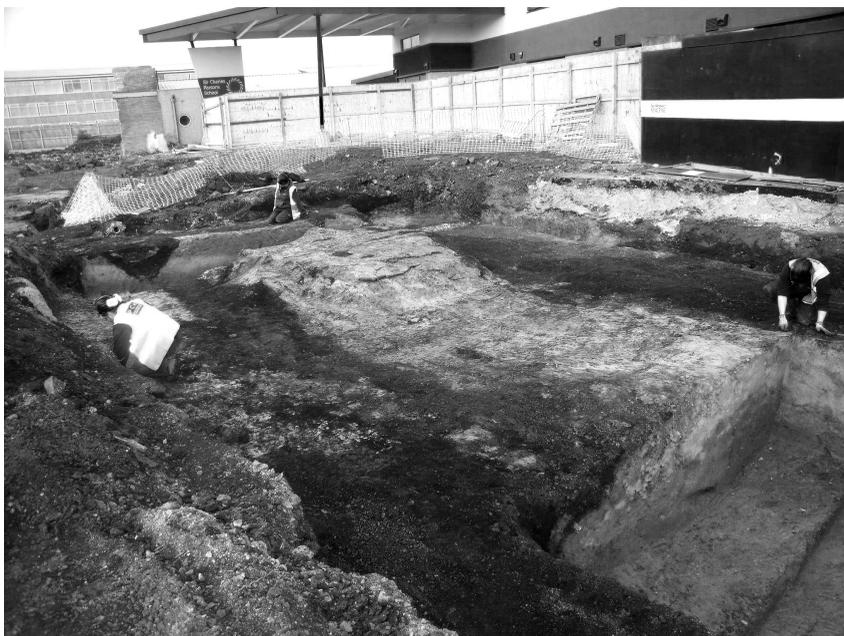
Fig. 8 Sir Charles Parsons School: waggonway embankment in Area 1, looking north-east, with trackside ditches to left of picture, ditch [75] visible in section in background.

Further stretches of the inner south-western ditch were recorded intermittently in plan and section in Area 1; the sequence of activity was more complex here, with several intercutting ditches present. The inner ditch was traced in Area 1 as ditch [75] for a distance of 8.1m (fig. 6). It had steeply sloping sides and a narrow flat base and measured up to 1.55m wide by 0.70m deep (fig. 8).

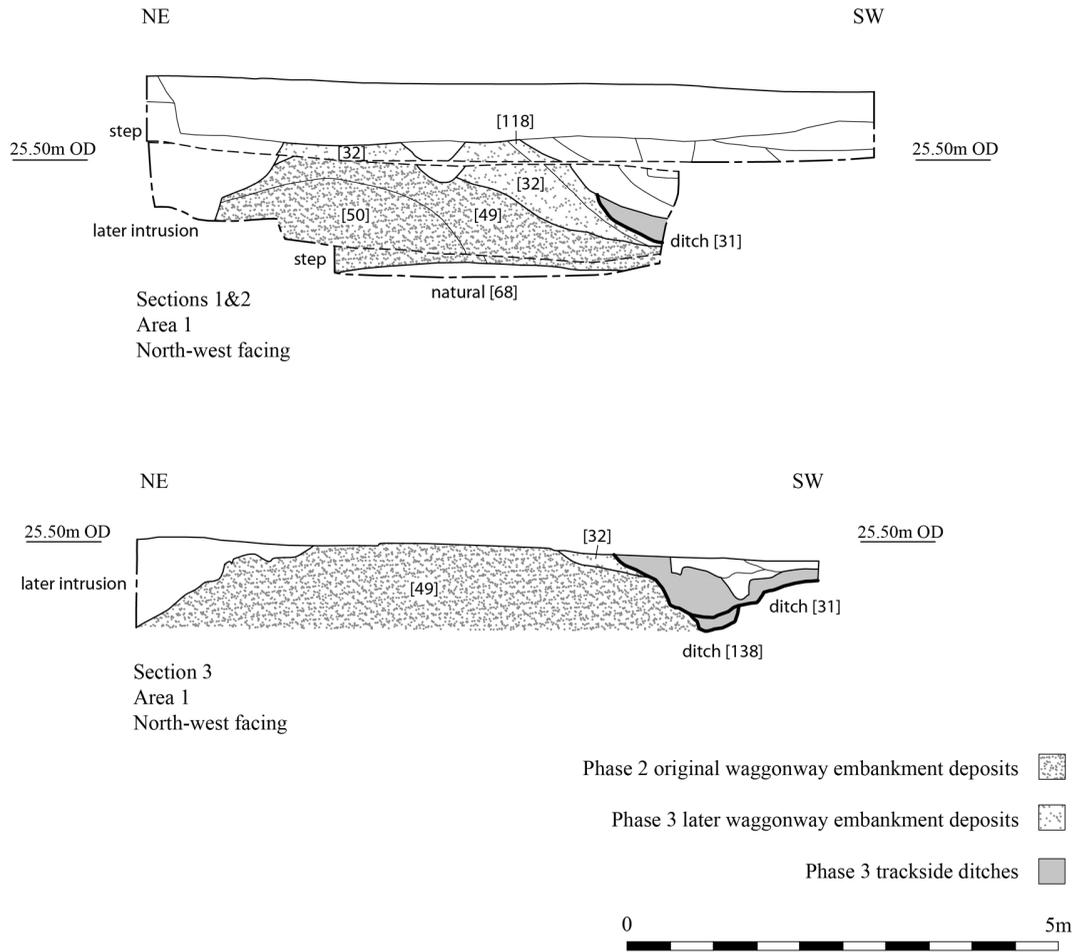
Fig. 9 Sir Charles Parsons School: sections across the waggonway embankment and trackside ditches in Area 1.

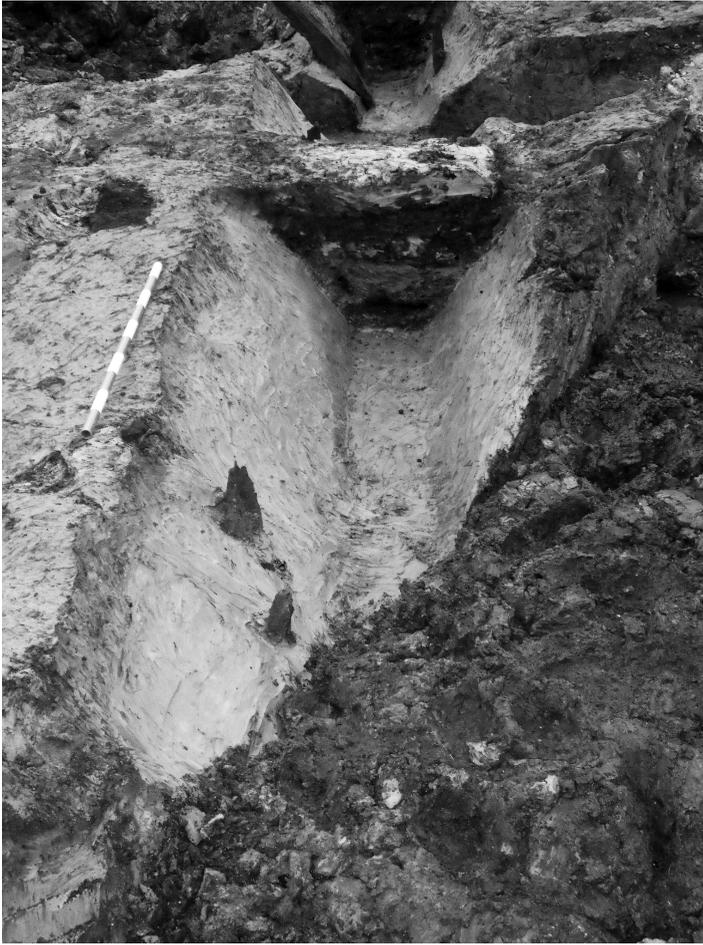
Fig. 10 Sir Charles Parsons School: trackside ditch [8] and recut [5] with timber revetment stakes, in Area 2, looking north-west; scale 1 m.

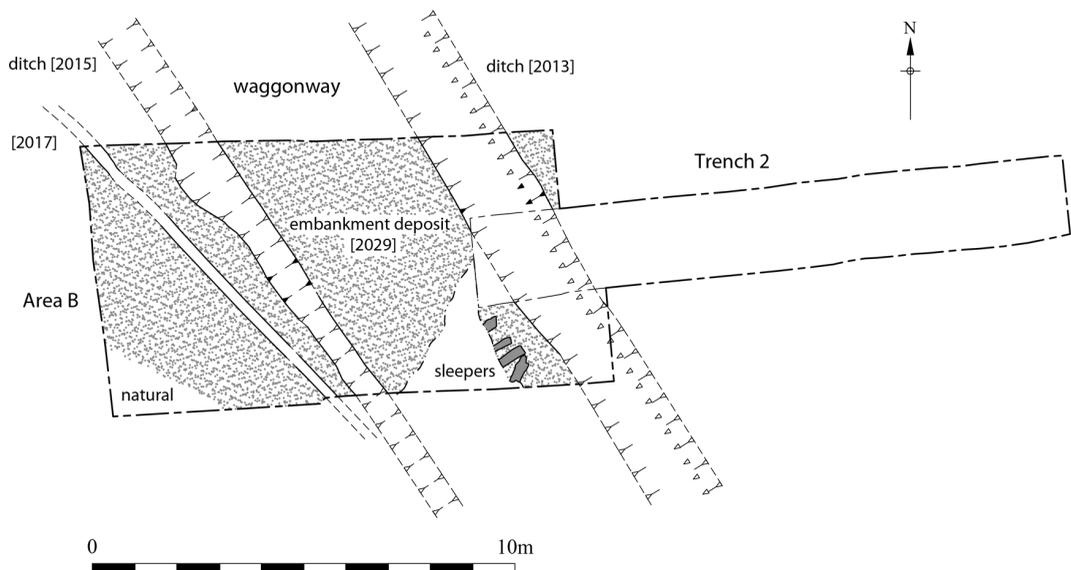
Fig. 11 The Lightfoot Centre: plan of waggonway in Area B.

The truncated remnants of a colliery waggonway were recorded in the south-western part of the development site at the Lightfoot Centre, within the western end of evaluation Trench 2 (fig. 2), where the ditch flanking the eastern side of the track was visible. The trench was subsequently extended to the west (Area B) and both trackside ditches were recorded in plan (fig. 11) with sections excavated across both.

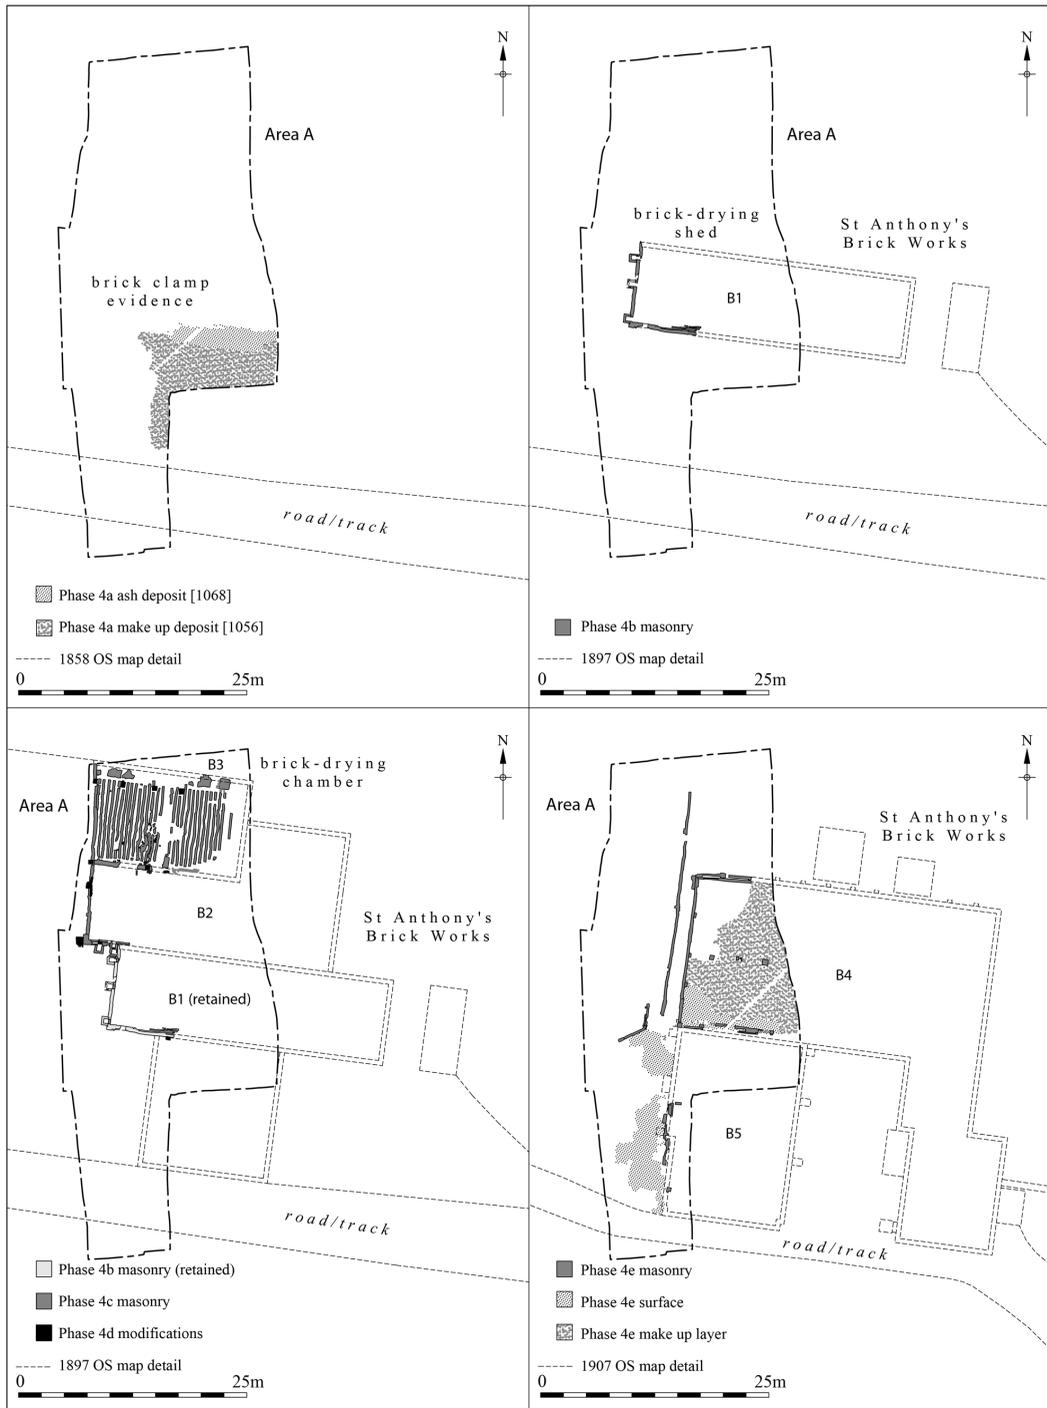
Fig. 12 The Lightfoot Centre: the main phases of activity at St Anthony's Brickworks.

The evidence for brickmaking activity within Area A at the Lightfoot Centre, dating from the mid-nineteenth through to the mid-twentieth century, has been divided into five sub-phases, 4a–4e (fig. 12).

The earliest deposit associated with brick manufacture at the site comprised a compact brownish red ash deposit with fragmented burnt sandstone throughout; this was the basal deposit in the section at the southern limit of excavation. It was overlain by a layer [1056], 0.10 m thick, of brownish red clayey ash with frequent pebbles which was exposed across an area measuring 12 m from north to south by 15 m from east to west (fig. 12). These deposits had evidently been subject to intense heat and are interpreted as levelling and make-up deposits for the floor of a brick clamp. Along much of its northern extent, deposit [1056] was overlain by a layer of black ash [1068], probably the remnants of the clamp flue; this black ash was exposed for a distance of 12 m by 2.10 m (fig. 12; fig. 13).

Building 1 (B1), situated in the central part of Area A (fig. 12), was a brick-drying shed which is depicted on an architect's plan of 1886 (see fig. 20). Much of the structure had been truncated by the early twentieth-century rebuilding of the complex, but the foundations of the west wall and a short length of the south wall survived (fig. 14). It had an external and internal width of 9.5 m and 8.8 m, respectively, and was recorded for a length of 7.45 m. The external elements of the drying shed were all built using pressed wire-cut common brick (average size 220 mm × 110 mm × 70–75 mm) bonded with brittle sandy mortar. The western wall [1102] was up to 0.35 m wide and survived to a maximum height of 0.35 m in four courses at its southern end; elsewhere just one or two courses survived. Three small, square

The drying shed was constructed sometime between the submission of the plans in 1886 and the compilation of the 1898 Ordnance Survey map; the building can be seen on the map as a long narrow range in the central part of the brickworks, but additional structures had been constructed to the north and south by this date. Elements of the northern range of the building as shown on the 1898 map were recorded within Area A, but no traces of the element constructed to the south of the drying shed survived (fig. 12).

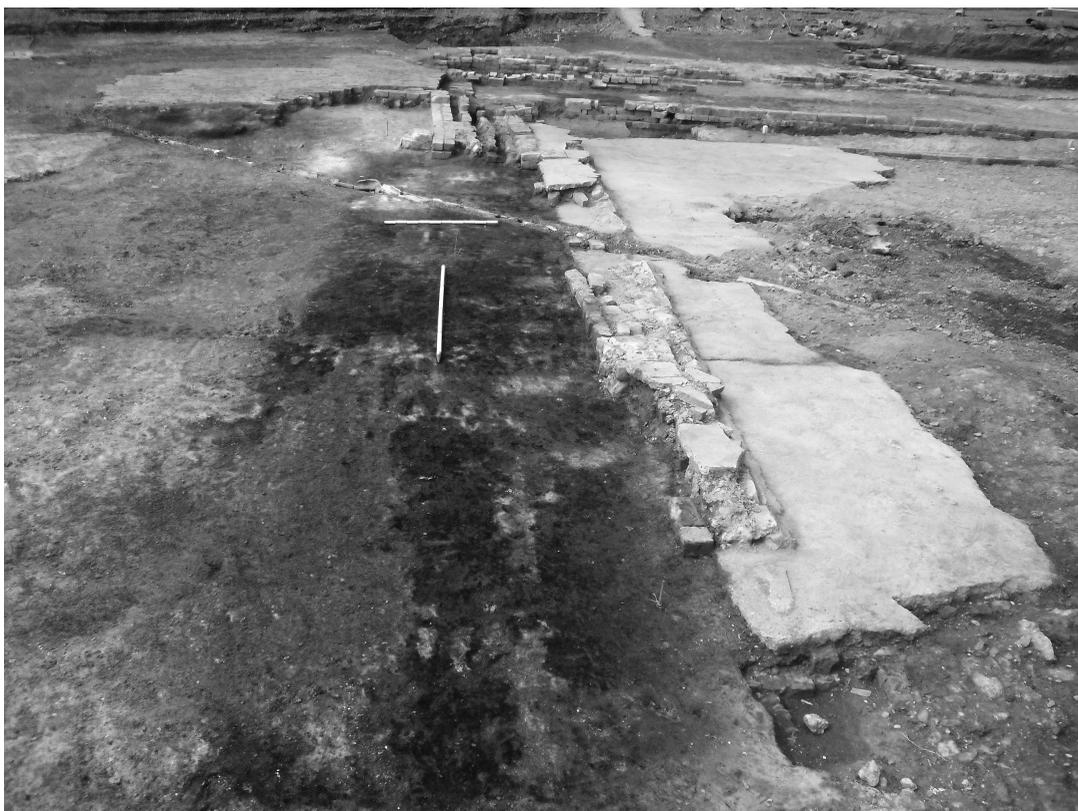
Fig. 13 The Lightfoot Centre: phase 4a brick clamp deposits to centre and left of picture and Phase 4e brickworks structure to right, looking west; scales 1 m and 2 m.

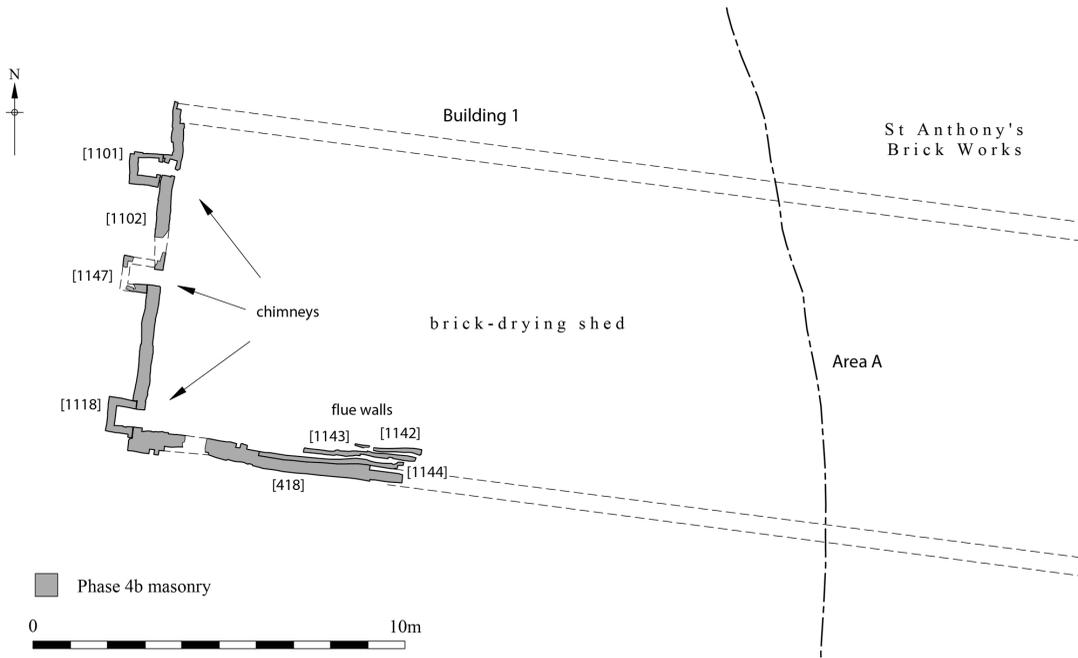
Fig. 14 The Lightfoot Centre: plan of Phase 4b brick-drying shed (Building 1).

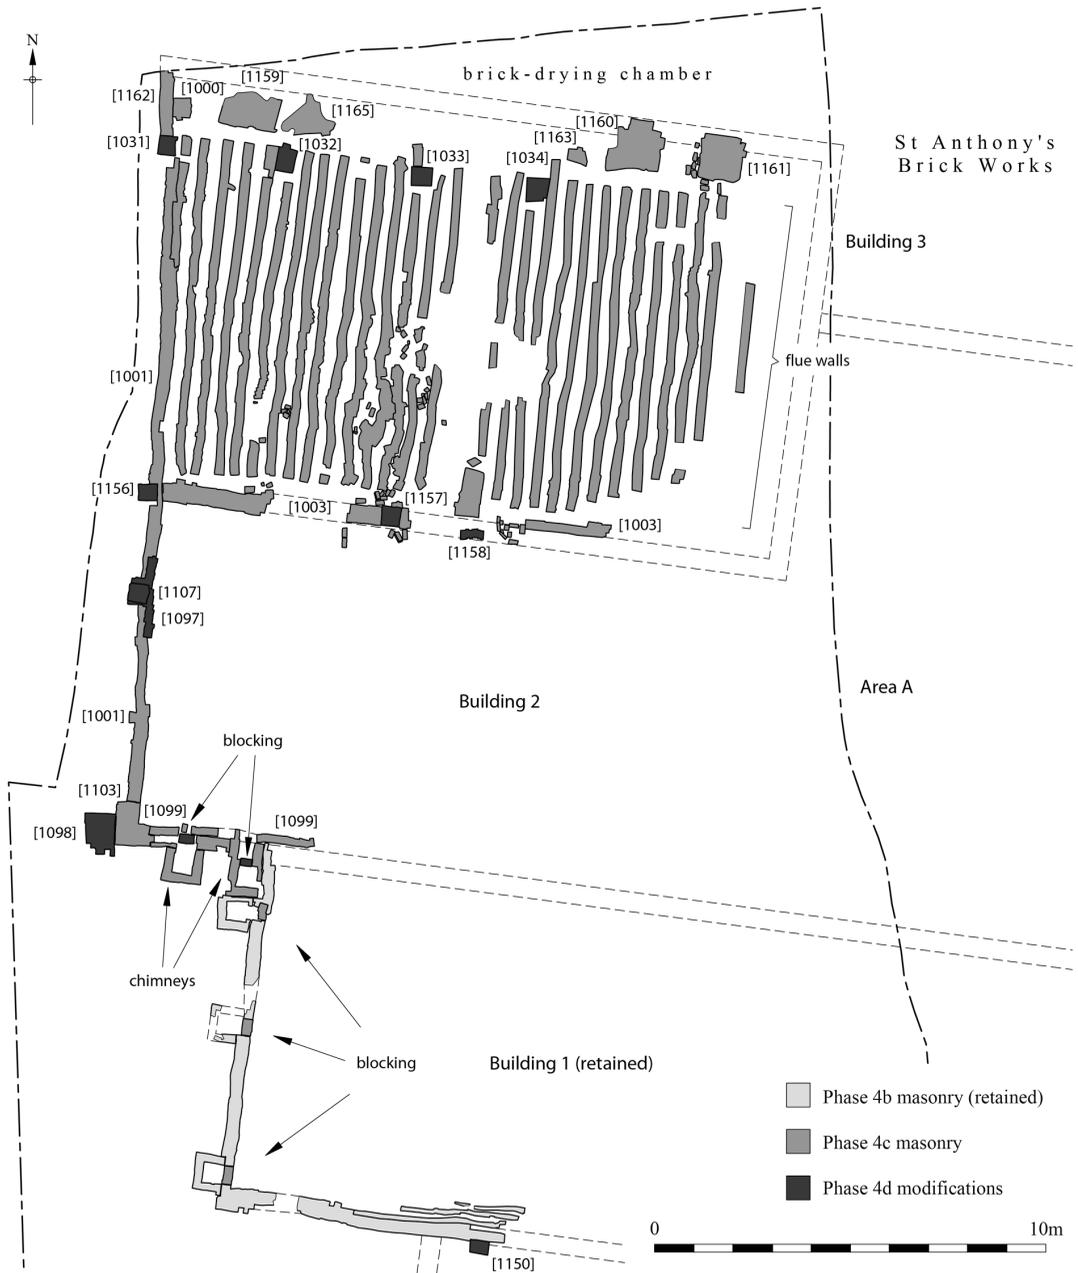
Fig. 15 The Lightfoot Centre: plan of Phases 4c and 4d brickworks (Buildings 1-3).

The two chimneys on the southern wall of B2 were blocked at some stage internally with brickwork, indicating a change in function for this part of the brickworks (fig. 15). Four square brick piers [1031], [1032], [1033] and [1034] at the northern end of B3 evidently post-dated the construction of the flue walls and were presumably added to provide additional structural strength. Three other piers [1156], [1157] and [1158], at the southern end of the drying chamber, were similarly constructed, using pressed wire-cut common brick (average size 240 mm × 120 mm × 70 mm) with a sandy mortar bonding.

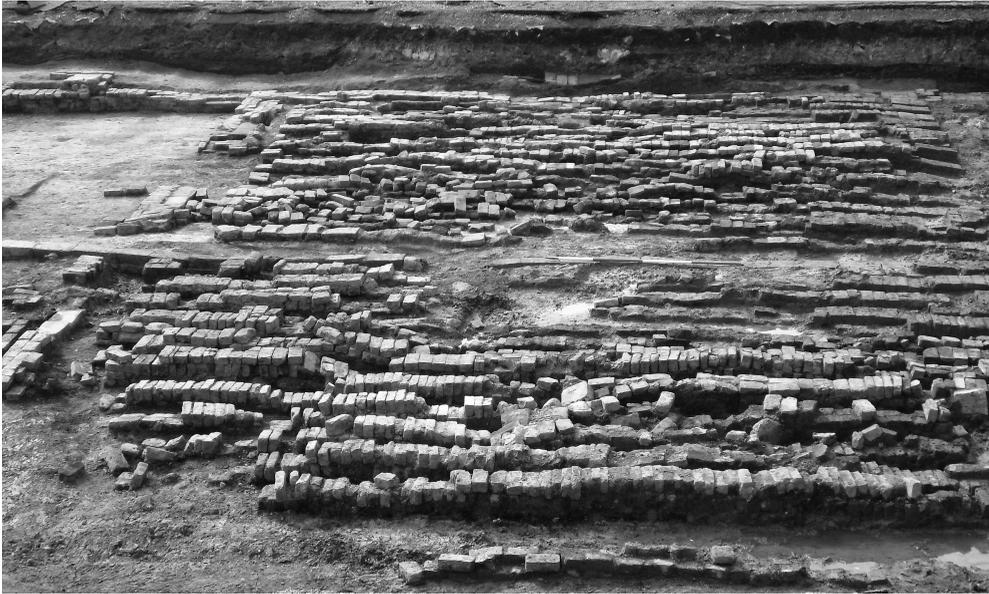
Fig. 16 The Lightfoot Centre: brick-drying chamber in Building 3, looking west; scale 2 m.

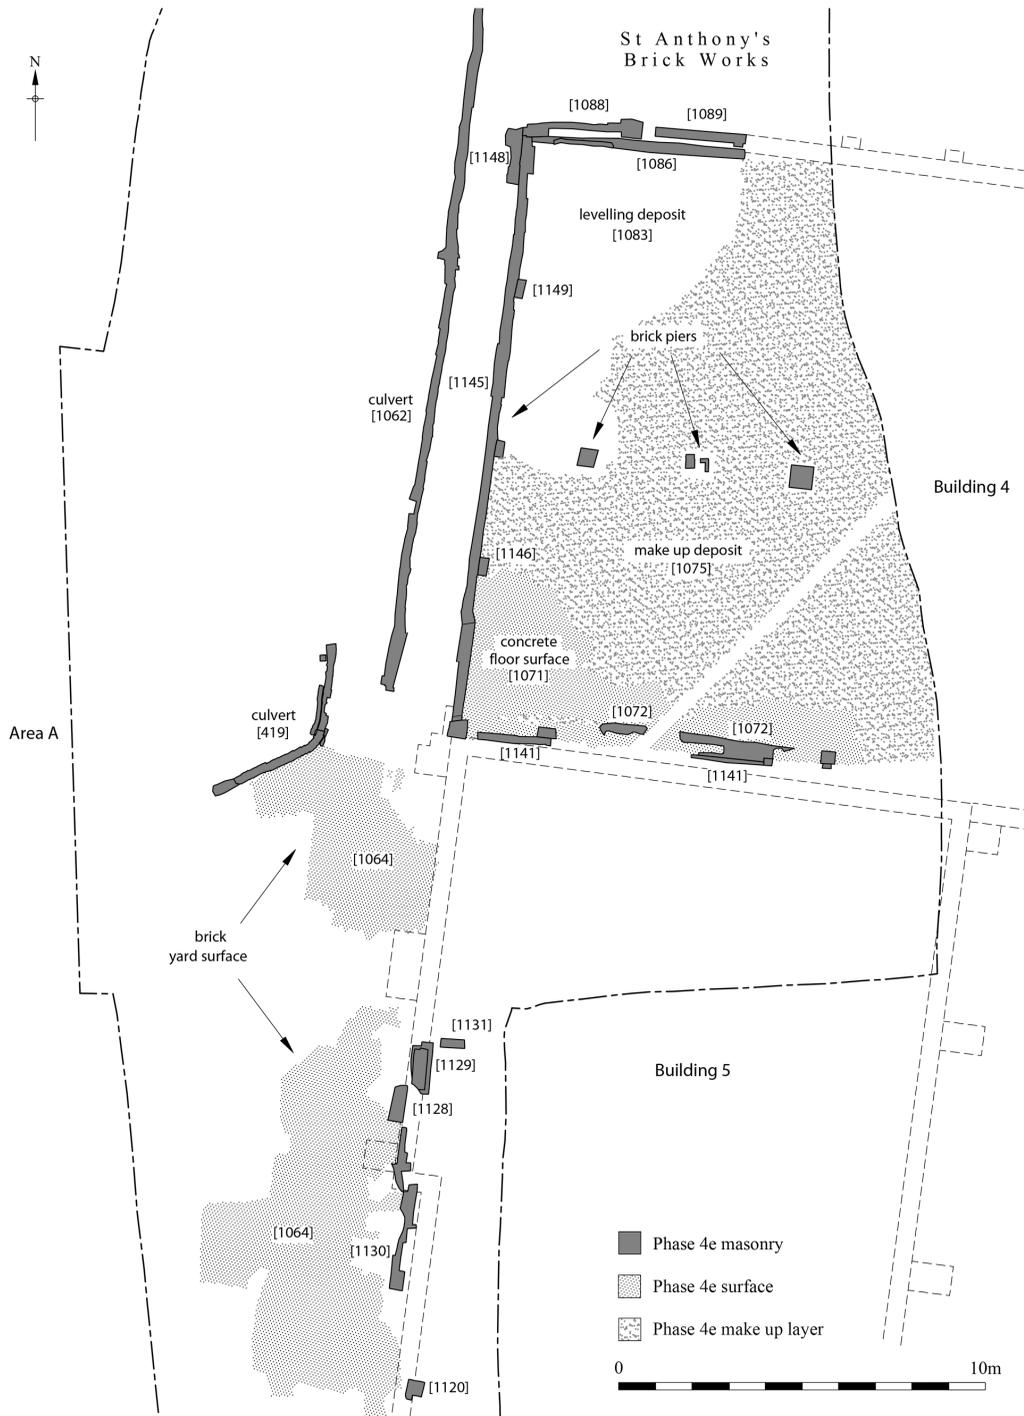
Fig. 18 The Lightfoot Centre: plan of Phase 4e brickworks (Buildings 4 and 5).

The north wall of B<sub>4</sub> comprised two sections of walling [1088] and [1089] with a combined length of 6 m (fig. 18). For the most part, wall [1088] was up to 0.50 m wide and survived to a height of 0.18 m, in two courses, the upper course in stretcher bond. At the eastern end of wall [1088] was a rectangular pier, fully integrated into the wall rather than a separate element, which projected a short distance to the north of the wall-line. This was *c.* 2.5 m from the corner of the building and corresponds to the location of a small rectangular projection shown on the north wall of the building on the 1907 map; several similar projections were depicted along the length of the north wall. A break in the line of the wall, about 0.3 m wide, to the east of the projection, indicates that this was probably the location of an air vent through the external wall. A concrete foundation and a brick wall [1086] ran parallel to the northern wall, presumably representing part of an internal feature.

To the south of B<sub>4</sub> were the fragmentary remains of Building 5 (B<sub>5</sub>), although little survived due to extensive disturbance in this part of the site. A few segments of wall [1128], [1129] and [1130], recorded for a combined length of *c.* 6.8 m, represent parts of the west end; another fragment [1131] may have been part of an internal east–west wall (fig. 18). To the south was an isolated brick pier [1120].

A brick-lined culvert [1062] ran parallel 1.50 m to the west of Building 4 and was traced for a total length of 24.70 m (fig. 18). It was built within a narrow construction cut, with the walls set just 0.10 m apart, and was capped with distinctive large pressed bricks (e.g. 400 mm × 240 mm × 120 mm, although with considerable variation). Brick culvert [419] lay to the west; this was aligned SW–NE for a distance of 3 m then ran northwards for 3 m, cutting through B<sub>1</sub>, beyond which point it was not exposed. It was built with a variety of brick types: wire-cut common bricks and firebricks, including a damaged voussoir brick, probably made *c.* 1870 at Lister's Yard, Scotswood.

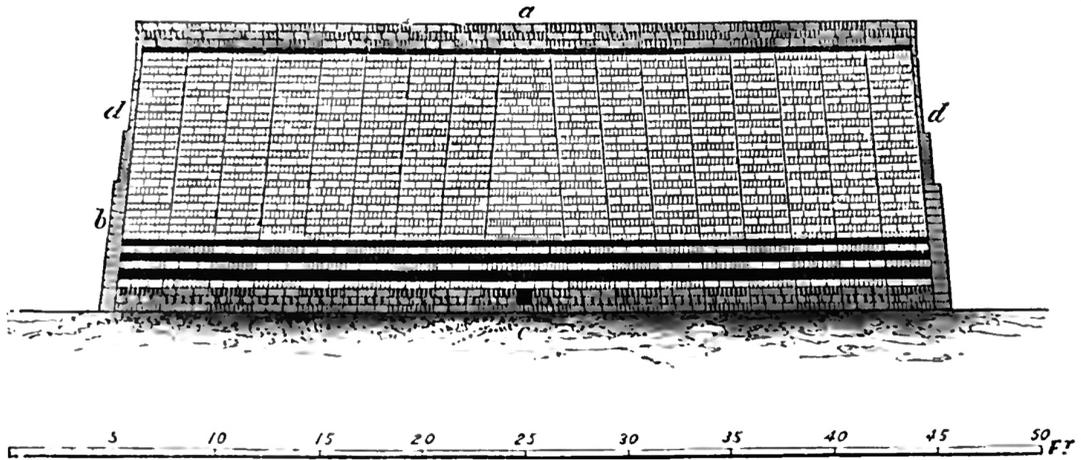
Fig. 19 Cross-section of a brick clamp showing flue channels filled with fuel (Dobson 1886, 146).

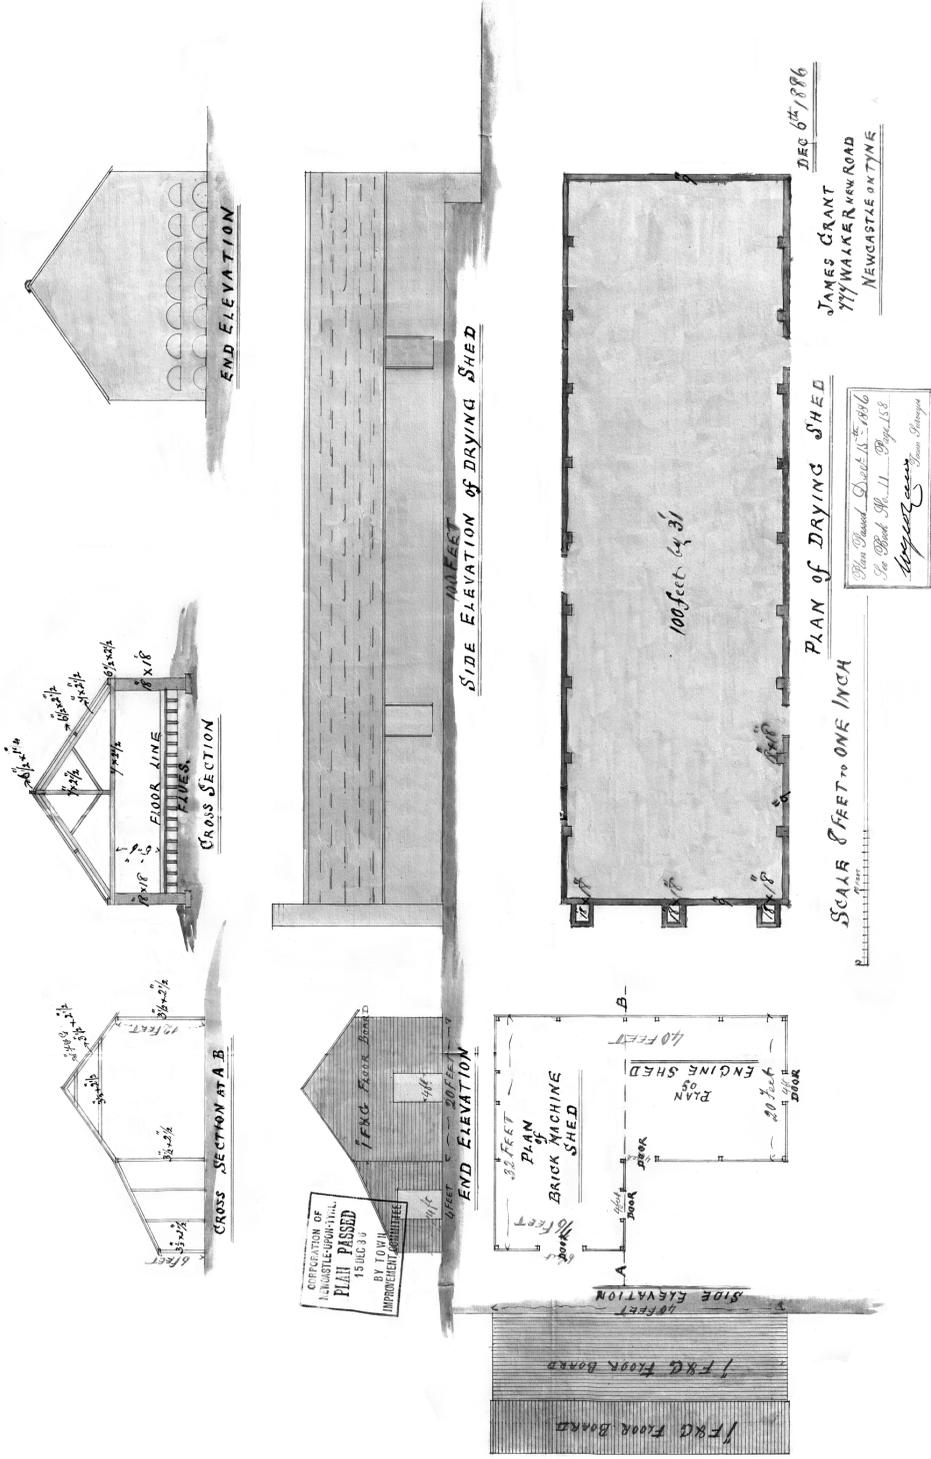
GRANT AND WATSON  
BRICK WORKS  
SAINT ANTHONY'S DEC 6<sup>th</sup> 1886

Fig. 20 Architect's drawings for proposed 'drying shed' and 'brick machine and engine shed' at 'Grant and Watsons Brick Works, St. Anthony's', reproduced by permission of Tyne and Wear Archives and Museums (T186/11858A).
