# The marking-out of Hadrian's Wall

David J. Breeze

*A small bank is visible along the northern edge of the ditch of Hadrian's Wall in various locations. The purpose of this bank is discussed together with similar features elsewhere on this frontier and on the Antonine Wall.*

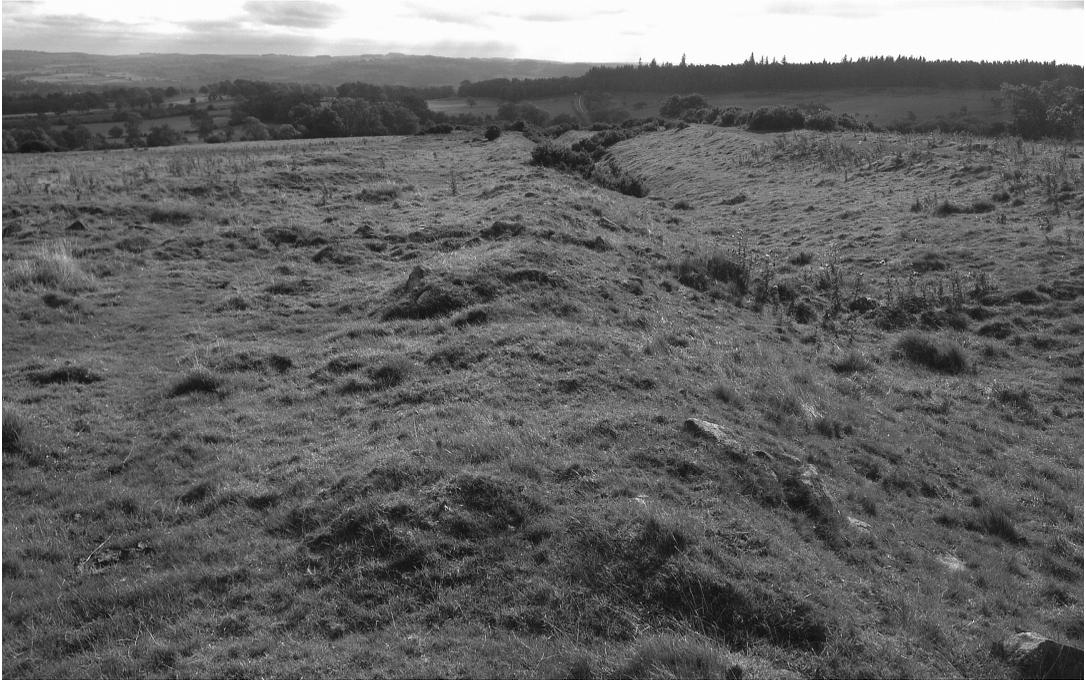
Fig. 1 Black Carts, looking east: the ditch, to the right, the bank and, to the left, the low mounds running north-south.

| T 29a/b–MC 30 | there is a stony bank on the north lip of the ditch characterized as 'the counterscarp' (Wilmott 2009, 82, fig. 193) in a sector where the glacia, up to 17 m wide, is not spread smoothly (fig. 1); |

The Vallum mounds were certainly constructed within revetments. The 'counterscarp' bank to the north of the Wall ditch recorded by Wilmott at Black Carts was largely composed of stones, still visible today, and the likely origin of these stones is the ditch so the bank could hardly have been created as a marking-out bank as the stone lay below the earth which normally appears to have been used for such a purpose. Its carefully-laid nature would suggest that it served as a revetment, and the smaller banks could have served the same purpose. In his report on his section across the ditch and glacis at Heddon-on-the-Wall, Jobey recorded that the upcast had slipped forward over the lip, which indicates that a carefully constructed revetment would have served the useful purpose of preventing more substantial slippage (Jobey 1958, 58).

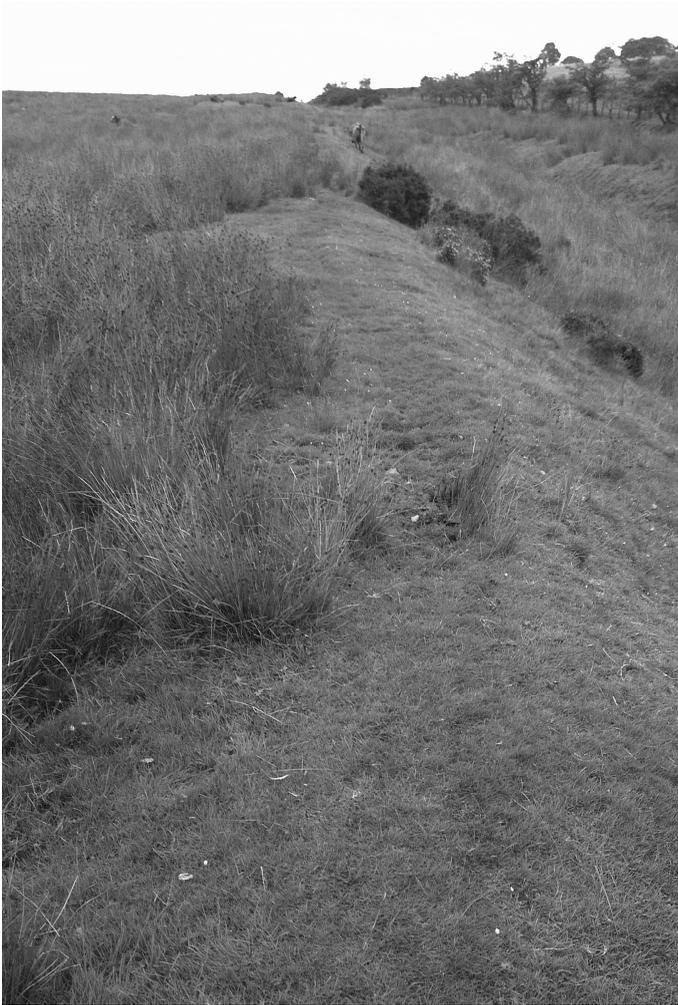
Fig. 2 T 50a SW; the bank, looking east.

| MC 50–T 50b SW | there are several stretches where the bank survives in a field of rough pasture (fig. 2). |

Characteristically, the bank is about 2 m wide and 300–400 mm high. It sits on the very edge of the ditch. It is difficult to photograph, but can be seen on Humphrey Welfare's photograph of the ditch and glacis to the east of MC 40 (Winshields) at the point where the main ditch ends, and also on Wilmott's photograph of Black Carts (Welfare 2004, 14, fig. 4; Wilmott 2009, 82, fig. 193). In some areas, there are rushes to the north of the mound emphasising its visibility (fig. 2).

<sup>4</sup> The situation is different at T50a SW. Here the upcast is about 17 m wide. To the west of the turret the northern edge of the mound is scalloped. To the east, there is no bank on the north lip of the ditch, but the upcast falls for 2–3 m to the north, then, after a wide depression, rises again; the northern edge is not smooth, but is not 'scalloped' as to the west.

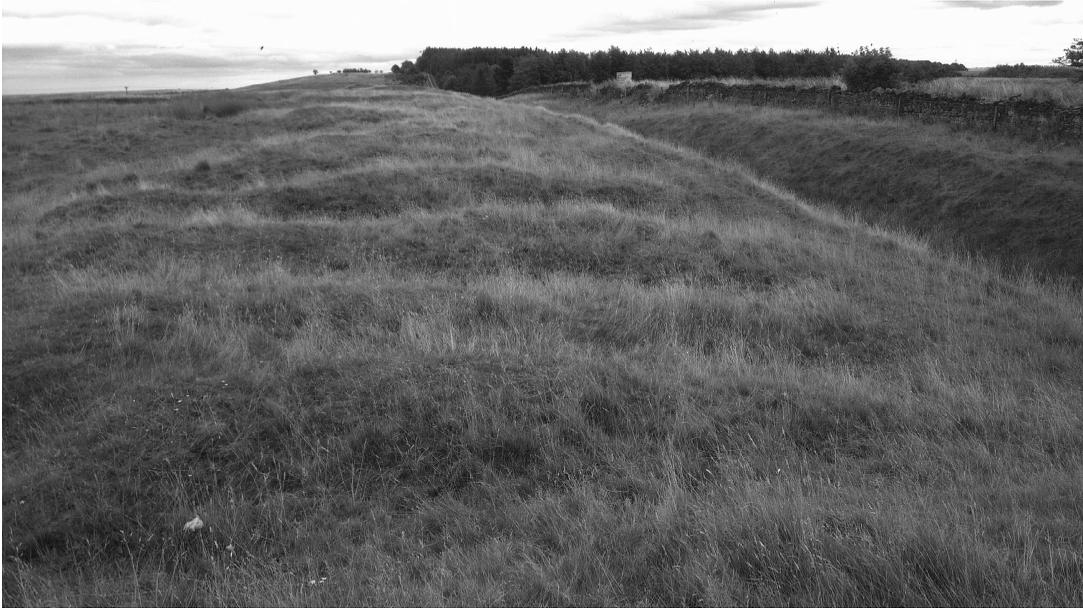
Fig. 3 The mounds at right-angles to the ditch of the Wall (right) to the west of T23b, looking east.

A clue to the survival of these low banks, however, may be given by observation of the section of Wall to the west of T23b (fig. 3). Here, as John Hodgson noted, 'the earth taken out of it [the ditch] lies spread to the north, in lines, just as the workmen *wheeled* it out and left it. The tracks of their barrows, with a slight mound on each side, remain unaltered in form' (Hodgson 1840, 276). An accurate description, with the exception that the earth would presumably have been carried not in barrows but in baskets as depicted on Trajan's Column. Richmond described this phenomenon in the following way: 'the materials that have been dug out of it [the ditch] are lying on the outer margin, rough and unlevelled, as if the labourers had but left the work to obtain some refreshment, and were about to return to it' (Bruce 1947, 72). This unfinished work consists of low, wide mounds lying at right angles to the ditch, the north lip of which is sharp, except where disturbed by later quarrying. The mounds of spoil do not run out from the edge of the ditch but start about 3 m or so to the north, and therefore beyond the edge of the visible bank where it exists in this sector, and decline in height to the north, as does the glacis where it is completed. A similar feature may be observed at Black Carts (Wilmott 2009, 82, fig. 193). It would appear that in both areas the ditch diggers dumped their spoil a little north of the edge of the ditch before spreading it out. This approach would help account for the survival of the marking-out bank. In the sections where it is still visible, the labourers presumably had not pulled the dumped spoil back to level with the top of the bank, or had failed to fill in the space immediately to the north of the

bank with new material just as they had not filled in the spaces between the north-south mounds. Where no such bank survives we may presume that it had been incorporated into the glacia.<sup>4</sup> These unfinished sectors are important because they allow us to observe the process of constructing the glacia.
