The Vallum of Hadrian's Wall

David J. Breeze

SUMMARY

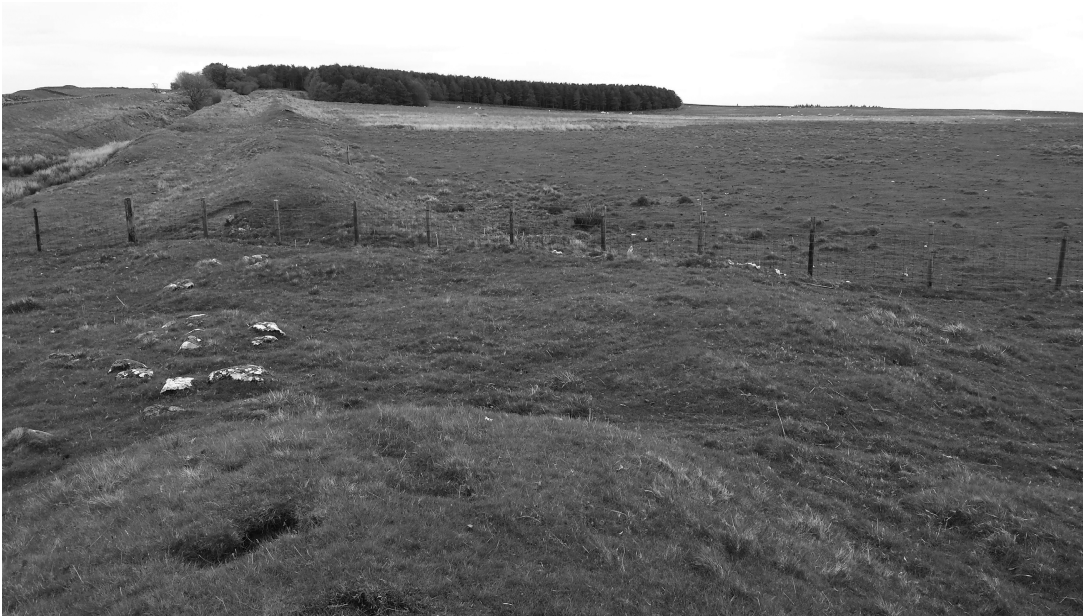
Fig. 1 The south mound of the Vallum, just to the west of Limestone Corner, looking east. The material from the gap cut in the mound has been spread out on the south side.

Swinbank pointed out that the situation on the ground is more complicated than the Simpson-Shaw analysis, noting, for example, that in relation to the south mound 'it seems clear that for the greater part of the well-preserved sectors of the earthwork the gaps were rarely deeper than half the mound' (Swinbank 1954, 296). She also emphasised the point recorded by Simpson and Shaw that there was not always a close relationship between the size of the gaps in the mounds and the amount of material in the crossings, and that where the gaps were shallow more material must have been added to create the crossing (Simpson and Shaw 1922; Swinbank 1954, 295–7). Swinbank also noted that to the west of Limestone Corner the basalt boulders previously lying on both berms were tumbled into the ditch to form the crossings (Swinbank 1954, 297). On Wallend Common (46–47), Simpson and Shaw stated that the material from the gaps was spread outside the Vallum and left lying in small heaps; Swinbank recorded that 'the exact position of this state of affairs could not be discovered' (Simpson and Shaw 1922, 400–1; Swinbank 1954, 99). Swinbank did, however, record that between Limestone Corner and Carrawburgh farm (30–31) the material from a gap was spread over the ground to the south (Swinbank 1954, 71); this is still visible (fig. 1).
