The military bath house at the Roman fort of Chesters, Northumberland

Margaret Snape and Graeme Stobbs

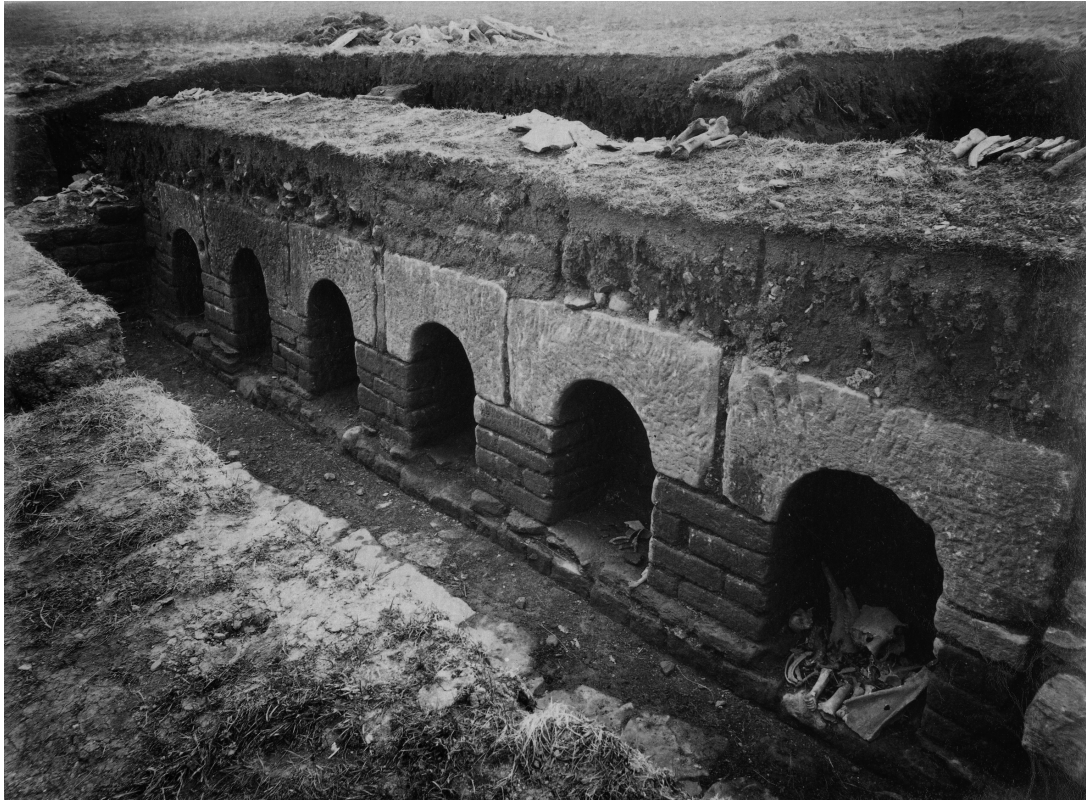
Fig. 3 Start of excavation of the bath house: trenches along the interior and exterior faces of the west wall of the changing room, viewed from the north-east. Part of the collapsed northernmost niche visible in the lower right corner. Finds of animal bones on display. Photograph by J. P. Gibson, 1884 (Copyright Tyne & Wear Archives and Museums).

Three previously unpublished Gibson photographs reveal how the initial discovery of the baths was made and the method by which excavation began. Figure 3 shows the interior of the west wall of the changing room, lined with niches. Apparently recording the start of excavation in 1884, the shortness of the grass indicates it is early in the year, the caption written before the building was identified as a bath house. This and a subsequent photograph (fig. 4) show the portion of wall containing the northernmost niche collapsed forward, most likely caused when workmen digging the trench for the drain accidentally struck the corner of the building.

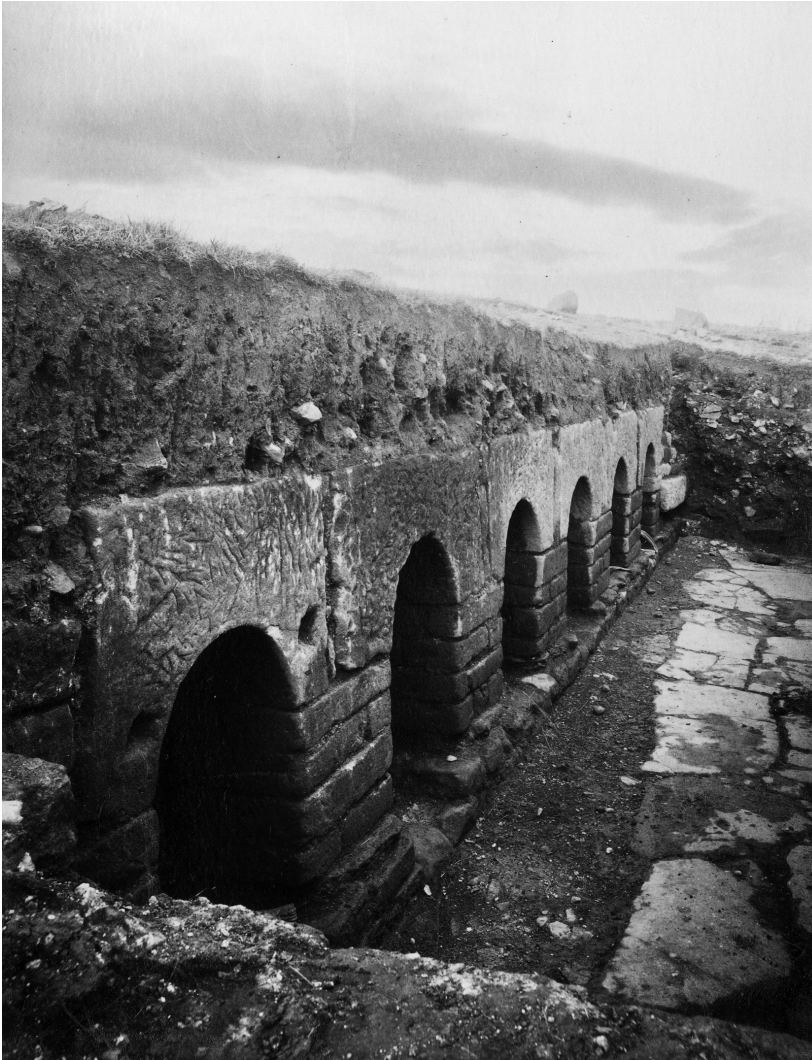
Fig. 4 Start of clearance of the interior of the changing room, viewed from the south; the arch of the northernmost niche collapsed. (The Victorian caption reads 'River-side buildings', rather than 'Baths'.) Photograph by J. P. Gibson, 1884 (Copyright Tyne & Wear Archives and Museums).

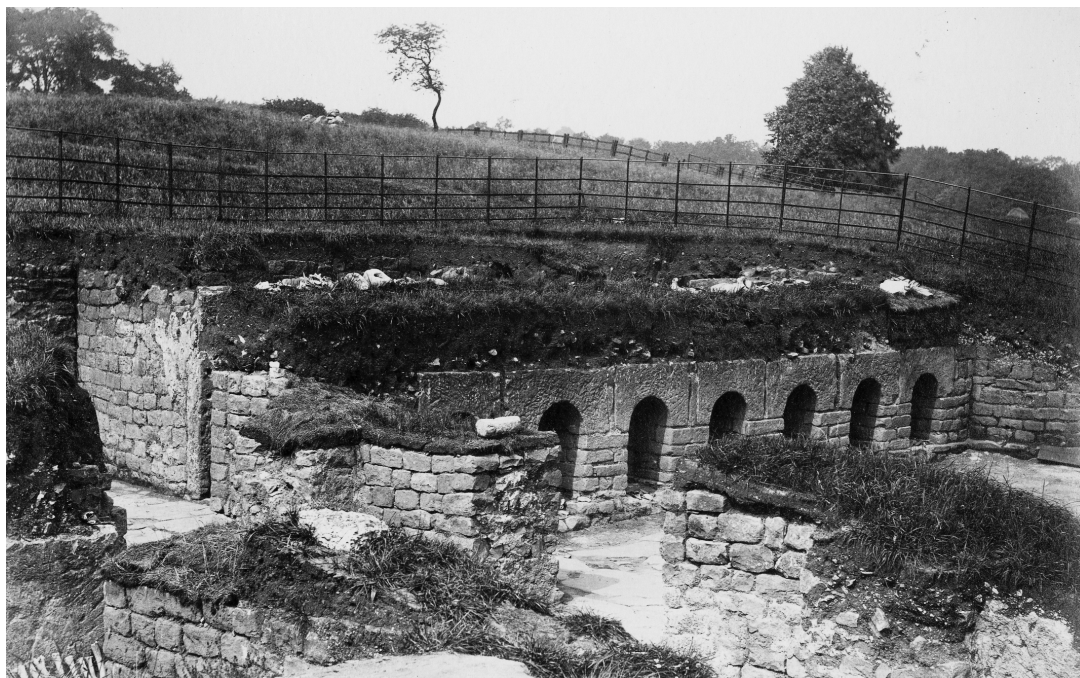
Fig. 5 Changing room, lobby and *laconicum* suite fully excavated, viewed from the south-east; northernmost niche in the changing room repaired. Finds displayed on top of baulks. (The Victorian caption reads 'River-side buildings', rather than 'Baths'.) Photograph by J. P. Gibson, 1884 (Copyright Tyne & Wear Archives and Museums).

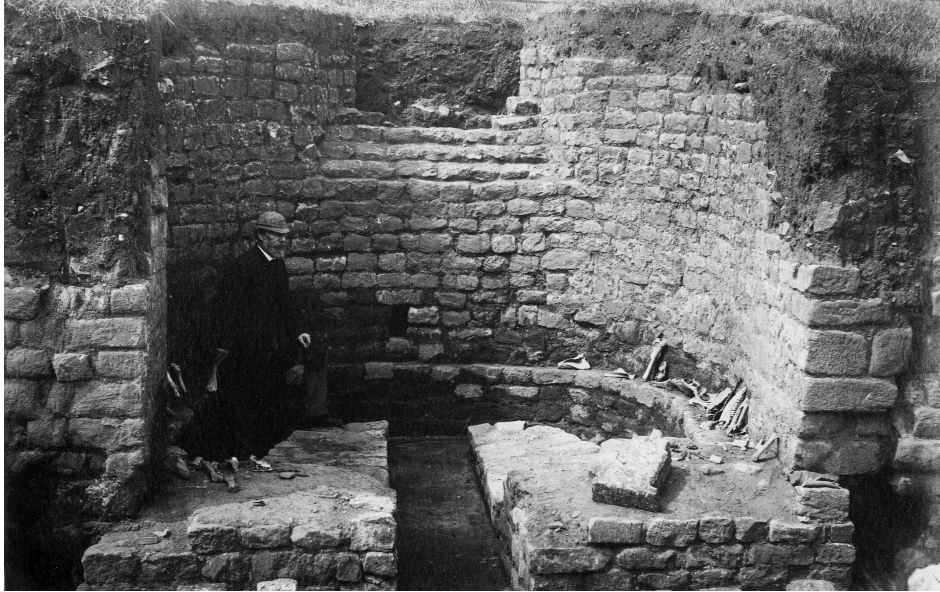
Fig. 6.i William Tailford Jnr standing in the excavated apse of the *caldarium* with finds including a tufa voussoir, hypocaust *pila* and animal bones on display; viewed from the east. (The Victorian caption reads 'River-side buildings', rather than 'Baths'.) Photograph by J. P. Gibson, 1884 (Copyright Tyne & Wear Archives and Museums).

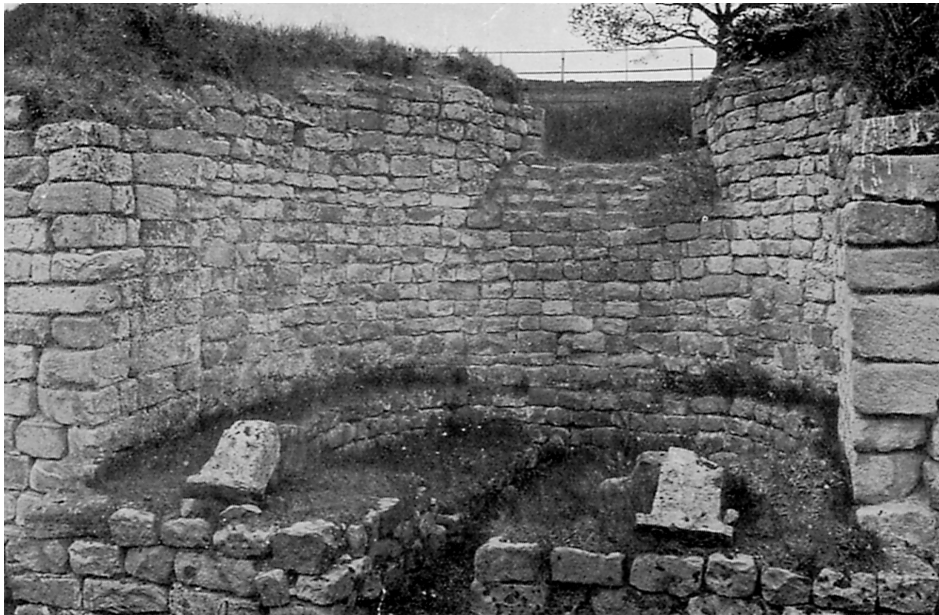
Fig. 6.ii The apse of the *caldarium*, photographed by J. P. Gibson in 1886, showing that the walls on the north and south sides had been built up (Copyright Tyne & Wear Archives and Museums).

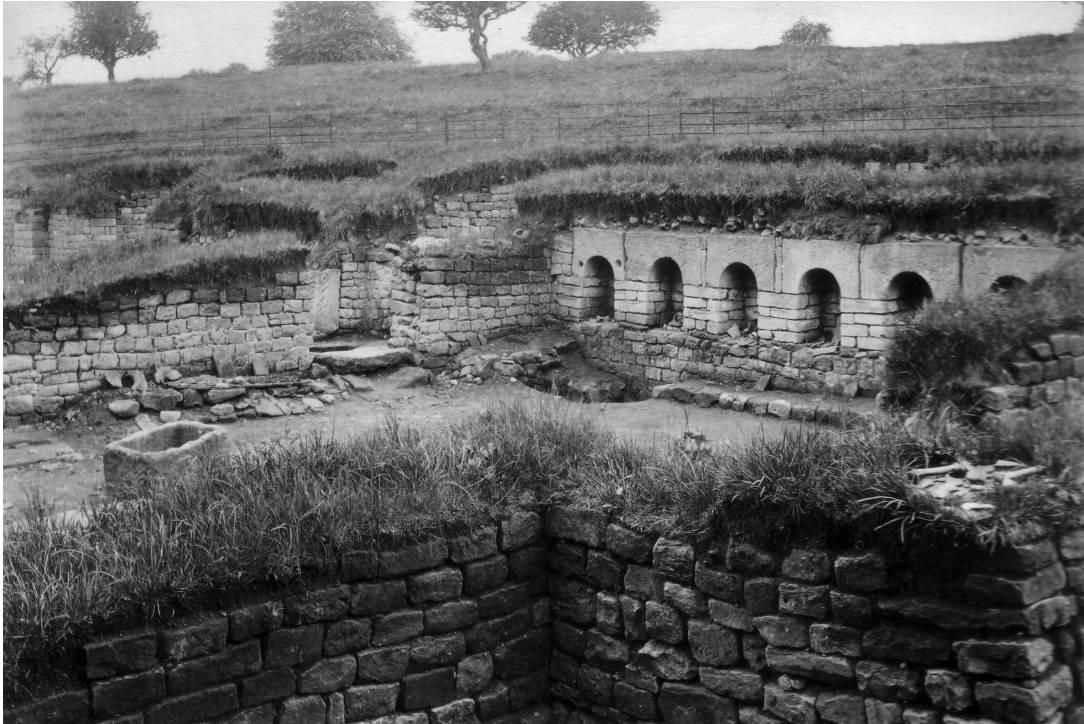
Fig. 8 Photograph by J. P. Gibson of the northern part of the building, sometime after July 1886, viewed from the north-east. Part of the porch in the right foreground, a sondage dug in the south-west corner of the changing room, finds on display against the south wall (Copyright Trustees of the Clayton Collection and English Heritage).

Subsequently the outer face of the north wall was cleared, revealing a porch attached to the main entrance and also a small lobby to the north of the latrine. A photograph (fig. 8) in an

album in the Clayton Collection in Corbridge Museum (CH5980, acc. no. 03.5066) shows part of the porch and the sondage in the changing room. The photograph must post-date the plan of July 1886, but the foliage visible in the background indicates it was still late summer or early autumn. Finds are arranged on the top of baulks, in the niches and grouped against the south wall. The stone trough is still *in situ* today.

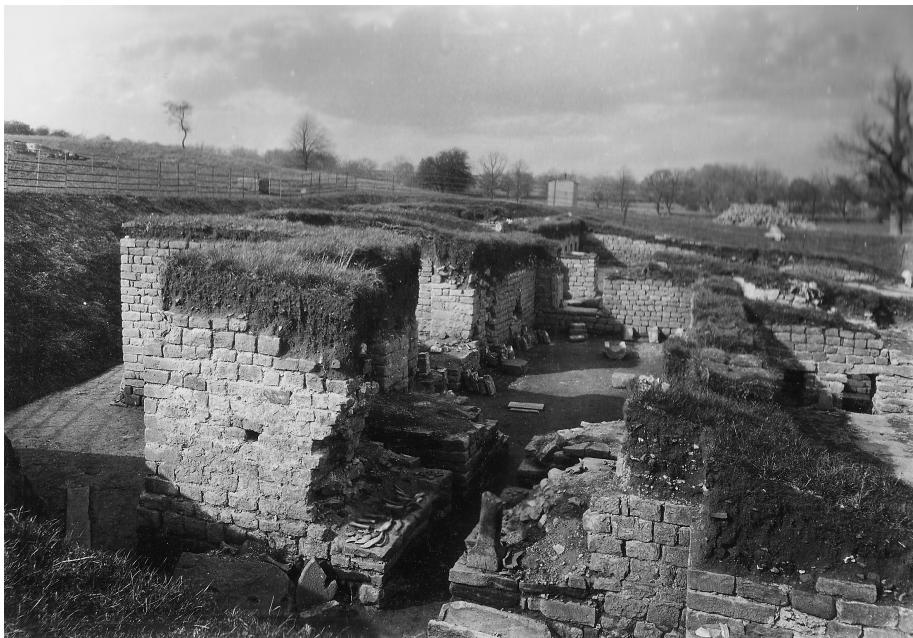
Fig. 9.i Photograph by J. P. Gibson of the baths from the south in 1885, probably in autumn/winter (Copyright Trustees of the Clayton Collection and English Heritage).

amongst the remains, but the arrangement of finds is exactly as displayed in a photograph taken late in 1885 (Macdonald 1931, Pl. XLIX, reproduced here as fig. 9.i).

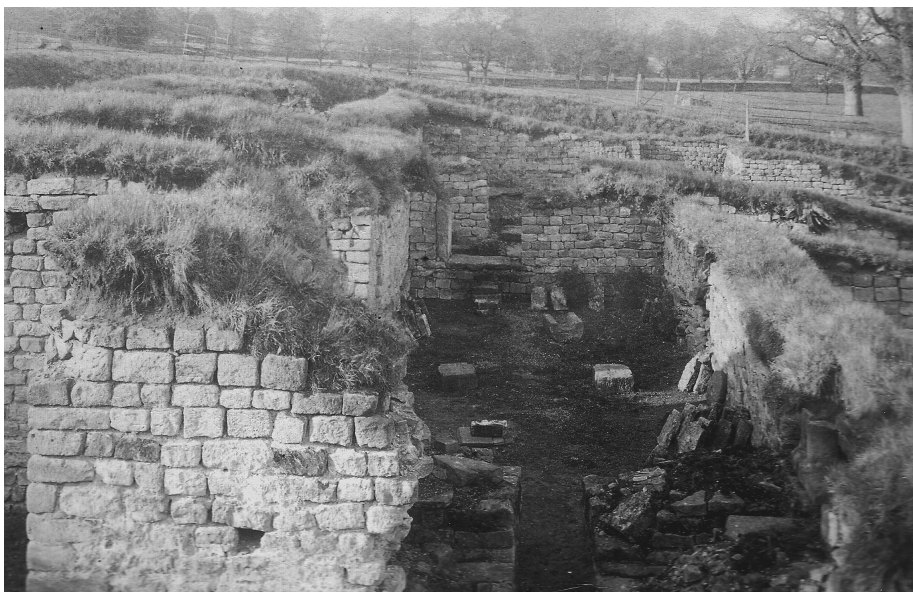
Fig. 9.ii Photograph by J. P. Gibson of the baths from the south, probably after the end of excavation in autumn/winter 1886 (Copyright Trustees of the Clayton Collection and English Heritage).

Another photograph from the Clayton Collection album (fig. 9.ii) (CH16686 (96.5013A)) records the end of excavation. Taken in the autumn or winter of 1886 — trees had shed their leaves — it shows a panorama of the building from the remains of the southern hot bath, looking towards the north wall of the changing room and entrance porch. Weeds sprout

Gillam’s observations of the MoW work found evidence of how spent gases left *tepidarium* E₁. The west wall had been altered by modifications throughout the Roman period, and has been the subject of repair and consolidation, making interpretation difficult. However Gillam (1956–8, 1, 3) stated that on the inner face of the wall there was a chimney (figs. 10.i, 10.ii). This may be identified as an ‘evacuation duct’; these features are defined as ‘vents running up through the walls at intervals and acting as chimneys for the hypocaust. Their presence usually indicates the absence of hollow walls’ (Bidwell 1979, 32–3, n. 4). An example was embedded in the south wall of the Period 1c *laconicum* ante-room, which had no wall jacketing; the chimney was formed of hollow box tiles which had broken to leave a narrow slit in the wall face (Macdonald 1931, 297, Pl. LVI, 1). Another northern example was found in the late first-century baths at Corbridge Red House (Daniels 1959, 128–9). Gillam’s identification seems vindicated by one of Gibson’s photographs taken in 1885, showing the whole building viewed from the south (fig. 9.i). Halfway along the inner face of the west wall of room E₁ is a narrow gap, beginning roughly at the level of the suspended floor and extending up the wall in a straight line for a short distance. There is no gap in the wall in the photograph taken at the end of excavation in 1886 (fig. 9.ii); evidently a repair had been carried out.

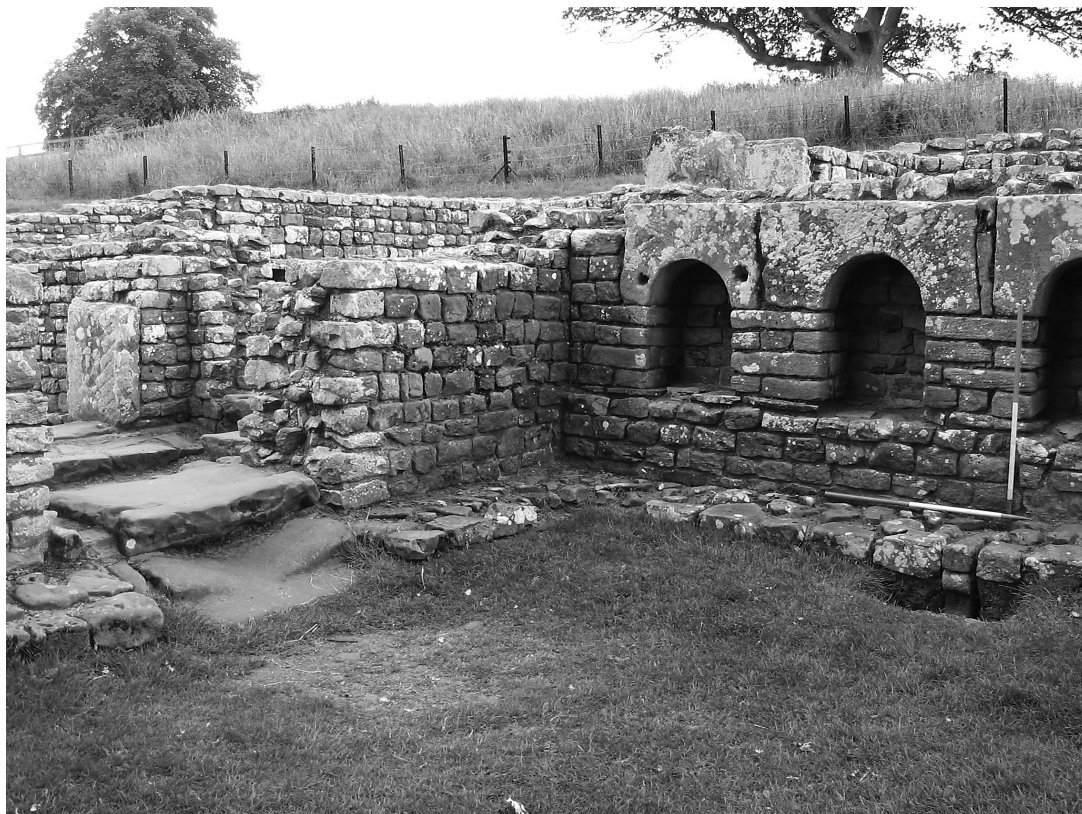
Fig. 15 The south-west corner of the changing room, viewed from the north-east. On right, surviving bench leg, on left, steps into lobby. Photograph, the authors.

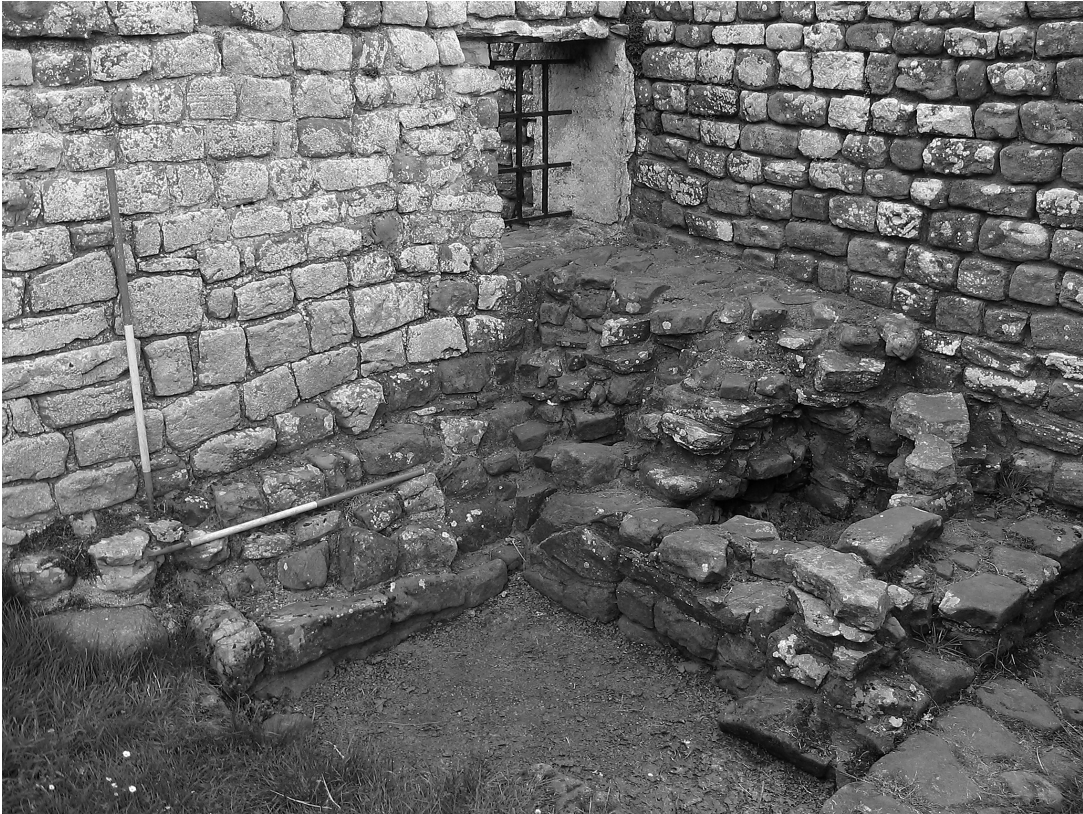
Fig. 17 Consolidated remains of the auxiliary furnace Q, viewed from the south-west.
Photograph, the authors.

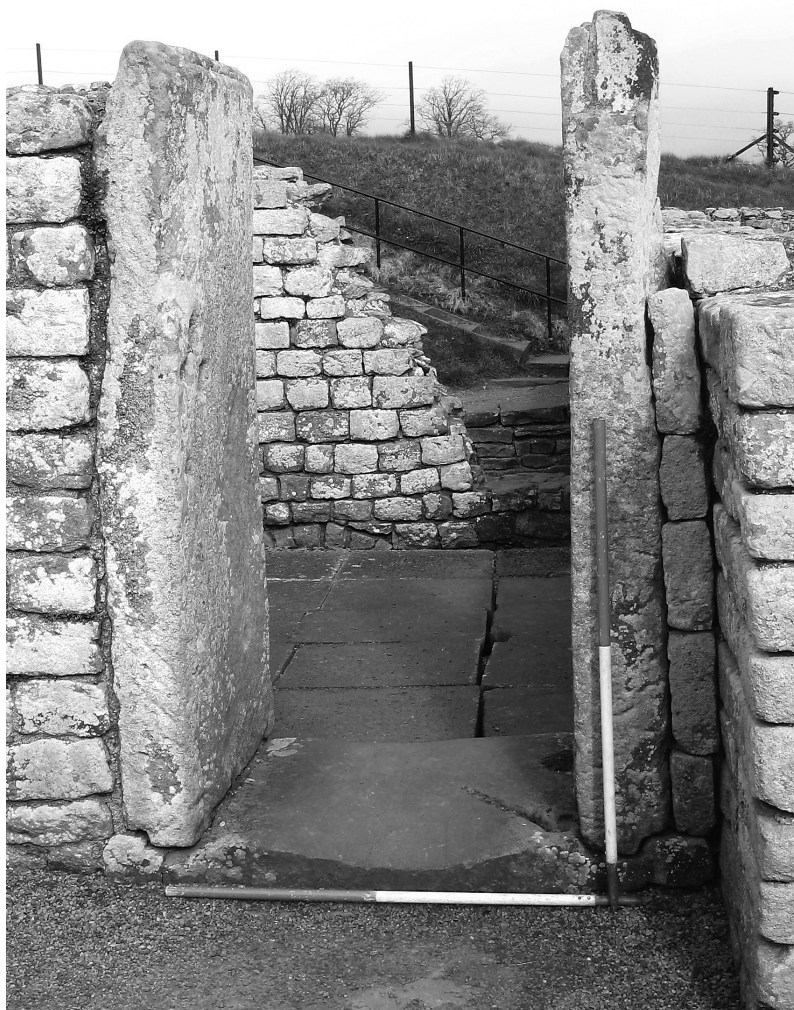
Fig. 20 Monolithic stone jambs in doorway between ante-room D and *laconicum* B, viewed from the south. Photograph, the authors.

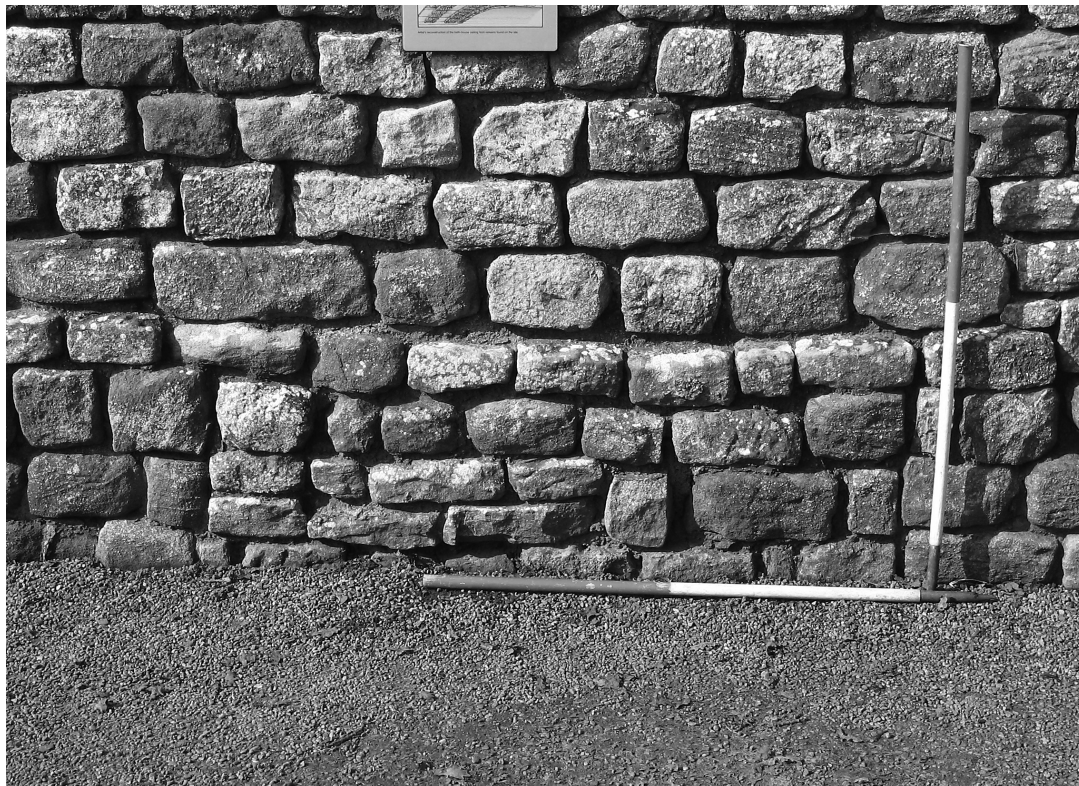
Fig. 21 Discontinuity on the inner face of the west wall of *tepidarium* E1, viewed from the east, indicating position of blocked flue from auxiliary furnace Q. Photograph, the authors.

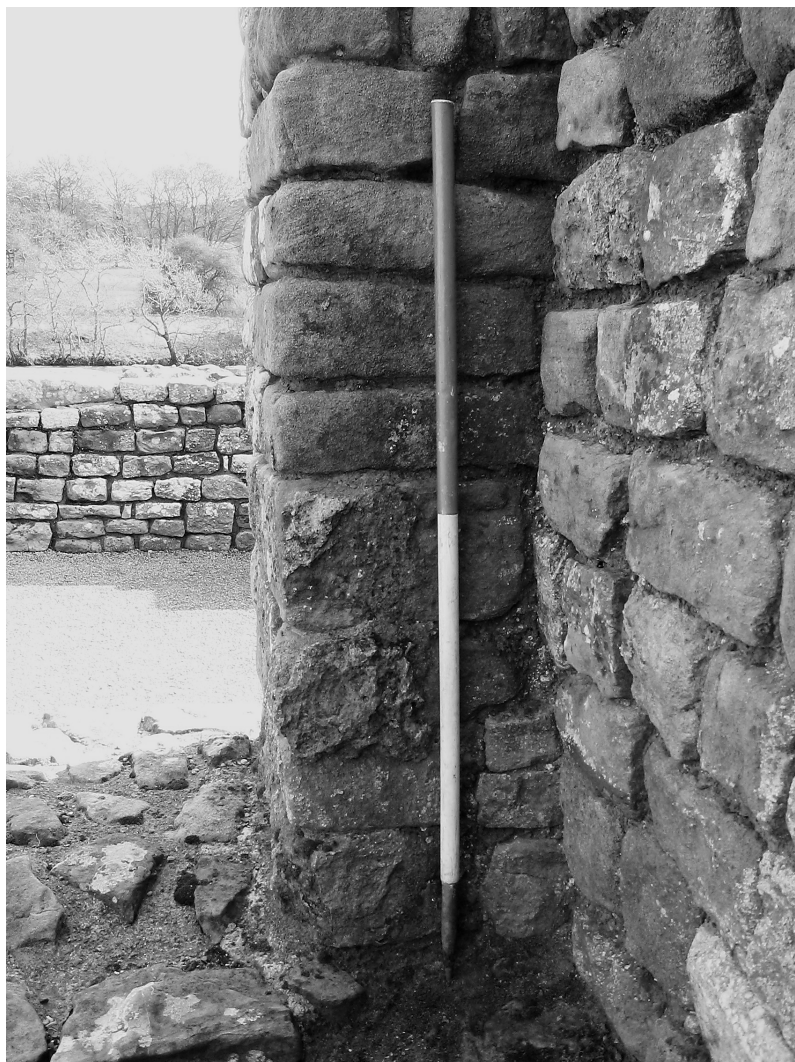
Fig. 23 Inner face of the southern arch respond of the apse. At centre left remnants of red plaster. Photograph, the authors.

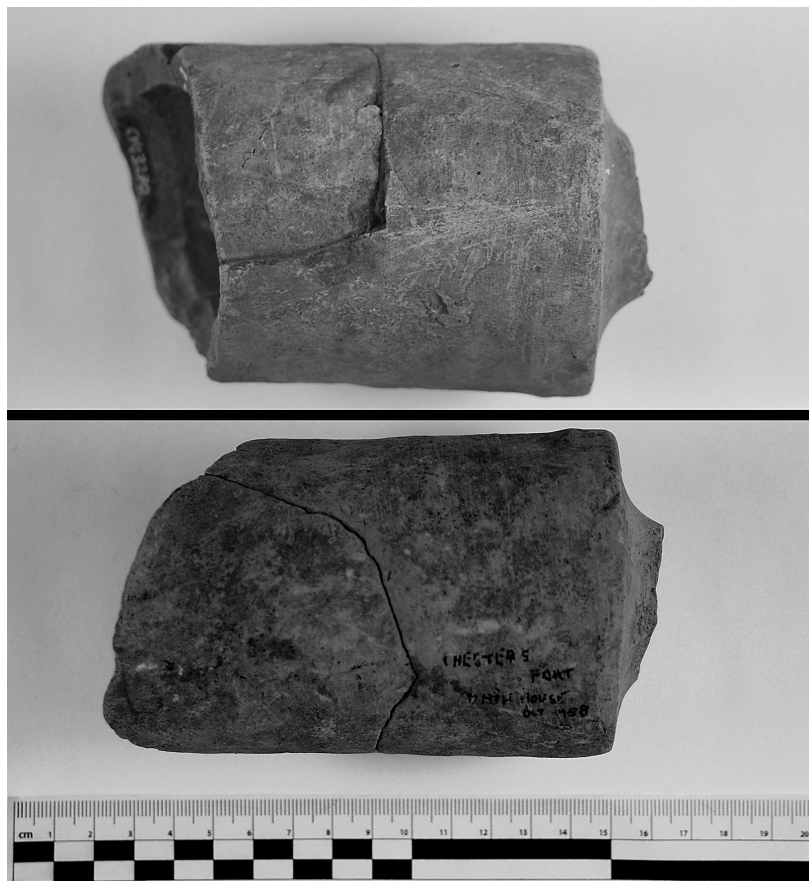
Fig. 24 Fragment of vaulting tube from the extra-mural baths, now in Corbridge Museum, kindly made available by Frances McIntosh, English Heritage. Photograph, Graeme Stobbs.

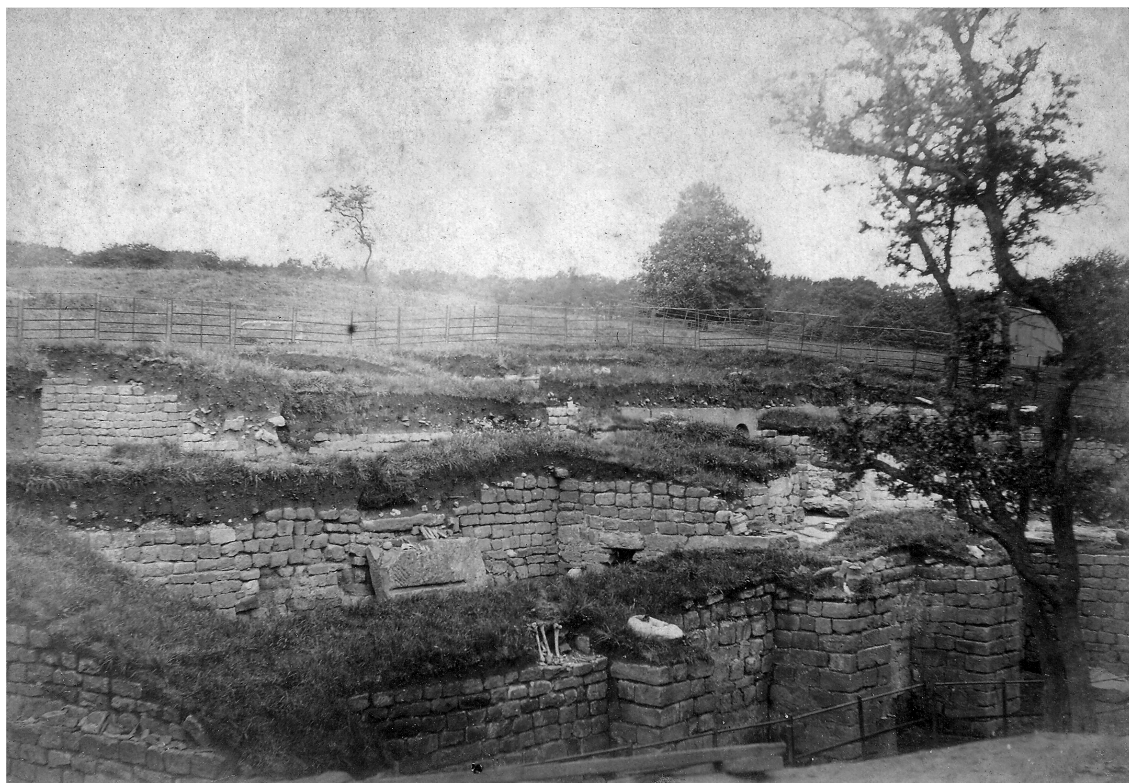
Fig. 26 Photograph taken by James F. Robinson in 1885, of the east side of the building, viewed from the south-east. Bottom centre, bones displayed on the outer face of the east wall of *tepidarium* H include one human femur and two tibiae (Copyright Trustees of the Clayton Collection and English Heritage).

A newly-discovered piece of evidence sheds further light on this. In the unpublished photograph by James F. Robinson (fig. 26) a collection of bones can be seen displayed on the outer face of the east wall of *tepidarium* H, between the two southern buttresses. Malin Holst is of the opinion that the collection includes at least one human femur and two human tibiae.⁴ Bruce's brief statement does not clarify whether the burials were found inside or outside the building. The new evidence is important in not only confirming the existence of the burials, but also seems to indicate that they lay outside. This is surely logical. If the burials had been within the building, there is no obvious reason why they should cluster in only two areas.
