Invasive Archaeological Investigations for
the Aberdeen Western Peripheral Route/Balmedie-Tipperty (AWPR/B-T)

ABERDEEN WESTERN PERIPHERAL ROUTE/BALMEDIE-TIPPERTY LOT 3 – SOUTHERN LEG

Assessment Report on the Results of Trial Trenching and Sample Excavations

VOLUME 1 – REPORT

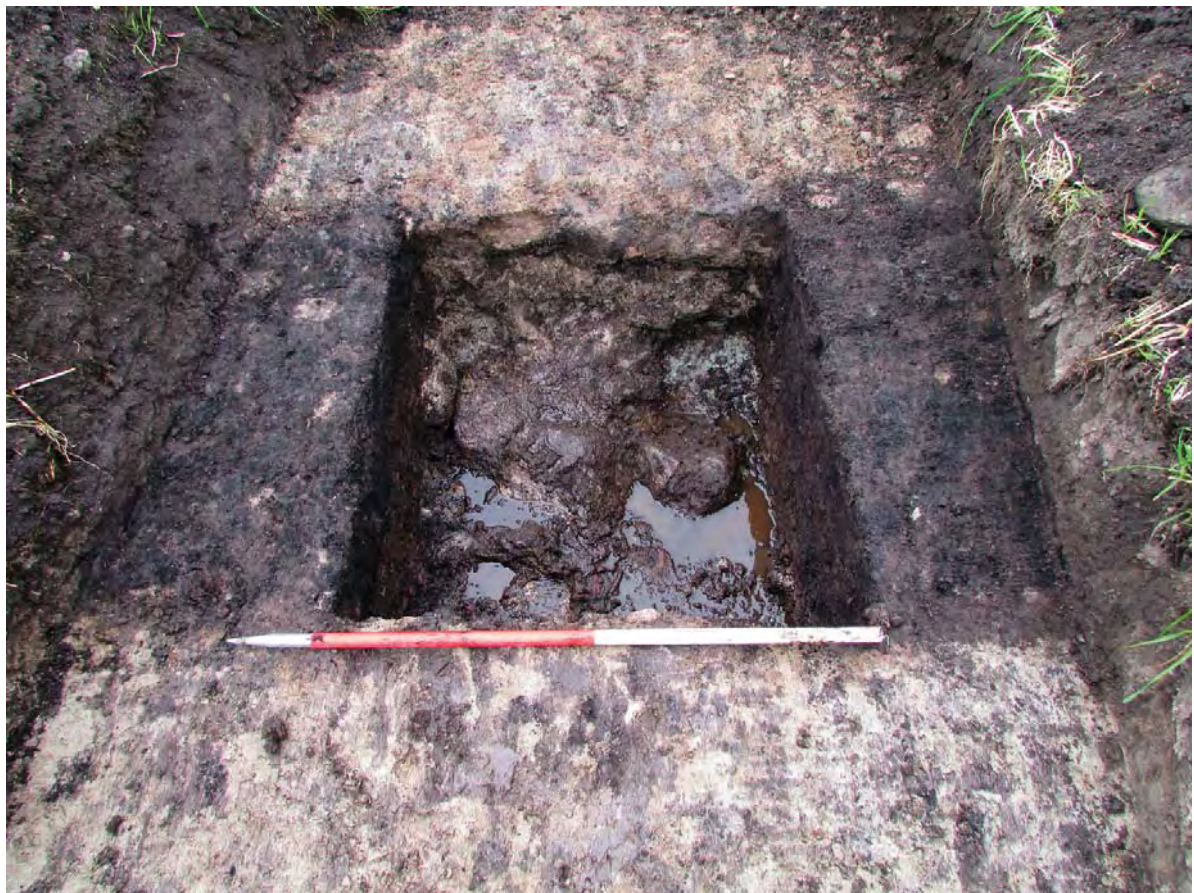
Illus 8

Detail of Trench SL0170 – plan, east-facing section and north-facing shot of Ditch [1173]

4.5.2 The only archaeological feature observed was a linear feature [1173] running north to south across Trench SL0170 and extending beyond the limits of excavation (Illus 8). Feature [1173] was cut into the subsoil and had vertical sides and a rounded base. It was 1.10m wide and 0.60m deep and contained two fills. The lower fill (1175) was mid-brown silty clay, 0.20m thick with frequent timber fragments and stone inclusions overlain by very dark grey peat (1174), 0.44m deep containing frequent timber fragments and stone inclusions. No dating evidence was recovered. The vertical and very straight sides of the feature could indicate a modern date possibly cut by mechanical means rather than by hand, although the layering of organic peaty material within the fill could indicate an earlier date.

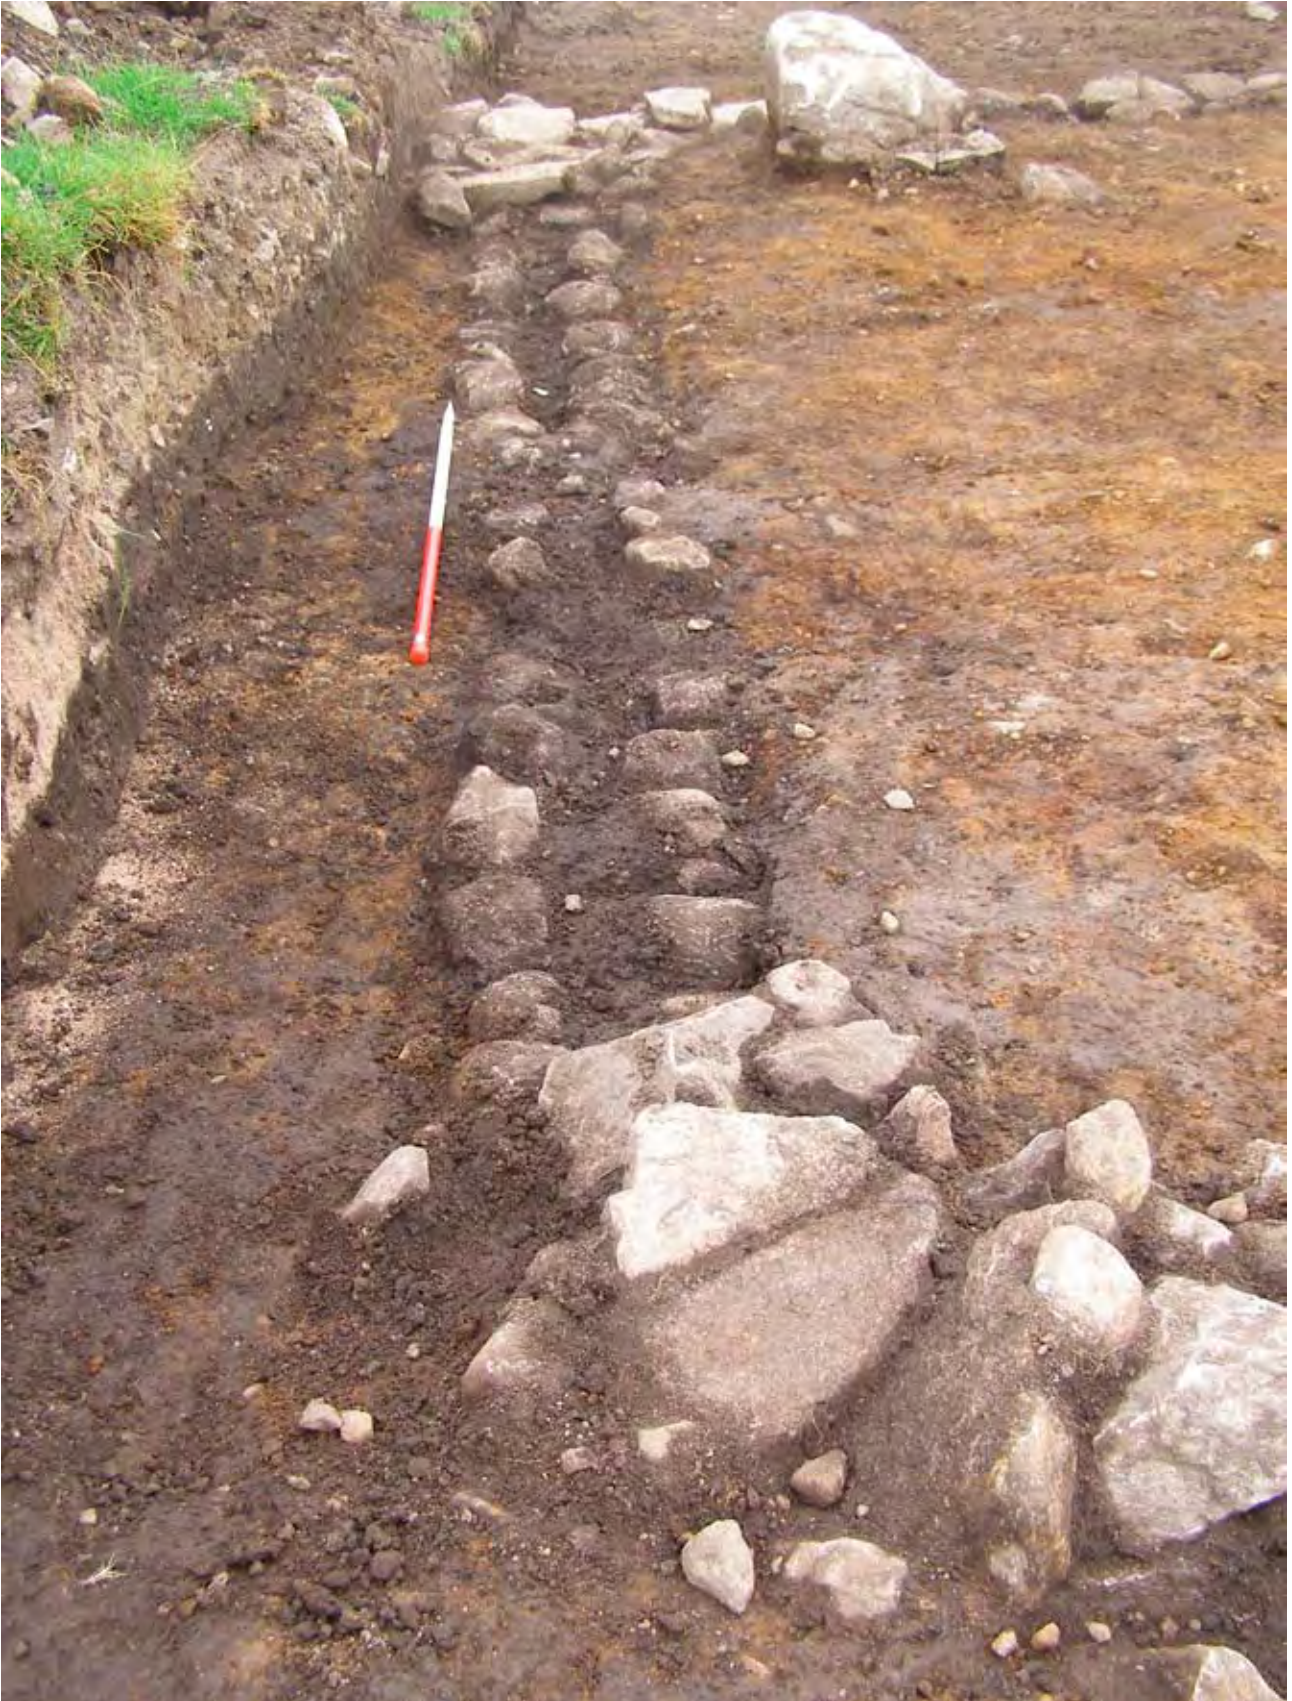
Illus 63

Detail view showing stone footing of SL-EX10a Phase 1 building. The dark brown deposit in the trench section is (3119), and the concentration of white material above in the foreground is the lime mortar bedding (3149) of the Phase 2 structure

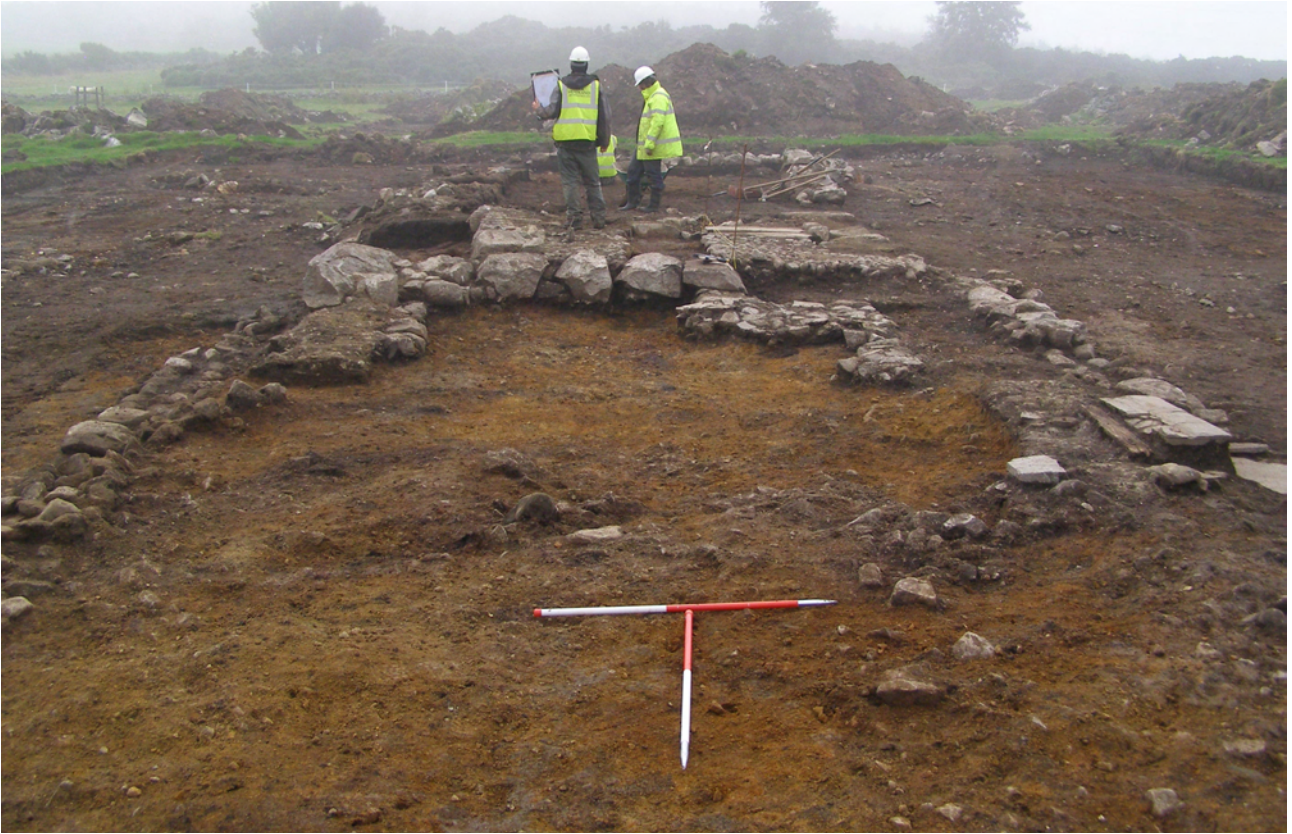
Illus 64a

General view showing the fireplace and remaining floor surface of SL-EX10a Phase 2 building

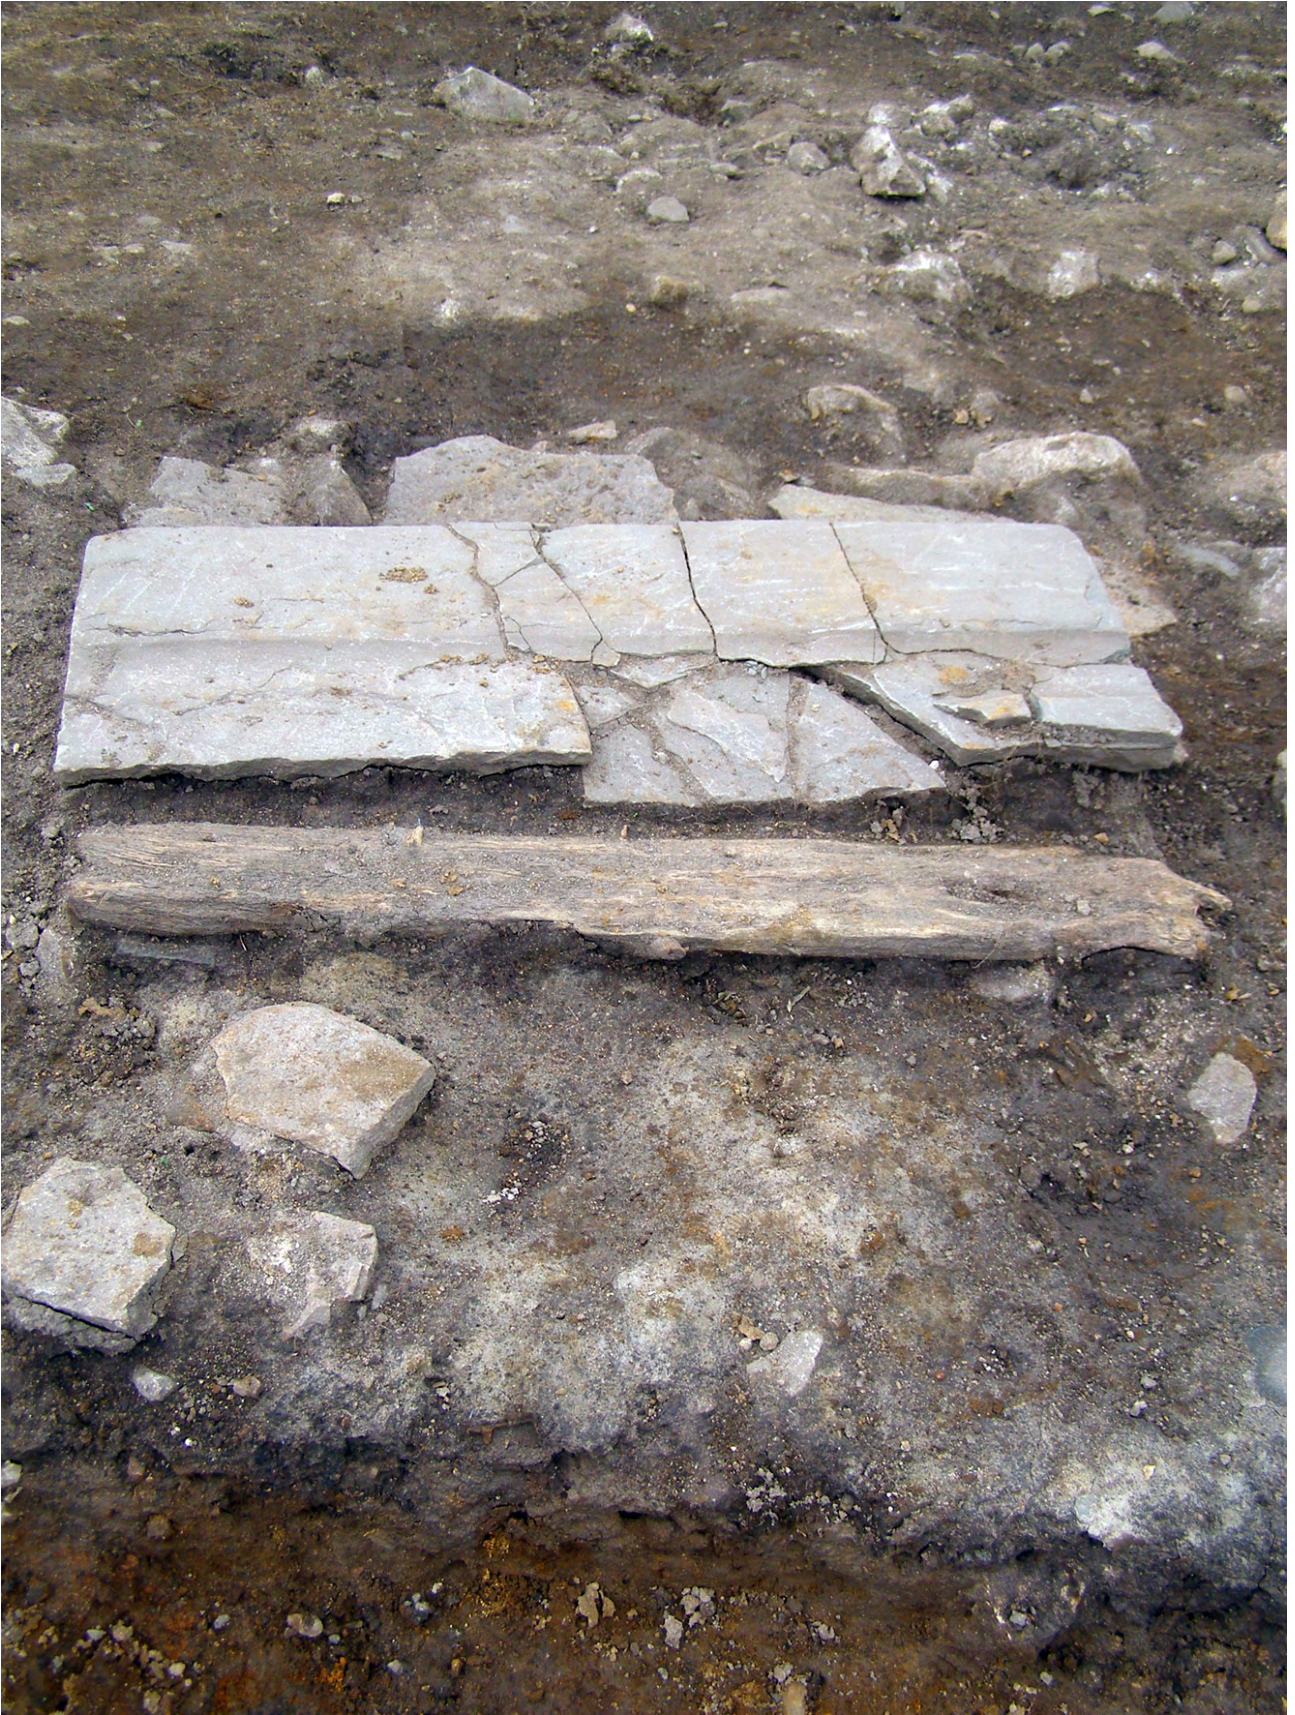
Illus 64b

Shot of doorstep [3177] south-west-facing

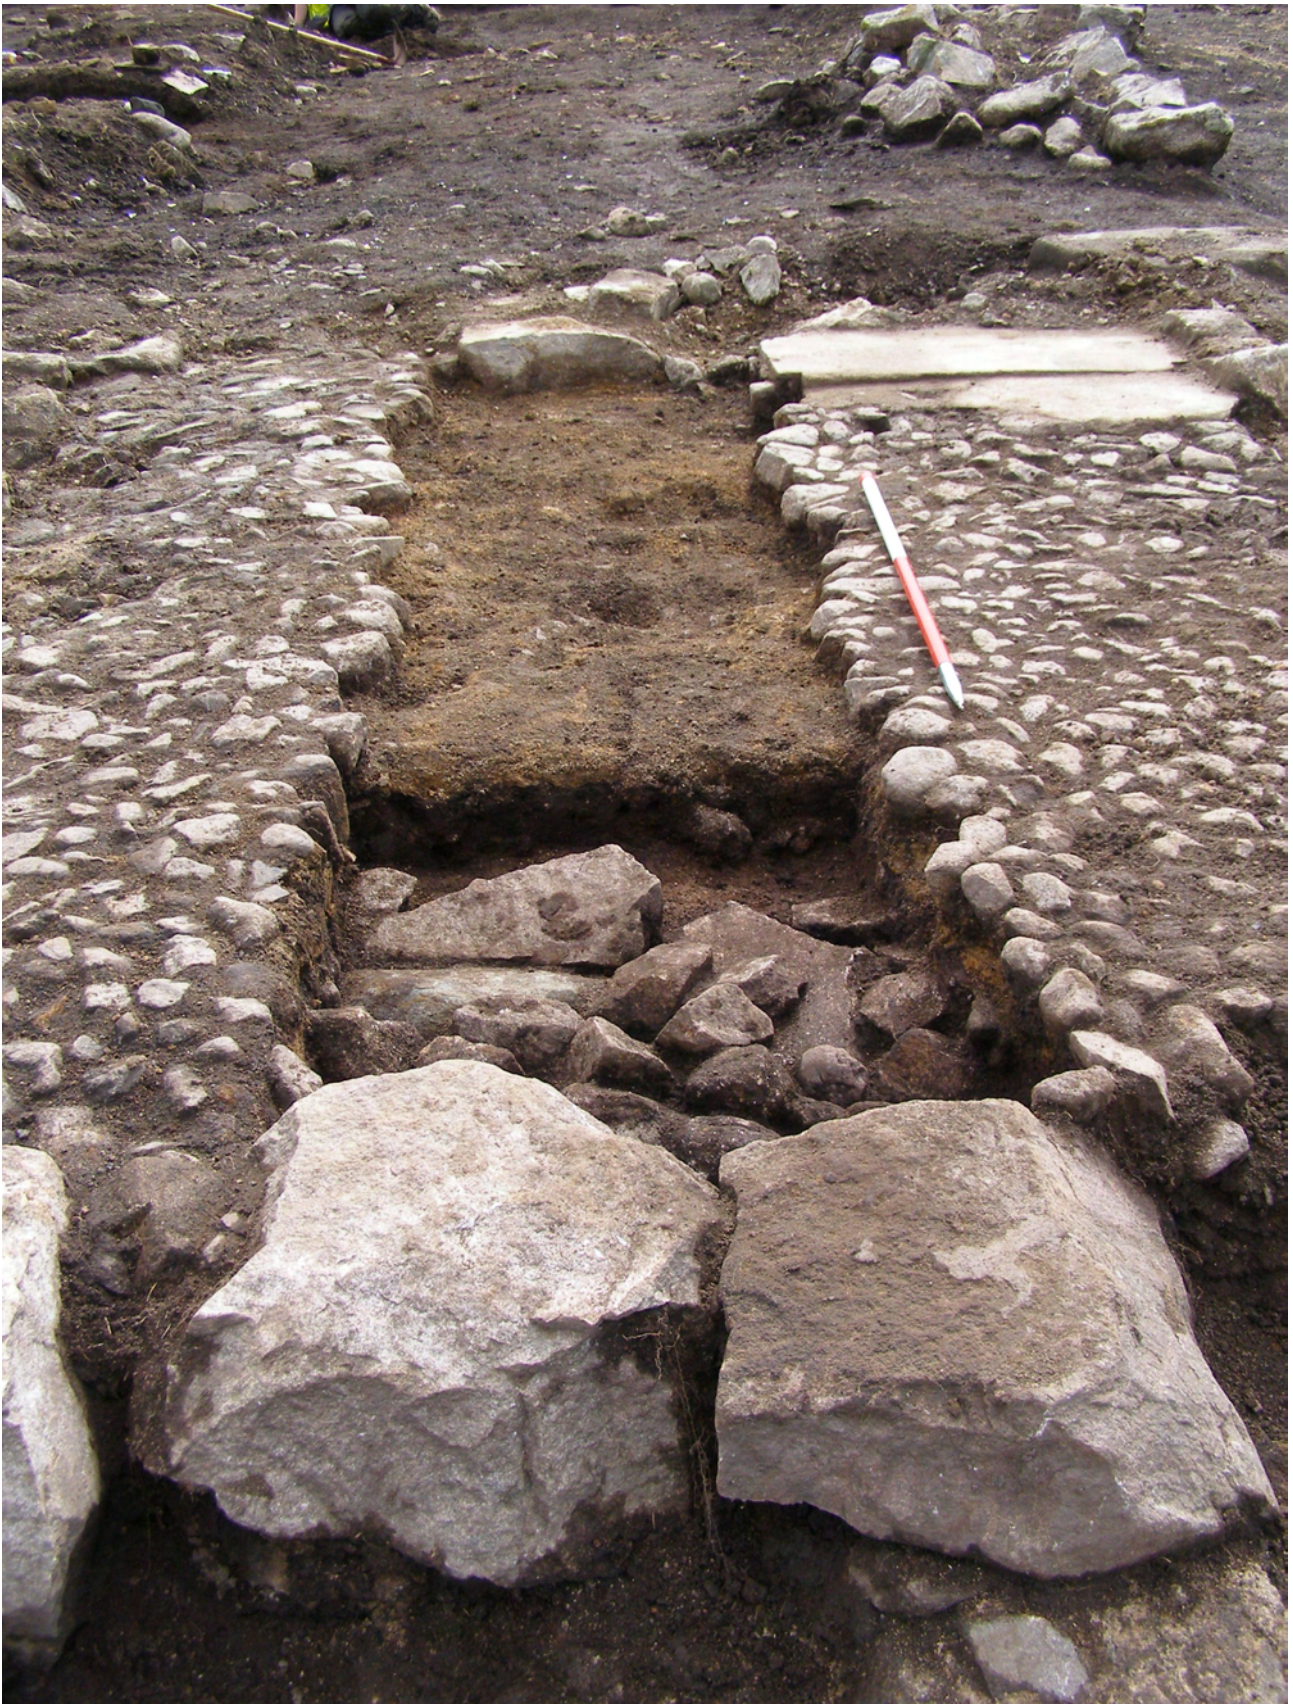
Illus 65

Sondage through Structure [3105] and Surface [3109]

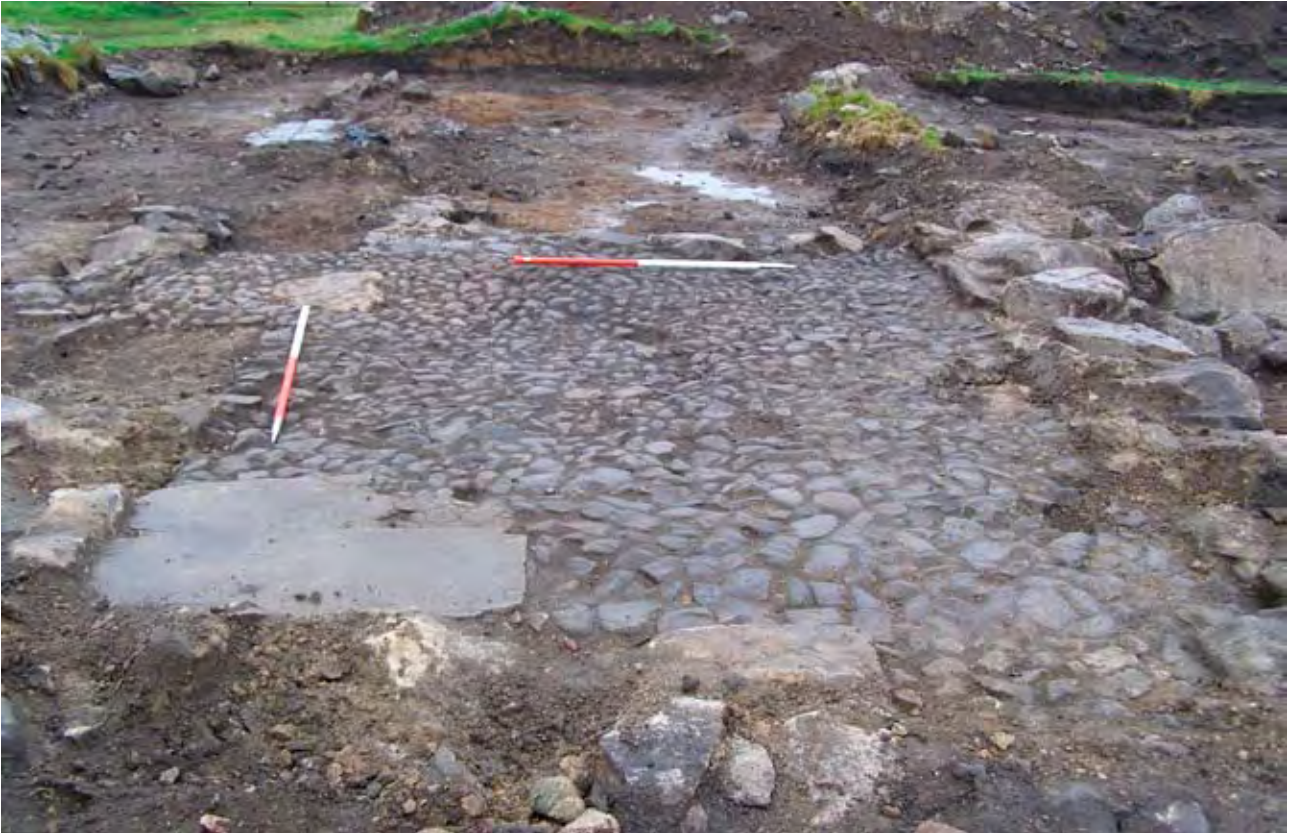
Illus 66

General view showing annex [3105] (Phase 3)

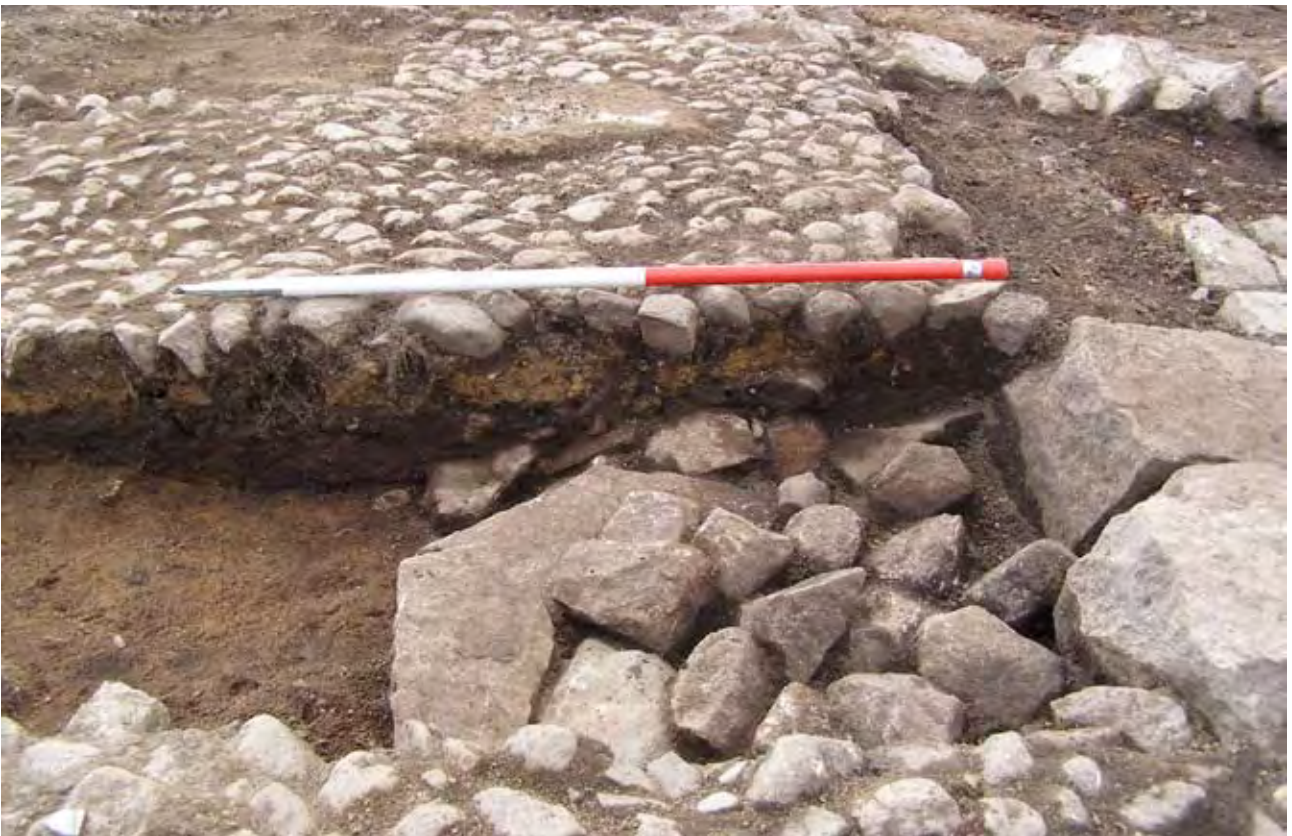
Illus 67

South-west-facing shot of section of sondage through annex [3105] showing stone footing [3147] of Phase 1 structure with deposit (3119) overlying it (the dark deposit at the base of the section)

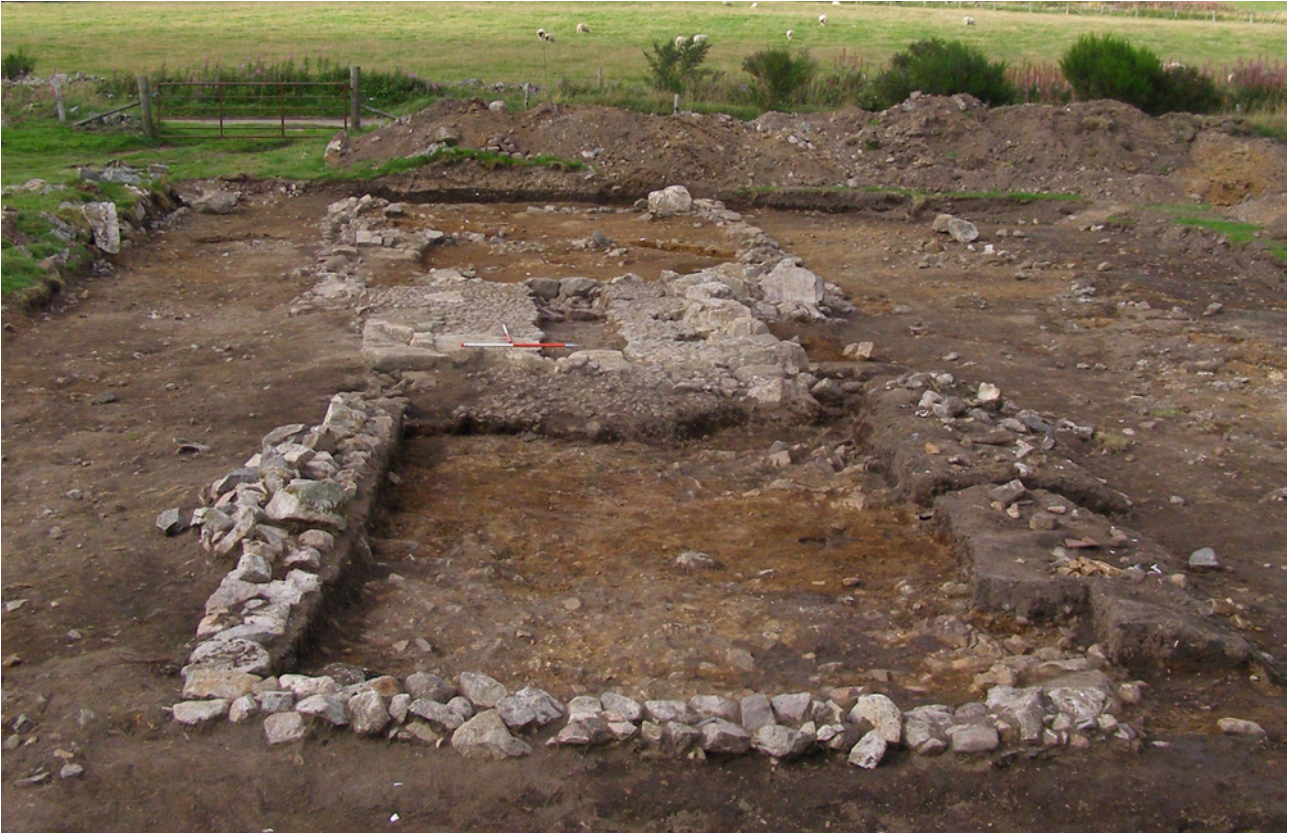
Illus 68

General view of the SL-EX10a site with structure [3106] in the foreground

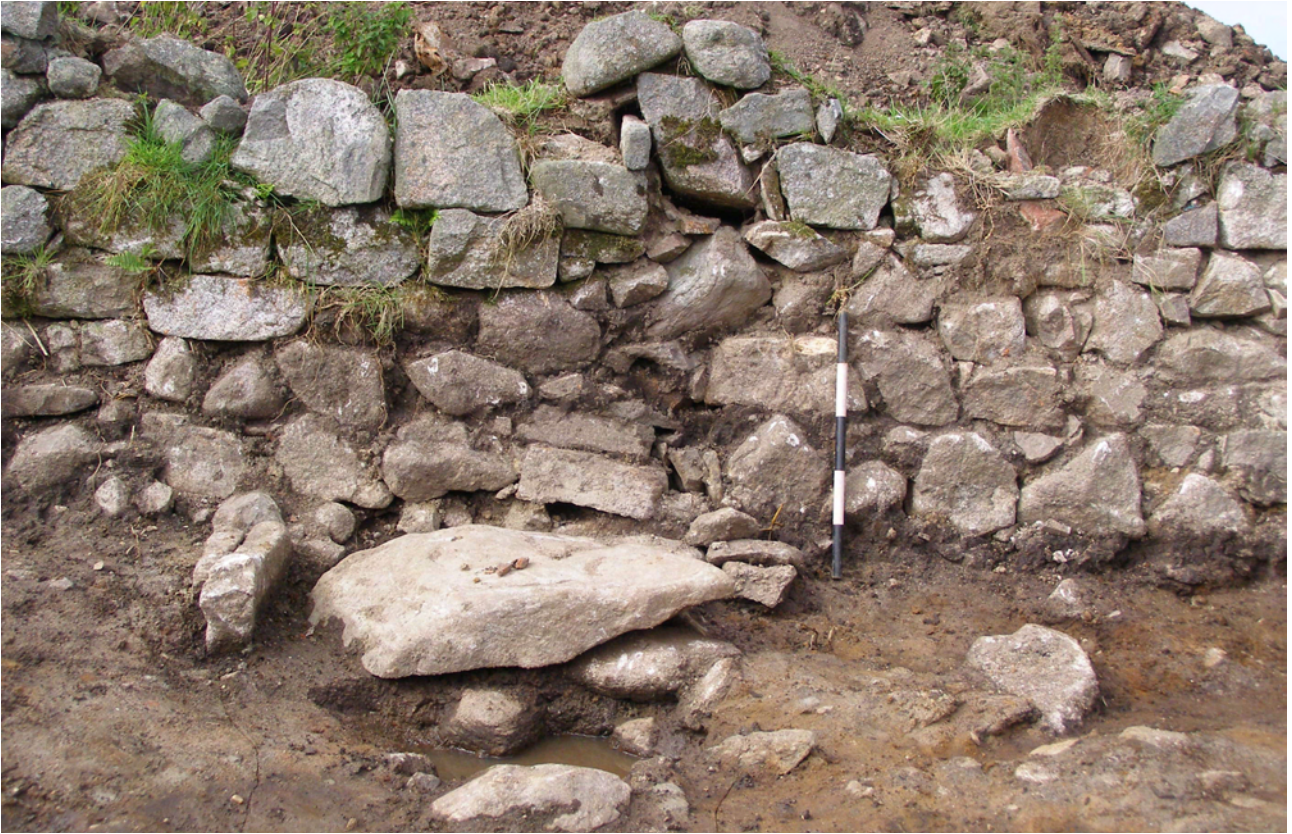
Illus 70a

Detail showing the construction break within SL-EX10b

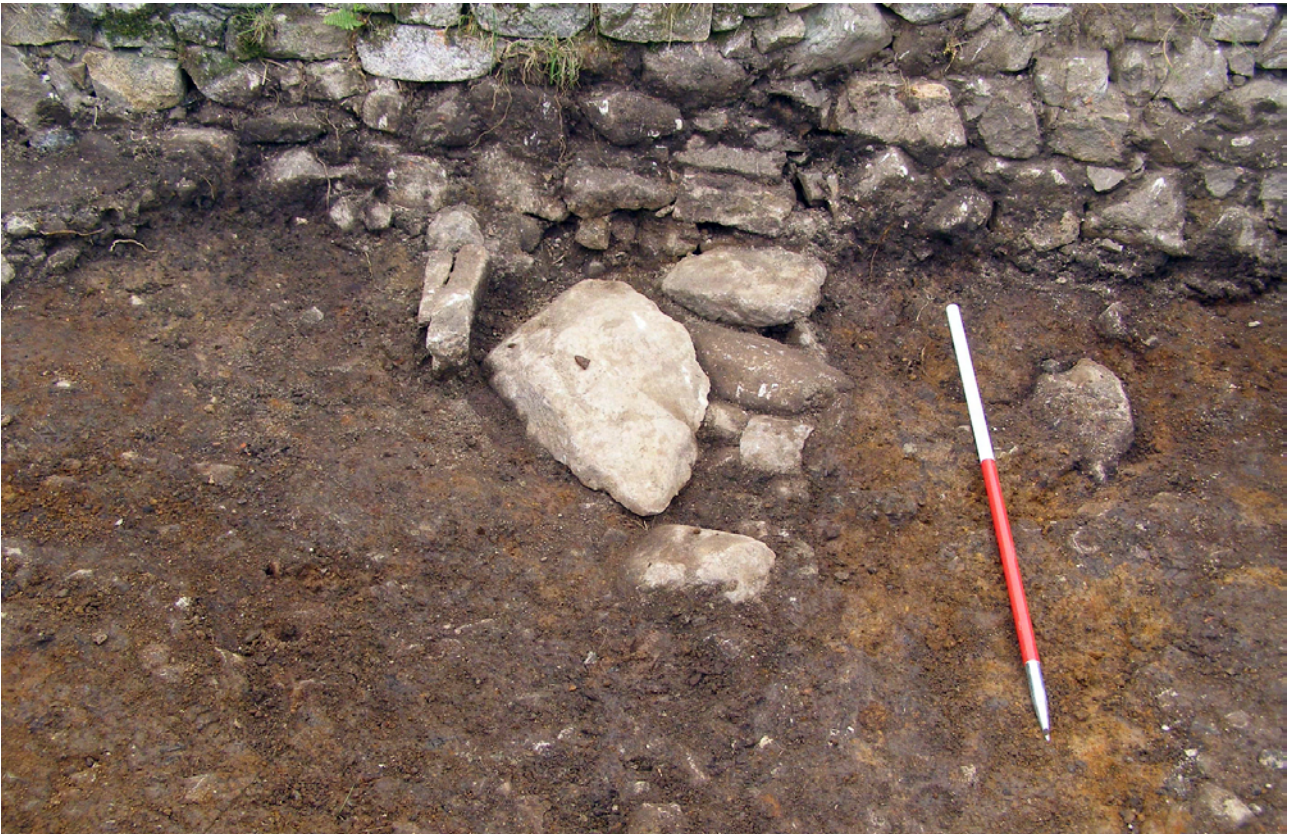
Illus 70b

North-west-facing shot of Wall [3502]
