Invasive Archaeological Investigations for the Aberdeen Western Peripheral Route/Balmedie-Tipperty (AWPR/B-T)

**Aberdeen Western Peripheral Route/Balmedie-Tipperty
Lot 2 – Northern Leg**

Post-Excavation Assessment and Mitigation Excavation Assessment Report

Date: July 2015

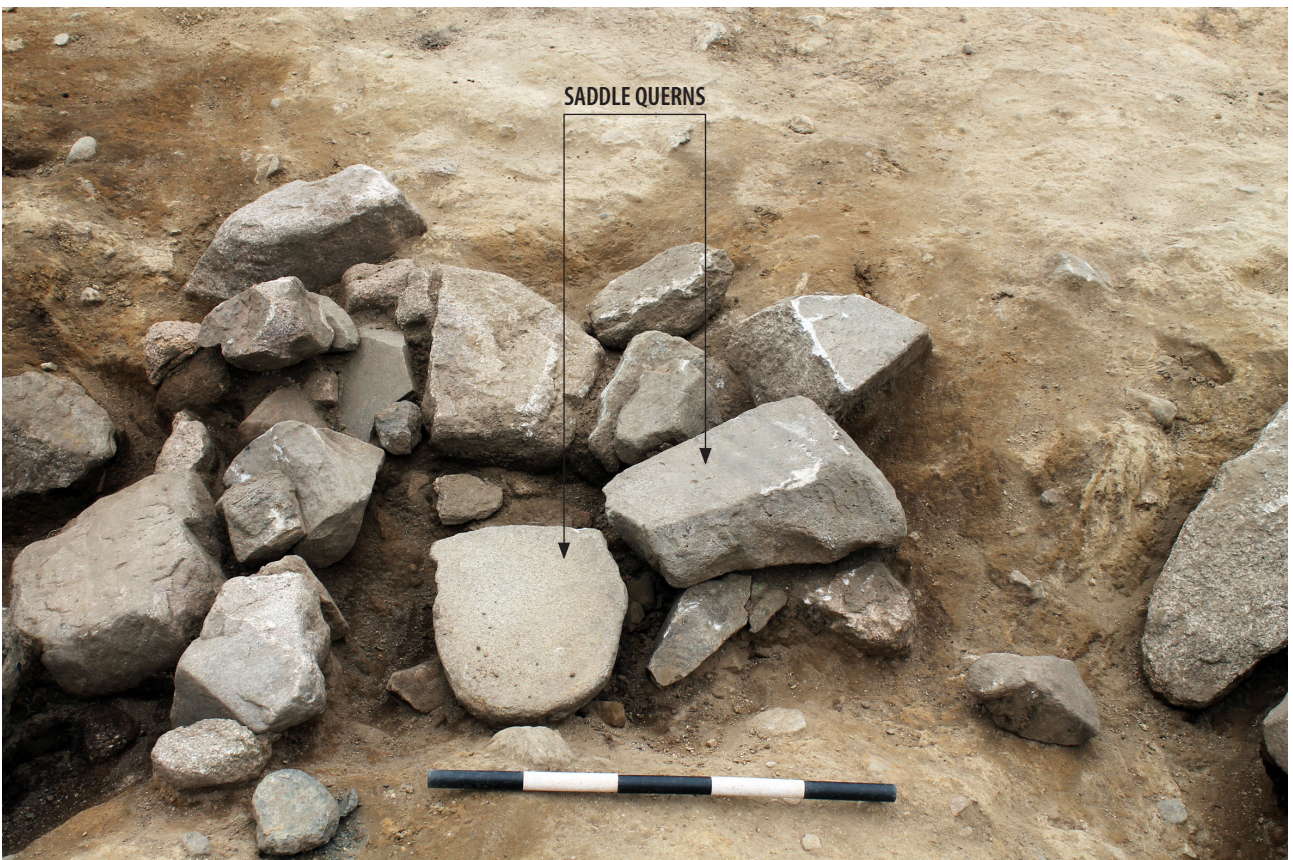
PLATE 14

NL/001C – Detail view of quern-stones set in Pit [1C-0114], facing north

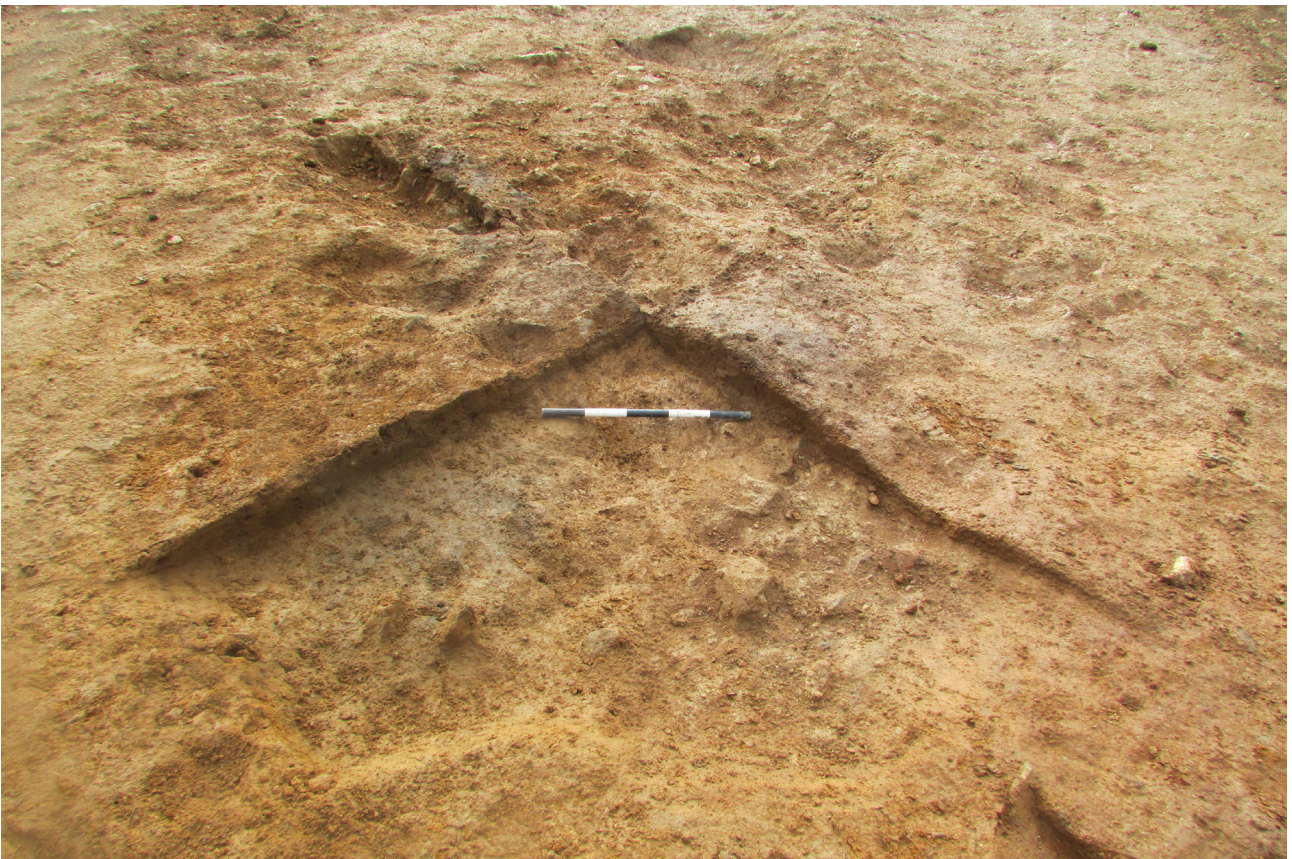
PLATE 16

NL/003B – Mid-excavation view of hollow [3B-0007], facing south-east

4.3.6.2 Hollow [3B-0007] was irregular in plan, with an uneven base and very gently sloping sides (Plate 16). No clear signs of intentional excavation were identified and it is likely that this feature was either a natural hollow or the result of wear from repeated re-use as a

fireplace (see 8.2.2 for discussion). The deposit found infilling this feature (excavated in quads and so comprising four separate context numbers (3B-0008), (3B-0009), (3B-0018) and (3B-0019) also sealed the four pits [3B-0020], [3B-0023], [3B-0025] and [3B-0031] immediately to the north, and may at one time have extended further (see Section 4.2.9 above). It comprised a thin layer (up to 0.13m deep) of compact mid-reddish-brown sandy silt, containing frequent charcoal and nutshell and an assemblage of 461 lithics. These were typologically dated to the Mesolithic and most likely represent the production of microliths. The assemblage is described further in section 5.9 below. There were no signs of *in-situ* burning around or below this spread but the reddish hue and presence of charcoal and burnt lithics suggests that burning had taken place during the formation of this deposit. A radiocarbon determination of 6743-6593 cal. BC (SUERC-57937) provides a provisional date in the early Mesolithic for this deposit.

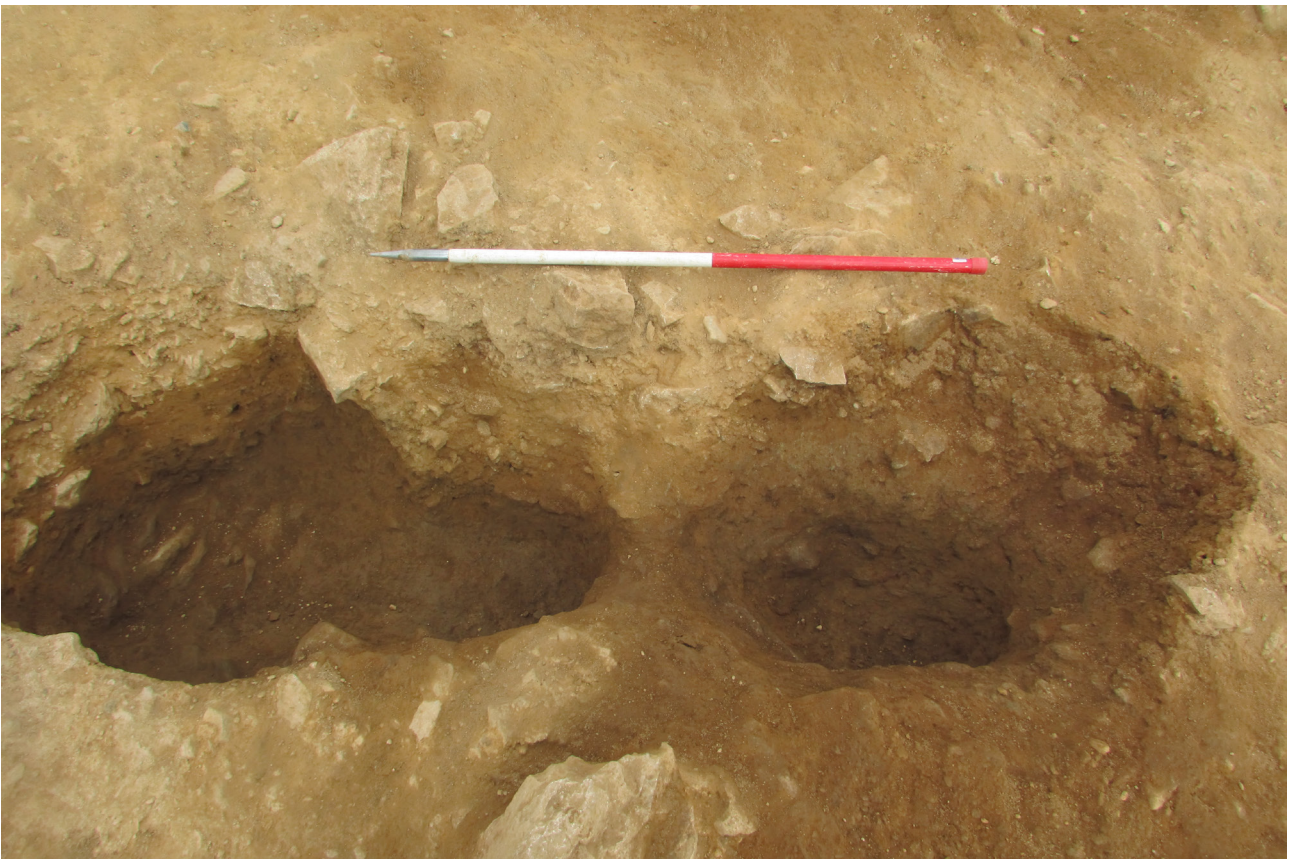
PLATE 18

NL/003B – Detail view of intercutting Pits (from left) [3B-0023], [3B-0025] and [3B-0031], facing north-north-west

4.3.6.6 Pit [3B-0029] was smaller than the others and had a pointed base. The fill (3B-0030) was looser and more orange than the material recovered filling the other pits, and it contained no lithics (although charcoal and nutshell were still present). It is suggested that this feature served a different, presently unknown purpose (although may still be contemporary).

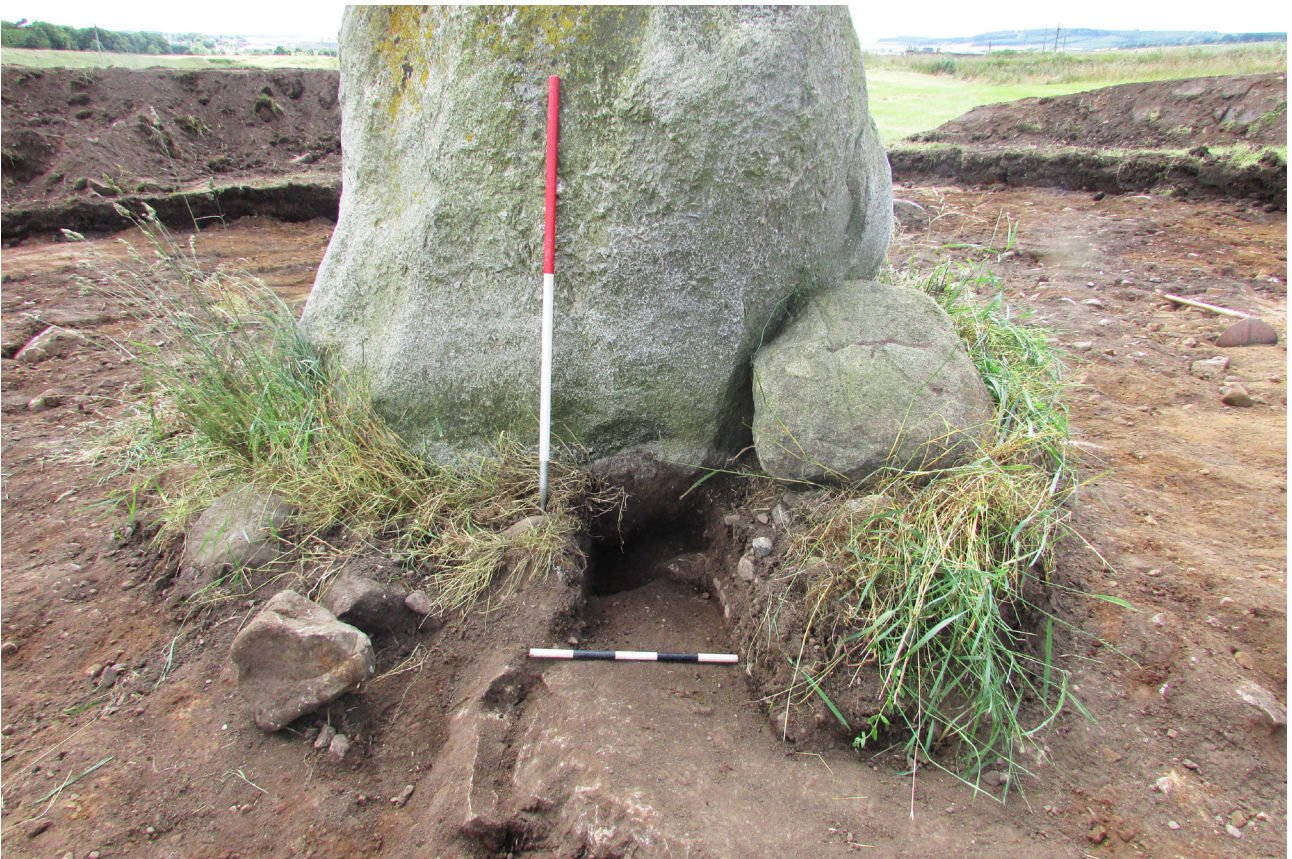
PLATE 30

NL/014 – Detail of test slot below orthostat, facing south-west

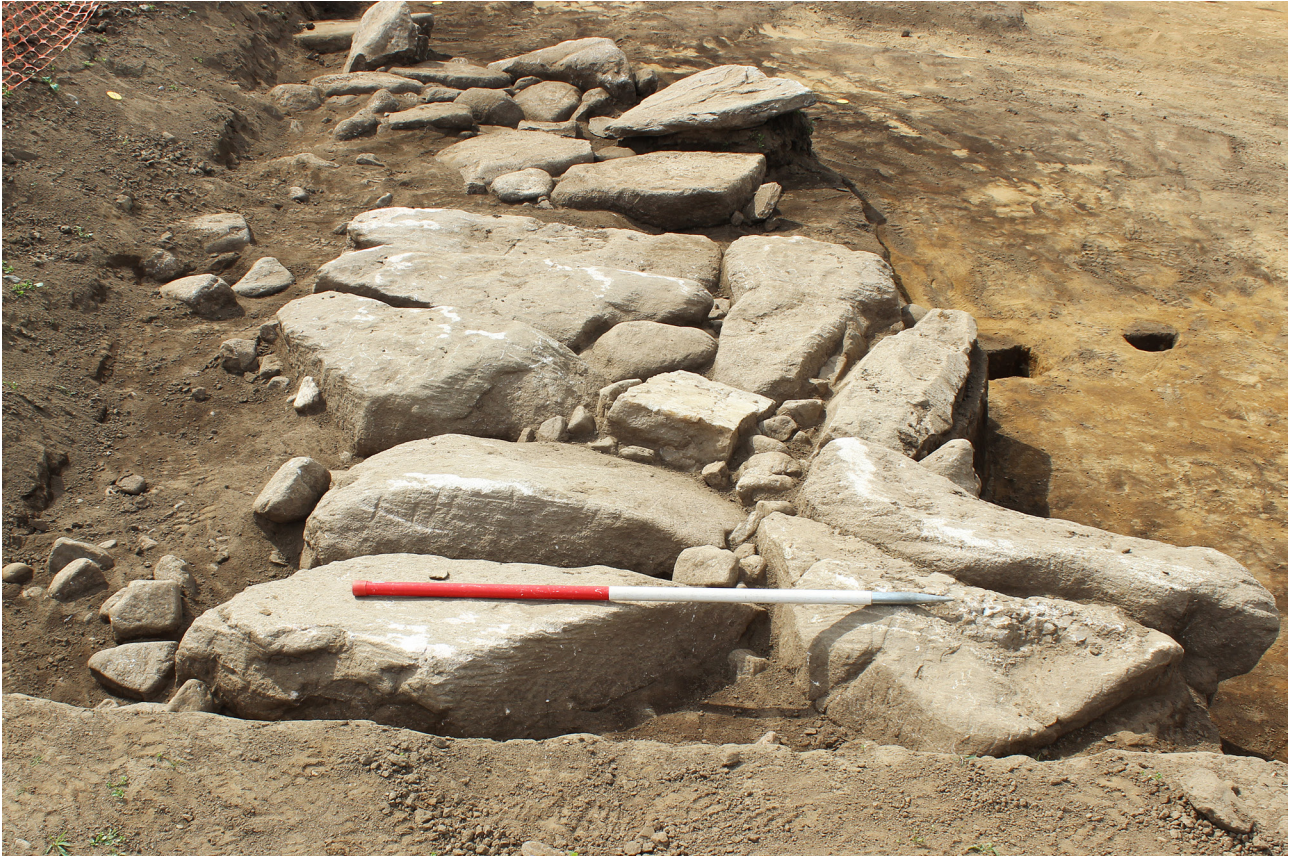
PLATE 35

NL/006A – Detail of Stone Paving (6A-0039) and (6A-0040), facing west

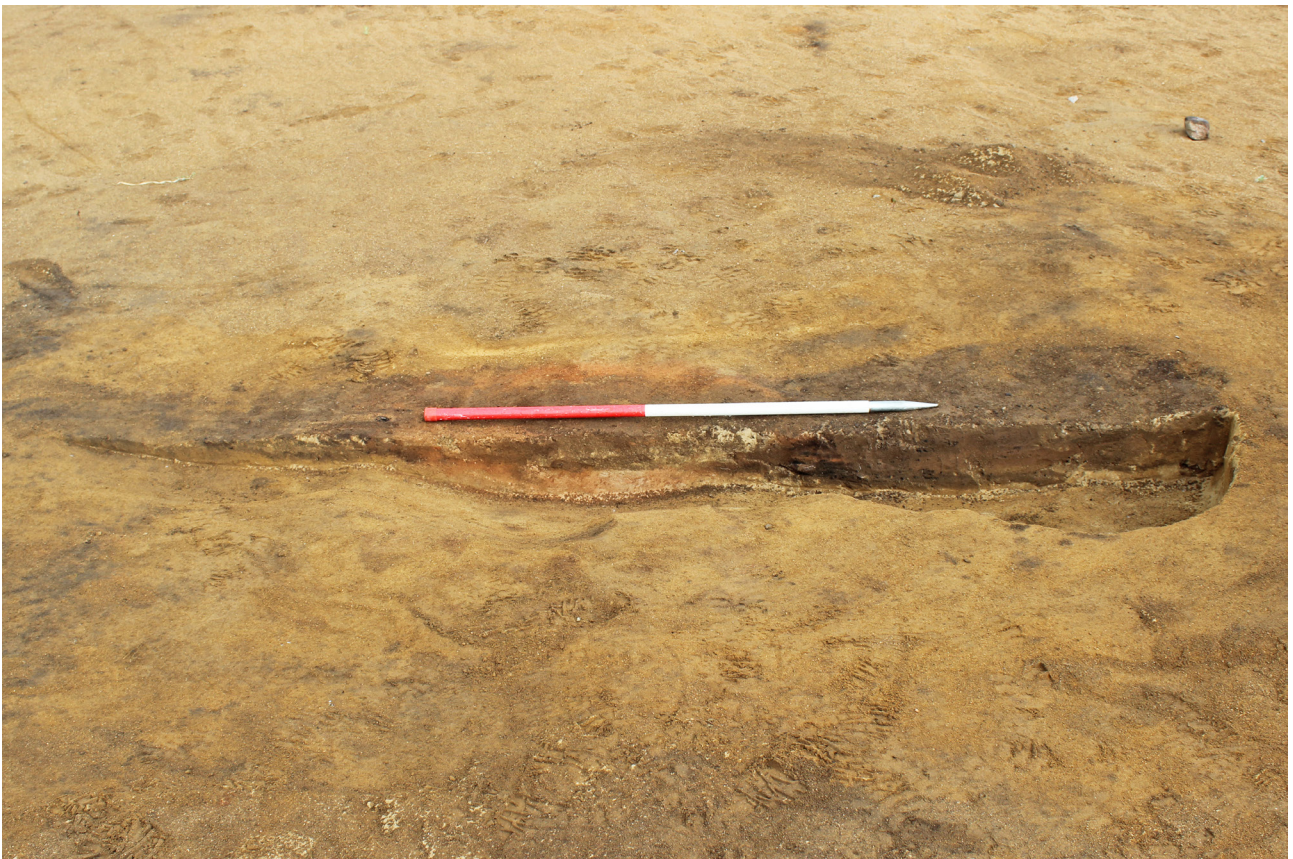
PLATE 36

NL/006A – West-facing section of possible Metalworking Furnace [6A-0096], facing east

4.7.4.1 A possible metal-working furnace [6A-0096] was recorded 18m north of Structure B (Illus 22). It consisted of three shallow sub-oval pits arranged on a north-south axis (Plate 36). These were cut into Remnant topsoil (6A-0003) but were not clearly defined until cleaned to the level of the geological subsoil (6A-0002). The middle pit [6A-0096] measured 0.78m x 0.48m and up to 0.11m deep, and appeared to be stratigraphically later than the others, with a clear halo of burnt sand overlying or cutting the pits to the north [6A-0097] and south [6A-0095]. This relationship was not as evident in section (Illus 22). If this feature was indeed used as kiln or furnace, this sand may have been redeposited inside a clay superstructure (perhaps for levelling) prior to being burnt. The two latter pits were of a similar size and form as the central one. All three pits contained charcoal, significant quantities of barley grain, and iron slag. The middle pit showed evidence for in-situ burning and contained possible metalworking waste; the outer pits contained fragments of daub. The artefactual evidence was retrieved from the sample processing. The interpretation of this feature is made difficult by the severe degree of vertical truncation, but is likely to represent a metal-working furnace similar to [6A-0118] below. The presence of significant quantities of barley grain may indicate another function entirely (for example grain drying) or merely that other domestic activity was taking place nearby.

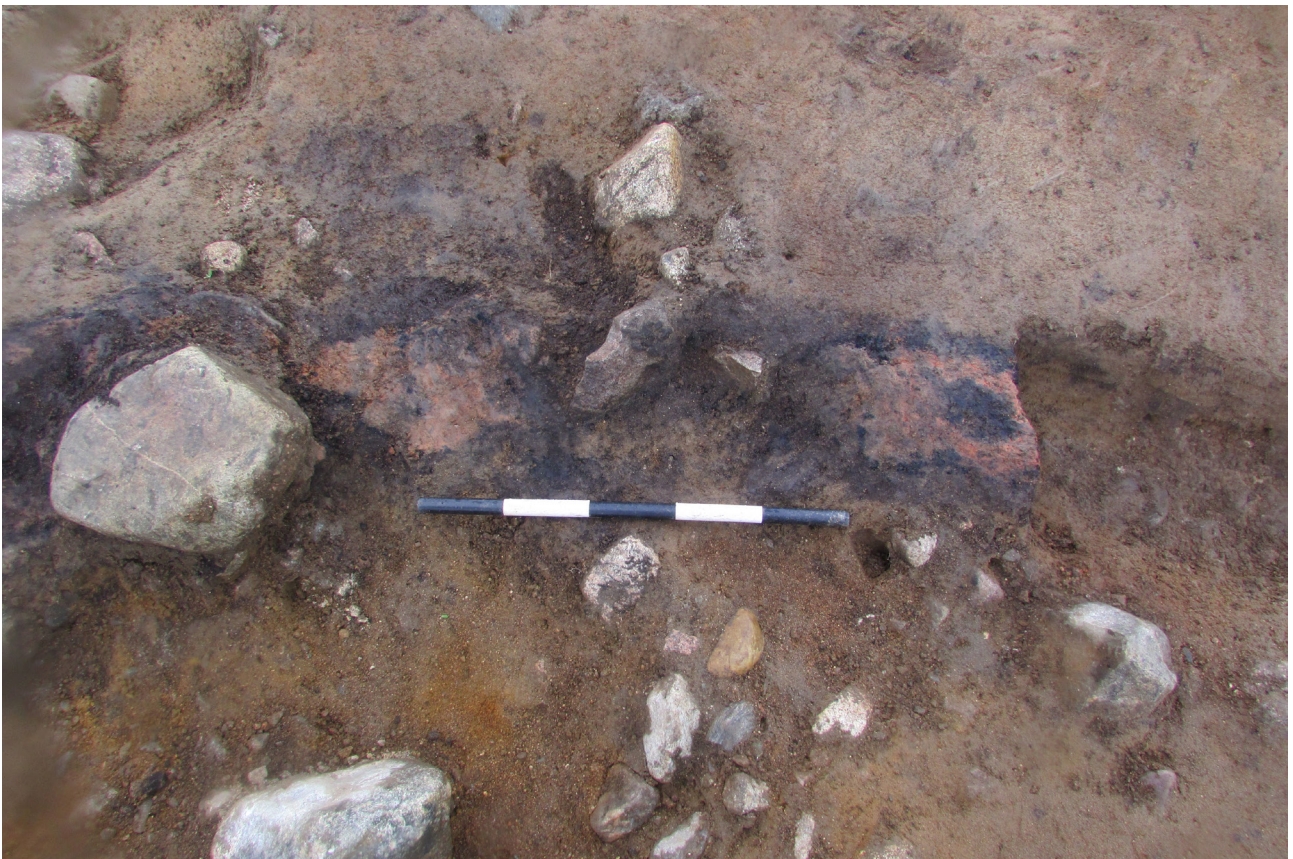
PLATE 40

NL/006B – Detail view of possible burnt timbers in [6B-0003], facing south

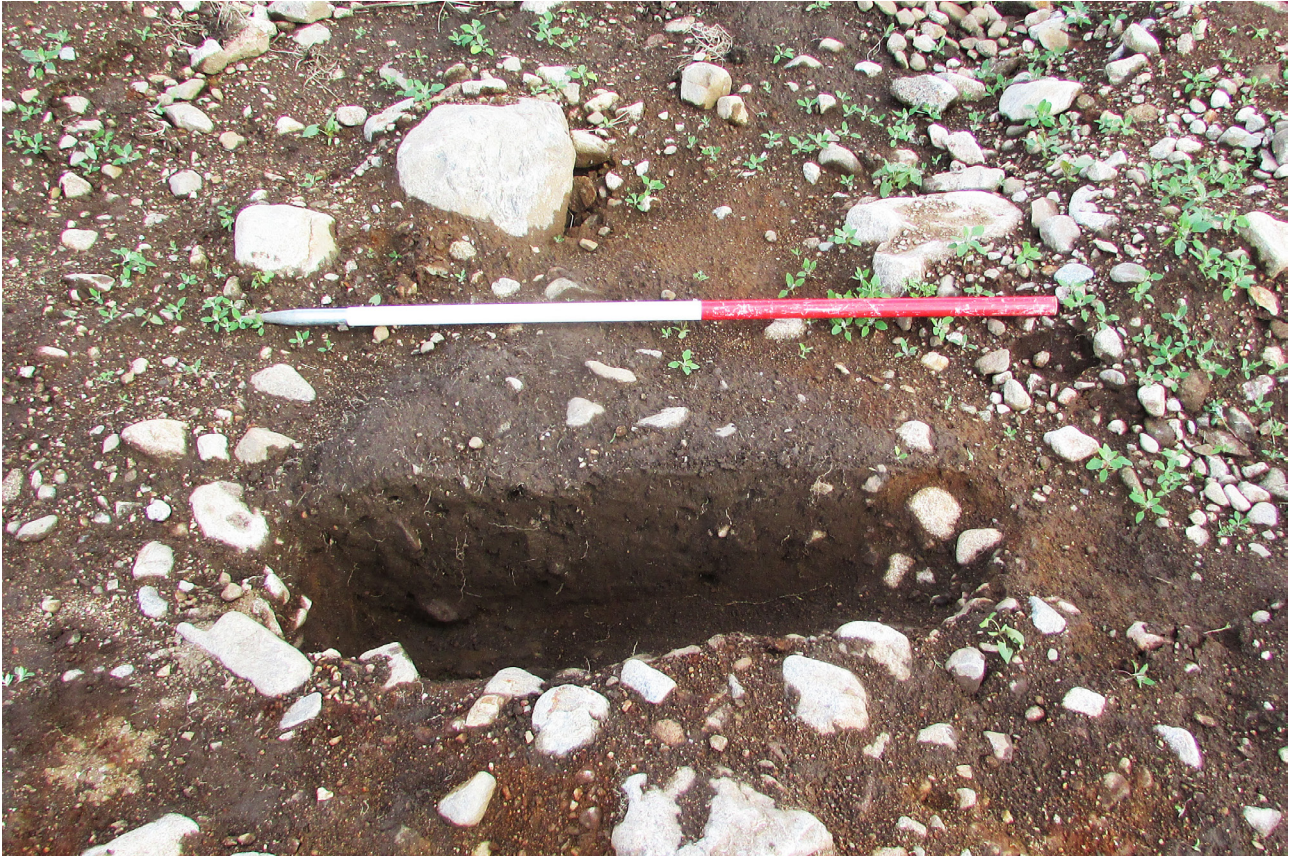
PLATE 41

NL/006B – South-east-facing section of Pit [6B-0010], facing north-west

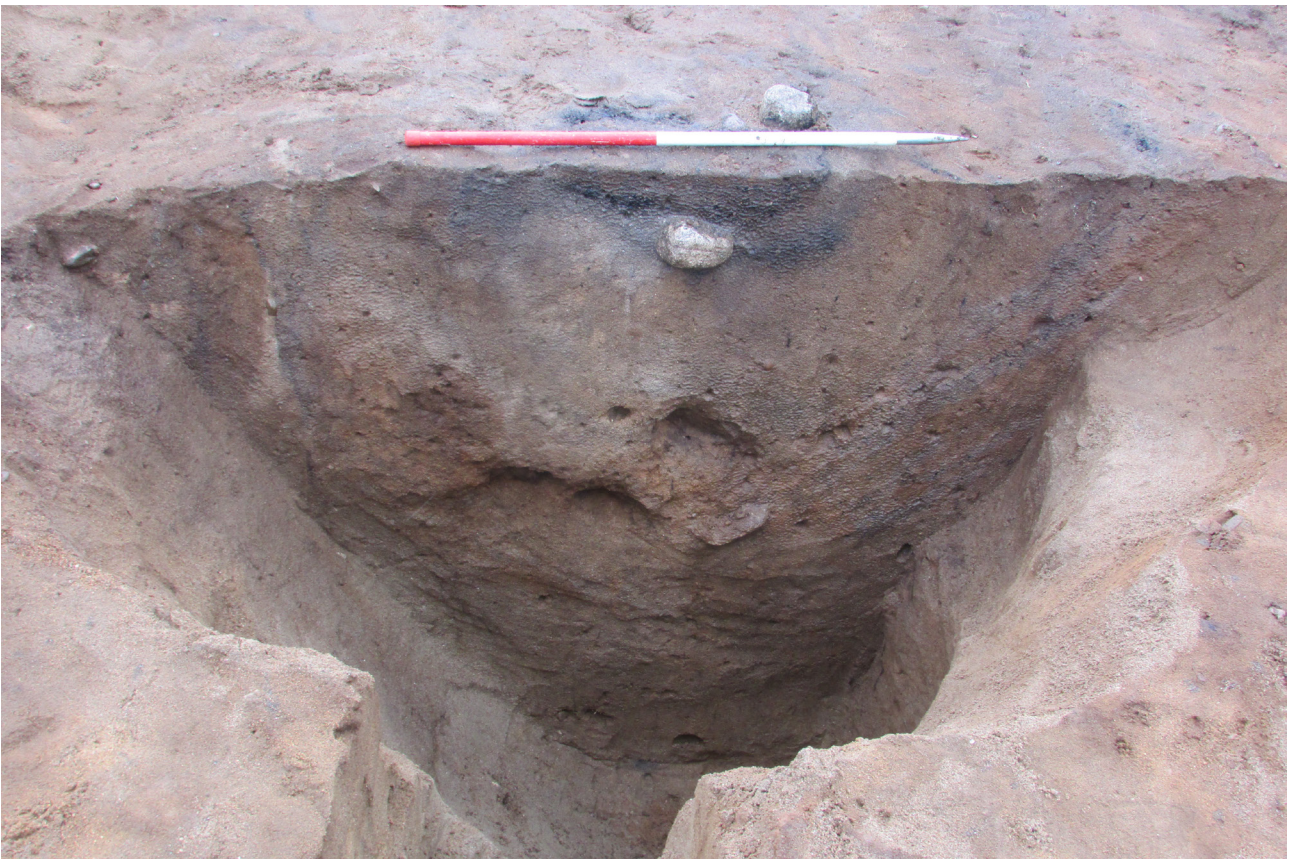
PLATE 52

NL/012 – South-east-facing section of Pit [12-0034], facing north-west
