# BANCROFT HERITAGE SERVICES

**ARCHAEOLOGICAL MONITORING:  
CHESTNUT FARMHOUSE  
2 PRIORY ROAD  
CAMPTON  
BEDS SG17 5PG**

NGR: TL 1269 3828

Ref: BHS/0035/CPR/3

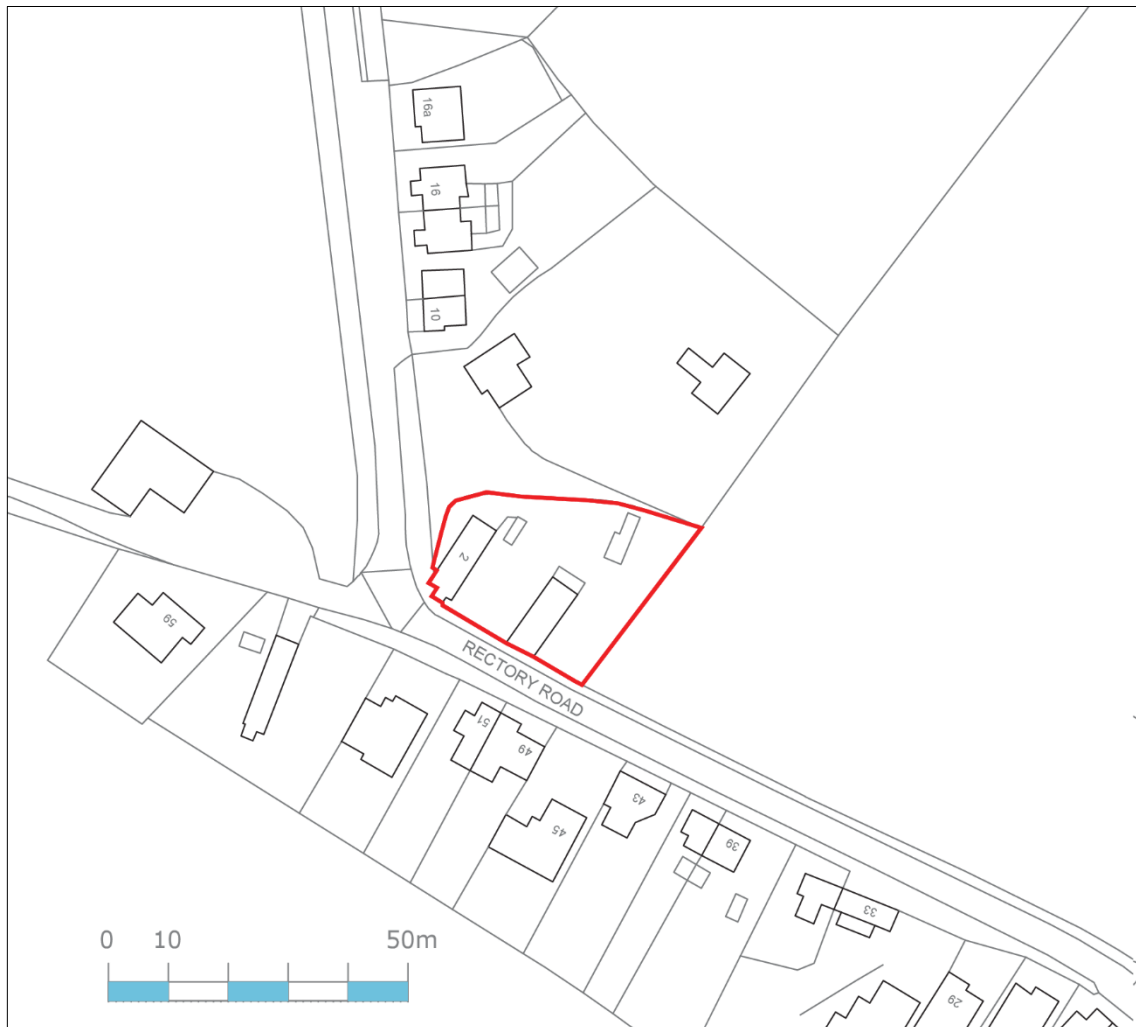
**Figure 2:** Site location (scale 1:1250)

The development site is located in the village of Campton and civil parish of Campton & Chicksands, in the Central Bedfordshire unitary authority area, centred on National Grid Reference TL 1269 3828 (Fig. 1). It lies c.0.4km north-west of the church, occupying an irregular area of c.800 sq. m. on the north side of Rectory Road, at its junction with Priory Road. The site is bounded by open farmland to the south-east and residential properties to the north and north-west (Fig. 2).

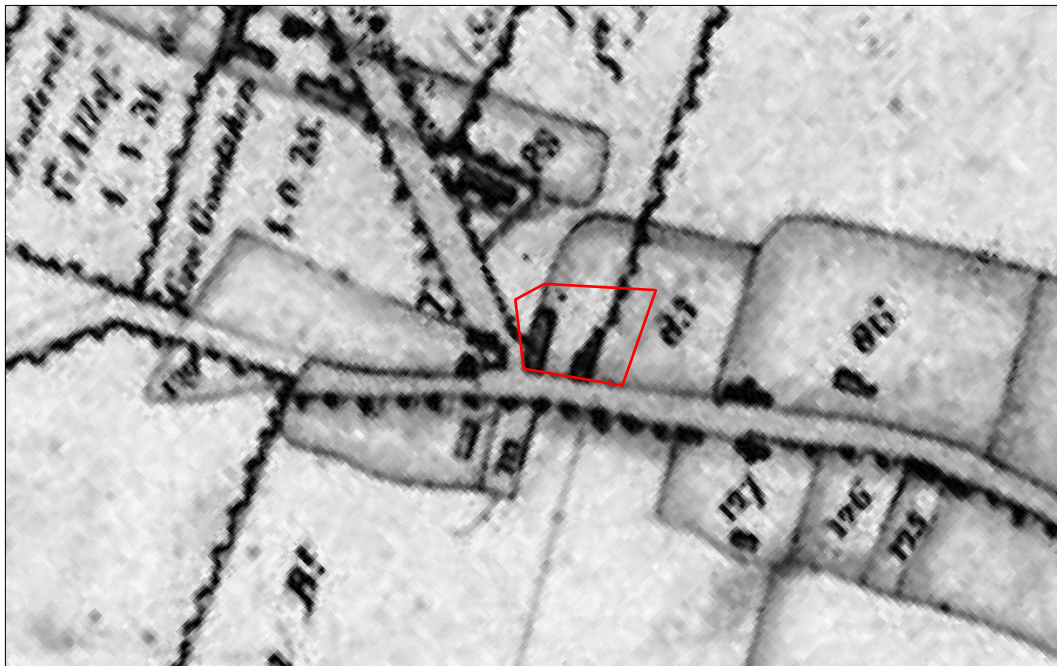
**Figure 4:** Extract from Campton Enclosure map, 1797 (BLARS MA9A)

The fields of Campton parish were enclosed at the end of the 18<sup>th</sup> century. The enclosure map of 1797 (BLARS MA9A: Fig. 4) shows buildings on the assessment site corresponding to the present house and barn. The enclosure award (*ibid*, Book D) also states that there was a brick kiln on the site (HER 18039). The location of this is not clear: the HER gives it a grid reference closely corresponding to that of the farmhouse.
