# BANCROFT HERITAGE SERVICES

**HISTORIC BUILDING RECORDING:  
6 THE WHARF  
GREAT LINFORD  
MILTON KEYNES  
MK14 5AS**

*on behalf of James Beechey*

Ref: BHS/0078/GLW/1

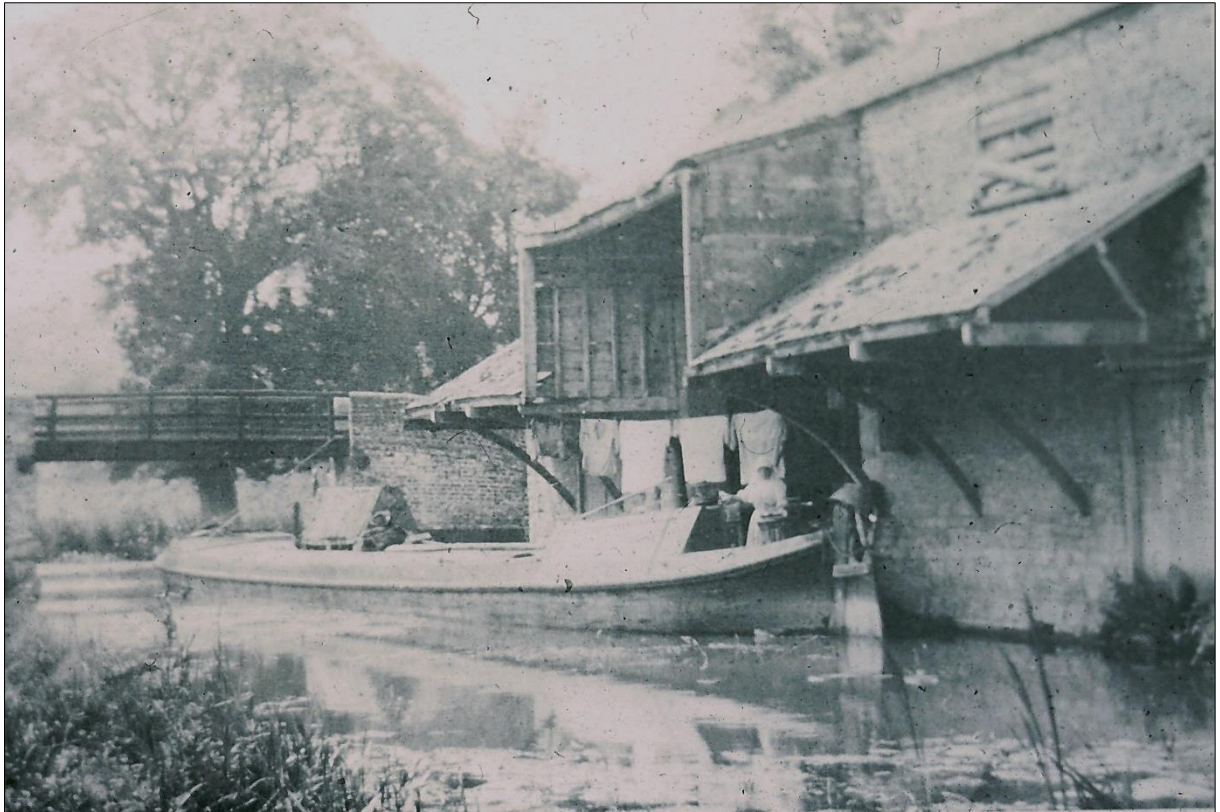
**Figure 4:** Linford Wharf: the warehouse and basin, c1910 (*Faulkner 1993, 191*)

Although the branch canal to Newport Pagnell had closed, it appears that the basin remained in use for some time after. A photograph, variously dated 1880 or 1910 (Fig. 4) shows Thomas Clayton's wide boat *Chess* moored in the basin, apparently waiting to load a cargo of crude tar from the Newport Pagnell gasworks (Faulkner 1993, 191). Above the basin on the east side of the warehouse is a distinctive projecting timber-framed canopy, apparently slate-clad, with a raised central section over a loading bay probably open to eaves-height. It is evident that not much trade was passing through the warehouse at the time: the boatman's wife has her washing on a line across the warehouse entrance. The towpath bridge spanning the entrance to the basin appears on other contemporary photographs. It is uncertain when the basin was filled in and the bridge removed. The inn appears to have ceased to trade in the mid-1930s, becoming a private house.

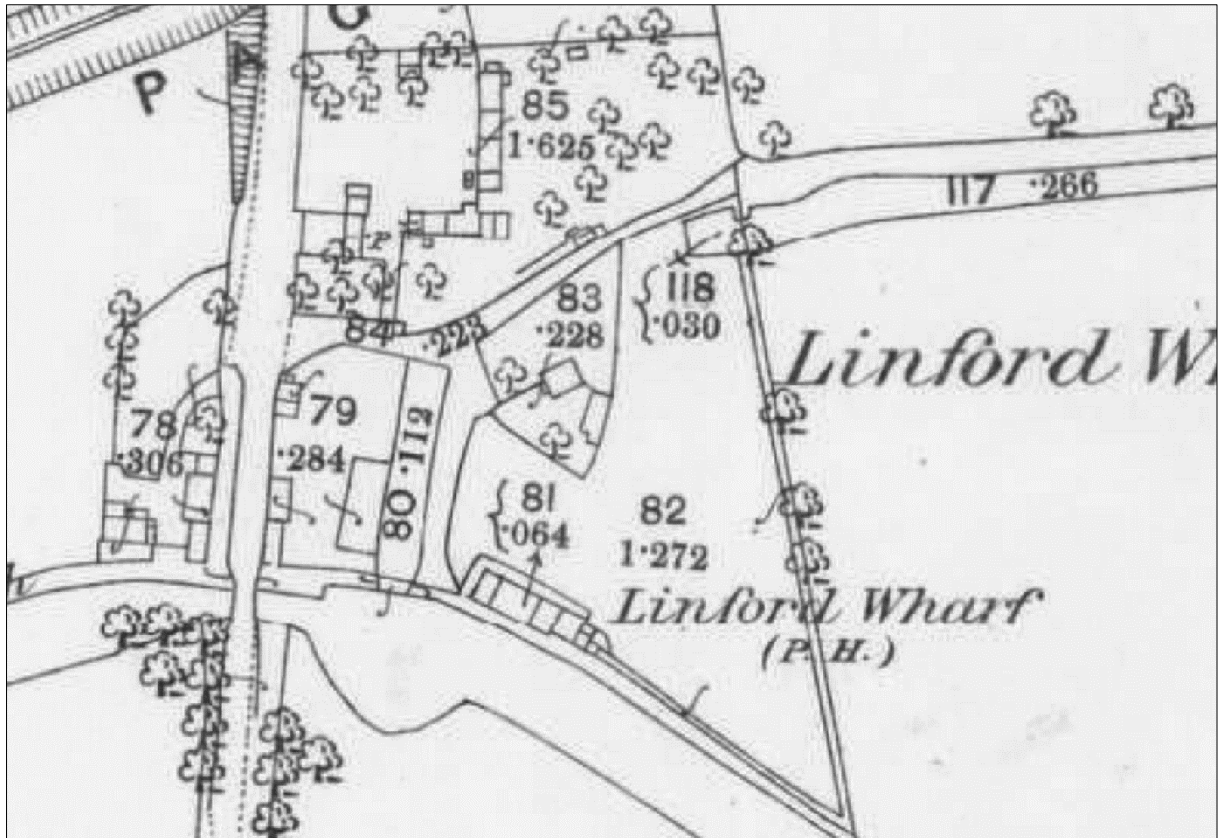
Figure 6: Extract from the Ordnance Survey First Edition 25" sheet, 1881 (not to scale)

By the publication of the Ordnance Survey First Edition 25" sheets in the late 19<sup>th</sup> century the Newport Pagnell Canal had been closed for nearly twenty years and its line partly taken by the Newport Pagnell branch railway. The sheet for Linford Wharf (Buckinghamshire X.5), issued in 1881 (Fig. 6), shows the single-track railway in a cutting to the north of the wharf. The basin and warehouse remain: these were still in use, though by a private tenant. To the north of the lock cottage the entrance lock to the branch canal has been infilled and its site incorporated into the cottage garden, which now has a defined boundary separating it from the inn. East of the wharf, the truncated branch canal remains in water, presumably because there was no incentive or urgency to infill it.

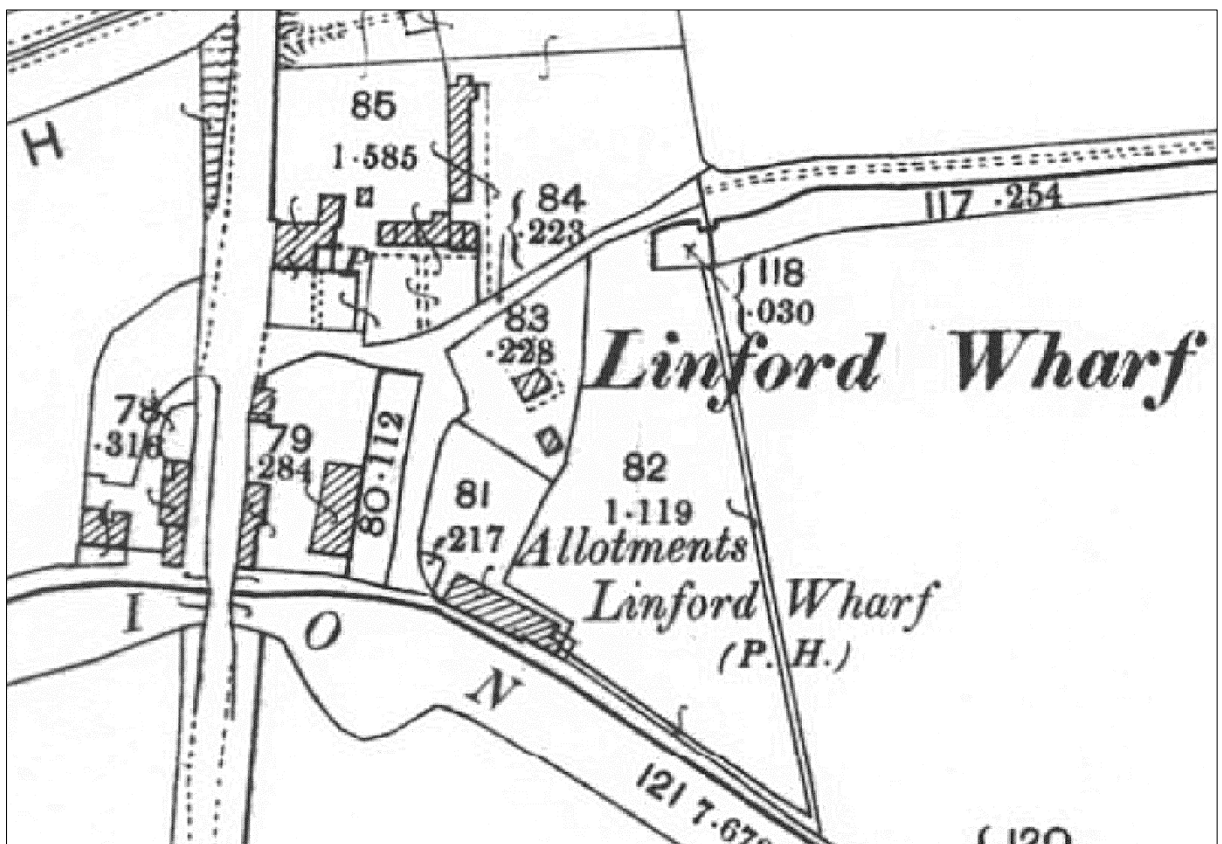
Figure 7: Extract from the Ordnance Survey Second Edition 25" sheet, 1900 (not to scale)

The Second Edition Ordnance Survey sheet of 1900 (Fig. 7) shows further changes to the site and surrounding areas. On the site, the large outbuilding to the rear of the lock cottage has been demolished and replaced by the present smaller structure. The area to the east of the cottage and inn has been separated from the curtilage of the inn, to which it originally belonged, and is labelled 'allotments'. A similar picture is presented by the Third Edition Ordnance Survey sheet for 1925 (Fig. 8).

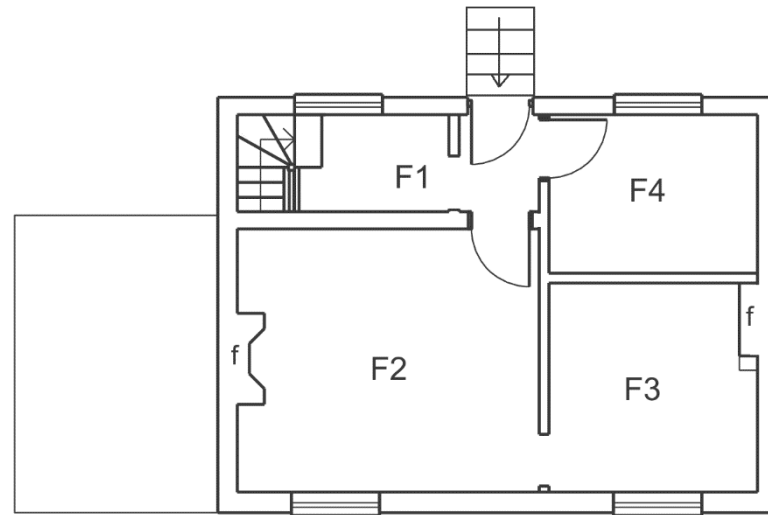
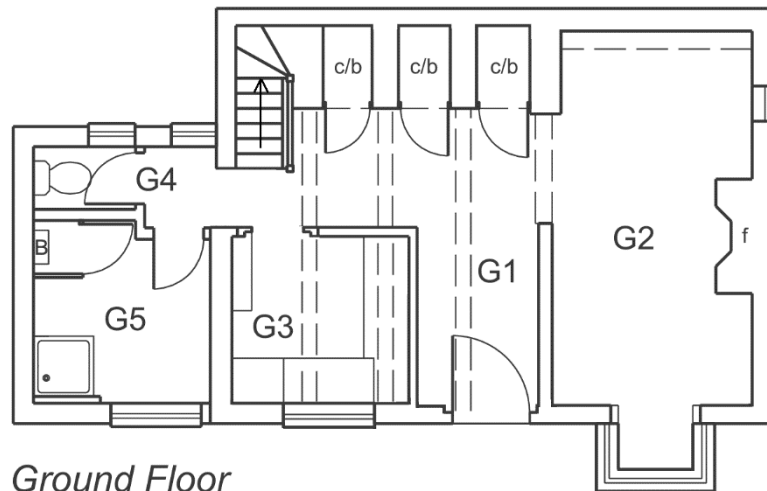
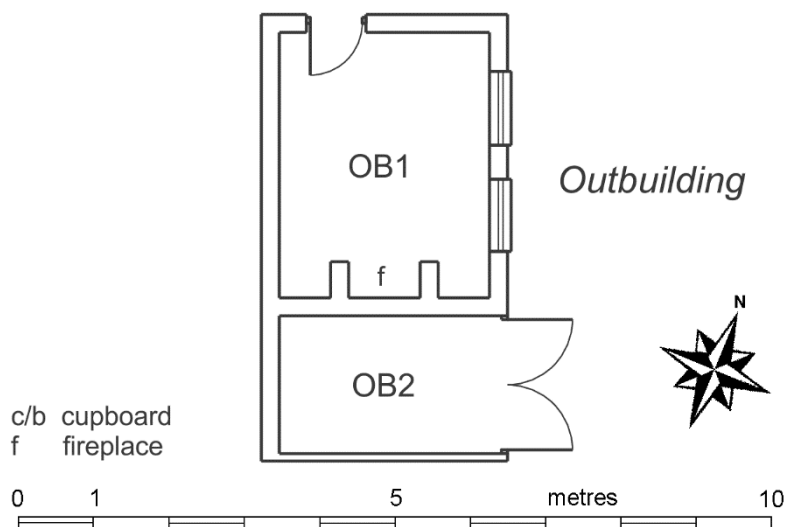
**Figure 12:** House and outbuilding, floor plans (scale 1:100)

The outbuilding is approximately 5m south of the house, its west wall in line with the original west wall of the house. It has a footprint measuring 5.95 x 3.30m: it stands 2.25m to the eaves and c.3.05m to the ridge of its hipped, slated roof, above which rises a single, central brick chimney stack. The building's walls are constructed of similar brick to the core of the cottage, laid in Flemish bond.

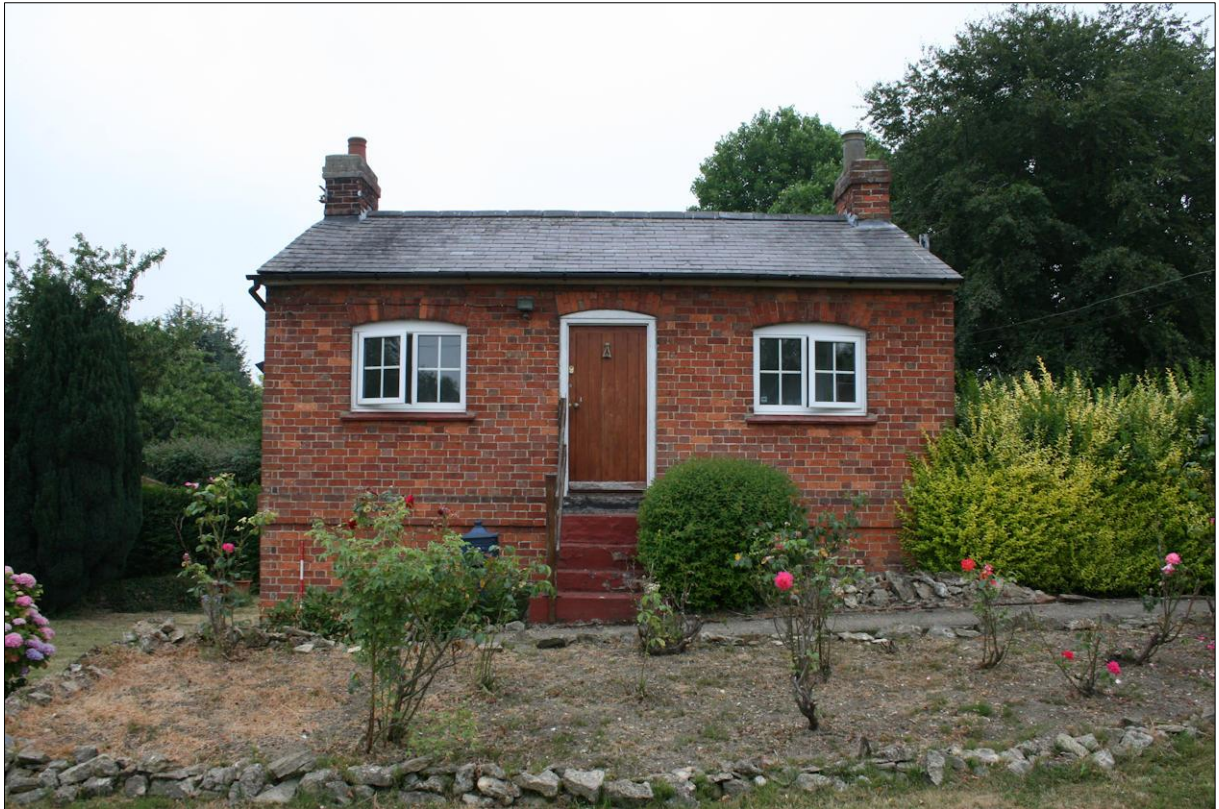
**Figure 13:** Cottage, north elevation from north

The cottage is set into the bank which formed the south side of the branch canal entrance lock, hence only its upper storey is visible when viewed from the north (Fig. 13). On this elevation the only openings are a central door flanked by casement windows, set in openings with bonded arch lintels and stone sills. The windows are modern UPVC double-glazed casements. At first-floor level, a raised band of bricks, three bricks deep, is present on all four walls. The central 'front' door is about one metre above the adjacent ground level and is accessed by a flight of four concrete steps with a single timber handrail to the left. The extension is not visible from this side: its only external features are two small windows, both with modern UPVC units.

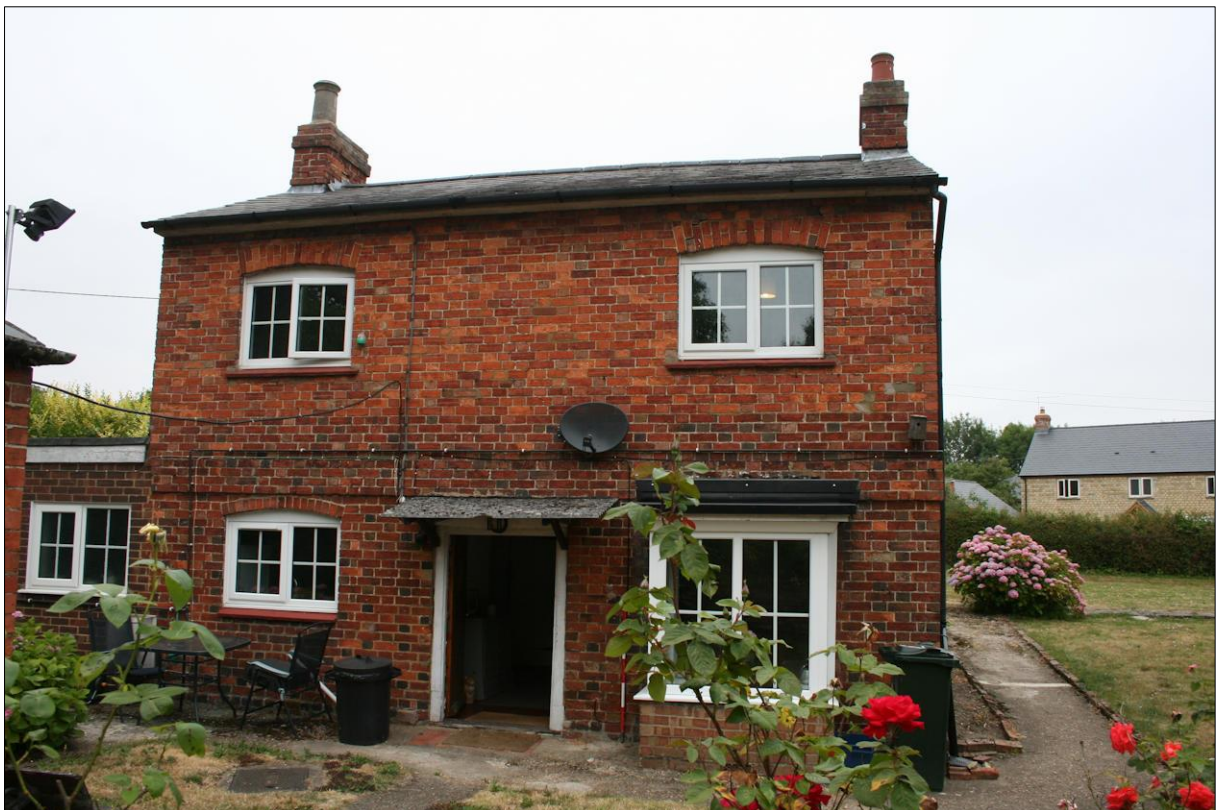
**Figure 14:** Outbuilding, south elevation from south

On its south side, the cottage is visible to its full height (Fig. 14). There is a wide, low central door at ground-floor level, flanked to the west by a modern UPVC casement set in an original opening beneath a segmental arched brick lintel and to the east by a modern, three-sided UPVC bay window, set on a plinth of modern bricks and having a flat roof. At first-floor level, set above the ground-floor windows, are two windows identical to those in the north elevation. The south face of the extension has a single, wide window opening, fitted with a modern UPVC casement unit.

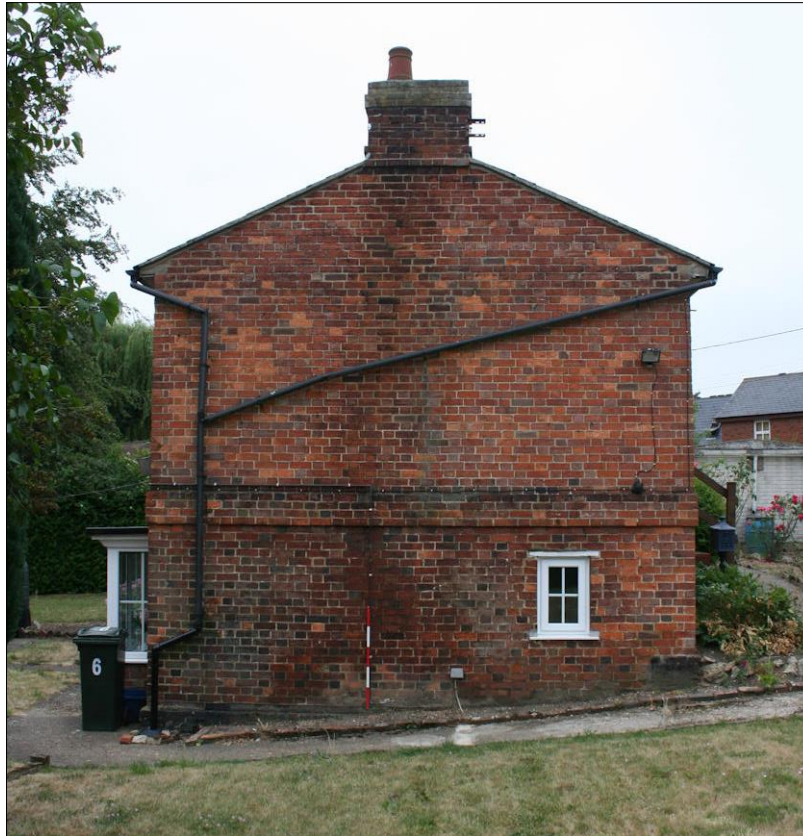
**Figure 15:** Cottage, east elevation from east

The east elevation (Fig. 15) has a single, small UPVC casement window at ground-floor level, possibly a later insertion as there is no evidence of a segmental or bonded brick lintel. The west elevation (Fig. 16) has no openings: its lower part is obscured by the single-storey extension, which also has no openings in this direction.

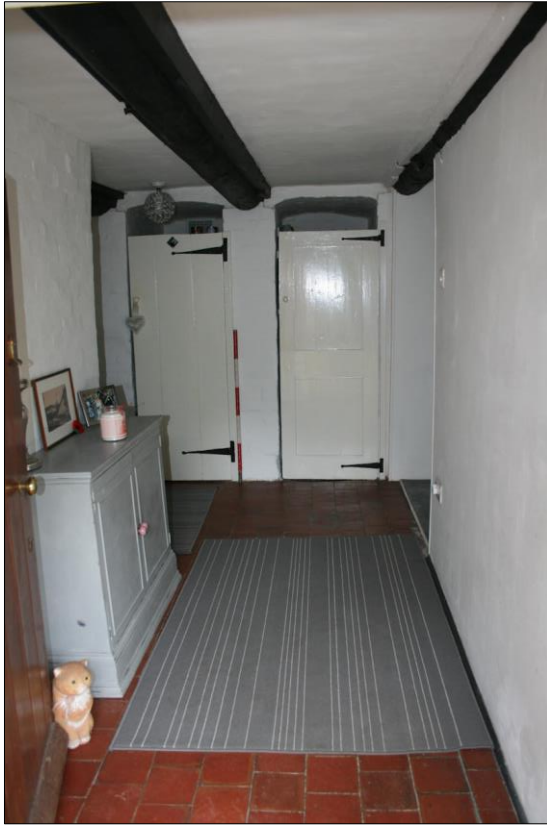
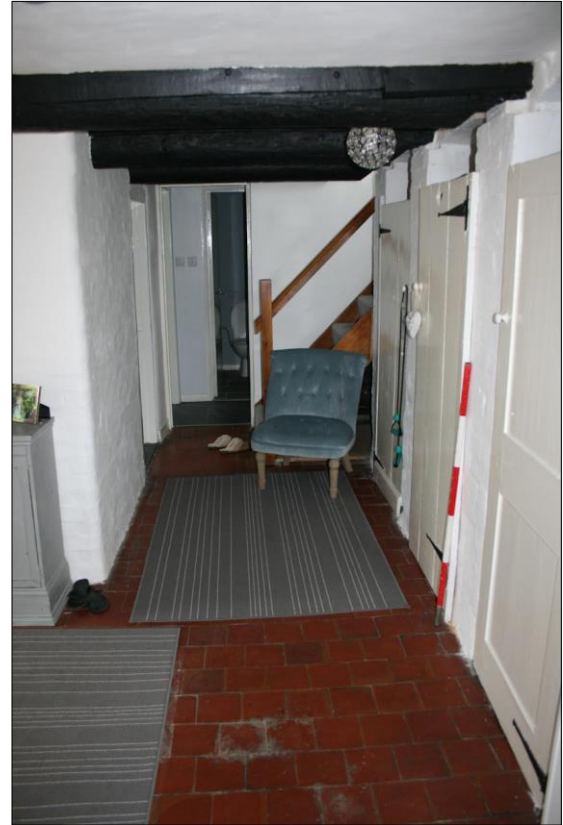
*Size:* 1.6m wide: south and west arms each c.4m in length. Height c.2.1m

*Description:* L-shaped area, providing access to all other ground-floor rooms and stairs to upper floor. Original quarry-tiled floor throughout. Painted brick walls, ceiling supported by substantial half-round north-south timber beams. Along the north side of G1 are three brick-built alcoves with brick-vaulted ceilings. Each alcove has shelving and a front door. Two doors are plank and batten, the third is two-panel. Wide opening to G2, normal-width opening to G3, opening (later insertion?) to single-storey extension. Steep stairs with simple timber handrail to upper floor in north-west corner.

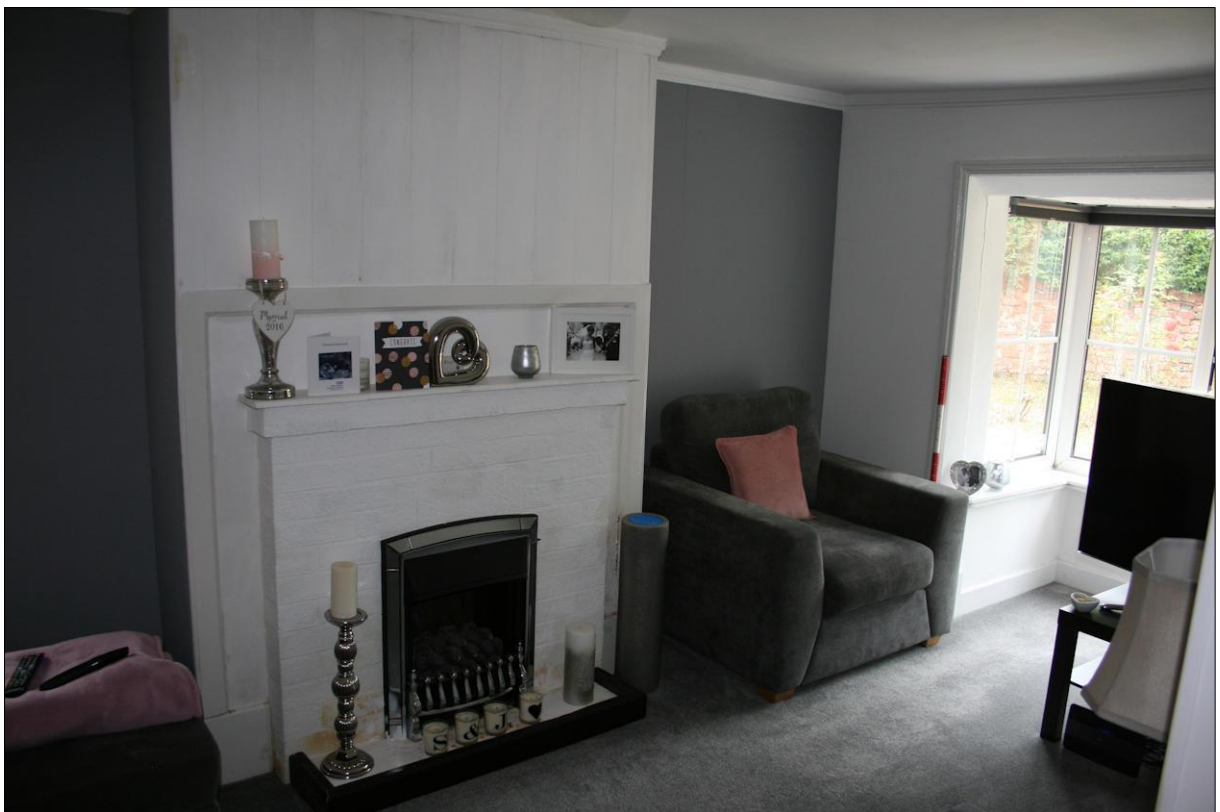
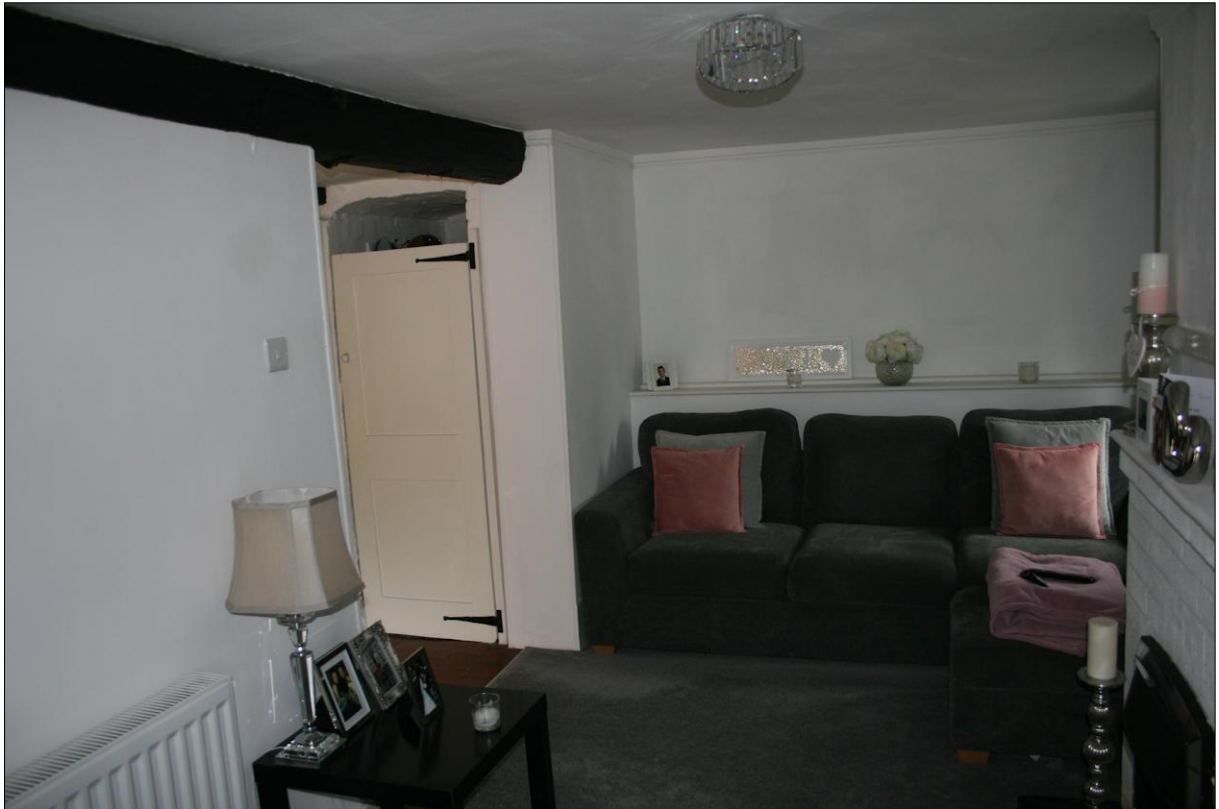
*Size:* 4.95 x 2.65m, height c.2.1m

*Description:* Occupies east end of ground floor. Solid floor, carpeted, with plastered walls and cornice. Plastered ceiling. On the east side is a chimney breast with a painted brick fire

surround with modern grate and small tiled hearth front, above which the chimney breast is clad with vertical match-boarding. Small window to north of chimney breast, modern bay window at south end of room. The lower part of the north wall is wider (possibly related to the need for increased structural strength on this side?), capped by a narrow shelf.

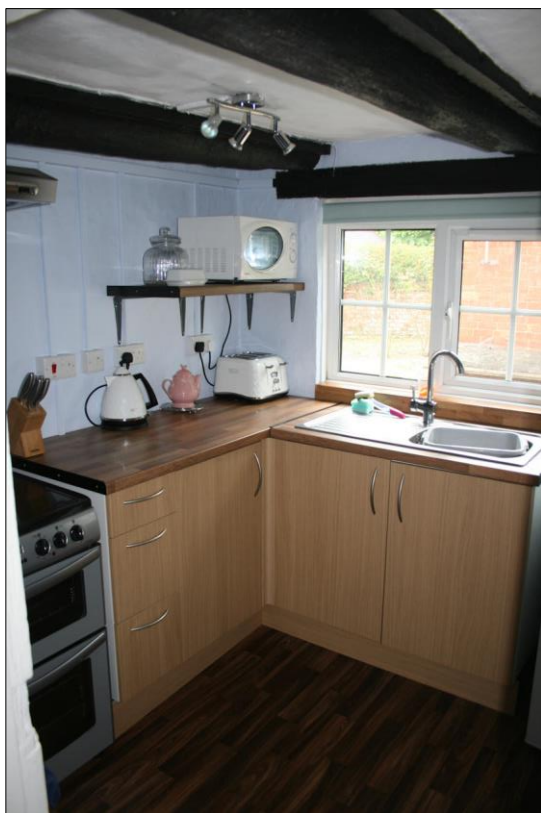
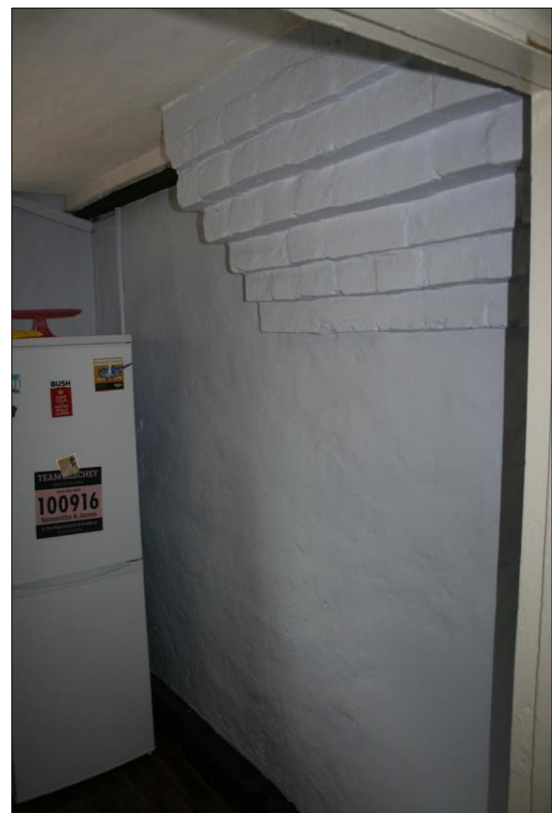
*Size:* 2.85 × 2.20m, height c.2.1m

*Description:* Laminate wooden floor, painted brick walls, beams supporting ceiling as described for G1. The upper part of the west wall is corbelled out to support the fireplace in F2 above. Modern casement window to south: modern kitchen fixtures and fittings.

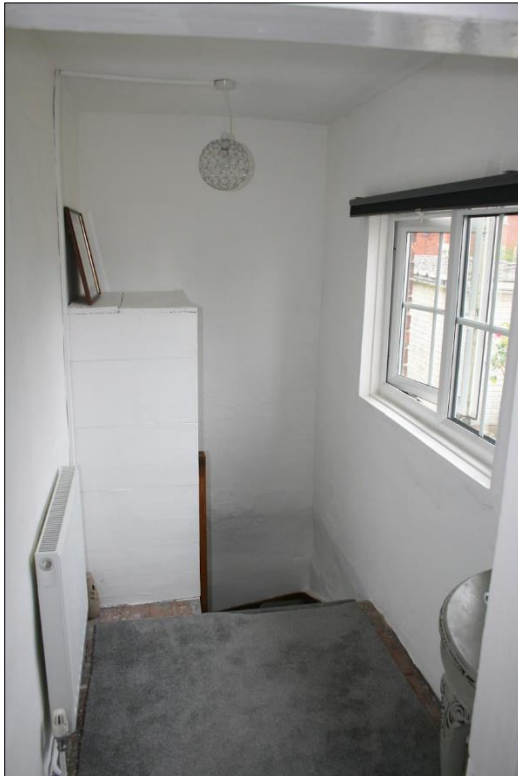
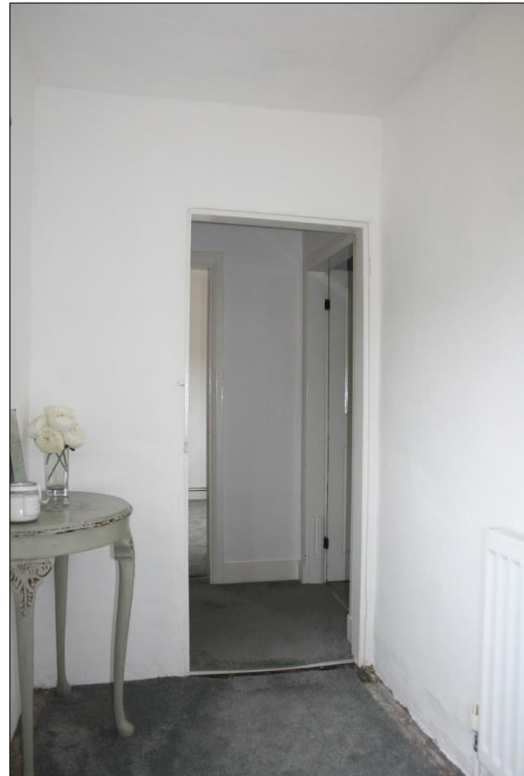
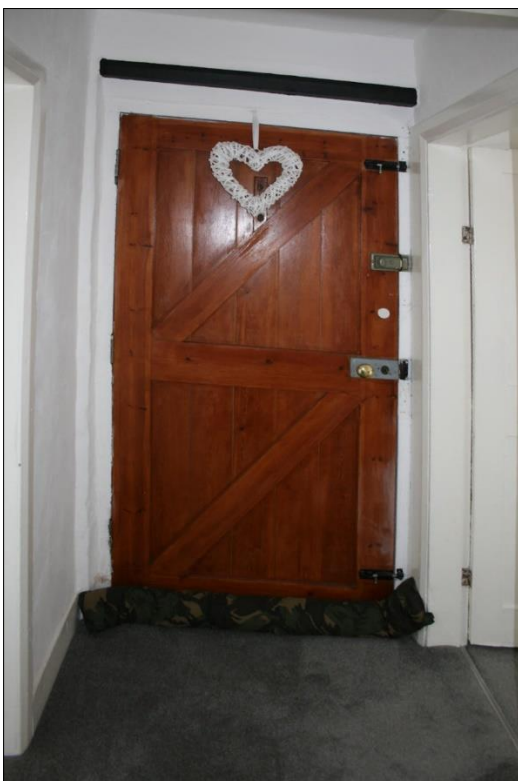
*Size:* 4.0 × 1.3m, height 2.25m

*Description:* Brick floor. Walls and ceiling plastered. The wall between F1 and F2 is notably the only brick wall on the upper floor: others are all studding walls. The lobby at the east end of F1 provides access to F2 and F4, and to the first-floor 'front' door on the north side of the cottage. At the west end of F1, a steep dog-leg stair with a plain timber handrail leads to the ground floor. F1 has one north-facing window. Internal doors are typical 19<sup>th</sup>-century 4-panel type, with inset locks.

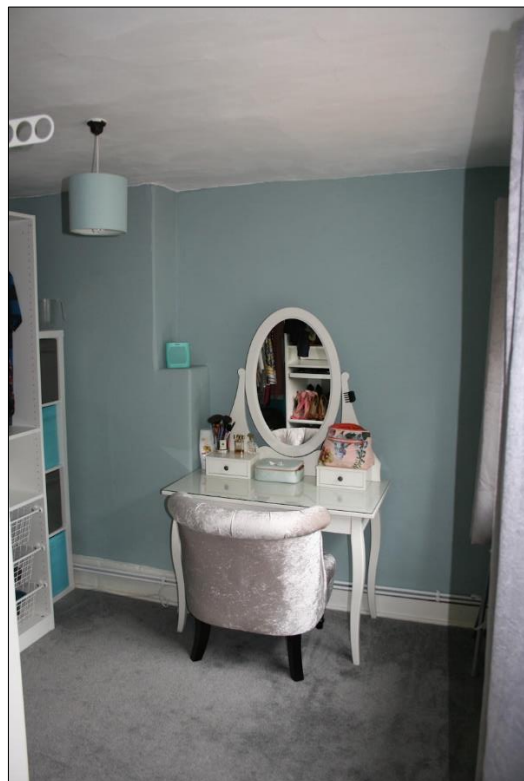
**Figure 26:** Cottage, F3 dressing room, looking east

*Size:* 2.75 × 2.75m, height 2.25m

*Description:* Floor carpeted: walls and ceiling plastered. Plain skirting boards and architraves. On the south side is a window: in the south-west corner, a doorway to F2. On the east side of the room is a broad chimney breast: the fireplace has been blocked up.

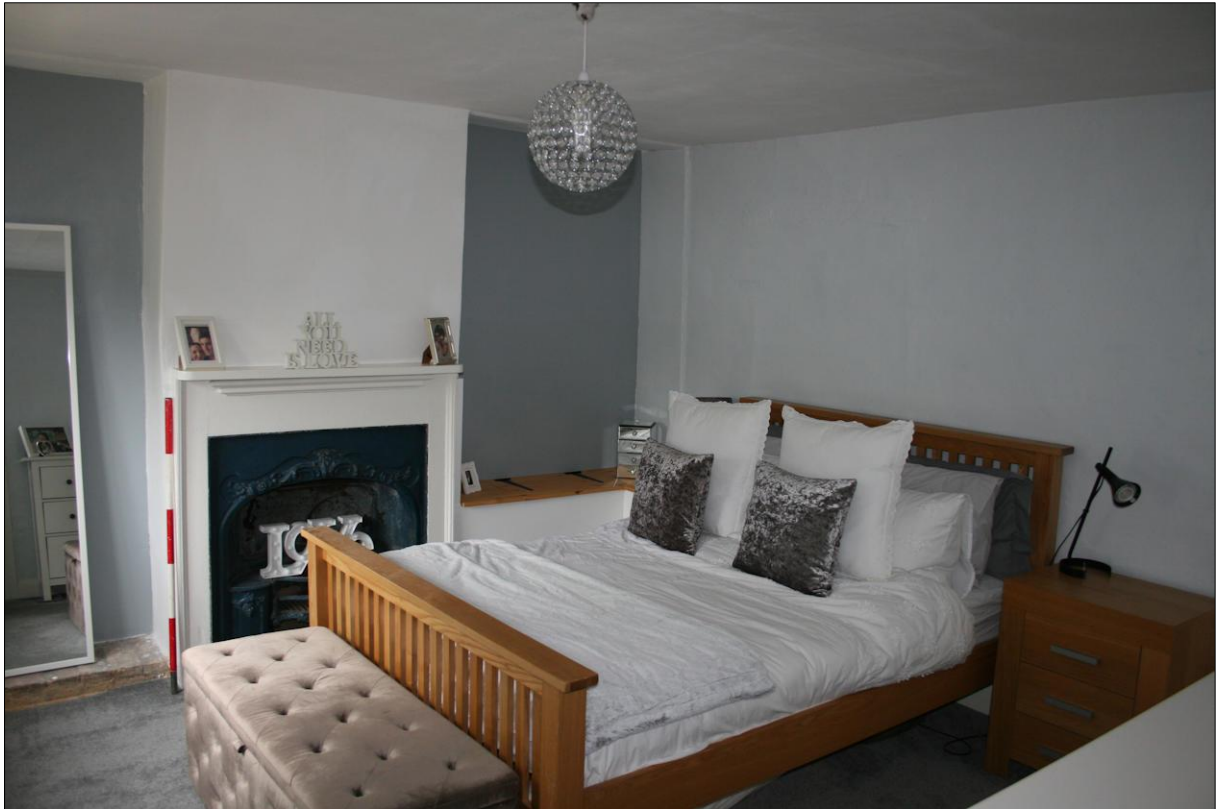
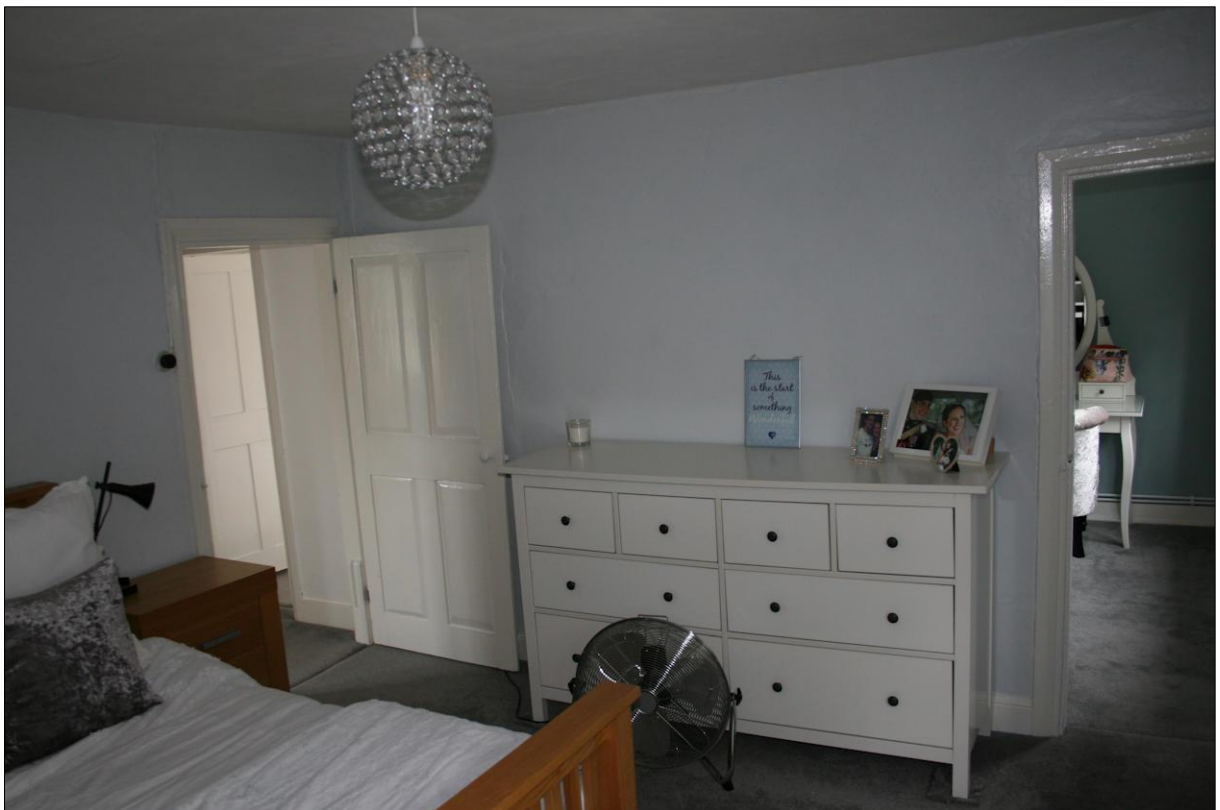
*Size:* 4.0 × 3.5m, height 2.25m

*Description:* Brick floor. Walls and ceiling plastered. Plain skirting boards and architraves. On the south side is a window: in the south-east corner, a doorway to F3. On the west side of the room is a broad chimney breast: the fireplace has a plain surround and a wide, cast-iron surround and grate with Rococo detailing, probably c1820-40 (Galloway 2005, 190.6).

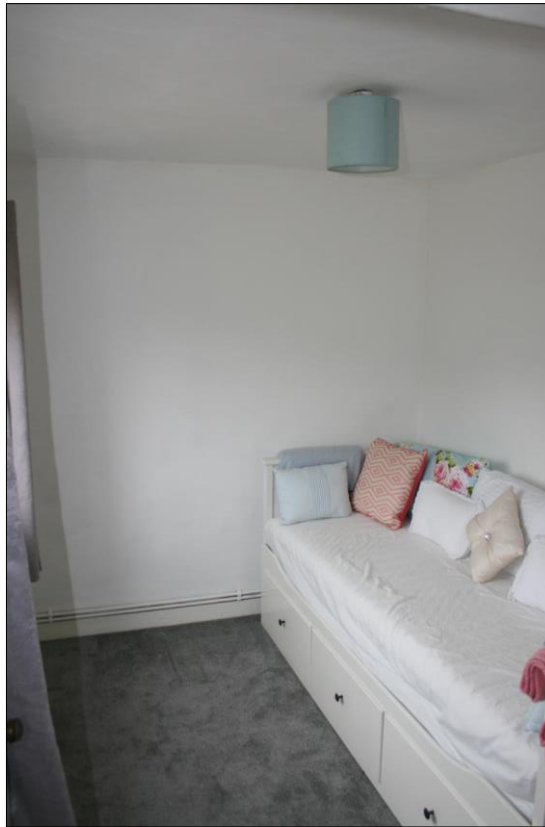
**Figure 29:** Cottage, F4 bedroom, looking east

**Room F4** (Fig. 29)  
*Size:* 2.75 × 2.10m, height 2.25m  
*Function:* Bedroom  
*Description:* Floor carpeted: walls and ceiling plastered. Plain skirting boards and architraves. On the north side is a window: in the north-west corner, a doorway to F1.

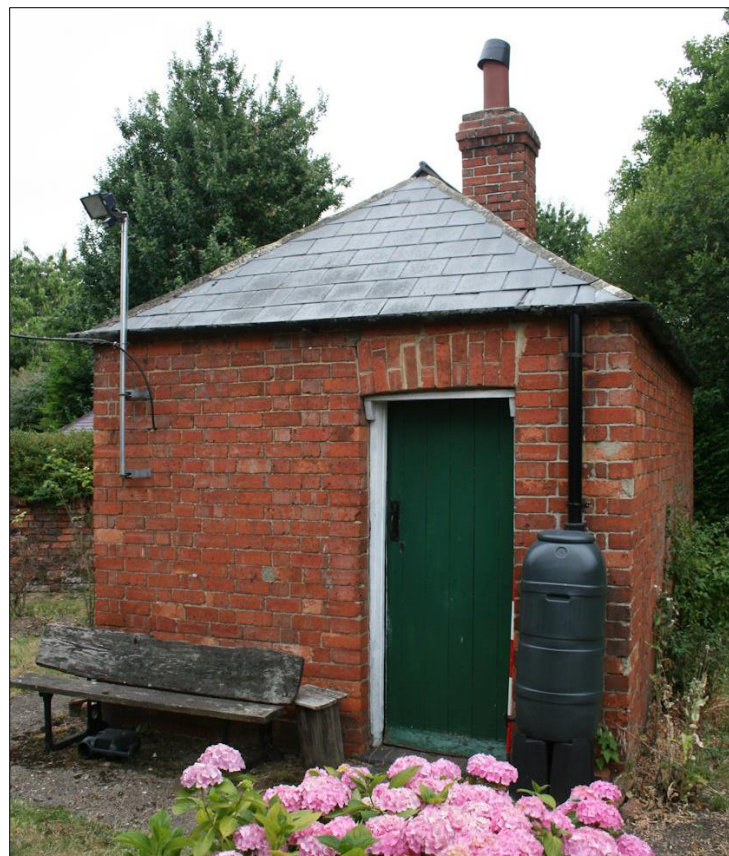
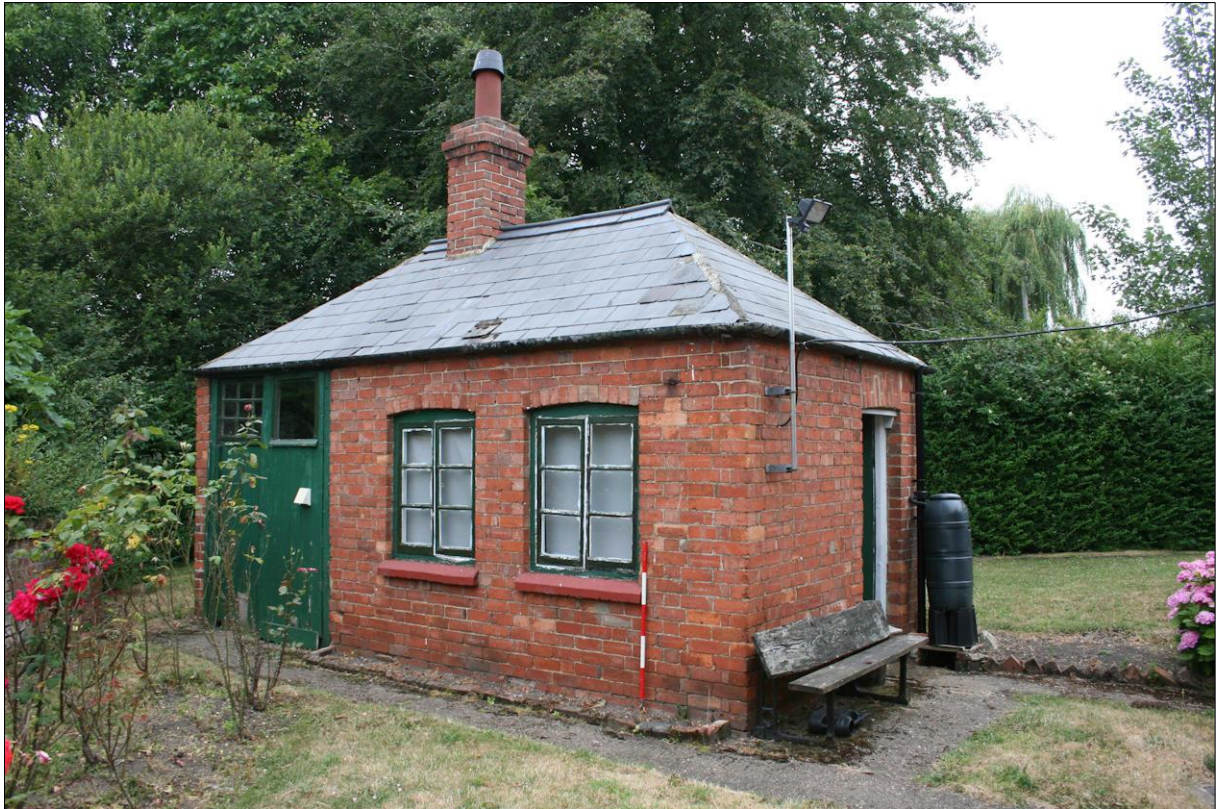
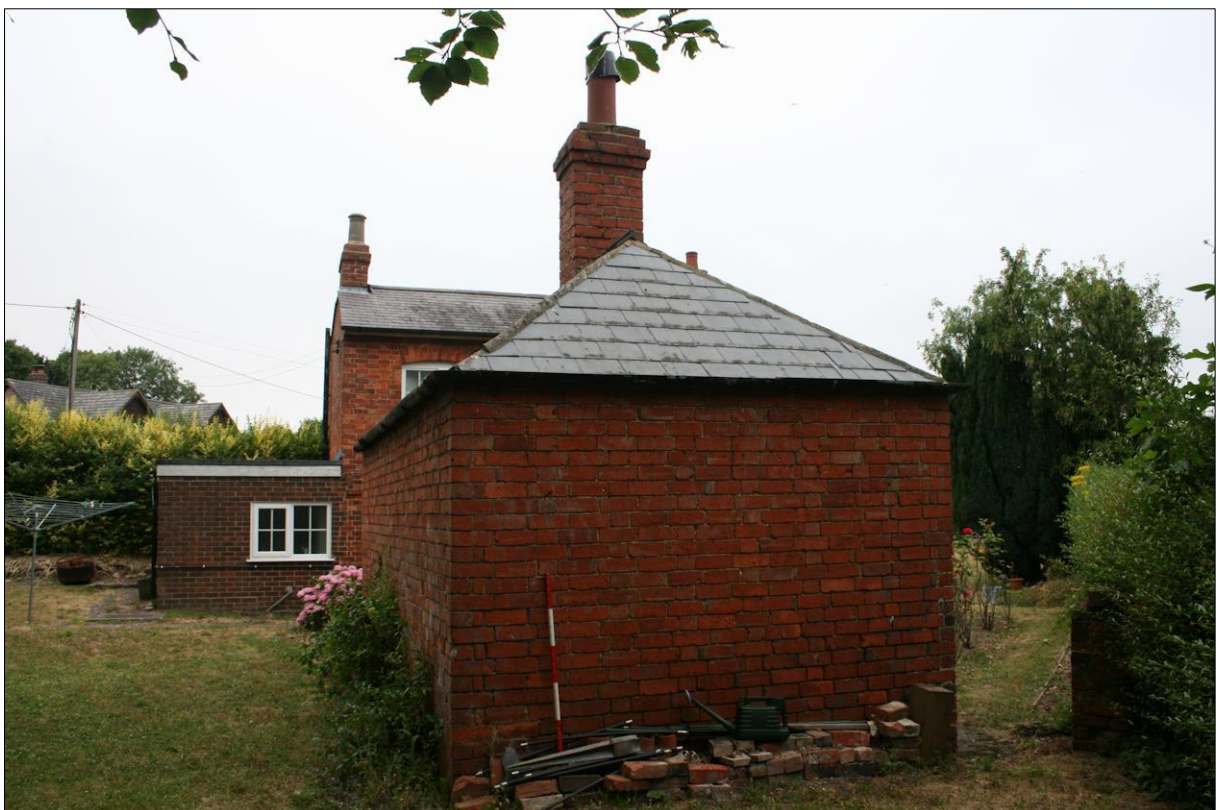
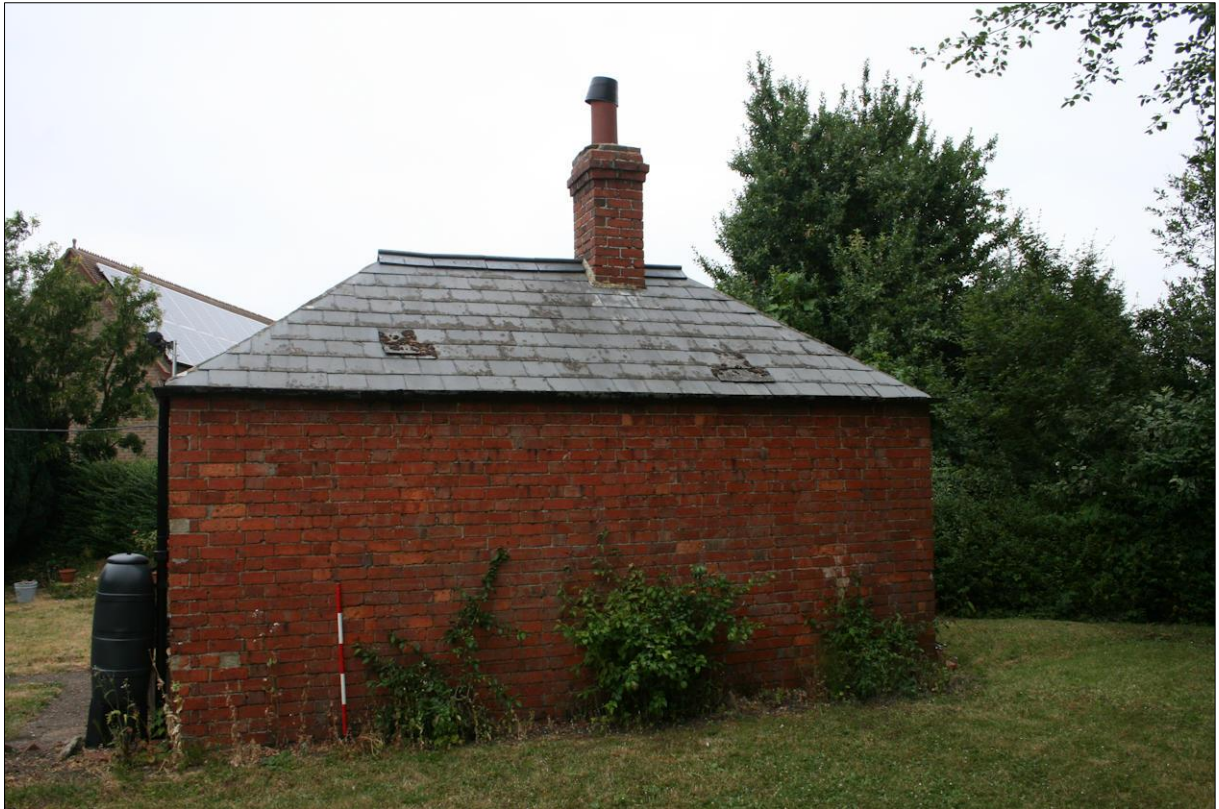
The outbuilding has two rooms, each with its own external entrance. Access to the northern room, OB1, is gained by a doorway beneath a bonded brick arch in the north wall, fitted with a plank-and-batten door (Fig. 30). This room has two east-facing 6-light timber casement windows beneath segmental brick lintels, with brick sills. At the south end of the east elevation, two-leaf timber doors with rectangular glazed lights above provide access to the southern room, OB2 (Fig. 31). The south and west walls (Figs 32 & 33) have no openings or other detail.

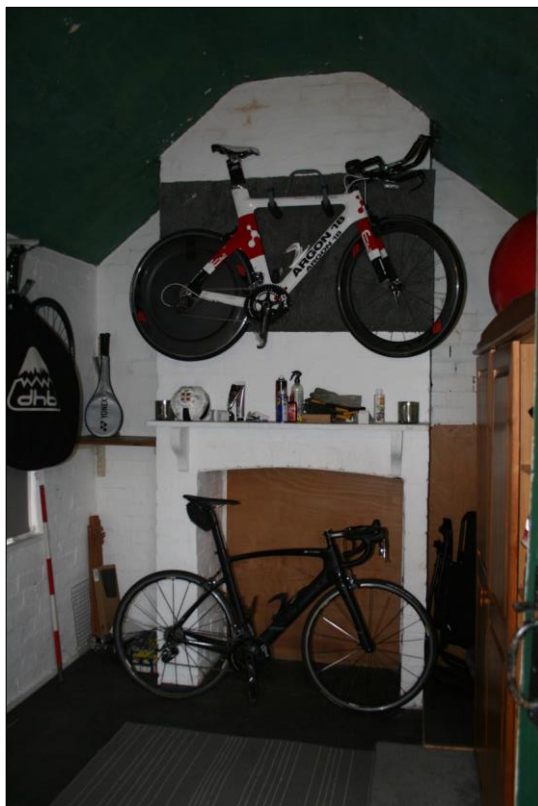
**Figure 34:** Outbuilding, OB1 looking south

*Size:* 3.50 × 2.75m, height c.3.0m

*Description:* Solid floor, painted brick walls, sloping ceilings. Apart from the door and windows described above, the only feature of note in this room is the brick chimney stack with open fireplace and mantel shelf at the south end of the room. The presence of a fireplace and the abundant natural light provided by the two east-facing windows suggests that this room was originally intended as some sort of workshop.

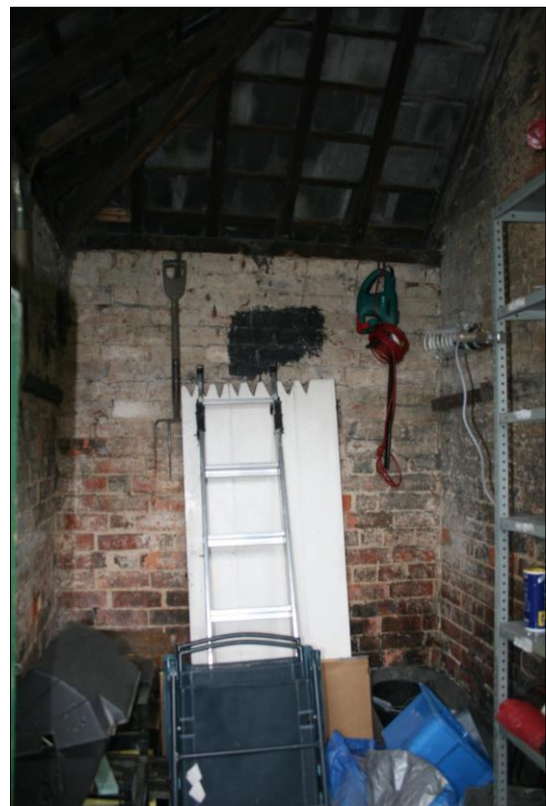
**Figure 35:** Outbuilding, OB2 'garage' looking west

*Size:* 1.80 × 2.75m, height c.3.0m

*Description:* Solid floor, unpainted brick walls, open to roof. Presently used as a store, OB2 is described in the planning documentation as 'garage', though it is too small and inconveniently located to have housed a car or van. Probably intended originally as a storeroom: the double doors suggest it might have housed a tradesman's hand-cart?
