Barn at The Mordaunts, Crowle

Building Recording

October 2018

EHI809-1

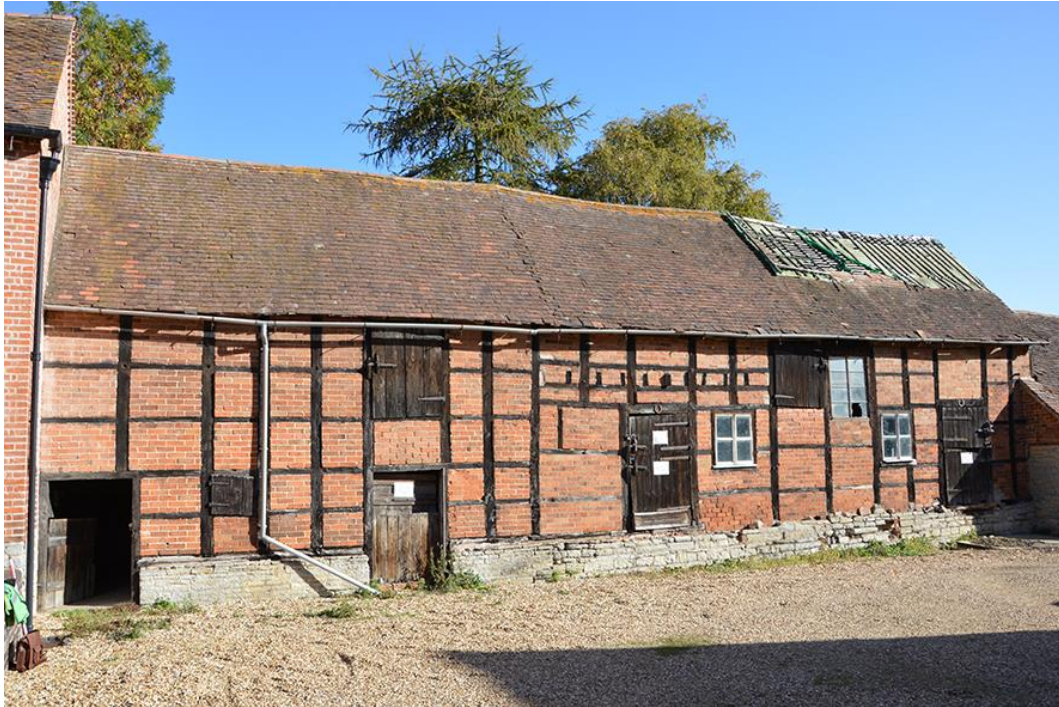
The buildings recorded at The Mordaunts consist of a timber-frame building (Plate 1), last used as a stable, and an adjoining stone and brick cart shed (Plate 2). They lie to the immediate north of The Mordaunts house and adjoin further former farm buildings to the west some of which date from the 17th century and are listed. The majority of these are now converted with the stable and cart shed recorded in this project being the only unconverted structures. The stable is listed (NHLE1350108) and is described in the listing information as: *'Stable about 20 yards north of The Mordaunts GV II Stable. C17 with mid-C20 alterations. Timber-framed with brick infill, brick replacement walling, plain tiled roof. Three framed bays aligned east/ west; two levels. Framing: irregular, mainly five panels from sill to wall- plate,*

Plate 1 Timber-frame building from the south west

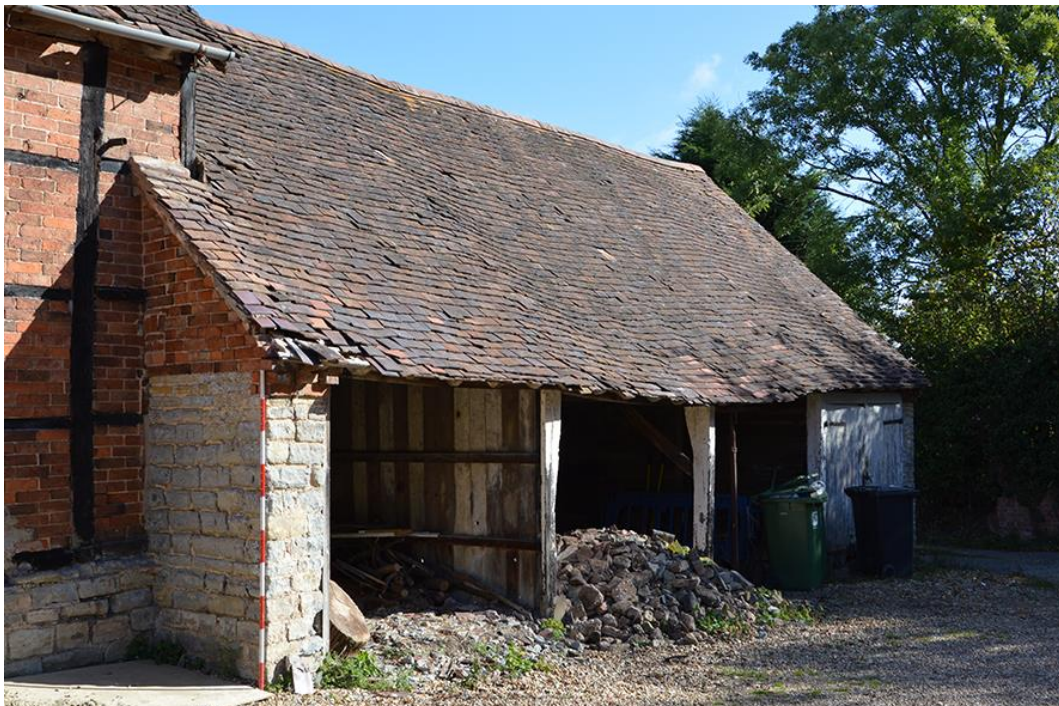
Plate 2 Cart shed from the south west

The adjoining cart shed, to the east, was built of coursed lias rubble walls with a small amount of brick in the north wall and all of the top of east gable. The south elevation of four bays had three bays completely open with the roof supported on timber posts and the east bay was closed with garage doors. The ground was higher against the north elevation and, as a result, little of the lias wall was visible. The eaves were of brick with a dentilated eaves cornice.

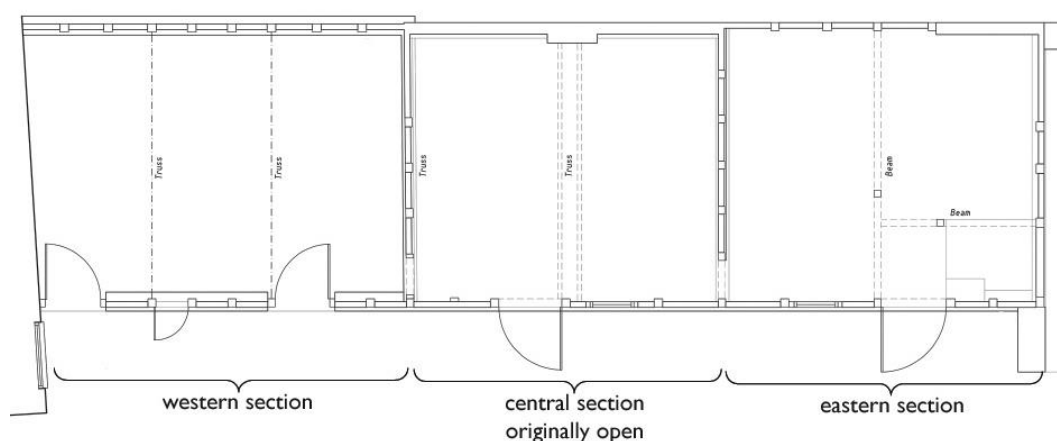
The timber-frame building has been divided into three sections for ease of description.

Plate 3 Layout of timber-frame building

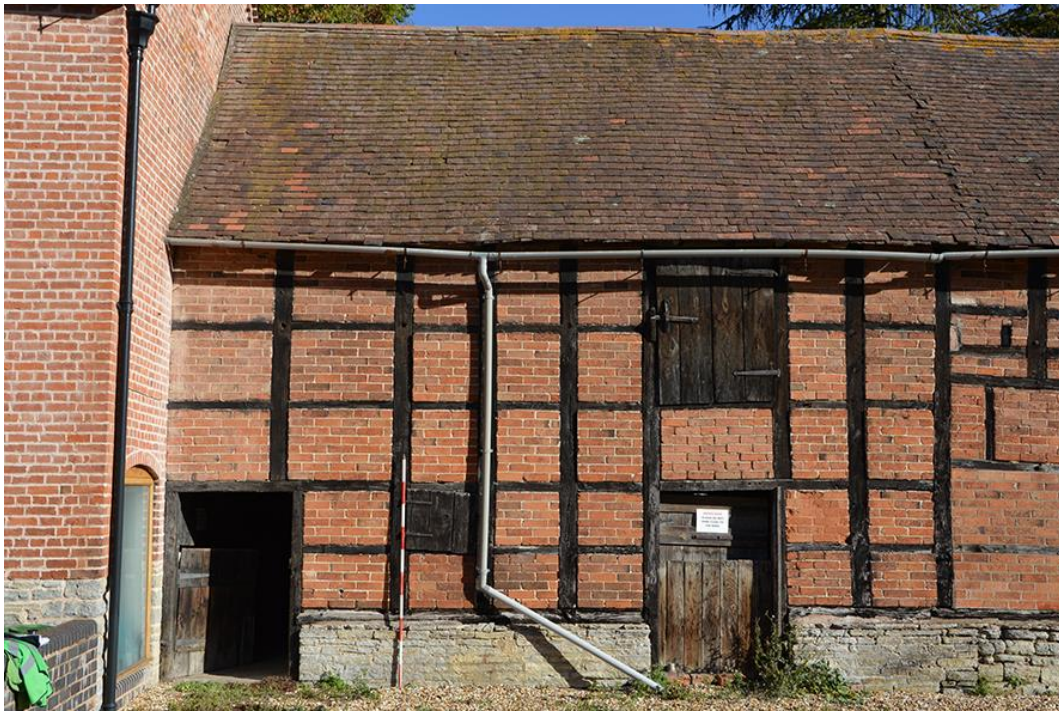
The framing of the timber-frame building's western section was regular with five panels between wall and sill plate (Plate 4; Fig 4). There were two 'stable' doors and a small hatched window opening. The upper part of the frame had a pitching opening. Evidence of peg holes showed that there had been a lean-to attached to the south elevation of this section (Plate 5; Fig 4).

Plate 4 Western section of timber-frame building

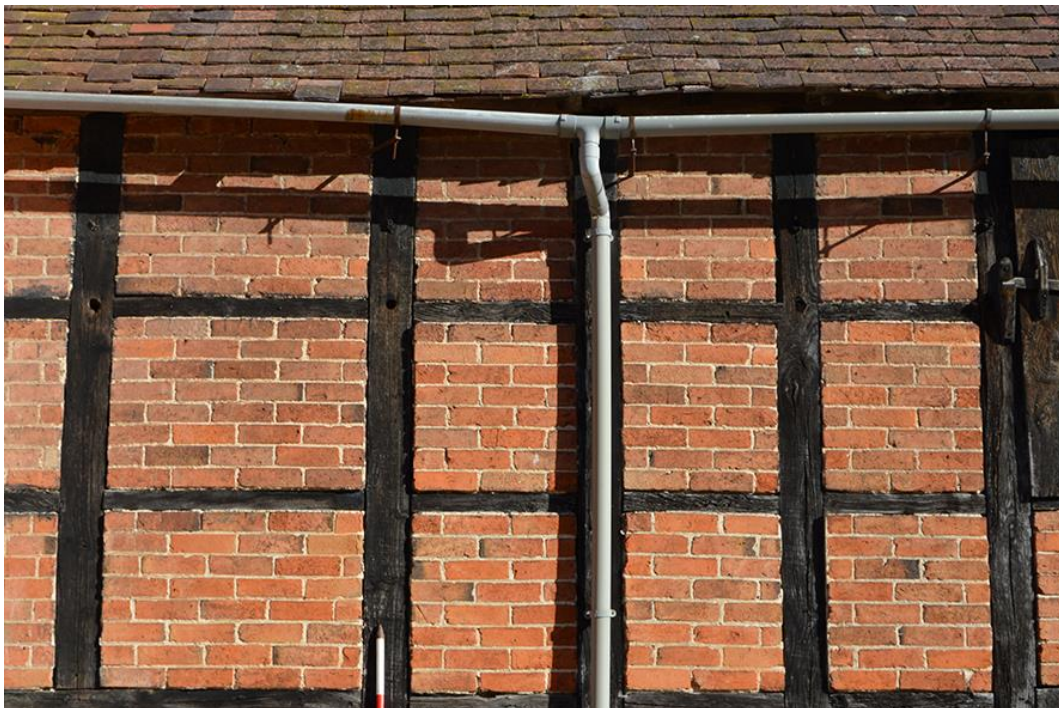
Plate 5 Peg holes from former lean-to extension

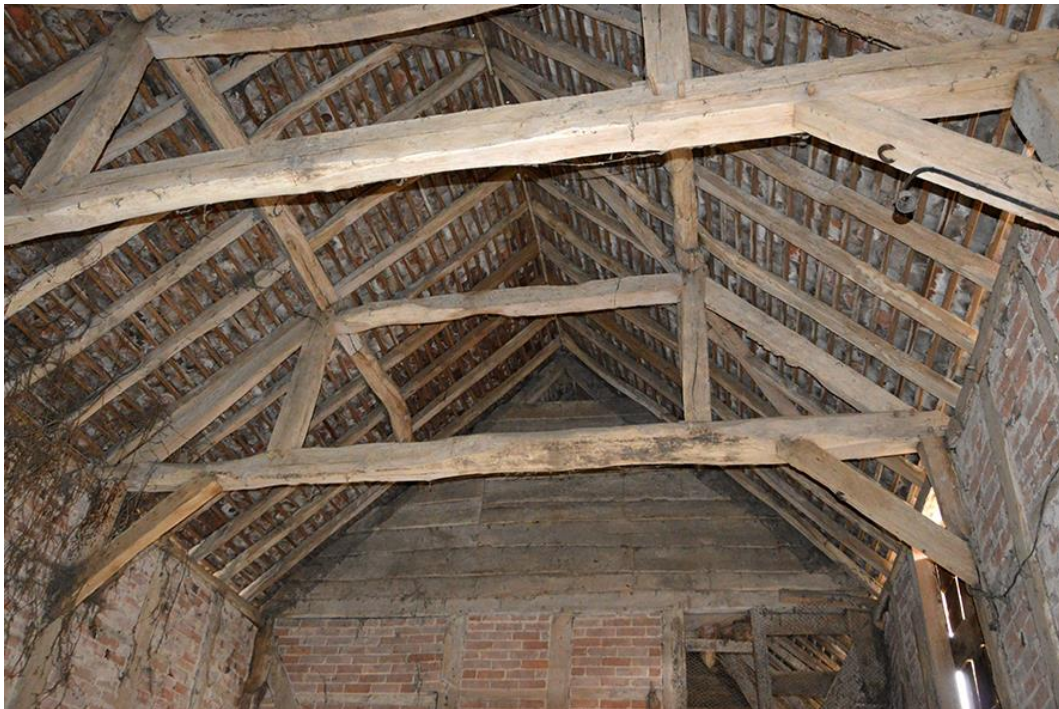
Internally this section was open to the rafters with two collar and post trusses visible (Plate 6). The building was abutted by the adjoining listed barn (now converted) to the west with the brick and lias gable of this barn forming the west elevation of the timber-frame building of The Mordaunts. The east elevation of this section was a full height frame (Plate 7), the top of which had been covered with weatherboard.

Plate 6 Western section interior, collar and post trusses

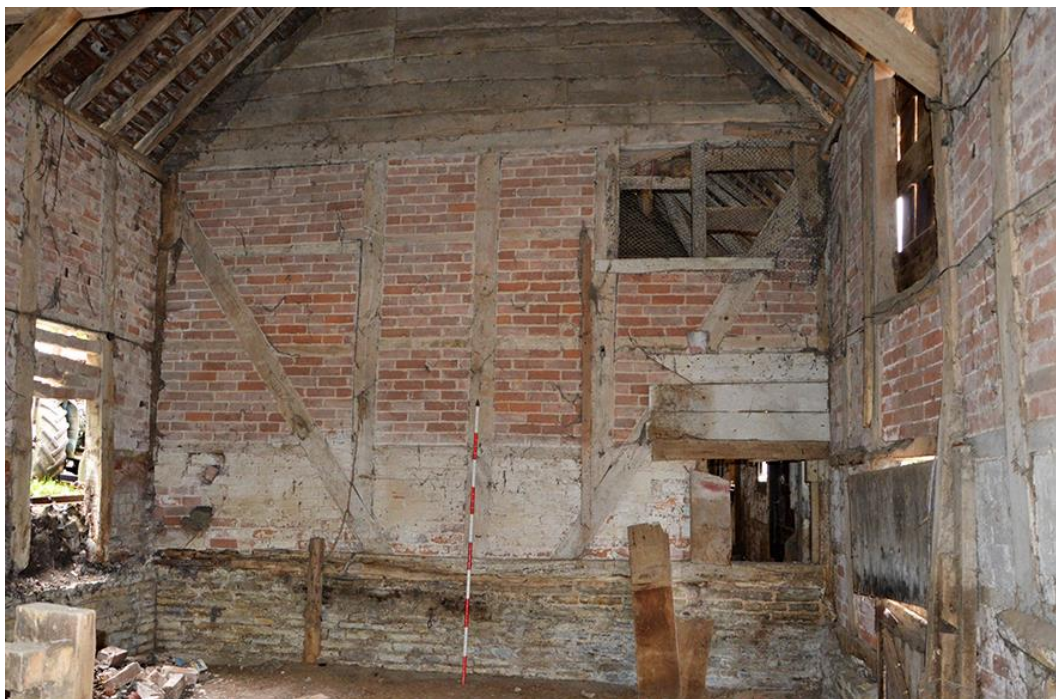
Plate 7 Western section interior, east frame

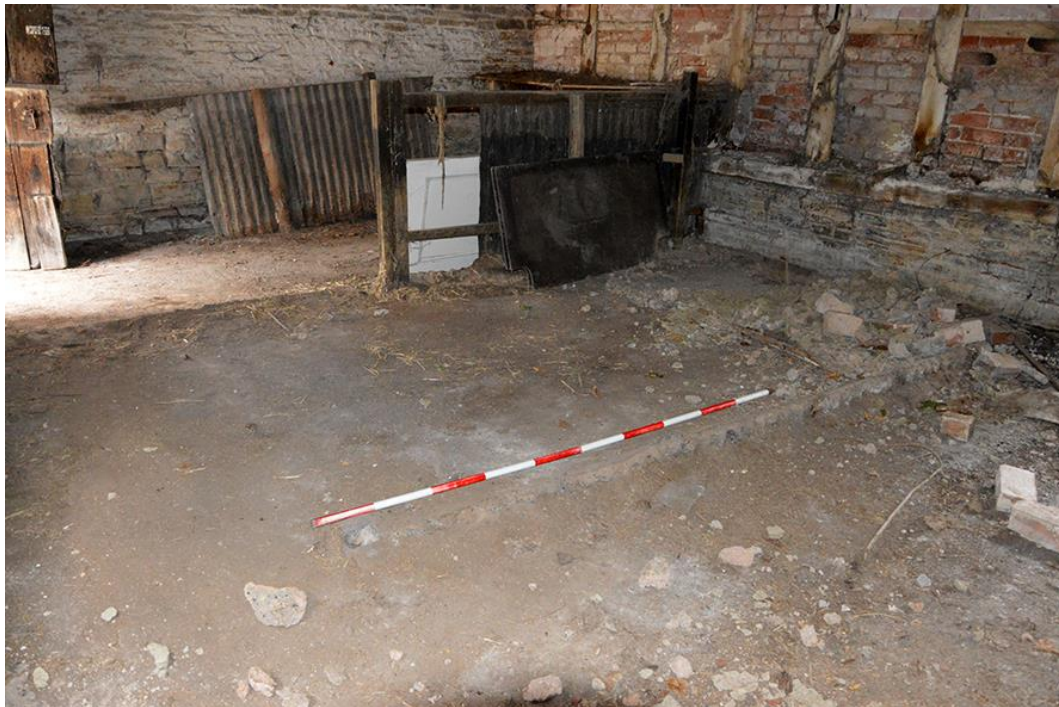
The floors within this section were of concrete and showed evidence of there being internal divisions creating three stalls (Plate 8). These were accessed through the two 'stable' doors visible in the southern elevation. At some point this section was used for the storage of hay or straw which was loaded through the pitching door in the south elevation.

Plate 8 Western section interior, evidence of former divisions

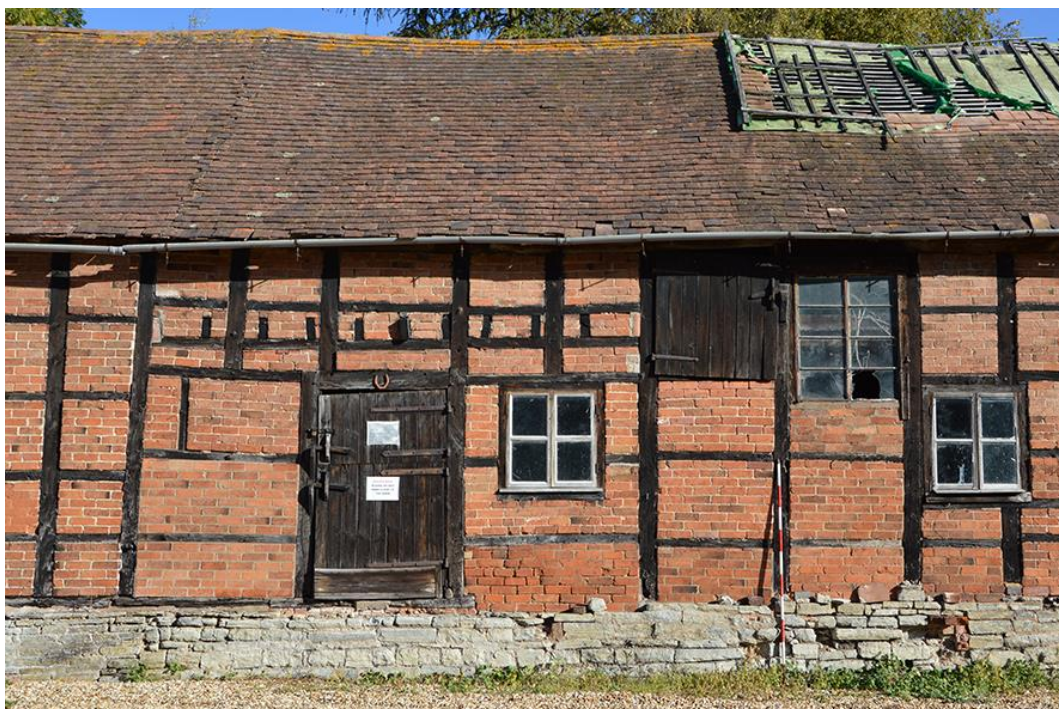
The south elevation of the central section of the timber-frame building had a large ground floor 'stable' door with a window to the side and a pitching door on the first floor (Plate 9; Fig 4). The framing of this section was very irregular and inconsistent with that of the frame of the western end. Above the stable door, were five panels that had been cut to insert the joists to hold a floor. The framing to the right of the stable door and window was more consistent with three upright posts and dividing rails but it also did not match the framing of the western end.

Plate 9 Central section from the south

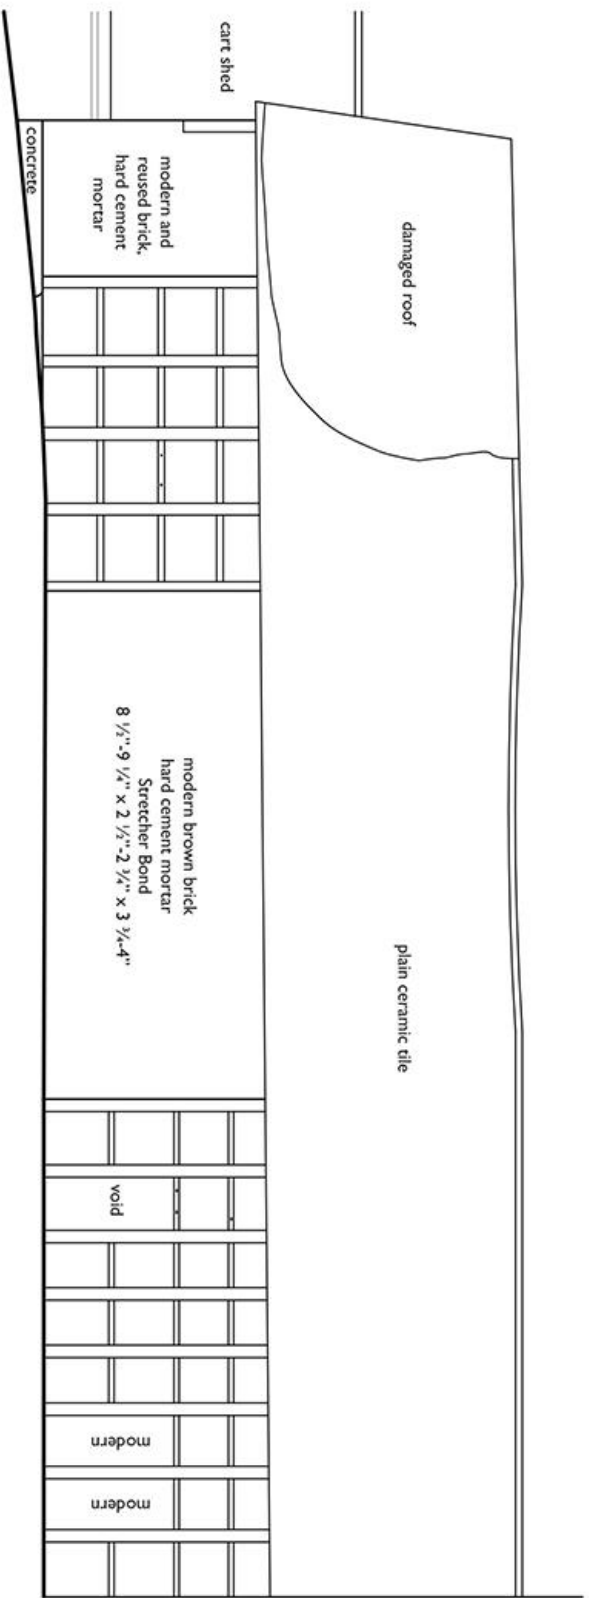
Figure 4
Timber-frame building
south and north
elevations

South elevation

North elevation

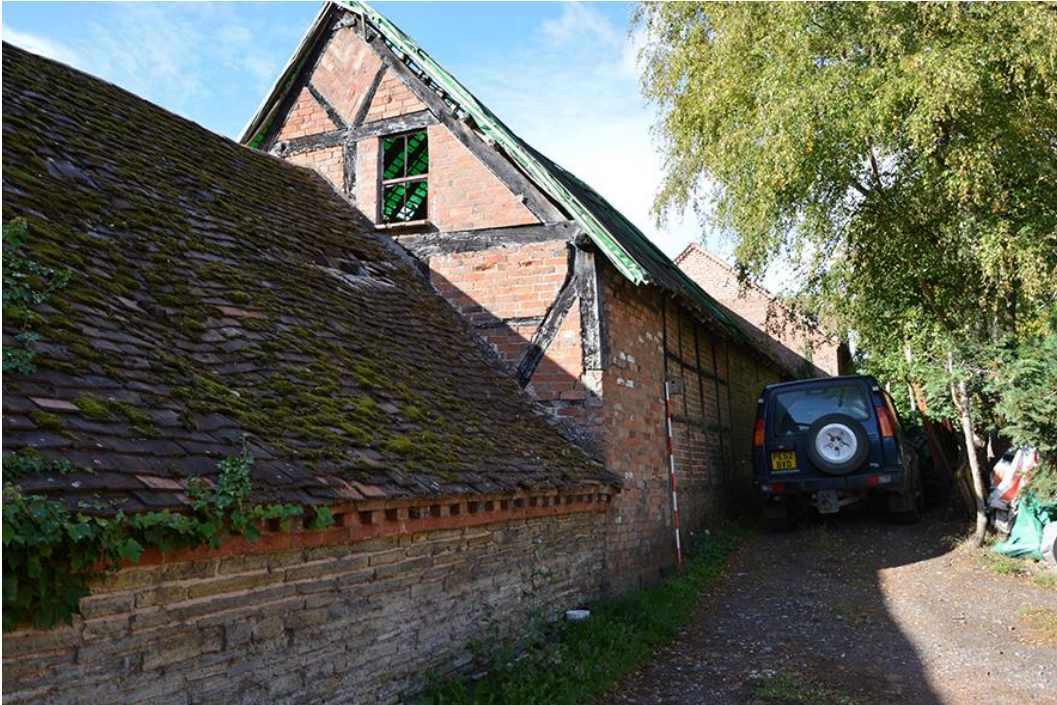
The north elevation was not fully accessible for detailed photographs to be taken (Plate 10), however, it was visibly accessible, so notes were able to be taken. It could be seen from both the interior and exterior to have been rebuilt in brick (Plate 11).

Plate 10 North elevation of timber-frame building, central section behind Land Rover

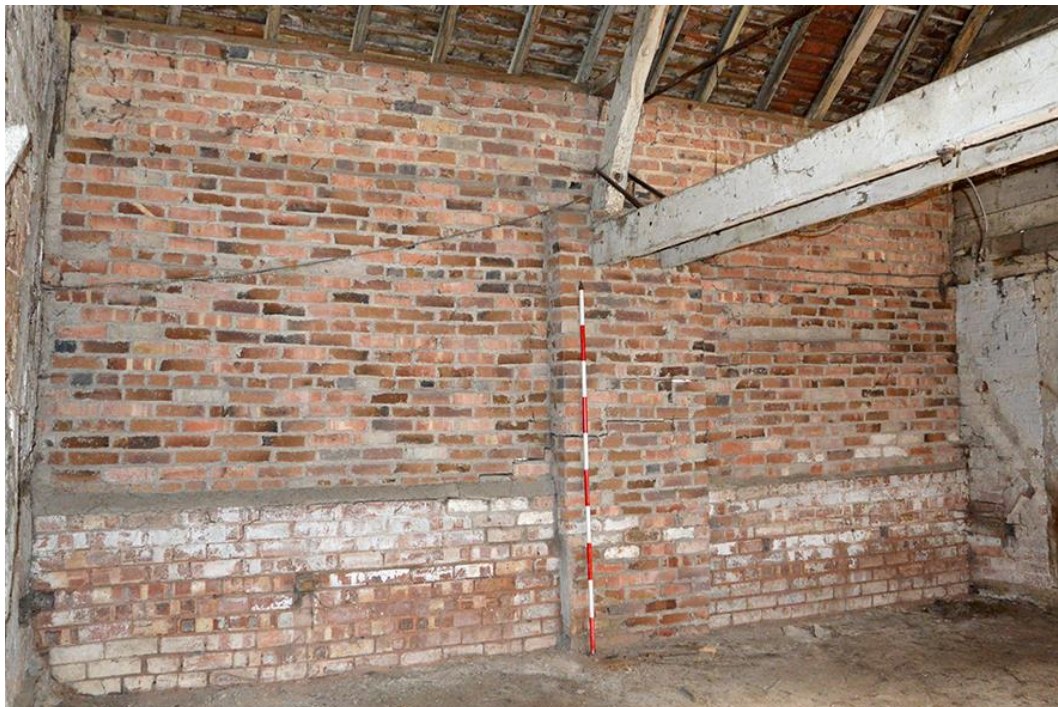
Plate 11 Central section interior, north wall

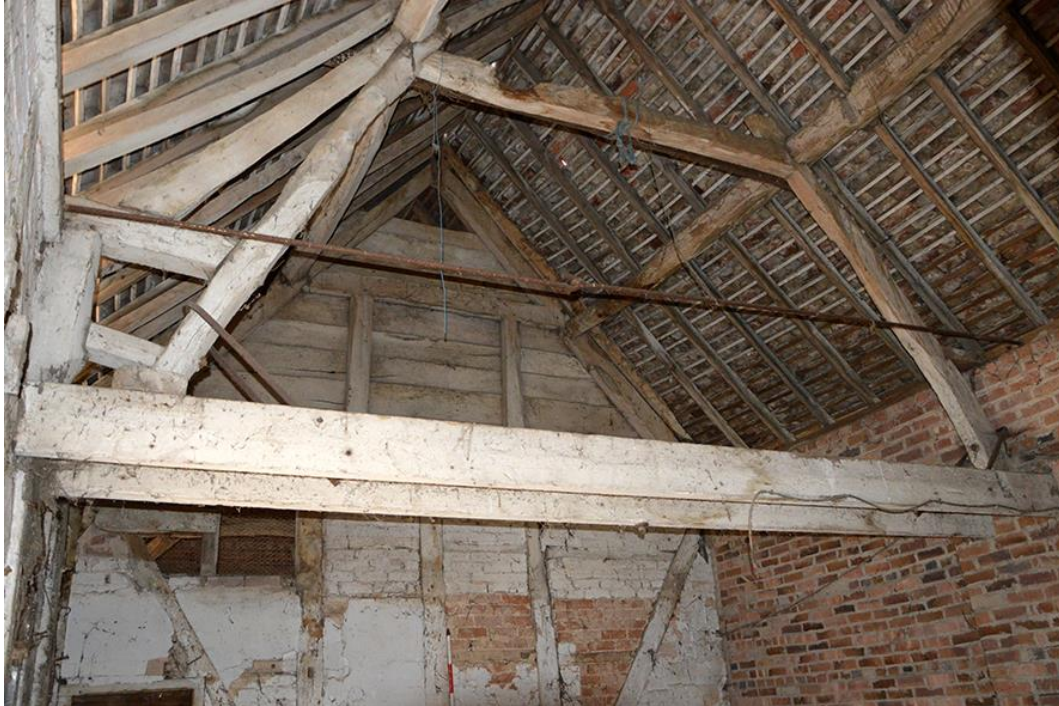
Internally, the central section was also open to the rafters (Plate 12). It had, at one time, had a first floor but this had been removed. The insertion of the floor had caused the cruck truss to be cut off. Once the floor had been removed the truss had to be propped up on a brick pier, on the north side, and supported by floor joists and iron ties.

Plate 12 Central section interior, much altered cruck truss

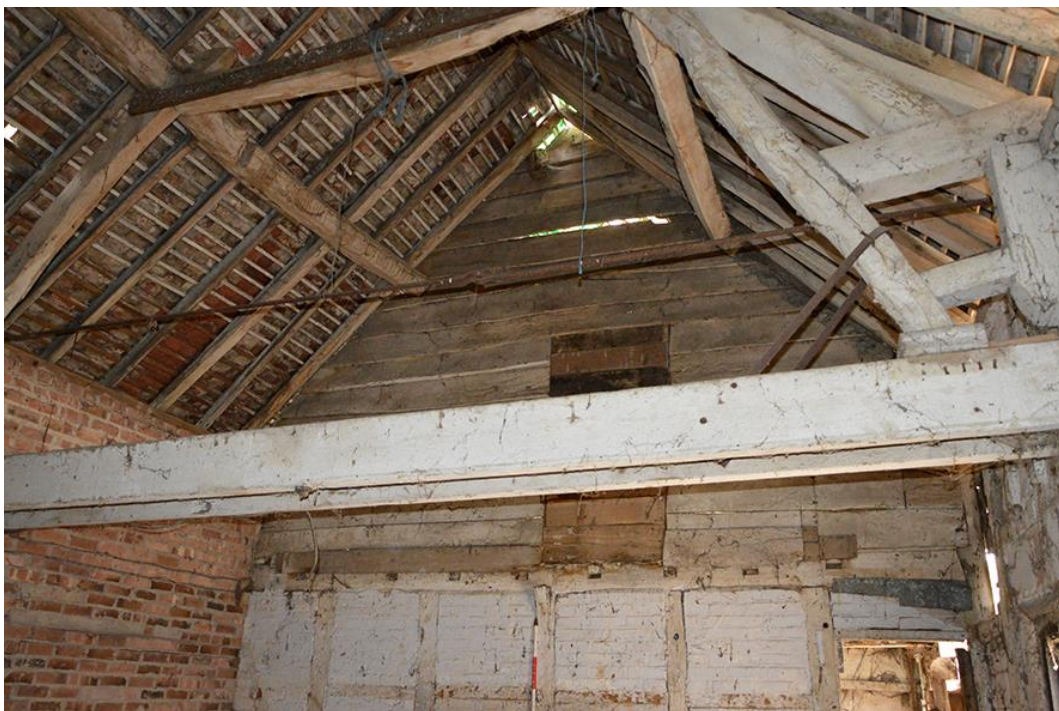
Plate 13 Central section interior, truss and east wall

The eastern elevation of this section of the building was a full height frame, the top part of which had been covered in weatherboard with an opening cut through and later blocked (Plate 13). The ground floor also had an inserted opening leading into the eastern section of the building.

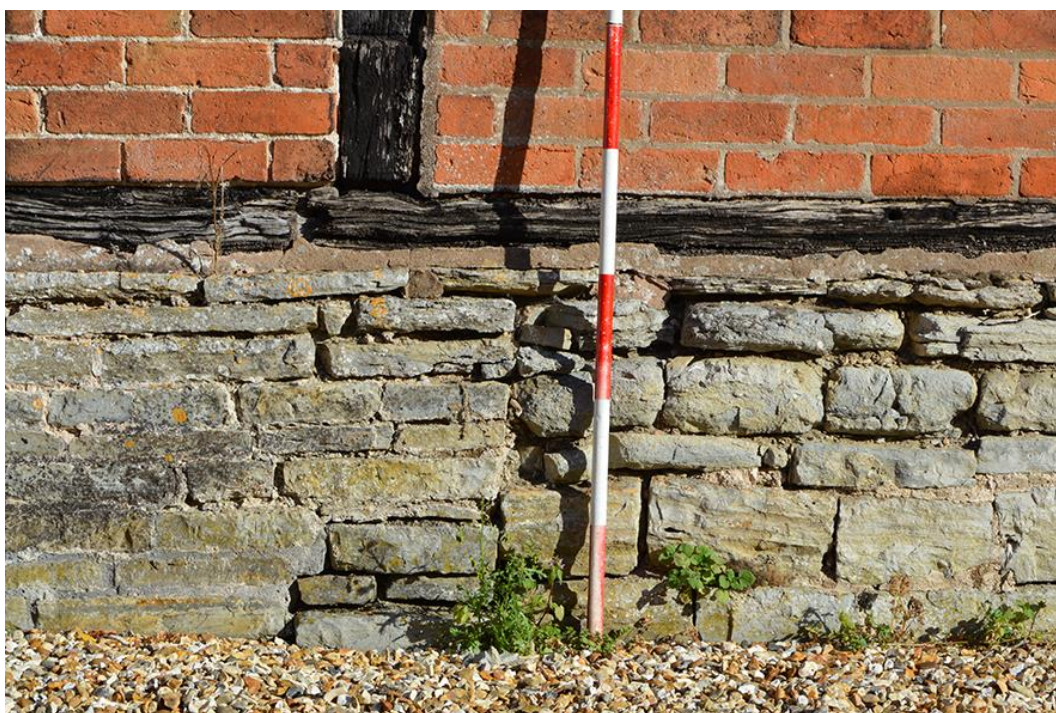
The unusual framing, the brick north elevation and building breaks in the plinth (Plate 14; Fig 4) all show that this section of the building was originally open. It is likely that the whole structure had two enclosed sections to the east and west with an open bay in the centre completely open to the roof. The full height frames to the sides of the centre section confirm this. Because the north elevation has been rebuilt, it is not completely certain that that elevation was open prior to being replaced in brick, but the timber-frame southern elevation definitely was.

Plate 14 Central section, west building break

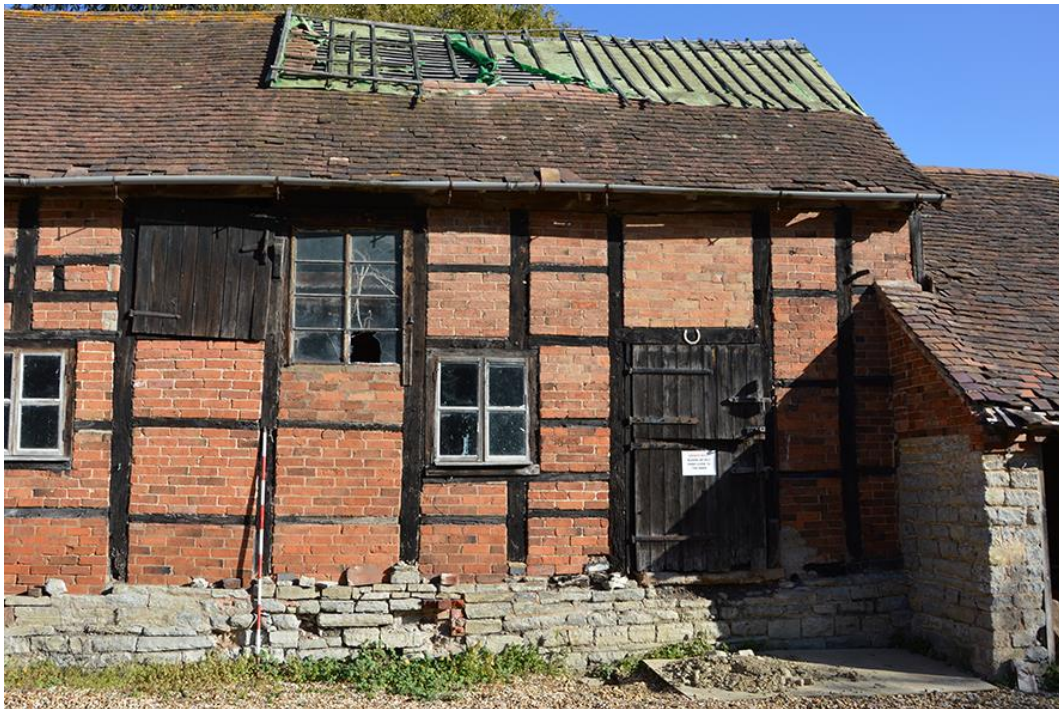
The eastern section of the building consisted of a section of framing that was very similar to that of the western end (Plate 15; Fig 4). There were, mainly, five panels between wall and sill plates with rails between the upright posts. The ground floor had a window and a 'stable' door whilst the first floor had a large metal framed casement window. A panel above the door may have originally contained an opening but has since been filled with brick.

Plate 15 Eastern section from the south

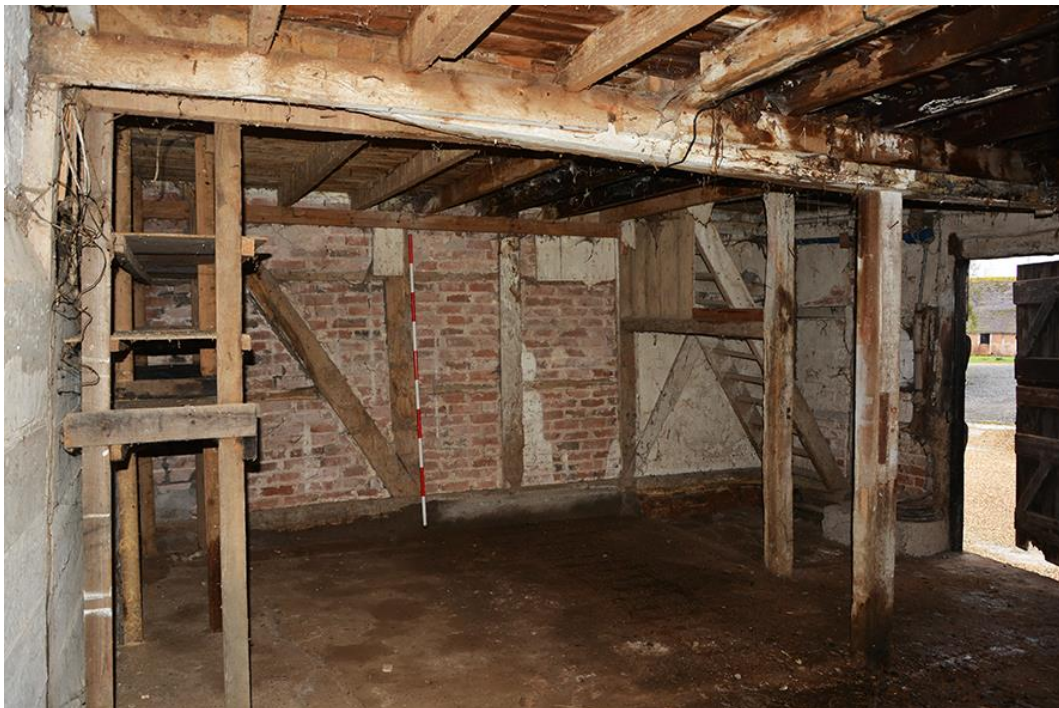
Internally, the eastern section had a single room on both ground (Plate 16) and first floors (Plate 17) with a staircase in the south eastern corner. The western wall and part of the north wall of the ground floor had been partially covered with wood panels, painted plaster or concrete.

Plate 16 Eastern section, ground floor interior, note stairs

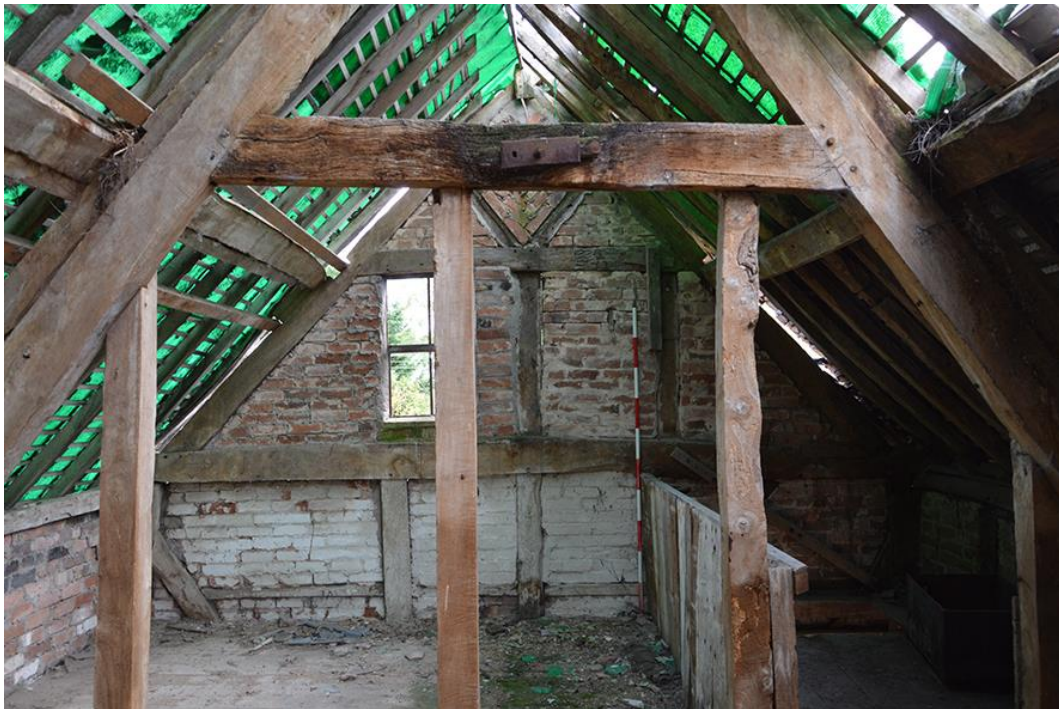
On the open upper floor of the eastern section of the timber-frame building, the cruck truss was visible, although it was marred from the ingress of water through the damaged roof.

Plate 17 Eastern section, first floor interior

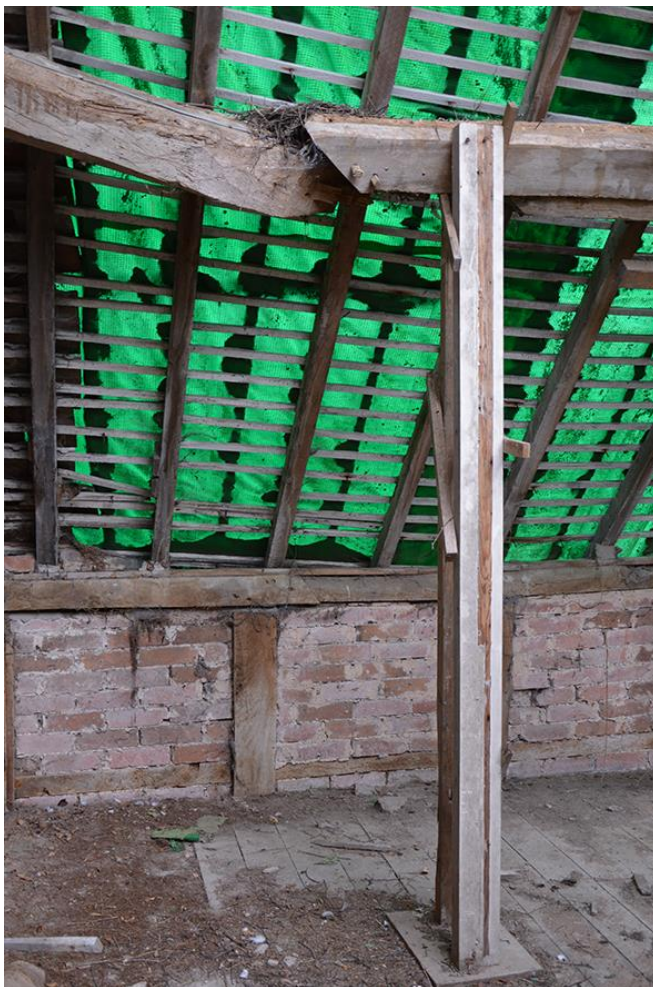
The roof on this section of the timber-frame building had been compromised for a number of years, as a result a number of posts were being used to prop the floor structure and the roof structure. This was most evident on the first floor where one of the purlin joints had broken and was propped up with a timber beam (Plate 18). The floor was also rotten in this section of the building.

Plate 18 Eastern section, first floor interior showing broken purlin joint

It seems that both the cart shed roof and the roof of the eastern end of the timber-frame building became unstable during the 20th century. The cart shed frontage is now propped with a metal acrow prop and a number of timber props have been used in the timer-frame building to support a snapped purlin joint.

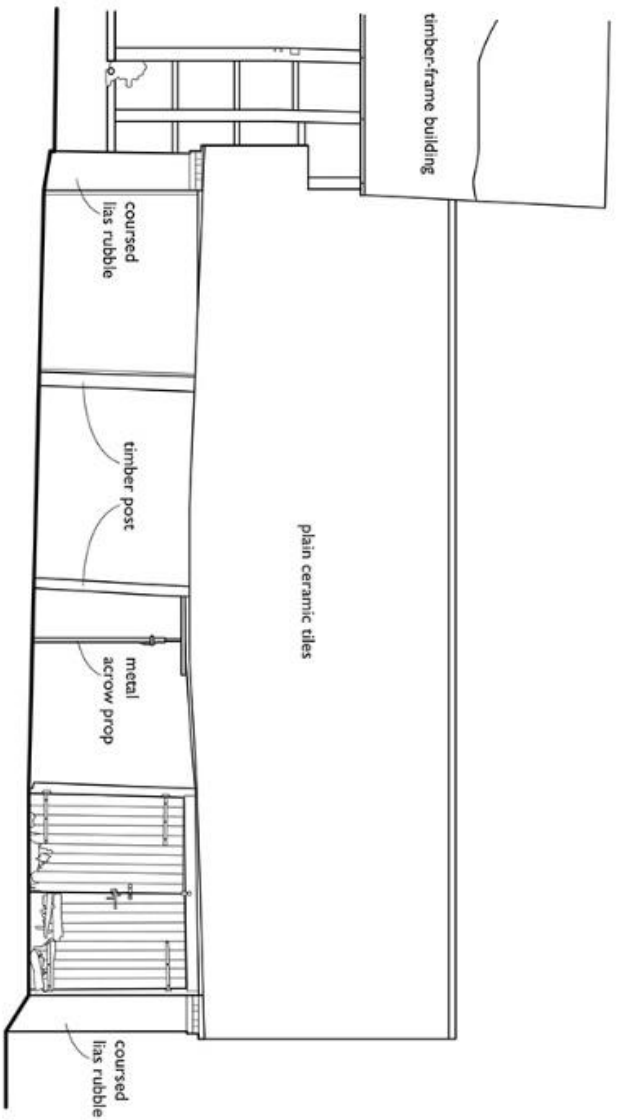
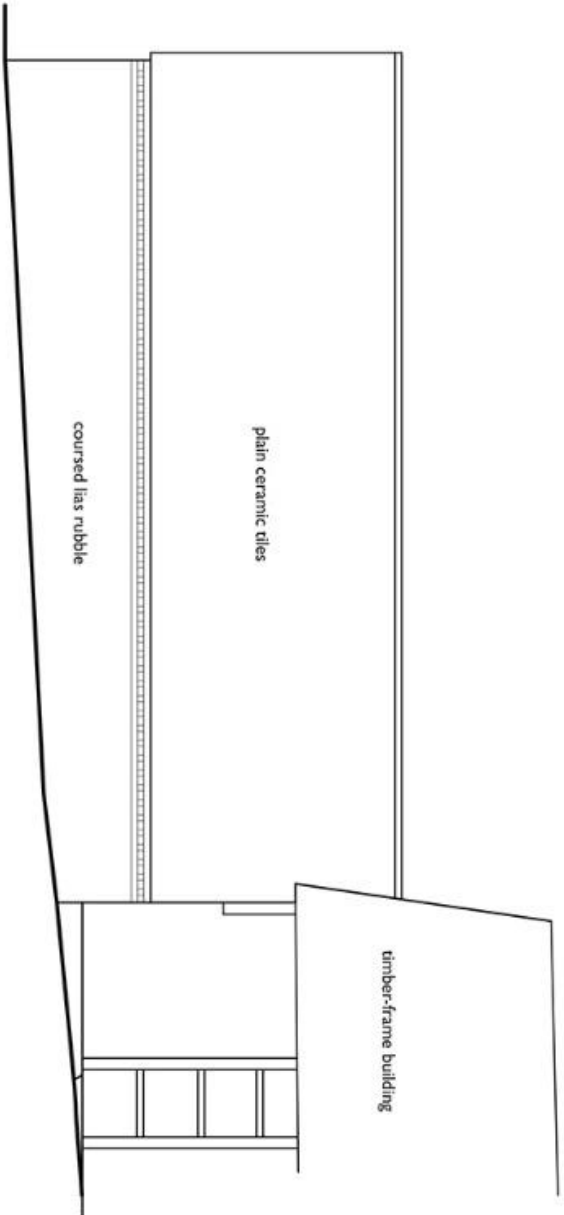
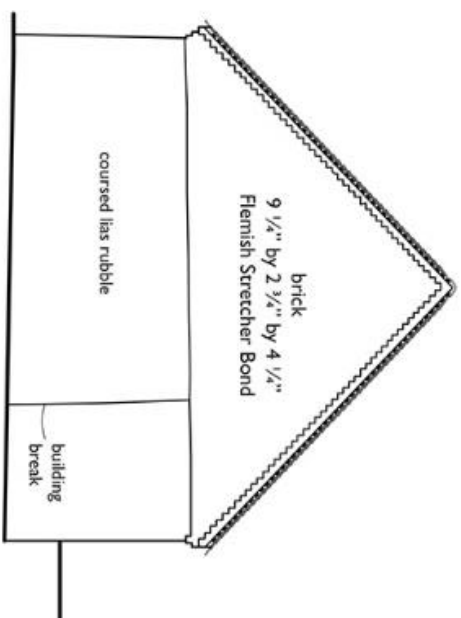
Figure 5
Cart shed south and north elevations and east gable

The cart shed (Plate 19; Fig 5) was not unusual in its construction or layout. It is probable the lias north and east walls were boundary walls of the farmstead that were utilised to create the building. This is borne out by the use of brick in the top of the eastern gable and for the eaves.

South elevation

North elevation

East gable

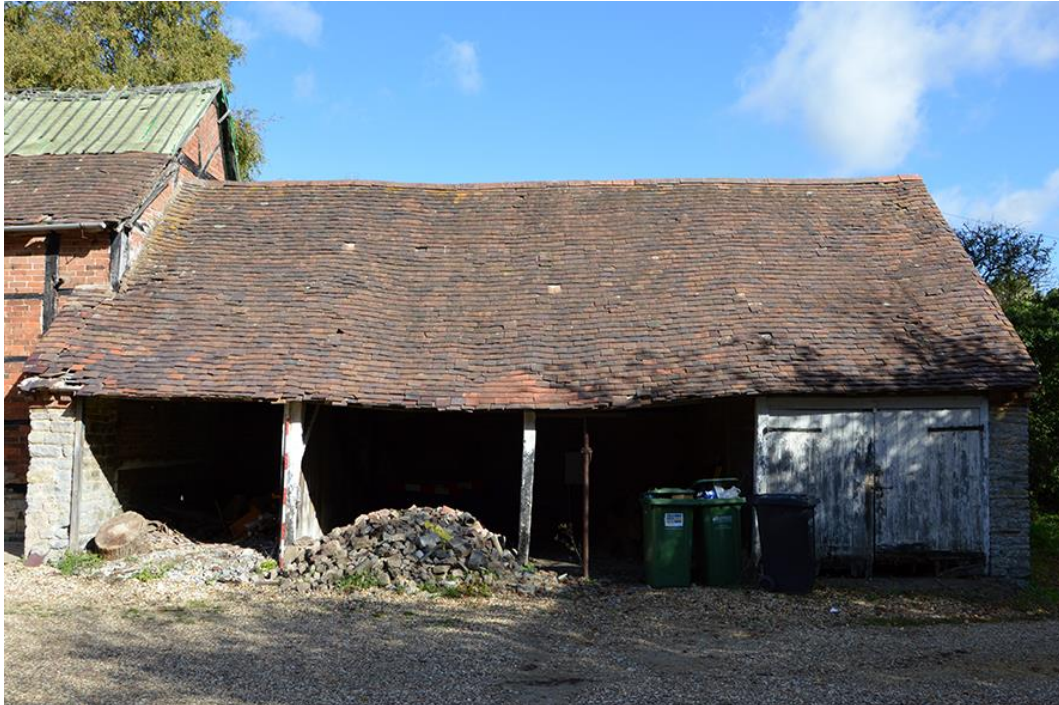
Plate 19 Cart shed, from the south

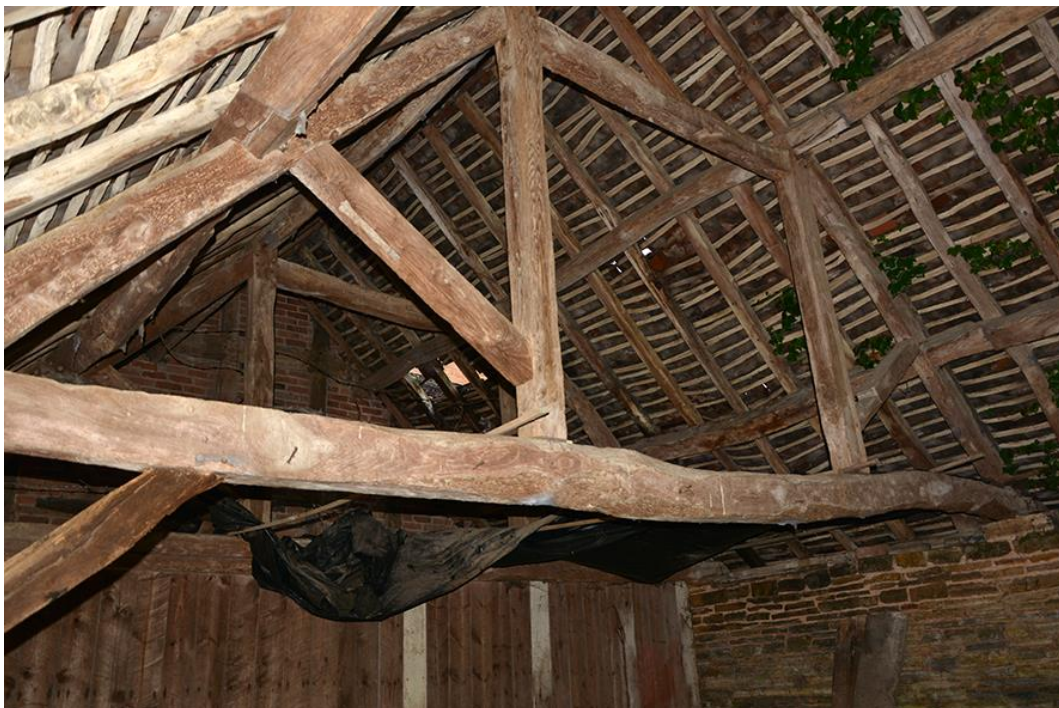
Internally the cart shed had been divided into three distinct spaces by the addition of timber partitions attached to the trusses. The trusses themselves were of crude collar and post construction (Plate 20).

Plate 20 Cart shed, one of the trusses

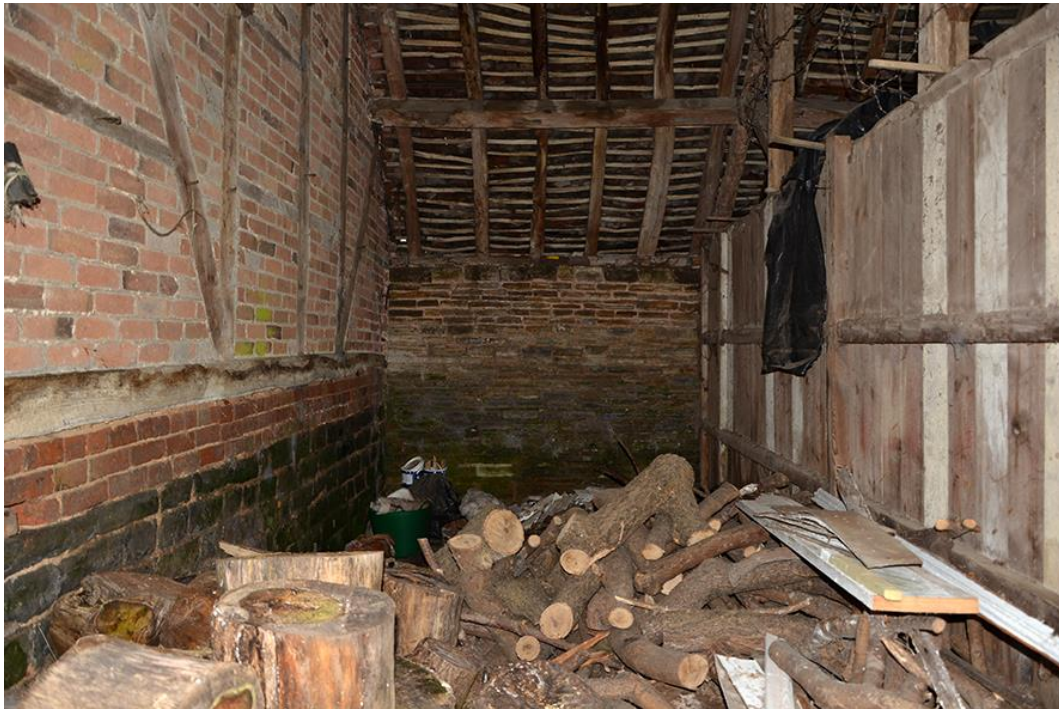
The spaces within the cart shed had distinct functions, with the western space being used for wood storage (Plate 21) and the eastern space as a garage and store (Plate 22). This area also had a roof over it with limited access (Plate 23). The central area was used for cutting wood and storing rubbish bins and rubble (Plate 24).

Plate 21 Cart shed, west end

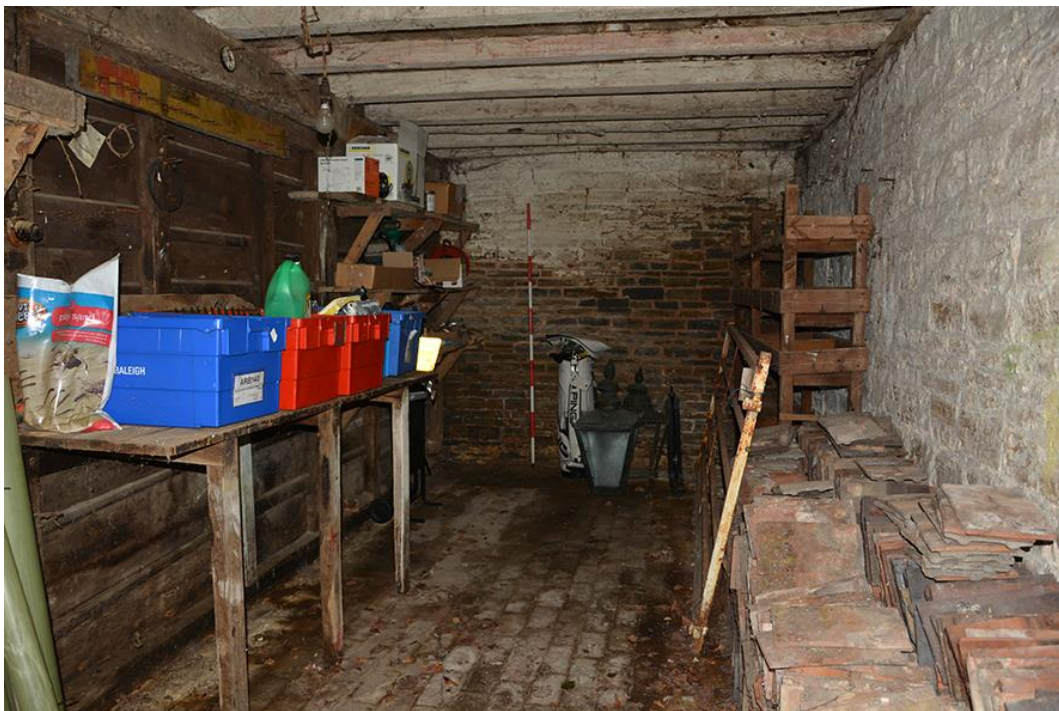
Plate 22 Cart shed, east end garage space

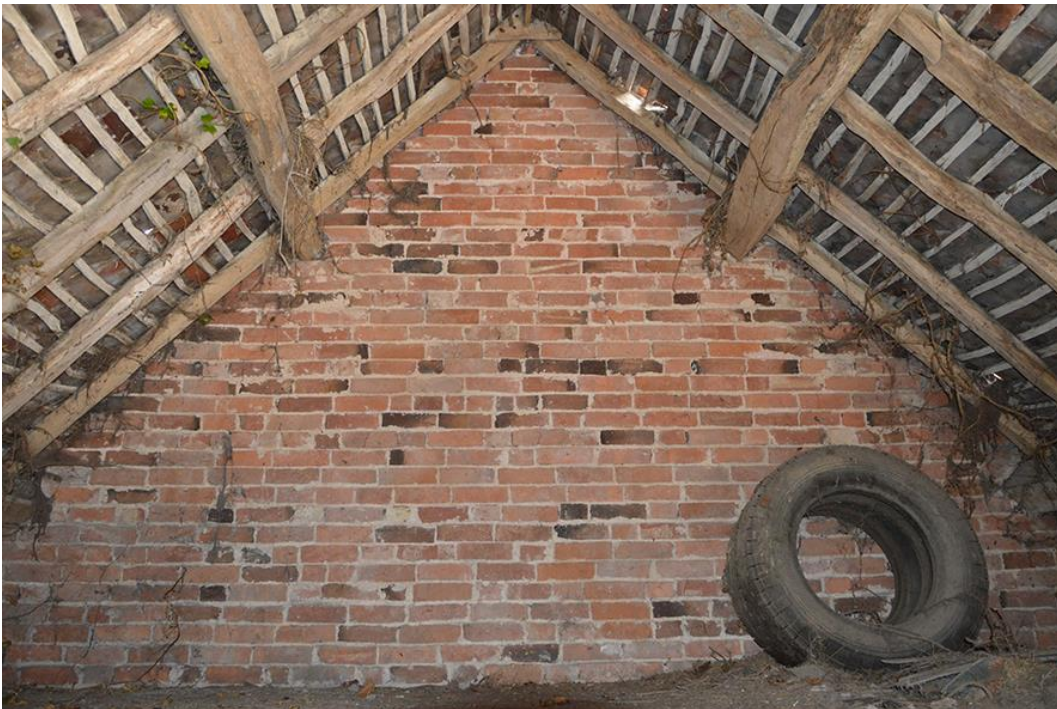
Plate 23 Cart shed, garage roofspace

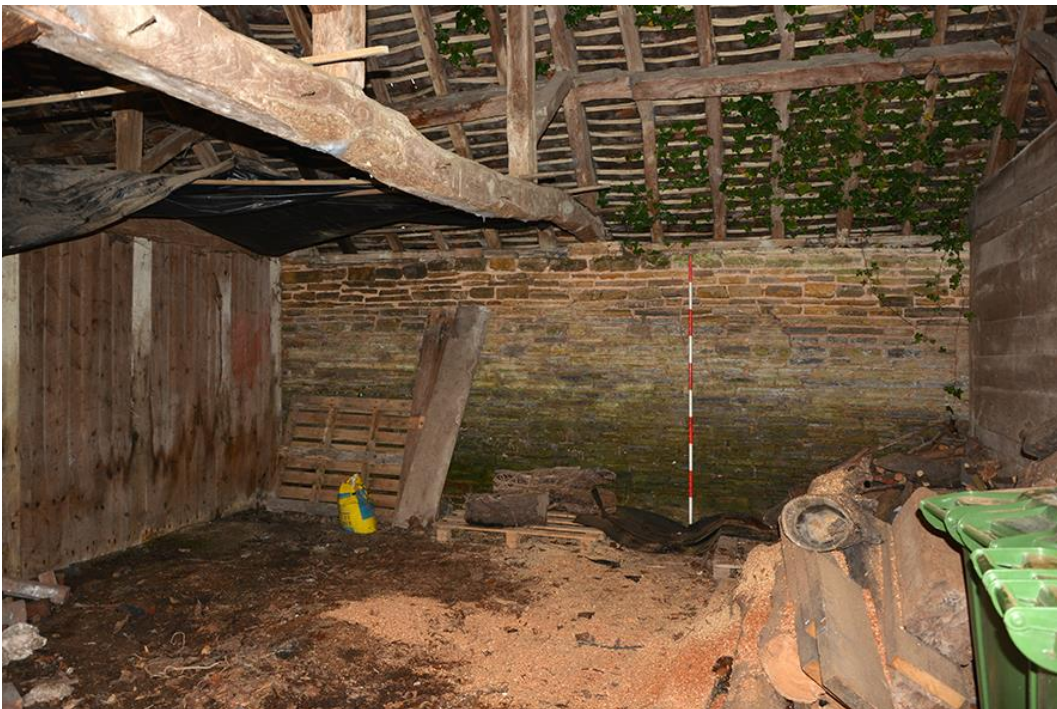
Plate 24 Cart shed, central area
