Barn at The Mordaunts, Crowle

Building Recording

October 2018

EHI809-1

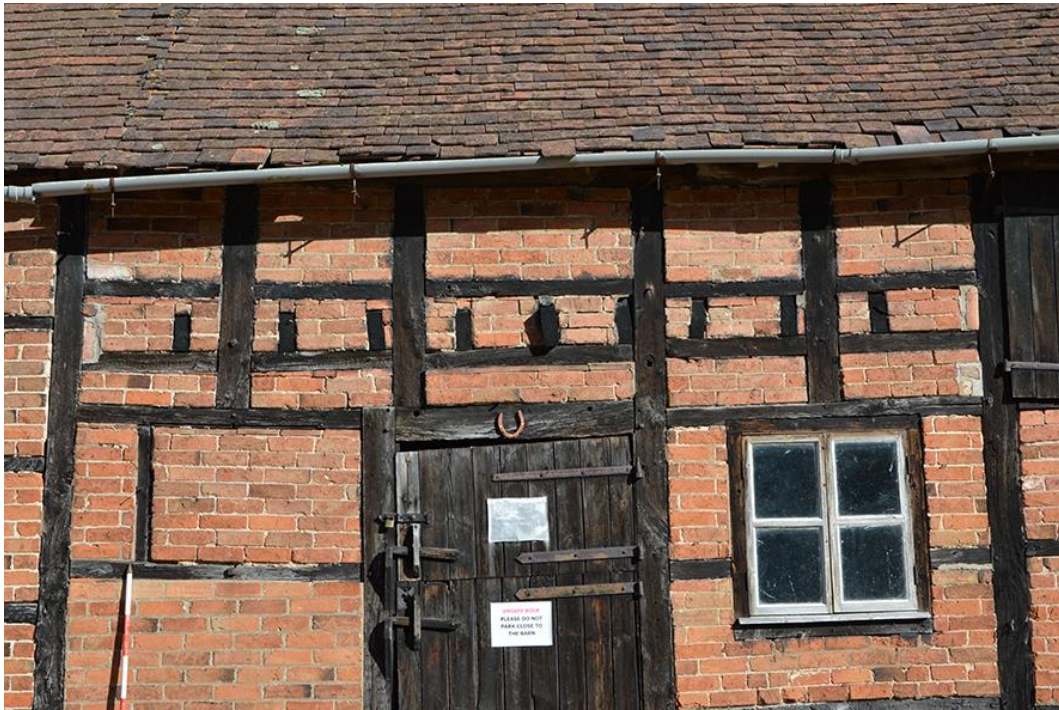
Plate 25 Timber joists of inserted floor in timber-frame building

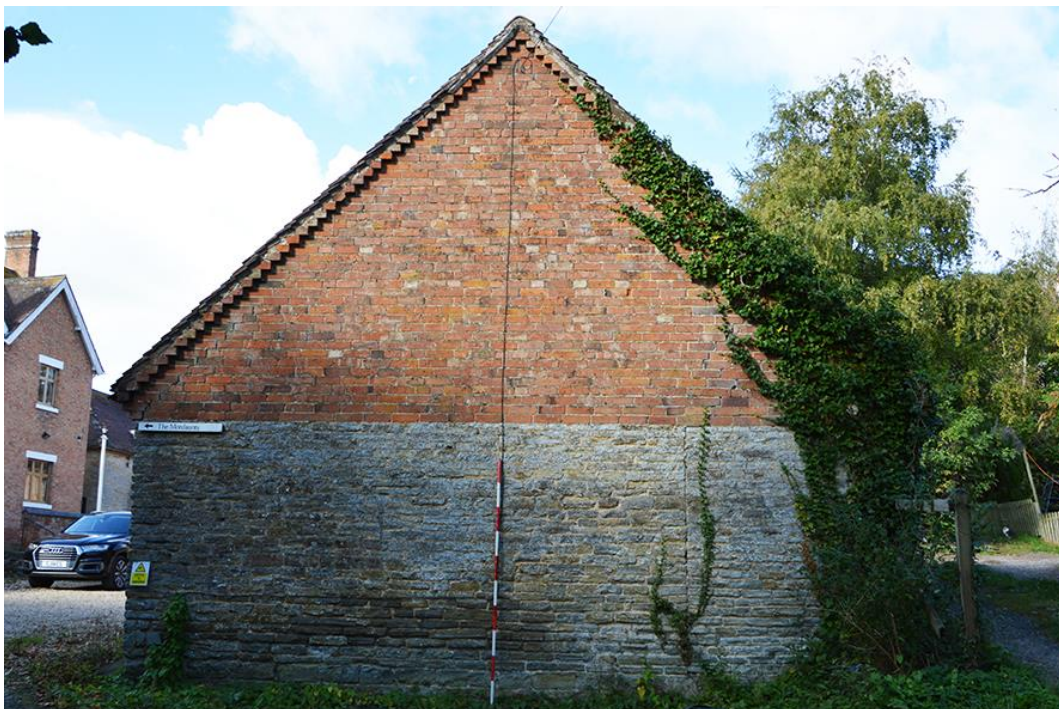
The cart shed was also built in the mid 18th century. It utilised the later 17th century lias boundary wall, adjoining the eastern end of the timber-frame building. The eastern part of the wall was added to and a brick upper portion raised the wall to roof height. A straight joint on the eastern gable shows where the boundary wall was extended to create the cart shed (Plate 26). The brick used in this gable was the same as that used in the infill panels of the timber-frame building but coursed in Flemish Stretcher Bond. The cart shed originally had a completely open internal space which was used for the storage of farm carts and implements.

Plate 26 Cart shed gable with building break to right of ranging rod

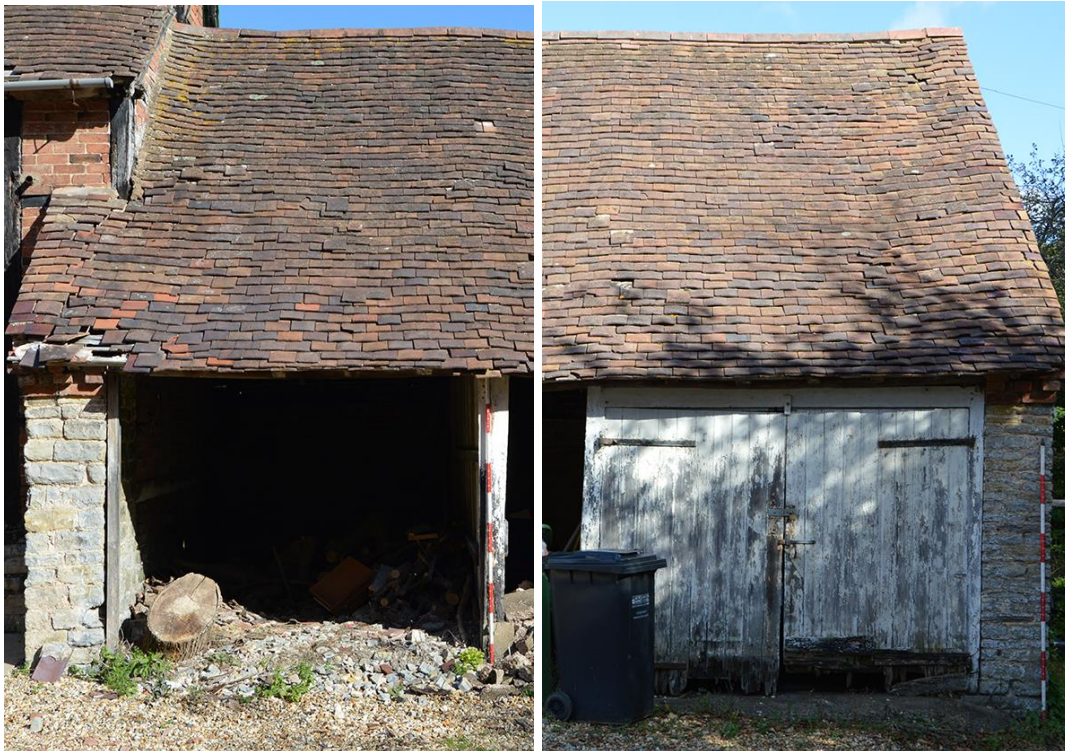
In the later part of the 19th century, small changes were made to the buildings particularly the cart shed and the eastern end of the timber-frame building. The cart shed had two timber partitions added into the structure to create three individual spaces, the two ends enclosed by double doors (Plate 27). Only the eastern end has its double doors surviving. The partitions were formed of reclaimed wooden panels (Plate 28), possibly from cattle or horse stalls, and were attached to the trusses. It is possible that these spaces were still used for the storage of farm implements and carts with the enclosed spaces used for the house carts rather than for farm carts.

Plate 27 Cart shed, west (no doors) and east (with doors)

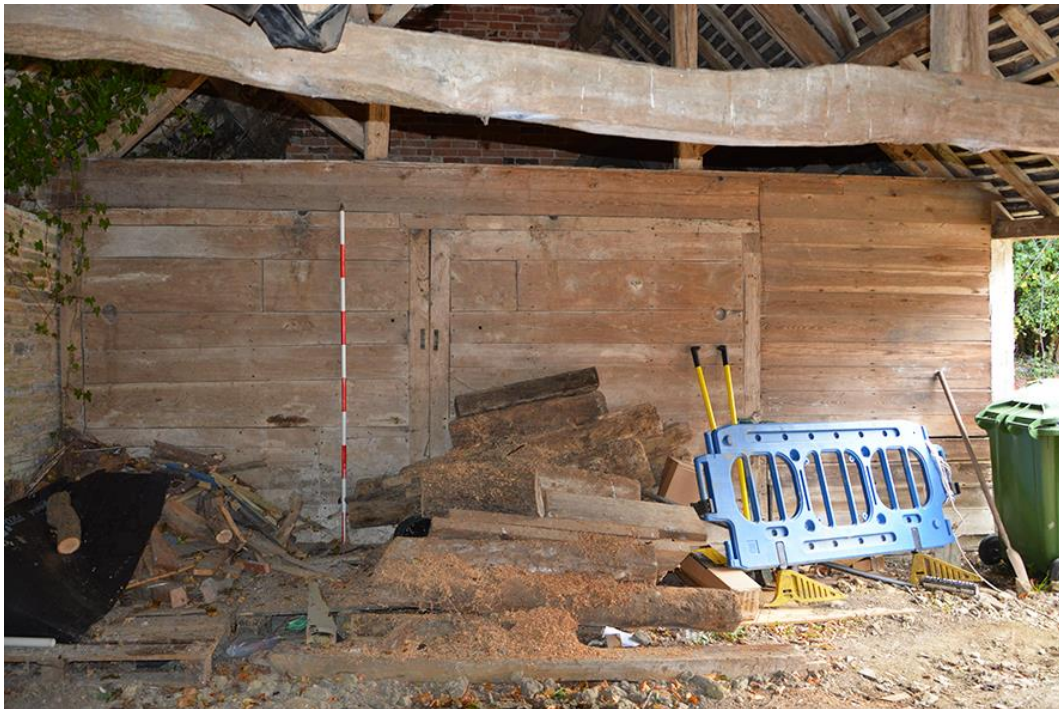
Plate 28 Cart shed interior division of reused timber panels

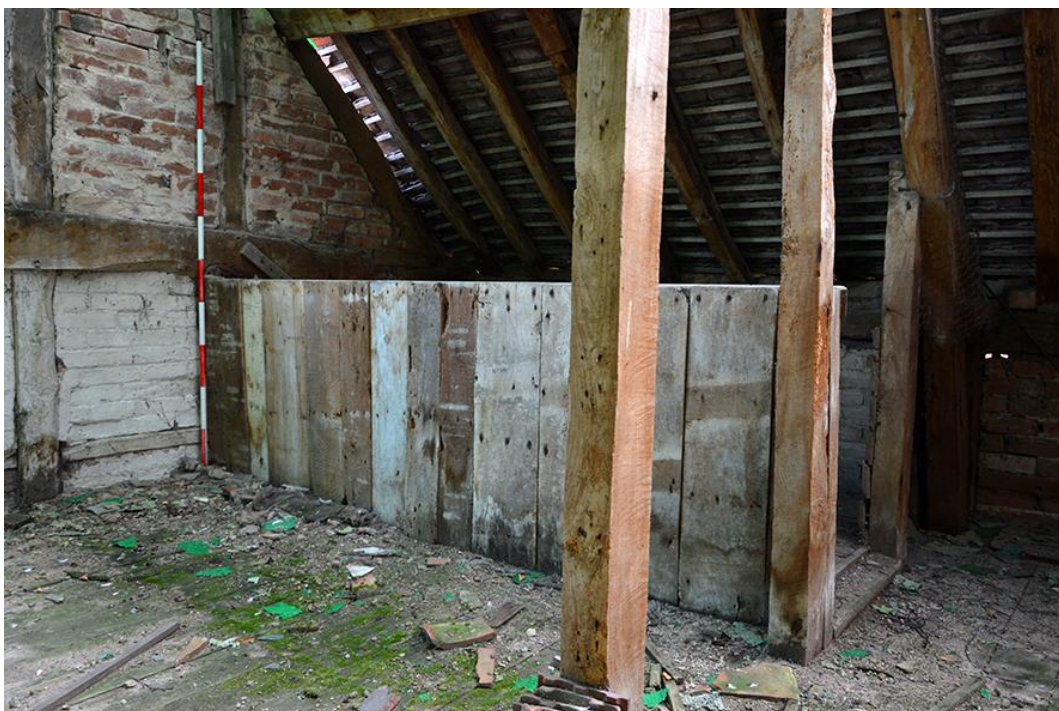
The upper floor of the eastern section of the building had obviously been used as a granary or apple store at some point with a timber division and a hatch in the floor still in existence.

Plate 29 Timber-frame building first floor granary or apple store partition
