Sandal Lodge, Hanbury Wharf

Building Recording

EH1812-1

WSM71324

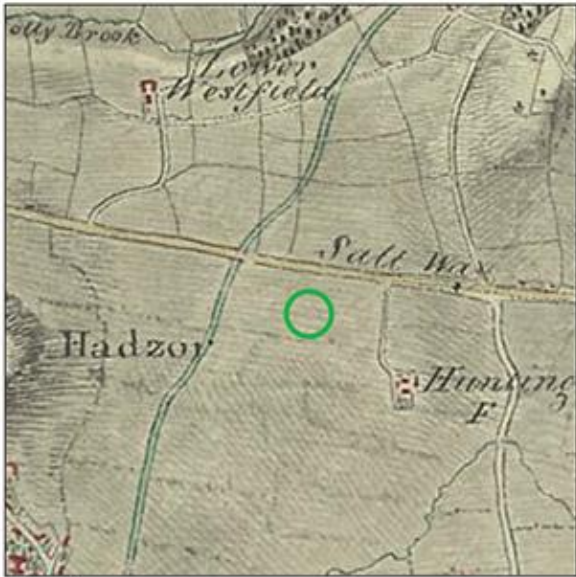
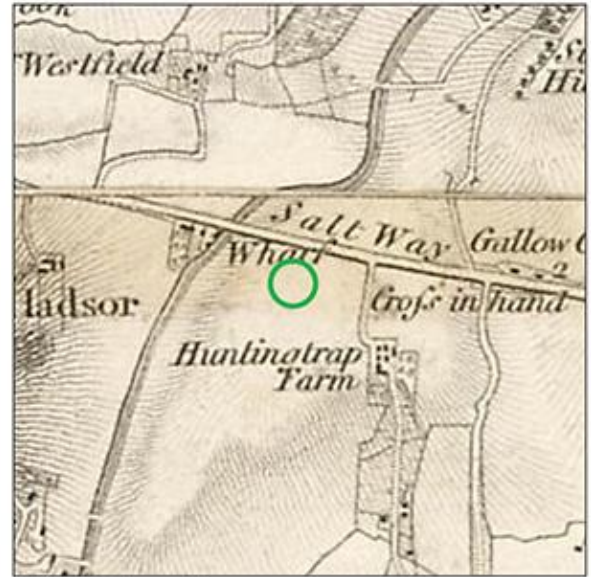
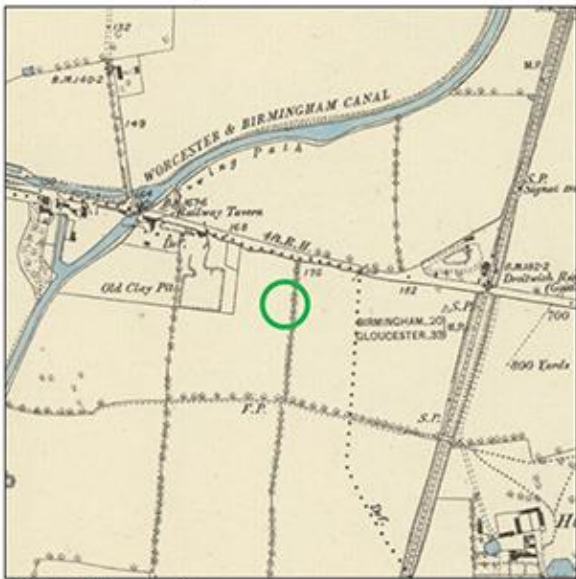
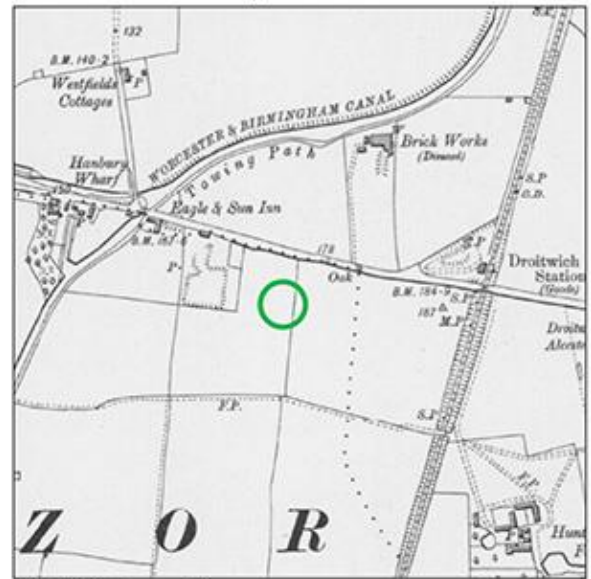
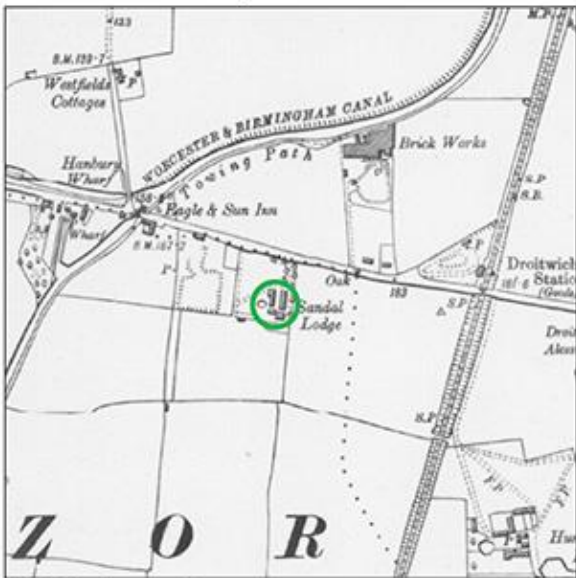
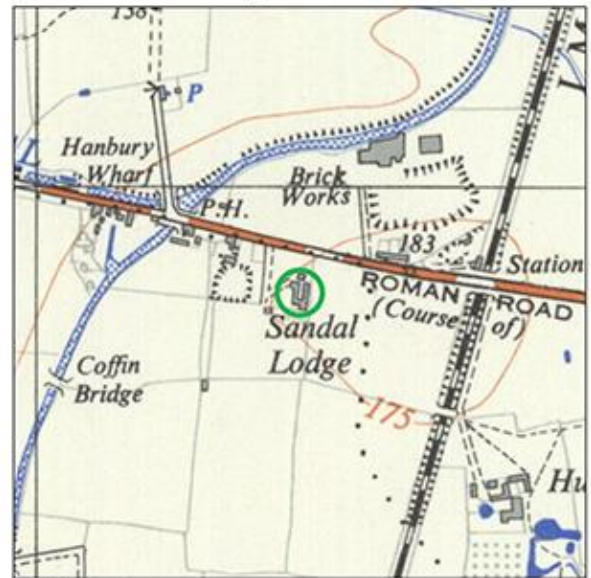
Figure 3 Historic mapping
Location of Sandal Lodge circled

Historic mapping of the area around the site can be traced back to the 17th century, however these maps show little detail. The first map that shows any detail of the area of Sandal Lodge is the 1813 Dawson map (Fig 3). This map was part of the original survey that became the 1830s Ordnance Survey. The Dawson map shows the rough alignment of the Worcester and Birmingham Canal, which was not complete at this time, with the Salt Way crossing it. Huntingdrop Farm, shown as Huntingtrap Farm, can be seen in the lower central part of the map with Lower Westfield in the upper part. The location of Sandal Lodge is marked to the north west of Huntingdrop Farm. At this time, 1813, the area was open fields.

The 1831 Ordnance Survey (Fig 3) shows a similar situation to that of the 1813 map. The canal and wharf are visible running up the centre of the map with a few buildings clustered at the wharf. The Salt Way crosses the map with Westfield to the north and Huntingtrap Farm to the south. The location of Sandal Lodge is marked but the still the area is open fields.

The next map is the 1883 Ordnance Survey (Fig 3). This has more detail than the previous maps, including individual fields and footpaths, but still shows the relevant features of the canal, Hanbury Wharf, Salt Way and Huntingtrap Farm. The 1840 Droitwich Junction Canal can also be seen running from Hanbury Wharf Bridge to the west. An old clay pit can be seen to the east of the Railway Tavern (now Eagle and Sun) and the Birmingham and Gloucester Railway line, opened in 1840, is shown in the east with a station and yard close to the Salt Way. The site of Sandal Lodge can be seen within fields in the centre of the map extract. To the west is the old clay pit and to the south is a footpath. The field boundary is marked with deciduous trees.

The 1902 Ordnance Survey (Fig 3) is virtually identical. The only changes are to the name of the pub, from the Railway Tavern on the 1883 map to Eagle and Sun Inn on this map, and the construction of a Brick Works to the north of the Salt Way, against the canal. This is marked as 'disused' but only has a small clay pit attached. The site of Sandal Lodge is still shown as fields, with no change in the boundaries.

By the time of the 1951 Ordnance Survey (Fig 3), the Dutch barn has been added to the north of the rest of the Sandal Lodge buildings. The only real difference visible on this map is the size of the clay pit associated with the Brick Works, which has more than doubled in size. The more detailed 1960s mapping (Fig 4) shows little change from the earlier 1927 map except for the Dutch barn. By the time of the latest mapping (Fig 4), the Dutch barn has increased in size and the western outbuildings have been reduced in length.

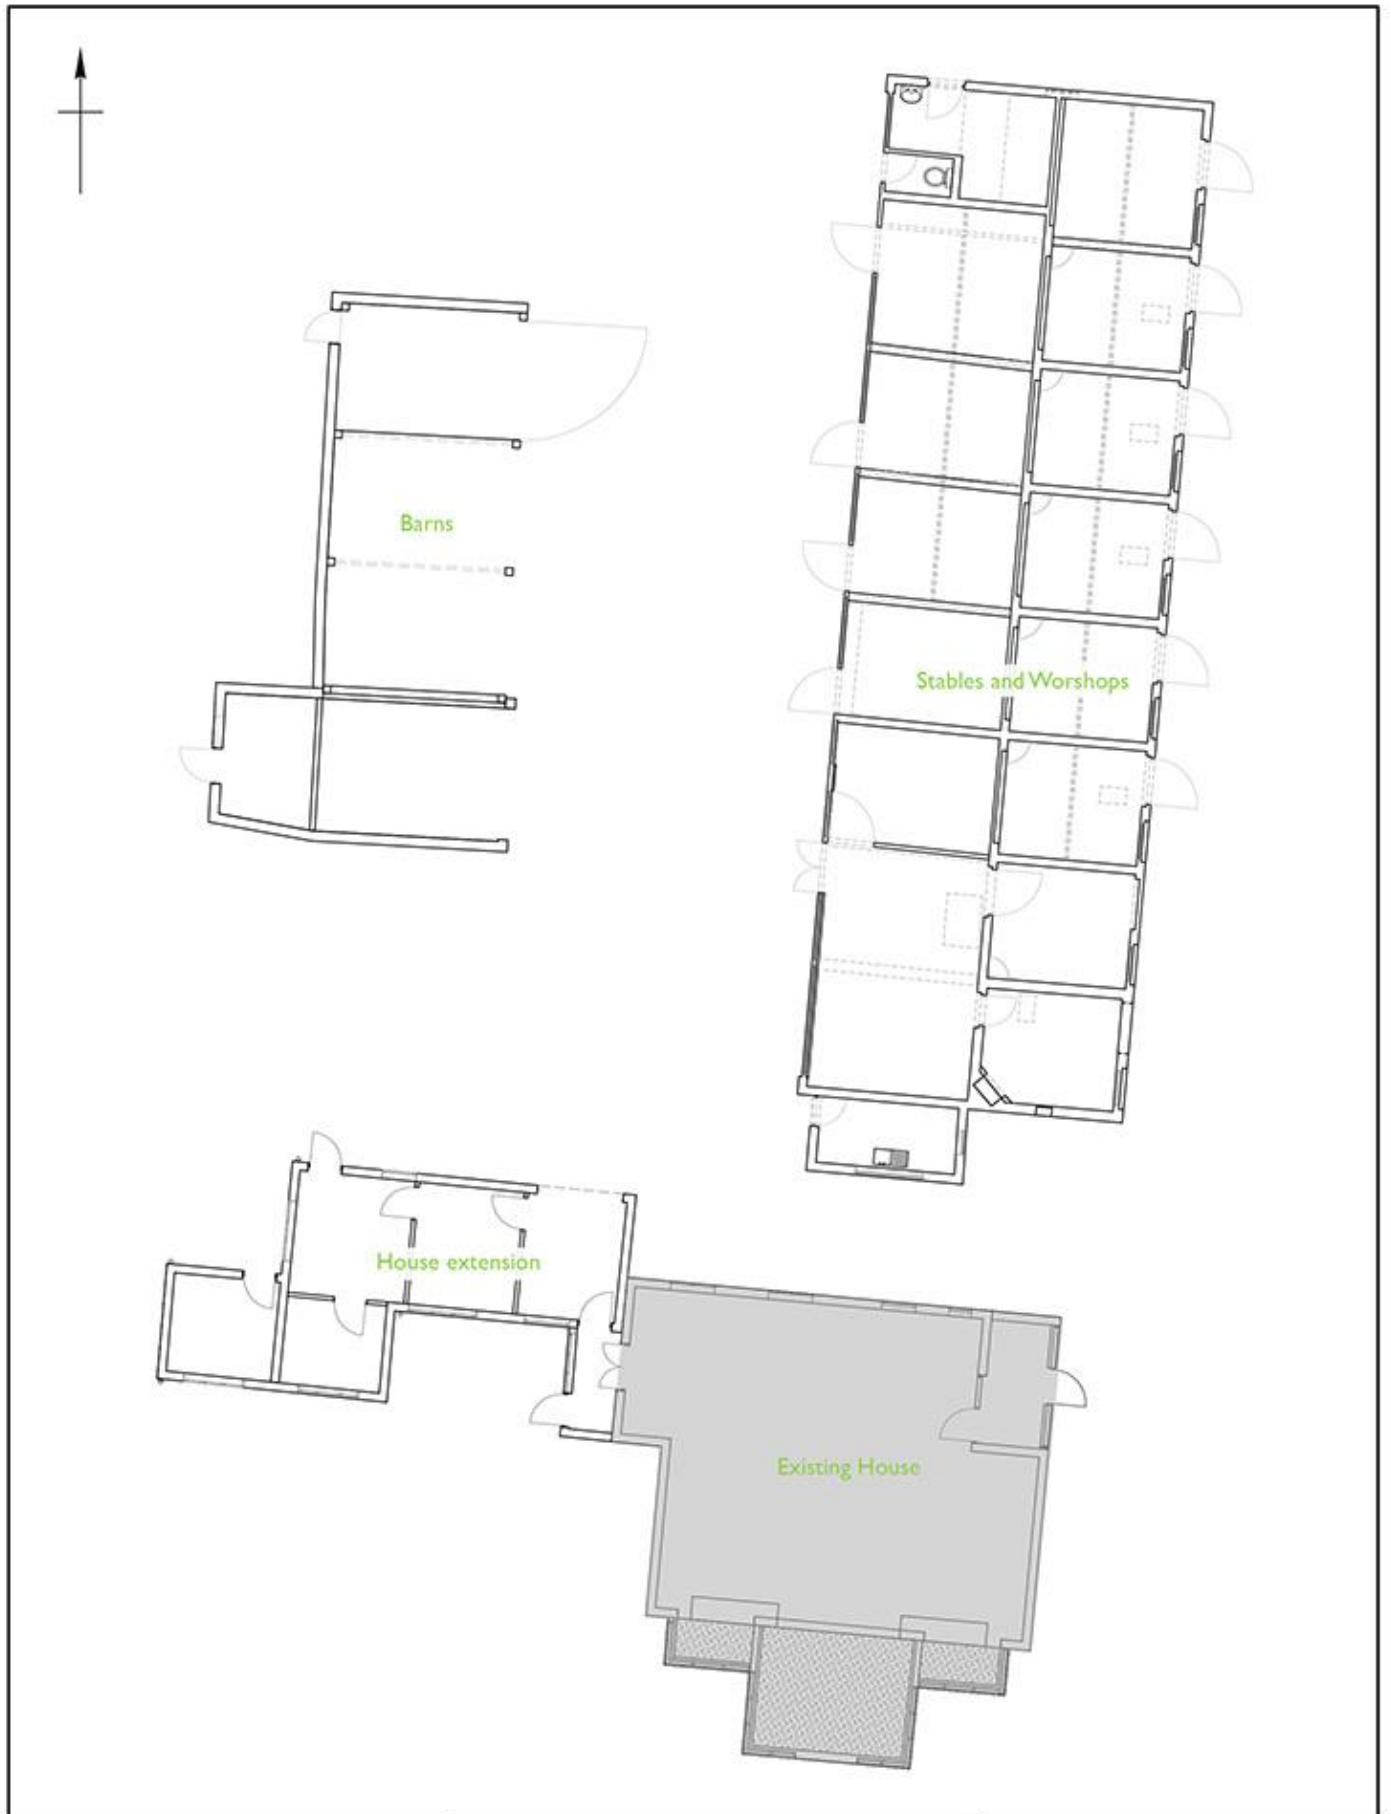
Figure 6 Ground plans of Sandal Lodge buildings

Based on dwg no. AL-0-02 by Herlig Marles

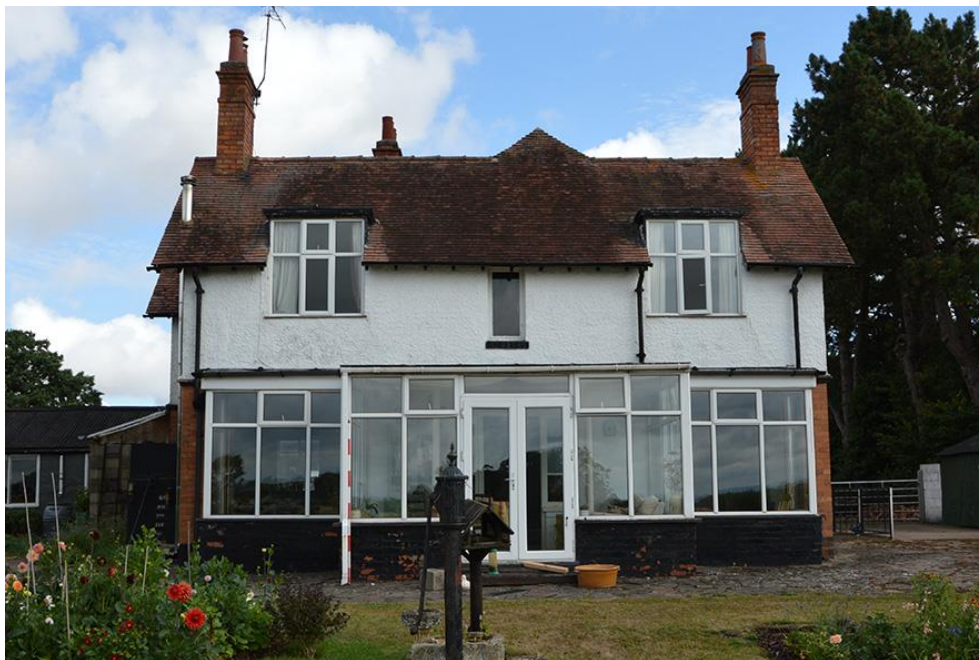
Plate 1 Sandal Lodge house from the south

The house (Plate 1) was built in a style typical of the early part of the 20th century. The main fabric is brick coursed in Flemish Stretcher Bond. The ground floor brick is visible whilst the first floor has been pebble-dashed and painted white.

The house faces south onto a garden and fields. This elevation originally had square bay windows with a central door on the ground floor, but this has now been covered by a glazed extension.

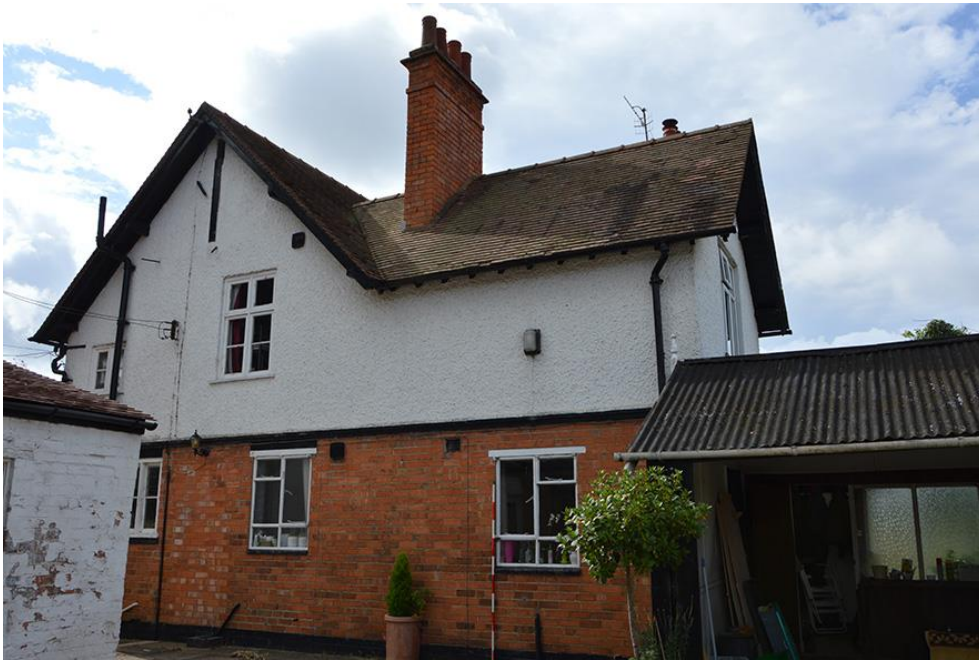
Plate 2 North elevation of Sandal Lodge house

The windows have all been replaced at varying times with only three original windows surviving, all on the first floor. The first is the central first floor window on the south elevation (see Plate 1 above). The second and third are the first-floor windows on the north elevation (Plate 2). The north elevation (Plate 2) also shows evidence of a blocked doorway.

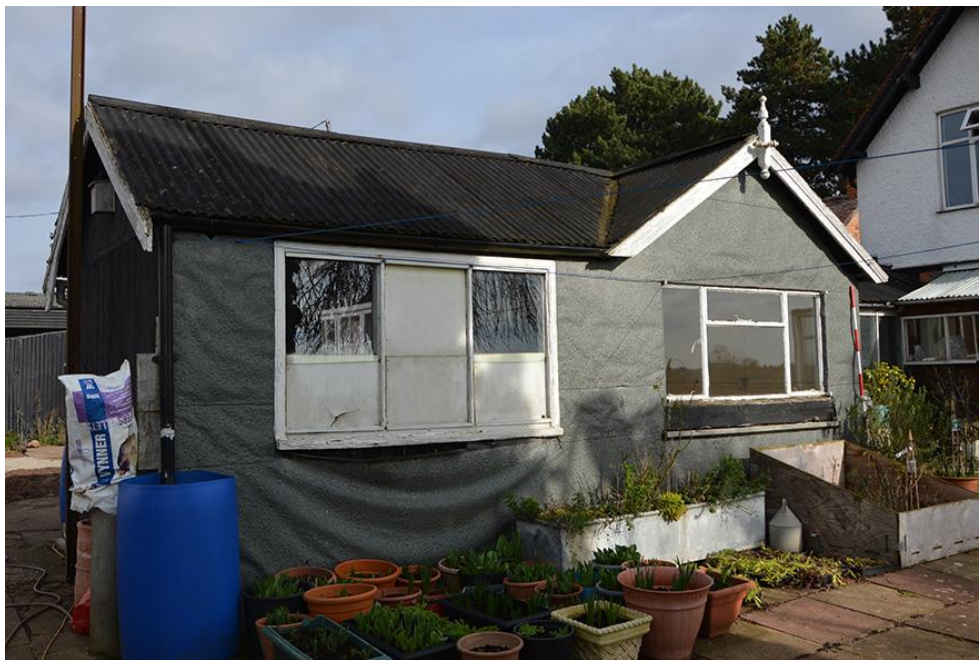
Plate 3 South elevation of house extension

The south elevation (Plate 3) has been covered with roofing felt, presumably to make it more weatherproof. This elevation also has a gable topped with a decorative pediment. The windows of the southern elevation are replacements. The western elevation has a large original window in one of its gables (Plate 4). The other gable looks as though it may have a blocked window on it. The northern elevation also contains an original window and a large opening creating a porch-type entry into the main house (Plate 5).

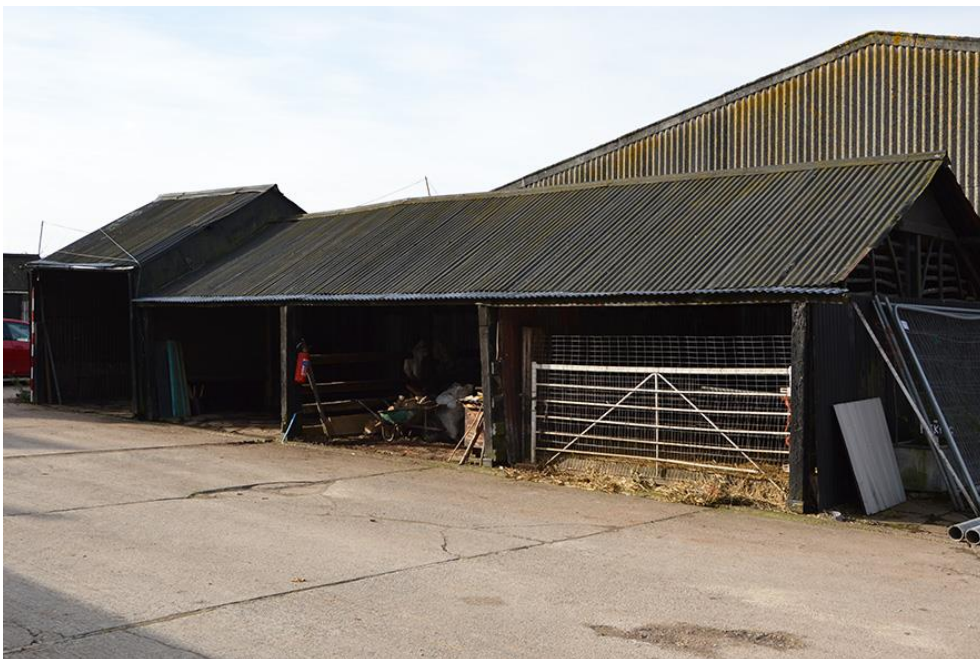
Plate 6 Barns from the north east

A range of barns lies at the western edge of the Sandal Lodge site. This range consists of a corrugated metal walled structure with a corrugated metal roof. It is divided into two sections (Plate 6) with a long narrow section to the north and a smaller, wider section in the south.

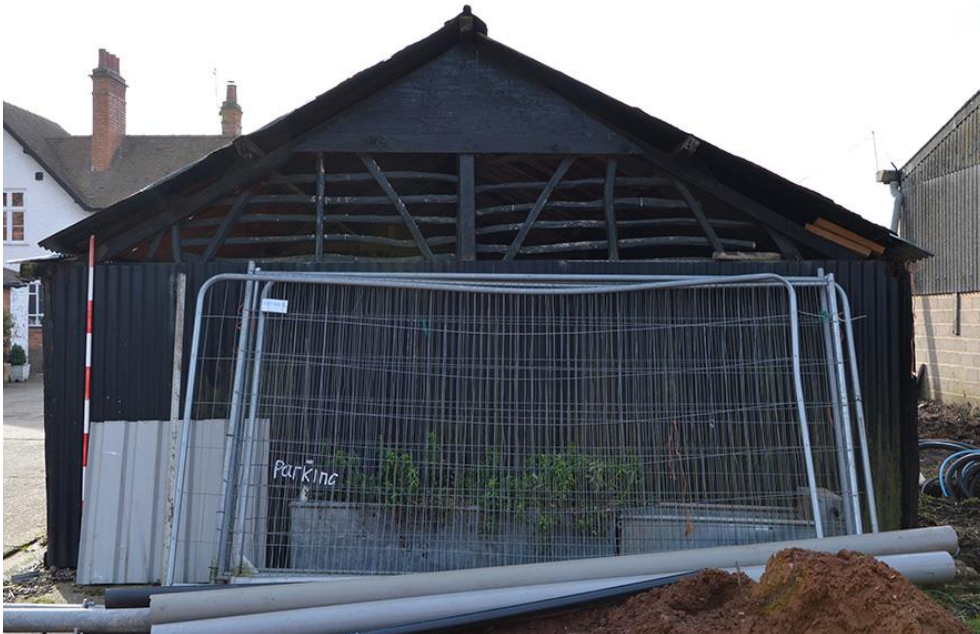
Plate 7 North gable of barns showing stave framing

The northern part has previously been used partly for housing goats and partly for the storage of wood and other items. The north elevation of the range shows that the corrugated metal is attached to a wooden frame which, in part, is formed from staves creating a form of timber-frame (Plate 7). Historic mapping (Fig 4) shows that the barn formerly ran further northwards. The stave timber-

framing would have been an internal division between the existing part of the building and its now demolished part.

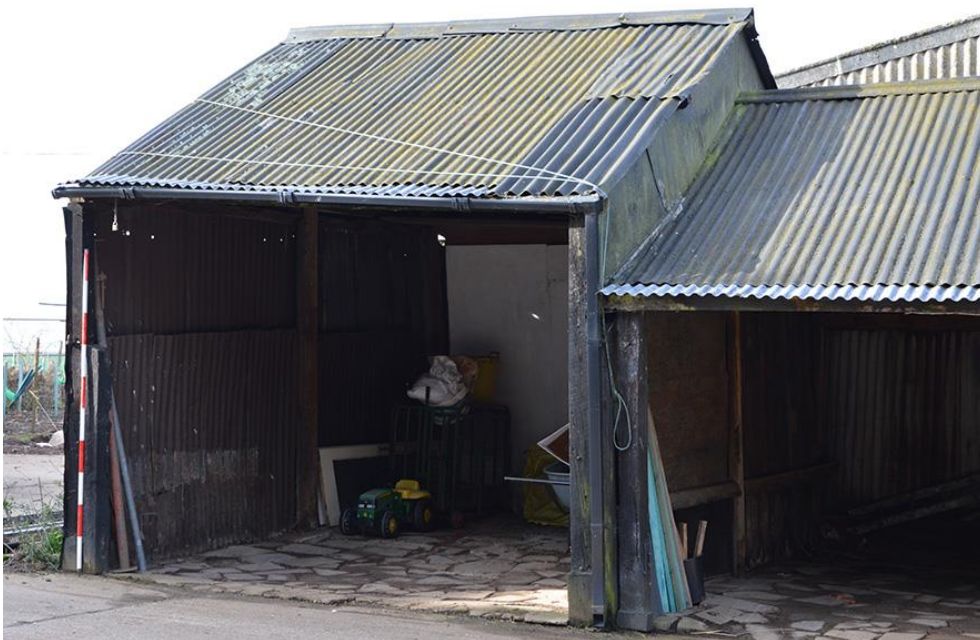
Plate 8 Southern section of barns from the west

The southern part of the barn range may have been used as a cart or implement shed but is now used for storage (Plate 8). It is taller than the northern section and is open-fronted. Its construction seems to be identical to the northern part.

Both sections of the barns are in incredibly poor condition and have been subject to numerous repairs and replacements of the original fabric. The corrugated metal cladding is rusting and the remains of the original timber-frame is rotting at ground level.

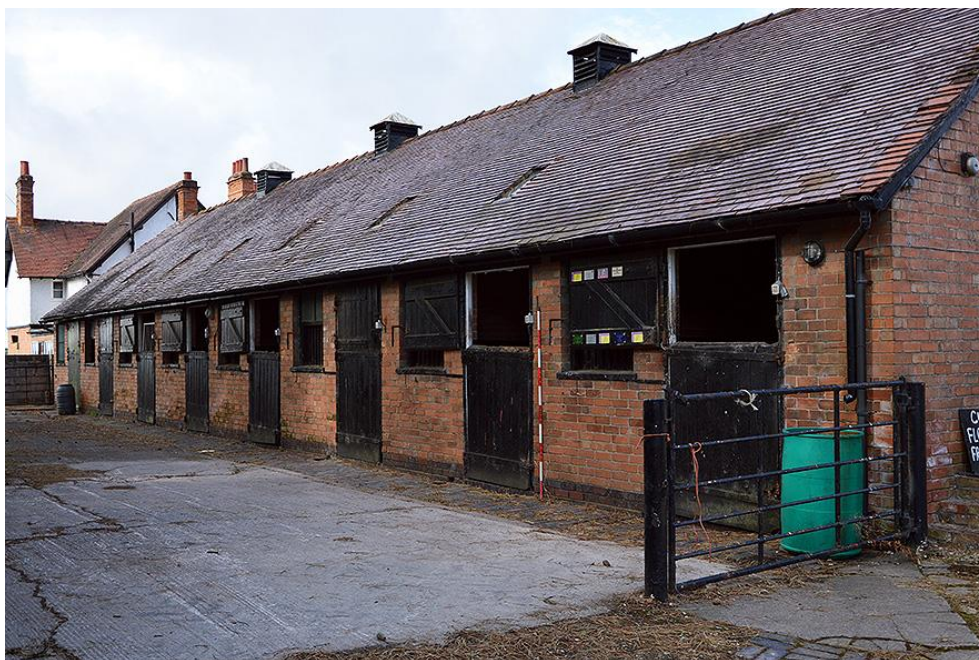
Plate 9 East elevation of stables and workshops

The eastern elevation (Plate 9) has eight stables all with the usual paired stable doors and windows. The northern elevation (Plate 10) has a mounting block against its base, a louvred opening at the top of the gable and is surmounted by a weathervane.

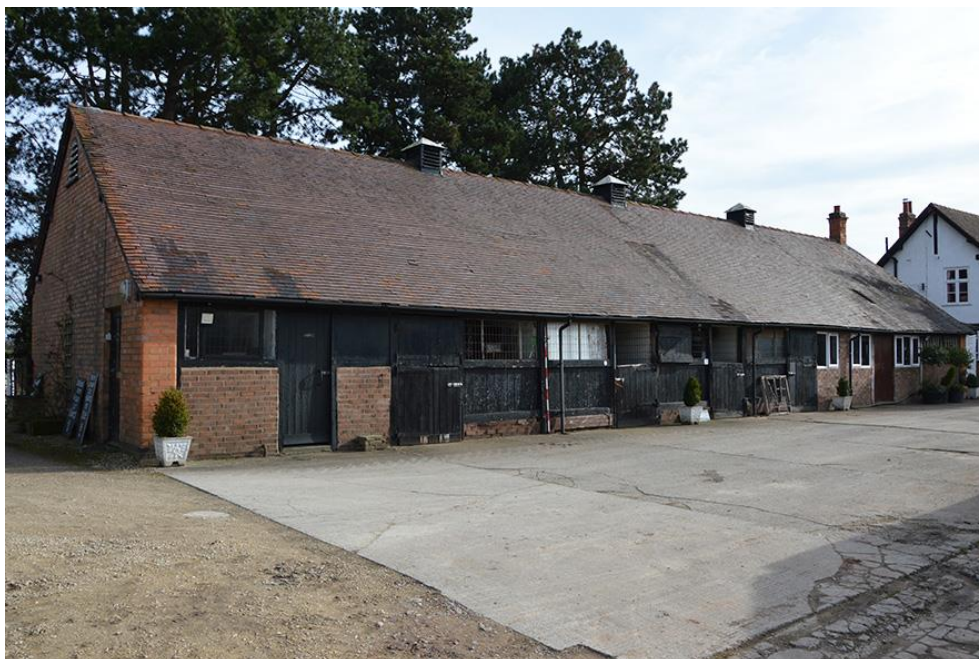
Plate 11 Western elevation of stables and workshops

The western elevation (Plate 11) has a number of varying openings and brickwork for the walling between timber posts. This evidence suggests that this side of the building was originally an open-fronted shelter shed. The infilling of the space between the posts has occurred through time and therefore the brickwork and openings do not match each other.

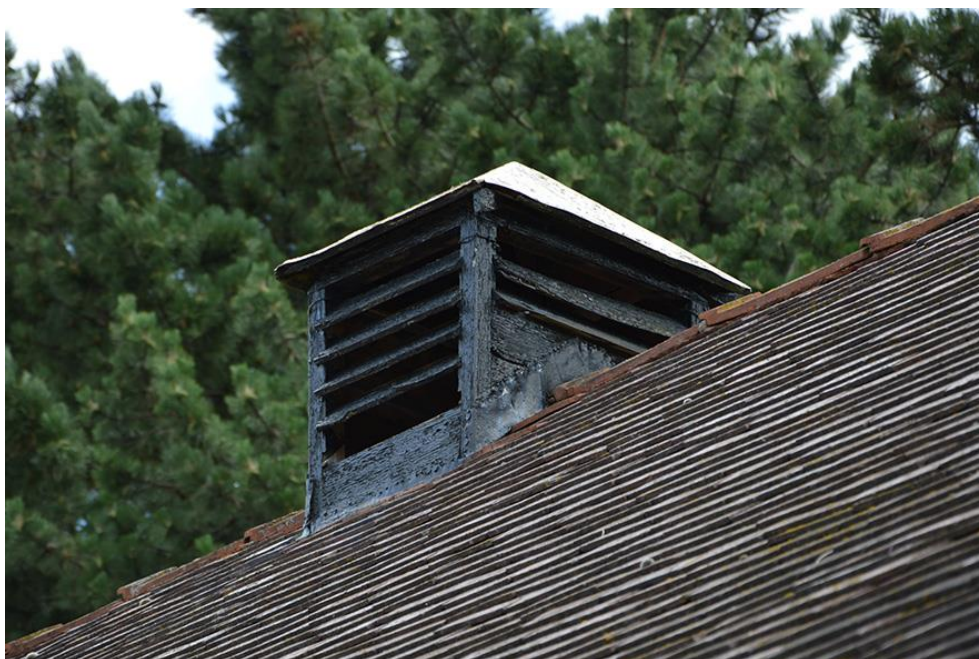
Plate 12 Cupola style ridge vent on stables and workshops building

The building had a complicated ventilation system to draw the stale air away from the animals. Within the central spine wall are vents that lead to the cupola-style ridge vents (Plate 12) that can be seen along the length of the building. The louvred vent on the north elevation is also part of this ventilation system.

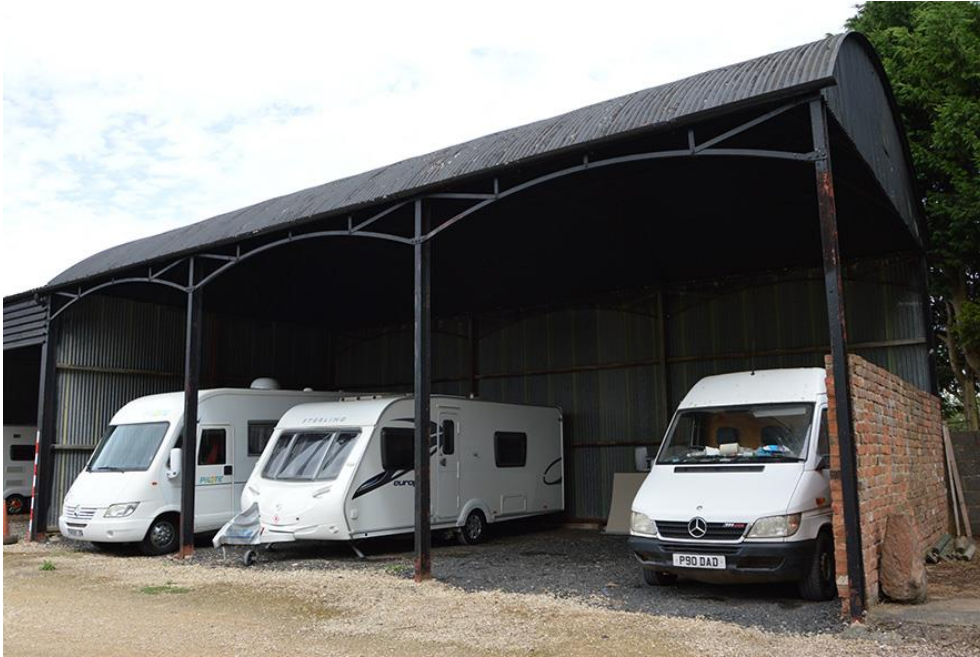
Plate 13 Mid-20th century Dutch barn from the south east

At the northern end of the site lie two Dutch barns, used for hay or straw storage, that are going to remain unaltered during the proposed changes to the site. The earliest of the structures (Plate 13) is shown on historic mapping from the 1950s onwards. It is built on a frame of cast iron stanchions and has a semi-circular roof.

Along the north and south elevations are bracing structures between each of the stanchion uprights. It currently has corrugated metal walling to the north and west walls which are of a later date as the structure would originally have been open on all sides. The later Dutch barn (Plate 14) is fairly

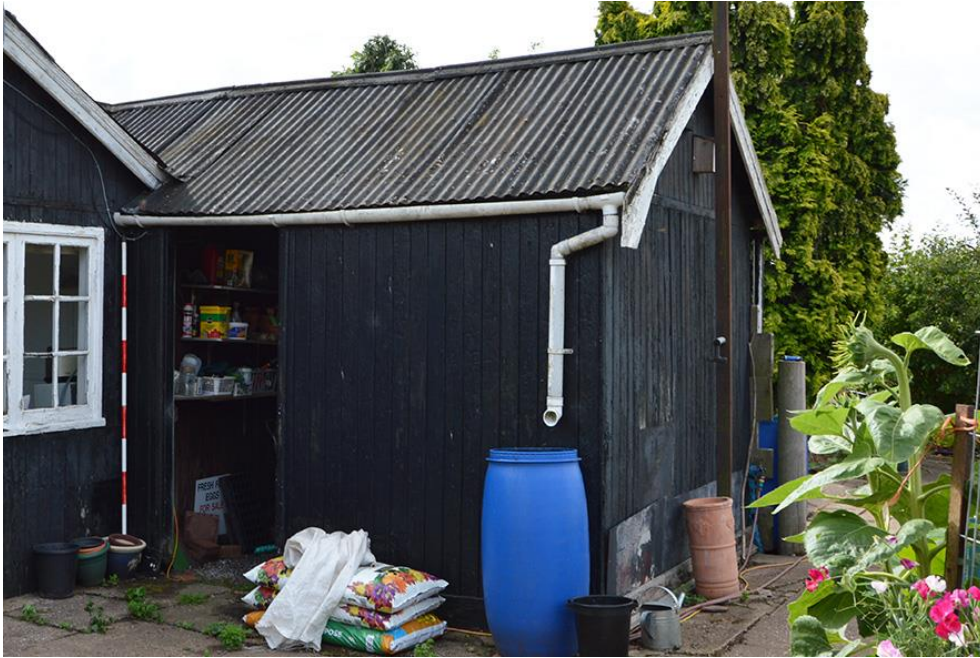
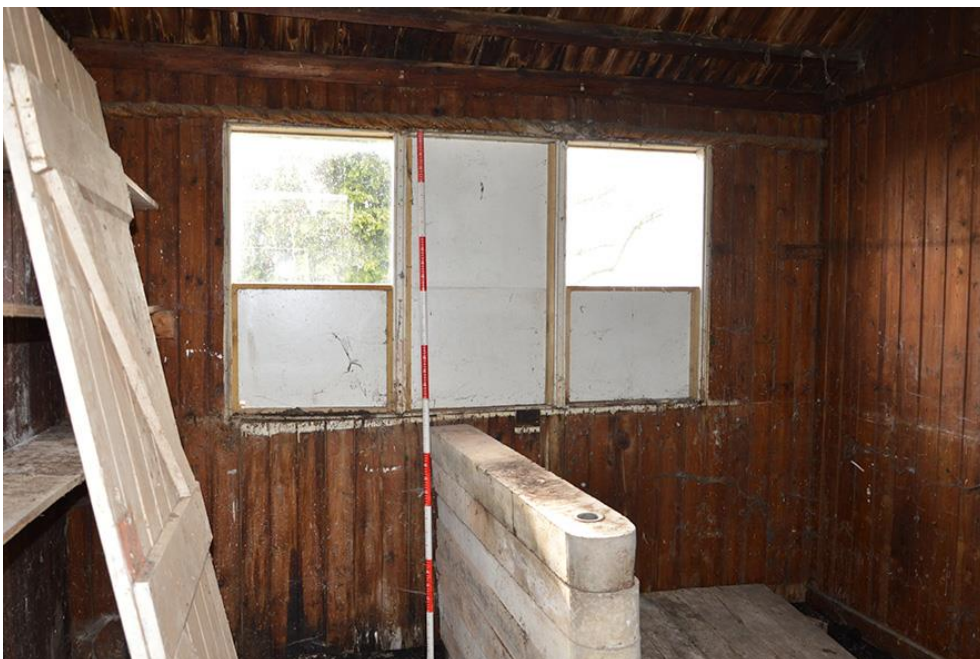
Plate 15 Exterior of external store from the north west

Plate 16 Interior of external store showing wooden panelling and division for stalls

The external store (Plate 15) was accessed from a door on the north elevation. It's internal walling was wood panelled, and it had an unsurfaced floor. It had been converted at some point for use as a stable and had a concrete block divider added to create two stalls (Plate 16). The window had also been replaced, probably in the 1970s.

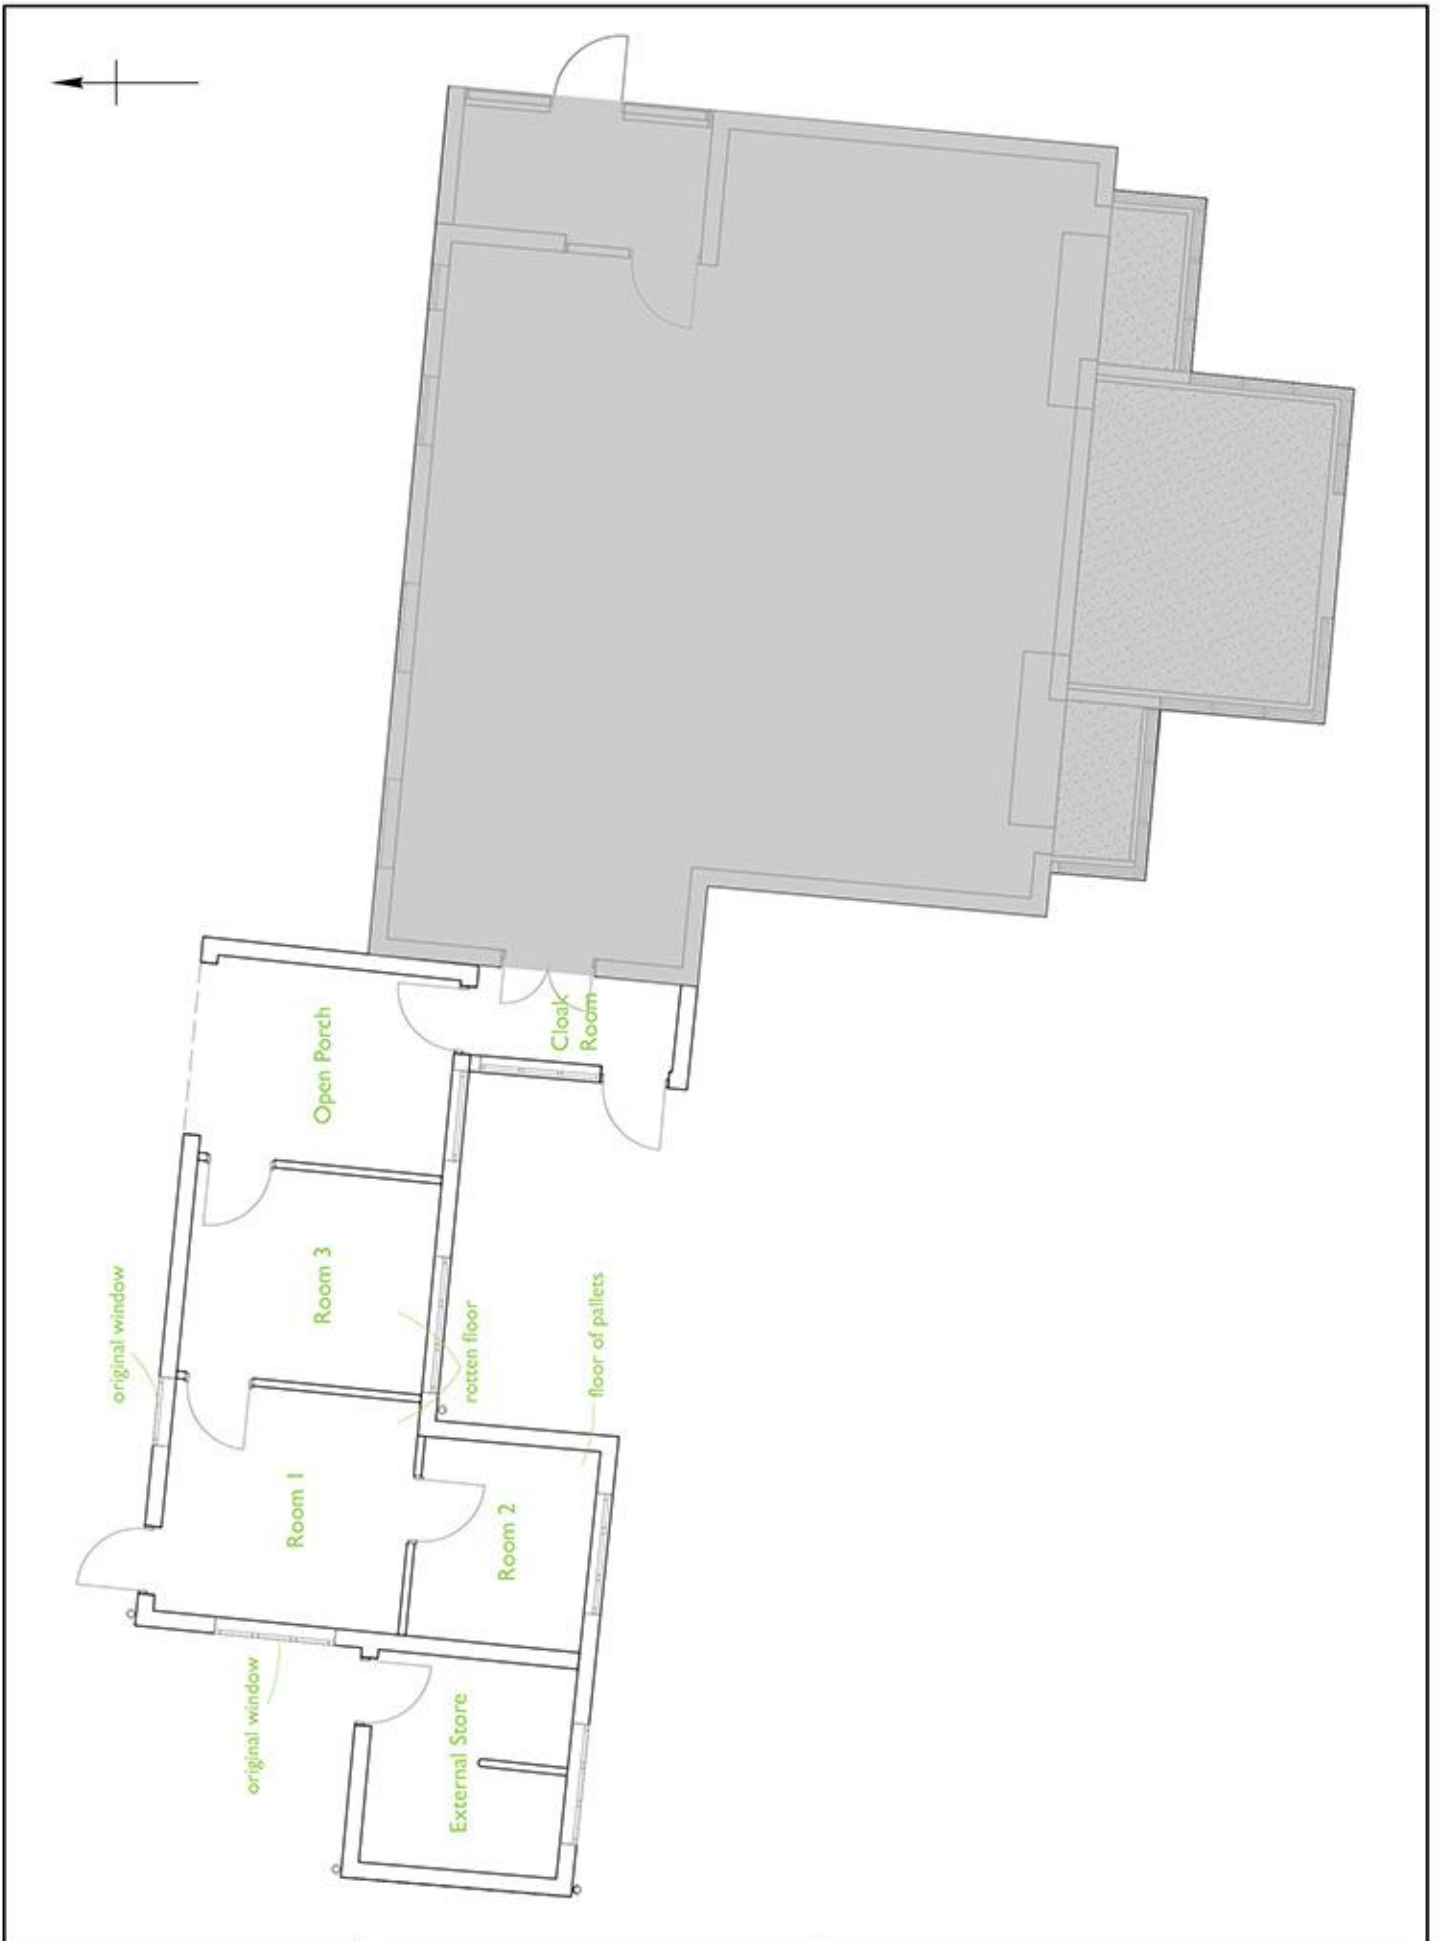
Figure 7 Ground plan of House Extension

Between 1903 and 1927, the buildings of Sandal Lodge were constructed (Figs 5 and 6). The house extension (Fig 7) was built at this time, although local belief is that it was a scout hut that was moved to the site after the house was built, there is no evidence to suggest this. The building consists of an external store, three rooms used for storage and an open porch (Fig 7).

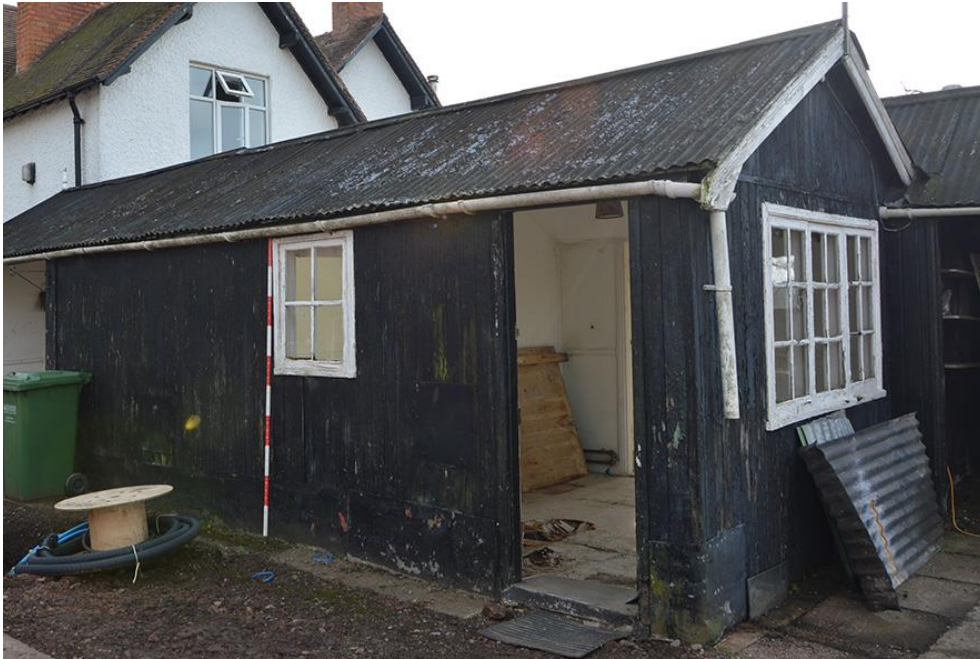
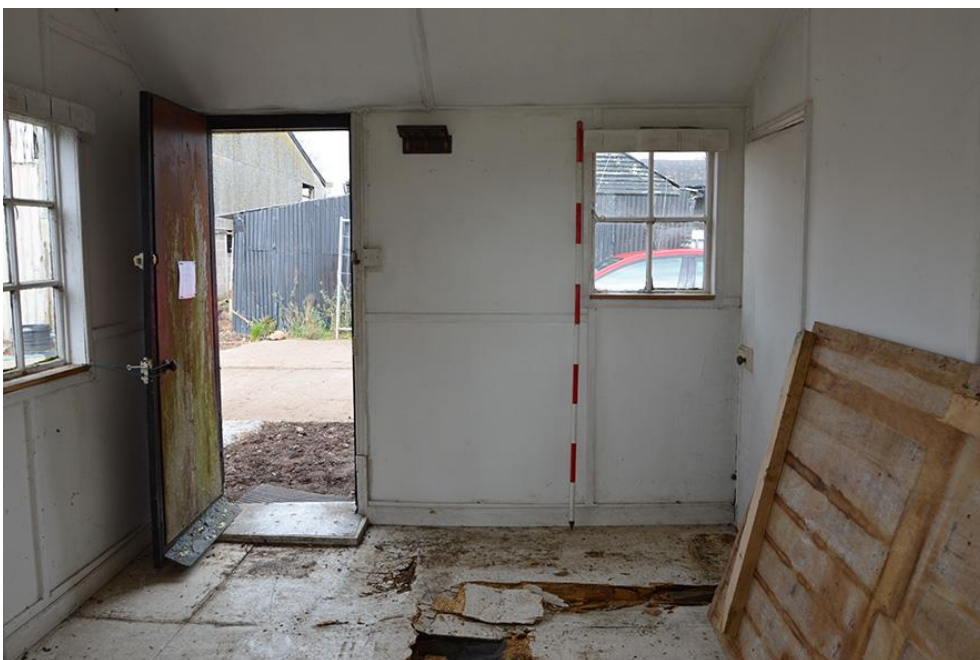
Room 1 (Fig 7) was entered via a door on the north elevation (Plate 17). It was the largest room within the house extension, except for the open porch. The room had a wooden floor and wooden walls (Plate 18) with two original windows.

Plate 17 Exterior of Room 1 of house extension from the north west

Plate 18 Interior of Room 1 from the north

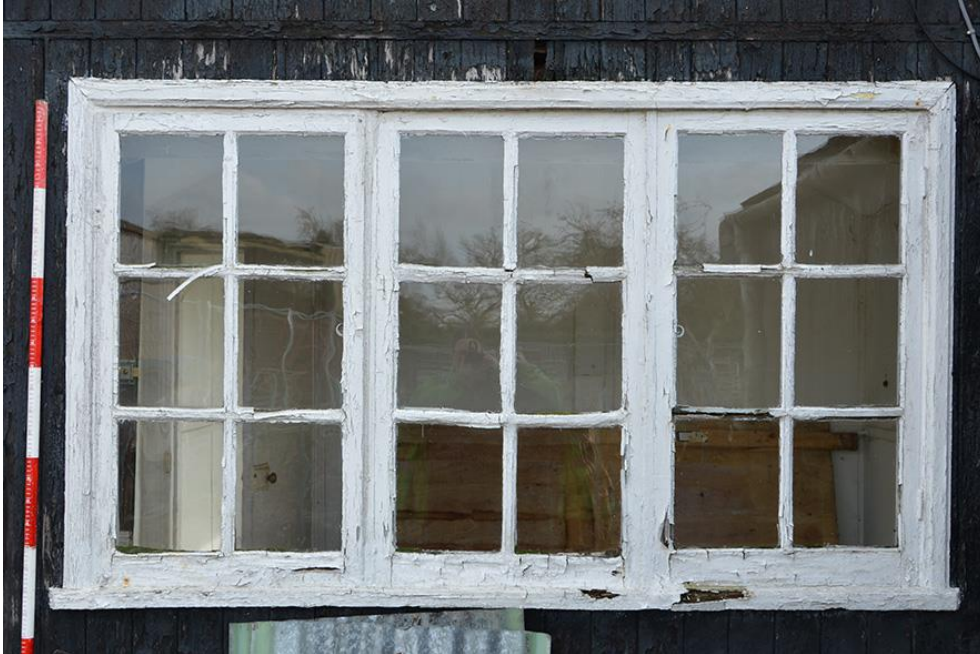
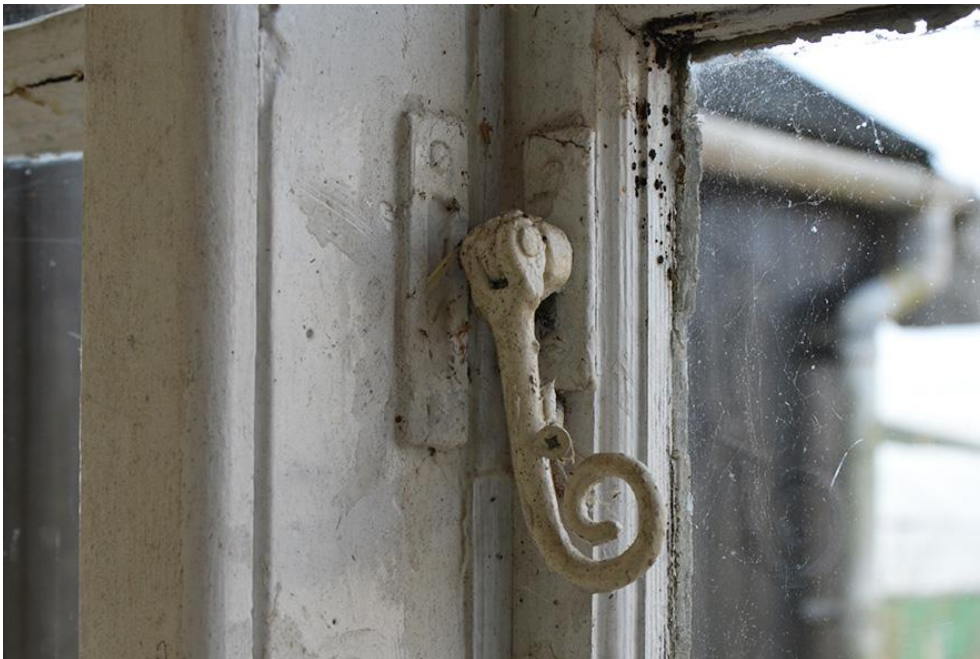
The largest window was in the western wall and was mullioned (Plate 19). It had eighteen panes, six to each section with the outer two sections being casements. These had spiral-ended turnbuckle catches (Plate 20). A smaller window was in the northern wall and also had a spiral-ended turnbuckle catch. The floor was not very secure and had rotted in places.

Plate 19 Large window of Room 1 from the west

Plate 20 Spiral-ended turnbuckle catch on window of Room 1

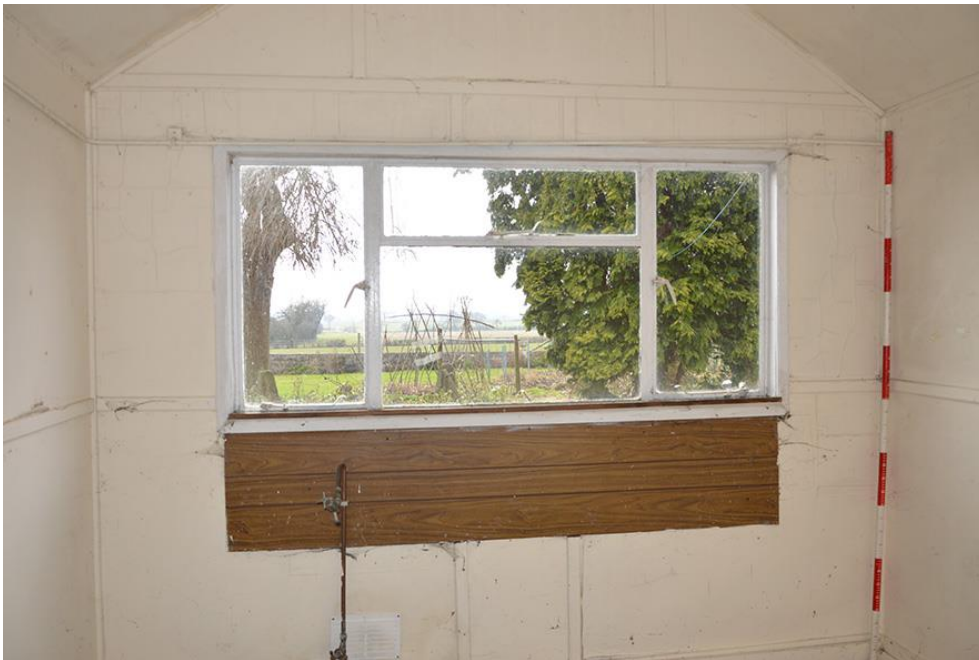
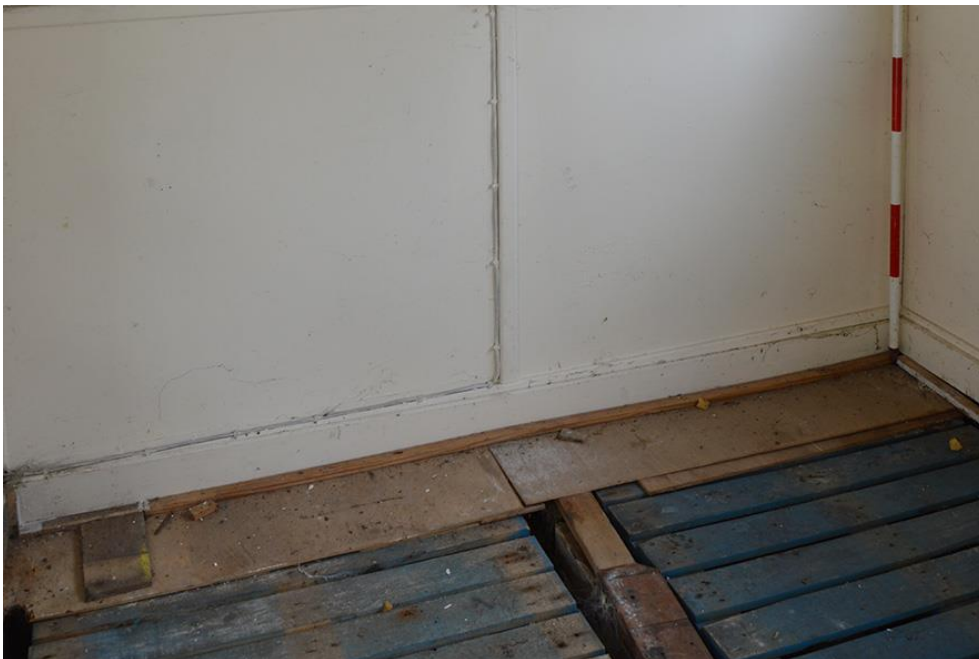
Access into Room 2 (Fig 7) was through a door in the south wall of Room 1. This was a small room with wooden walls (Plate 21) and the floor had been replaced by pallets (Plate 22). The only window in this room was large and had been replaced, probably in the 1970s.

Plate 21 Interior of Room 2 from the north

Plate 22 Part of pallet floor of Room 2

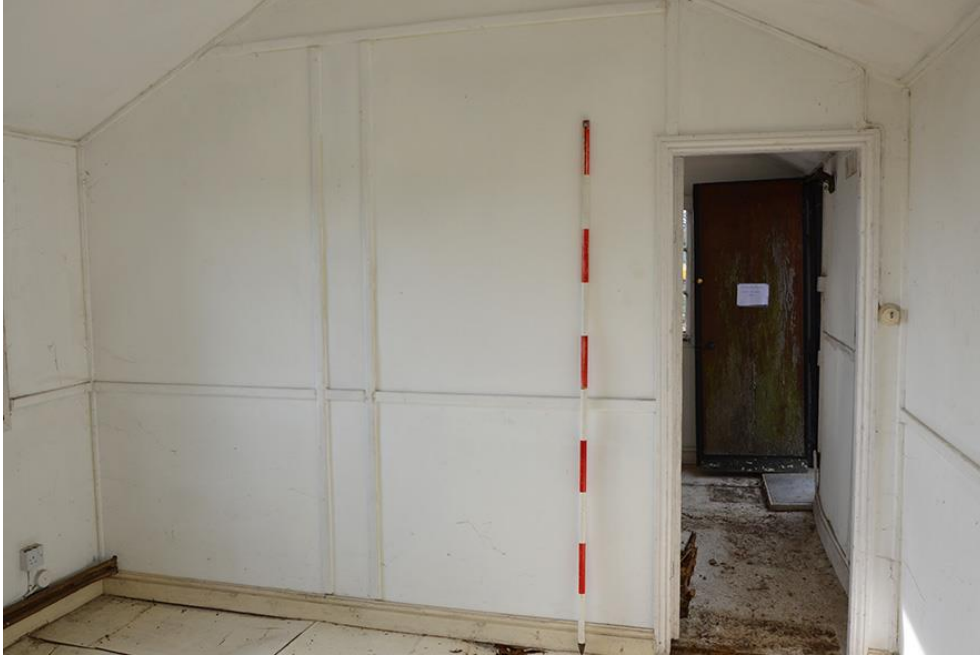
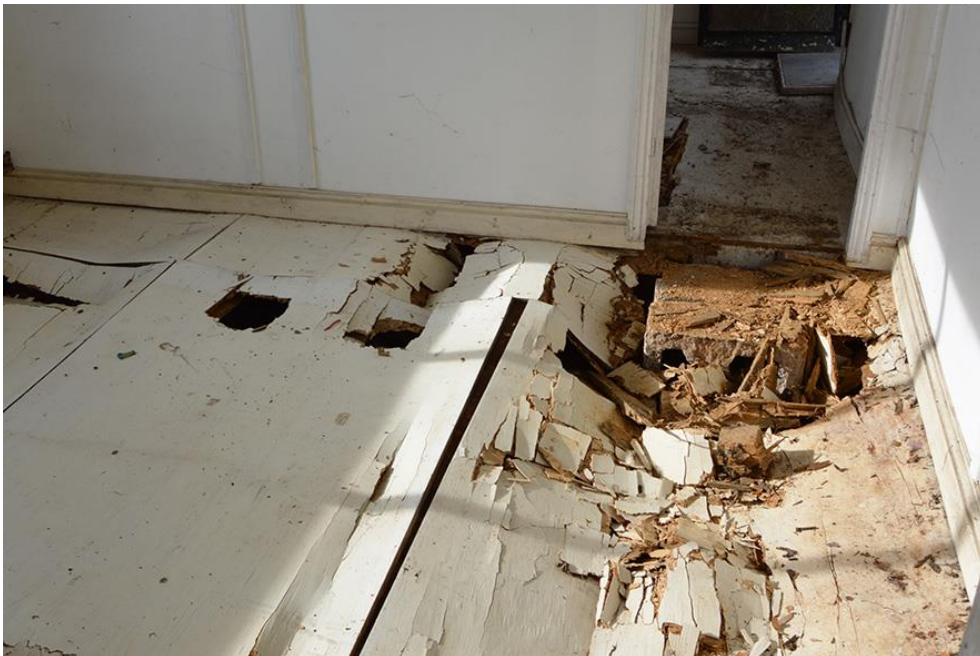
There was access into Room 3 through the east wall of Room 1 (Fig 7) and also from within the open porch. Room 3 had wood walls and floor (Plate 23) although the floor in the room was rotten in most places and it was not possible to fully access the room (Plate 24). There was a radiator and a large window on the south wall. The window had been replaced, probably in the 1970s.

Plate 23 Room 3 from the east

Plate 24 Part of floor of Room 3
