Sandal Lodge, Hanbury Wharf

Building Recording

EH1812-1

WSM71324

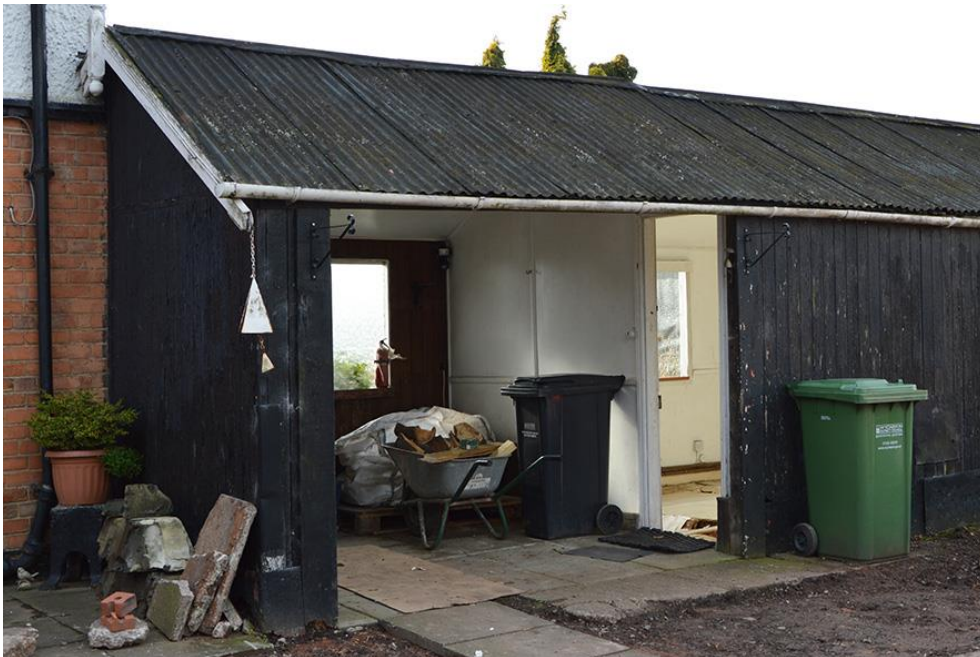
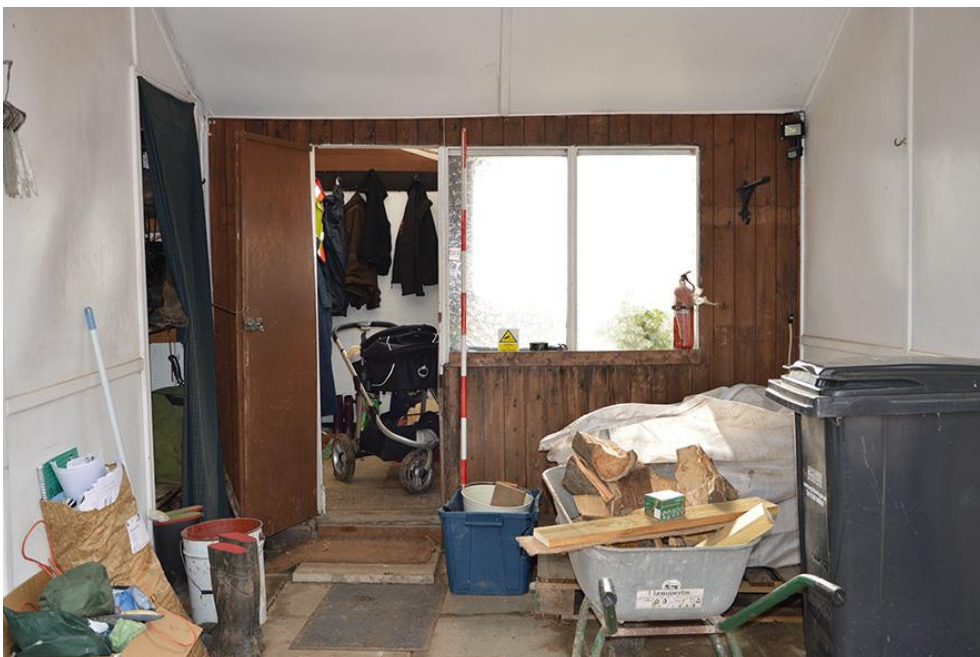
The open porch (Fig 7) had a large opening on the north elevation (Plate 25) that was as wide as the room itself. It had wooden walls and a stone floor (Plate 26). There was a large window on the south wall that had also been replaced, probably in the 1970s. The room was used for storage and there was access into Room 3 through a door in the west wall, into a cloak room (Plate 27) through

Plate 25 Exterior of Open Porch from the north east

Plate 26 Interior of Open Porch showing doors to house (left) and cloak room

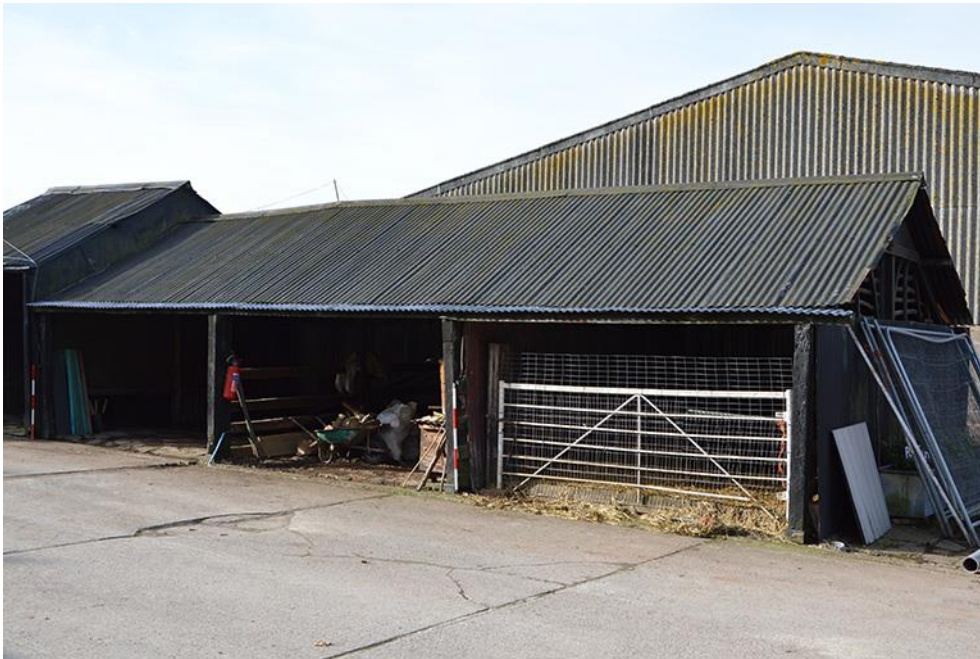
Plate 28 Exterior of north section of barns from the north east

The northern section (Plate 28), Areas 1, 2 and 3, was constructed in the original phase of development at Sandal Lodge, between 1903 and 1927. This section of the barn was originally longer with a further two bays to the north as can be seen on the historic mapping (Fig 4). The building originally had a pigsty attached to its western elevation in the position of the missing two bays. The barn is timber-frame in construction with a simple king-post truss roof (Plate 29). The most northerly of the trusses includes two panels of woven staves (Plate 7 and Plate 30). This truss would originally have been within the building prior to the bay removed from the north of the existing structure. There is also evidence of the next truss to the south having similar stave panels.

The timber-frame has been covered, on the western elevation and the roof, with corrugated metal panels which are likely to have been replaced since the building was first constructed. The east elevation of the building is open and appears to have been open since it was constructed. The

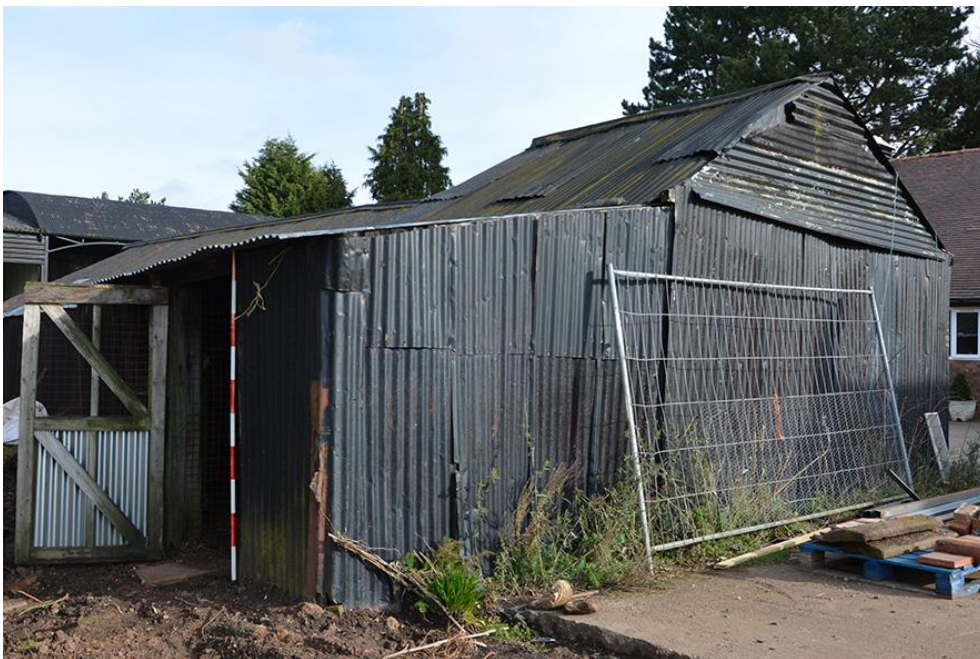
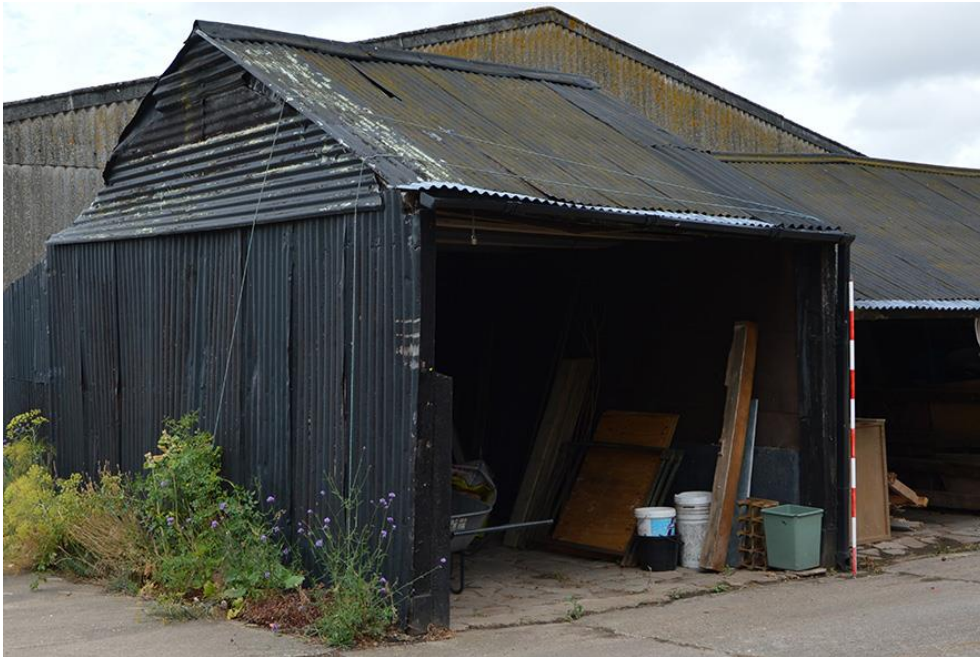
The southern section of the barn (Plate 31), Areas 4 and 5, was constructed later than the northern section and in two phases. Area 4 (Plate 32) was the first to be constructed not long after the northern section of the barn and before 1927, when it is shown on the historic mapping (Fig 4). The

construction style is similar to that of the northern part – a timber-frame with a king-post truss roof – but has a taller profile than the earlier structure. The 1927 map (Fig 4) shows that there were also a further two structures to the south. This part of the barns, Area 4, can be seen to be later than the northern section, Areas 1 to 3, by the construction of the roof line. The truss for the roof of Area 4 has been added above the truss of Area 3 (Plate 33) with the Area 3 king-post being replaced. This has caused the posts for the east elevation of Area 4 to stand further forward than those of the northern section of the barns. Area 4 was last used for storage but may have originally been used to hold the larger implements or carts.

Plate 31 Southern section of barns from the south west

Plate 32 Area 4 of southern section of barns, showing difference of roof heights

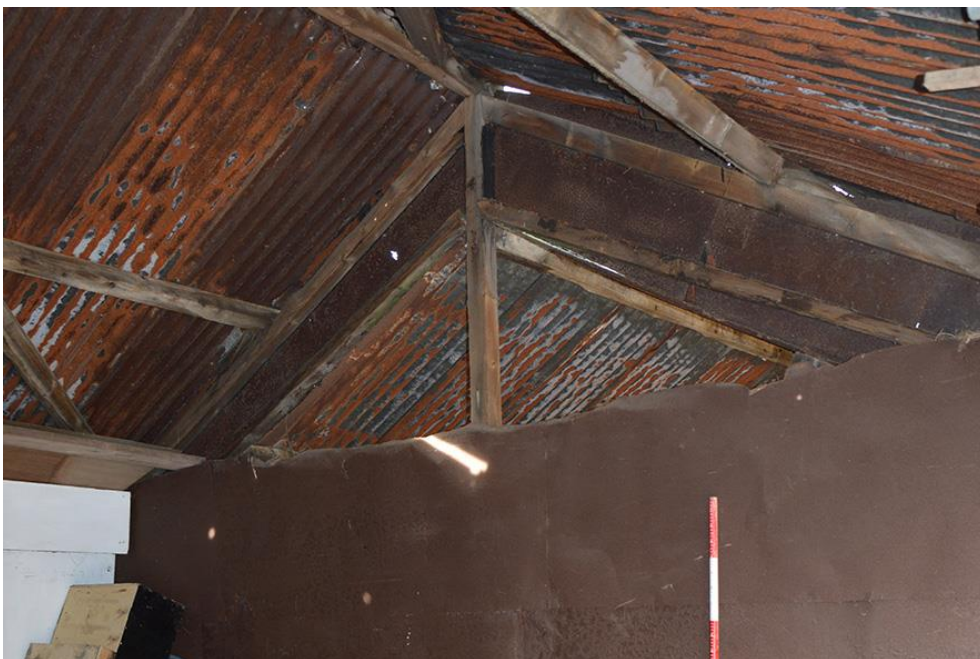
Plate 33 Trusses of Areas 3 (below) and 4 (above), note replaced king-post

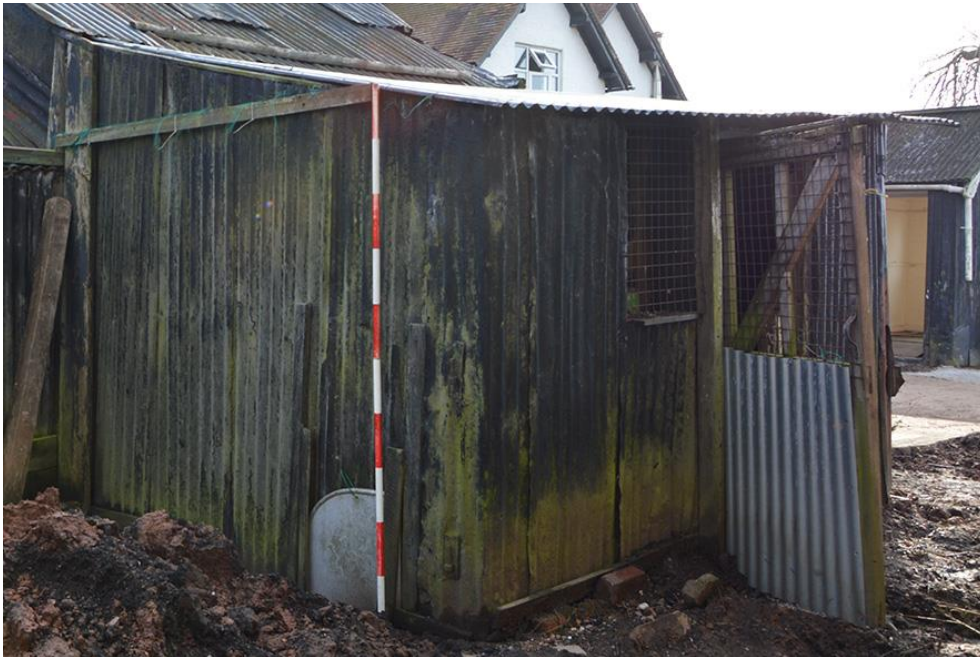
Plate 34 Exterior of Area 5 of southern section of barns

Area 5 (Plate 34) was added in the mid 20th century and is first shown on historic maps in 1964 (Fig 4). It is a small, simple timber structure with a catslide roof attached to the west elevation of Area 4. Both Areas 4 and 5 have corrugated metal walling and roofing which matches that of the northern section of the barn (Areas 1 to 3). It is probable that this is a replacement from the original walling material, which could also have been metal. Area 5 was last used as a hen house and a store and was

most likely originally used as a store area and later used as a loose-box stable with the window being added at that time.

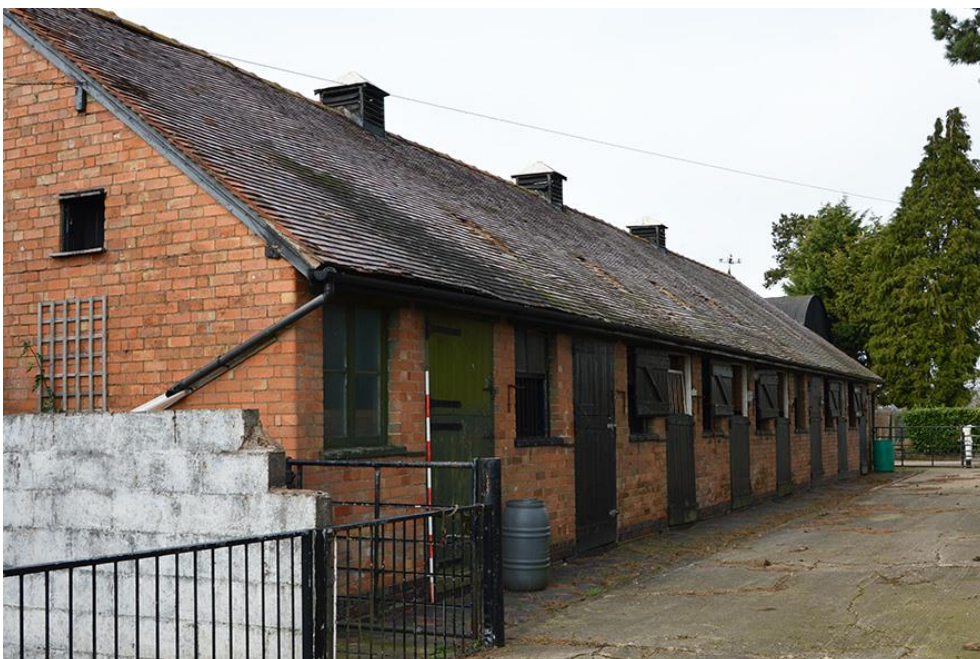
Plate 35 Exterior of stables from south east

In the early 20th century (Figs 3 and 4), between 1903 and 1927, the stables and workshops building (Fig 9) was built at the same time as the rest of the structures at Sandal Lodge. The building originally consisted of stables along the eastern side of the building, as now (Plates 9 and 35), with the western side being a shelter or cart/implement shed although this was later converted into separate rooms now used as workshops (Plates 10 and 36). The two sides of the building were separated by a spine wall running along the building at the ridge.

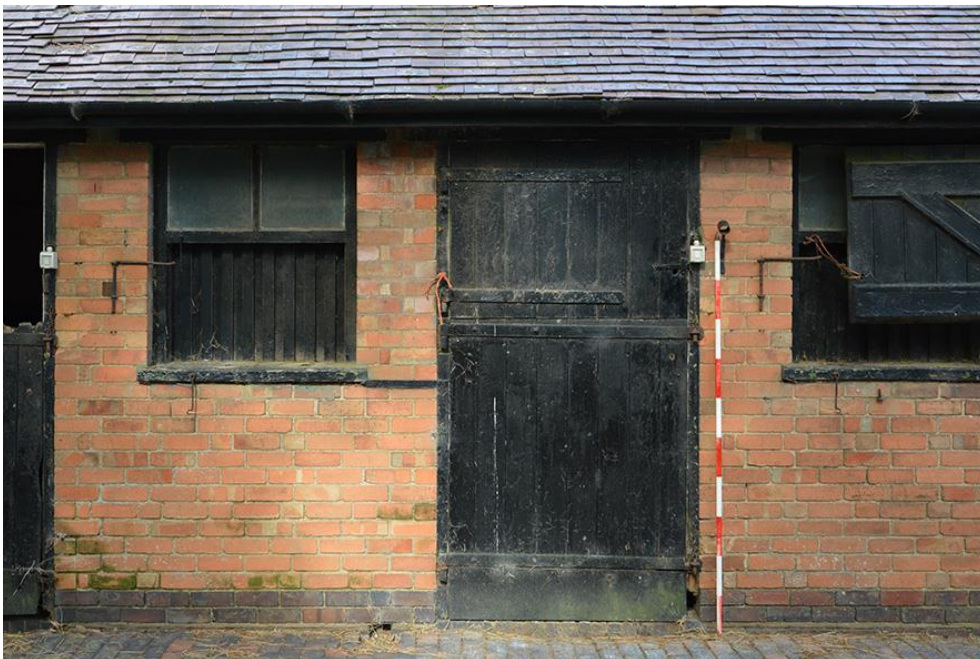
Plate 37 Stable door and vented window

The stable side of the building consisted of eight individual rooms, seven stalls and one tack or harness room (Fig 9), each with a stable door and a window to the left (Plate 37). Most of the windows were typical 'stable style' with glazing at the top and vertical wooden vents in the lower portion. The tack room has a glazed window. In the stalls the floor surfaces were brick and incorporated a brick drain (Plate 38). Each of these stalls had a hay feeder and a water trough (Plate 39) and some also retained hitching posts (Plate 40). The rooms were tall, stretching up to the ridge, and the roofs were insulated with straw (Plate 41). Built into the spine wall was a ventilation system with ventilation bricks (Plate 42) in each stall and ridge vents on the roof (Plates 12, and 35). The ventilation bricks allowed cool air to flow through the stalls from the open side of the building (the

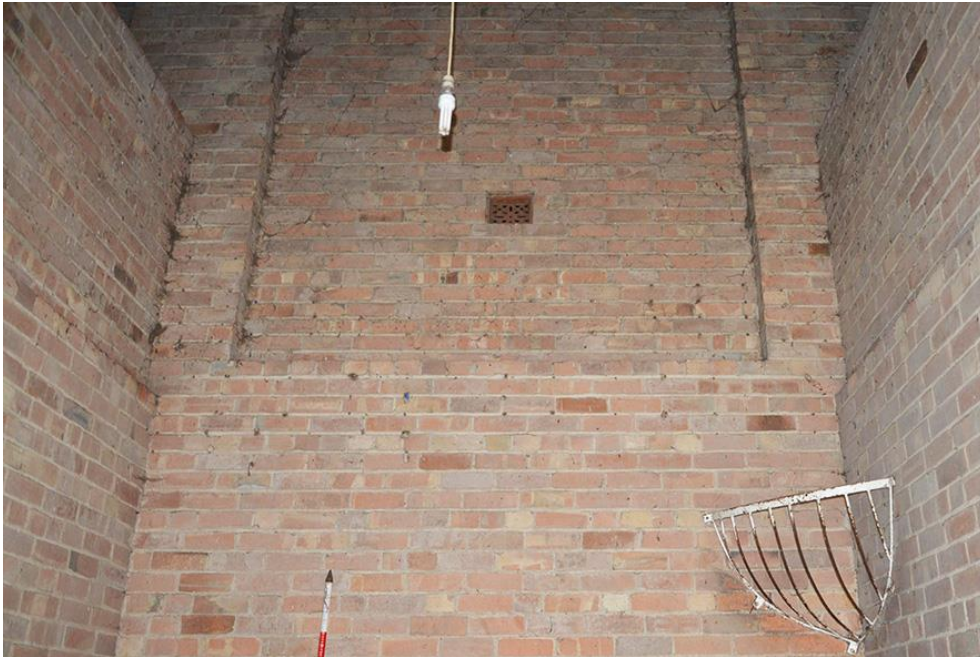
Plate 42 Stable interior showing ventilation brick

workshops) with the windows providing cool air from outside. The warm air was then drawn out of the stalls through the roof vents. The most southerly room had a fireplace (Plate 43) and was used as a tack or harness room. It had panelled walls and was used to keep the stable hands or carters warm and the harnesses dry.

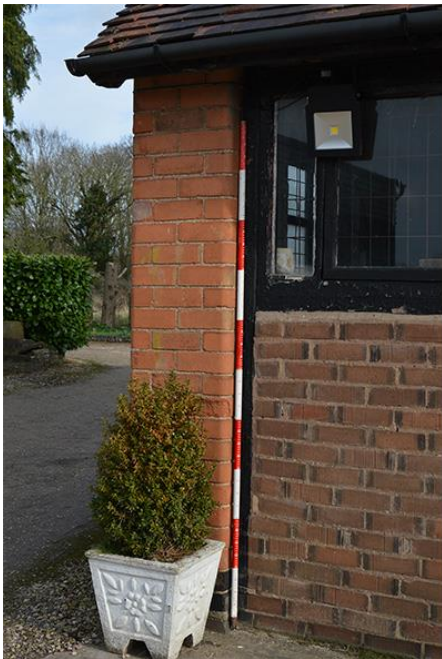
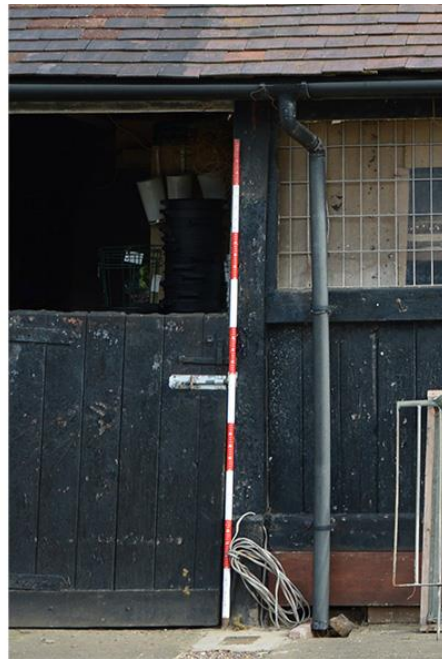
Plate 44 Curved edged wall and post to hold roof

The workshops side of the building was originally open on the west elevation with the roof supported on the curved brick end walls and wooden posts (Plate 44). The original function may have been a shelter shed for the housing of cattle or draught animals. Alternatively, it may have been a cart or implement shed for the storage of carts, wains and farm machinery. The ventilation bricks

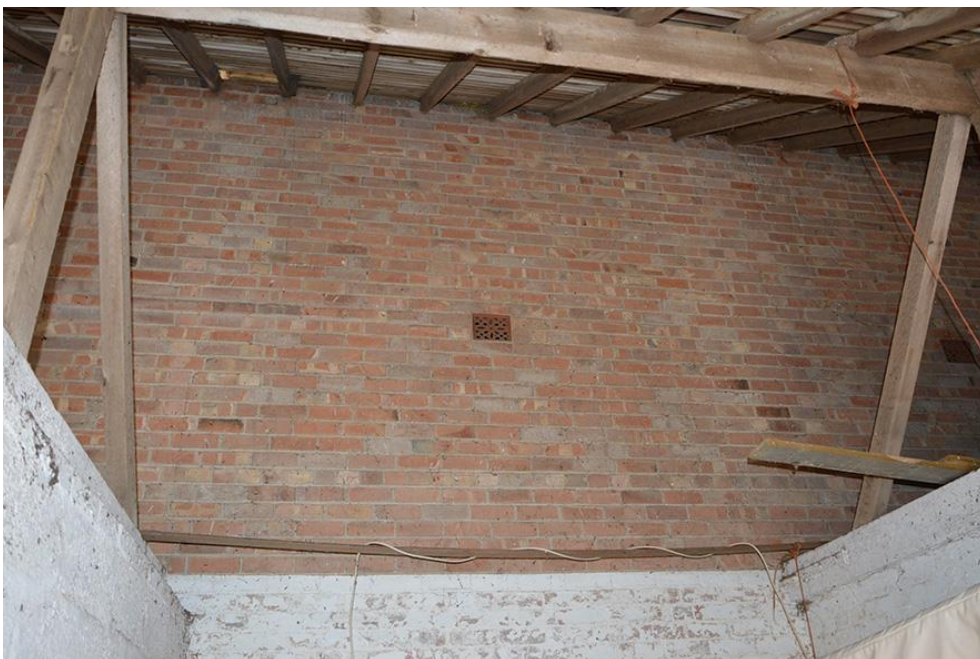
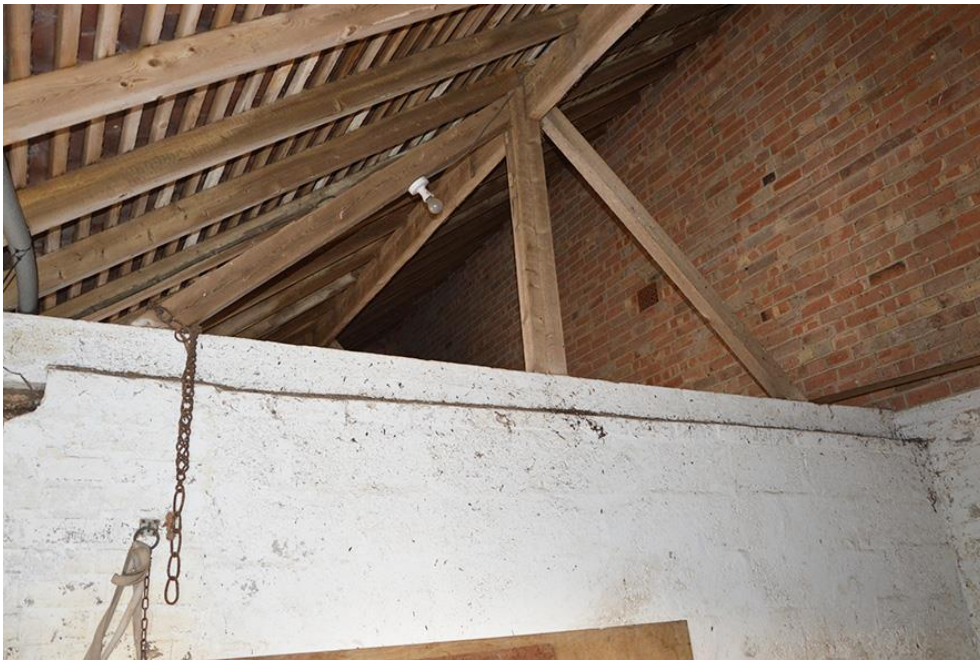
were still visible on this side of the building (Plate 45). Given that these bricks were allowing cool air into the stables, it is unlikely that the workshops side of the building was used as an animal shelter. The roof was formed of half trusses built off the central spine wall (Plate 46).

Plate 45 Ventilation brick on workshops side of the building

Plate 46 Interior of workshops showing roof timbers

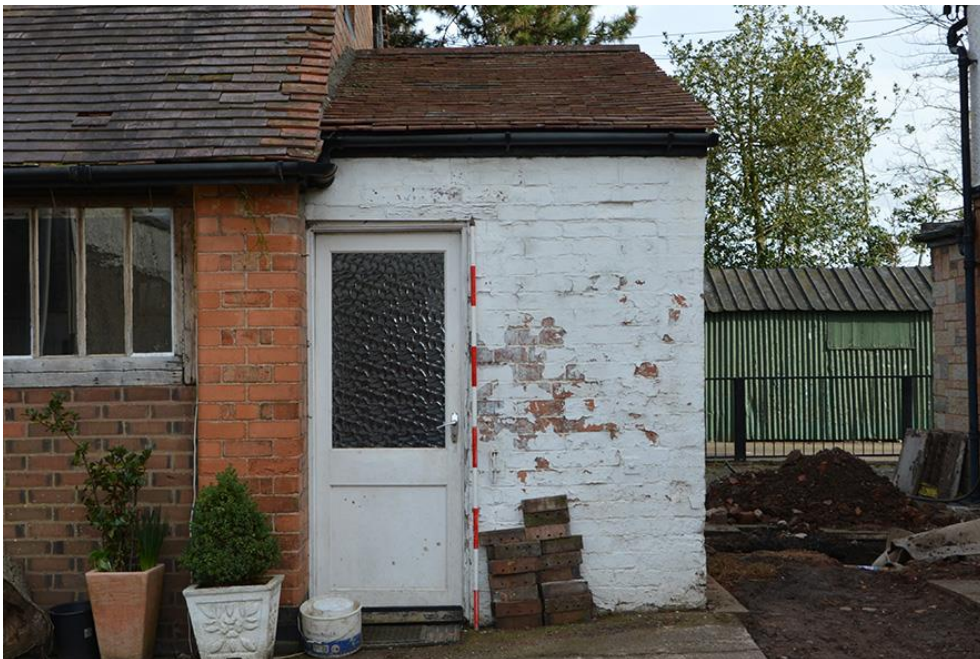
Plate 47 Extension to workshops building from the west

Whilst the stables and workshops building was constructed between 1903 and 1927, the building is first shown on mapping in 1927 with a smaller structure against its south gable (Fig 4). This structure (Fig 9; Plate 47), currently a utility room, was not built at the same time as the rest of the building as is evidenced by the blocked opening now partially hidden by this same extension (Plate 48).

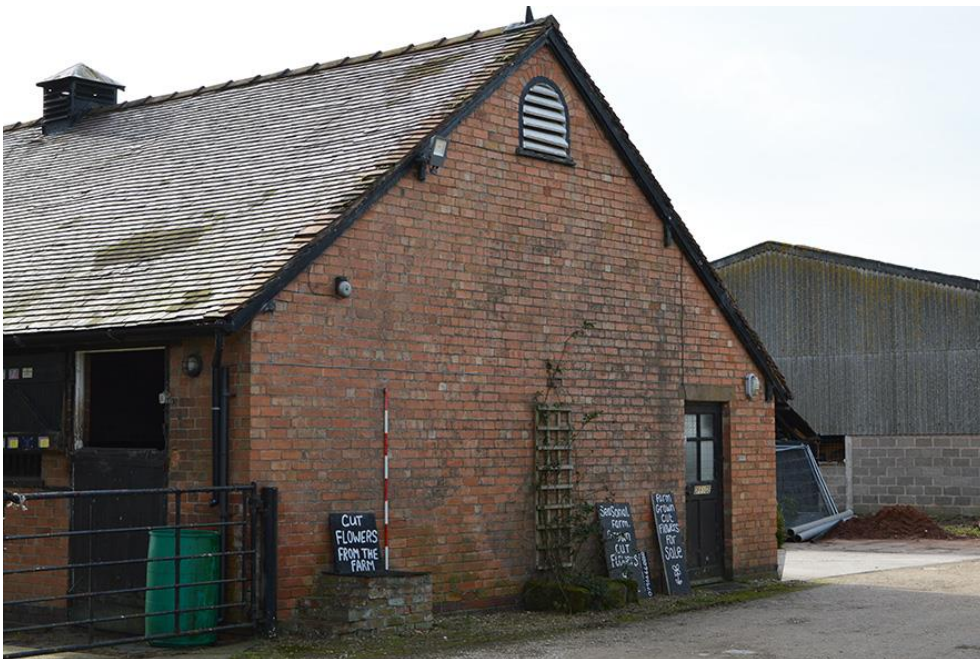
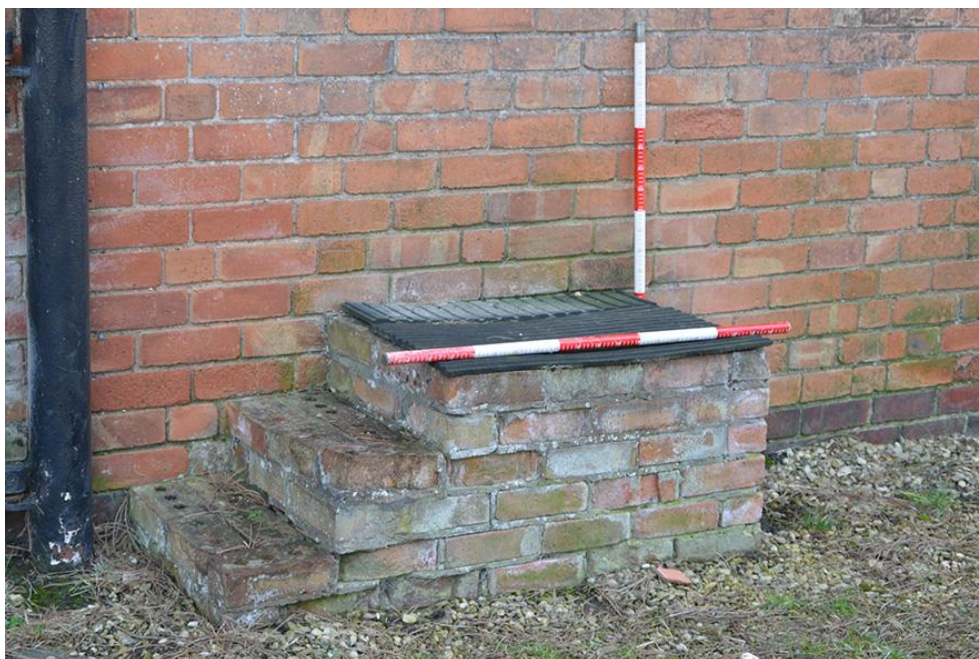
In the mid 20th century, a mounting block was added against the north gable of the building (Plate 49). The bricks of the mounting block are different to those of the main building and have holes in them (Plate 50) a modern manufacturing technique. The mounting block itself consisted of a flat platform reached by three steps.

Plate 49 North gable of stables and workshops showing mounting block from the north

Plate 50 Mounting block of modern bricks

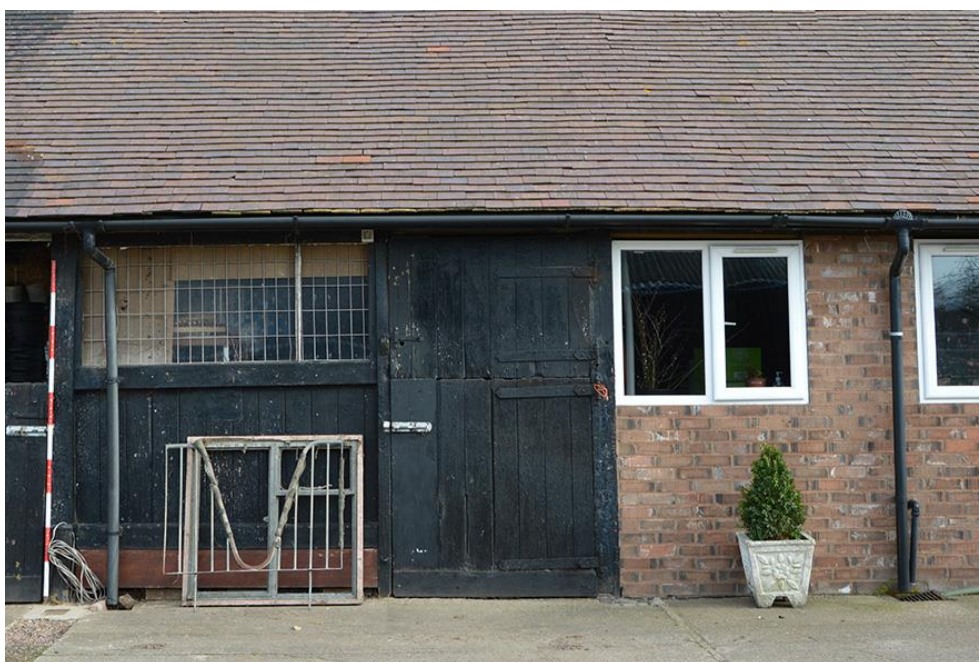
Plate 51 West elevation of workshops showing brickwork and panelling of blocking

Later in the 20th century, probably towards the end of the century, the open elevation of the workshops was bricked or boarded up (Plate 51) and the interior divided to create more stable stalls (Fig 9). Stable doors and windows were included within the brickwork closing the elevation. The divisions were built of brick and abutted against the surviving posts of the open elevation (Plate 52). Around the same time, or a little later, a toilet was added into the most northern of the divided sections (Fig 9) and doorways were inserted through the spine wall into the tack room and the southern most stable stall (Fig 9). The latest function of the building changed the stalls on this side of building into workshops and storage for a flower business.
