# **Clattercut House, Rushock**

## **Building Recording**

EH2001-I

WSM72713

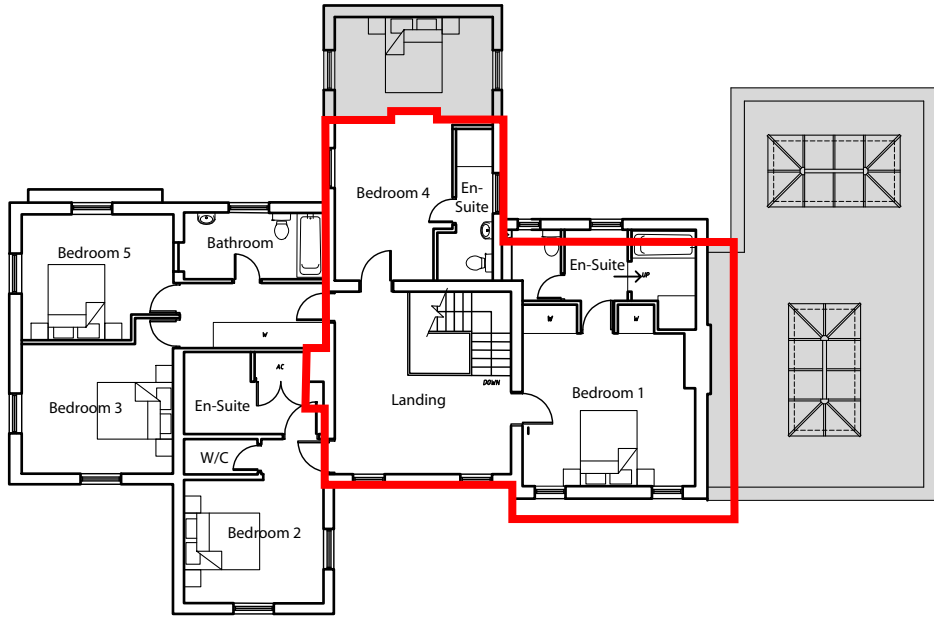
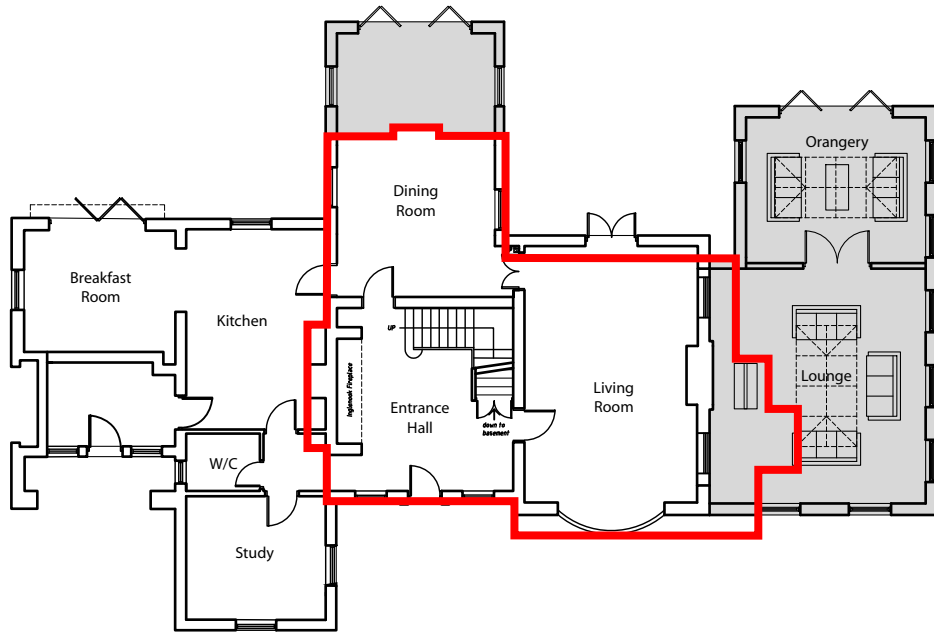
Figure 2 Current ground plan of Clattercut House showing location of original house

Outline of Original Dwelling
-

Foundations laid but walls not constructed

The building recorded consisted of Clattercut House (Fig 2). This is the former farmhouse of Clattercut Farm.

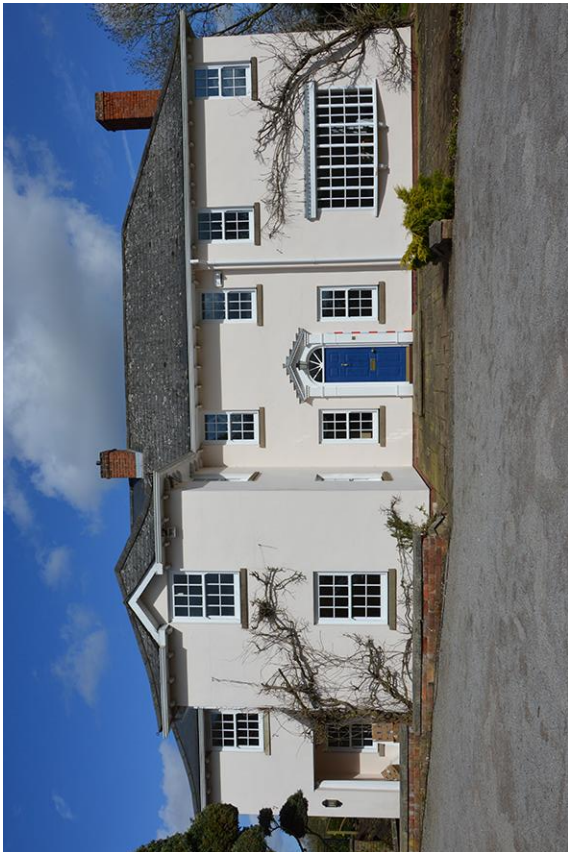
Plate 1 South elevation of Clattercut House

The south elevation, closest to the driveway, consists of four bays (Plate 1). The left-hand bay (Plate 5) of the house has a recessed, covered porch on the ground floor, the opening of which has half, fluted, Ionic columns to each side (Plate 6). The porch shelters multi-pane sash windows to each side of a simple doorway into the building. The first floor only has a single sash window. The adjoining bay (Plate 7) of the building is a wing that projects forward from the elevation. It has one large multi-paned sash window to both ground and first floors on its south wall with a dormer above that

The south elevation faces onto a patio and driveway (Plate 1) and has a wing that projects forward. The east elevation (Plate 2) has a large central, brick chimney stack and faces towards Clattercut Lane. The northern elevation (Plate 3) faces the large gardens to the north of the house. One section of the building projects forwards into the garden and a chimney stack running up to the eaves line. The west elevation (Plate 4) is partially obscured by the close-to, high-level, patio.

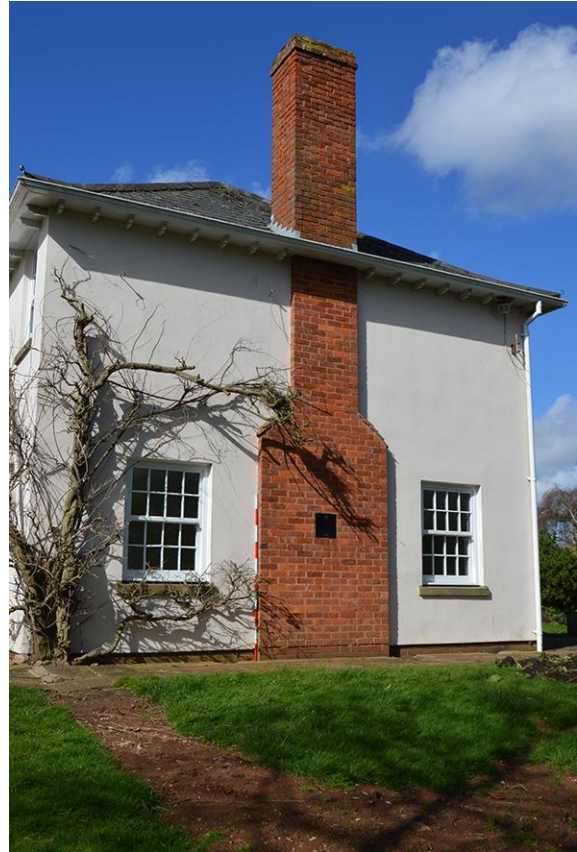
Plate 2 East elevation of Clattercut House

The eastern elevation of the building (Plate 2) has a central chimney stack that projects from the face of the building and rises through the over-hanging eaves. There are two rectangular, flat head, window openings with sash windows on the ground floor. The upper portion of the chimney stack, where it rises through the roof, has been built using re-used brick (Plate 11) and has a simple string course close to the top.

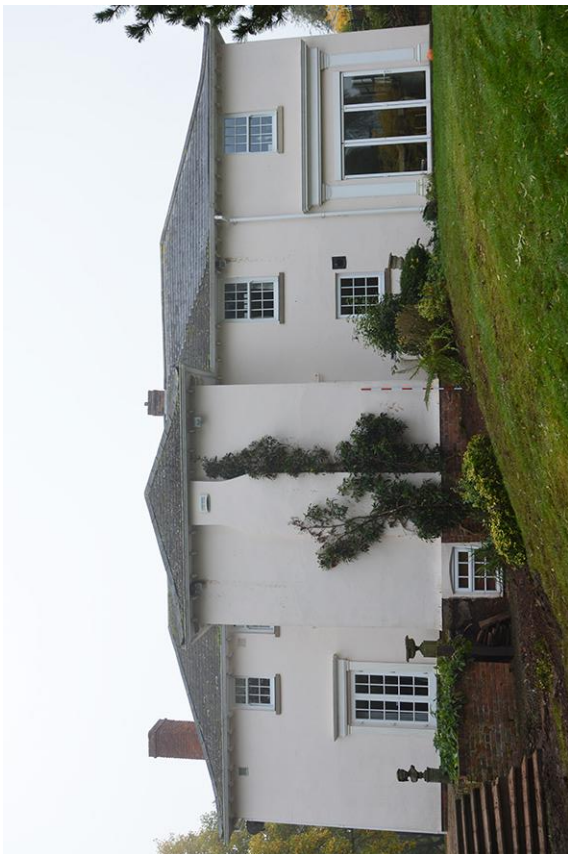
Plate 3 North elevation of Clattercut House

The northern elevation of Clattercut House (Plate 3) looks over the large gardens. As with the south elevation, this has four bays. The left-hand bay (Plate 12) has a ground floor doorway with pilastered surround and cornice over. It has French doors which open onto a raised patio. The first floor has two small rectangular window openings set against the eaves. Both contain sash windows. The second bay projects forward from the rest of the elevation (Plate 13). Its eastern side (Plate 13) has a single rectangular window opening on both ground and first floor floors with multi-paned sash windows. The brick foundations of the building are visible at the base of the north part of this bay (Plate 14), along with a small segmental head window opening. In the centre of the wall, a chimney stack rises to the eaves and the upper part has been removed. The western part of this projecting bay has first and ground floor windows that match the eastern side (Plate 15). The final two bays (Plate 16) of this elevation contains a square window opening and a large set of glazed doors on the ground floor. The glazed doors are flanked by flat pilasters and have a large cornice over them. The first floor has two flat head window openings at eaves level containing multi-paned sashes.

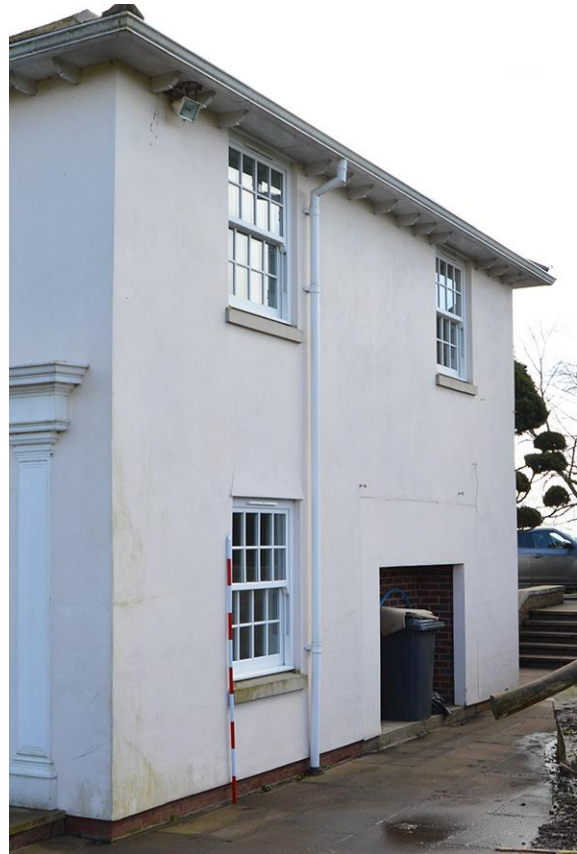
Plate 4 West elevation of Clattercut House

The western elevation of Clattercut House (Plate 4) has a single flat head window opening on the ground floor with two on the first floor all of which contain multi-paned sash windows. The ground floor also has a recessed area, with a concrete floor, that is currently used as a rubbish bin store.

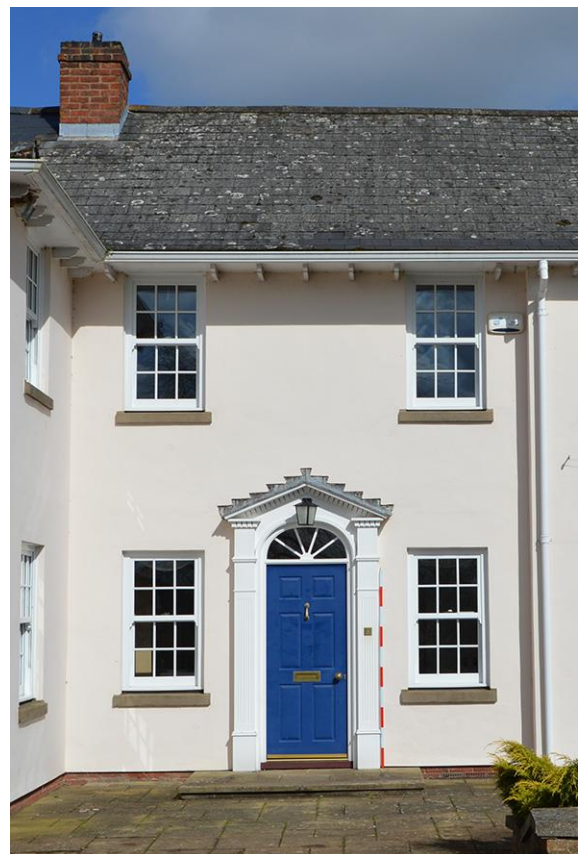
*Plate 8 Bay 3 south of elevation*

breaks the eaves cornice and guttering. The east wall also has matching flat head window openings. The principal bay (Plate 8) of the building contains a central front door with broken pediment and flat pilasters. Over the door is a semi-circular fanlight with sunray glazing bars and the door itself has six panels (Plate 9). These all give the doorway an 18<sup>th</sup> century style. Flanking the doorway are two rectangular, flat head window openings with matching openings on the first floor above them, all of which contain sash windows. The right-hand bay (Plate 10) of the house has a large, rectangular, bowed, oriel window on the ground floor on two moulded brackets. Above this, the first floor has two, smaller, flat head window openings both with sash windows.

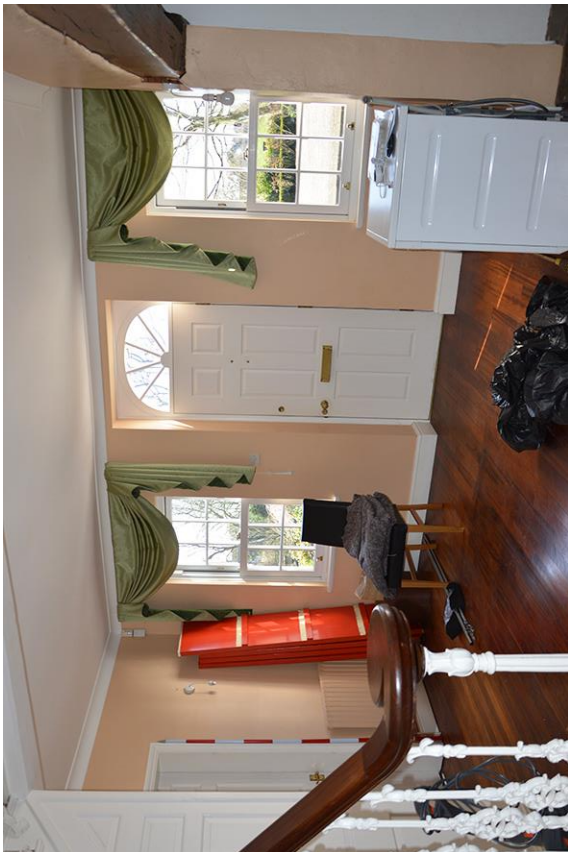
Plate 17 Hall interior from north

Internally, Clattercut House consists of three floors, basement, ground and first floor, and a roofspace. On passing through the front door, you enter a large hall (Plate 17) containing an inglenook fireplace (Plate 18) to the left, open-string staircase, with decorative balusters (Plate 19), leading to the first floor ahead, doorways to right and straight ahead along with an archway to the left. The door ahead opens into the dining room (Plate 20) which French doors into the living room and a door to the kitchen (Plate 21) and breakfast room. The door to the right in the entrance hall, leads to a living room (Plate 22) with a fireplace on the outer wall. There are also cornices at the top of the walls, deep skirting boards and French doors opening into the garden. The archway to the left in the entrance hall, leads towards the kitchen and to a washroom and a study (Plate 23). This has a simple cornice and skirting board with a more decorative chair rail. A door from the kitchen opens into an entrance way into the house.

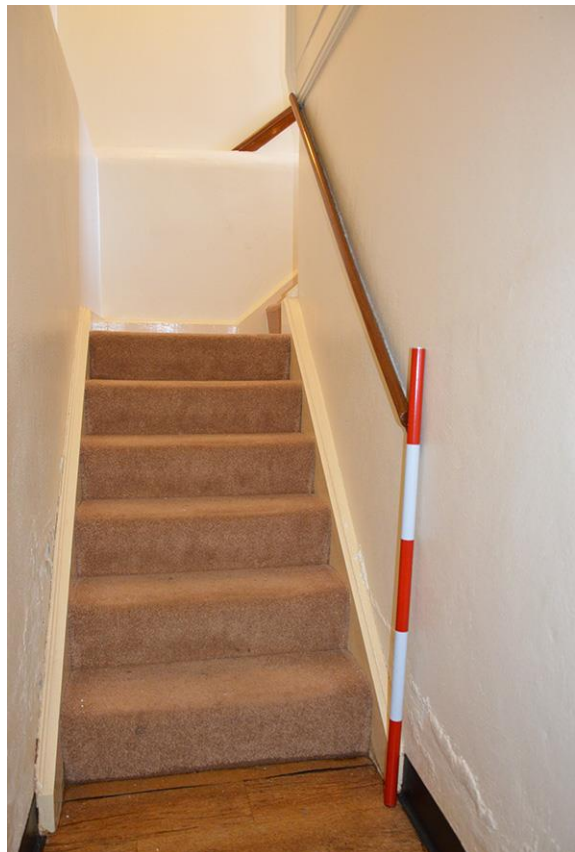
Plate 24 Basement stairs from west

A doorway under the stairs in the entrance hall leads to the basement. It consists of two rooms opening off a stairway (Plate 24). The southern room (Plate 25) is fitted as a utility room with tiled floor, partially tiled walls, sink and work surface. The room also contains the oil-fired boiler. The northern room (Plate 26) has built in cupboards and shelving.

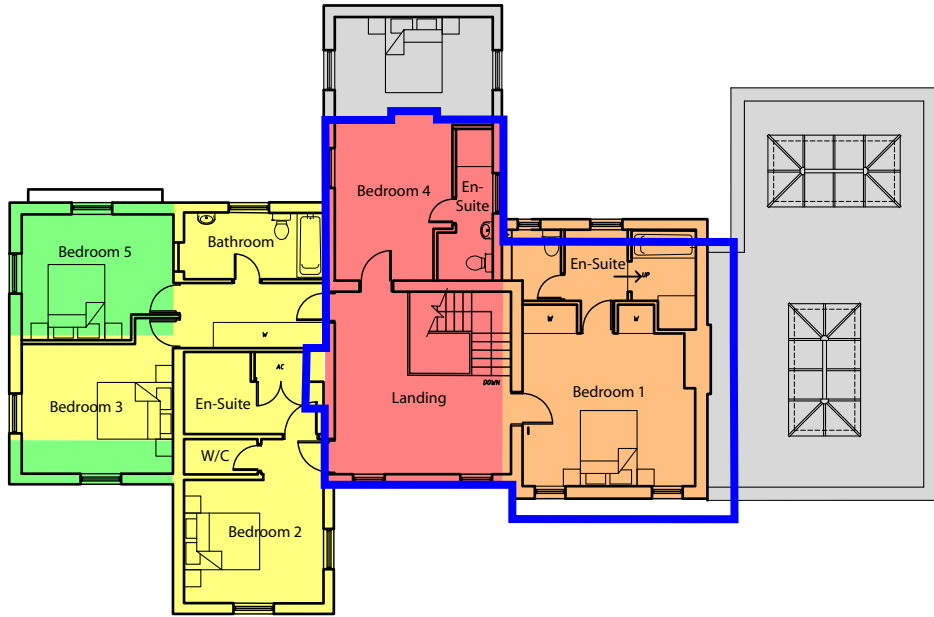
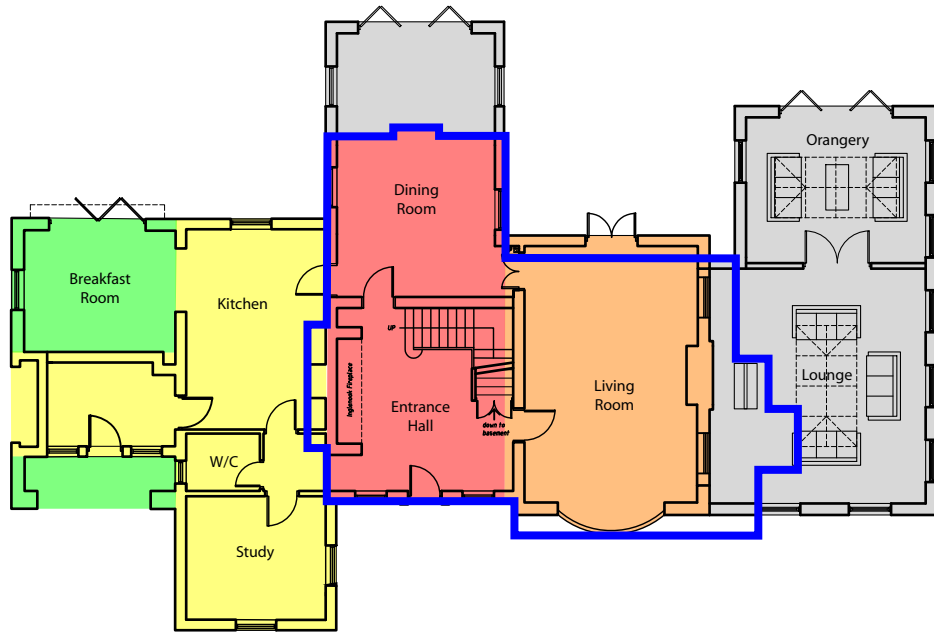
Figure 4 Phased ground plan showing location of original house

- Outline of Original Dwelling
- 2019/20 Foundations laid but walls not constructed
- 17th century
- 1970s to 200s extensions
- 1970s rebuild
- 2010-11 extension

Between the 1970s and around 2010 a number of extensions were added to the western side of Clattercut House (Figure 4). These consisted of the rooms shown as the kitchen (Plate 21) and study (Plate 23) on the ground floor with bedrooms 2 (Plate 21), an ensuite and a bathroom on the first floor. The roofs (Plate 47) of the new extensions were constructed in a similar style as that of the 1970s rebuild.

Foundations of new extensions were excavated in 2019 (Fig 4), although no walls for these have been built. These extensions would add a new lounge and orangery to the eastern side of the and extend the current dining room and bedroom 4 to the north.

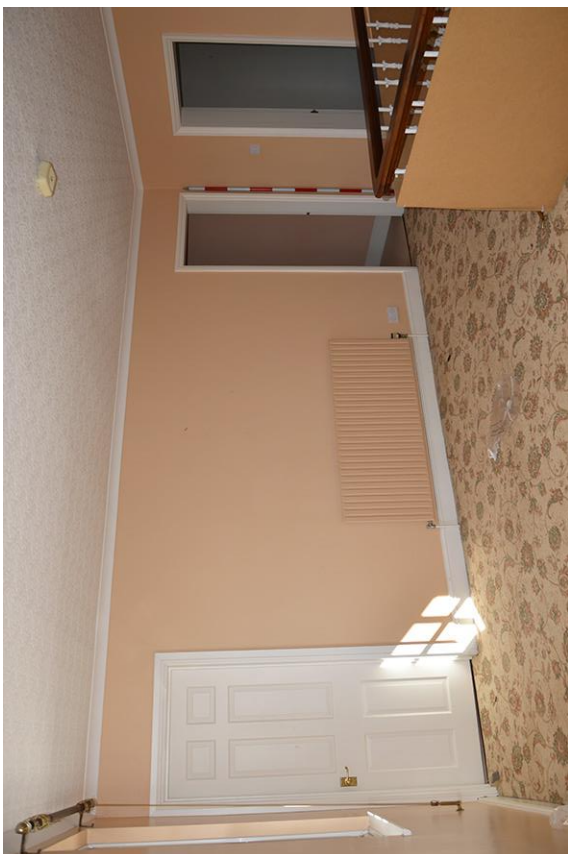
Plate 27 First floor landing from south east

At the top of the stairs on the first floor is a large landing (Plate 27) with four doors leading off it. The landing has a simple coved cornice and skirting board with a decorative ceiling rose (Plate 28). Bedroom 4 (Plate 29), through the door to the north, has a simple, small, skirting board and access into the roofspace. It is adjoined by an en-suite bathroom with a toilet, sink and shower cubicle. The large bedroom 1 (Plate 30), to the east off the landing, has fitted wardrobes, coved cornice and beaded skirting boards. There is access to an adjoining en-suite on two levels, with toilet, sinks, bath and shower cubicle. There are a further three bedrooms (Plates 31 to 33) on the first floor. Bedroom 2 has an en-suite and a toilet and there is a separate bathroom for use by bedrooms 3 and 5.

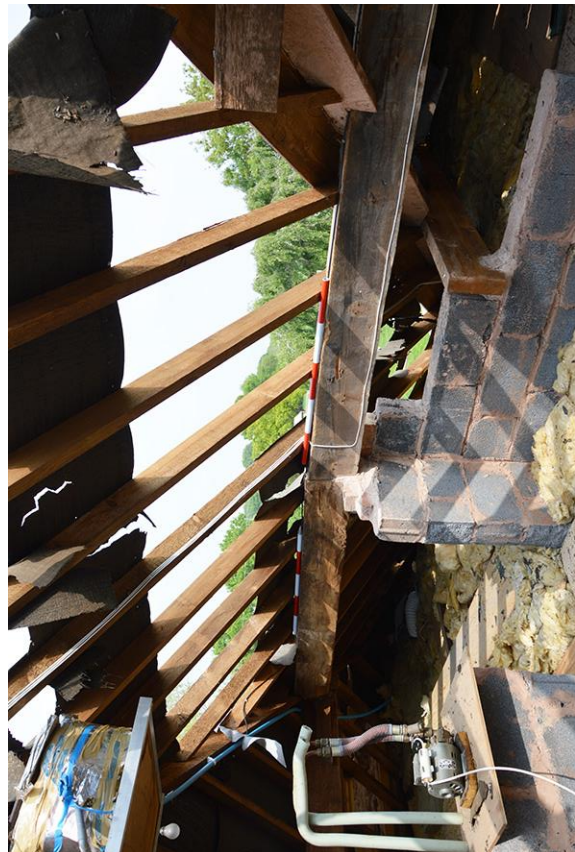
Plate 34 Old purlins in roofspace

The buildings at Clattercut Farm consist of a 17<sup>th</sup> century timber-framed barn, a modern outbuilding and Clattercut House. The mapping evidence shows that the house was in existence in the early 19<sup>th</sup> century and it is likely to be of the same date as the 17<sup>th</sup> century barn. The only surviving part of this early house (Figure 4) is the entrance hall (Plate 17) with inglenook fireplace (Plate 18) and dining room (Plate 20) with the landing (Plate 27) and bedroom 4 (Plate 29) on the first floor (Fig 6). The roof structure has also mainly been replaced with only some of the purlins surviving (Fig 34) from the early building.

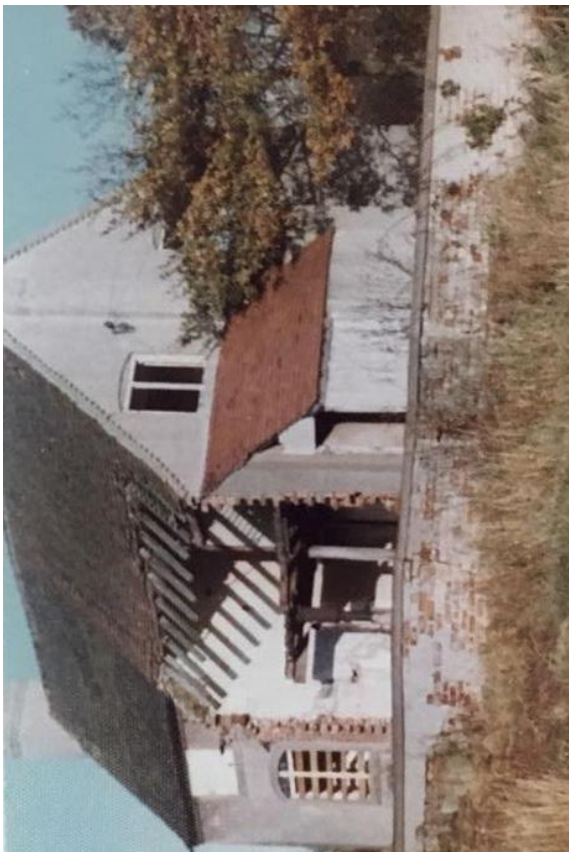
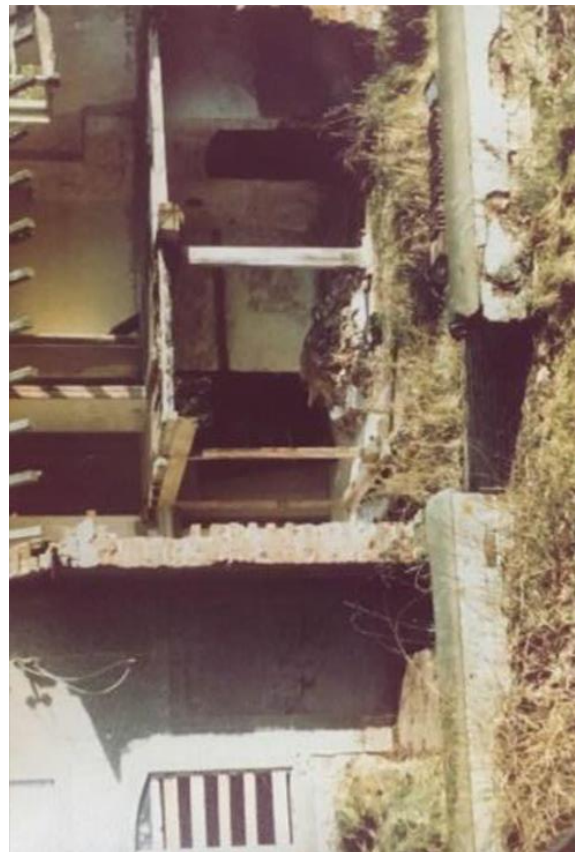
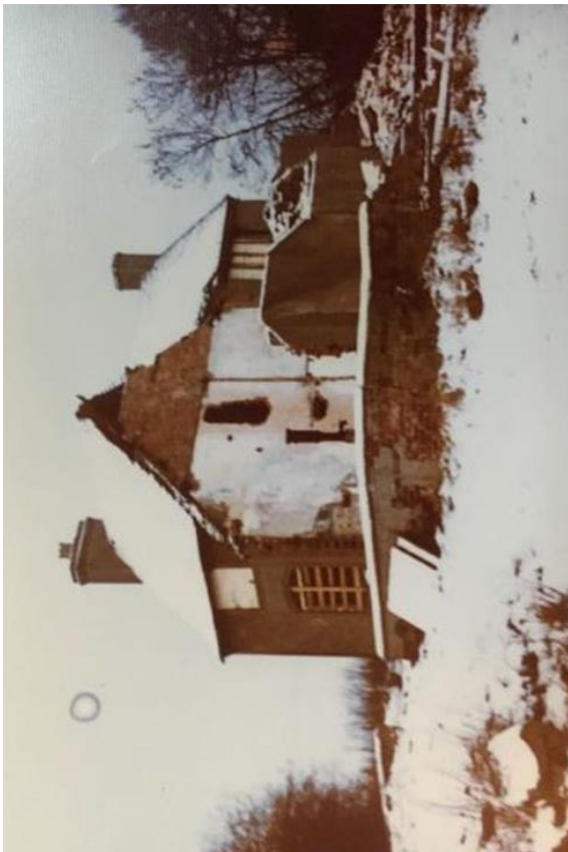
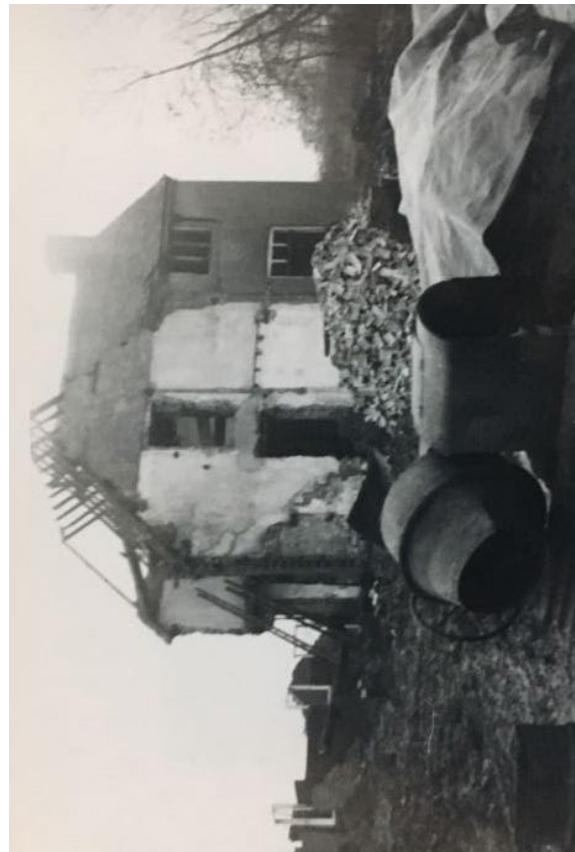
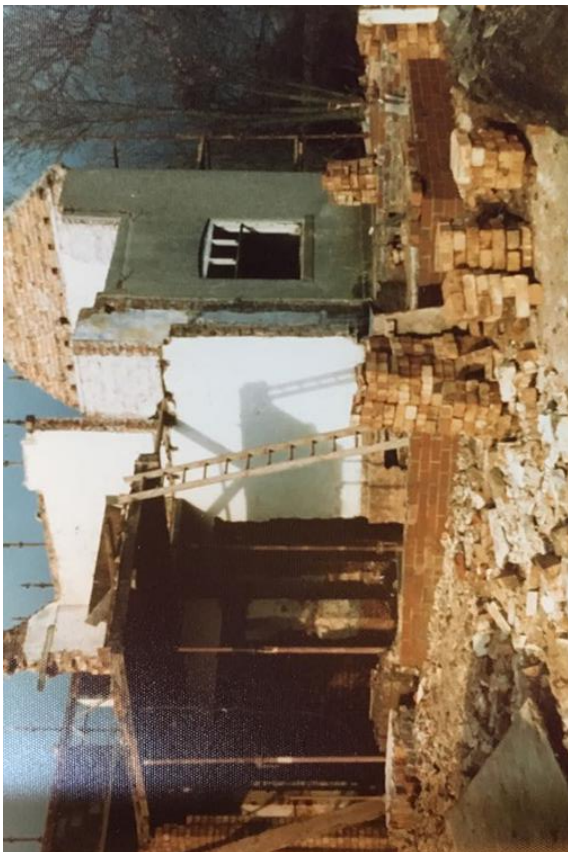
It seems that Clattercut House was vacant for a number of years prior to the early 1970s. During this time the eastern portion of the house became derelict and collapsed resulting in a structurally unsound building (Plates 35 to 39). The house was restored in the early 1970s (Figure 4) with the eastern portion and much of the roof being rebuilt. The former lounge of the house (Plates 35 and 36) was replaced with a new living room (Plate 39; Plate 22) and a bedroom and bathroom on the first floor (Plate 30).

Plate 35 Clattercut House in 1970s from south east

Plate 36 Clattercut House in 1970s from south

Plate 37 Clattercut House in 1970s from south east

Plate 38 Clattercut House in 1970s from west

Plate 39 Clattercut House in 1970s from south east

Another part of this early house had become ruined by the 1970s and had to be demolished (Plates 35 to 39).

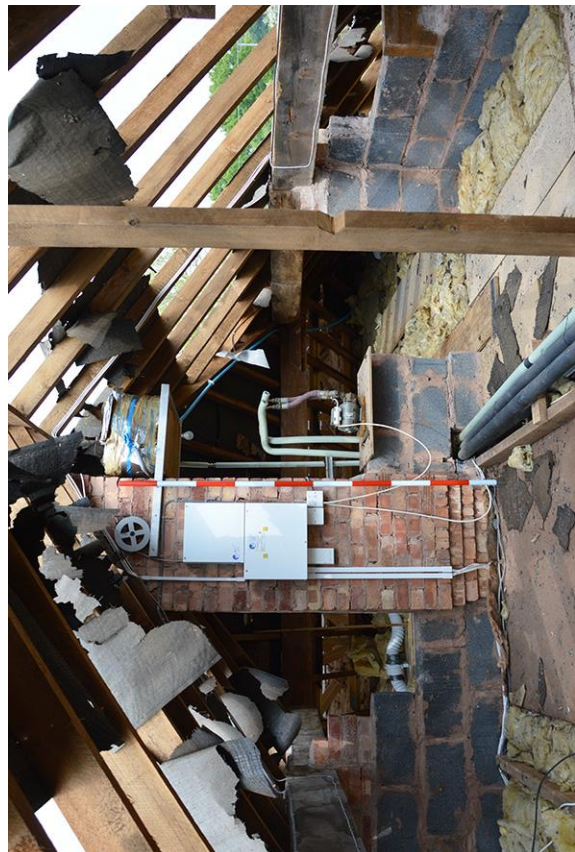
Plate 40 Modern roofstructure

As part of the rebuilding, the roof of the entire building was replaced with a softwood structure (Plate 40) and only a number of the original purlins being re-used (Plates 34 and 41). Some of these timbers had marks (Plates 42 and 43) that indicate they had been shipped from elsewhere, possibly the Baltic. Shipping of timber into Britain from the Baltic began in the 17<sup>th</sup> century and continued into the early 20<sup>th</sup> century and can be identified by the marks they carry. These marks became standardised in the 18<sup>th</sup> century with the shipping ports having their own identifiable symbols.

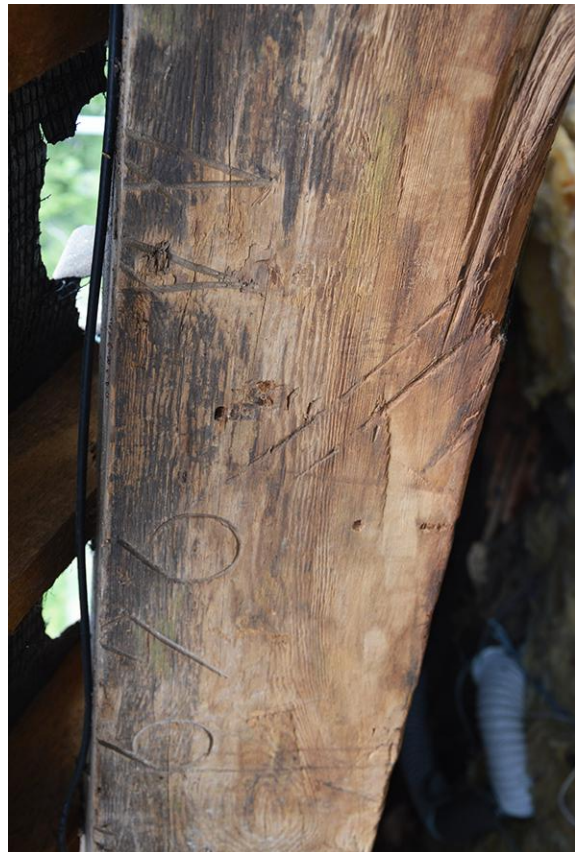
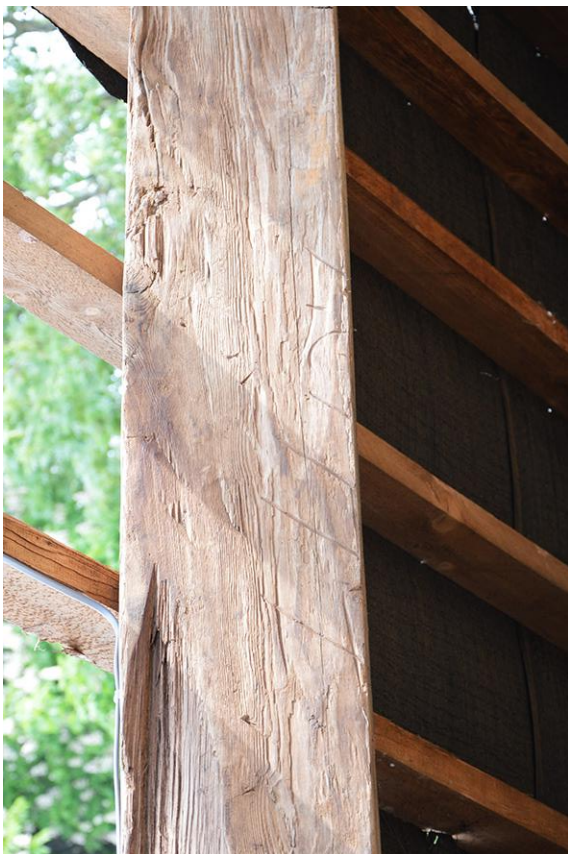
Plate 42 Timber marks on old purlins

Given that the timbers in Clattercut House have none of these marks, it seems probable that they are earlier.

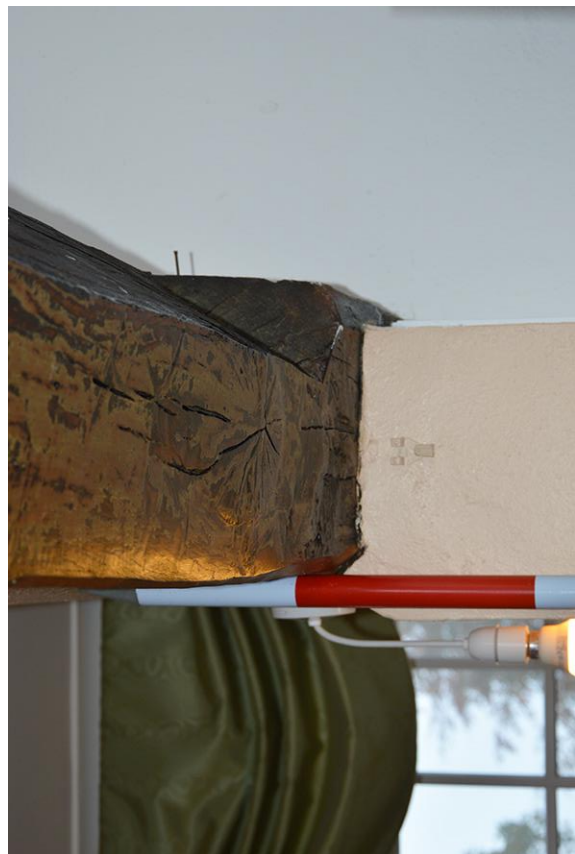
Plate 44 Inglenook bressummer with chamfer on interior

As well as the roof timbers being replaced and the lounge area rebuilt, other alterations were made to the original house in the 1970s. The 17<sup>th</sup> century inglenook (Plate 8) was altered and the bressummer was reversed in the reconstruction. This resulted in the chamfer being on the inside of the fireplace (Plate 44) rather than, as a decorative feature, outside. The rebuild also included adding a staircase (Plate 19). This staircase had, apparently, been salvaged from a house in Worcester and is mid to late 18<sup>th</sup> century in date. It is an open-string winder staircase with cast iron balusters that are highly decorative and attach to the side of the stairs (Plate 45) with a simpler newel post on the curtail step (Plate 46) and a mahogany hand rail.

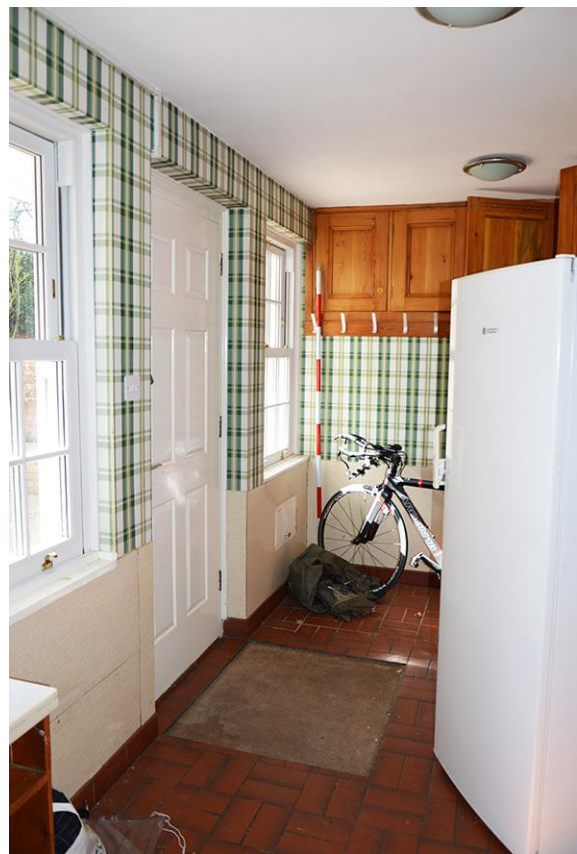
Plate 48 Porch interior from east

By 2010, a porch (Figure 4) had been added against the western side of the house. This porch (Plate 48) had a wide doorway, was flanked by two sash windows and only had a ground floor. The western elevation of the porch had a recessed bin store, as today (Plate 4).

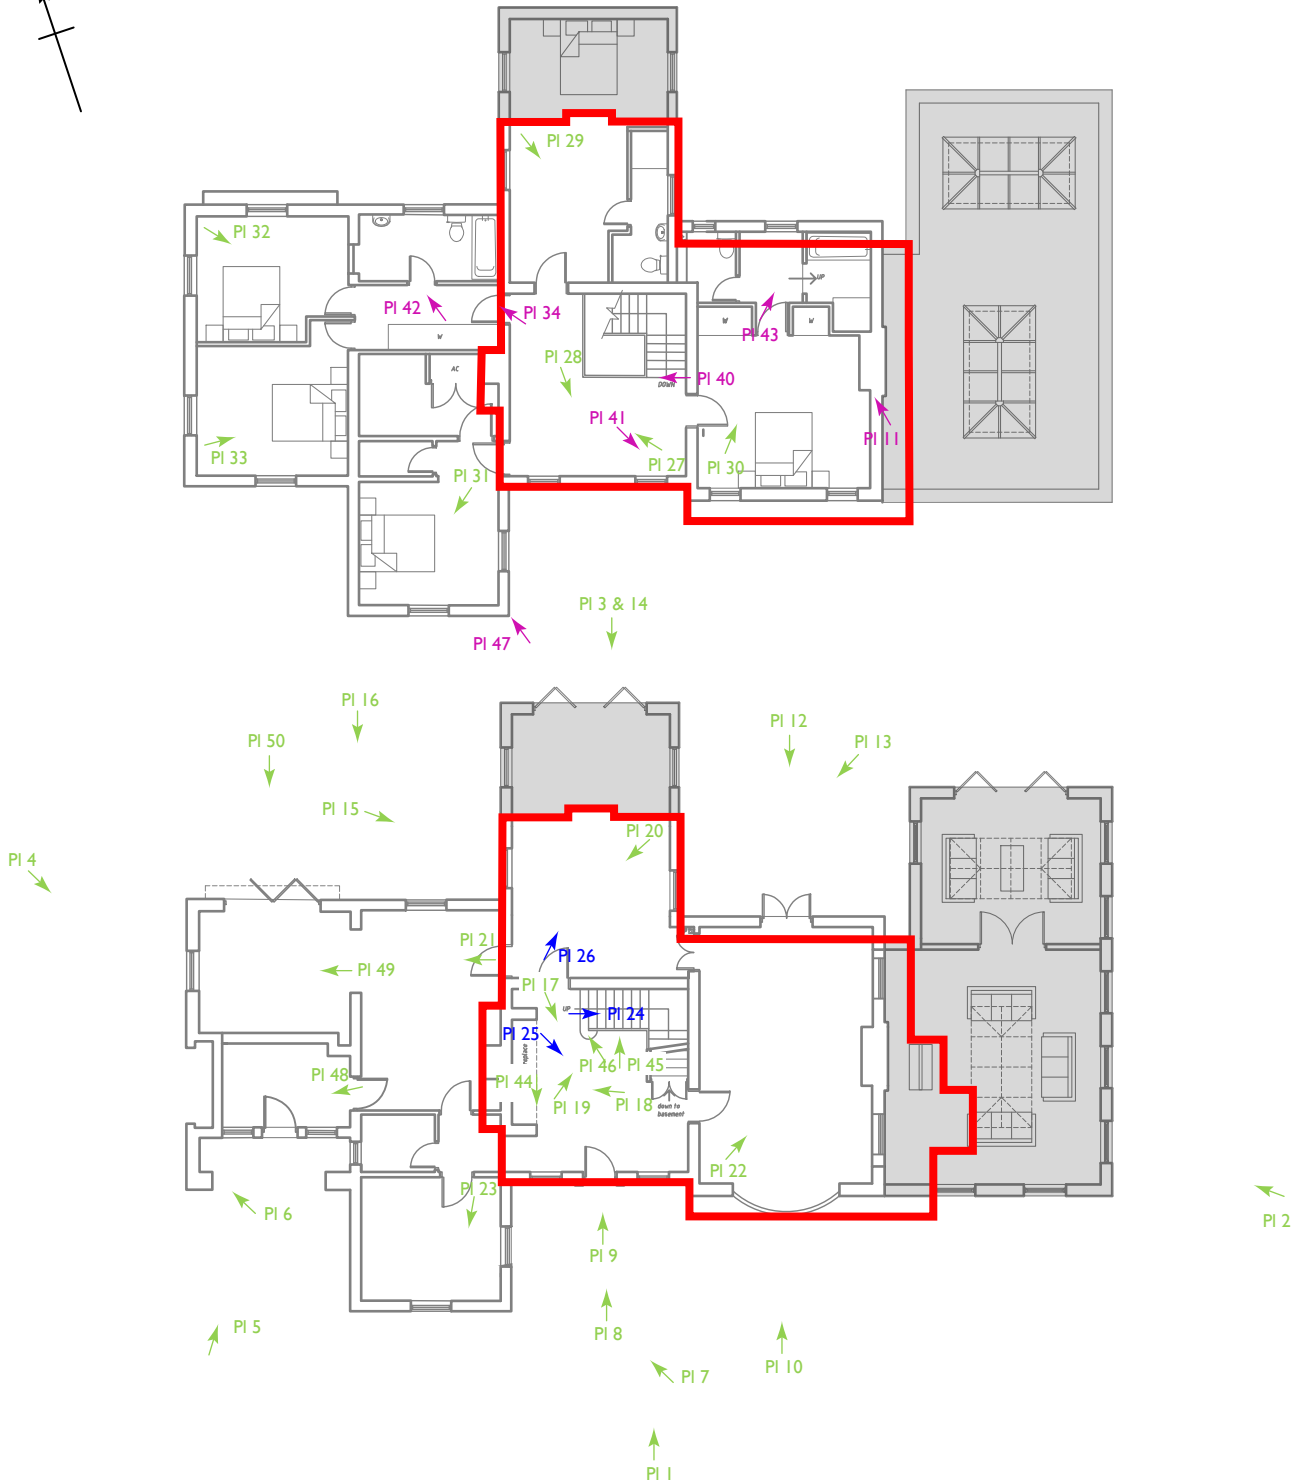
Foundations laid but walls not constructed

Outline of Original Dwelling
